2020-12 LRep
28 October, 2020

Attention
Mr Wayne Spencer
Area Engineer – Northern
Horizons Regional Council

Responses to Whanganui Rivermouth Mole deterioration

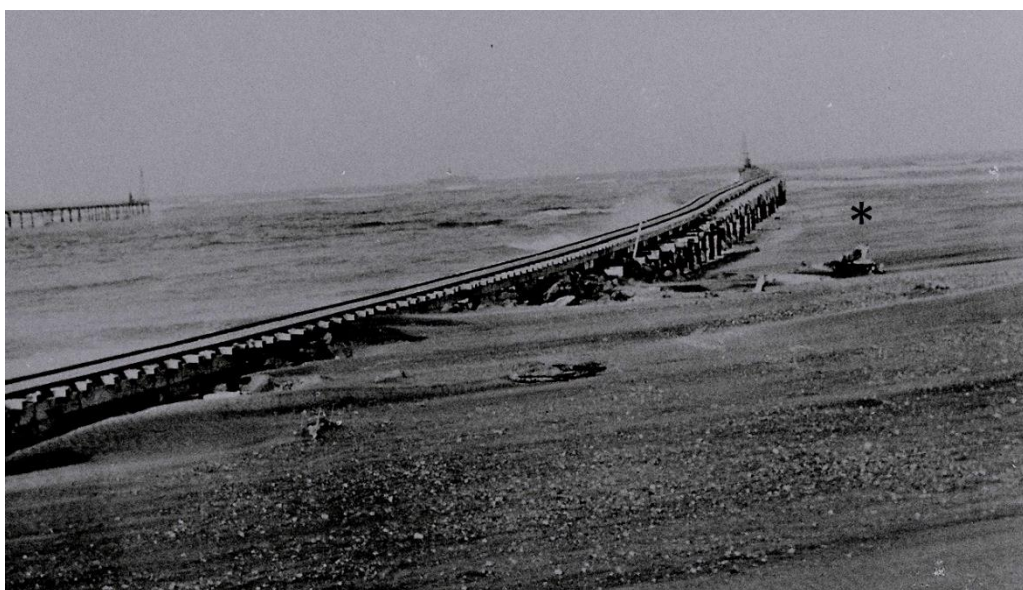
Figure 1 Partially completed moles in the early 1920s raised to high tide level in the foreground and half tide in distance. Sand is washing into the river from the intertidal beach (located by the asterisk) and evidenced by the breaking waves on the river side of the North Mole – this being an indication of lesser depth. At this time the entire South Mole had been only raised to half tide level.

2.2 Waves washing littoral sand into the river resulting in localised shallowing. This occurred along both moles during the 1920s when the superstructure was in place but had only been raised to half tide level (Figure 1). It also occurred on the South Mole adjacent to the beach during the 1950s, a situation occurring again at present. In these cases the structures were raised to at least high tide level or individual voids were infilled.

Mole remnants are likely to persist under both the mole subsidence and mole shortening scenarios. These remnants would create subtidal reefs which may persist for a considerable time. These structures will prevent complete loss of updrift *trapped littoral sand* (on the Castlecliff side) and potentially result in a very wide beach that will dissipate wave energy and provide some shoreline protection thereby limiting shoreline erosion. Figure 1 illustrates how the mole's rock level control the adjacent beach level.

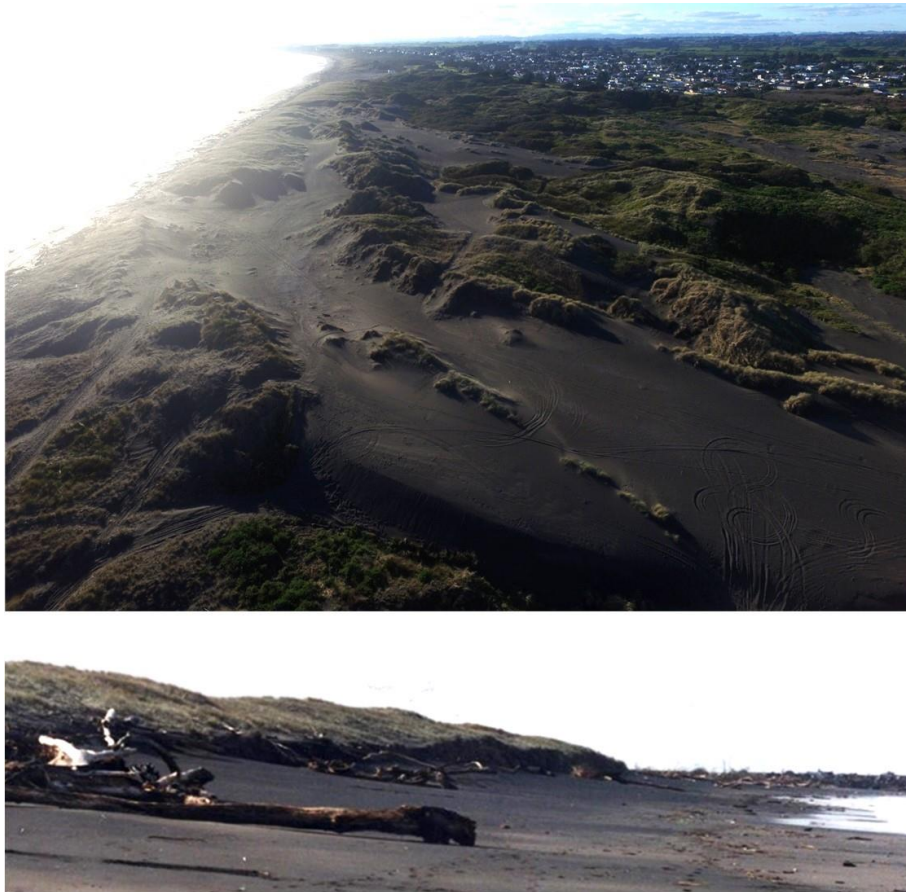
Figure 2 Lower photo: wave cut foredune scarp in 1989. Upper photo: resulting unstable dune field some 30 years later.

3.1.2 The Wanganui coast is subject to episodes of foredune erosion and this process can be expected to increase in frequency and extent under the shoreline retreat that will accompany mole shortening. If the resulting foredune scarp (sand cliff) is at least 2 m high, wind erodes the bare face and sand funnels through topographic lows where guts (blowouts) can form which rapidly increase in size and bury landward vegetation and property. For example, in 1989 storm waves eroded a 300 m length of foredune immediately NW of the rivermouth car park with a scarp some 2 to 3 m high (Figure 2, lower photo). The resulting unstable dune field now has 34,000 m² of bare sand (Figure 2, upper photo).
