Coastal Erosion Hazard Assessment: 4401 Mokau Road, Tongaporutu North Taranaki

A report prepared as part of a resource consent application for
Kate Middleton and Justin Post

By Dr Roger D Shand

COASTAL SYSTEMS Ltd

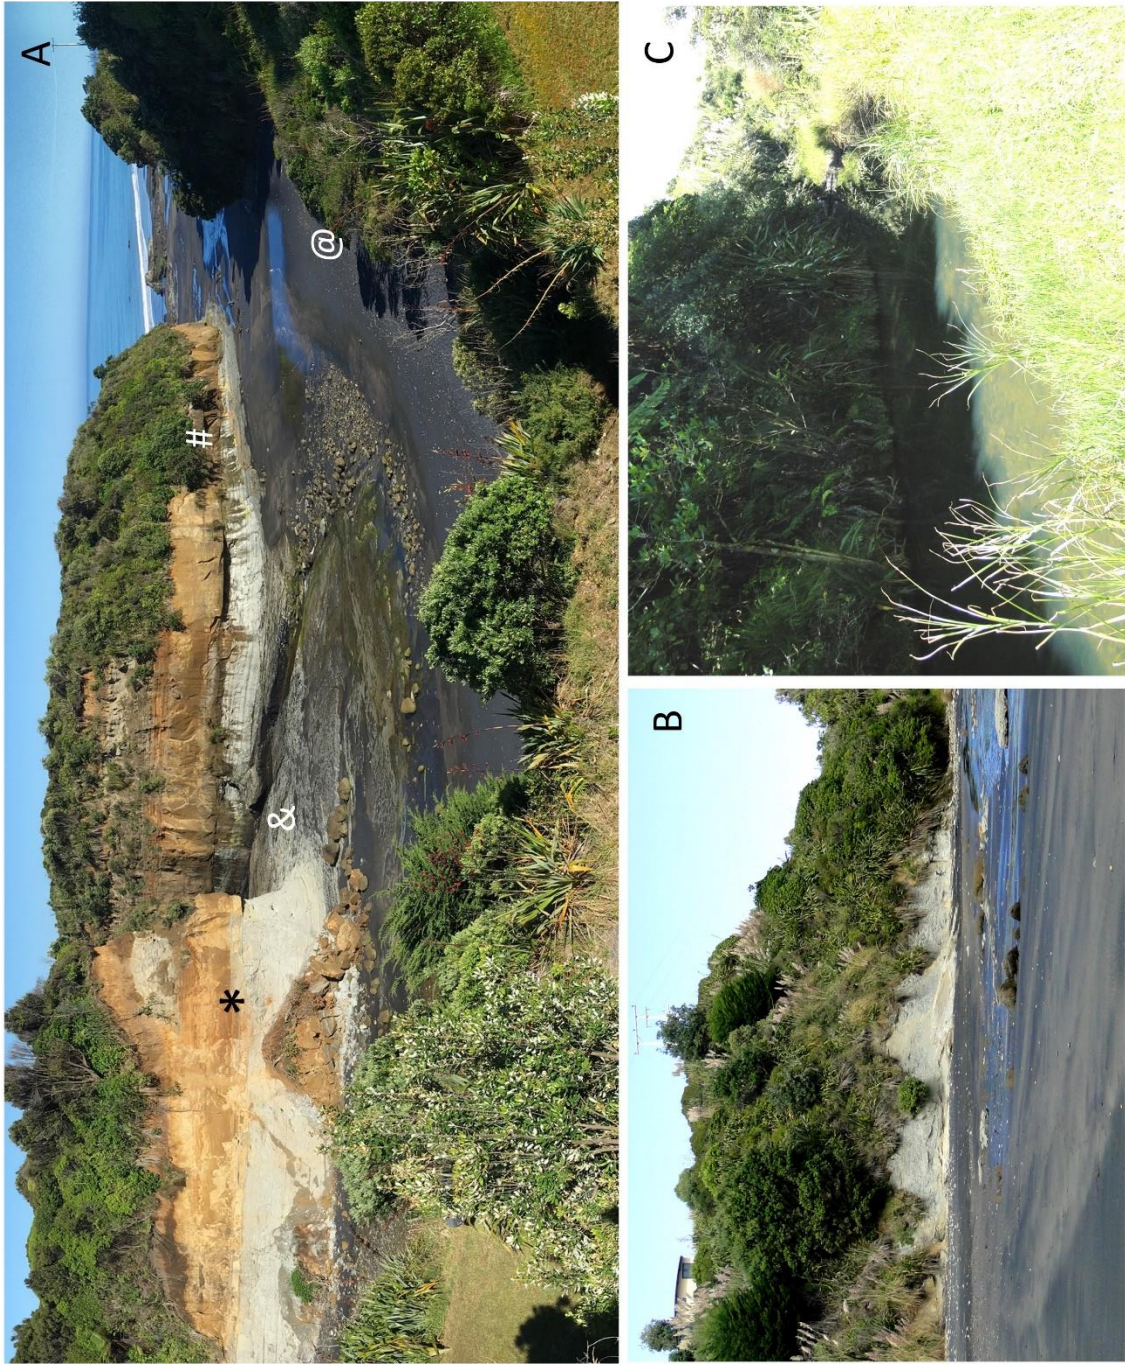
Figure 3 Inlet sub-environments described in the text. Photo orientations are marked in Figure 2. Photo A was supplied by the Client.

The shoreline change rates within the inlet infer variation in wave exposure with highest rates opposite and adjacent to the seaward entrance (@ and * in Figure 3A), although the latter appears to be associated with the upper strata erosion. The lowest values are in the lee of Kawau Pa (# Figure 3A) and in the mud and siltstone cliff fronting the property (Figure 3B). Most wave energy must therefore enter the inlet via the seaward entrance, a conclusion also supported by the exposed mudstone base within the entrance (& in Figure 3A). Further upstream and beyond the effects of wave penetration, the bank fronting the property is entirely vegetated and stable (Figure 3C).

The inlet side walls are steep and rise to about 20 m above the mean high water spring line (MHWS). On the inland side of the inlet the side wall is mostly vegetated which is indicative of relative stability. However, closer to the inlet entrances they become less stable with areas of current/recent slippage evident especially within the upper sandstone strata and cover beds (Figure 3A).

The cliff and its vegetation fronting the property are depicted in Figure 3B. Shoreline change based on the 1964 and 2020 georeferenced photography was found to range between 1.4 and 2.4 m with a central value of 2.0 m. To these (independent) values was

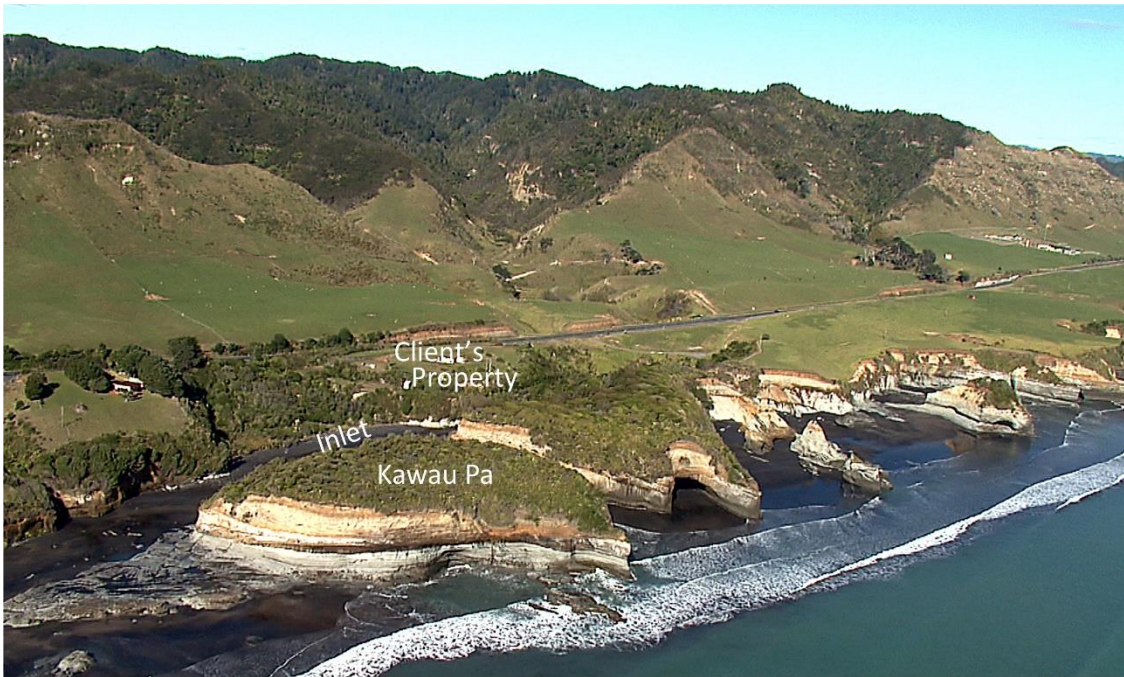
Figure 4 The open coast fronting the Middleton/Post property and the inlet. Caves, stacks and intertidal rock platforms attest to ongoing sequential and cyclic landscape change.

This geomorphology is the result of coastal agents (waves, tides etc) interacting with complex geology that will now be described. The site lies within the Lower Mt Messenger Formation which comprises up to 650 m (thick) of fine to very fine grained sandstone interbedded with mudstone and siltstone that was deposited during the Miocene Epoch some 11 million years ago. Massive and particularly resistant mudstone and overlying sandstone outcrop along the base of the coastal cliffs. The formation is overlain by the younger Upper Mt Messenger Formation and then the Urenui Formation. The cliffs fronting the site have thus undergone greater compaction and theoretically are more resistant than the overlying strata (which outcrop along the coast to the south). However, the site materials are part of the Otukehu group which were mass transported into their current position and consequently are characterised by fractures and faulting; this results in alongshore variation in weathering and wave resistance. Indeed, such faulting and fractures are both evident and inferred in the vicinity of the site by reorientation of bedding planes and the dramatic/nonuniform three-dimensional landforms clearly depicted in Figure 4.

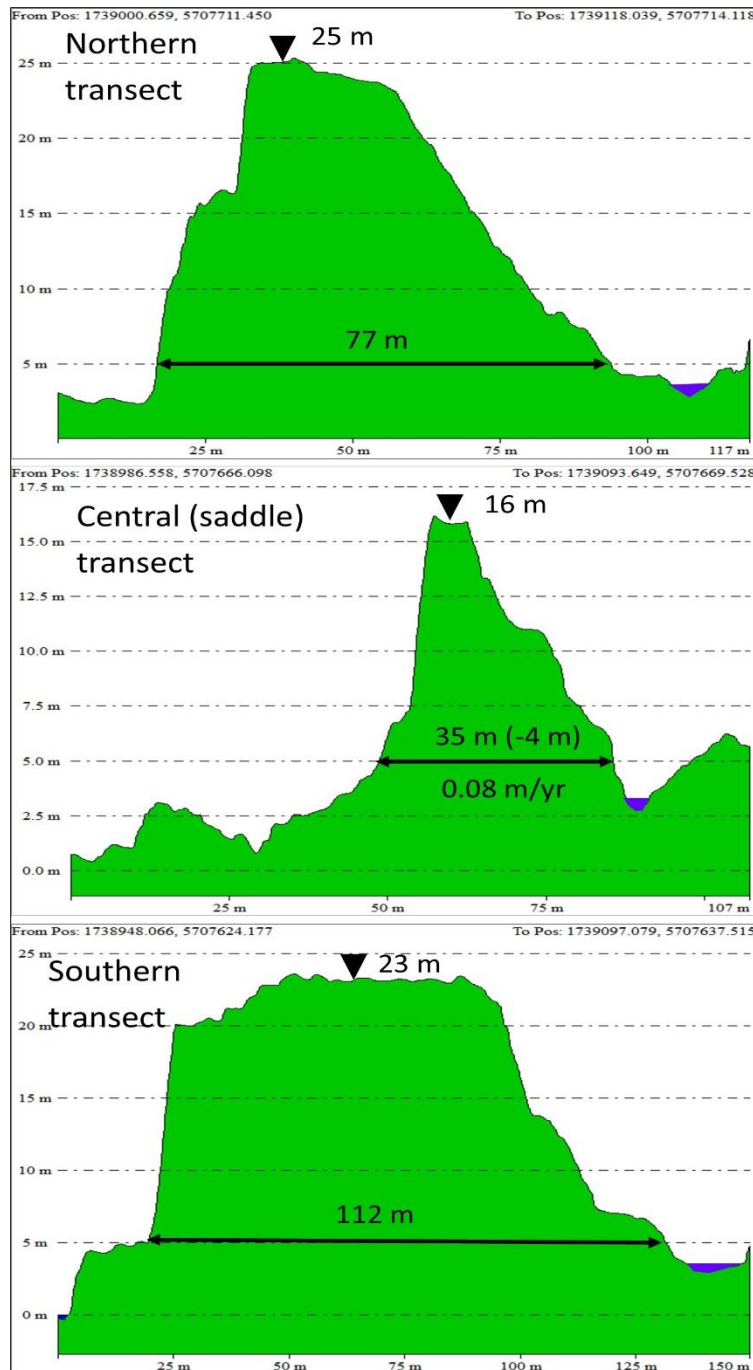
Figure 8 Profiles at transects marked on the 1964 aerial in Figure 7, define the “saddle” (central profile) and illustrate its vulnerability. The profiles are from the 1964 aerial photo DEM obtained as part of this assessment. The open coast is on the left and the Kuwhatahi stream on the right side of each graph. The 5 m elevation width is marked – this being the height when storm wave overwash and beach sand could begin to impact the stream system. The bracketed number in the saddle (central) profile is the erosion between 1964 and 2011-12 and the associated rate of change is also given.

developing. Indeed, the configuration of the stream at this location could be assisting the narrowing which is further illustrated by the series of profiles depicted in Figure 8 (their locations being shown on the 1962 aerial photograph in Figure 7).

Storm-wave overwash can be expected once the saddle elevation lowers to about 5 m (above MSL) as marked in Figure 8. At the current erosion rate (0.08 m/yr) this will take centuries. However, as the headland decay progresses, the nearby enhanced erosion (0.45 m/yr) may transfer to this area and overwash could occur within the planning period.
