Coastal Monitoring Review

A report prepared for the South Taranaki District Council

Reference	2021-9 CRep
Version	1.3 FINAL
Status	For Council
Date	23 June, 2021

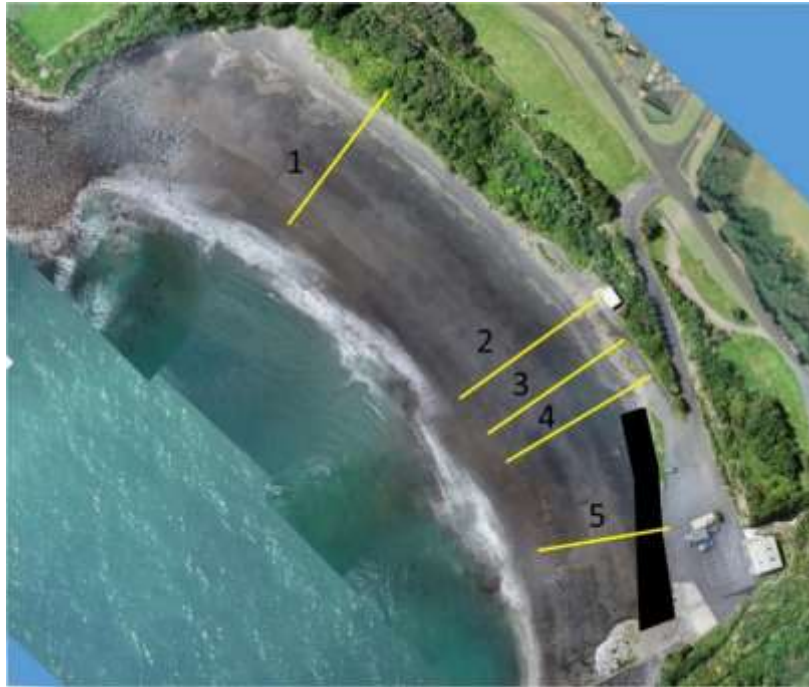
Figure 1 Middleton Bay where transects 1,2 and 5 are used for environmental monitoring and the additional transects 3 and 4 are required to identify any adverse effects from future modification (repair, strengthening) of the revetment structure – the existing structure is shown in black.

At Middleton, two further transects were agreed upon with TRC officers – these to provide more detailed coverage of that area immediately beyond the NW terminus of the rock revetment. It is in this area that shoreline impacts are most likely to eventuate when maintenance/strengthening works are carried out as detailed in the 2019 resource consent reapplication. In the meanwhile these additional profiles provide baseline data. The location of the 5 Middleton transects are shown in Figure 1. This monitoring is already underway to meet special condition 3 in resource consent 5504-2.

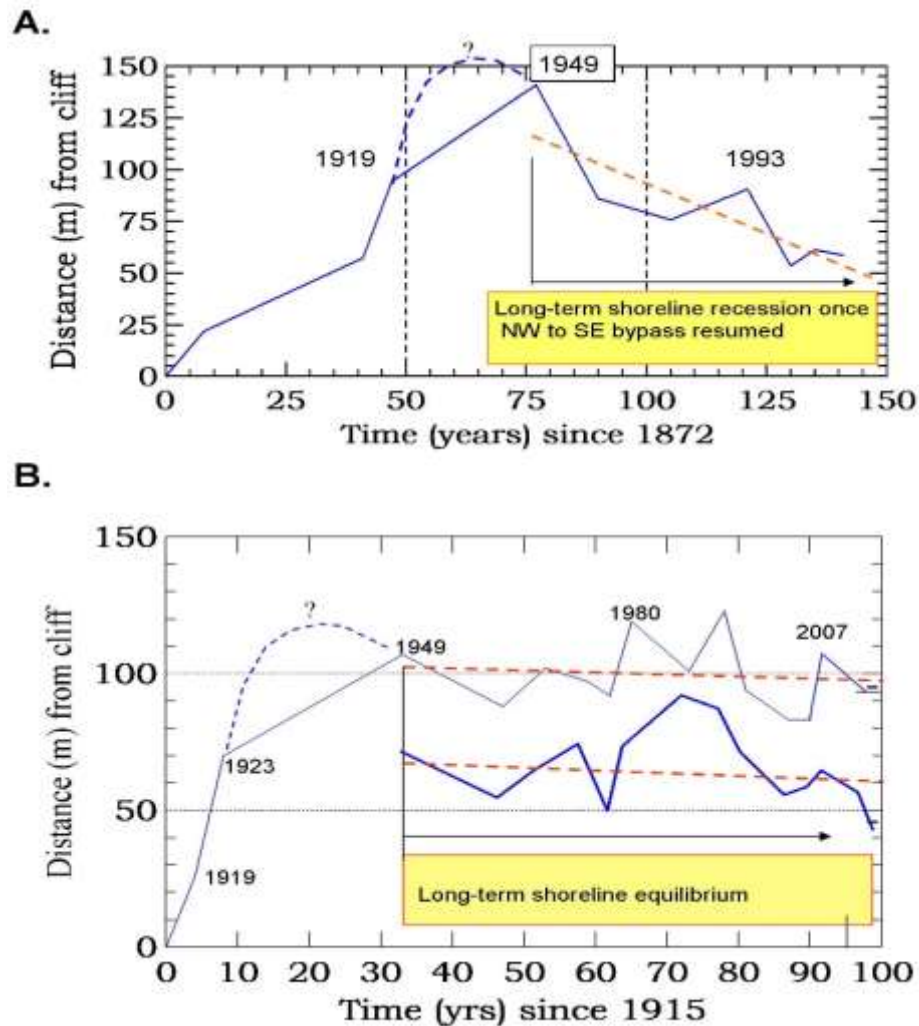
Figure 4 Shoreline responses to the rivermouth moles. Upper graph shows a South Beach transect 100 m SE of the South mole. Lower graph shows North Beach transect 250 m NW of the North Mole (thin line) and the bold line at a transect 700 m to the NW.

a southern orientation a shore-normal alignment (Figure 3). The long-term southern shoreline behaviour contrasted with the northern coastal response with significant erosion occurring after the initial accretional phase (Figure 4, upper graph).

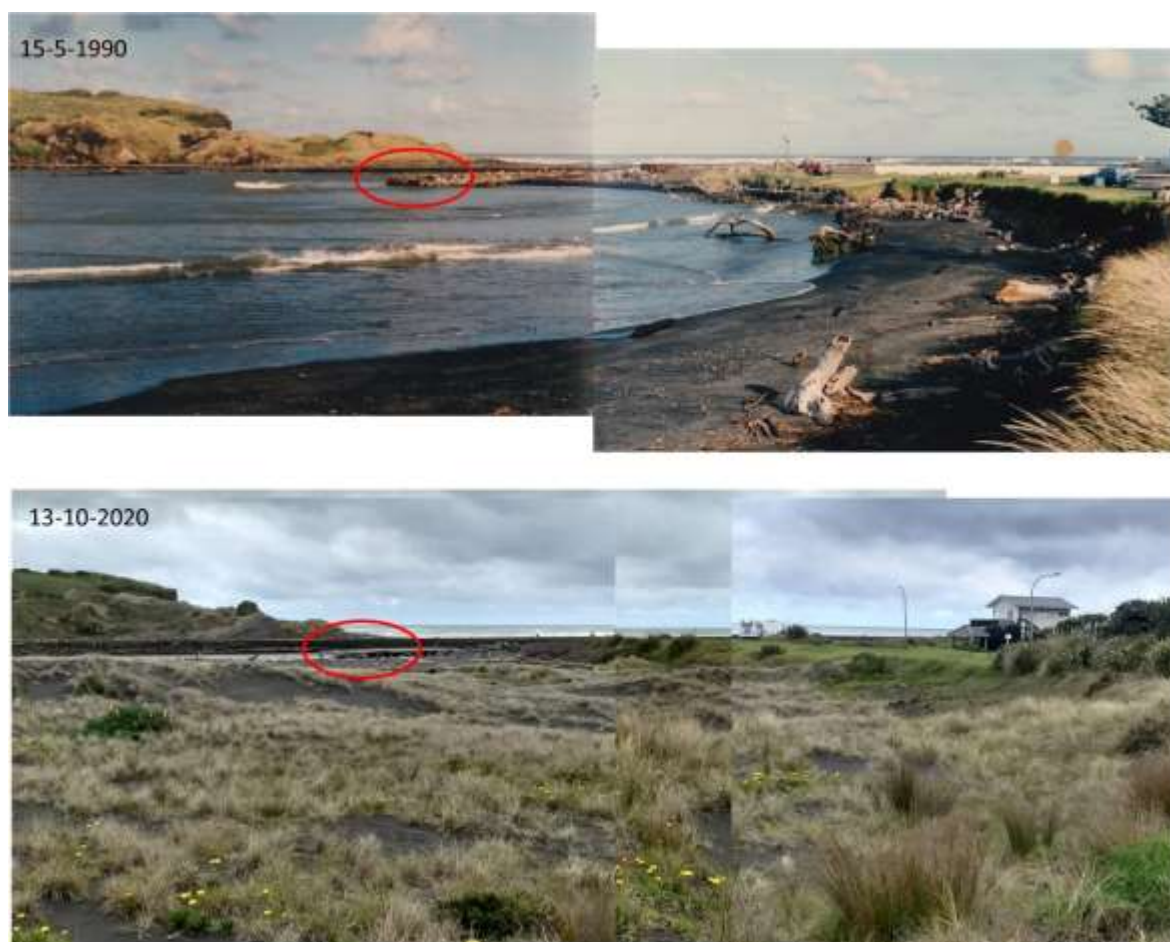
Figure 7 Carlyle Bay in 1990 (upper photo) with water, waves, a sandy beach and backed by an erosion scarp which was subsequently infilled with boulders. By 2020 (lower photo) the bay had filled with sand, dunes and vegetation. Red ellipses mark the upstream end of the wave guide wall. Photos

By the early 2000s, however, it can be seen (Figure 6) that Carlyle Bay morphology had changed considerably with the point bar migrating downstream and the size of the embayment reducing substantially. Furthermore, dunes are now developing on the sand/driftwood infill where there was once a popular and sheltered recreational beach (Figure 7).
