Wave Energy Dynamics And Coastal Erosion
A Case Study On Narrow Neck Bay, Auckland

Auckland University of Technology
School of Science

A dissertation submitted to Auckland University of Technology in
partial fulfilment of the requirements for the degree of Advanced Bachelor of Science
(Honours)

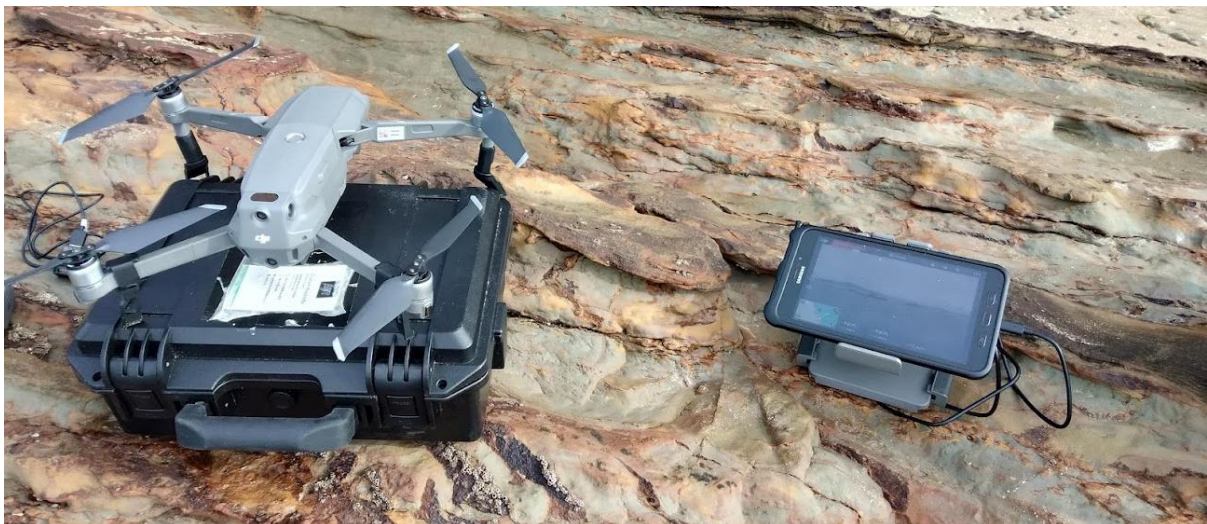
Figure 7: Image of the DJI Mavic 2 Pro UAV and mobile device that was operated on site to collect the FMV data.

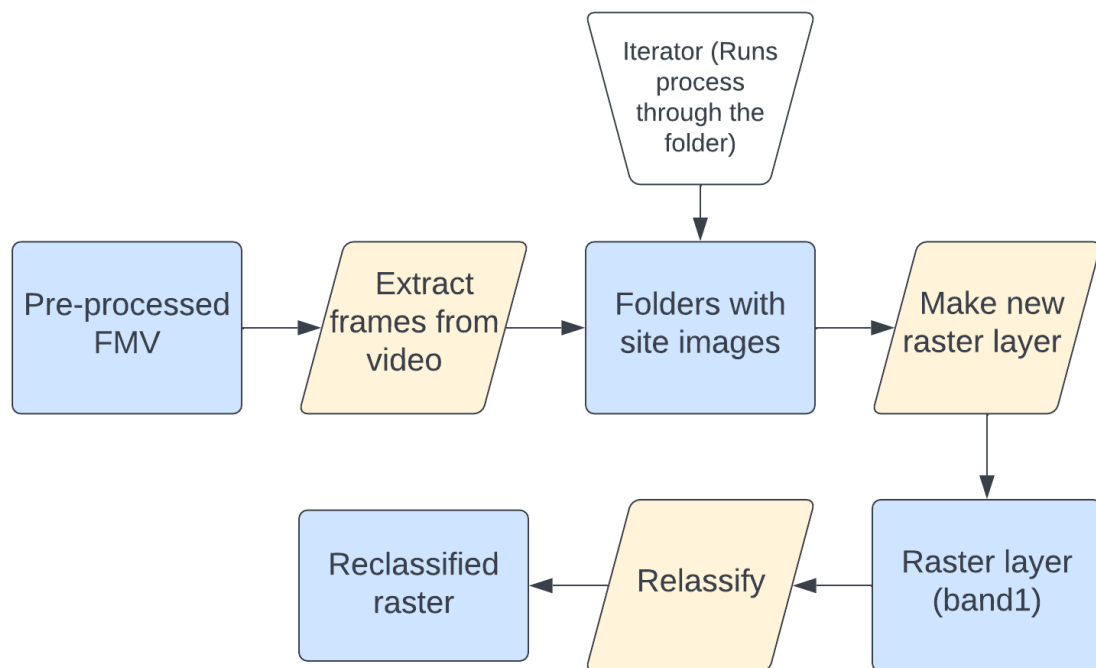
Figure 9: Flowchart of the model used in ArcGIS Pro Model Builder to complete the first section of the GIS analysis. This model extracts images from the FMV and processes the images into raster layers to prepare for the image time stack.

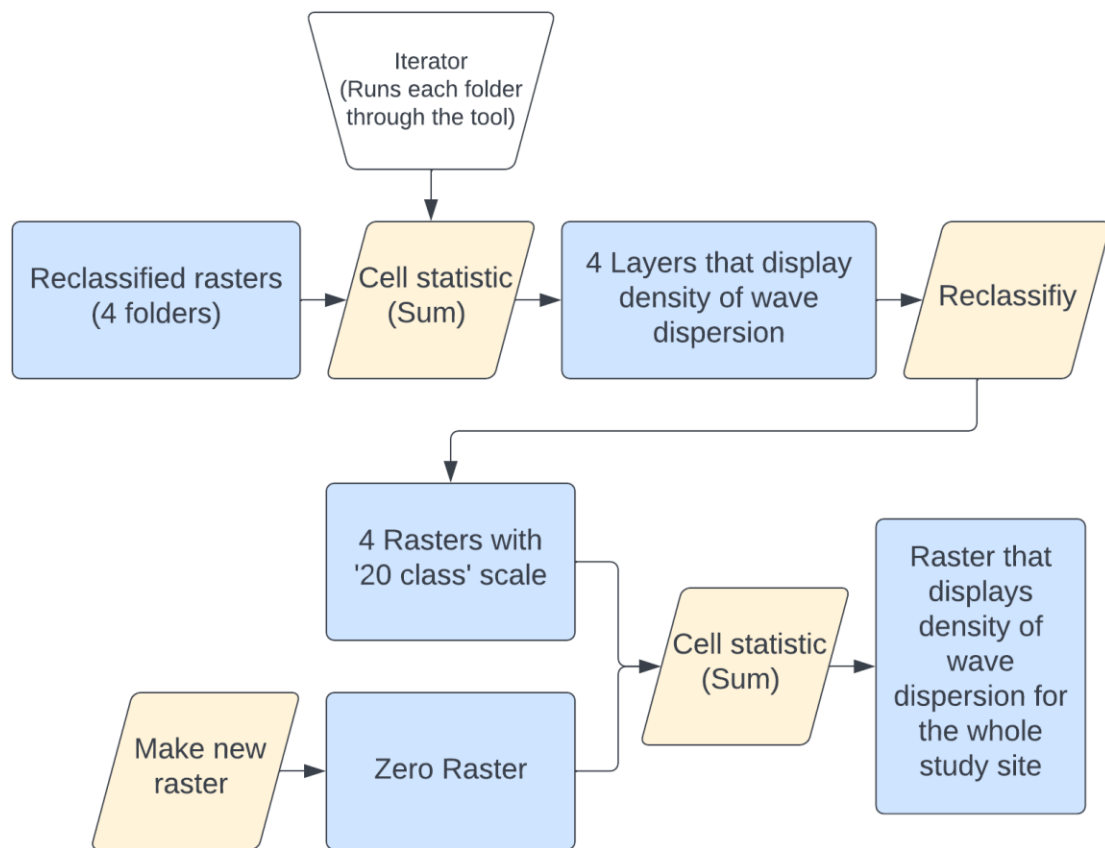
Figure 11: Flowchart of the method used in ArcGIS Pro to complete the second section of the GIS analysis. This section of the analysis creates the image time stack and combines the rasters for the different sites together.

To tidy the data and remove noise, the raster was run through a majority filter to remove any outlying singular cells that have a cell value that do not match its surrounding cells. The layer was then reclassified once more into 6 classes to allow for the data to be clustered by similar cell values. Once the layer was reclassified it was converted into a polygon layer which created polygons around each cluster of cells in the data. The new output still displays the density of wave action that occurs along the study transect; however the area of dissipation that was mapped has been classed into fewer categories making it easier to visually distinguish high, medium and low levels of wave action density.

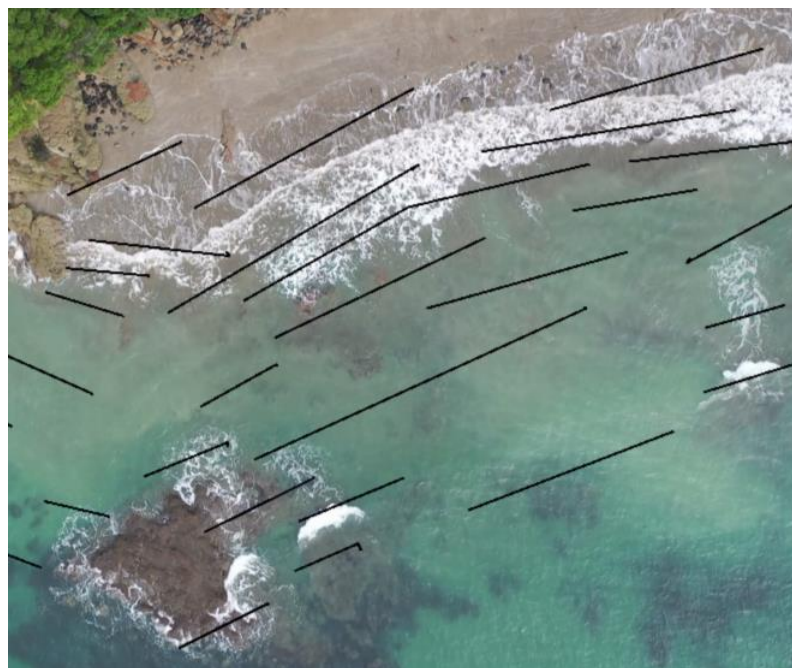
Figure 12: Image of the interim stage in the GIS wave refraction analysis. This is an example of line features being drawn on top of wave crests to track the wave's movement and patterns.

recorder (DVR). The DVR acts as a video player for the FMV data. In the DVR there is the ability to add graphics or annotation layers on top of the FMV. This tool was used to undertake the wave tracking analysis. The 90 degree orthographic angled videos were selected for this analysis and were played via the DVR and paused every 15 seconds. Using the annotation tool, a line feature was drawn on top of significant wave crests that were visible in the paused frame (Figure 12). This process was repeated throughout the duration of the FMV. This method resulted in the tracking of the wave crest and showed how the waves moved and changed as they approached the shore over time. The wave crests were identified and tracked for each of the four individual study sites. The spatial metadata of the FMV pins the video to an exact location which is used as a base to derive the spatial location of the features drawn on top of the video frame. The spatial information attached to the annotation line features enables the features to be mapped. Once these features are mapped, wave direction and angle could be inferred.

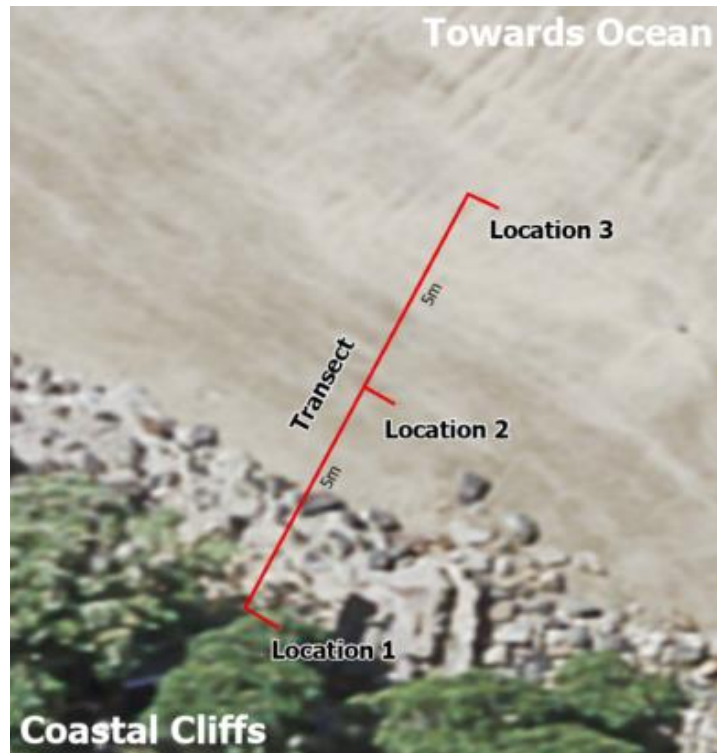
Figure 13: Image of one of the 10 metre transects used to collect the sediment clast size data. Each transect has 3 locations where data was collected.

Sediment clast size was measured at 3 different locations along each of the transects (Figure 13). The first location was at the beginning of the transect, located at the foot of the coastal cliffs. The second was 5 metres down the transect line and the third was a further 5 metres away, located at the end of the transect, towards the ocean. The sediment clast size was measured using a 1 metre by 1 metre square wooden frame and a measuring tape (Figure 14). The frame was placed on the ground at each transect location and the sediment clasts that lay within the frame were measured. Rock clasts are not symmetrical and can have irregular shapes and therefore it was decided that the largest width of each rock clast will be the measurement recorded.

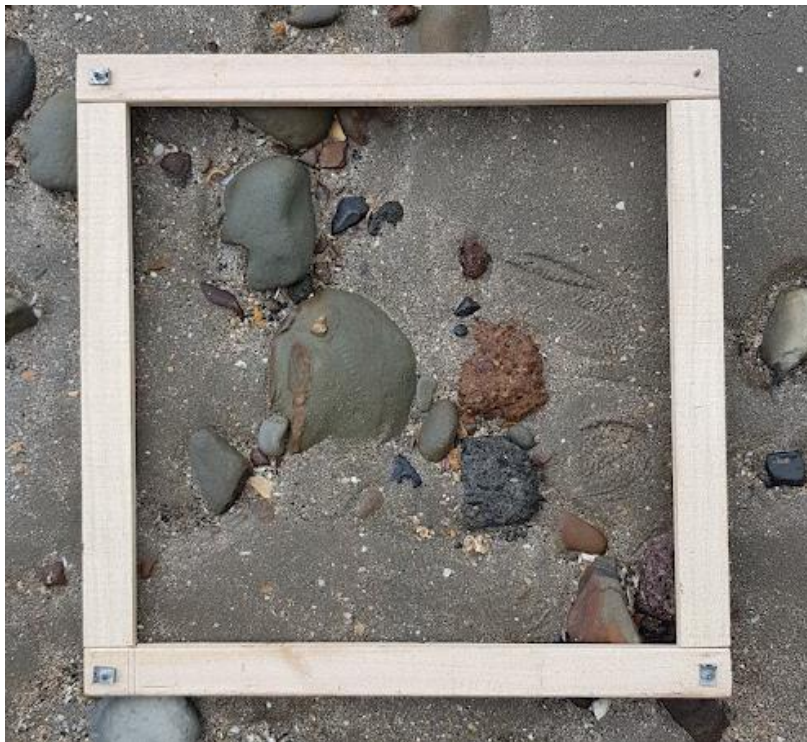
Figure 14: Image of the 1 metre by 1 metre square wooden frame that was used to select which rocks were measured for the sediment clast size analysis

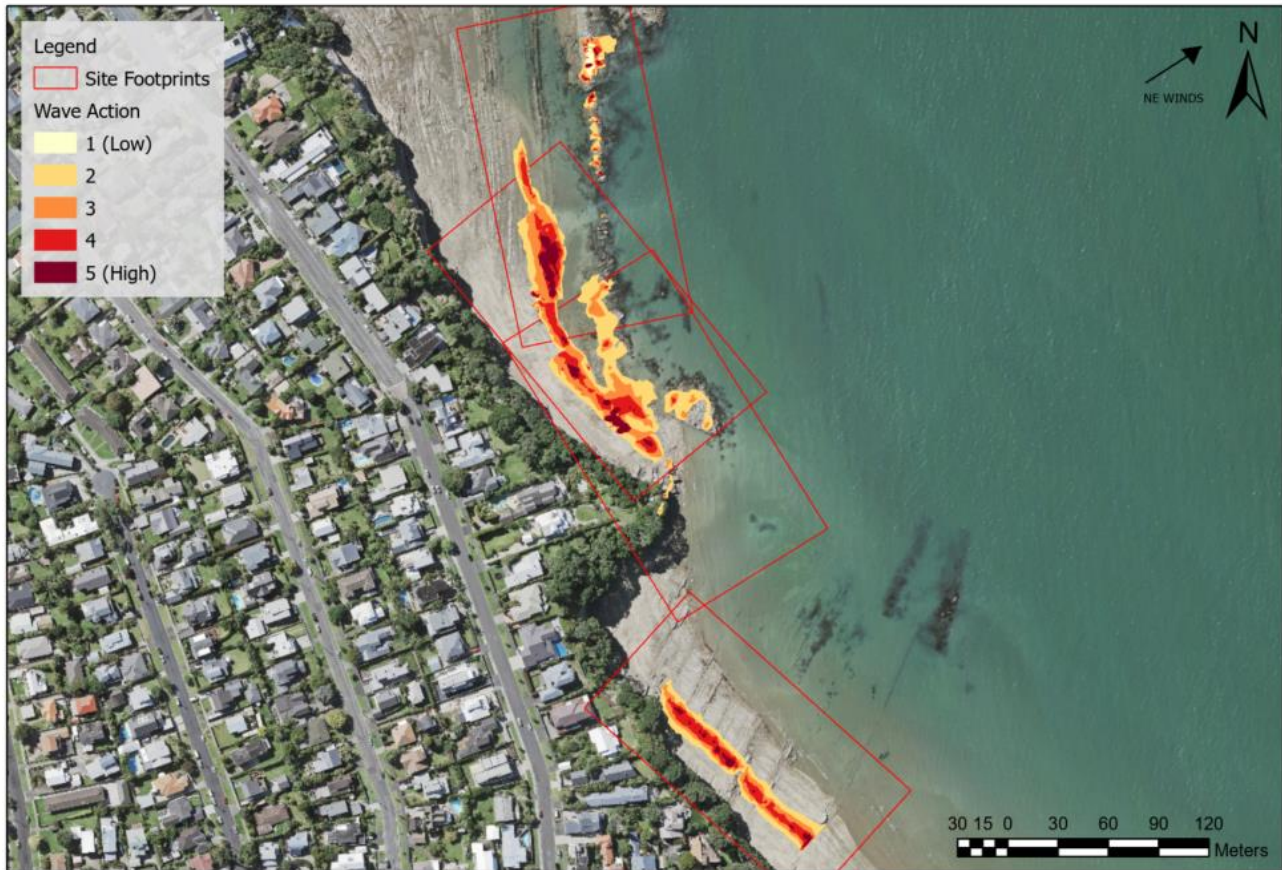
Wave energy distribution at Narrowneck Auckland NZ

Figure 16: Vector results from the Image time stack - wave energy analysis taken at the study location (Narrow Neck). Map displays the spatial distribution of wave energy dispersion along the coastline as well as the occurrence of the wave action (Low to High scale of wave action).

The variation seen between the headland area and the rest of the shore in figure 16 & 17 is that the headland receives a smaller frequency of wave action as well as having a much smaller and concentrated dispersion zone. This observation is due to multiple factors. Firstly, it was found in the geological survey that was undertaken, that the headland cliffs are surrounded by a large marine platform at the base (Figure 21). This marine platform would act as a barrier to the cliffs and prevent waves from travelling further inwards (Hahn, 1994). The obstruction the marine platform poses to further wave movement means the waves are subjected to having a small surf zone. The small surf zone means the incoming wave energy is not dissipated over a large area but instead exerted onto one location, this results in the wave energy at the headland being more concentrated which corresponds to Map 2 (Wave Concentration) in figure 17. The marine platform also prevents the wave dynamic of swash and backwash to occur. Since the platform acts as a constraint to wave movement, the waves are not able to travel up the shore as swash. In standard wave environments, when the swash of the waves begin to travel down the shore as backwash, new incoming waves come in at the same time, resulting in constant wave action (Brookes & Green, 2001). The lack of swash and backwash occurring at the headland contributes to why waves are shown to be less frequent in the results. The absence of swash means that the waves dissipate faster than standard wave environments resulting in there being less constant wave action (Munk & Traylor, 1947). This has been captured in the results as the time period that wave action is visible is less and therefore wave action is not captured in all frames extracted from the FMV unlike the areas that experience swash.

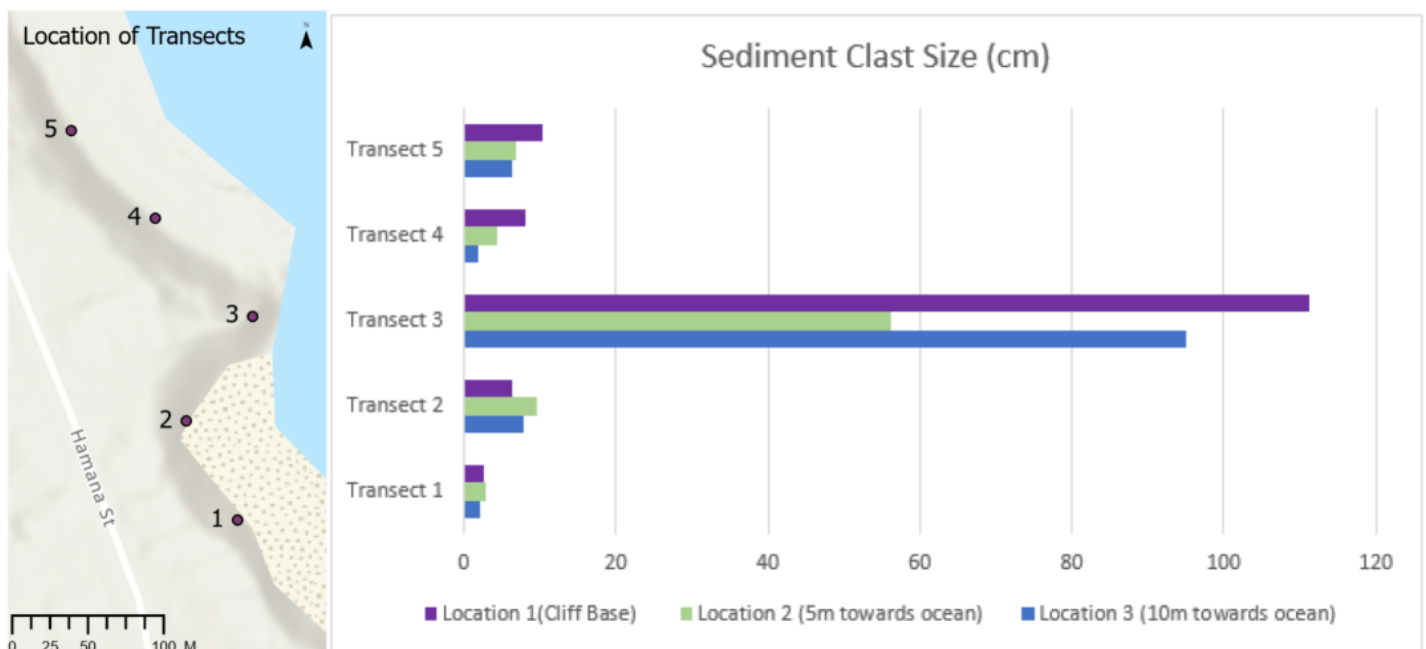
The Sediment Clast size analysis shows how the size of rock fragments vary along the coastline (Figure 23). Through the relationship between sediment size and erosion, the amount of active erosion that is occurring along the coast can be inferred. Large rock clasts indicate that active erosion is occurring as the cliff/substrate is actively being broken down into smaller fragments. Small rocks also represent erosion however at a greater rate as the rocks fragments have been ground down and deposited. In the bar graph it can be seen that most transects appear to have an average clast size of around 10cm however transect 3 had much larger rocks present. Transect 3 is located at the headland and was surrounded by larger boulders whereas the other sites were straight sections of cliff and did not have any rock clasts of significant size. It can also be noted that in general the samples collected at Location 1 (Cliff base) tended to have a larger average size than the other locations.

Figure 23: Bar graph of the Sediment Clast size measured along the coast of Narrow Neck.

This differential erosion has been made evident in the sediment clast size analysis (Figure 23). In the results of this analysis it can be seen that transect 3 that is located at the headland, had the greatest clast size measured whereas the transects along the North and South sections of the coast had much smaller sized clasts. The larger rock clasts indicate that the headland is experiencing active erosion as the cliff/substrate is actively being broken down, producing the large boulders surrounding the headland (French & Burningham, 2011). The smaller rock clasts also indicate erosion; however the erosion is more intensive as the rocks fragments

have been ground down into much smaller clasts (French & Burningham, 2011). The difference in clast size also shows how erosion has contributed to coastal development. The smaller clast sizes seen on the North and South sections of the coast is evidence of depositional beaches. Wave action has preferentially eroded the headland and the sediment clasts have been ground down via erosional processes such as abrasion and attrition and deposited on the coast resulting in beach formation adjacent to the headland (French & Burningham, 2011). In figure 18 it can be seen through the patterns of wave refraction, that the sides of the headland receive more targeted energy. Narrow Neck also has a high overall wave action rating along the North and South sections of the coast and a low rating for the Headland (Figure 17, Map 3). This heterogeneity of wave action along the coast coincides with the observation that headlands are eroding preferentially as the areas adjacent to the headland have more wave energy being exerted onto the coast to drive the process of erosion.
