Archaeological Assessment of Proposed Pedestrian Swing Bridge Across the Whangaehu River, Te Araroa Trail

Title: Archaeological Assessment of Proposed Pedestrian Swing Bridge Across the Whangaehu River, Te Araroa Trail

Reference: iSA24_005

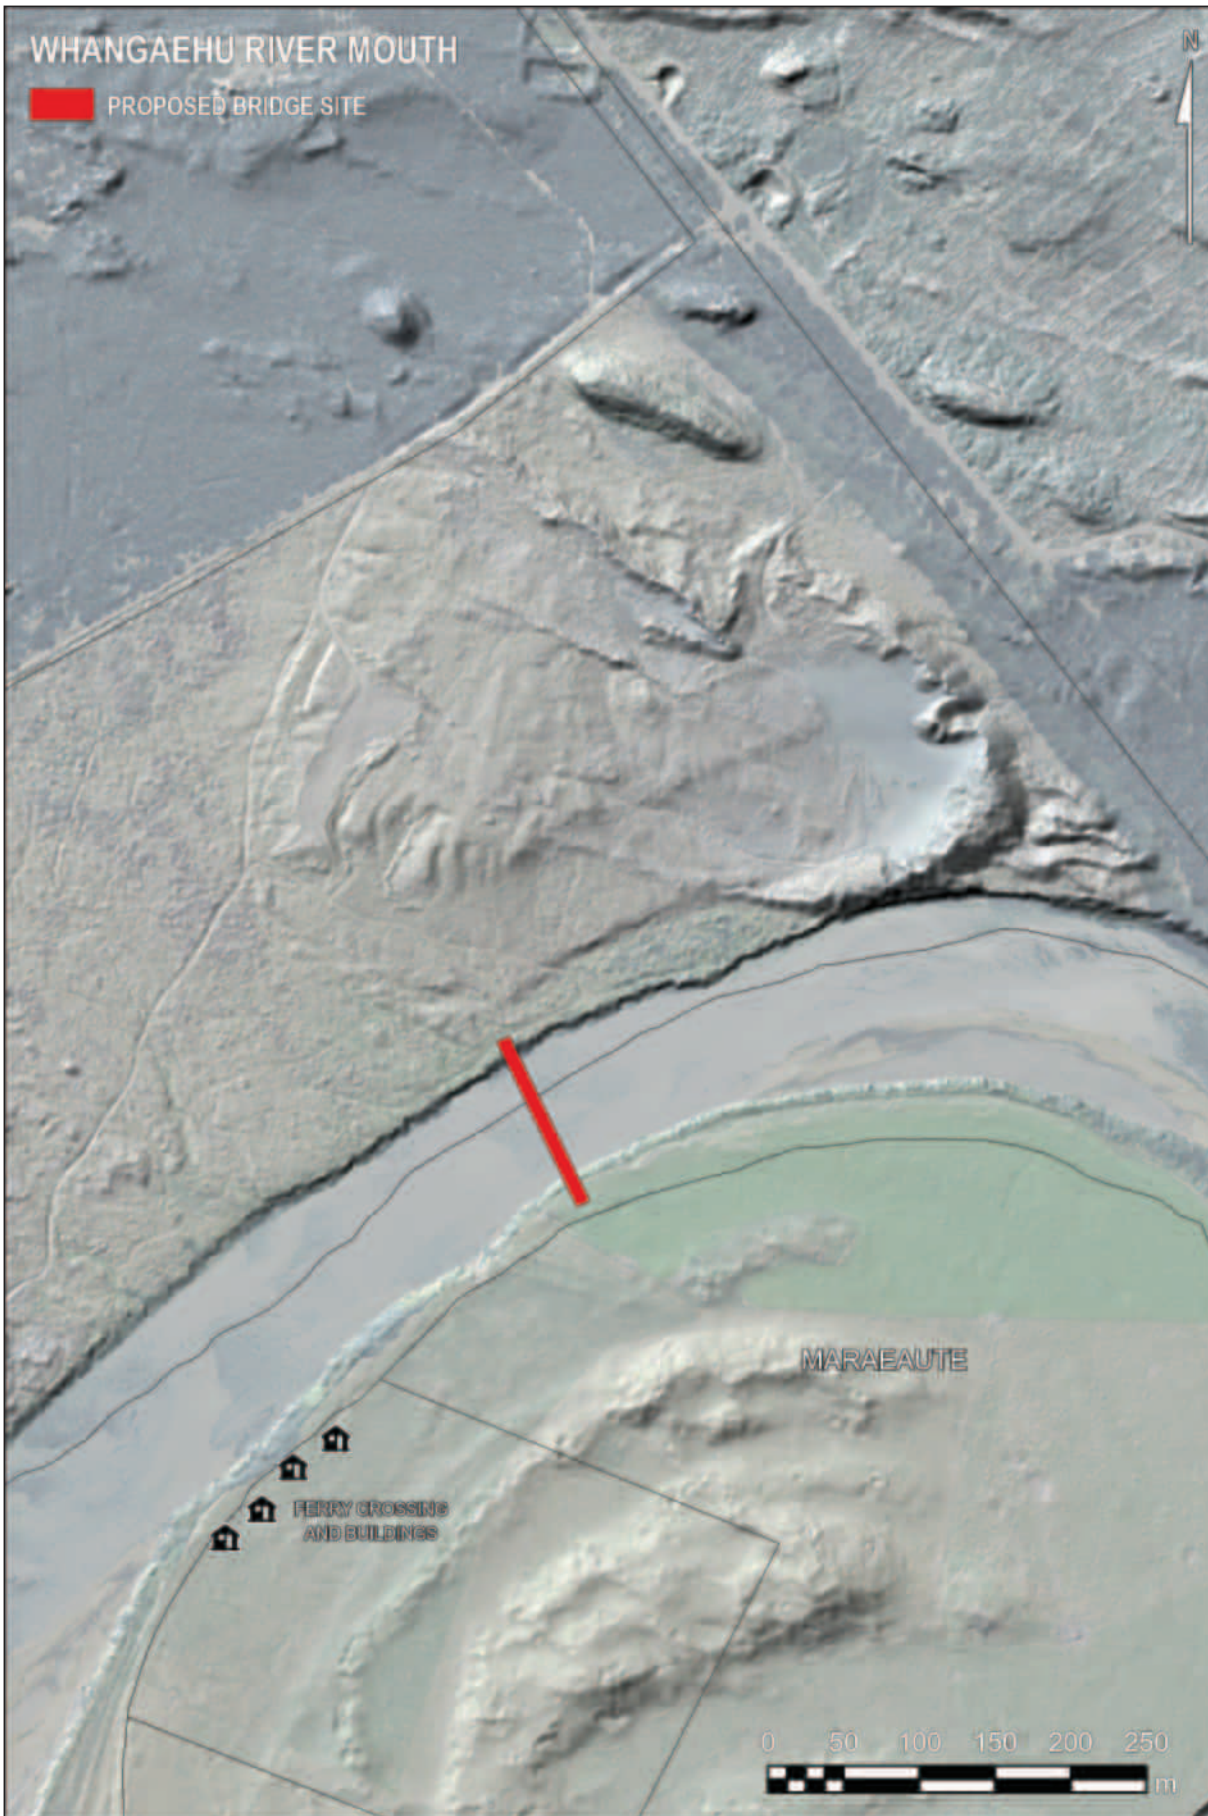
Figure 3: Detail of proposed pedestrian swing bridge location, showing differences in the stable (true left bank) and unconsolidated (true right bank) dune topography, historic place names and structures.

The historic survey plan ML 3148 indicates the NZAA recorded archaeological sites on the left bank are associated with the historic name, Maraeaute (Figure 3). The ‘aute’ of Maraeaute is a likely reference to paper mulberry, *Broussonetia papyrifera*, a cultivated tree of which the bark was used to make cloth: an historic import from island Polynesia but which is no longer found in New Zealand. Witnesses stated to the Māori Land Court, during the partition hearing for the Rakautaua Block, that Maraeaute was a “kumara, potato and taro cultivation, the soil for these cultivations being brought from the river” (Whanganui Minute Book 14: 72). The survey plan also shows a small collection of buildings situated on the left bank at a ferry crossing site, but these are situated 200 m down river of the bridge and will not be affected (Figure 3).

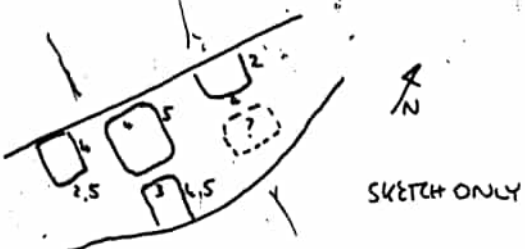
2. State of site and possible future damage Fair .			
3. Description of site (<i>Supply full details, history, local environment, references, sketches, etc. If extra sheets are attached, include a summary here</i>) A very deep pit measuring 5 x 4, three other well defined features and one shallow hollow probably representing a further pit.

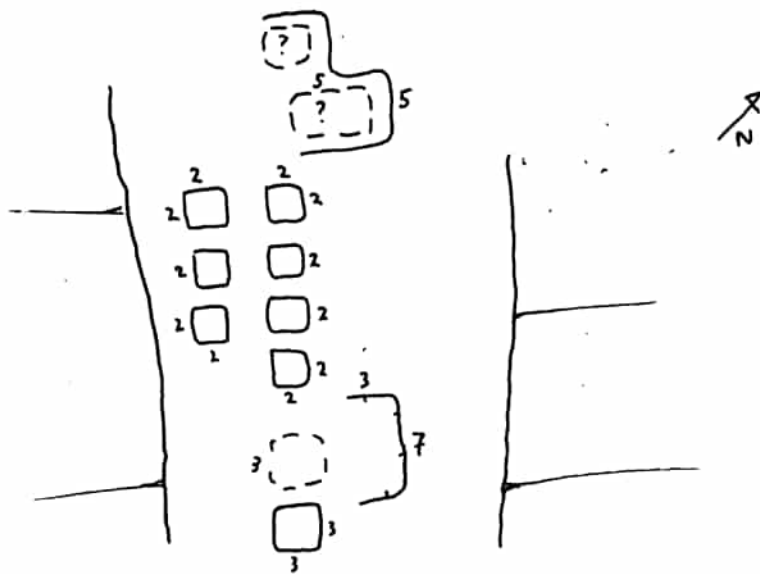
SKETCH PLAN (FN42)

N143/107
PITS
