# Reversal of Human-induced Dune Erosion Processes - Ōmaro Spit - attachments.

## Attachment B: HISTORIC COASTAL SYSTEMS PERSPECTIVES

### Attachment C: Mount Manganui - TAY ST BEACH accretion

**Attachment E below: Matarangi beach - Ōmaro spit erosion reversal and enduring protection.**

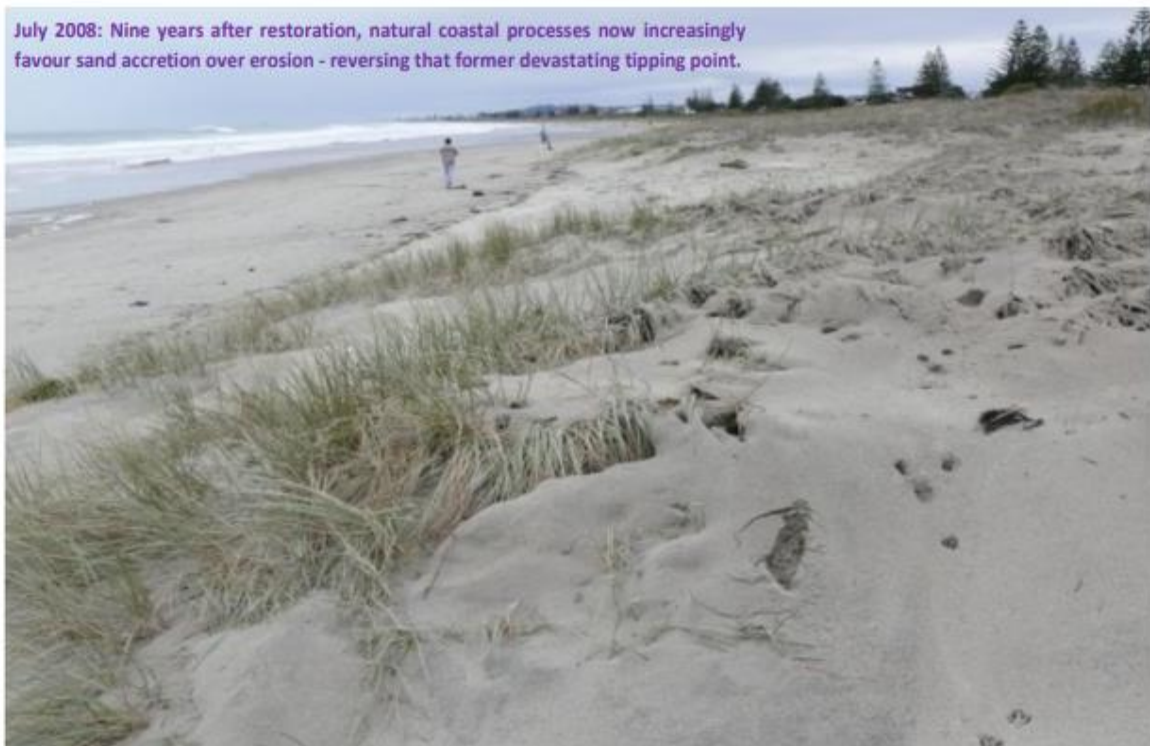
### **Banks Avenue beach July 2008 – sand accretion during the North Island NZ 'Weather Bomb' (Ref NIWA NZ)**

**27 July 2008: The remarkable post-restoration effects of fresh sand accumulation during a severe winter storm – Banks Avenue beach, Mount Maunganui**

- This is the same beach shown at top, but after diligent restoration of indigenous halophyte (salt-tolerant) foredune plants in **1999** (see the Norfolk Island pines).

- This functional dune is 20m wider than in the 1995 photo above and is now proving dramatically more resilient to wave erosion than that weed infested sand mound.

- This July 'weather bomb' generated onshore swells exceeding **7 metres**, with winds gusting over **111km/hour** ([WEBLINK: niwa.co.nz/event/July 2008 Weather Bomb](http://niwa.co.nz/event/July_2008_Weather_Bomb))

- This accumulated sediment resembles snow rather than storm-tossed sand - note all sand is stabilised within the most seaward 10m of this restored foredune.

- The large volumes of accumulated sand are obviously both extremely soft and porous, another natural function of these indigenous foredune plants (Müller 2011).

- This photo also reveals the beach now remains unaffected by erosion, while the plants exhibit useful salt-tolerance and natural abilities to endure significant burial.

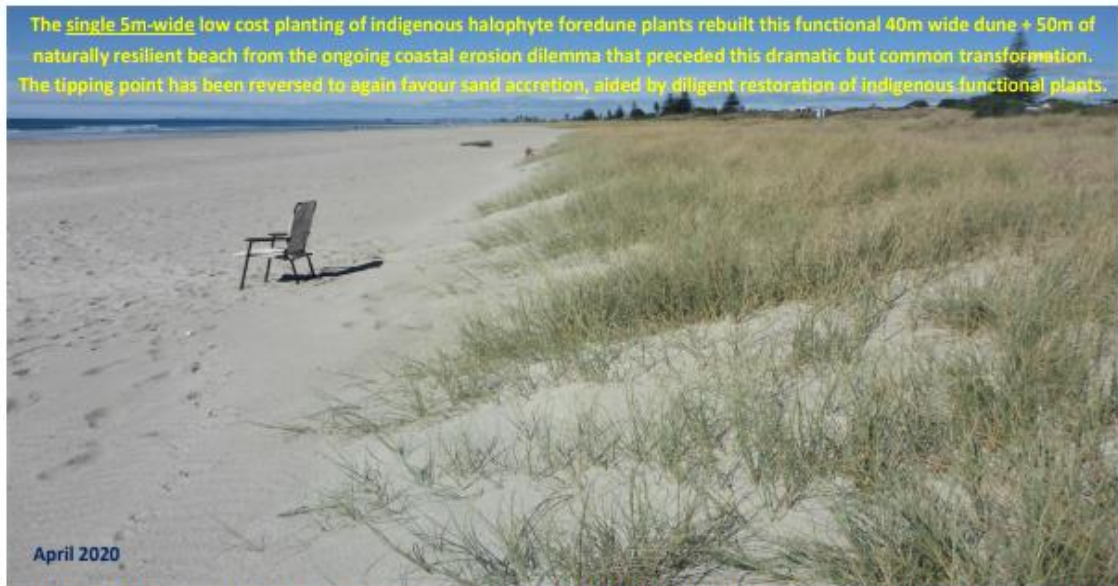
**Banks Avenue beach 2020 – this restored beach just keeps further growing seawards from that narrow planting back in 1999**

**April 2020: The enduring fresh accretionary effects of calm weather induced sand deposition post-restoration – Banks Avenue beach, Mount Maunganui**

- This is the same beach shown at top 21 years after the **1999** diligent restoration of indigenous halophyte foredune plants (see the background Norfolk Island pines).

- This functionally resilient dune is now greater than 40 m wider than the 1995 photo, a fresh sand accumulation rate approximating 48m<sup>3</sup>/lineal m of beach.

- The high tide beach has also vastly expanded seaward – it now exceeds 50m in width, compared to the non-existent dry beach in the above 1995 photo.
- This fresh sand now has improved slope & porosity - aiding natural resilience to storm surge impacts (Müller 2011) & maintains the beach ecosystem in a positive state.

- Significant storm erosion seen in 1995 photo above no longer occurs here, though many ex-tropical cyclones have passed through here during the long post-restoration period (and see the 2008 storm shown above) - storms that still induce heavy losses on many other similarly exposed but still non-restored east-coast beach systems.

- This diligent restoration paradigm comprehensively addresses the “true root cause of erosion” (Jackson *et al.* 2012) by simply and ethically replacing the erroneously utilised surrogate introduced non-halophyte and non-functional plant species with naturally evolved indigenous functional halophyte foredune plant species.

- **No need for carbon intensive seawalls or ‘managed retreat’ here yet**, this community-involved restoration of indigenous dune plants has reversed erosion processes while enhancing amenity opportunities, faunal habitats and increased natural coastal biodiversity - **while actively sequestering carbon** – a true win-win-win scenario.

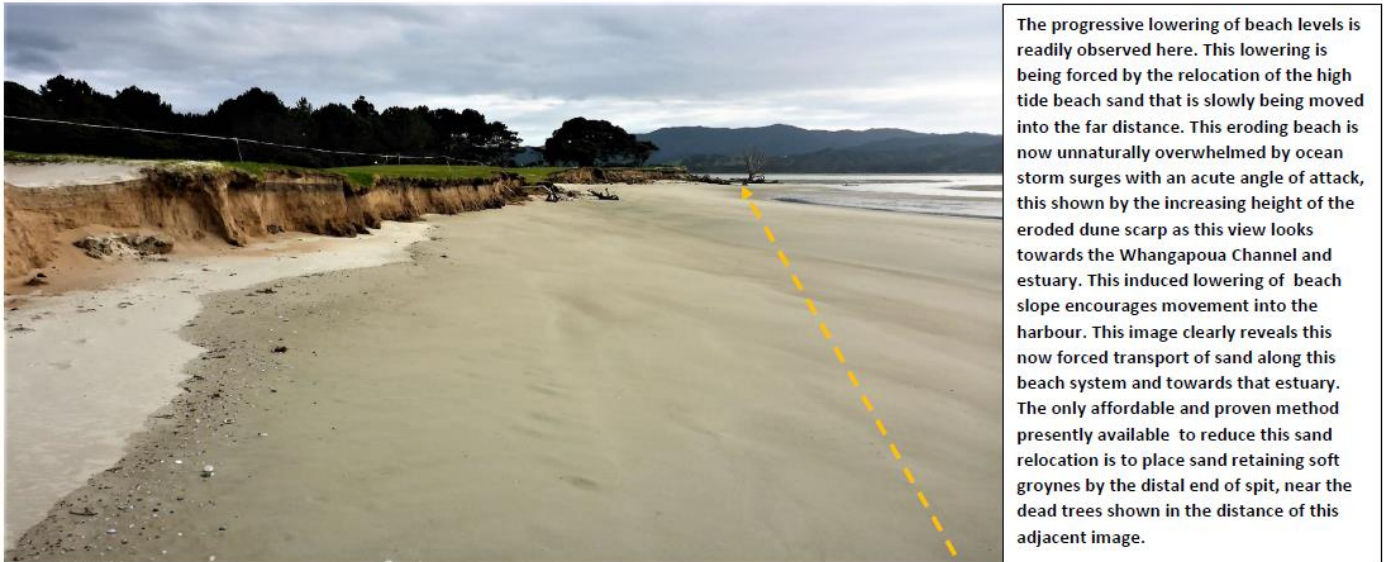
The physical reality of that present process can also be observed onshore in the photo below, taken during the beach survey visit on 14 September 2021.

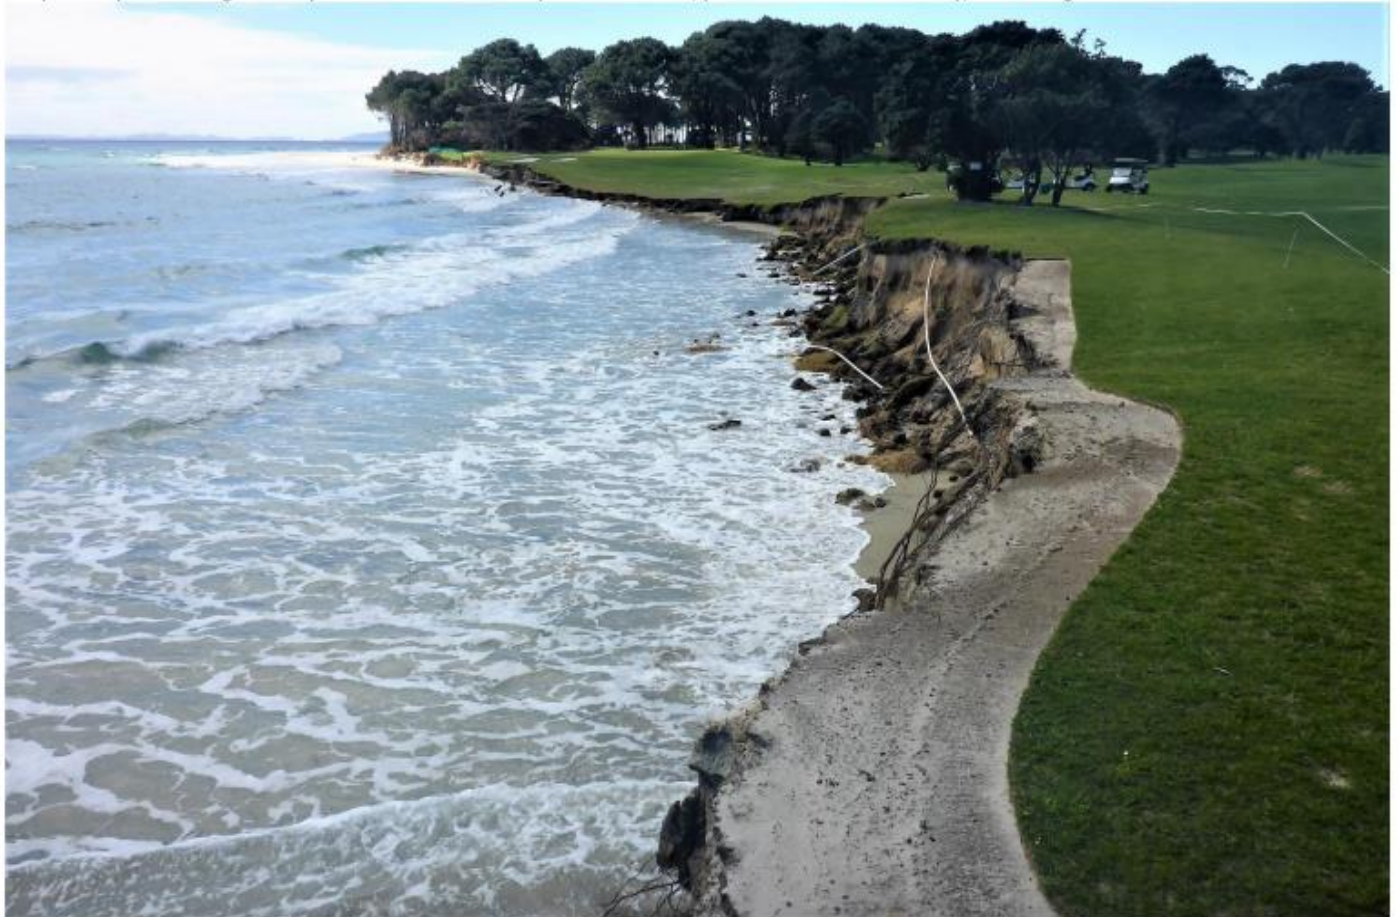
This presently unrelenting erosion process can be also readily observed below, photo taken on the same day, but looking back towards the Northeast:

The above image reveals the impact of sand being stripped off the former high tide beach by waves impacting at 50–60-degree angles, and progressively relocating that sand into the estuarine channels.

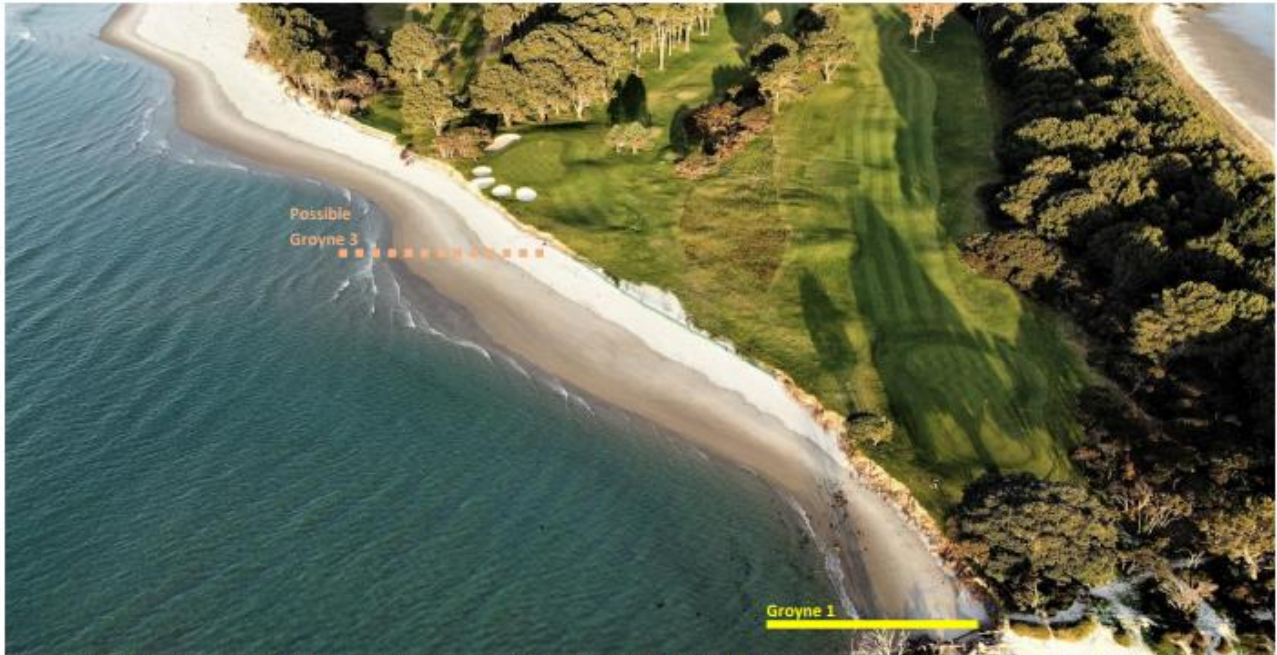
A new drone photo (16 October 2021 - kindly supplied by Ray Fanning) also reveals similar effects of this intensified unnatural sand relocation process, but now after some expected fresh sand has returned from offshore bars. Carefully observe the angle of attack of the incoming waves (nearer to 80 degrees on this day), and the consequent poor high tide sand recovery in the bottom right corner of this photo. For superior sand trapping results, groynes function best when placed perpendicular to incoming waves – see further explanation of this sediment restraining process in the main plan report. The proposed location of one of the soft groynes (peer reviewed by Geofabrics NZ Engineer and approved on site by their contractor, Ray Blackler) is shown in yellow superimposed below. Other groynes to the north of that shown could also be considered if suitable funding allows.

**As these erosion processes are unstoppable presently (with existing conditions), it is imperative that both the sand nourishment operation (push-ups) AND groyne construction occur simultaneously, or as close in time together as possible. If a preference were possible, groyne construction would slightly precede sand nourishment.**
