# Te Ao Turoa Environmental Centre

## Site Examination Undertaken By Te Ao Turoa Regarding Proposed Spraying At Pukepuke Lagoon & Log Jam Removal To Allow Fish Passage At Koputara Stream

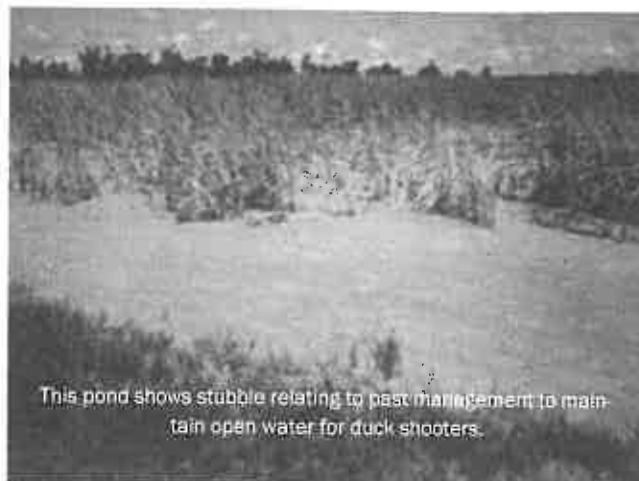
The photographs relating to Pukepuke Lagoon depict the ponds signalled for the inclusion in the additional spraying to be undertaken by

DOC and Fish and Game, Wellington. This is one of the ponds to be included in the extended spray operation. This pond shows stubble relating to past management to maintain open water for duck shooters.

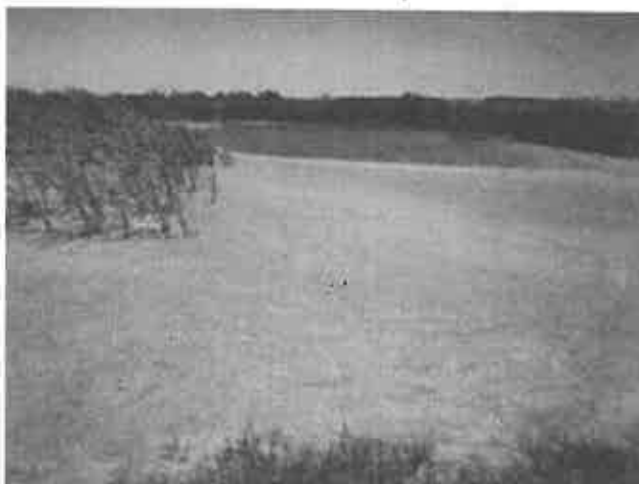
Following the heavy rains of February that signal the eel migration several reports were received that many eels were dead on the beach above the high tide mark at Koputara Stream mouth. Te Ao Turoa investigated the reports and found that there was evidence of eel mortality and although there was a satisfactory flow of water from the stream into the surf zone there was significant stagnation present in the mouth of the stream that had not been cleared by the increased water flow. Despite evidence that significant water had passed over the sand bar the native inanga (*Galaxias maculatus*) present on the standing water were experiencing difficulty breathing and were unable to progress up stream as a substantial log jam was preventing their passage. Several fish were observed swimming with their heads out of the water 'gulping air'; many more were resting at the very edge of the water sand interface also gulping air. Several of these were able to be caught by hand indicative of abnormal behaviour at this site.

TMI are investigating the possibility of excavating this Stream mouth with the relevant agencies.

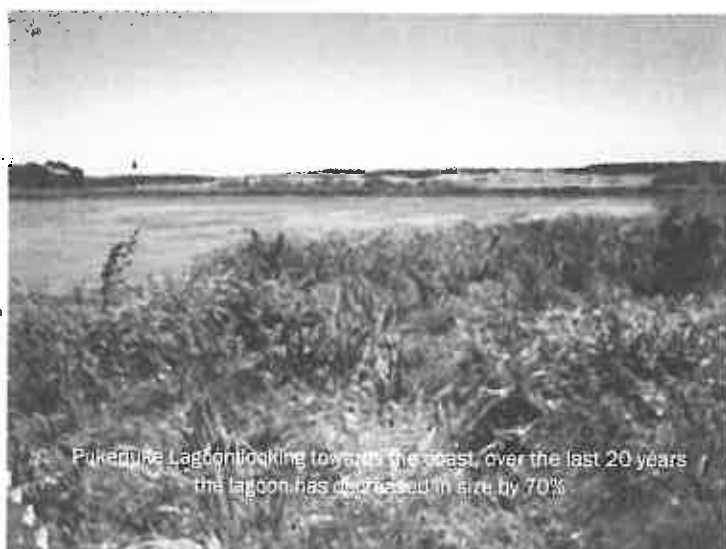
Pukepuke Lagoon looking towards the coast. Over the last 20 years the lagoon has decreased in size by 70%.

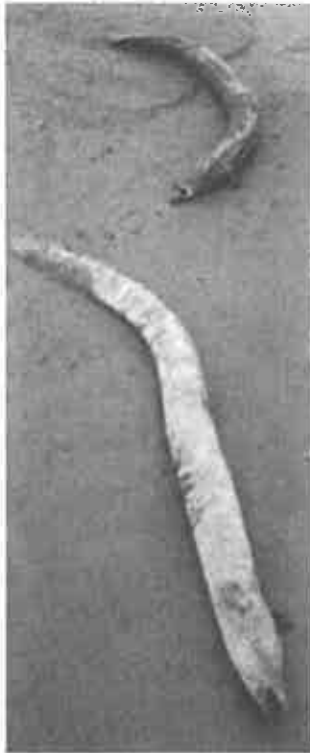
Biodiversity Managers from Horizons who are responsible for water quality and the stream flow attended a site visit with Te Ao Turoa at the end of February. They recommended monitoring the stream periodically over winter to see if seasonal storm surges will dislodge the blockage and remain open to the possibility that the stream may need further intervention prior to spring migration events.

Following the February 2009 rains locals reported numerous dead eels at the mouth of Koputara Stream; Paul from Te Ao Turoa found some evidence of fish mortality during a site visit shortly after these reports. He also recorded a large number of inanga showing the effects of oxygen

deprivation at the terminal pool at Koputara.

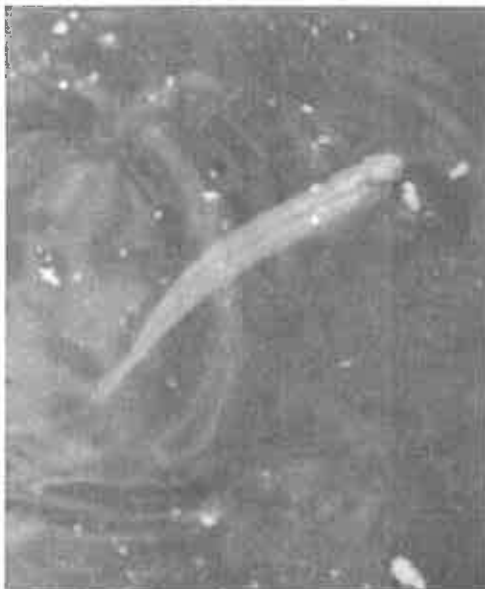
To determine the extent of the problem Matua Pauwinawina Te

Rangi and Paul visited the source of the stream to gauge the effect of stream chocking on fish passage. They found by fixing GPS points, that the chocking problem begins shortly after the stream leaves the farmland boundary approximately 2-5 km from the mouth.

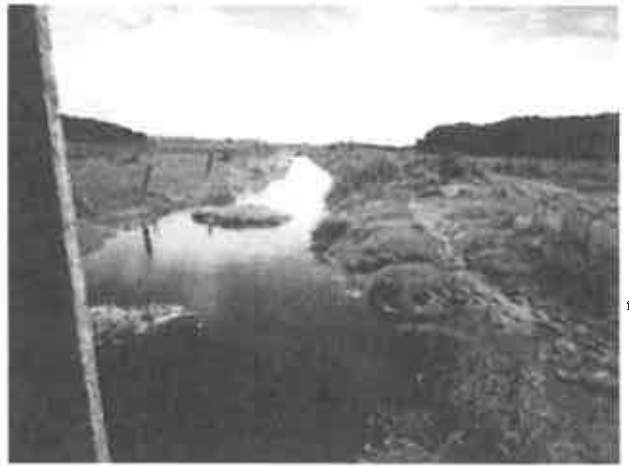
Koputara stream, just after it leaves Roto Koputara on Sextons property, has good flow and reasonable quality across the farm.

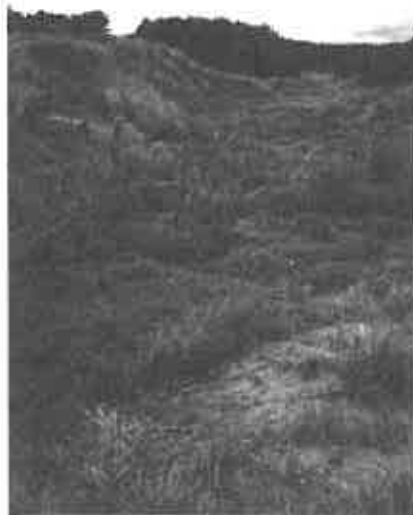
Koputara Stream reverts to sluggish flow and extensive reduction of water quality very soon after leaving the farm boundary and mitigating this problem will be the focus for Paul from Te Ao Turoa as we approach spring.

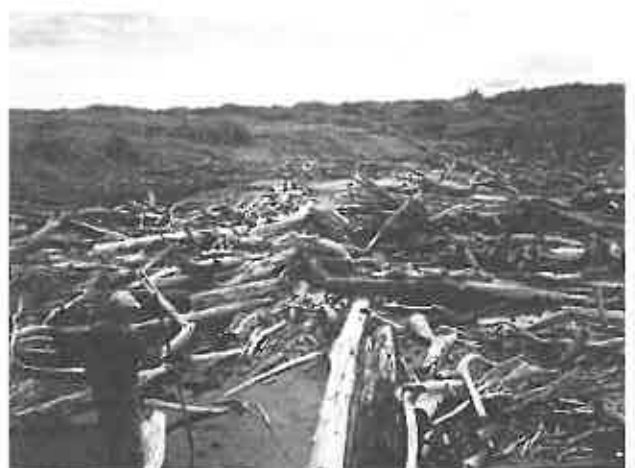
In the photo below, Matua Puawinawina Te Rangi investigates the extent of the log barrier at Koputara stream mouth. The log field forms a solid barrier for several hundred meters and has resulted in major stagnation in both the terminal pool and the waterway well upstream.
