Morphology, Dynamics and Hazard Management of the New River Lagoon, Westland, New Zealand

A thesis submitted in partial fulfilment of the
requirements for the Degree of
Master of Science in Geography
at the
University of Canterbury

Michael J. Fifield

**Department of Geography
University of Canterbury
Christchurch, 2012**

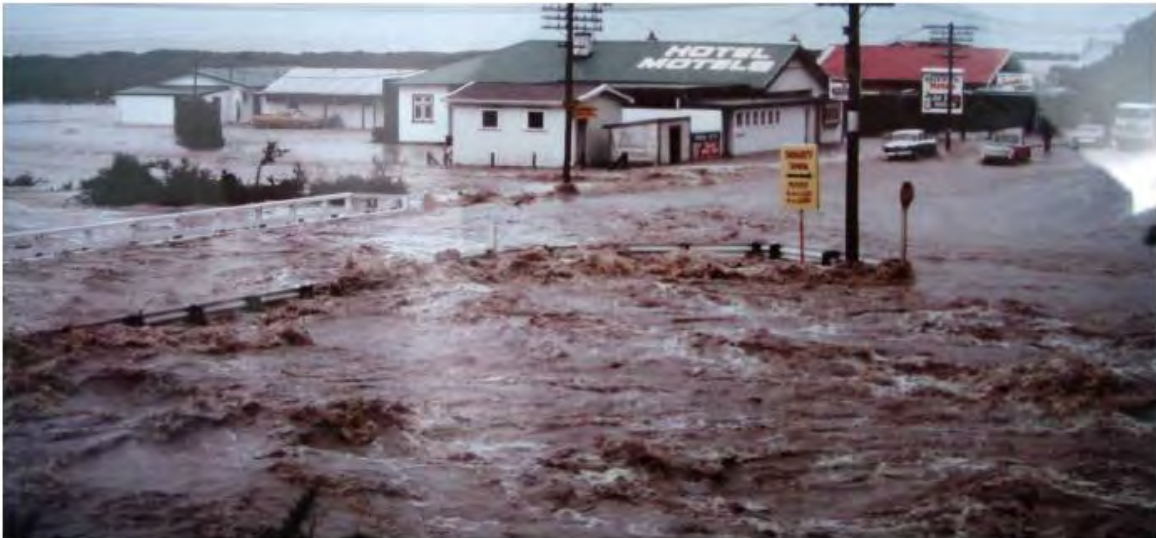
Figure 1.4. 1978 flooding of Saltwater Creek causing inundation of Paroa Hotel (Source: Smart, 2010 pg. 2)

Lagoon outlet blockage at the New River Lagoon is caused by the deposition of beach sediment forming a barrier that restricts the exchange of water between fluvial and marine environments. Blockage occurs during times of low river flow when there is insufficient discharge of water to flush sediment through the outlet (Benn, 2004; Smart, 2010). If there is insufficient drainage through the lagoon outlet, the convergence of flood water from Salt Water Creek and the New River at the same point can cause Salt Water Creek (the smaller of the two waterways) to back up and flood the surrounding low lying land. There have been various flooding events over the last 50 years at the New River Lagoon. On the 11 and 12 February 1997, extensive backwater flooding of the Paroa Primary School occurred as a result of heavy rainfall following blockage of the New River Lagoon outlet. Other documented examples include, extensive flooding of the Paroa Hotel during heavy rainfall in 1978 (Figure 1.4), and the most recent flooding of the Paroa Primary School on the 28 December 2010.

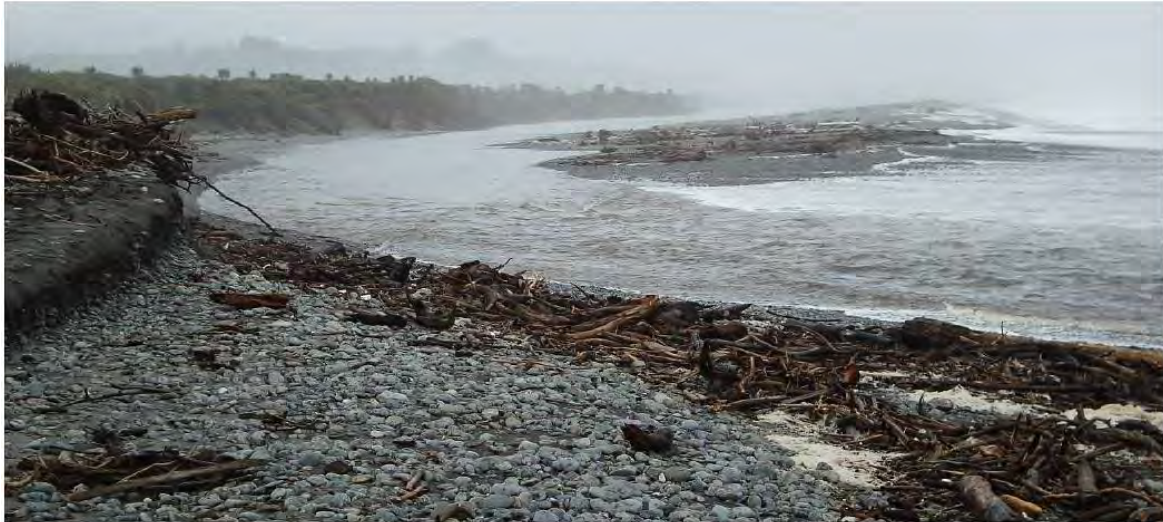
Figure 1.5. Formation of a gravel bar as the lagoon outlet migrates north, creating a barrier between the lagoon channel and the sea and forcing the river to erode its outside banks (Source: Smart, 2010 pg. 5)

Lagoon outlet migration is caused by the longshore transport of sediment, predominantly deflecting West Coast lagoon outlets to the north, or river flooding, which can breach established outlets and create new ones (Benn, 2004). The New River Lagoon outlet has been recorded to have migrated from north of Paroa to Cameron's in historical times, a distance of over 7 km (Figure 1.1). Until recent management intervention, northward movement of the river outlet had been consistent, caused by the longshore migration of beach gravel from the south. The northerly drift of gravel would deposit as a bar on the southern bank of the river outlet (Figure 1.5). To compensate and maintain flow, the river would erode the northern bank of the river outlet, which resulted in a northward movement (Smart, 2010). As the lagoon outlet migrated further north, so did the flow of water from the New River Lagoon. The New River Lagoon eventually travelled parallel to the southward flow of Salt Water Creek, separated only by a thin, vegetated dune system. Erosion of the outside banks of the lagoon channel often occurred during periods of high river levels, which increased the migration rate of a northward deflecting river outlet and increased the risk of dune breach and subsequent disruption of the southerly flowing Salt Water Creek. If a breach were to occur, there would have been major flooding implications for infrastructure on the seaward side of the highway, caused by the interaction of two opposite flowing waterways. It is also notable to mention that scouring of the outside banks of the outlet as it migrated north, was slowly eroding land north of the outlet that was being preserved and protected for the nesting of blue penguins. Further analysis of past lagoon outlet and channel dynamics are provided in Chapter 4.

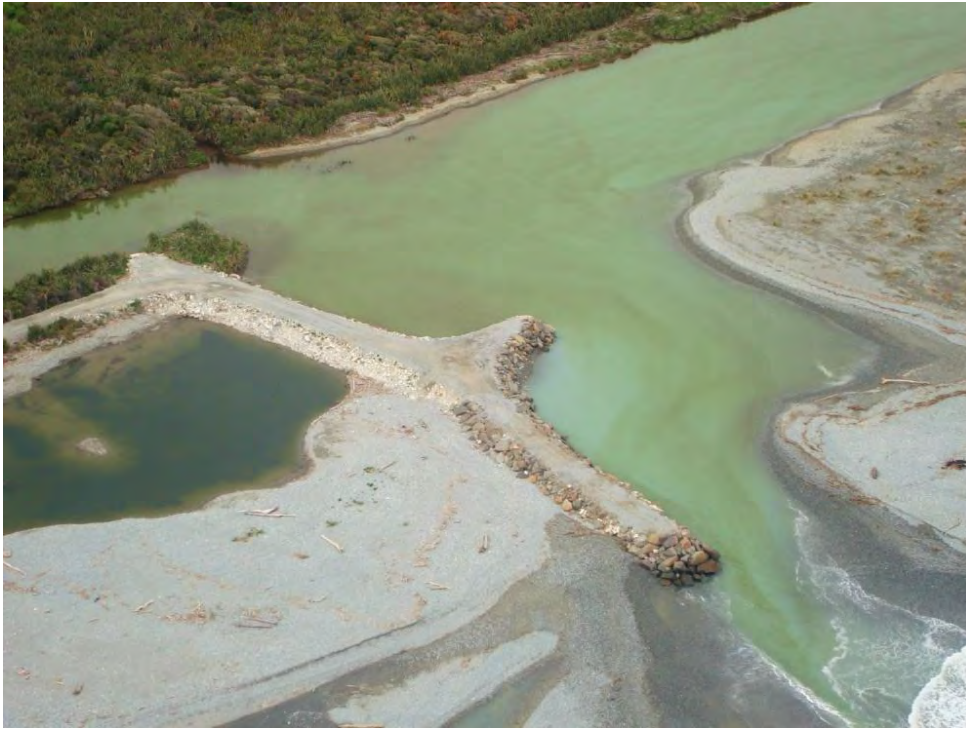
Figure 1.6. Artificial lagoon outlet and rubble-mound breakwater at the confluence of New River and Saltwater Creek (photo courtesy of Laurie Anderson, 23/05/2011)

Further to the emergency engineering works at the lagoon and the initial consent application by the PTCAT, the Grey District Council applied for a coastal permit for on-going works at the lagoon. Consent was granted on the 21 March 2011. It is uncertain as to whether the reinstated outlet will stay in place for any length of time; therefore, consent was granted on a medium term basis for five years. Consent allows the applicant to maintain/re-excavate no more than five times during the term of the consent. The exceptions to this are in times where the backup of water is likely to reach the trigger level (height at which flooding becomes a hazard) and/or the outlet moves north of the location identified as the beach opposite the northern exit to SH6 off Sumner Road, when excavations above and beyond the consented five occasions may be undertaken.

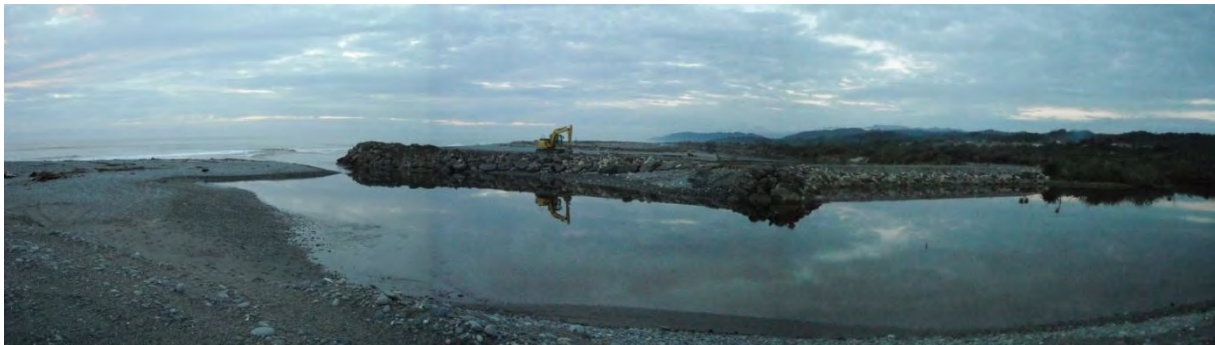
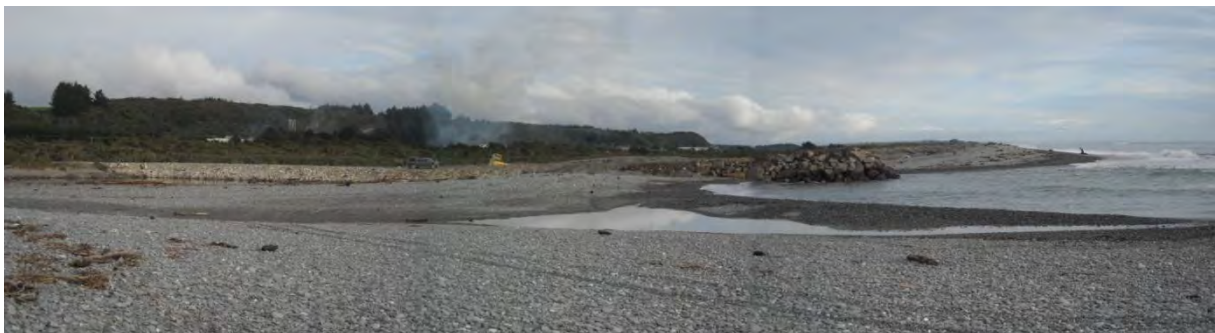
Figure 1.7. Artificial lagoon outlet and rubble-mound breakwater looking north (above) and rubble-mound breakwater and updrift beach looking south (below) (23/05/2011)

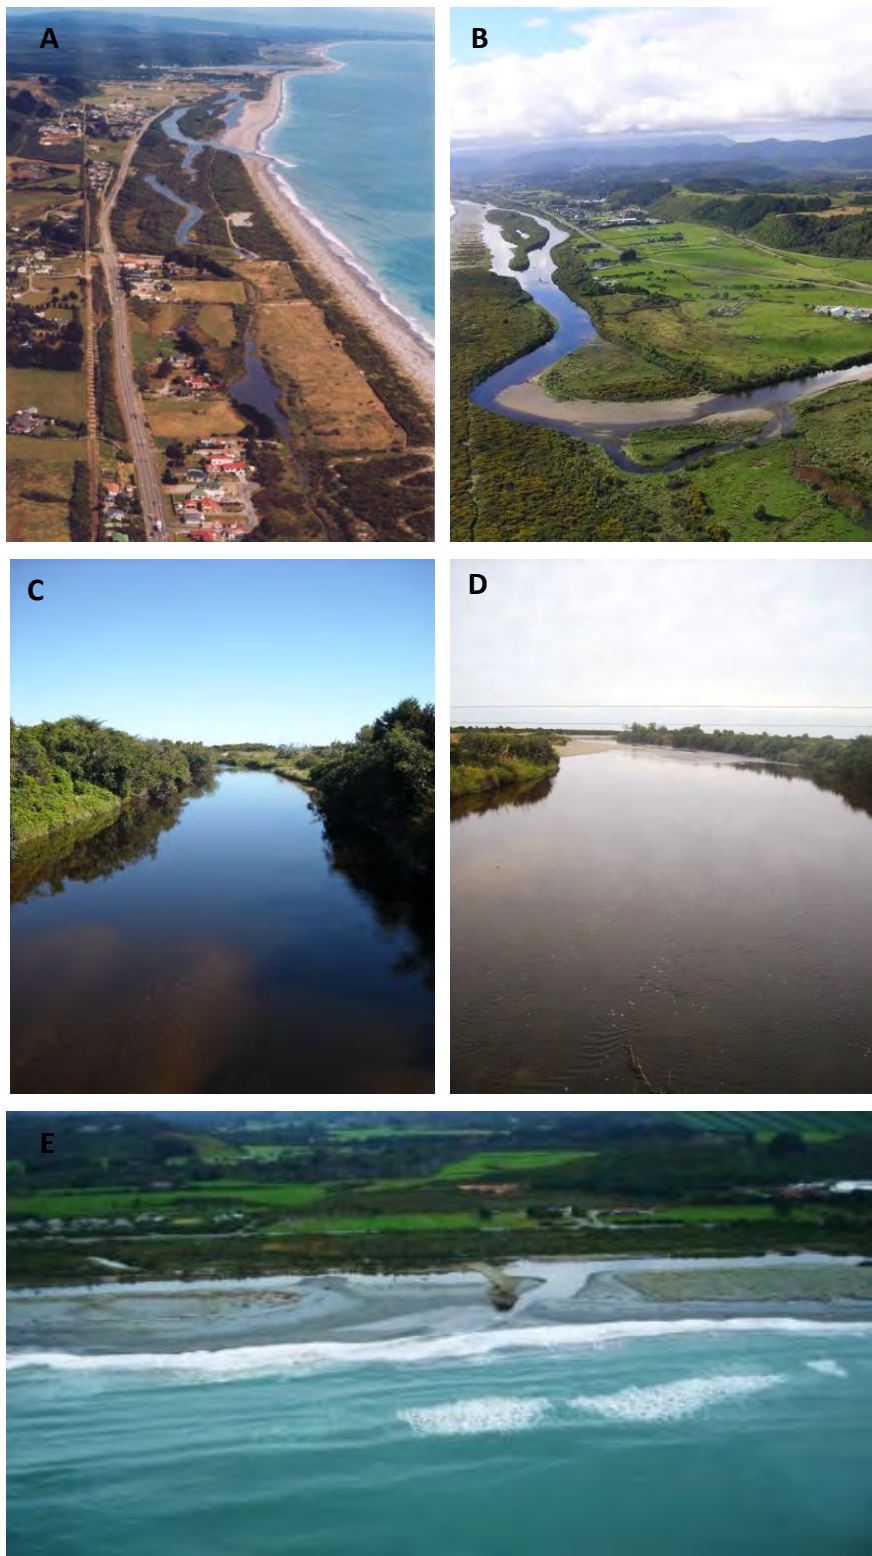
Figure 2.6. The New River Lagoon environment. A) Longitudinal view of the lagoon looking south, showing remnant lagoon channels flowing into the Saltwater Creek channel in the foreground and the New River in the background (photo courtesy of Trevor Johnson, taken in 1999). B) Longitudinal view of the lagoon looking north, showing the New River channel bending and flowing parallel with the coastline. Vegetation is dense landward of the lagoon and surrounding channels and islands, whilst the seaward extent of vegetation decreases northwards (photo courtesy of Don Neale, taken on 01/05/2006). C) Saltwater Creek channel, highly vegetated on both sides and approximately 10 m wide (03/03/2011). D) New River channel, highly vegetated on both sides and approximately 25 m wide (02/03/2012). E) Wide angle view of the artificial lagoon outlet, showing the New River channel to the right, remnant lagoon channel to the left and Saltwater Creek in the background (09/10/2011, photo courtesy of Laurie Anderson).

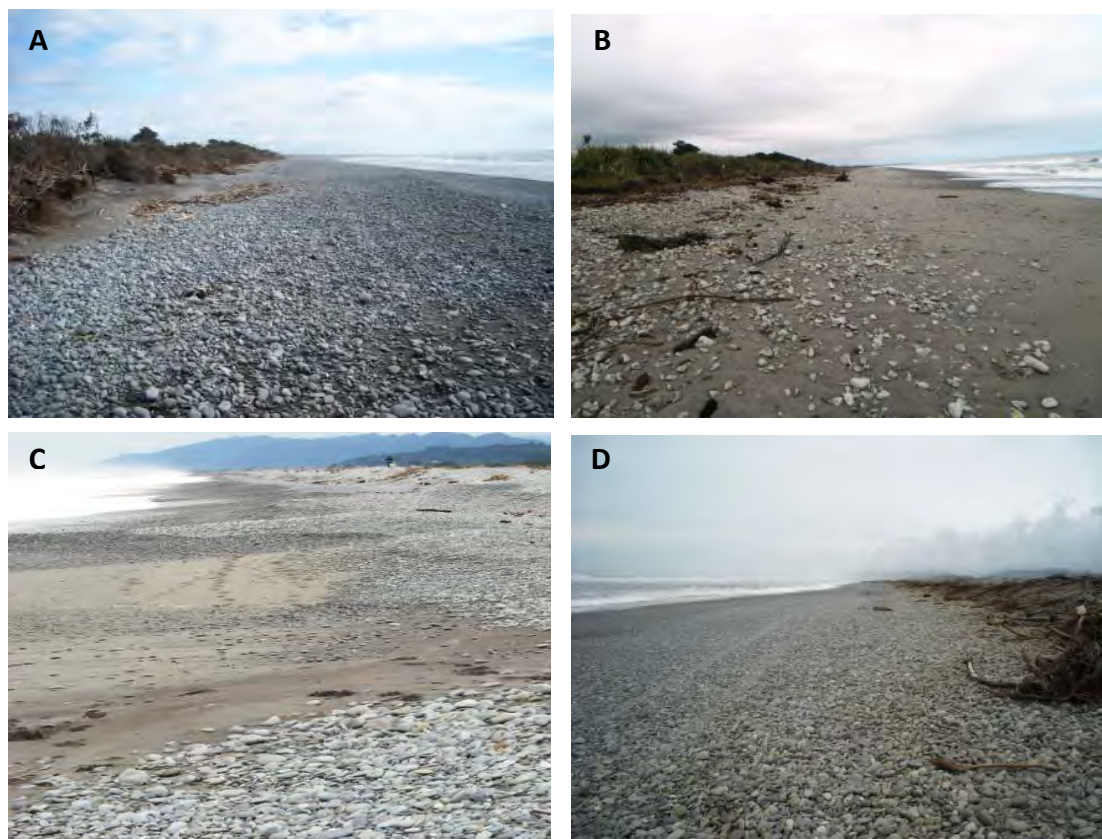
Figure 2.7. Beach environment fronting the New River Lagoon. A) Barrier beach immediately south of the New River Bridge. The berm is relatively low lying and the landward extent of vegetation cover extends close to the beach. There is evidence of scouring of the back beach due to storm surge and a lack of built-up protection (27/10/2011). B) The same stretch of beach 4 months later. Note the change in sediment composition from predominantly gravel dominated to sand dominated (02/03/2012). C) Barrier beach north of the lagoon outlet is steep and wide (04/08/2011). D) The same stretch of beach 7 months later. Sediment composition has changed from composite sand and gravel to dominant gravel (02/03/2011). Note the alongshore differences in sediment compositions between photos C and D, both taken on the same day.

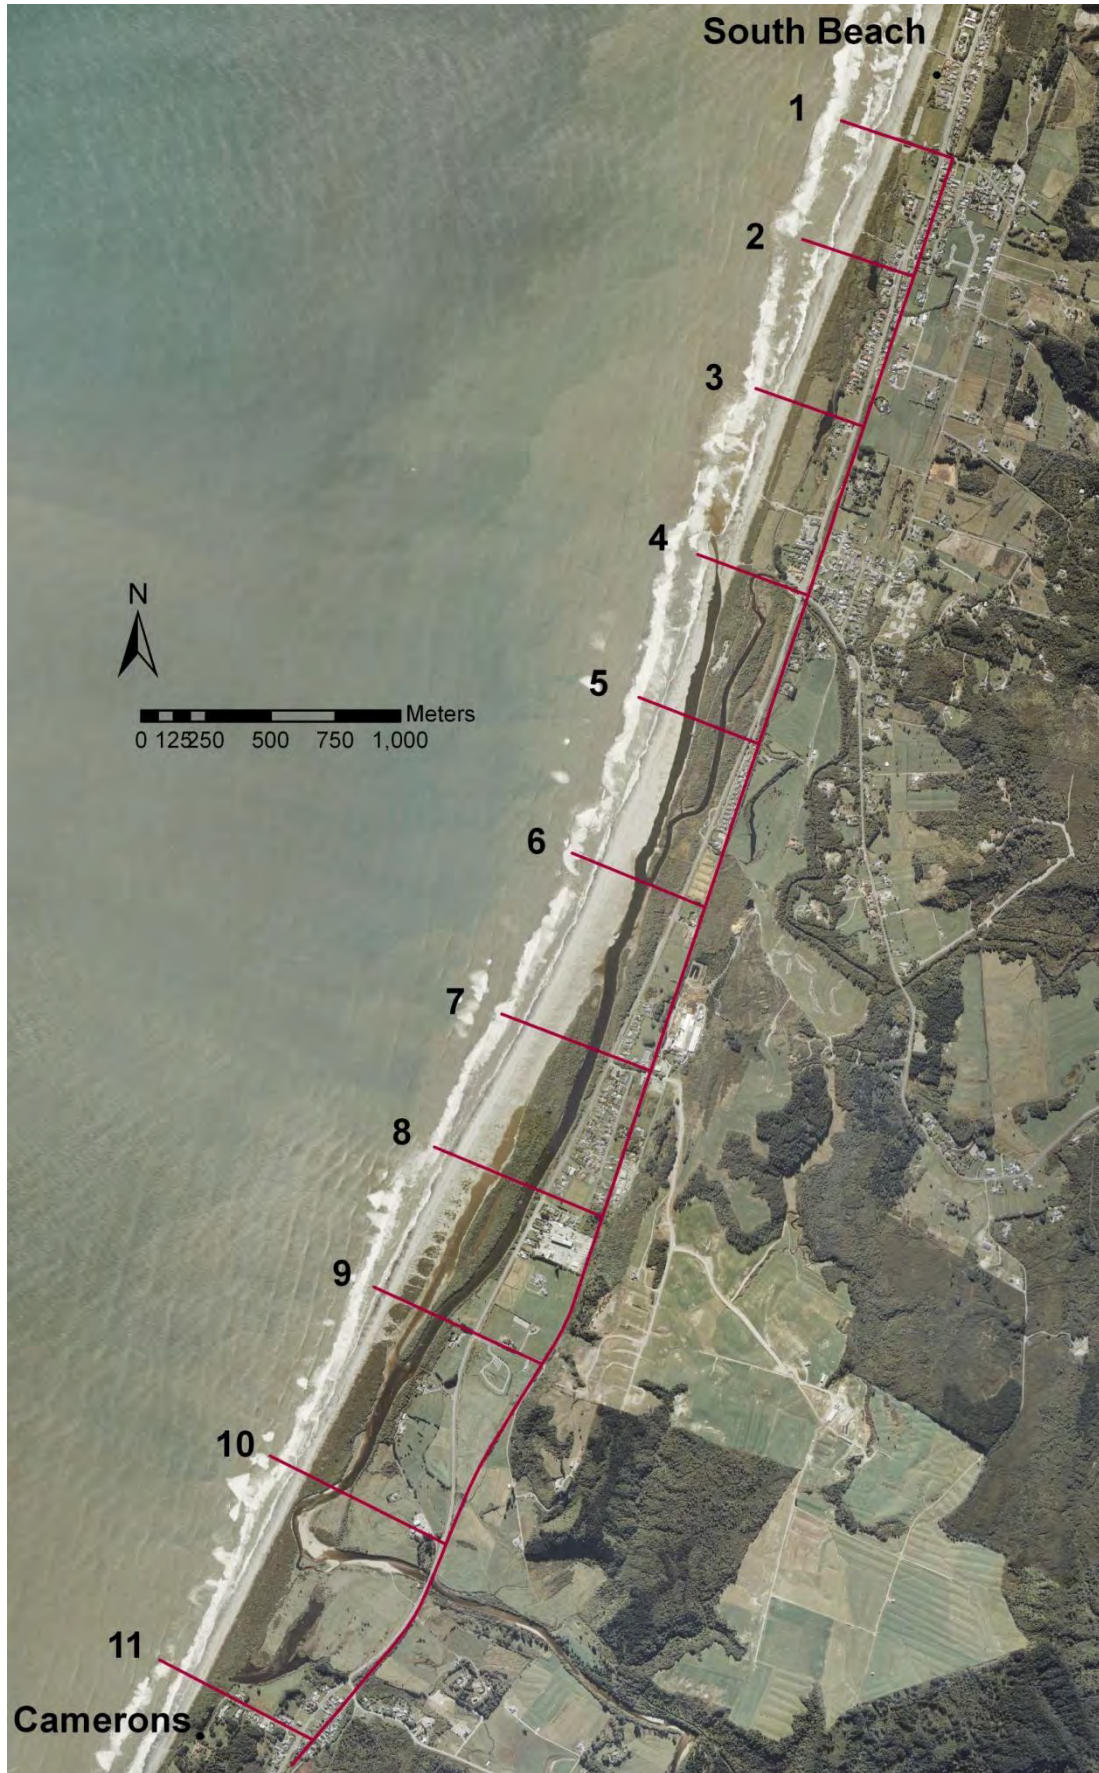
Figure 4.1. Beach profiles 1 to 11 covering the extent of the coastline between Camerons (in the South) and South Beach, north of the Paroa Hotel

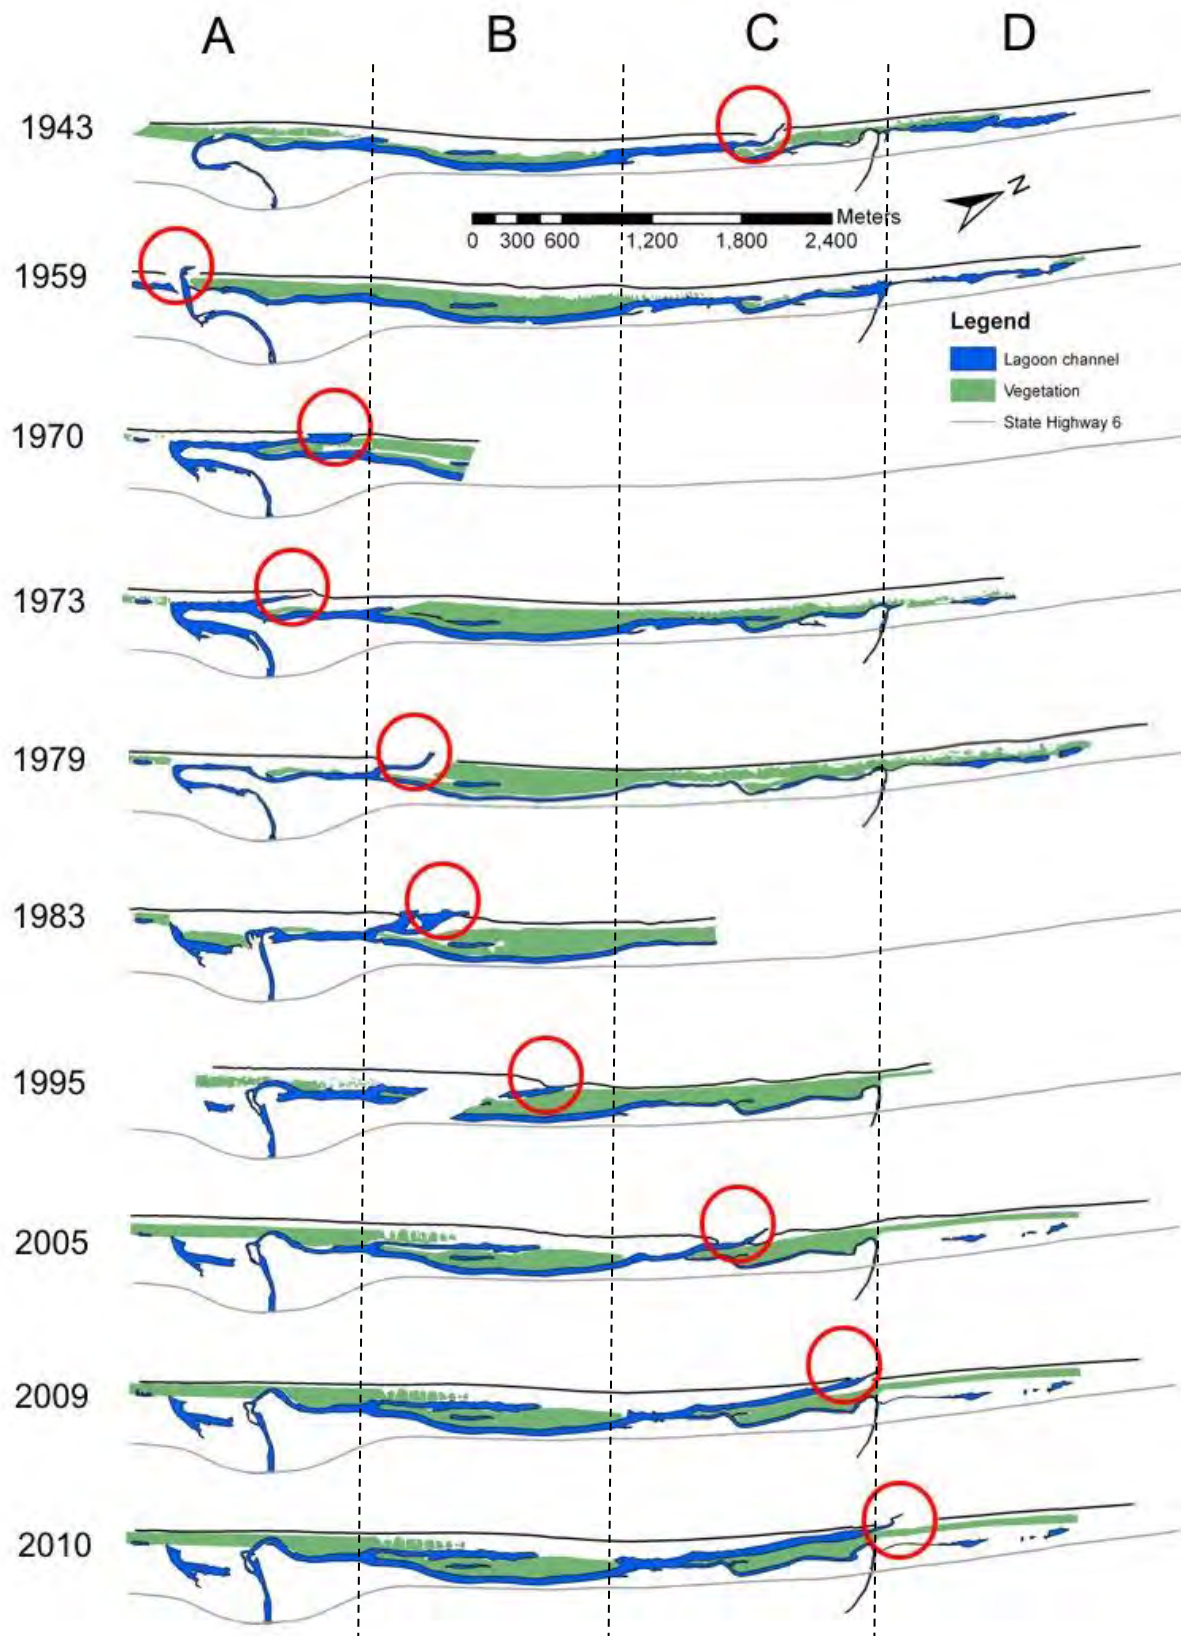
Figure 4.3. New River Lagoon occupied and unoccupied channels and the seaward extent of vegetation cover from 1943 to 2010. Images have been digitised from a 2010 orthorectified aerial photograph and outlet positions circled in red.

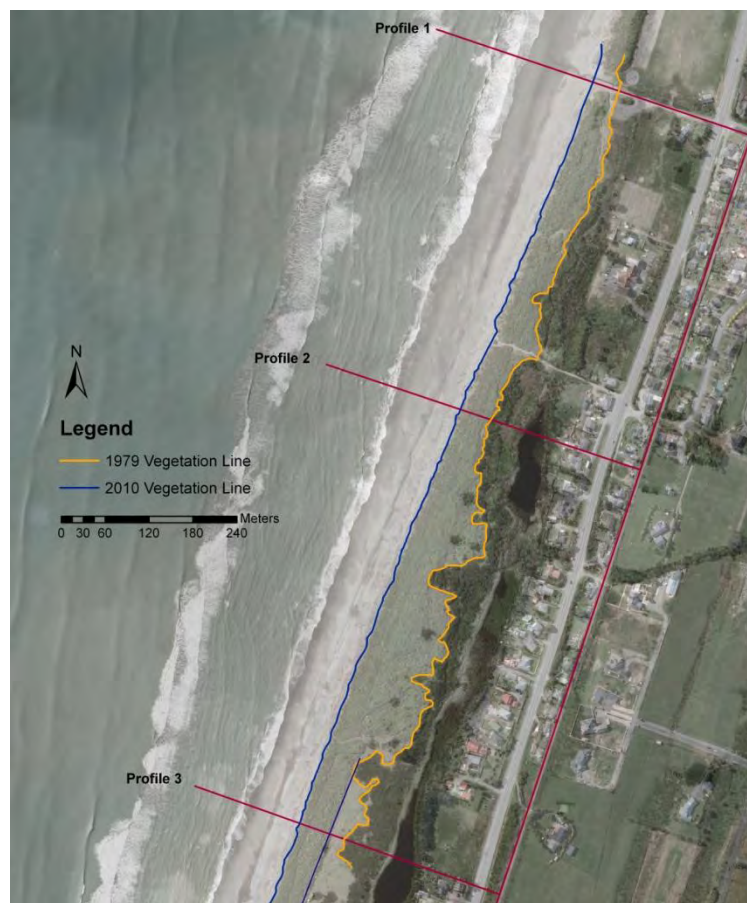
Figure 4.6. 2010 orthorectified photograph overlying a 1979 orthorectified photograph shows the progradation of the vegetation line at profiles 1 to 3, north of the Paroa Hotel.

Quantitative analysis of shoreline stability, based on changes to the vegetation line, was difficult to determine for profiles 4-10, because of its continuous fluctuation caused by migration of the lagoon outlet. However, profiles 1-3 north of the Paroa Hotel and profile 11 south of the New River Bridge were not directly influenced by the lagoon outlet after 1973. Therefore, they are considered to represent the true state of vegetative shoreline stability without fluvial disturbances. Figure 4.5 shows change to the vegetation line for profiles 1-3 between 1979 and 2010, and profile 11 between 1973 and 2010. The detailed measurements are presented in Appendix 3. All profiles show an overall trend of progradation. Profiles 1 and 11 each showed the least amount of net change, advancing +34 and +38 m respectively. While profiles 2 and 3 each recorded higher net changes of +45 and +65 m respectively. Figure 4.6 shows the extent of vegetation progradation between 1979 and 2010 at sites north of the Paroa Hotel.

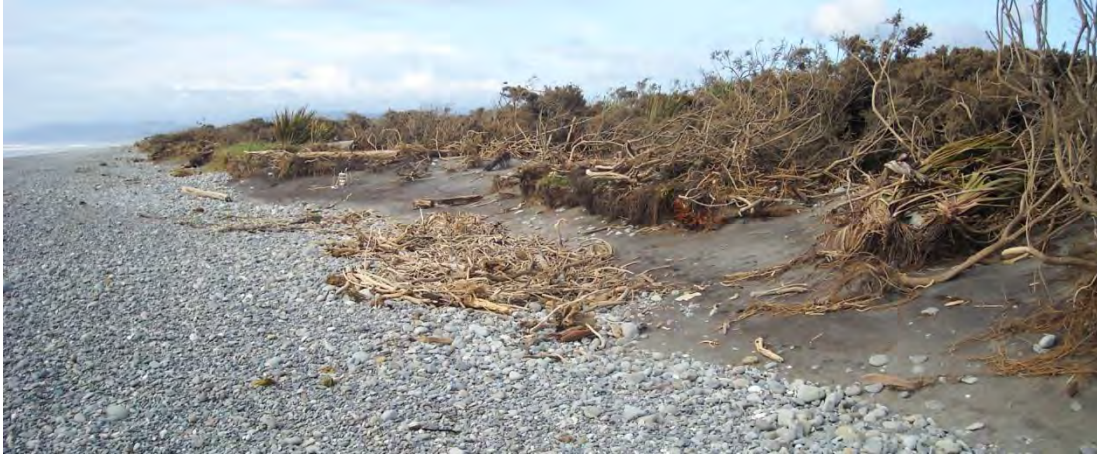
Figure 4.8. Landward erosions north of the New River Bridge (27/11/2011)

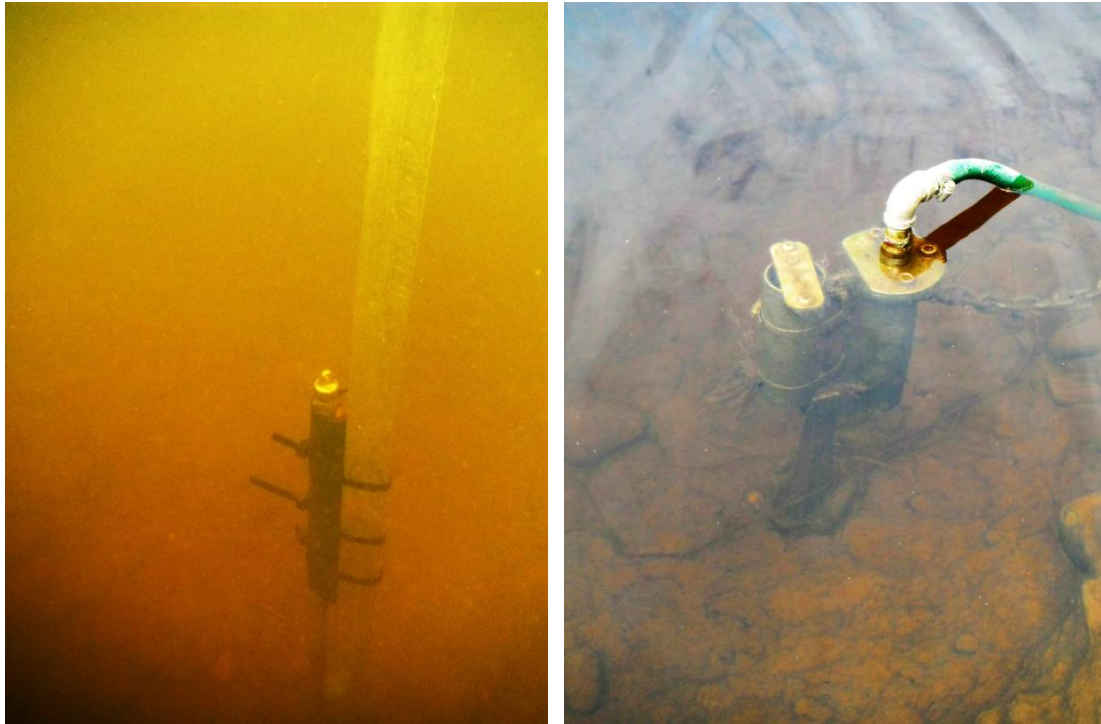
Figure 5.3. To the left is the short term water level, temperature and salinity recorder fastened to a steel pole and to the right is the long term water level, temperature and conductivity recorders, both encapsulated in steel brackets and fastened on either side of a steel pole (05/03/2012).

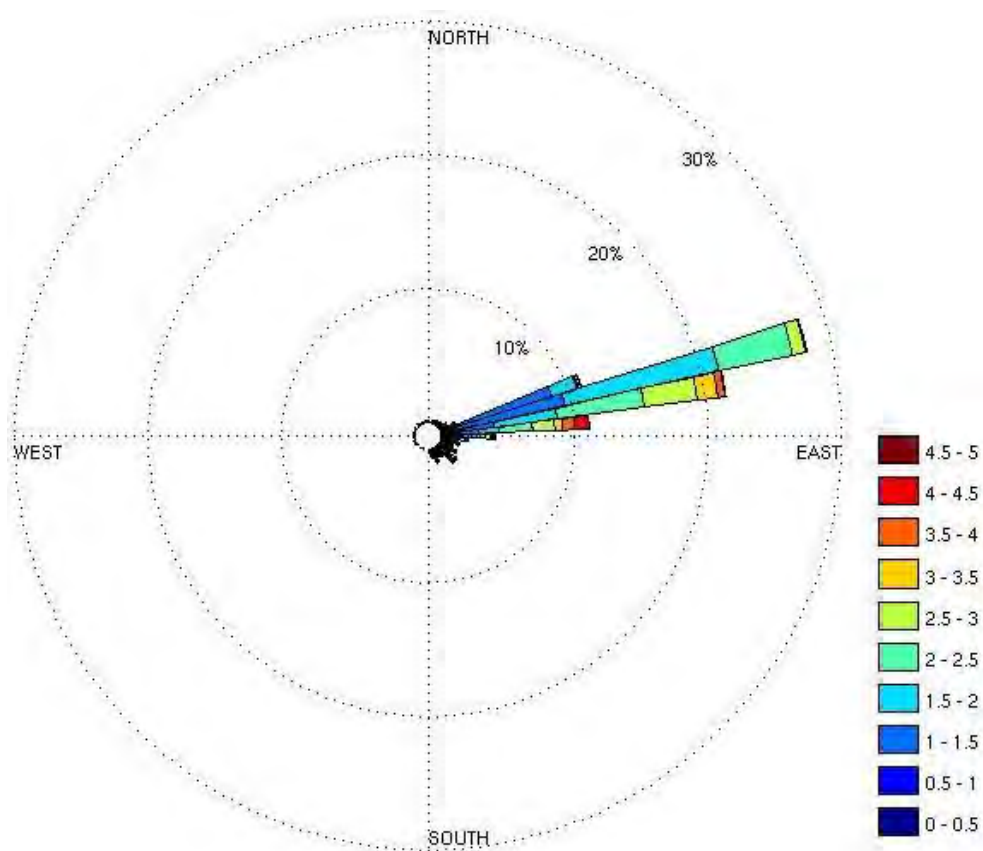
Figure 5.9. Percentage frequency wave height and wave direction from the 1st August 2011 to 5th March

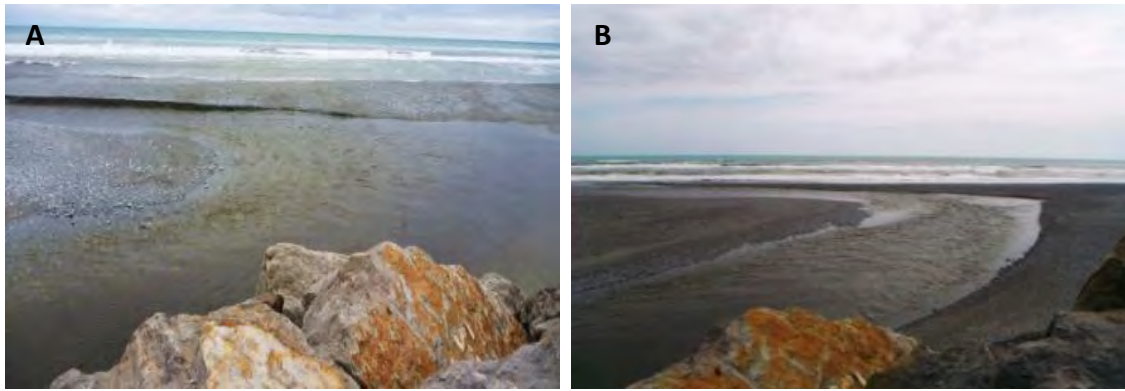
Figure 5.13. Southward outlet migration on the 24/10/2011 (image A) and 06/03/2012 (image B) (Photos courtesy of Charlie Teasdale)

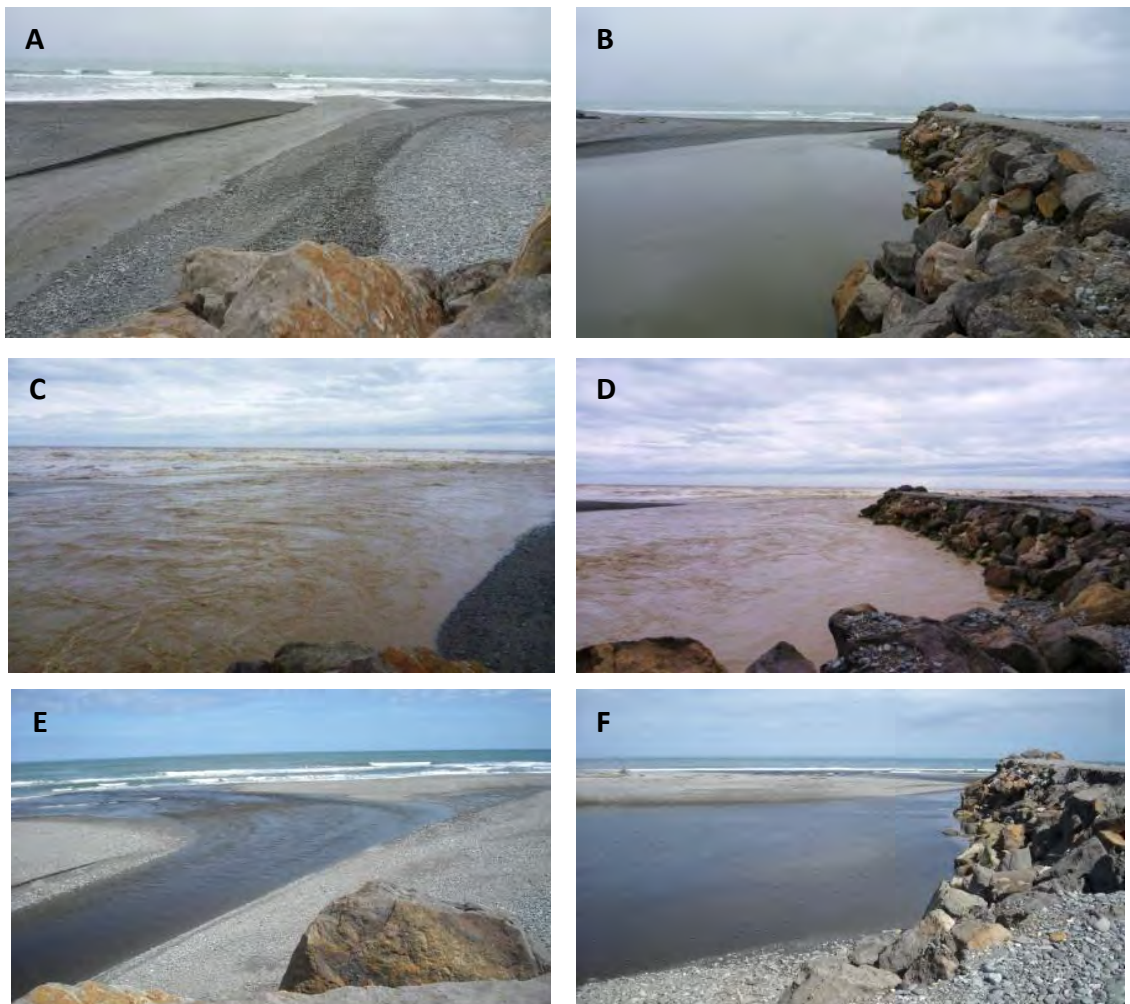
Figure 5.14. Outlet morphology on 20/11/2011 (A, B), 21/11/2011 (C, D), and 02/12/2011 (E, F) (Photos courtesy of Charlie Teasdale). Images A and B show the general direct outlet position for November and December 2011. Images C and D show flooding of the lagoon causing increased water levels and widening of the outlet and images E and F show the lagoon outlet following flooding.

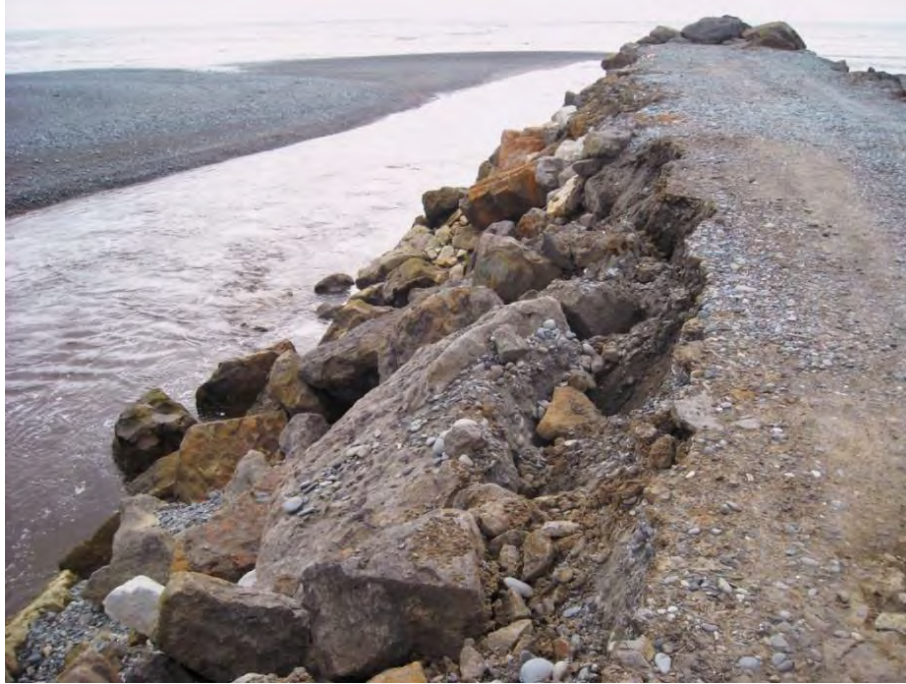
Figure 6.4. Slumping of the southern side of the engineering breakwater at the outlet of the New River Lagoon (27/10/2011)

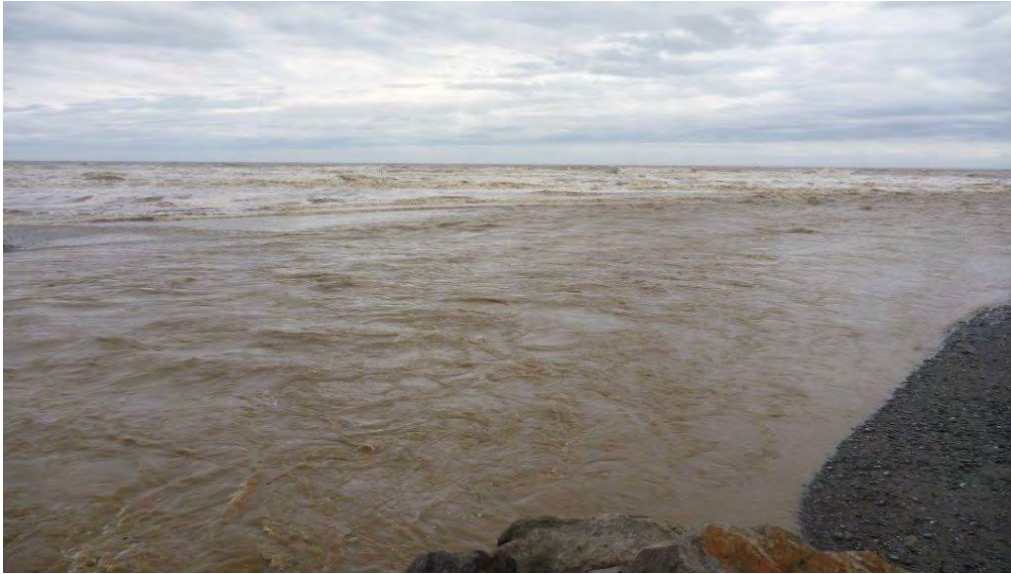
Figure 6.5. Seaward view of from the breakwater at the New River Lagoon showing opposing outflowing river water during flood conditions and inflowing marine waves (photo courtesy of Charlie Teasdale, 21/11/2011)
