**ECOLOGICAL ASSESSMENT AND DUNE  
RESTORATION PLANS FOR A PROPOSED  
CARPARK FACILITY, CASTLEPOINT,  
WAIRARAPA**

**APRIL 2009**

**Contract Report No. 2195**

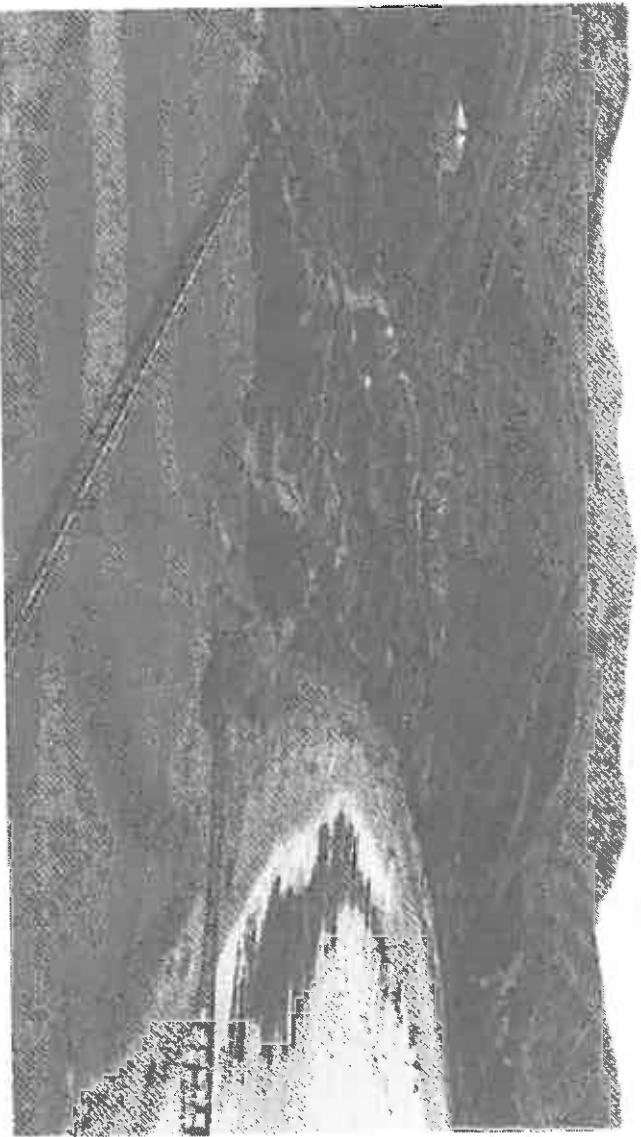
Plate 2: Township and marram dominated dunes 1920s.

The dune system at Castlepoint is unnaturally high - over 15 m above sea level - due to domination by marram, a situation which has permitted wind and wave erosion to continue over time (see Plates 2 & 3). This state was very likely induced by the early impacts of dune grazing and burning reported by Cockayne (1911). The response to these detrimental impacts common at the time was to introduce and plant a range of exotic species to ameliorate the worst effects of the 'sand menace'. Species such as marram, lupin, and various *Pinus* species were all introduced in the mid-late 1800s in attempts to solve the many and calamitous erosion problems (Cockayne 1911).

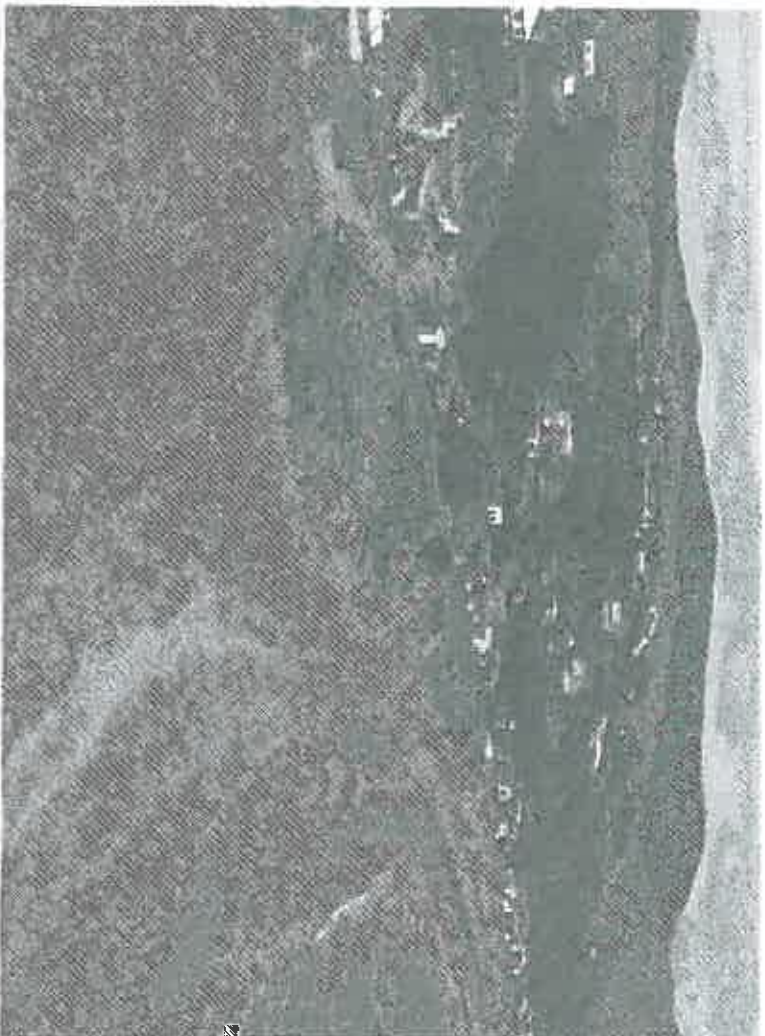
**Plate 3: Current state of Jetty Road beach 2009. Compare to Plate 2.**

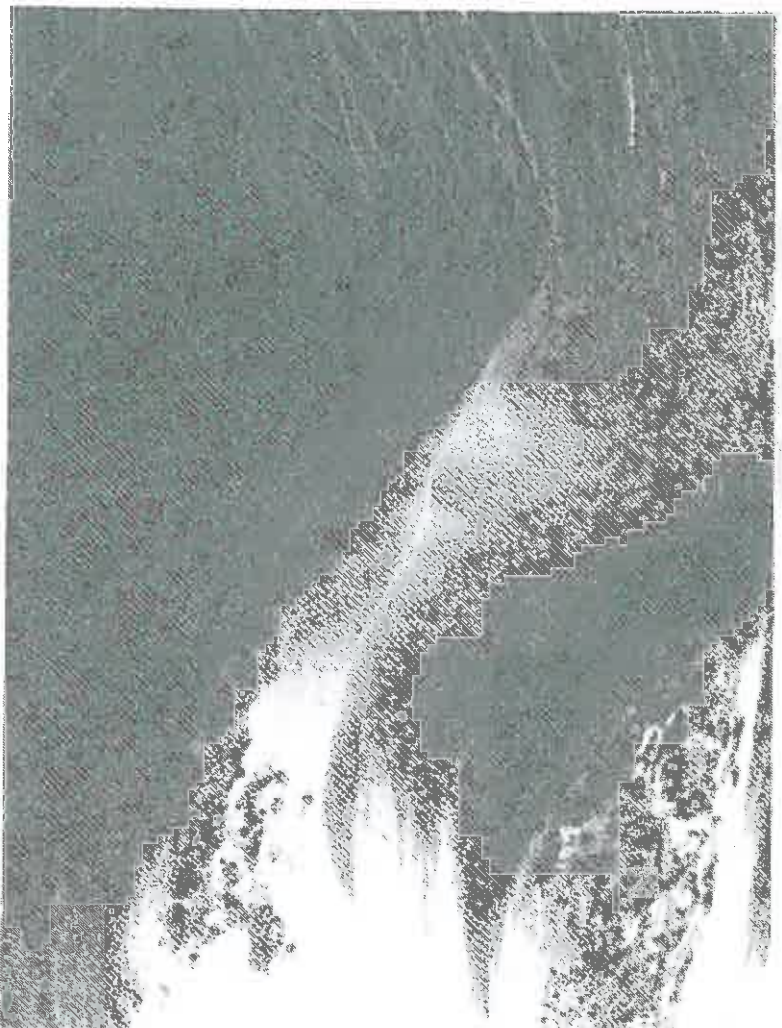
**Plate 4: Typical, problematic wind erosion of the martram dune.**

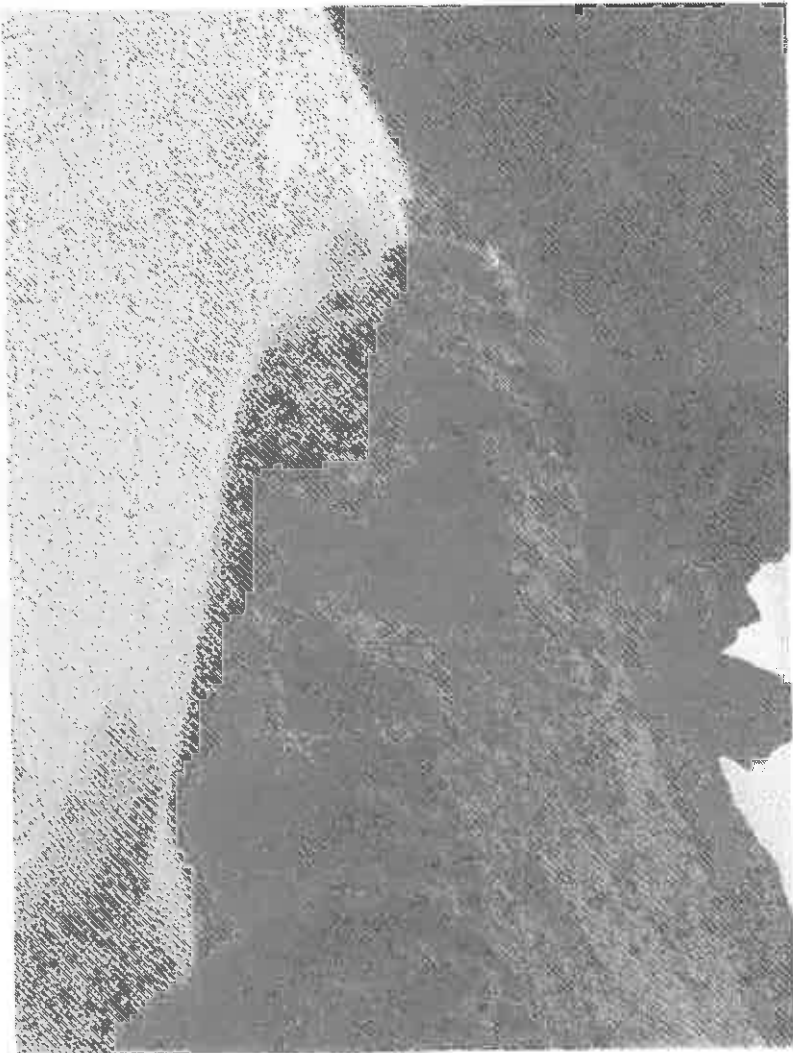
Plate 5: Losses of the finite sand resource, seen here blowing up and over the lighthouse reef complex to the open ocean.

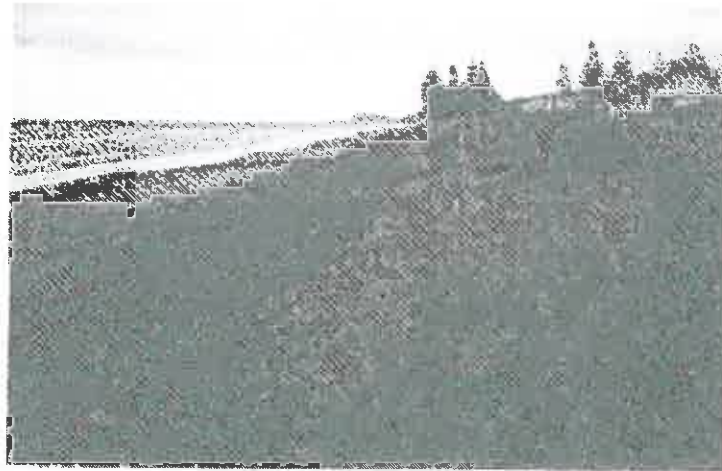
2002

Many years of damage to natural dunes resulted in ongoing erosion. The rocks and seawall were placed here during the 1970s to provide a sense of protection for the property owners. The first restoration plantings of native dune species occurred here in 2003.

Restored dunes have the ability to become increasingly resilient to storm attack as sand accumulates in the seaward edge of the dune. Indigenous dune plants are salt-tolerant and their deep roots help to prevent damage to dune faces during storm surges. A study undertaken in association with Waikato University has revealed that tolerance of damaging storm surges improves with dune accretion (i.e. elevated foredune height and run-up slope) and increased dune resilience, which can be gauged using a device to measure sand porosity (with increased porosity being directly correlated to presence of indigenous dune plants (de Lange and Jenks 2007). Over a period of 5-10 years, with appropriate establishment of indigenous dune plant cover, dunes can again function as an effective 'shock absorber' for the band of sand between the sea and the land (Plate 6).

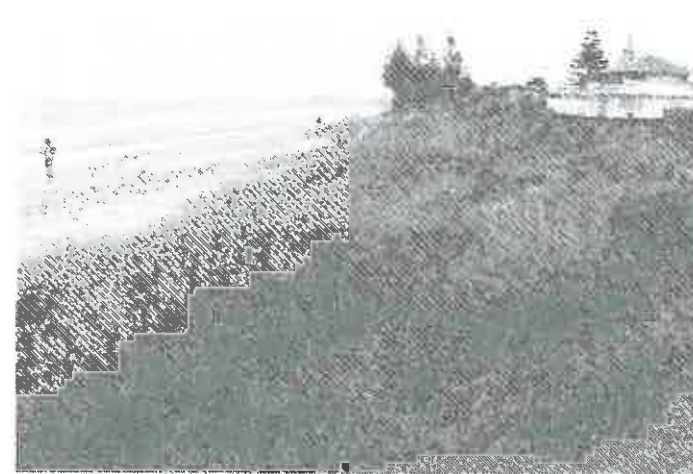
2008

Using increasing knowledge of sustainable coastal management techniques, this dune is now undergoing restoration with functional dune plants. The remnants of the seawall and rocks are now buried beneath the increasingly wide and protective dune. This photo shows the amount of accumulated sand just two years after the initial plantings occurred. Dune building will continue.

Plate 6: Shaw Road dune restoration, 2006.

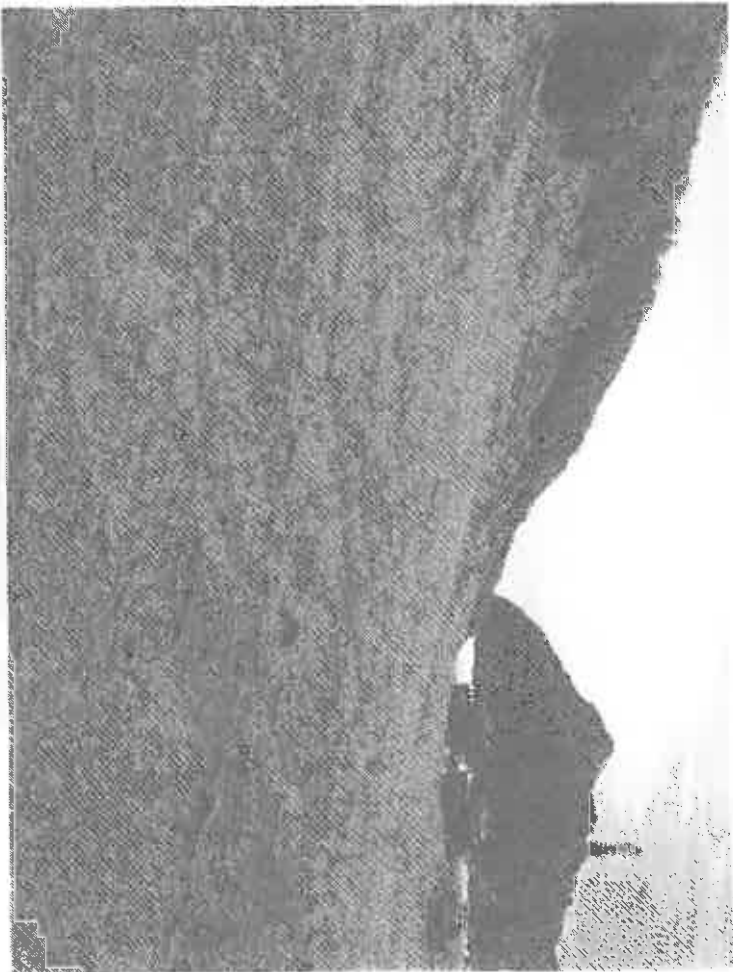
Plate 7: Concave dune face induced by wind erosion.

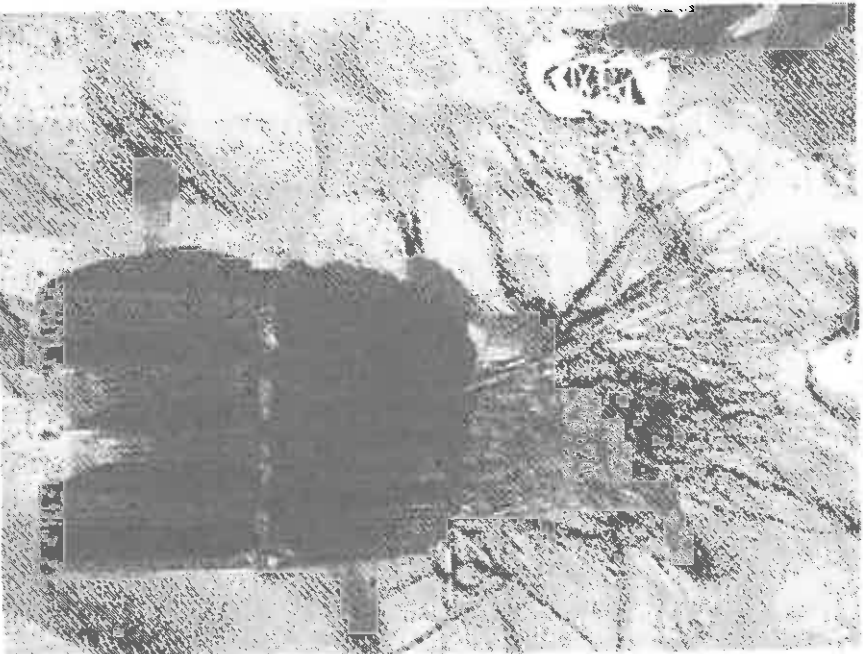
Plate 8: Spintex grown in RTT containers.

Experience indicates that indigenous dune species establish most reliably from Tinus Root Trainer (RTT) stock (Plate 8). The resulting plants are tall and vigorous (top growth must be greater than 40 cm above potting mix level), with roots pre-disposed to grow deeply and so seek suitable moisture before the summer dry period. Plant deeply to ensure that the potting mix is well below the sand surface (at least 100 mm below), with only about 50% of the foliage showing above ground after planting. A useful practice is to leave a shallow depression around the plant to trap any rain after planting. These techniques will ensure that the root mass is not exposed by wind erosion during establishment (see attached Planting Guide). Collar rot fungi are not normally problematic in the dune environment.

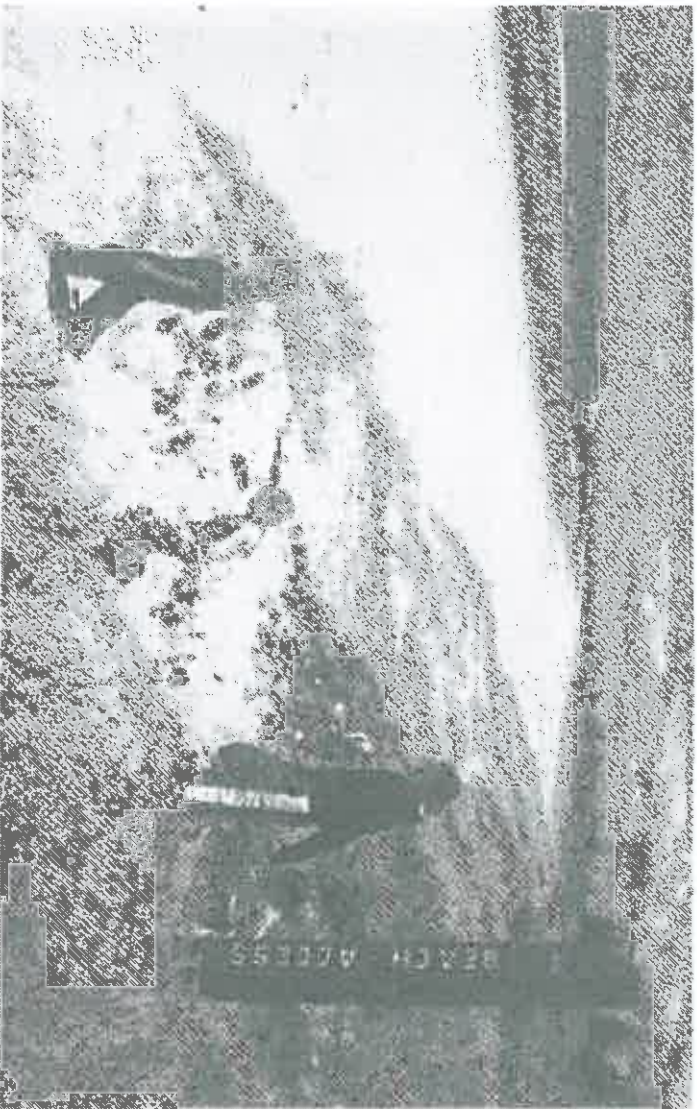
Plate 9: Example of a suitable beach access marker.

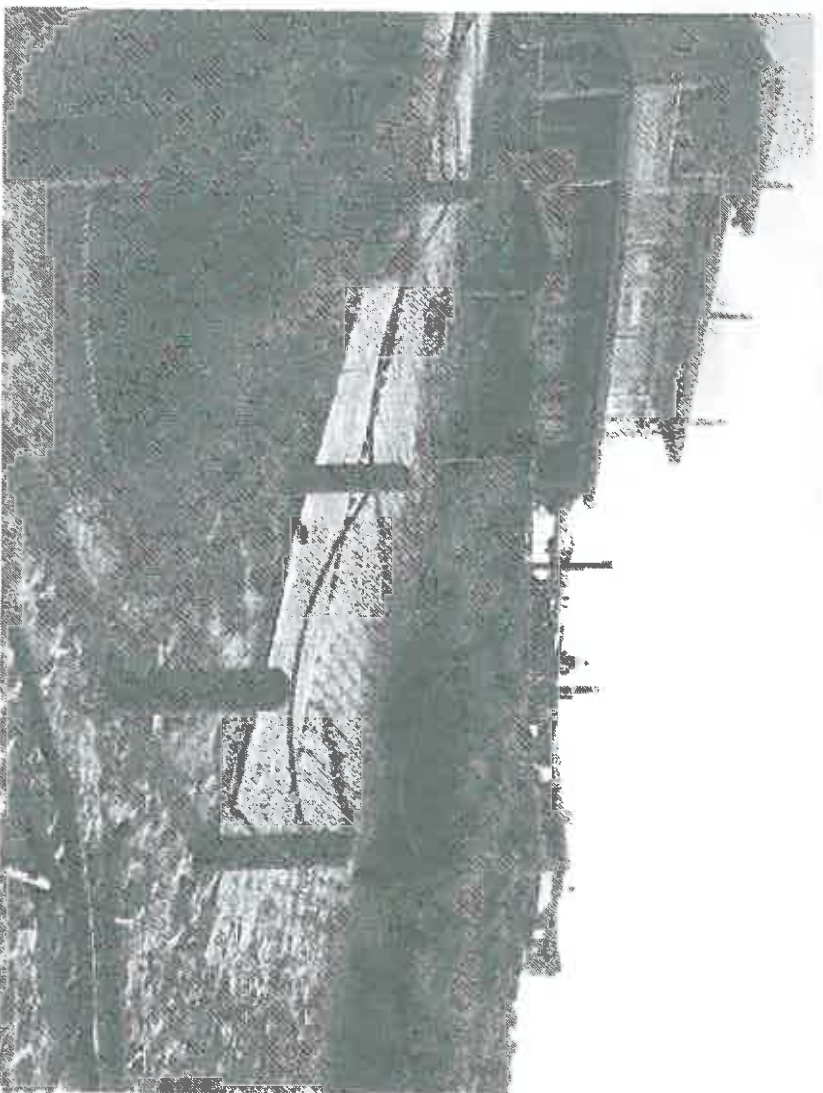
Plate 10a: Example of bollard & rope barrier in use.

Bollards and rope materials for barrier construction are widely available, so a local supplier should be able to assist. Bollards can be replaced with No. 2-sized fence posts if costs are prohibitive. Both options should be about 1.4 m long, with the lower 700 mm placed firmly in the ground, holes for rope or cable (discussed below) should be drilled at a point about 1,300 mm from the base (or 600 mm above ground level), and 100 mm from the top. The rope commonly used is a 30 mm diameter polypropylene 'manila' look-alike. This rope is extremely durable, but is not completely vandal proof. If cost or vandalism is problematic, then 6 mm galvanised multi-strand wire cable is a less-cost and more durable option, especially where used in conjunction with No. 2-sized fence posts.

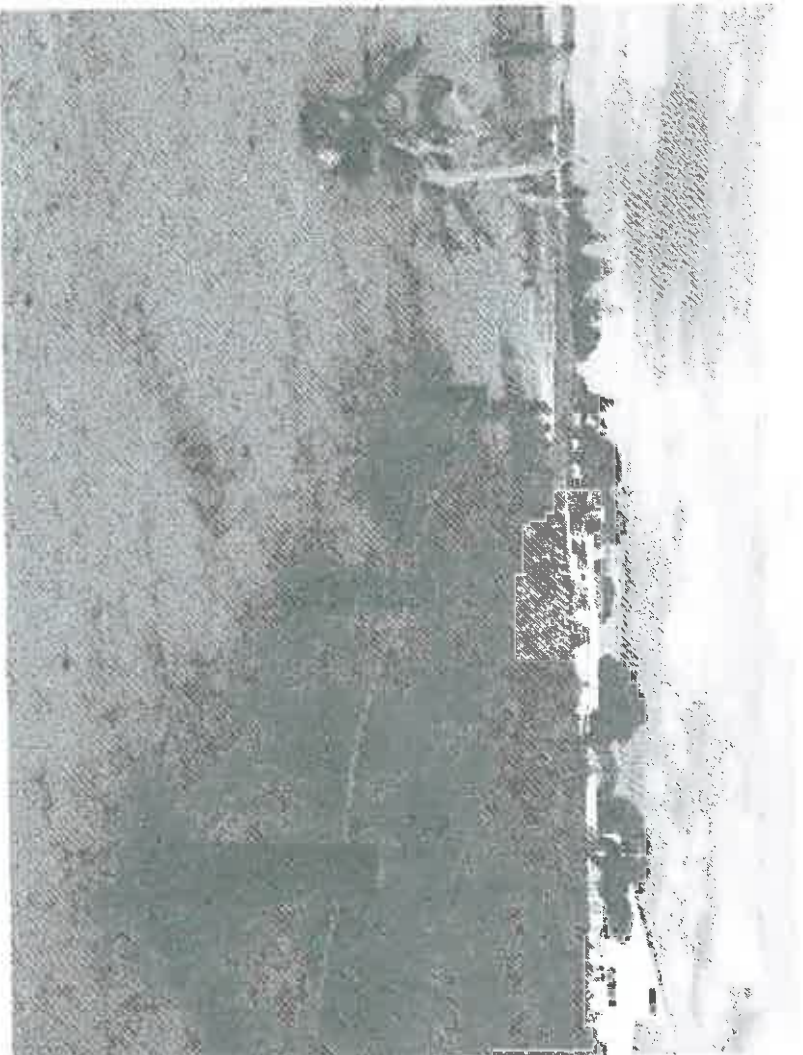
Plate 105: Example of a post and rope barrier in use.

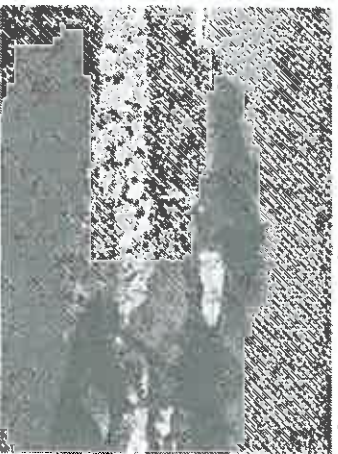
Post and Rope Barrier Guthrie Stream

The post and rope barrier [17m] along the top of the planting is completed except for a final splice. The barrier along the bottom is on hold pending suitable beach conditions. The barrier is being constructed from recycled posts and roped recovered from the temporary assess post and ropes installed up the bank at planting.

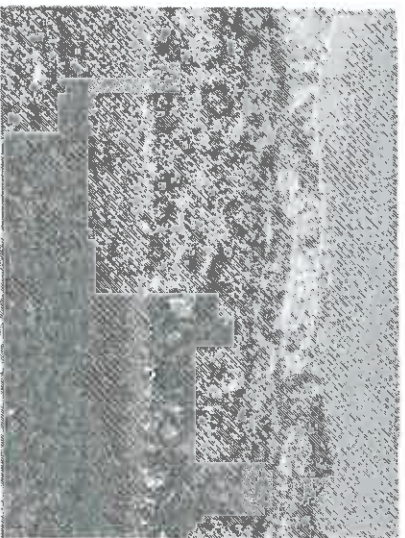
View of eroded sand wedge Profile 9-10

- a. The beach level is at about 500 mm below where it was when the sand wedge was designed by Wildlands Consultants
  - b. The front 5 meters was eroded in a week during calm sea conditions.

- c. All the small rocks left on the beach from the seawall construction have been pushed up the beach to the eroding edge.
  - d. We have already erected 120m of temporary batten, rope and wire barrier of which 90m has been damaged, but has been recovered.

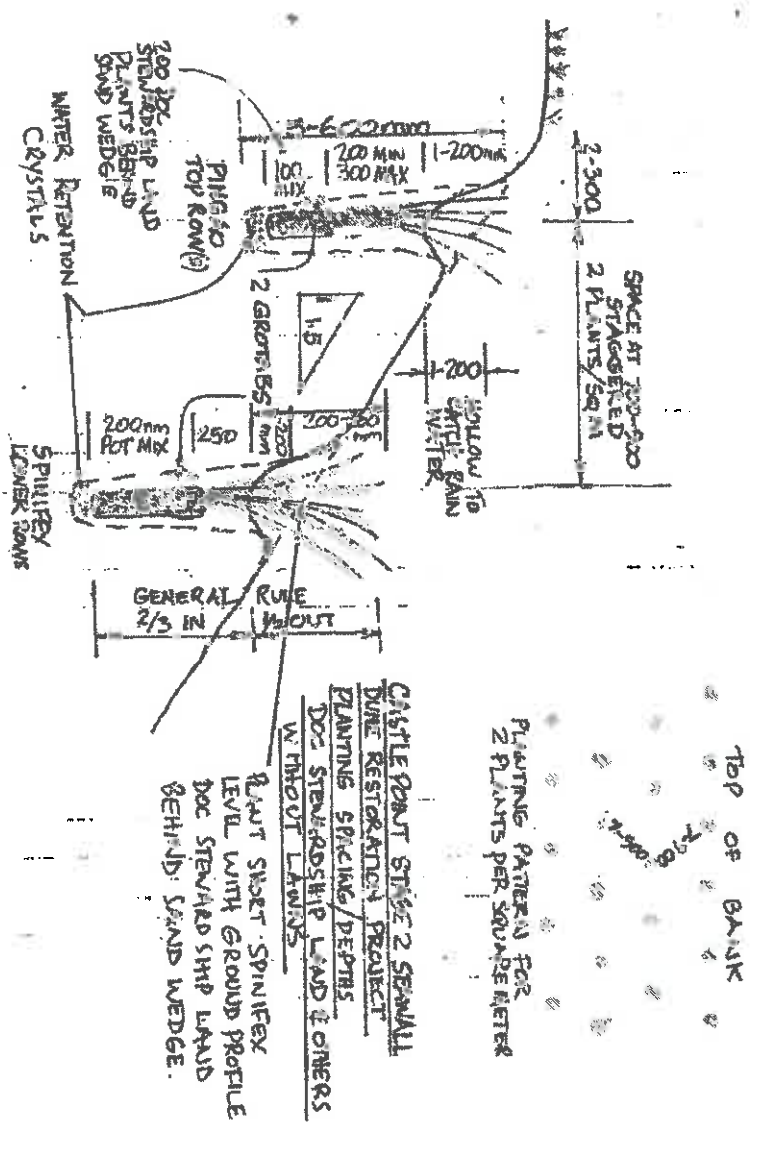
Diagram Planting and spacing Depths Doc Stewardship Land & Other Areas without Lawns

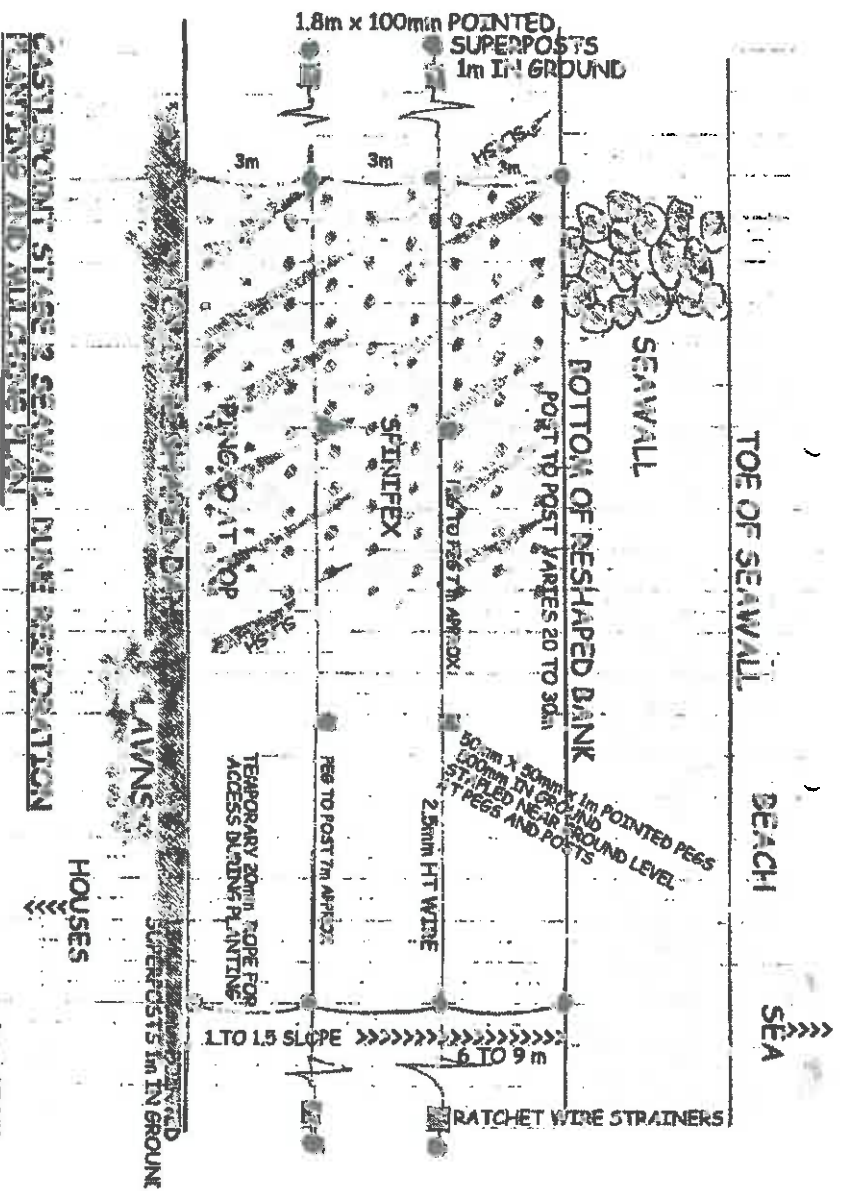
A system of wires to stabilize the slash mulch will need to be placed over the area to prevent severe winds moving the mulch. [See Plan below] Wires will be strained and stapled at ground level.

There will be a post and rope access down the bank at approximately each second property boundary to assist planting and mulching. [See Landscape Plan]

Following planting and mulching the rope access down the bank will be removed. The center posts will remain to anchor the wires. Top and bottom posts can be removed and reused towards the Basin.

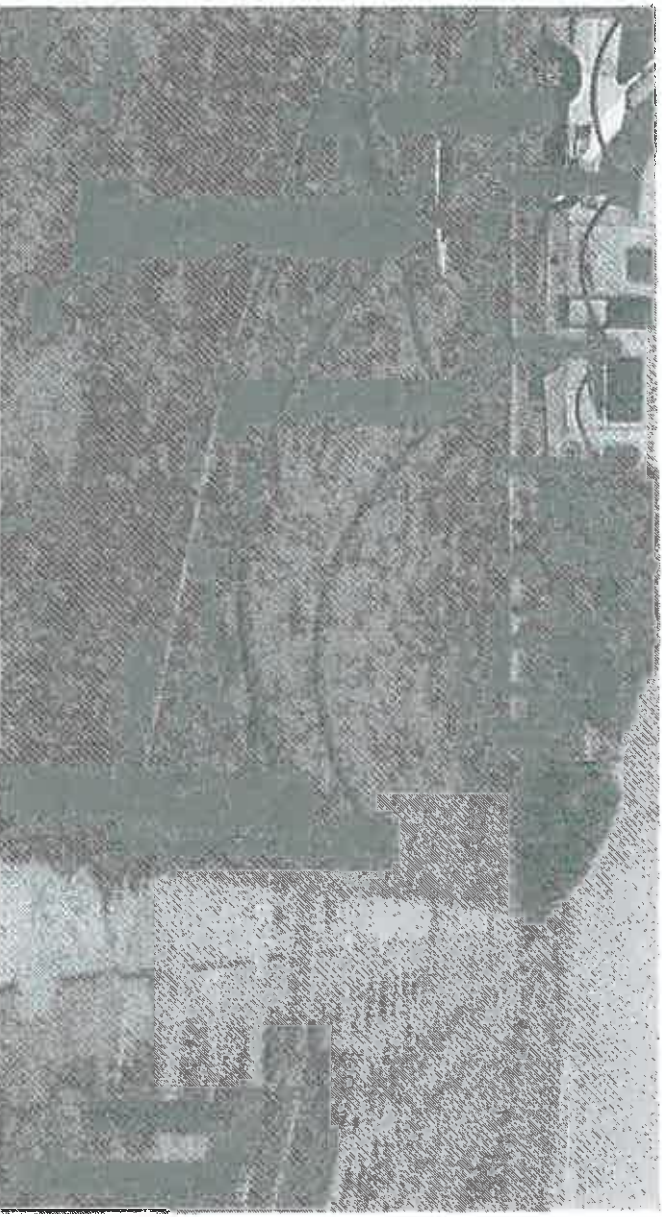
### Foxton Beach Barriers

The photo below of Foxton Beach shows Domelock posts and 32 mm rope

Post and Rope Barriers will be erected following planting and mulching between profiles 1 & 2 and 10 and the Basin to exclude the public from the planted areas. Post and rope barriers using Domelock [straight post] Bollards 175mm No 2 posts by 1.8 m long, hole 35mm hopefully reduced to 32mm or what's recommended for the 28mm polypropylene rope. [Note the ropes swell near the sea and the wood takes up moisture too.] Spacing will be up to 4 meters and less where a more dominant looking barrier needs to be expressed. Bollards 700mm above ground, 1100mm in ground and 2 m clear of plants on sand wedge. This specification is agreed with Doc to match the proposed barriers in front of the upgraded car park. I will order the posts and rope when the MDC issue the consent. Larry Patterson has been requested to provide an hourly rate for post hole boring. [A detailed set out plan will be provided following planting using the Landscape plan as a guide.] Grait Hathaway has been requested to erect publicity signs re Seawall and Dune Restoration. CRRA can re-erect the 'No Vehicles on Beach' sign when doing the Bollards. 8 Mini 'Feet Kill' signs to be erected at strategic places. Keep 2 spare for replacement.
