# COAST CARE AND COASTAL VEGETATION ISSUES FOR SAND DUNES WITHIN THE HAWKES BAY REGION

April 1999

## ABSTRACT

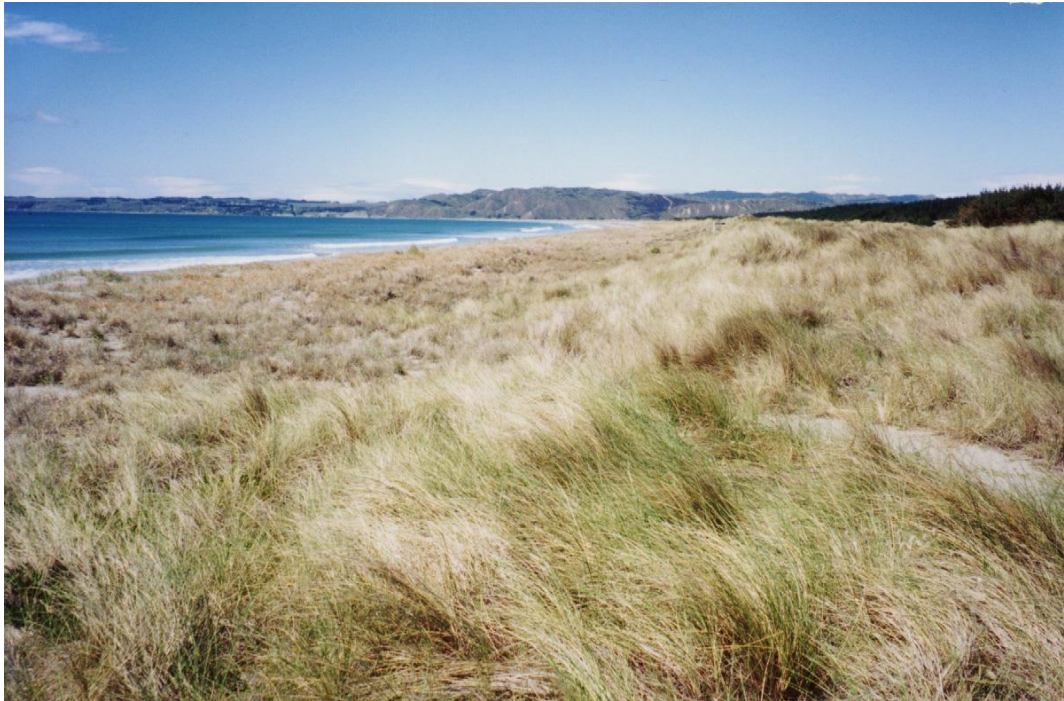
- Beach consists of relatively flat slightly undulating dune system.
- On less disturbed sections of beach south of settlement foredune dominated by spinifex (*Spinifex sericeus*) with some sea rocket (*Cakile* spp.) and back dune with marram grass (*Ammophila arenaria*) (Plate 1).

**Plate 1:** *View of Mahanga Beach to the south with spinifex dominating the foredune and marram grass on the backdunes. Angle accessways across the foredune with some fencing to guide beach users in the heavily used parts of the beach would decrease damage to spinifex cover. Photo David Bergin.*

- Provide basic accessways at 2-3 points which may only need to be post and wire fencing.
- Plant small groups of low-growing indigenous ground cover and shrubs (refer to Appendix 1 for species) as vegetation buffer along parts of scarp between access points.
- In areas immediately south of toilet/main carpark provide post and wire accessways from backdunes to beach. Angle accessways through foredunes with Y-shaped junctions where appropriate to prevent onshore winds funnelling sand toward backdune areas (Plate 1).
- Boost spinifex strip on foredune with application of Urea at rate of 200kg N/ha. On backdunes remove pampas and discourage dumping of garden waste and planting of exotic and garden ornamentals.

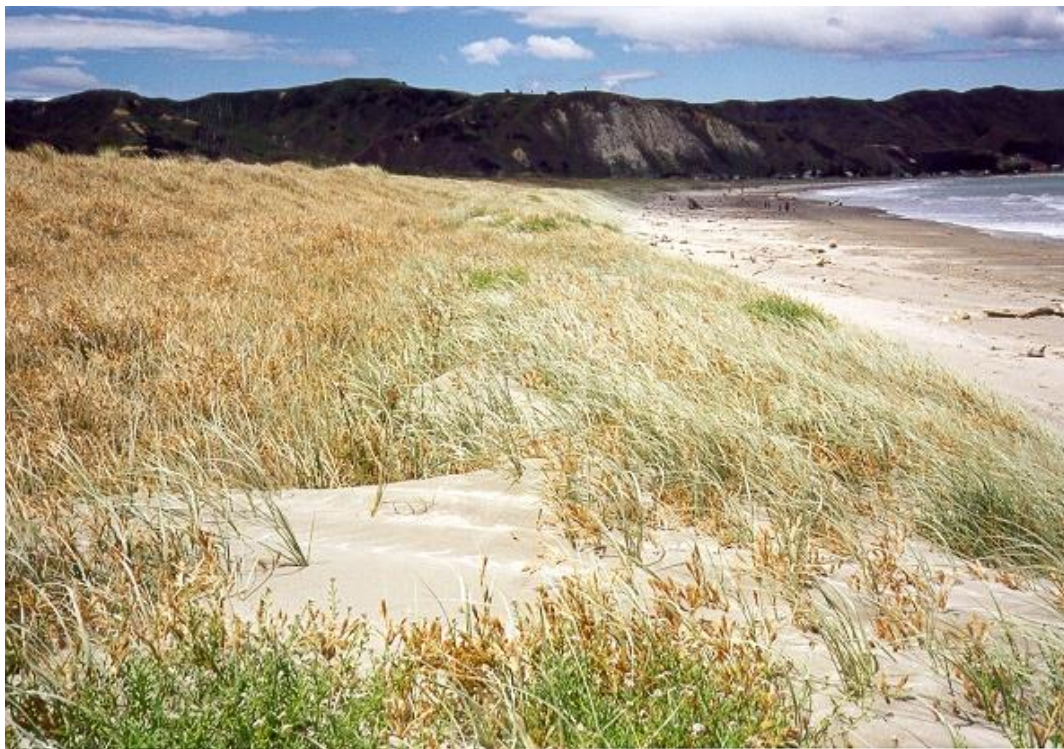
- Appears that public usage along accessways leading from small carparks on roadside is causing minimal damage (Plate 2).
- Accessways and small informal carparks at intervals along the length of this beach may be assisting to spread public use and therefore minimising impact on vegetation cover over a wide area.

**Plate 2:** *An excellent cover of spinifex covering the foredunes along Opoutama Beach with marram grass dominating the backdunes. Narrow unfenced walking tracks serving as accessways from the road to the beach are not detrimentally affecting dune vegetation. Photo Sally Hobson.*

- Fencing not required at this stage unless beach user numbers increase and damage to dune vegetation cover becomes apparent.

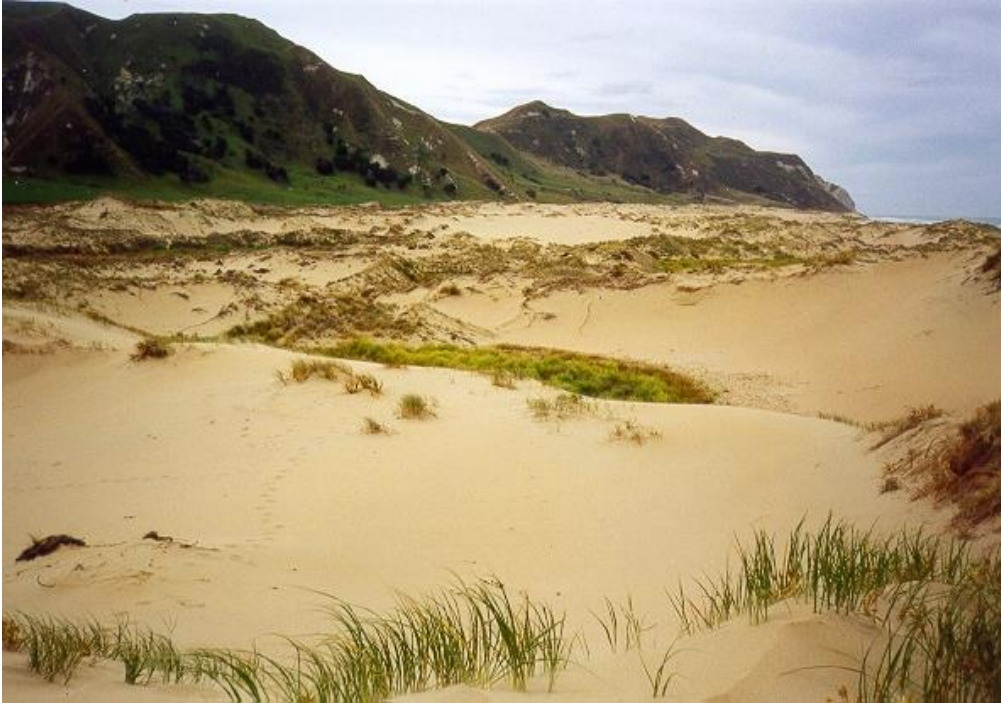
- The northern end is a 1 km wide sand dune complex consisting of a series of irregular hummocky dunes with spinifex and occasional patches of pingao (refer to Partridge 1992 for further detail) (Plate 3).
- Significant areas of bare sand in large sand drifts. Marram grass on backdunes with blackberry and rushes in dune slacks. Occasional clumps of sand coprosma (*Coprosma acerosa*). Pingao seedheads ready for harvesting in late December.

- Partridge (1992) identifies this as a dune/vegetation complex of high ecological value.
- Some sign of stock wandering through. Dune system fenced with a mixture of electric and standard fence materials. Fences in area inspected appear adequate.

**Plate 3:** *The northern end of Ocean Beach comprises a sand dune complex up to 1 km wide has high ecological value. Marram grass occurs on backdunes with patches of spinifex and occasional pingao on the hummocky dunes seaward. Deflation sites are dominated by a range of rush species and some blackberry. Continued maintenance of fencing along the backdune is essential. Photo Sally Hobson.*

- Encourage station owners/managers to maintain good fencing to protect this significant coastal site.

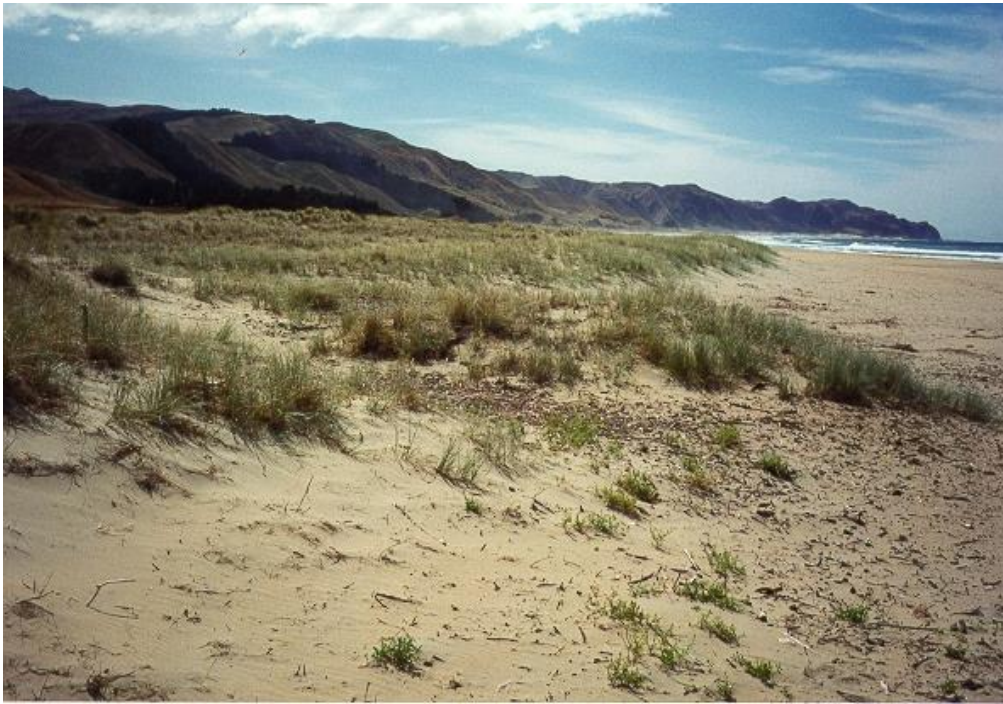
**Plate 4:** *This relatively stable spinifex-dominated foredune and marram grass-dominated backdune is adjacent to a proposed subdivision immediately north of the settlement at Ocean Beach. Planning should include provision of fencing and accessways to allow access to the beach and protection of the vegetation. Photo Sally Hobson.*

- Dunes appear relatively stable.
- Proposed new subdivision by Haupouri Station immediately north of present coastal settlement on flat area between spinifex/marram grass dune system and base of steep grazed scarp (Plate 4).
- Proposed retirement and revegetation of grassed steep hill side immediately landward of proposed subdivision.

- Work with developers and station owners to ensure sufficient set back of subdivision, provision of formal accessways and fencing to protect marram grass/spinifex dune system (Plate 4).
- In collaboration with station owners, consider establishment of a range of trials evaluating hardy exotic and indigenous species and revegetation strategies (eg., planting pioneer species, fencing only...) for revegetation of the exposed seaward facing scarp.

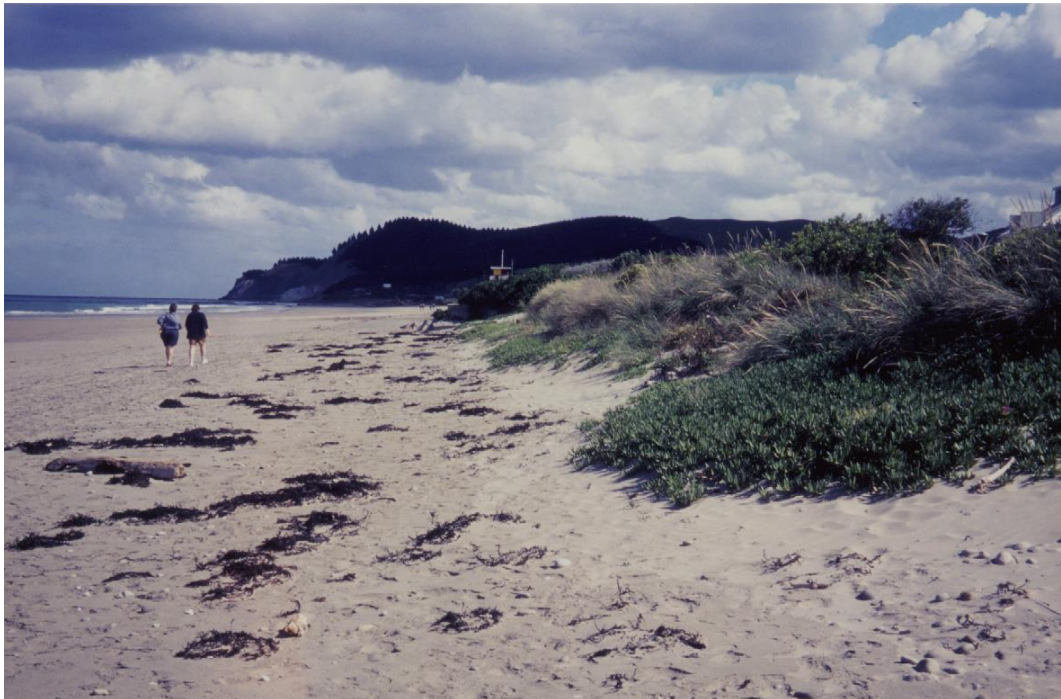
- Local support for armouring of beach due to infrequent storm damage and apparent success of rock walls along southern part of beach.
- Informal access paths and boat launching sites north of surf watch tower is damaging foredune vegetation.

**Plate 6:** *North of the surf life saving tower at Waimarama Beach, scope exists for the planting of groups of spinifex and pingao in gaps along the foredune amongst the patches of spinifex, marram grass and ice plant. Fertilising existing spinifex with urea is also recommended. Establishment of a well-vegetated dune is an alternative option to armouring the beach with rocks as has been carried out along the southern section of this beach. Photo David Bergin.*

- The remaining section(s) of the beach which have not been armoured as yet could provide the local community and managing agencies with a good opportunity to demonstrate effectiveness of sand binding vegetation in building up a foredune to provide erosion control and a more user-friendly beach system (Plate 6).

- Scope for planting gaps with small groups of pingao and spinifex and selectively fertilising existing spinifex clumps with fast-release fertiliser.
- Need to improve access to beach along sections without armouring so that locals and other beach users do not trample on vegetation.

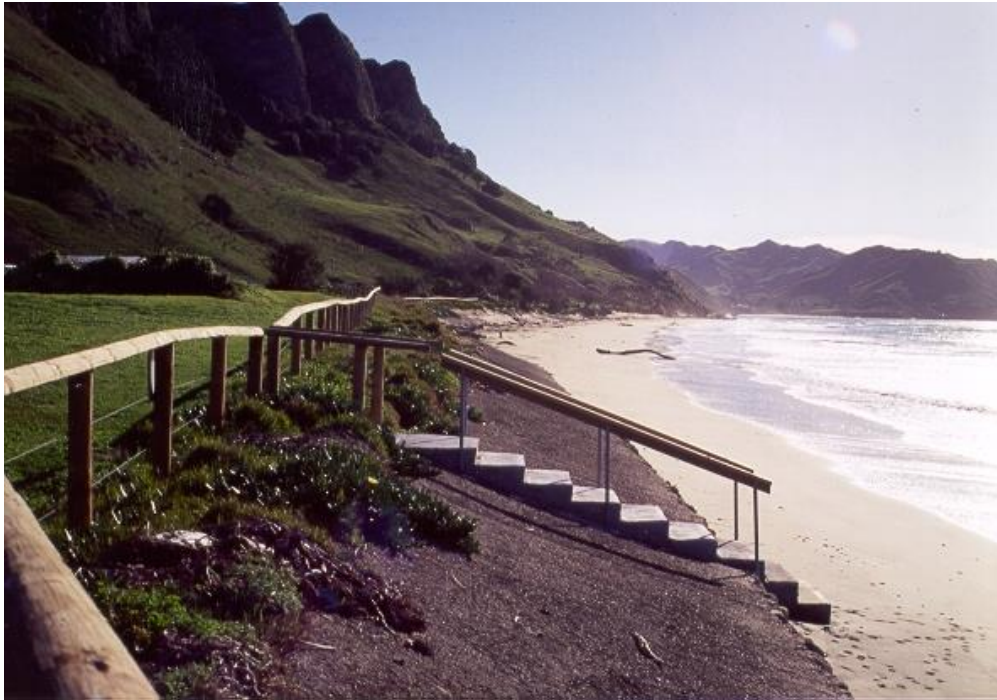
- Short distance between mean high water and grassed parking area resulting in a steep dune system.
- Beach dominated by a steep, sloping concrete wall along a considerable section of beach. Early attempts at armouring using railway irons, vertical concrete walls, wooden walls, netting and rocks along part of beach to the north (Plate 7).

- Armoured sections of beach largely without vegetation along foredune zone and consequently with low natural character.
- Steep access over a short foredune system with some sand movement over top during high onshore winds (Plate 8).
- Early erosion-control structures largely ineffective and unsightly.

**Plate 7:** *Armoured sections along most the Kairakau Beach has resulted in low natural character and virtually no beach at high tide. Beyond the walls toward the northern end, there may be scope to plant some native sand binders to trap sand and build up a small dune in the vicinity of scattered clumps of marram grass. Photo Sally Hobson.*

- Some sand movement along concrete walls with perhaps some scope to establish a zone of sand binders although likely to be difficult unless there is a reasonable build-up of sand (Plate 8).
- At northern end beyond concrete wall, could plant pingao and spinifex in gaps between marram grass clumps to trap sand and obviate the need to extend wall.

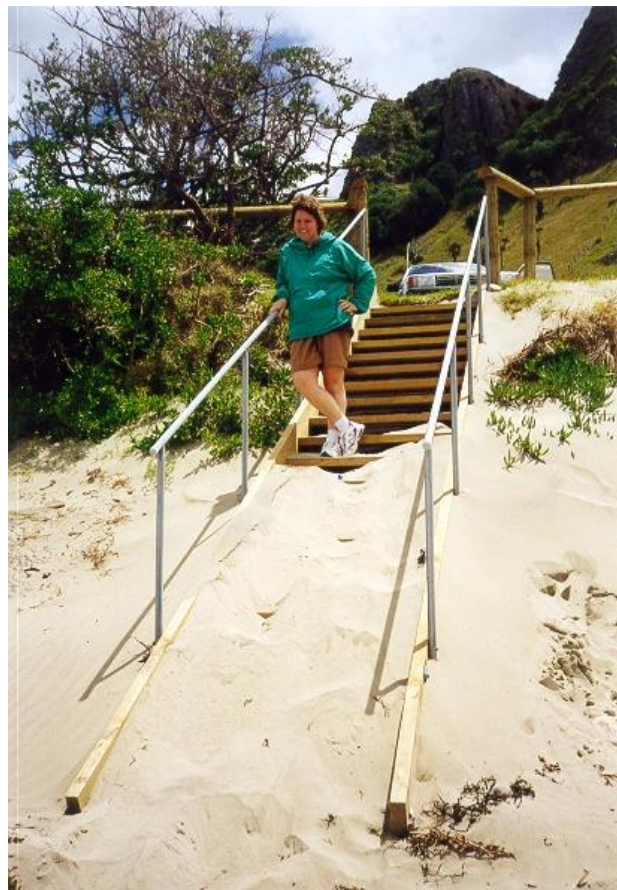
- Recently constructed steps and handrails as accessways over armoured sections of beach. Some inundation of lower parts of stepped accessways covered in sand within a few weeks of placement indicates considerable movement of fine sand along this beach.

**Plate 8:** *Recently constructed steps give access to the beach along the central portion of Kairakau Beach. Considerable movement of the fine sand since construction one month earlier covering lower steps indicates that revegetation of a zone of native sand binders could be attempted. Success will depend on a continual build of sand to create a small foredune and no storms during the critical establishment phase. Photo Sally Hobson.*

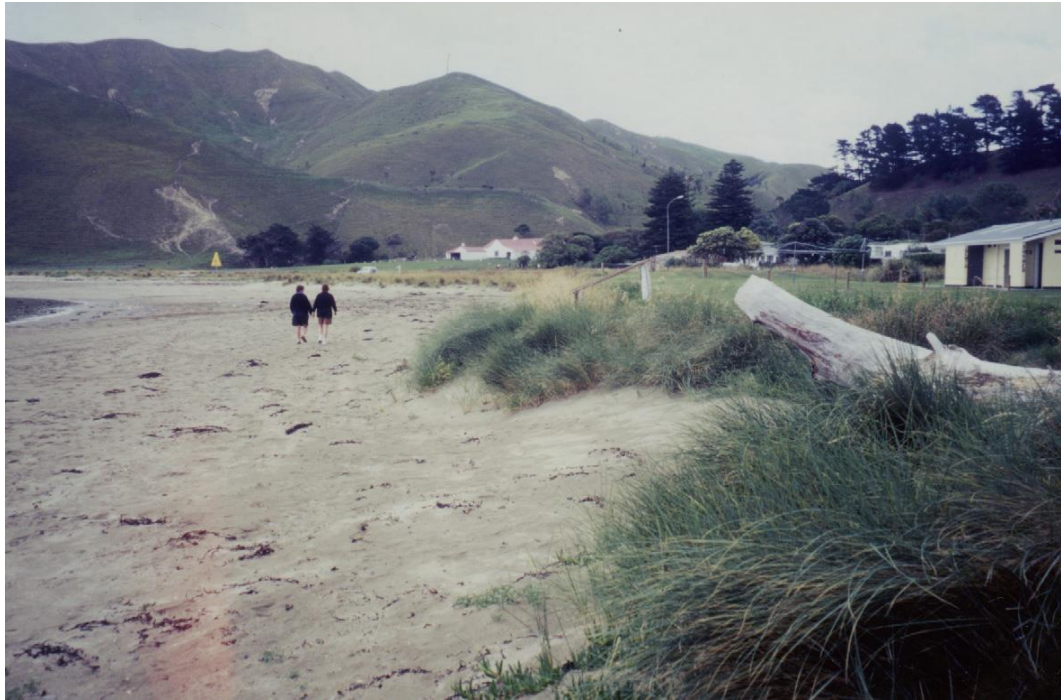
- Small flat dune system dominated by marram grass with kikuyu grass (*Pennisetum clandestinum*) on inland sites. Dense narrow band of healthy sand carex (*Carex pumila*) between marram grass and high water mark (Plate 9).
- Dune system appears to be relatively stable.
- No formal accessways.

- Increasing pressure on this beach due to marine reserve off-shore including buses of school children.

**Plate 9:** *Increasing pressure on Blackhead Beach due to the marine reserve will inevitably result in degradation of the dune vegetation. Low-cost, minimal post and wire fencing would be effective in guiding beach users to the beach along defined accessways and afford protection of the relatively flat dune system dominated by the exotics, kikuyu and marram grass. Photo David Bergin.*

- Could provide minimal post and wire fencing along backshore areas with accesses to beach where appropriate to protect existing vegetation.

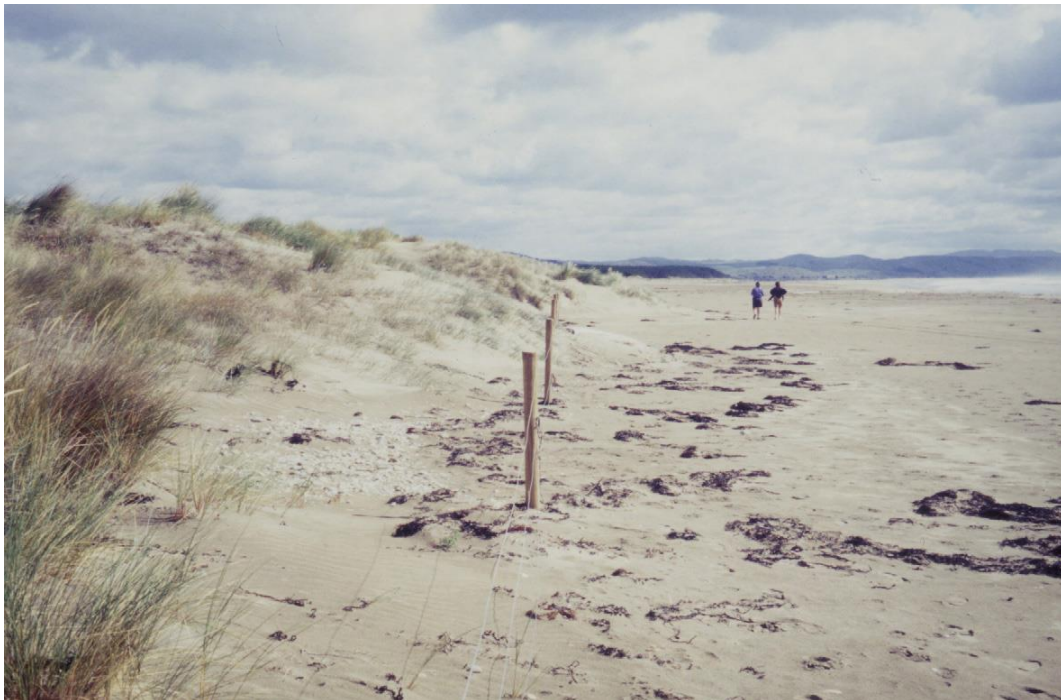
- A narrow dune in front of housing with spinifex and marram grass dominated foredune with occasional patch of pingao (Plate 10).
- Wider dunes further north in front of free camping area with spinifex along foredunes. Backdune with marram grass, knobby club rush, lupin (*Lupinus arboreus*) and scattered pines.

- Fencing along foredune at high water mark vulnerable to sand burial and undermining.
- Local school community keen to raise sand binding plants for revegetation of dunes.
- Vehicle access provided to beach.

**Plate 10:** *A relatively narrow foredune exists in front of housing at Porangahau Beach with fencing along the high water mark to deter trampling. Excellent sites along the seaward face of the foredune could be planted with small groups of pingao and spinifex seedlings. Fertilising existing spinifex cover to encourage spread of runners to bare sites will assist in developing a vigorous cover. Photo David Bergin.*

- Excellent sites along the foredunes in front of houses for planting bare sites with groups of pingao and spinifex seedlings (Plate 10).
- Could also encourage spinifex runner growth into bare areas by fertilising.
- Keep fencing simple and inexpensive along front of these foredunes where burial or excavation is likely to occur.
- Constant maintenance of accessways along informal camping areas is essential to prevent degradation of dune vegetation by beach users. Spinifex dunes immediately landward of the seaward face of these dunes would benefit from fertilising.
- Maintain signposting to encourage beach users to use four wheel drive vehicles at low tide and to keep off vegetation.
