**Lessons From The Past -
A History of Coastal Hazards at
South Brighton Spit, Christchurch.**

A thesis
submitted in partial fulfilment
of the requirements for the Degree
of
Master of Arts with Honours in Geography
in the
University of Canterbury

University of Canterbury
1995

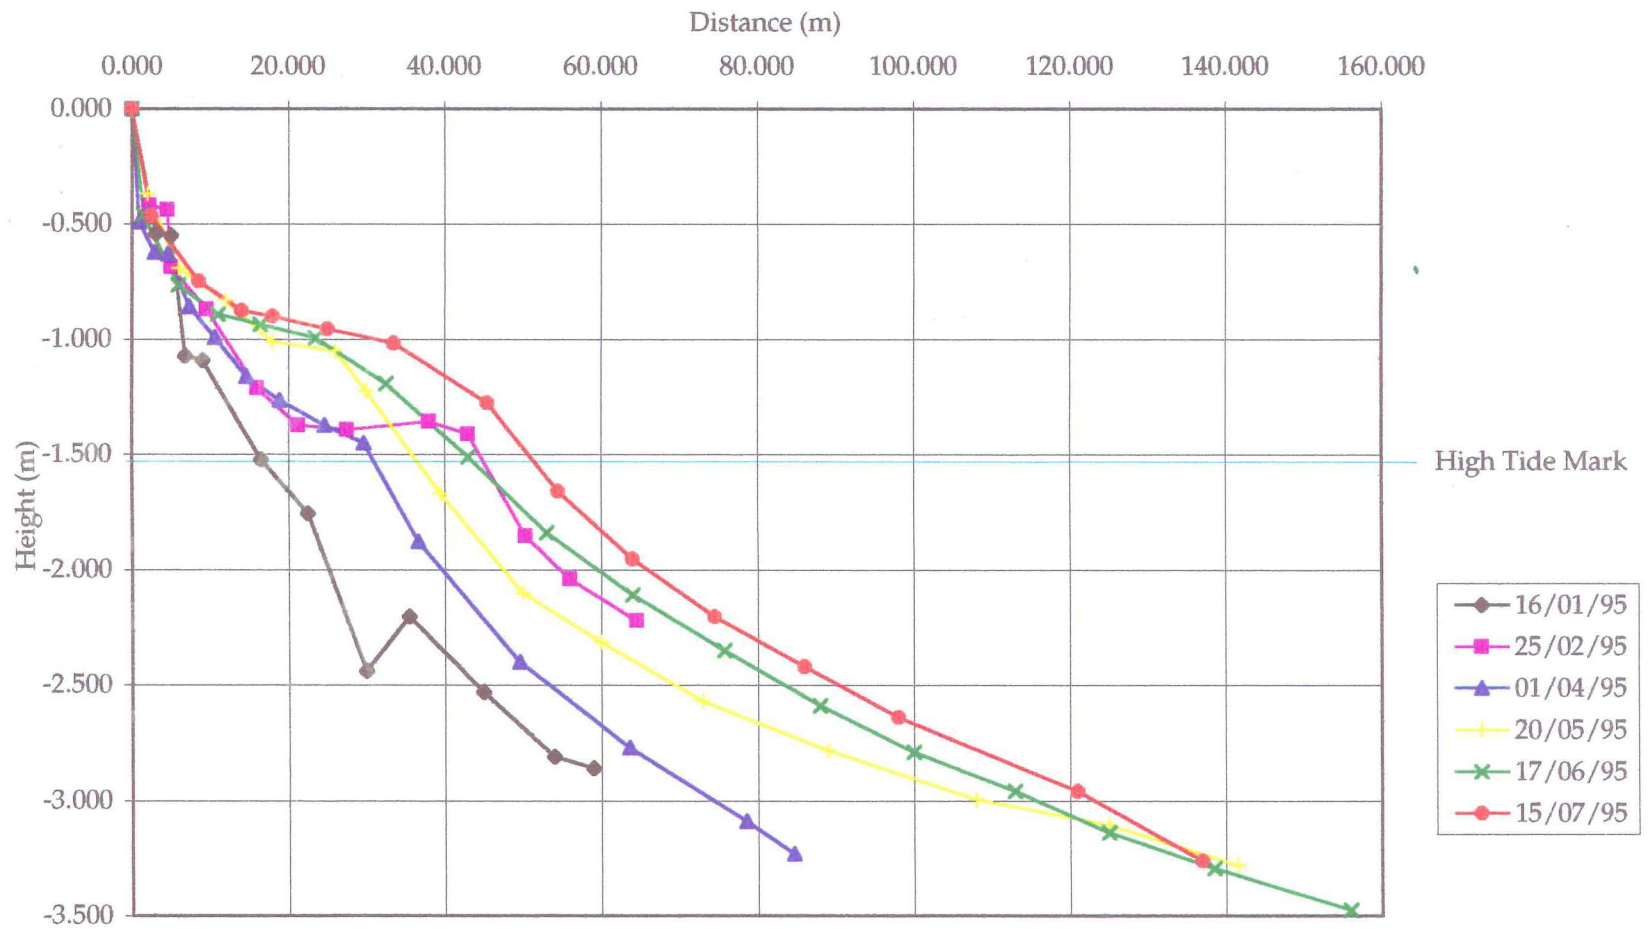
Figure 4.4 Monthly Surveys at Profile Site Three

Profile Three, located perpendicular to the end of Rockinghorse Road, shows major variations between surveys (Figures 4.1 and 4.4). Between the first and second surveys there was deposition of sediment. A small dune developed in front of a 1.8 metre scarp and a further berm is noticeable about 40 metres from the scarp. Between the second and third surveys, however, the small dune disappeared, while the berm in the second survey moved up the beach by about 10 metres and there was a loss of sediment from this point seawards. The fourth and fifth surveys show little variation over the landward 10 metres, however from this point outwards there was accretion of sediment. The final survey on 15 July 1995, shows the small dune developing again, with more deposition over the whole beach. The scarp noticed at the first two profile sites on 15 July 1995, was not evident at this site. In total over the six month survey period about one metre of sand, in terms of depth, and a volume of $6.04 \text{ m}^3 \cdot \text{m}^{-1}$ was deposited on the beach. The change in this profile may be explained by its close proximity to the channel of the Avon-Heathcote Estuary which is known to fluctuate in its position between the spit and Shag Rock.

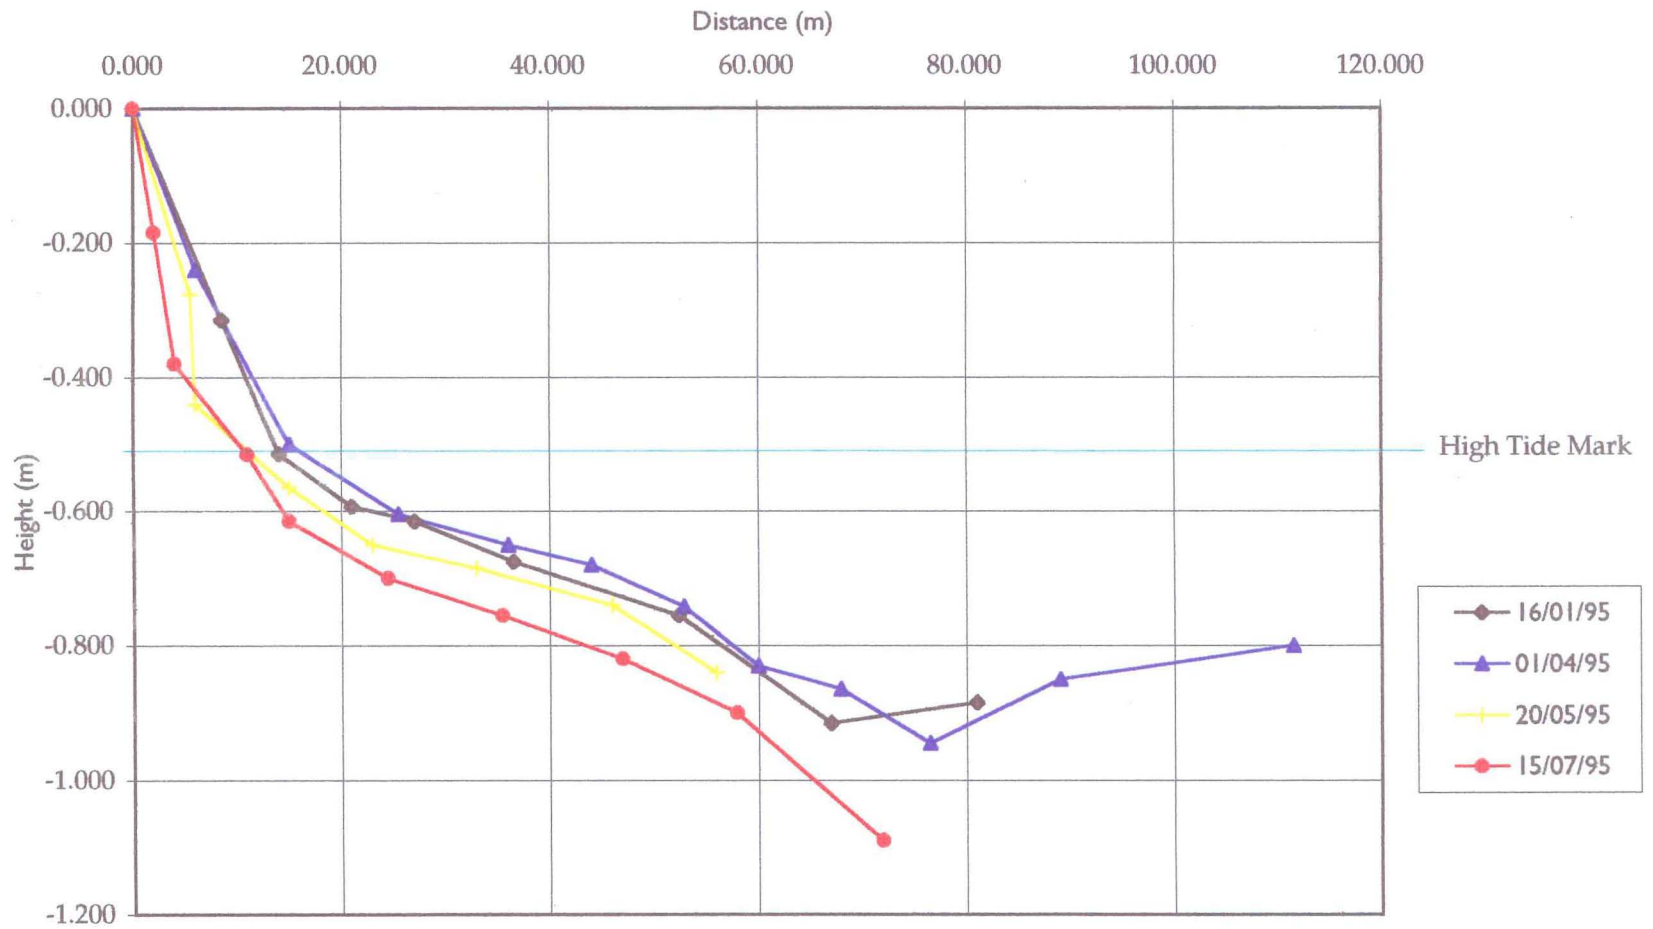
Figure 4.6 Monthly Surveys at Profile Site Five

Profile Five is the first of two profile sites that were established on the estuary side of South Brighton Spit (Figure 4.1). As stated above, this profile site used a Wildlife Reserve signpost at the edge of the estuary margin as the starting point for the surveys. The results of the four profiles taken over the six month survey period are shown in Figure 4.6. There was very little change between the first and second surveys, with the exception of a small movement westward of about 5 to 10 metres of a small channel. This channel is thought to be one of many small meandering channels through which an incoming tide will fill the estuary. Between the second and third surveys there had been some scouring about 10 metres out from the signpost, while the final profile shows a substantial amount of scouring. This latter scouring is most likely due to the very high and low tides experienced in the week before the profiling was carried out. Over the six months of surveying this site has lost $1.75 \text{ m}^3 \cdot \text{m}^{-1}$ of sediment. The channel visible in the first and second surveys, and shown by the dip in the profiles, was not present when the third survey was undertaken. However, by the fourth survey the channel had reappeared, and it was at the edge of this channel that the final survey stopped. This was due to the time the survey was done, as the tide was starting to rise, and the channel was about 0.6 to 0.9 metres wide and 0.15 metres deep.

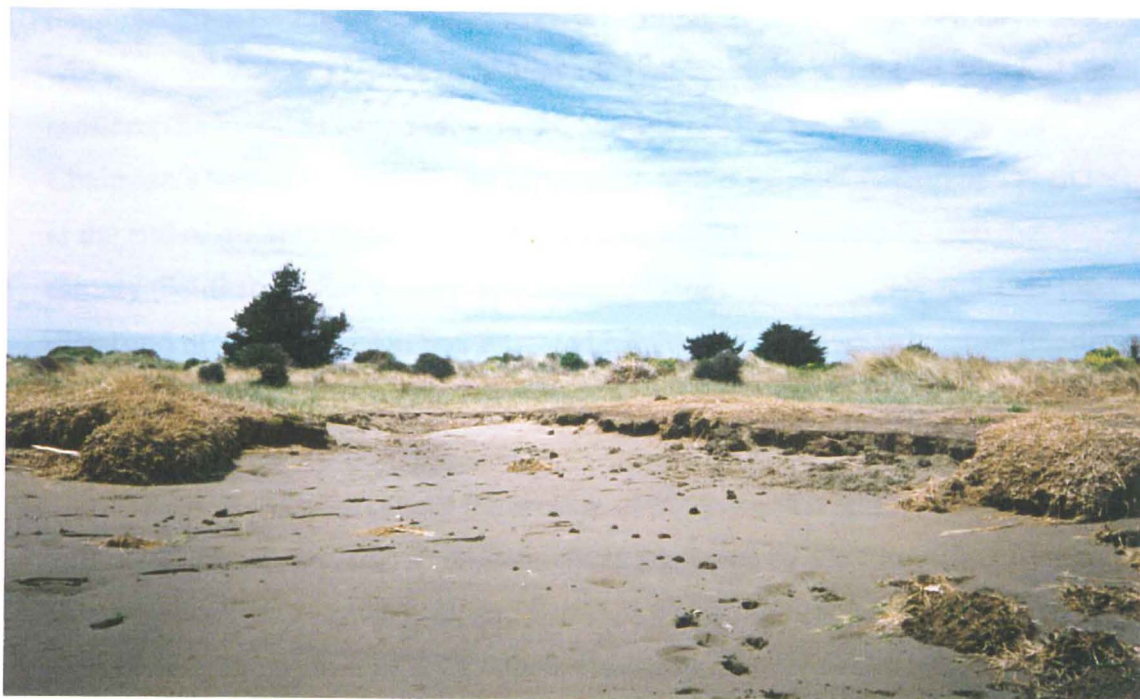
Plate 4.2 **Cut into Estuary as Distal End of South Brighton Spit.**

From the area portrayed in Figure 4.12 to just south of Tern Street, there was no vegetation in 1977, and this has remained the case. Erosion in this section consists mainly of the undercutting of property boundary walls by the estuary as it rises and falls from low to high tide. Further towards the south, on the recurved part of the distal end of the spit, the estuary has been cutting into the spit, as shown in Plate 4.2. Under the definition of hazard used for this study, the erosion of this section of the spit does not constitute a hazard as there is no human use of this area. The area is part of a reserve. If however, the erosion was to start threatening the properties east of this section then this erosion would be defined as a hazard under the terms of this study.

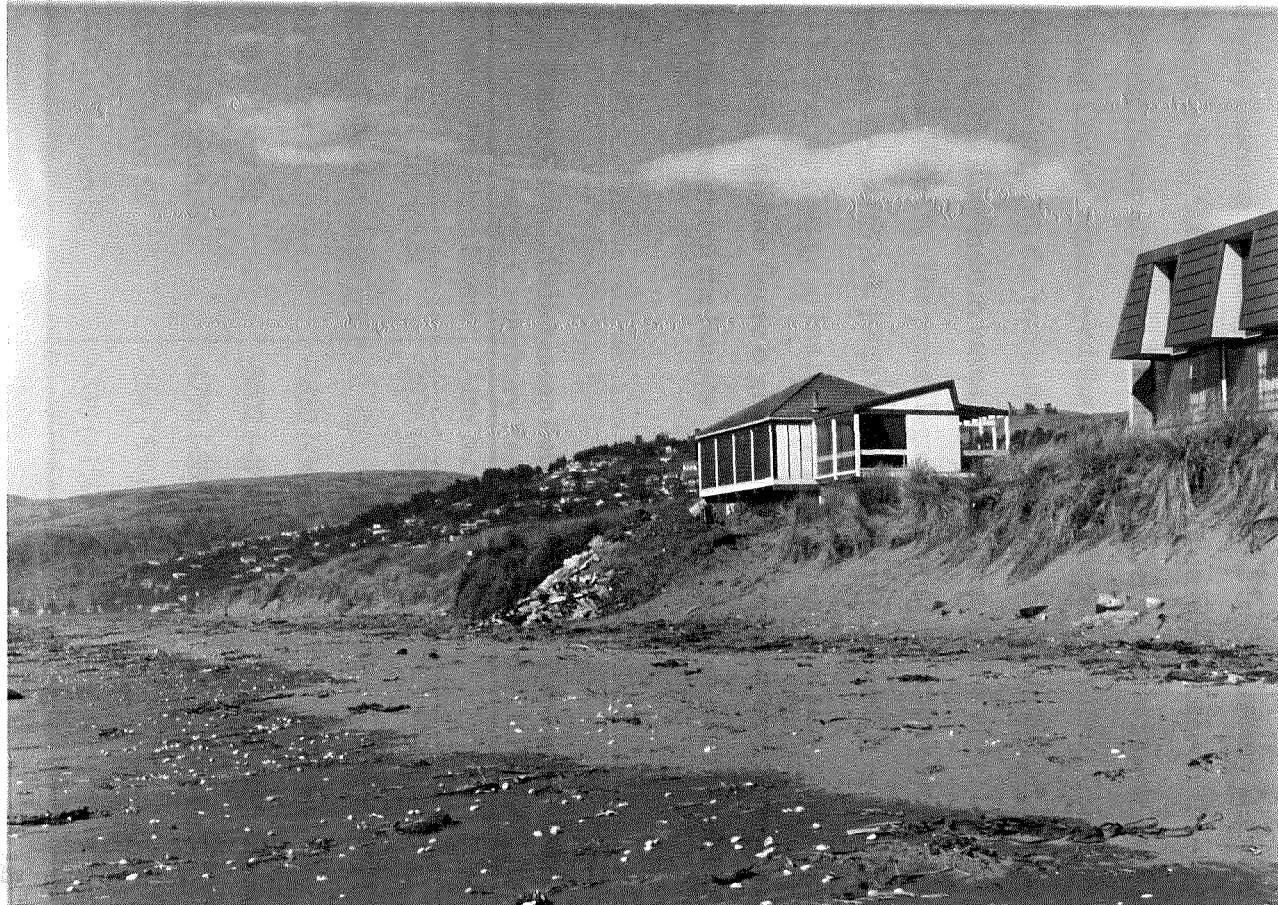
Plate 4.4 Scarp from 1977 Erosion Events - Torea Lane 1978
Note the 'protective' rubble to the left of photo and the overhang of the house
(Photo: R.M.Kirk, University of Canterbury)

At South Brighton Spit, it was again the houses located on the beach at Torea Lane that were threatened by this storm. By 1977 the middle house, as shown in Plate 2.1 had been built and the beach in front of these houses had recovered from the 1964 storm. As stated above, the erosive effects of this storm were not as great as those experienced in August 1964, although the beach in front of these three house was again scarped and lowered (Kirk, 1978). The protective works that were put in place in 1964 were still buried at this time. In the following two months there were subsequent storms, which although not occurring with higher than normal tides, were acting upon a beach that was already severely depleted and narrower than before the July 1977 storm. A storm at the end of August 1977, was particular severe, in that it pushed the face of the scarp in front of the houses back a further 5 metres, bringing it to within 10 metres of the houses (Kirk, 1978). The storm also lowered the beach by a further metre, exposing the 1964 protective works, and threatening both the protective structure and the scarp with further attack. It is believed that over 500 m³ of sand was removed from in front of these houses during the August 1977 storm (Kirk, 1978). With the exposing of the 1964 protective works by this and subsequent storms in September 1977, it was discovered that some of the drums were rusting, and the structure was strengthened with the addition of more rubble-filled drums (Kirk, 1987, Plate 4.4). In studying the 1964 and 1977 storms, Kirk (1978) identified a 10 to 15 year 'cycle' in which such storms occur.

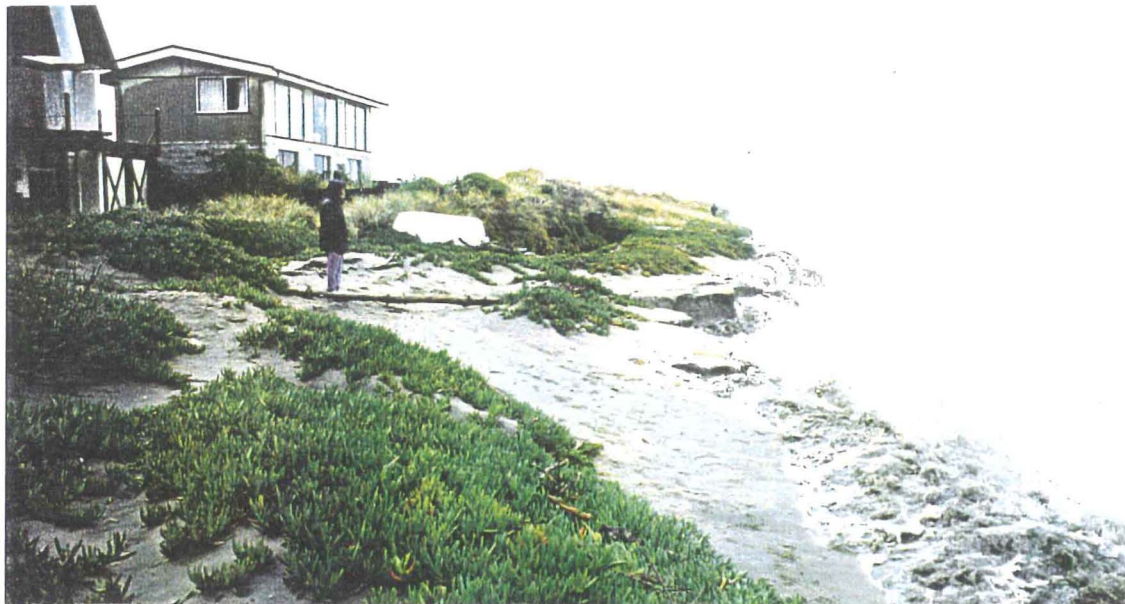
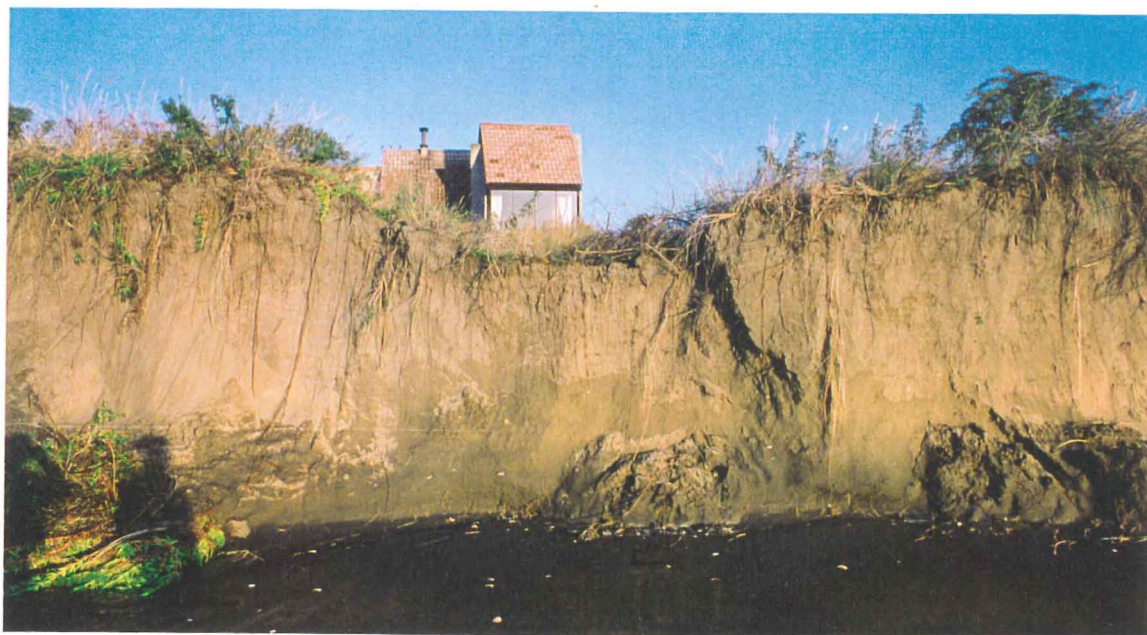
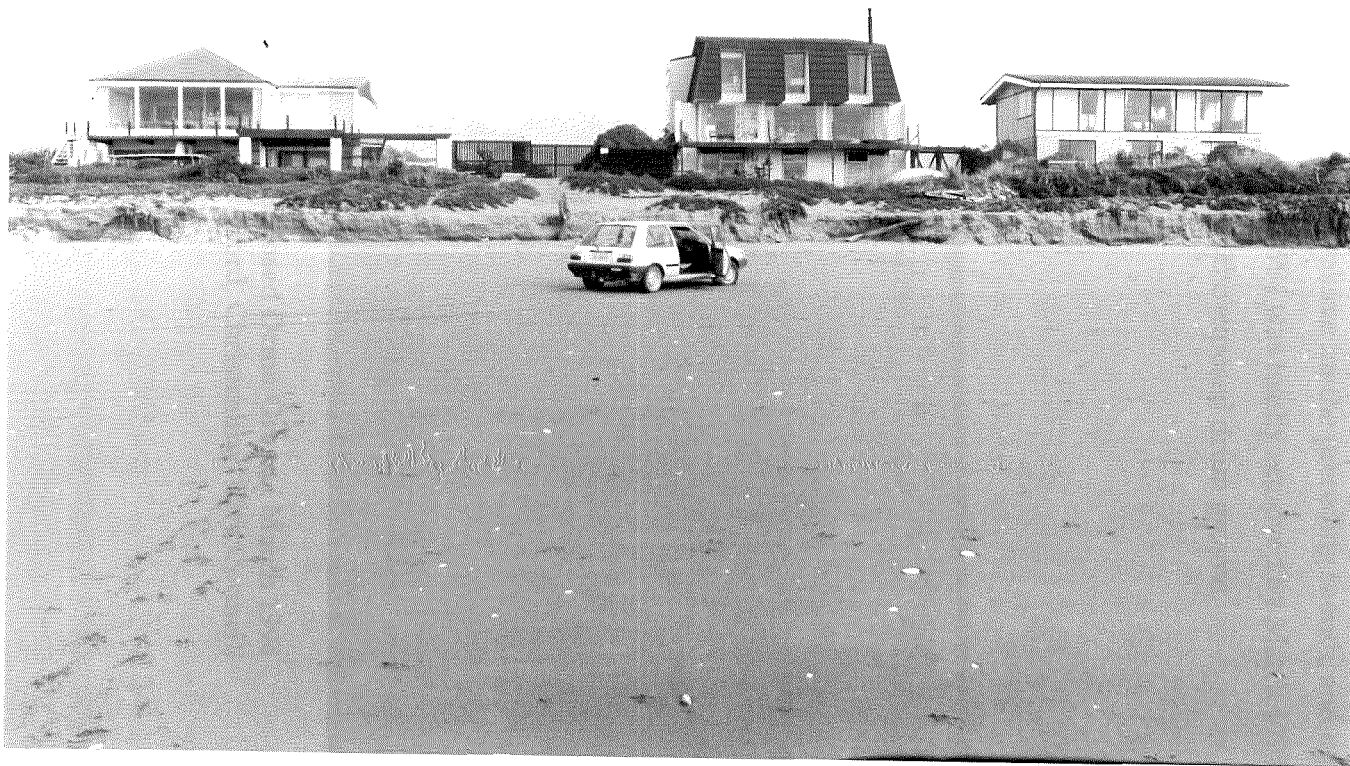
Plate 4.5 Torea Lane 28 August 1992, 4.30 pm.
(Photo: Ian Ellingford, Christchurch City Council)

Plate 4.6 Scarp in Front of Last House on Rockinghorse Road, August 1992.
(Photo: Ian Ellingford, Christchurch City Council)

Plate 4.7 Erosion From August 1992 Storm - Torea Lane
(Photo: Derek Todd, Canterbury Regional Council)

whole of South Brighton Spit this storm caused severe damage to both the dunes and beach. The severity of the August 1992 storm can be seen in Plates 4.5, 4.6 and 4.7. Note that the scarp shown in Plate 4.6 is within 20 metres of the house in the background. This photograph was taken about two metres to the north of the third profile site used for this study.

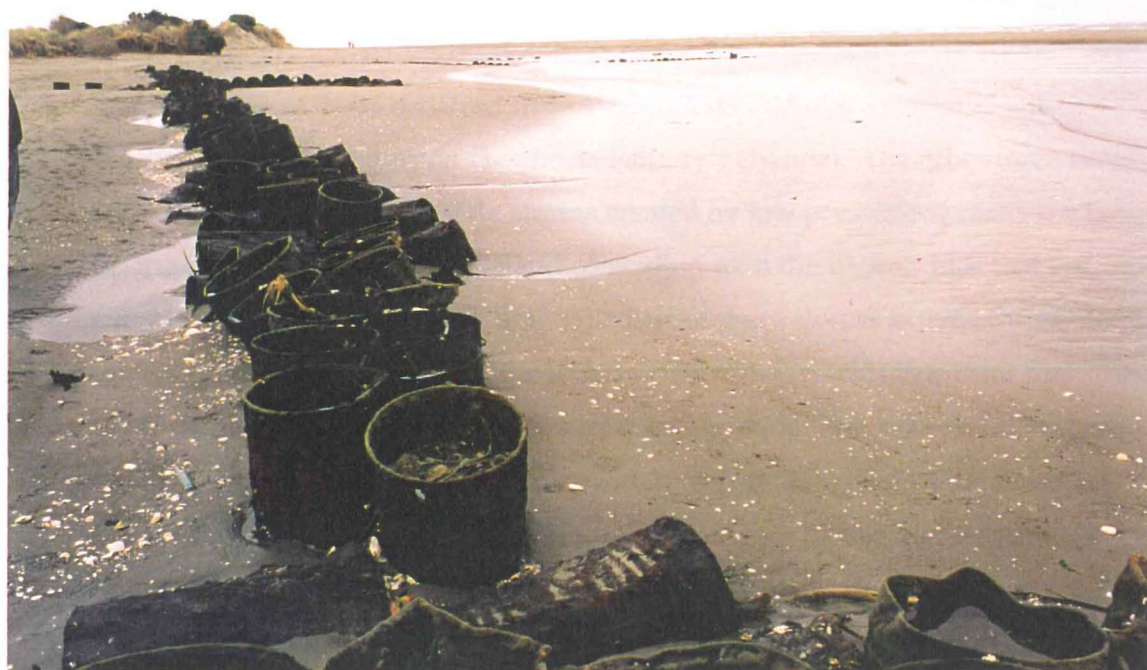
Plate 4.8 Exposed Drum Groyne March 1994
(Photo: Ian Ellingford, Christchurch City Council)

In March 1994, another erosion event occurred at the distal end of South Brighton Spit. Although this event did not pose a hazard as defined under this study, the event is interesting in that it exposed for the first time since the early 1950s the drum groyne that had been built by members of the Southshore Ratepayers' Association. Research at the time indicated that the beach volume in March 1994 was 65% of the beach volume for the preceding month, and that the foredune in existence in February 1994 was totally removed by March 1994 (Thompson, 1994). Plate 4.8 shows the exposed drum groyne.

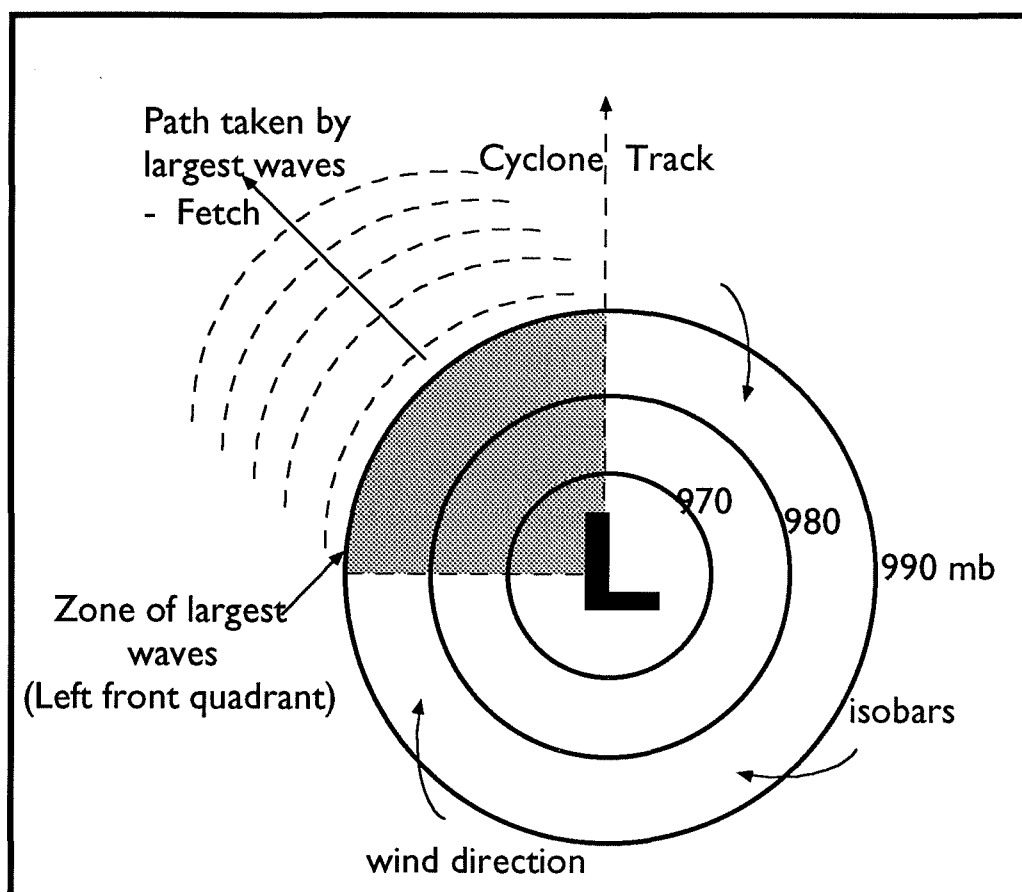
Figure 5.2 Wind Flow and Zone of Largest Waves in a Cyclone in Relation to Track. (Source: Kirk, 1976)

largest waves that are produced by a depression. The largest propagated waves come from the left-front quadrant of a depression because the wind at this point is following the fetch of the waves, thereby accentuating wave height. In New Zealand cyclonic storms tend to take defined paths over the country, and thus not

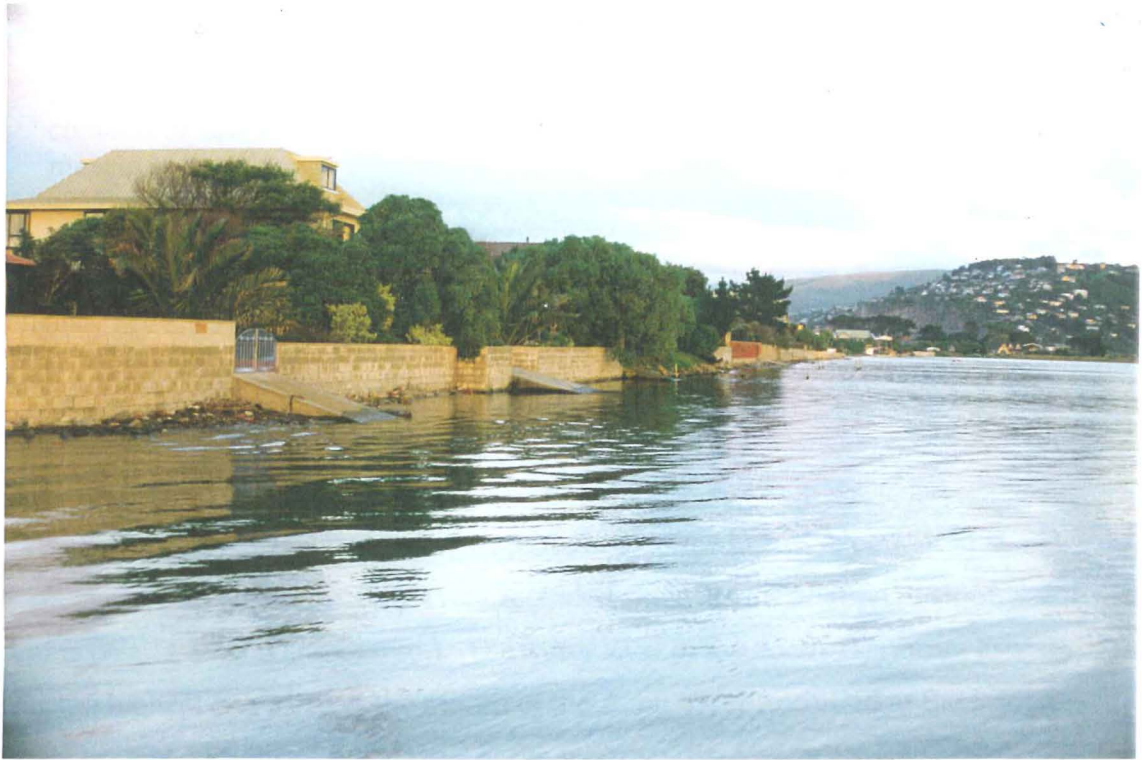
Plate 5.2 Gates and 'Protection' South of Plover Street

and the emergency control centre set up by the Police at the corner of Caspian Street and Rockinghorse Road was dismantled after 5 pm. Although the Southshore area was not properly serviced by stormwater outfalls during this storm, the flooding that occurred is worth noting as the lack of stormwater runoff was not the only source of the problem. Insufficient flood protection along the estuary margin of South Brighton Spit was also to blame. The ways in which both the residents and Christchurch City Council have attempted to protect properties from estuarine flood inundation will be examined further in Chapter Six. However, it should be noted that the majority of the structures that are protecting the residents' properties are little more than boundary fences (see Plate 5.2). Many of these have gates with either steps or ramps providing direct access to the estuary. Very few of the gates provide protection from extreme high water levels as there are gaps beneath the gates or those gates are like the one shown in Plate 5.2 and are made of wrought iron.

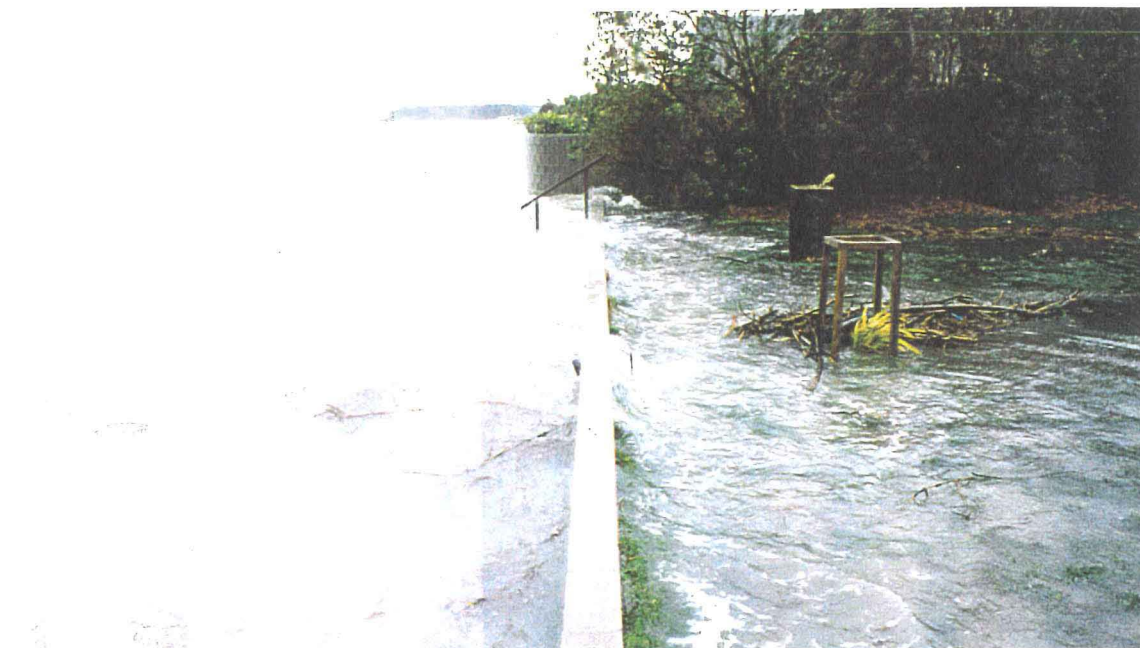
Plate 5.3 Overtopping of Seawall by Estuary at Plover Street, 29 April 1992.
(Photo: Ian Ellingford, Christchurch City Council)

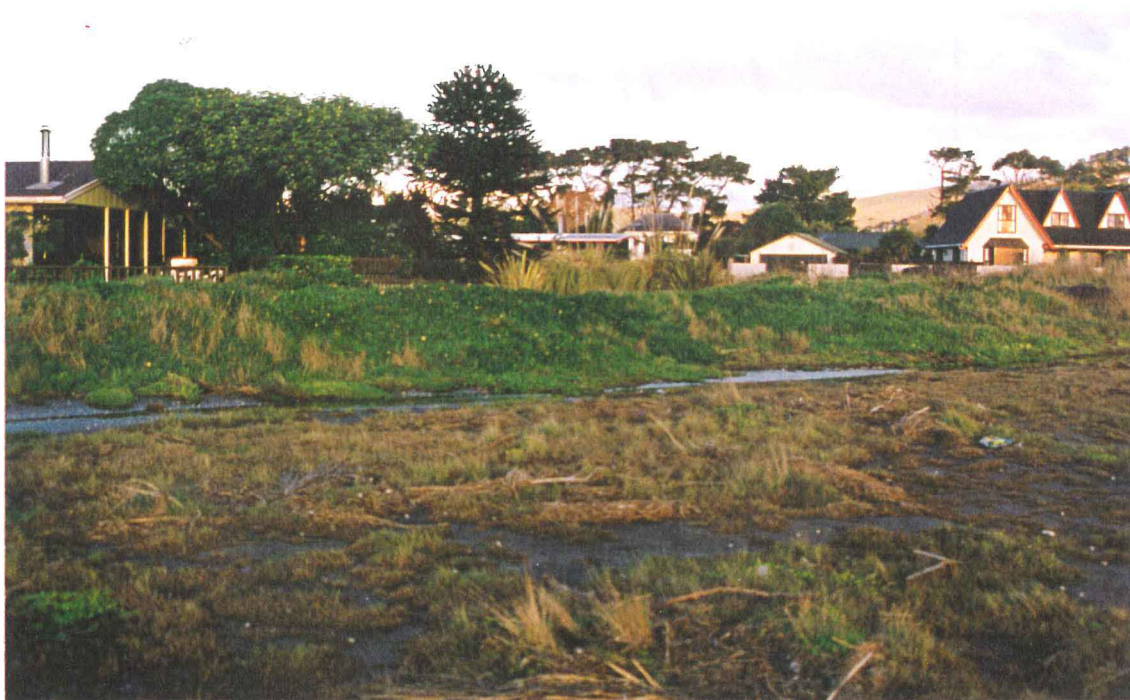
Plate 5.4 Stopbank in Front of Estuary Properties, South of Tern Street.

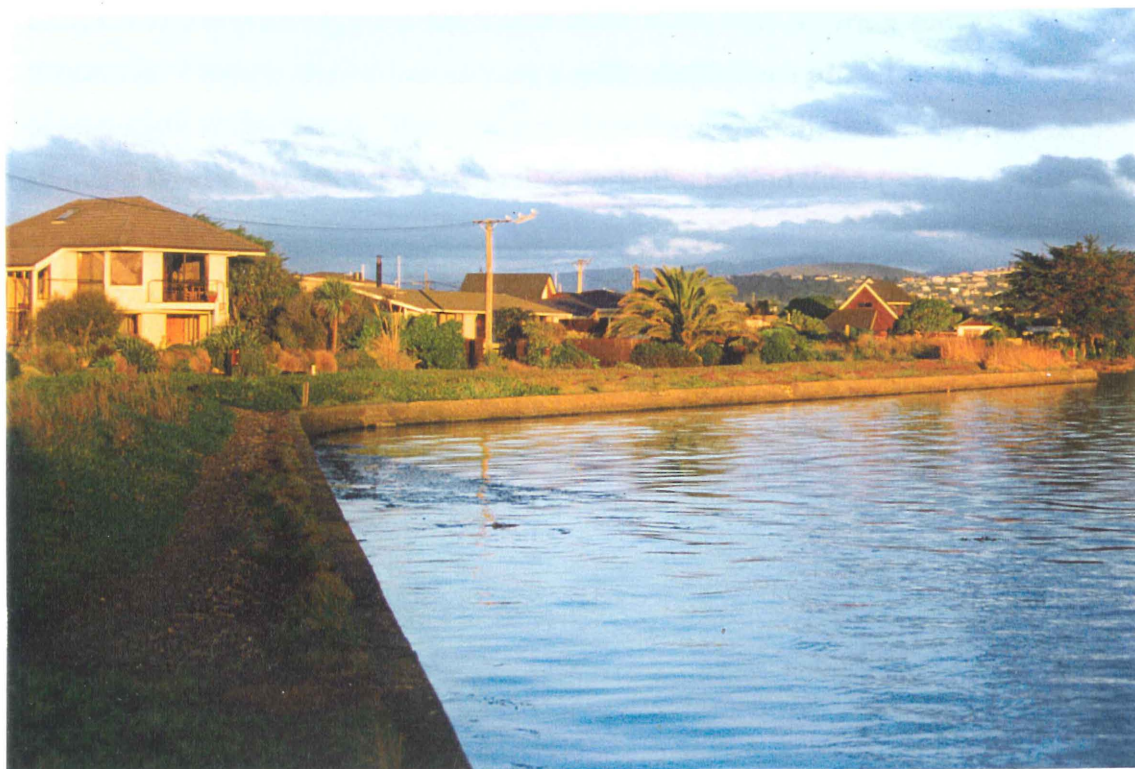
Plate 6.1 Seawall at Ebbtide Street - High Tide 27 June 1995

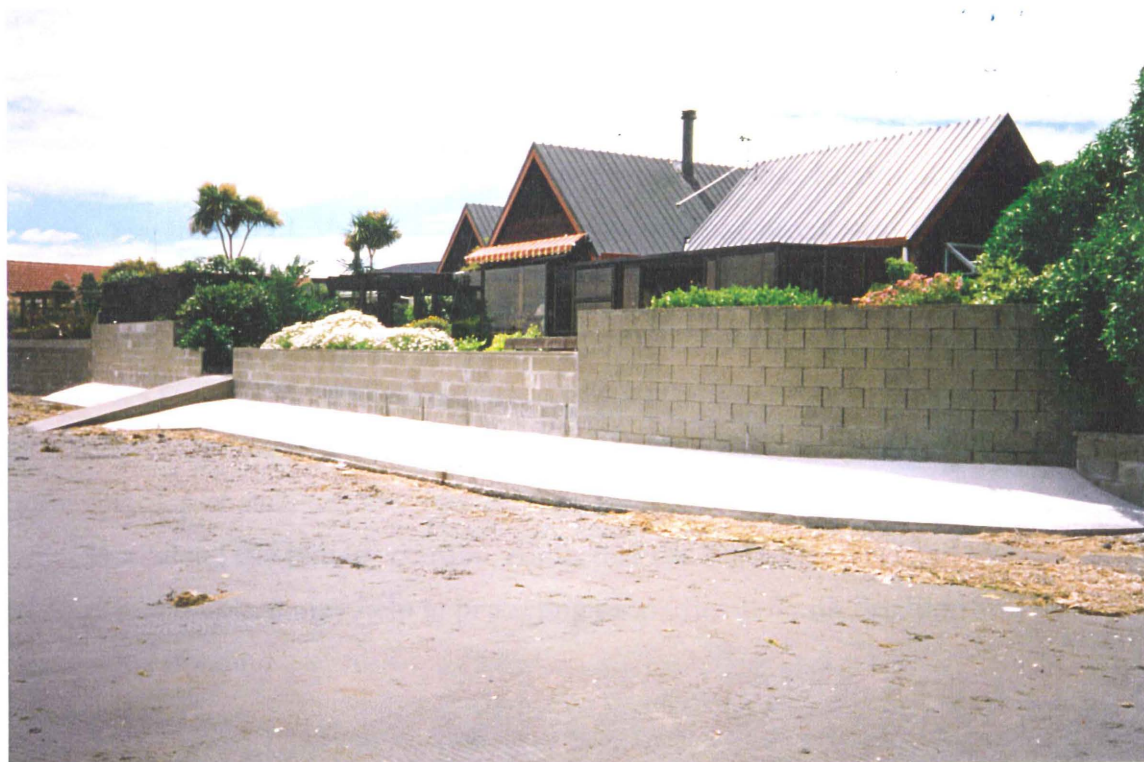
Plate 6.3 **Protecting the Protective Structure - Plover Street**
23 November 1994.
