## **Managing and adapting to coastal erosion on the West Coast: Gravity**

**NIWA Client Report: HAM2006-153  
October 2006**

**West Coast Regional Council**

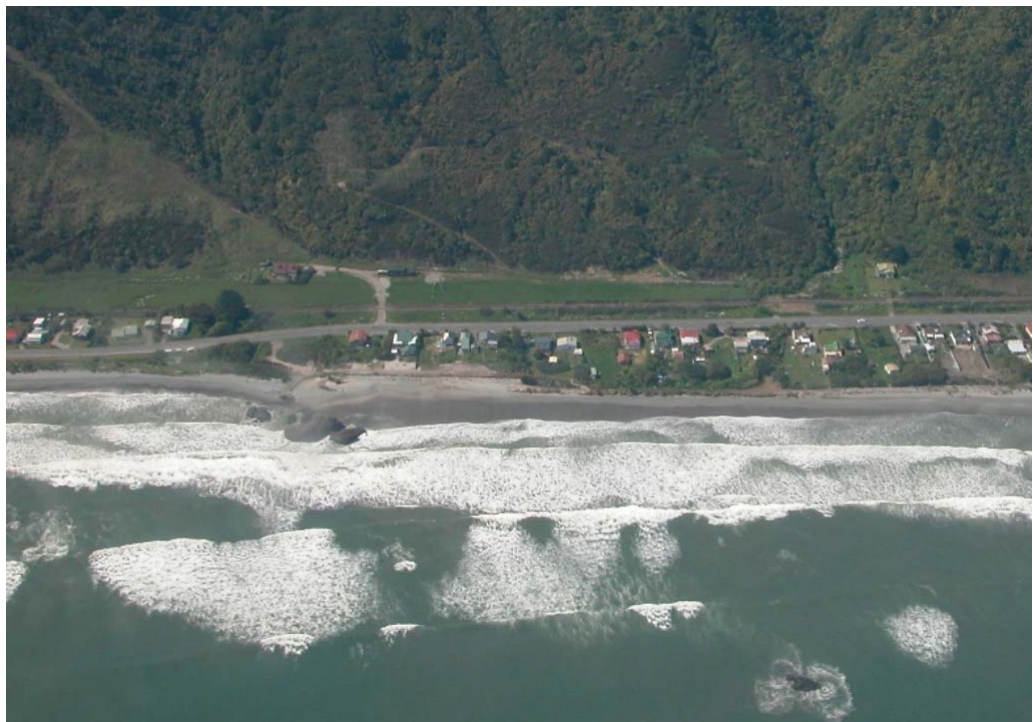
Whilst overwashing occurred along much of the frontage at Granity during these two events the most significant impact occurred at the northern end of the village adjacent to Lover’s Rock, Figure 1. Approximately 110 m of the gravel barrier in the lee, and to the immediate south of Lover’s Rock, was breached filling the outlet of the Bradley Stream, (which has been artificially deflected about 270 m northwards running behind the barrier to discharge in the lee of Lover’s Rock) and washing sand and gravel over the gardens and up and around the northern five houses on the seaward side of the road, Figure 2.

**Figure 1:** Overwashed section of gravel ridge at the northern end of Granity village (Photograph taken by Prof. A Short, University of Sydney; 28 September, 2006).

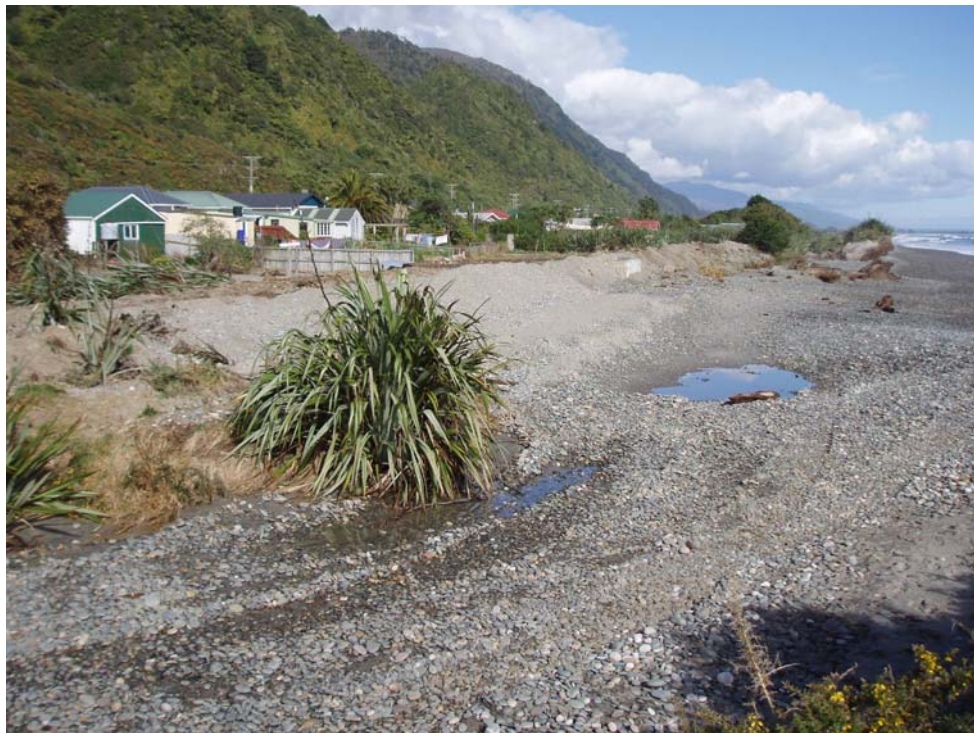
Given the conditions during the two events identified above, the response of the coastline at the northern end of Granity was not all that unusual. The gravel barrier, particularly between Chair Rock and Lover’s Rock is in a very poor state backed in

**Figure 2:** Looking south along the breached section of gravel ridge.

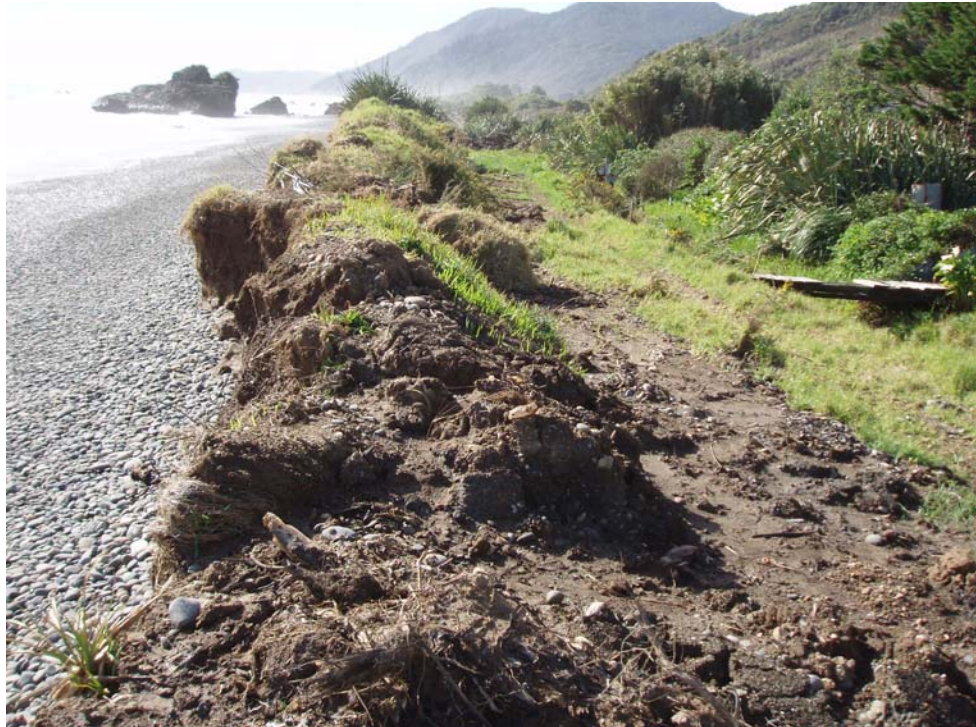
sections by a thin stopbank, likely created from the excavated material from the northward diversion of the Bradley Stream, Figure 3. This, along with the location of the Bradley Stream running behind the beach, the general low lying nature of the area upon which the northern part of Granity village is located, and the outlet of the Bradley and Cooper Streams, all act to make this section of coast highly susceptible to overwashing and retreat of the barrier.

**Figure 3:** Narrow ridge between Chair Rock and Lover's Rock.

- Immediately south of the breached section, there remains a section of stopbank assumed to have been built from the excavated material from the northward diversion of the Bradley Stream, (Figure 3). The height of the stopbank has prevented the fillet of gravel on the upper beach from being washed over the stopbank. However, the volume of gravel is insufficient to prevent the stopbank from being cutback during storm conditions and when it finally breaches, the crest of the beach will be rapidly drawn down and overwashing become more frequent as has occurred to the north (and also along a section to the immediate south, Figure 5).

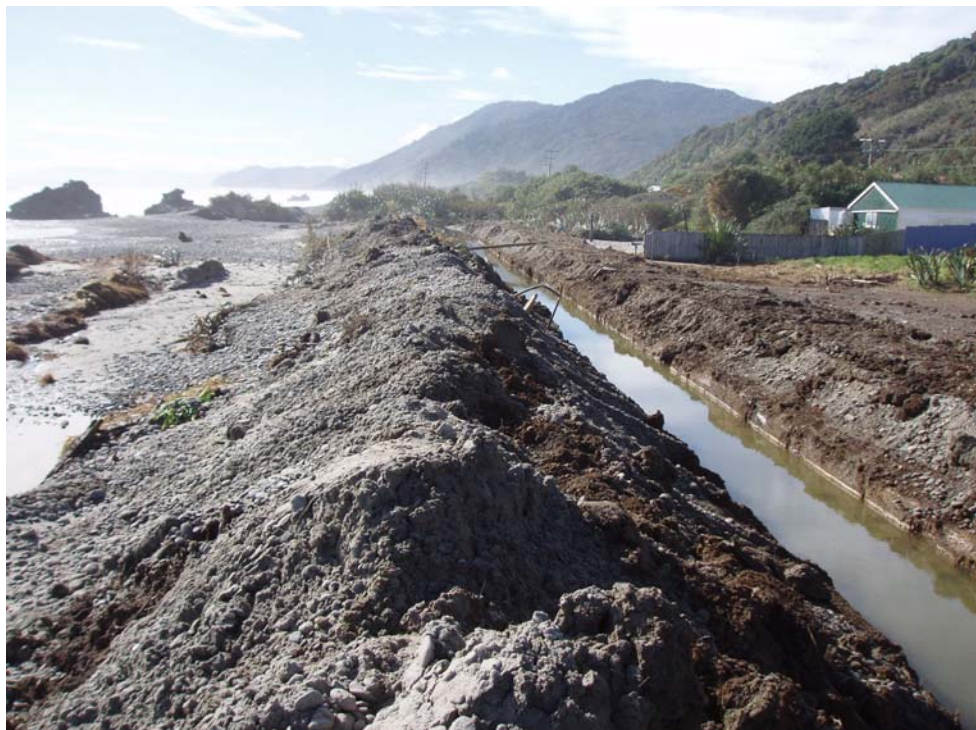
Along this breached section, the line of the old drainage channel which ran landward of the barrier is now over the upper part of the active beach. In the aftermath, this drainage channel was re-aligned further landward and the excavated material piled up to form a berm between the drain and the beach, Figure 4.

**Figure 4:** The re-aligned drainage channel and bund formed from the excavated material.

Finally a further option that may need to be considered is the re-routing of the drainage channels from along the back of the beach, e.g., Bradley Stream. Given the fragile nature of the beach crest between Lover's and Chair Rocks, the location of these diverted drains which now run immediately behind the beach reduces the stability of the beach crest. Whilst it is advantageous to maintain the outlet of these streams behind Lover's and Chair Rocks, the potential for diverting the streams further landward to the points of discharge, e.g., along the landward side of State Highway 6 should be explored. The existing drains could then be filled and re-vegetated.

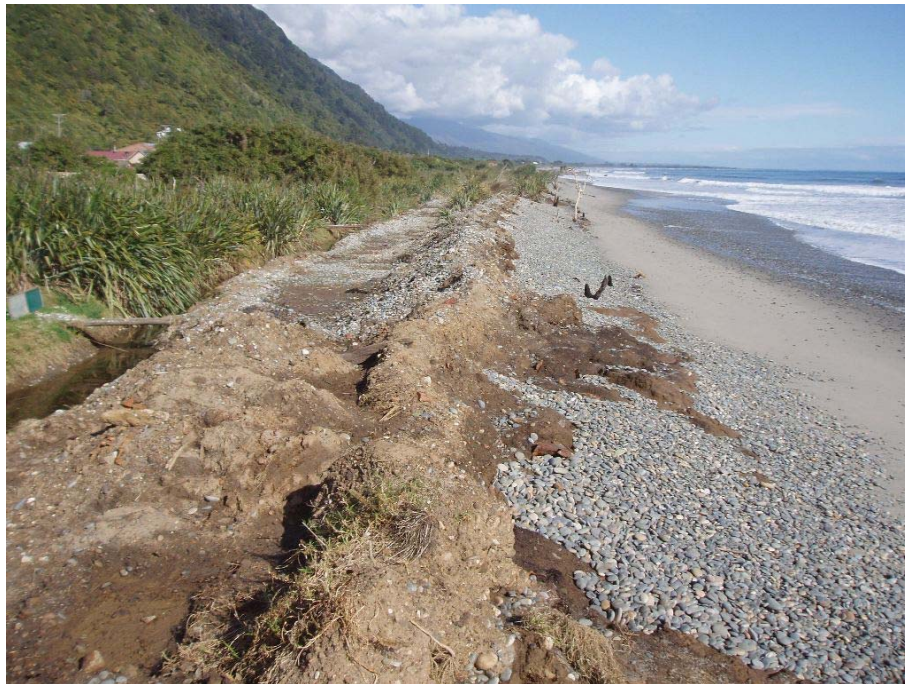
**Figure 5:** Breached section of stopbank looking south towards Chair Rock.

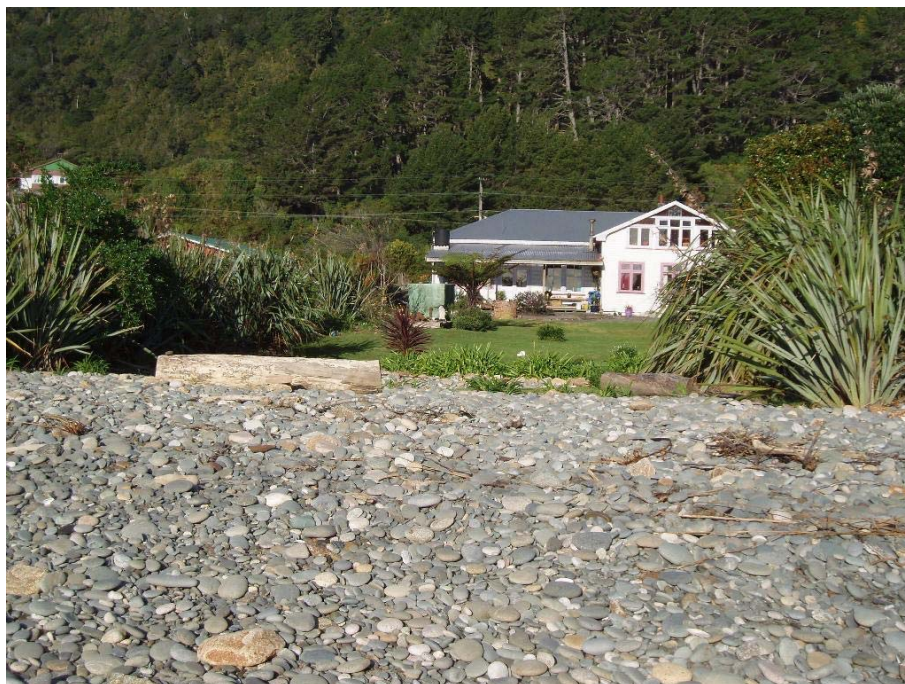
- Between Chair Rock and the outlet of the Granity River, and to the south of the river outlet, the beach is presently in a healthier state with a larger volume of gravel on the upper beach. Washover will still occur particularly along sections where residents have cleared the natural vegetation up to the back of the beach crest, Figure 6.

**Figure 6:** A buffer zone of natural vegetation such as flax behind the gravel ridge helps reduce overwashing by trapping gravel washed over the beach crest. Clearing such vegetation allows a greater volume of gravel to be washed over increasing the rate of roll-over and hence coastal retreat.

The planting of flax and other thick coastal vegetation helps considerably in reducing the rate that gravel is washed landward of the active beach when overwashing occurs. This is well demonstrated immediately to the south of the six northernmost property in Granity on an undeveloped section where a thick belt of flax is well established.

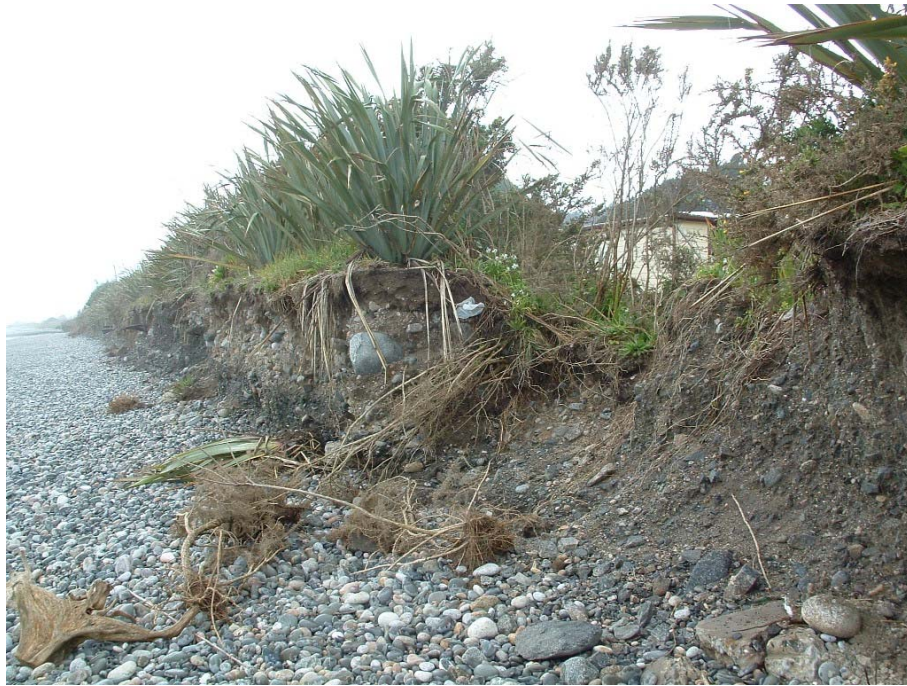
- The stopbank built to protect the school has now been breached at the southern end, Figure 7. Drawdown of the narrow gravel storm beach fronting the stopbank, or wave run-up over the gravel beach will further erode this protection. It is nearing the end of its serviceable life. There is now little room between the landward edge of the stopbank and the edge of the school buildings to re-build the stopbank, although this may be a short-term option. However, given the location of the school and swimming pool relative to the retreating beach, there needs to be serious consideration given to the landward relocation of these buildings/facilities. Past attempts at direct protection have not been successful and short lived, and more robust linear protection, e.g., a rock revetment on an open section of coast such as this, may well result in considerable exacerbation of erosion or outflanking at either end of the revetment.

**Figure 7:** Breach in the stopbank at the southern end of Granity School.

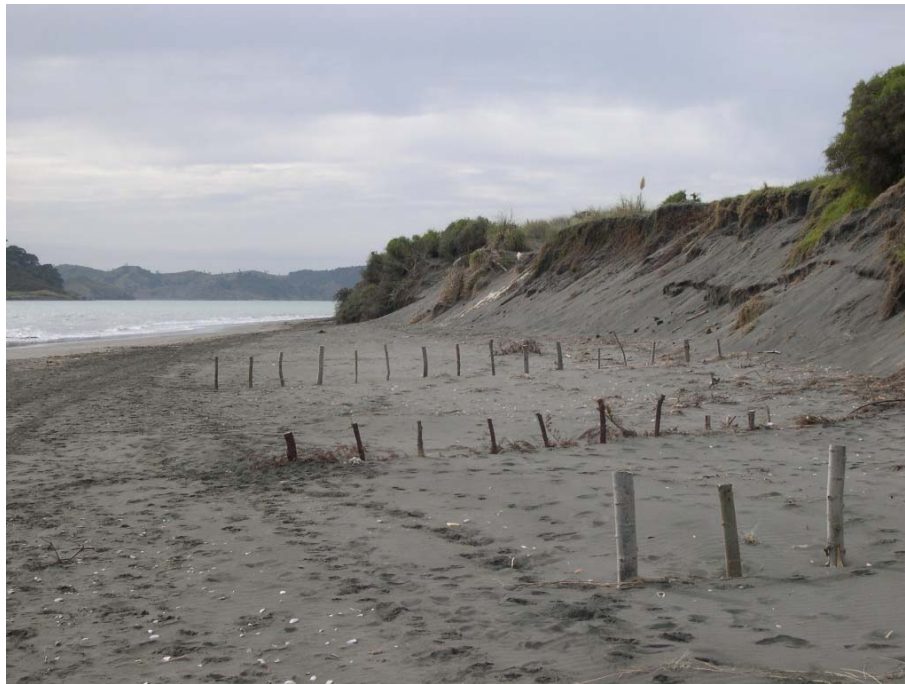
**Figure 9:** Use of Manuka ‘facines’ to help trap sand and raise beach levels in front of dunes at Raglan. The branches woven between the poles have now been covered with trapped sand.

The use of traditional ‘facines’ to also help trap and hold overwashing gravel is also an option to assist the role flax and other vegetation plays. These have been used in other locations in New Zealand to help trap sediment (see Figure 9) using Manuka (i.e., tea tree – which has good rot resistance) stakes driven in to the ground, with Manuka branches woven between the stakes. At Granity these would be positioned behind the beach crest to run parallel with the beach to complement the re-vegetation to further trap overwashed gravel (see Figure 10).

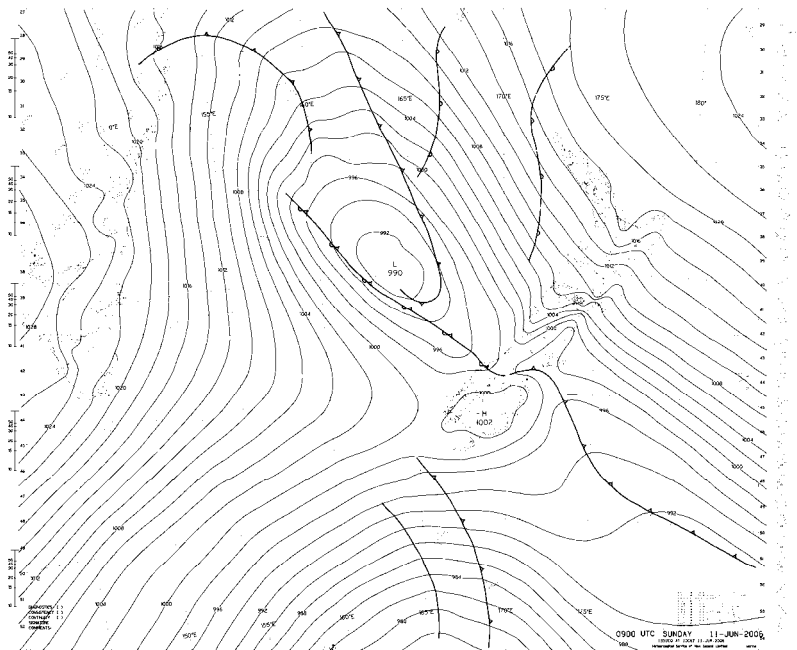
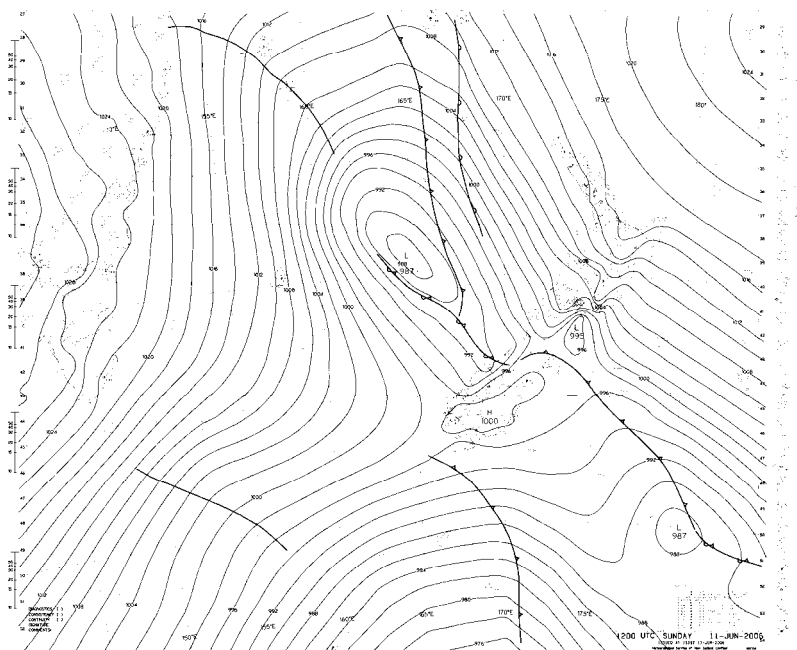
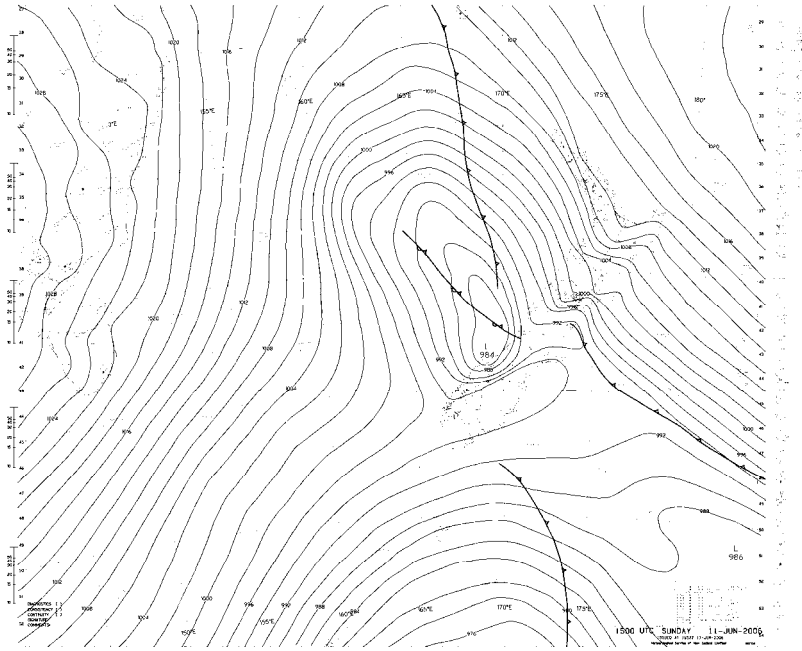
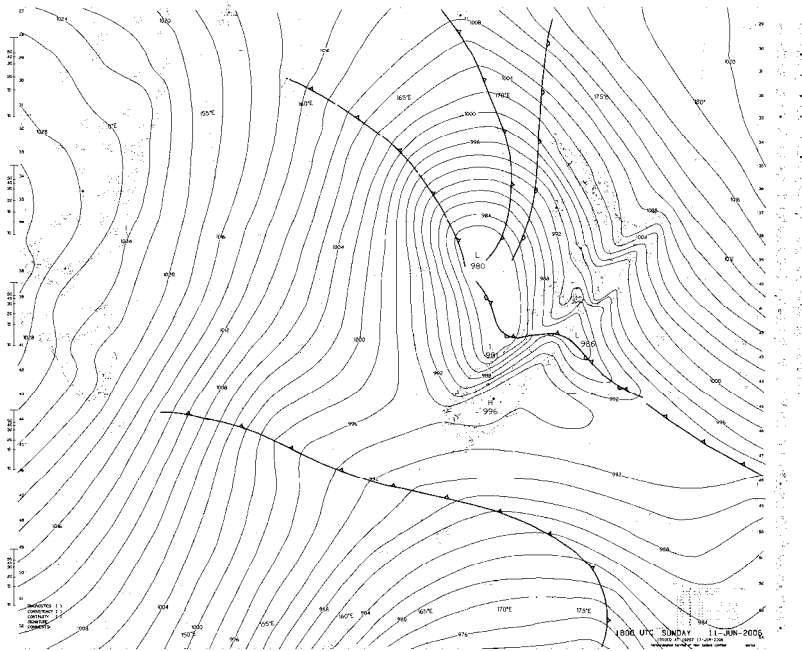
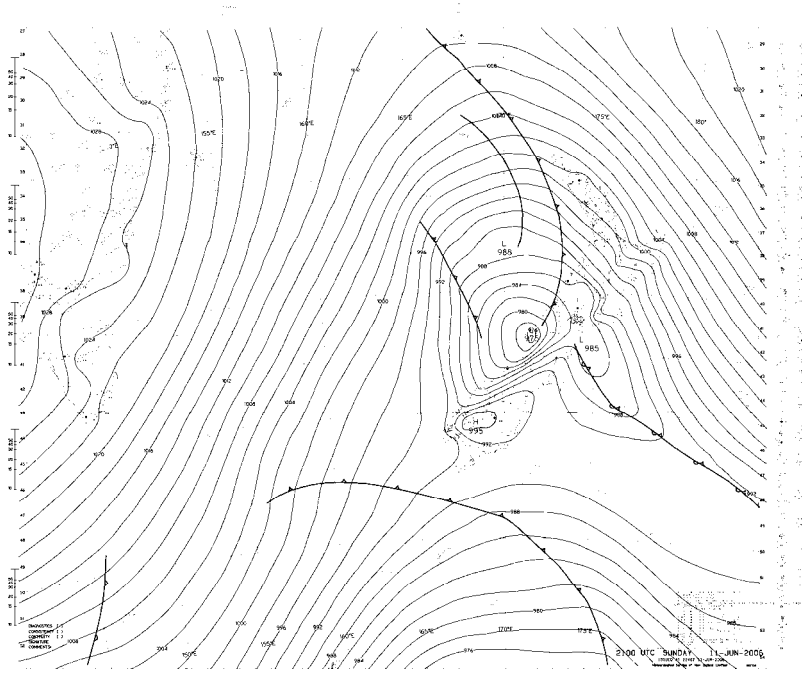
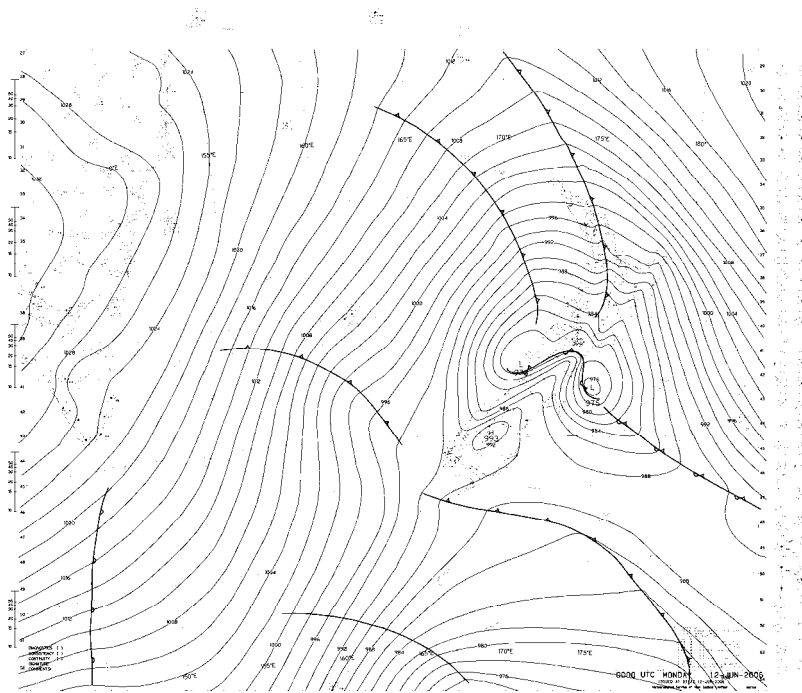
6. Appendix 2: Mean Sea level pressure maps over New Zealand for the period 11-12 June 2006.

The low pressure system on 12 June that created the strong winds and high waves crossed the South Island in a north-west to south-east direction (Appendix 2) resulting in winds and waves along the coast at Granity from the north-west. As the beaches on the West Coast tend to be more aligned with the dominant south-westerly swell, the effect of storm wave conditions from this direction resulted in more of a “shock” to the beach system.
