Chapter 5

Restoration of Foredunes and Transgressive Dunefields: Case Studies from New Zealand

Patrick A. Hesp and Michael J. Hilton

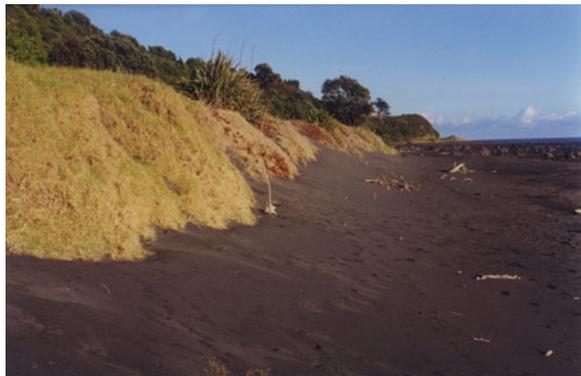
Fig. 5.2 View of the Oakura Beach site prior to restoration

The foredune was a narrow (18-m wide), low (3.5 m above mean sea level) flat-topped terrace that had been significantly modified in the past. It extended 150 m alongshore. As with many foredunes on New Zealand coasts with moderate to high recreational activity, the dune crest had been flattened, some unknown amount of building fill had been emplaced in the dune, clay had been laid over the surface, and the soil had been planted with exotic kikuyu grass (*Pennisetum clandestinum*). The area behind the “dune” was open grass and trees and utilized as a recreation/picnic area. The seaward face of the dune commonly displayed an erosion scarp along its length (Fig. 5.2). The only naturally functioning portion of the dune was this stoss, or seaward face, which on occasions, between storms, would fill with aeolian sand. Following discussions with the local New Plymouth District Council, a plan was developed with the objectives of reshaping the foredune to a more natural shape, improving the natural functioning of the foredune (i.e., enabling beach–dune interaction; see e.g. Hesp 1989), and carrying out dune re-vegetation utilizing *Spinifex sericeus*, the primary indigenous foredune species in northern New Zealand.

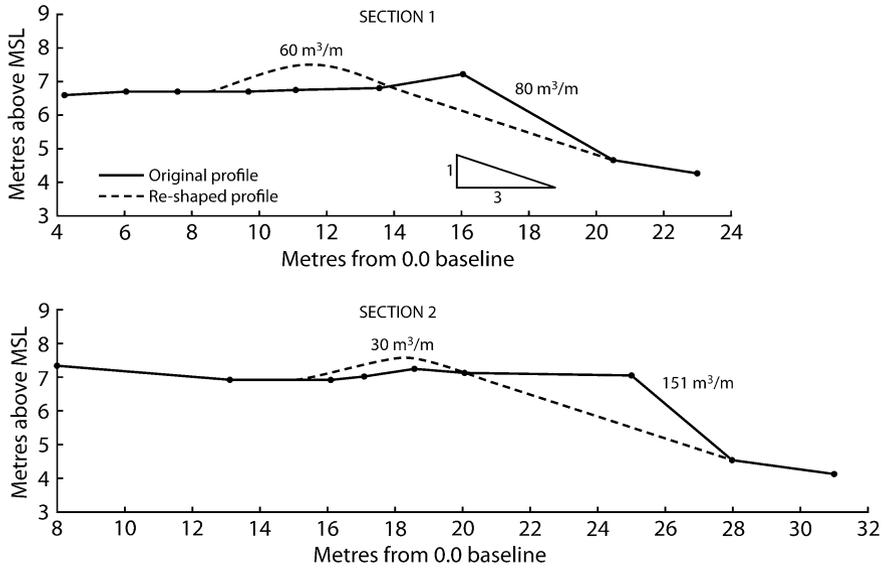
Fig. 5.3 Cross-sections of the original dune terrace, and the design foredune at two locations along the dune

The approximate volume of sediment (per meter alongshore of the dune) required for reshaping is indicated in Fig. 5.3. The volumes required to construct the desired dune profile ranged from 1,200 to 2,700 m^3/m depending on the location alongshore. There was a greater amount of sediment available in the northern section of the area to be reshaped and a deficit in the southern area. That is, the amount of material required to produce a minimal dune shape in the southern section was less than that available from the excavated area. Since it was desirable to build the reshaped foredune as large as possible, and since there was more sediment in the northern area, some of this northern sediment was transported to the southern area to make up the deficit.

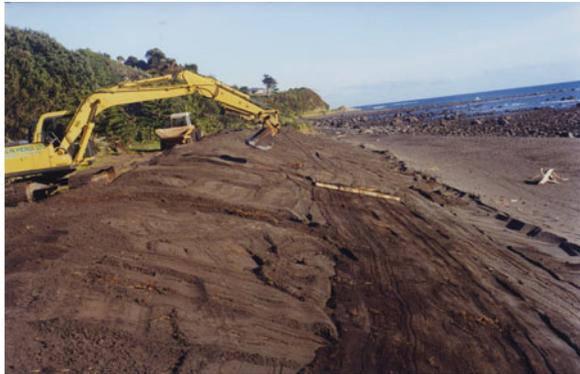
Fig. 5.4 View of the heavy machinery reshaping the foredune. The former clay surface and fill have been removed, and sand from the northern end of the beach has been transported to the site to increase the dune volume

Prior to dune reshaping and planting the kikuyu grass was eliminated by spraying it three times with RoundupTM at 8-week intervals (Bergin et al. 2000). The dune was reshaped, restored to a relatively natural profile (Fig. 5.4), and mostly planted

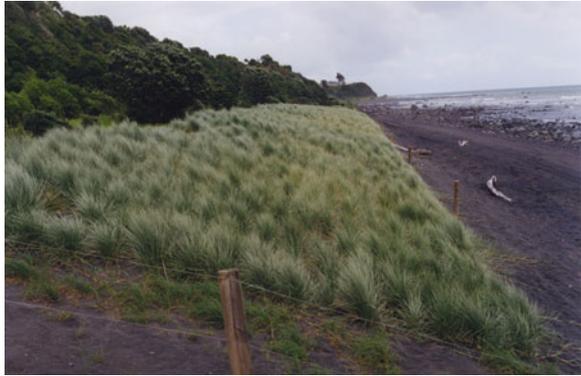
Fig. 5.5 View of the reshaped foredune in 2000, principally planted with etc., *Spinifex sericeus*, the native pioneer species for the region

with *Spinifex sericeus* (primarily raised from seed) at a spacing of 50–70 cm. This close spacing was desirable because the operation of high-energy, west-coast, “roaring forties” winds in this region means that there is a considerable chance of aeolian erosion occurring following planting. Some limited planting of *Carex pumila* plants was also undertaken as a trial to examine how well this native plant might survive in this environment (Bergin et al. 2000). The surface was fertilized with two slow-release NPK fertilizers at planting. A three-wire fence was erected along the front and back of the dune to restrict pedestrian access, and signs were erected to inform the public of the works. The plants grew rapidly and the dune displayed a high percentage of cover after 6 months (Fig. 5.5).

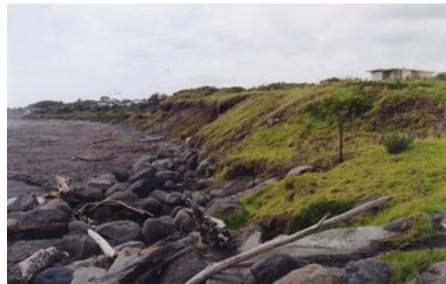
Fig. 5.6 View of the East End foredune prior to restoration

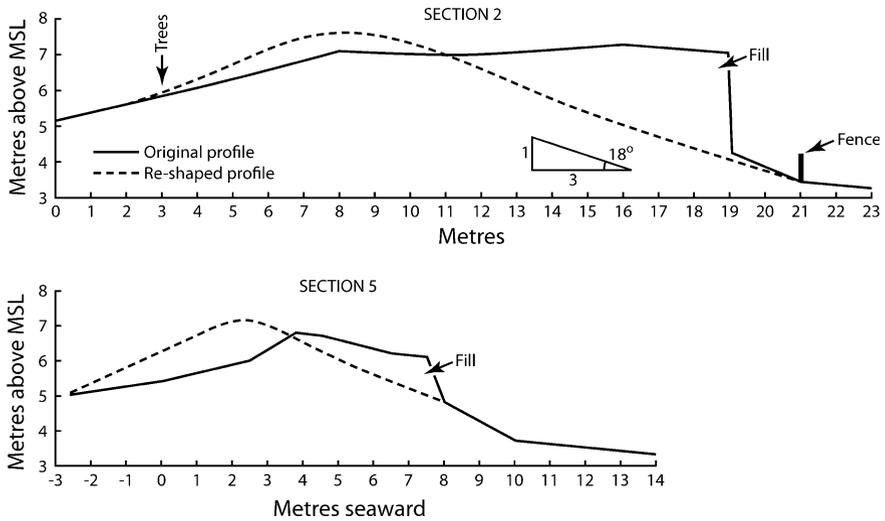
Fig. 5.7 Two cross-sections (Sect. 5.2 [southerly] and Sect. 5.5 [northerly]) of the foredune illustrating the pre- and post-restoration morphologies

The selected foredune section was situated just north of the main walkway onto East End Beach adjacent to the East End Surf Life Saving Club. Two typical topographic profiles are shown in Fig. 5.7, including the typical reshaped dune profiles. As in the case of Oakura, at East End there were four factors that limited the dune reshaping work:

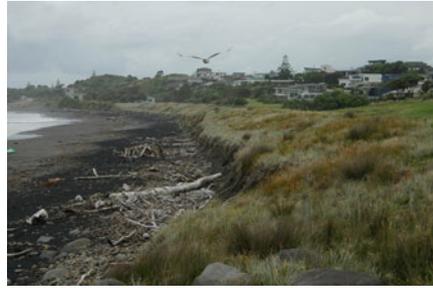
Fig. 5.8 The foredune at East End following restoration

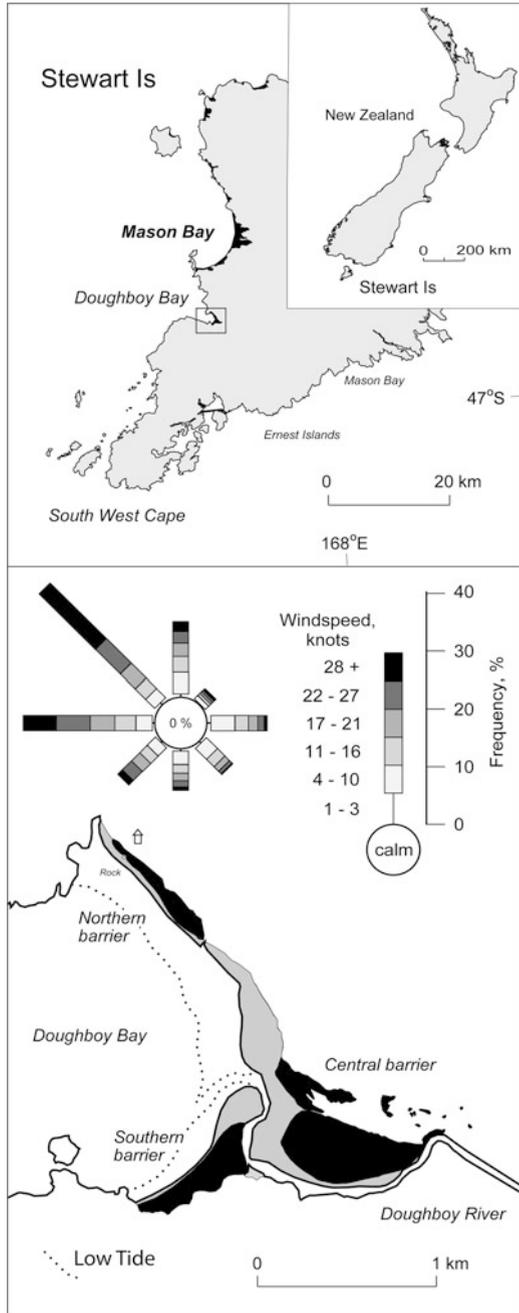
Fig. 5.9 Location of the southern barrier, Doughboy Bay, Stewart Island (Rakiura National Park). The prevailing and dominant winds are from the northwest. The wind rose is derived from data gathered at Southwest Cape, 20 km south of the study site, from 1992 to 2003

The beach systems of Stewart Island are moderate to high wave and wind energy environments. Beach morphologies are of the intermediate type with a broad intertidal terrace comprising either sand or mixed sand and gravel. The back-beach morphology has probably narrowed and steepened following the introduction of marram grass and the development of continuous, uniform (Type I) foredunes (i.e., continuous, morphologically simple, high vegetative cover—after Hesp 2002). Hart et al. (2012) measured the wind regime at Mason Bay from June 2002 to February 2004 using a permanent Vector 3-cup anemometer at a height of 2 m located on the foredune crest. The predominant direction of sediment transport is onshore; the wind regime is dominated by strong, episodic, west to southwest (onshore) winds throughout the year. Annual average wind speed is 6.4 ms^{-1} with $<1 \%$ calm conditions. The dune systems of Doughboy Bay occur at the head of a pronounced embayment. Headlands shelter the southern and northern margins of the sandy shoreline, but the central dune system and adjoining barriers are highly exposed to onshore winds (Fig. 5.9).

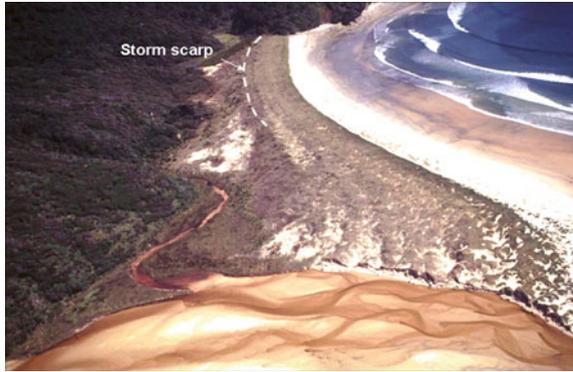
Fig. 5.10 An aerial oblique view of the southern barrier. The “scarp” separates the prograded foredune barrier associated with marram, which formed after the first aerial photograph was obtained in 1958 from the pre-marram dune system. The latter contains remnant blowouts and parabolic dunes

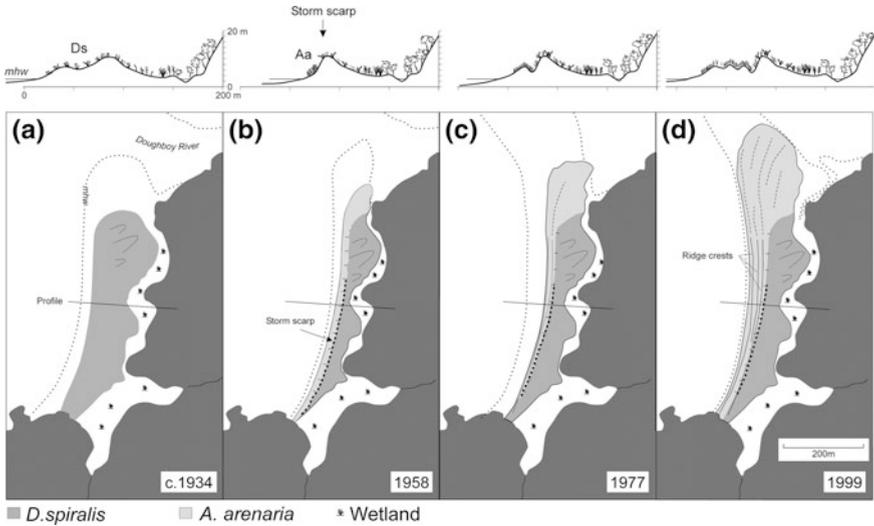
Fig. 5.11 Barrier and dune system development, 1934 to 1999 (Hilton et al. 2009)

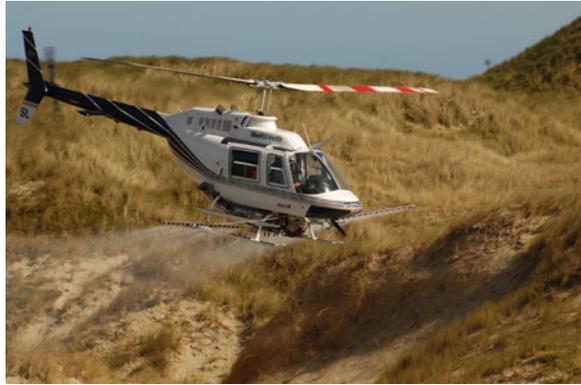
Fig. 5.12 A Jet-Ranger helicopter equipped with a spray boom, engaged in marram control operations, Mason Bay, December 2010

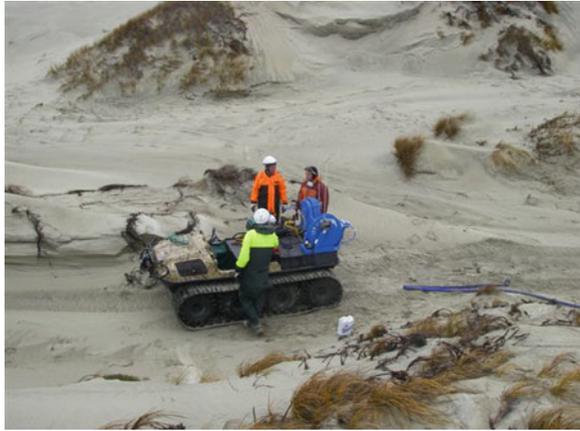
Fig. 5.13 Department of Conservation rangers spraying marram grass using an ARGO all-terrain vehicle equipped with a 500 liter spray tank and two 50 m hoses

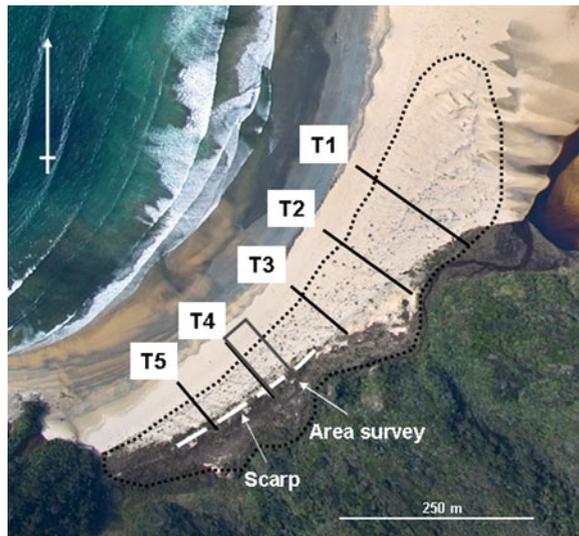
Fig. 5.14 Location of profile lines and features referred to in the text, southern barrier, Doughboy Bay

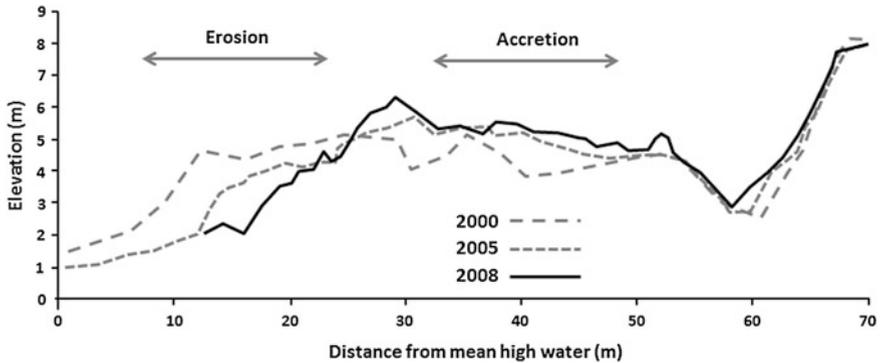
Fig. 5.15 A comparison of the first (2000), 2005 and most recent (2008) profiles surveyed across T4. Erosion is occurring seaward of 25 m. Landward of 25 m the barrier is accreting (Konlechner and Hilton 2010)

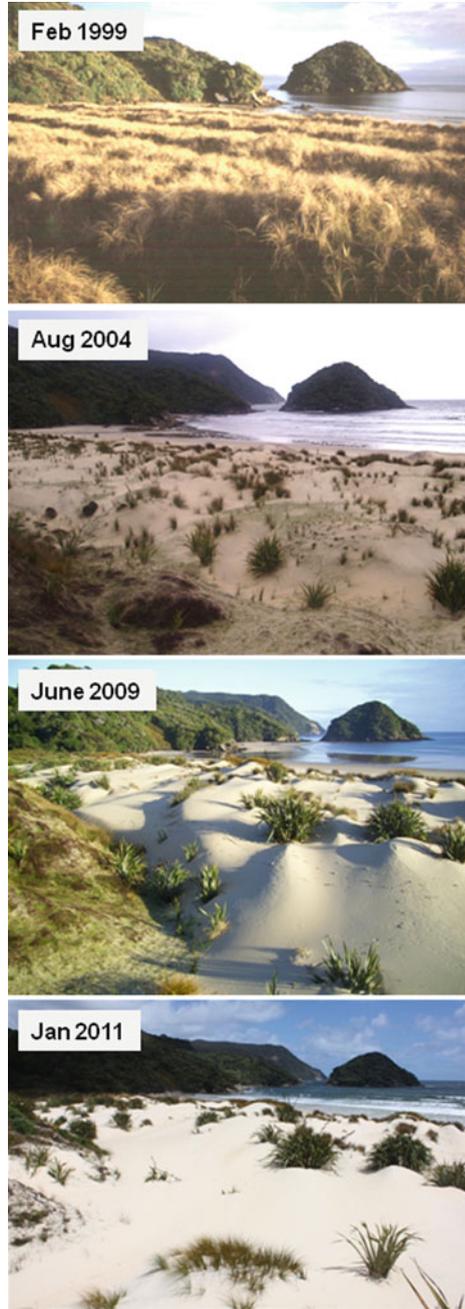
Fig. 5.16 A sequence of photographs from between T3 and T4, showing the initial marram cover and progressive de-vegetation and sandsheet and nebkha development (1999–2011)

foredune has experienced some minor erosion. The zone of active sedimentation reached the relict storm scarp south of T3 (Fig. 5.16) in 2010. This sandsheet should overtop the relict scarp before 2015. In general, the dune ridges of the northern section of the barrier are eroding relatively rapidly, fueling downwind sedimentation and the development of a slip face. This feature is advancing landward (i.e., to the east).

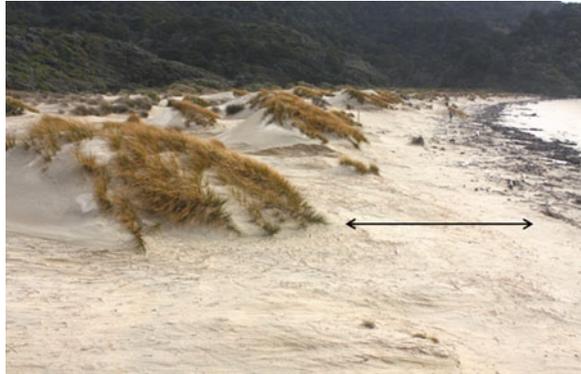
Fig. 5.17 The stoss face of the foredune after marram eradication. The arrow indicates where most marram seedlings have emerged, on an annual basis, since 2005. The shadow dunes have formed under pīngao, planted by the Department of Conservation in 2003

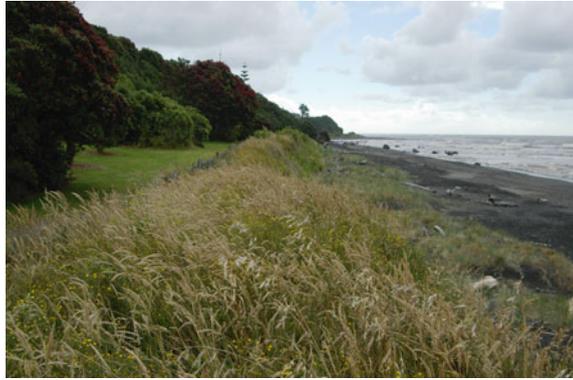
Fig. 5.18 View of the Oakura foredune in 2008. The dune displays a prominent scarp, and has been invaded by a variety of weed species

In the case of the Oakura restoration, by 2008, the dune had been scarped by waves on numerous occasions (as expected given the very limited or negative sediment budget), but had also lost around 8 m in width. The dune had also been seriously invaded by weed species (Fig. 5.18). This may be, in part, a response to over-fertilizing, which happened at least once, but also to the fact that the spinifex senesced to some degree following dune stabilization. Like many pioneer species, spinifex requires sand deposition to drive growth. On a beach such as this, with very limited sand deposition onto the middle to upper stoss slope and crest, secondary native plants should have been introduced to mimic the natural successional tendencies in such areas. In the case of the East End restoration, the dune appears to be functioning naturally and while there is occasional wave scarping, the sediment budget on this beach is such that scarp filling and re-establishment of scarp and beach cover by native species occur.
