## The "Wooden-Floor" Marker Bed—A New Method of Determining Historical Sedimentation Rates in Some New Zealand Estuaries

*Keywords:* Modern sediments, stratigraphic marker bed, historical sedimentation rates, Tairua estuary.

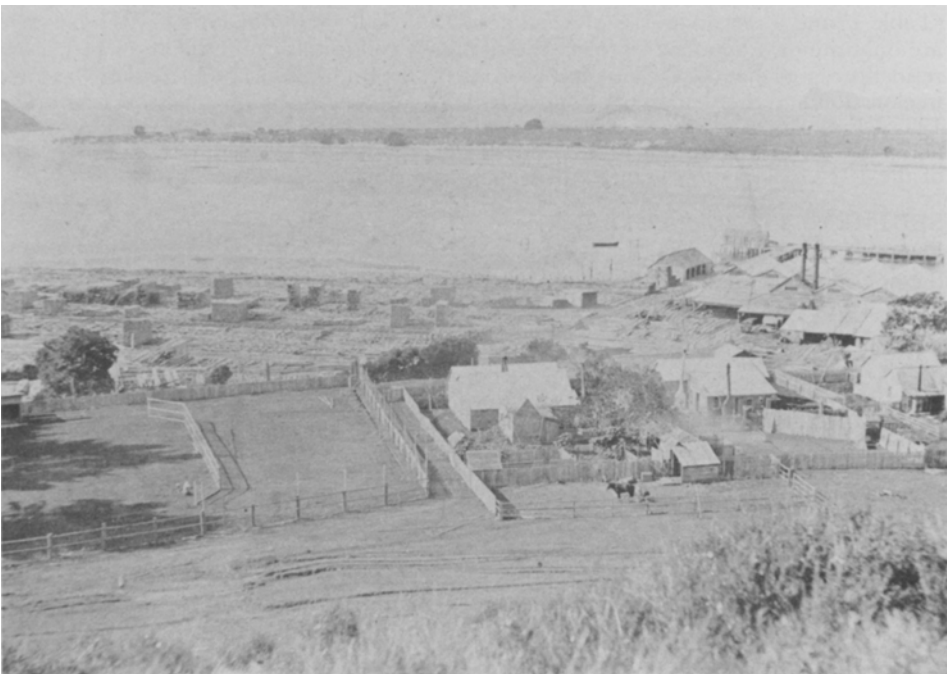
Fig. 2—Pre-1909 photograph looking east over the Tairua estuary tidal flats toward Pauanui sand spit from hills above the Tairua timber mills. The mill buildings are on mid right; stacks of sawn timbers, mid left, lie on the extensive reclamation formed from milled kauri timber and sawdust (Photograph supplied by Father F. Bennett, Tairua.).

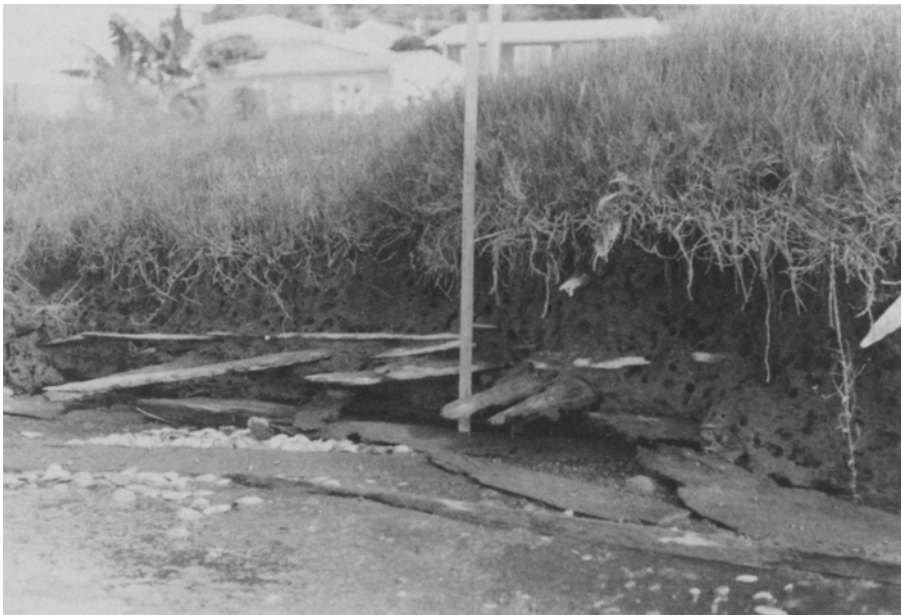
Fig. 3—Photograph showing the eroding reclamation of kauri sawn planks in a matrix of sawdust and wood chips exposed above high water mark near Bay Vue Road, Tairua. Plank orientation suggests that the slabs have been systematically laid rather than dumped (rule is one metre). Photo taken on 14 May 1984.

Coastal erosion between Tairua Wharf and Pepe Stream has shown that the low-lying foreshore bank is composed of sawn kauri planks, each several metres in length, in a matrix of wood chips and sawdust (Figs 1 and 3). Similar kauri debris underlies the adjacent tidal flats, forming the so-called 'wooden floor' (Fig. 4). Old style glass bottles, sometimes filled with sawdust, were also uncovered. Further away from source, the wood

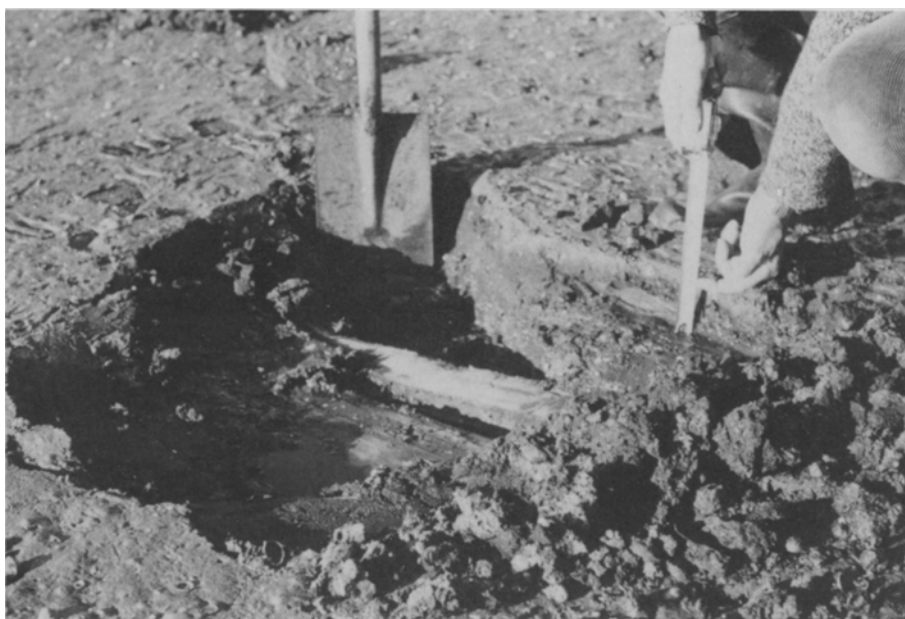
Fig. 4—Photograph taken at low-tide showing medium sands overlying sawdust and sawn kauri planks beneath the surface of the tidal flats off Bay Vue Road, Tairua. The sawdust horizon lies at the base of the tape measure and the planks at the bottom of the shovel blade. Photo taken on 3 June 1983.
