How can it be?

Both photos were taken at Waihi Beach on the same day, on the same tide and only 250m apart.

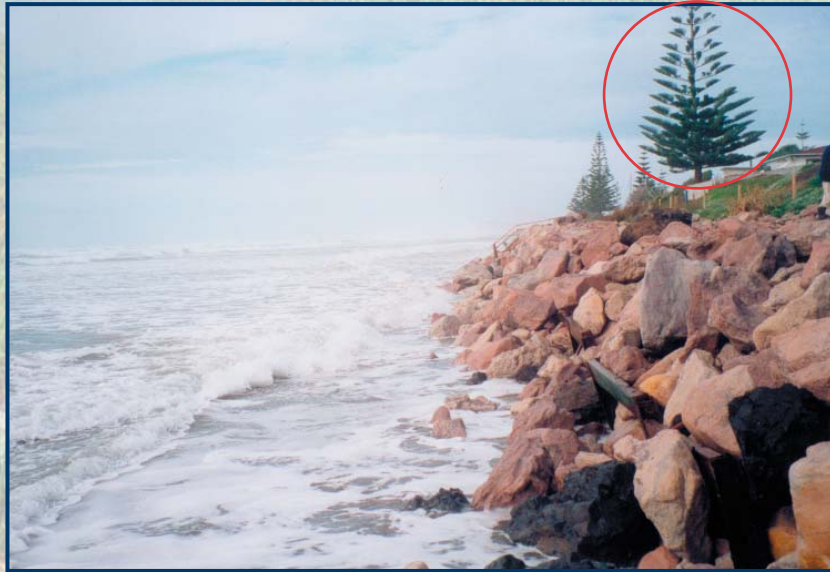
Waves Smashing Into Rocks At The Loop

Turbulence resulting from wave impact has stripped sand off the beach, lowered the level of the beach, which allows waves to reach close to the houses. This situation can not improve unless functional dunes are re-established.

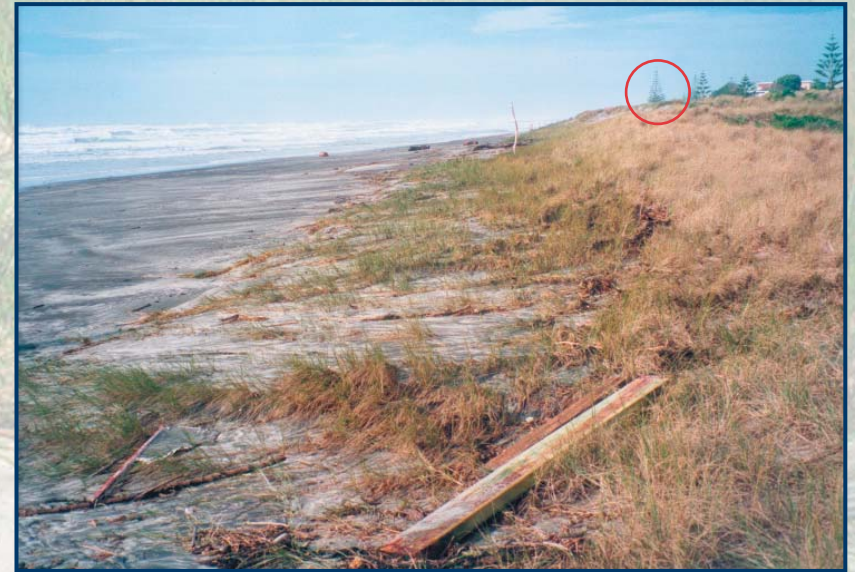
Affected But Secure Foredune

Native dune plants have resisted wave attack and minimised erosion. Note how wide the beach is at exactly the same tide time as Photo 1. Natural dune function is providing a stable and safe beach that is self-sustaining.

The Norfolk Island Pine tree circled in photo 2, is the same tree in photo 1.
