# Restoration of vegetation at Smugglers Bay, Bream Head Scenic Reserve, Northland

## Technical Advisory Notes

D.O. Bergin and M.J. Bergin  
Environmental Restoration Ltd  
Rotorua

Environmental Restoration Ltd Contract Report ERL10/09

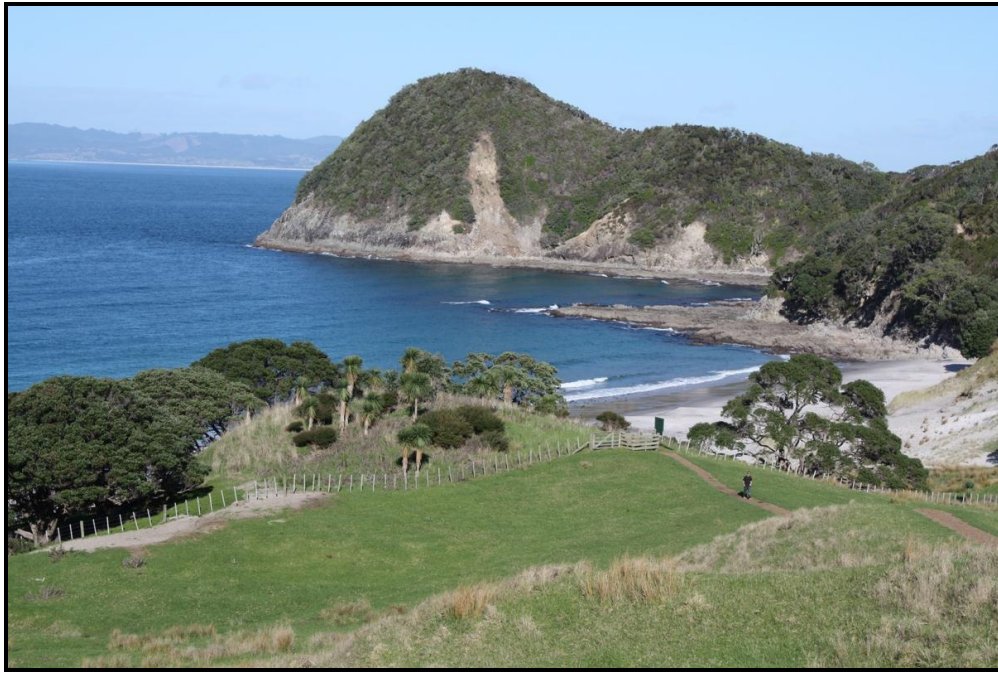
Figure 2: View looking southward over Smugglers Bay from near the highest point of the access track to the bay. This expansive view of the bay is the first to greet visitors as they make their way to this relatively isolated and undeveloped beach framed by rocky shores and indigenous coastal forest on headlands at both ends.

Smugglers Bay is very popular for recreation as it is relatively isolated from any development (Figure 2). Land access is by a 15 minute walking track that traverses the peninsula over a low saddle of grazed pasture. Headlands at both ends of the embayment are covered in dense indigenous shrubland or forest.

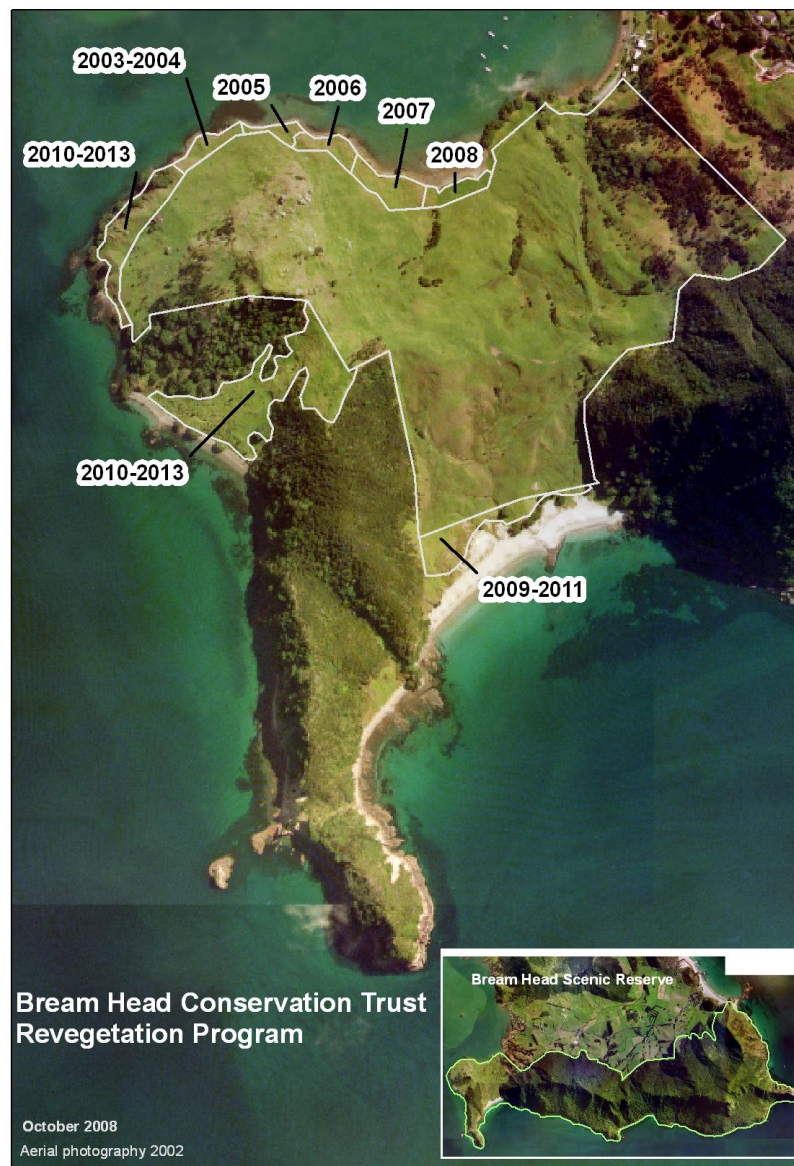
Figure 3: The western end of the Bream Head Scenic Reserve showing the staged revegetation programme using natives underway by the Bream Head Conservation Trust and Restoration Committee. This includes the current focus (2009-2011) at Smugglers Bay (Source of image: Department of Conservation).

The Bream Head Conservation Trust and Restoration Committee hold regular community events that assist with the Trust's aim to restore and maintain the ecological environment of Bream Head Scenic Reserve. Since 2003, an active revegetation programme has been underway establishing a range of local indigenous shrub hardwood and monocotyledon species on slopes around the western end of the reserve. The planting programme has involved focussing on slopes on the northern coast immediately west of Urquharts Bay with specific blocks revegetated each year (Figure 3).

The Northland Regional Council and Department of Conservation require technical advice on revegetating the beach at Smugglers Bay from the foredune landward to the fenceline indicated as the northern boundary for the 2009-2011 revegetation zone (Figure 3). The project brief is to provide a report advising on the best option for eliminating kikuyu (*Pennisetum clandestinum*) and replacing with naturally occurring natives as well as consideration of issues such as the erosion of the archaic midden sites, management of the bay for recreational use including the role of existing pohutukawa (*Metrosideros excelsa*), and habitat for a Nationally Critical land snail (*Punctidae* sp. 223) and for breeding variable oystercatchers.

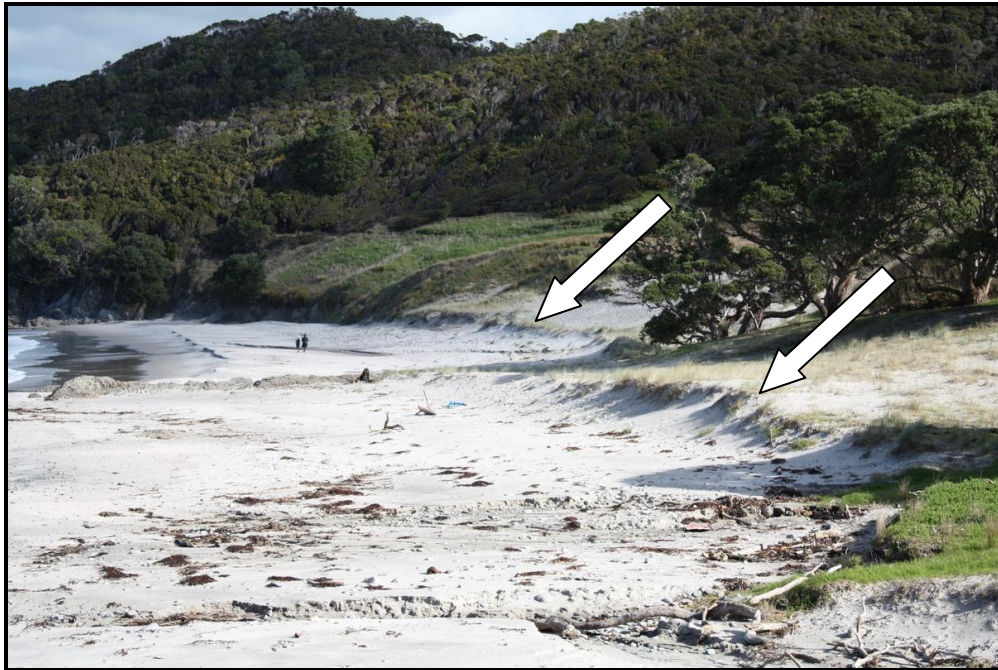
From the field visit, the beach and dunes at Smugglers is characterised by a narrow mobile foredune modified by both wave and wind erosion (Figure 4). The foredune is

poorly vegetated by spinifex. The remnant of a storm scarp runs almost the entire length of the foredune and remains largely unvegetated and vulnerable to wind erosion. The storm scarp may be a result of a '100-year' storm event in 2007 which caused very serious damage to Smugglers Bay (Maria Butcher, Department of Conservation, pers.comm.).

Figure 4: The beach and foredune system, Smugglers Bay, showing a narrow poorly vegetated and relatively mobile foredune. Note the storm erosion scarp along virtually the entire length of the foredune (arrows). With the lack of spinifex growth down the seaward face of the foredune it remains highly vulnerable to erosion by wind erosion.

***The foredunes at Smugglers are partially degraded. Evidence of a storm cut is evident (Figure 4), but there is little evidence of recovery.*** The foredunes lack a continuous zone of native sand binding plants along the seaward face of the foredune. Without a good cover of spinifex and pingao on the seaward foredune face, natural dune repair between storms tends to be very limited. This can result in the next storm picking up where the last one left off, giving rise to more serious dune erosion than would have occurred with some dune recovery between the two events.

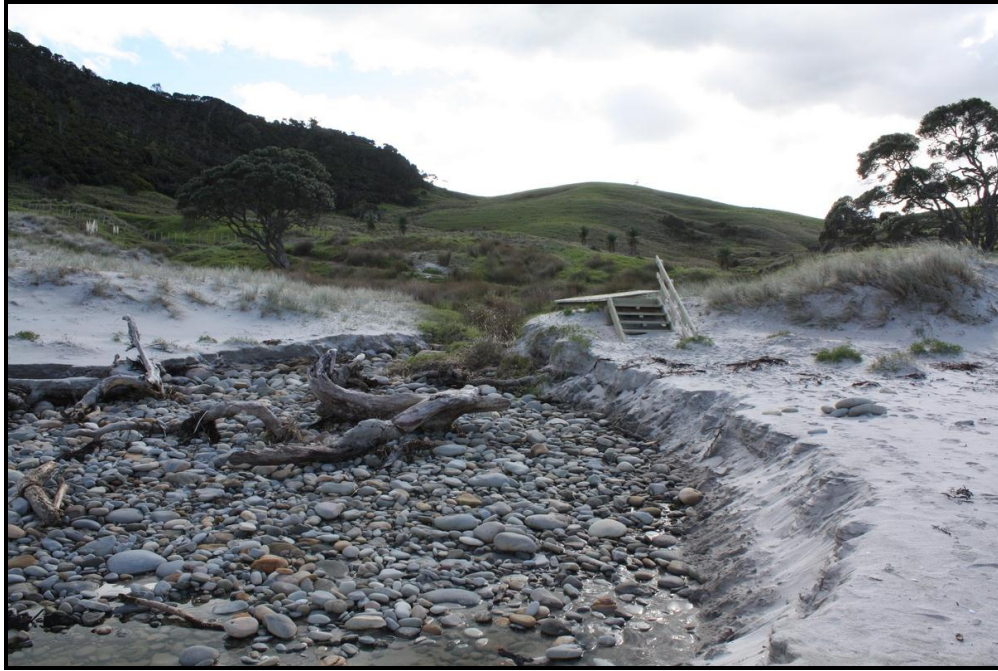
Figure 5: Boulders exposed by recent heavy rain and flows through this centrally located stream at Smugglers Bay.

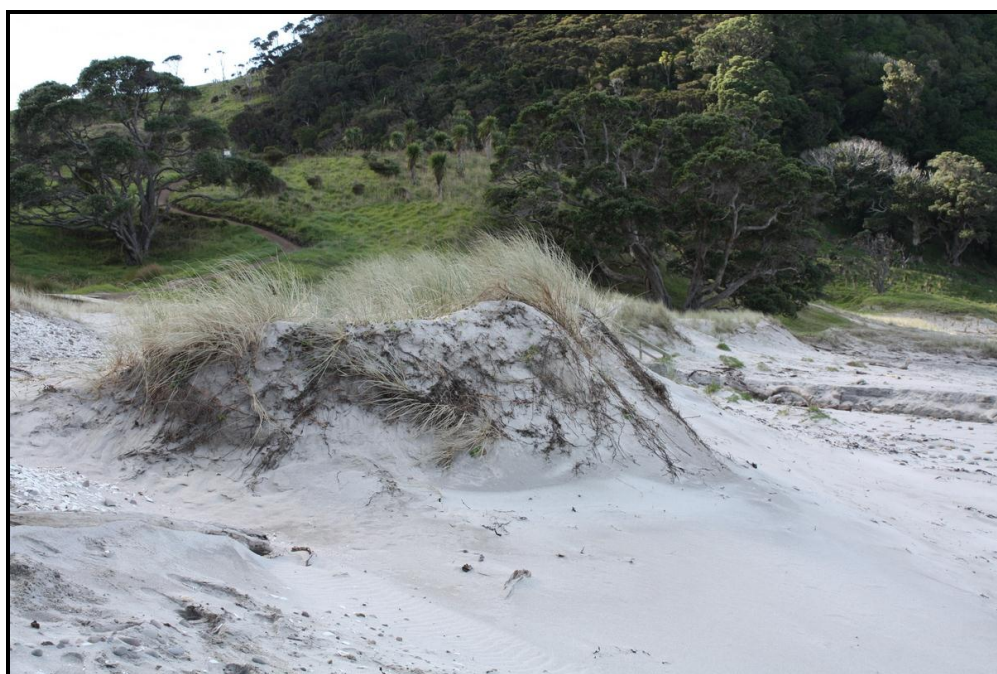
Figure 6: Part of the degraded foredune system at Smugglers Bay. Wind funnelling by onshore winds has caused a blowout (left foreground) and exposed root systems of spinifex. Remnants of the partially vegetated foredune remain highly vulnerable to further wind erosion.

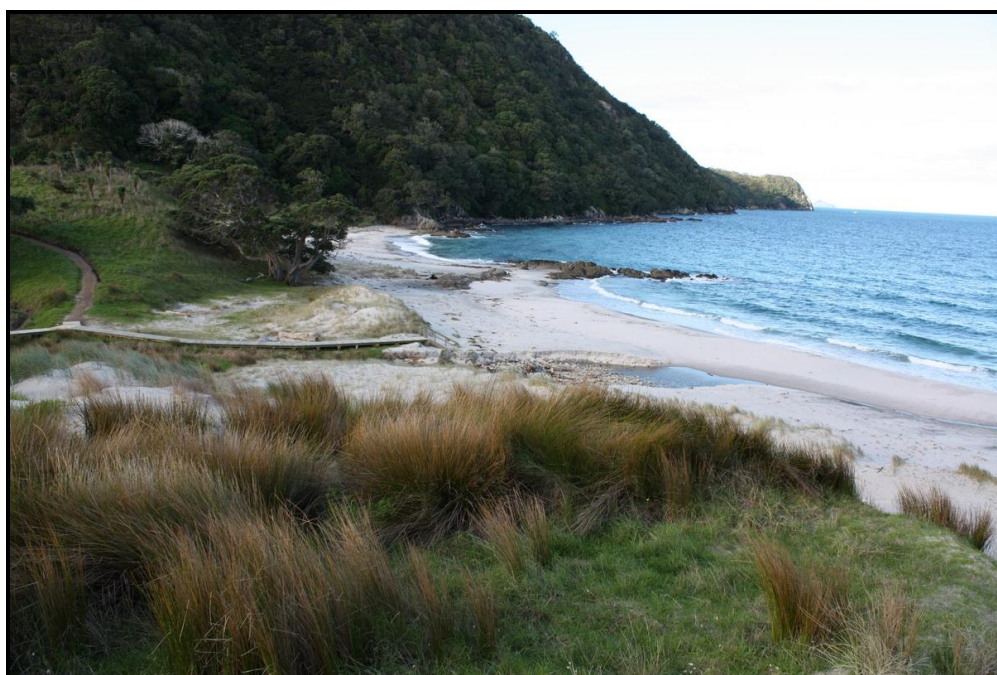
Figure 7: View eastward along Smugglers Bay with knobby club rush and exotic grasses in the foreground; the track and boardwalk that gives access to the centre of the beach adjacent to a small stream draining through the degraded foredune with limited spinifex cover; further along pohutukawa trees on the foredune; and the coastal forest on the headland in the distance.

Semi-stable backdune sties are dominated by an increasing density of exotic grasses, especially kikuyu that occurs through the fence into the grazed paddock behind the beach (Figure 7). Pohuehue is common amongst the rank grass. Colonies of knobby club rush, some of which are large, dominate significant areas of the dunes from near the foredune and throughout the dense grass areas on backdunes. Occasional small groups or isolated shrubs are scattered over parts of the backdune as well as ti kouka (*Cordyline australis*) and harakeke (*Phormium tenax*), some of which may have been from early plantings. Seven large pohutukawa trees occur in a curved line along the dune at the eastern end, which according to Simpson (1990), may have been planted. A dense thriving colony of New Zealand spinach (*Tetragonia tetragonioides*) dominates the ground cover at the eastern end of the line of pohutukawa trees.

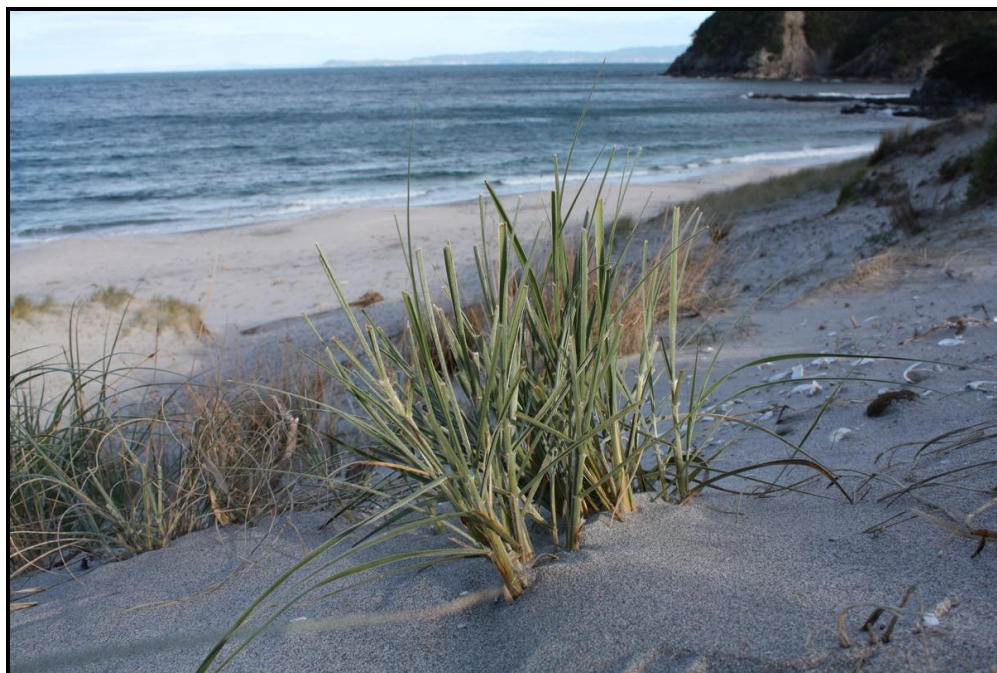
Rabbit damage to vegetation and sign (droppings, scraping) was observed during the site inspection in early June. This was particularly evident along the foredune and included browsed new growth of spinifex plants and runners along parts of the foredune toe (Figure 8). Browsing damage was also evident on knobby club rush, sand carex and sea rocket (*Cakile maritima*) all of which is likely to be from rabbits.

Figure 8: Browsing damage by rabbits of spinifex at Smugglers Bay. Rabbit browsing of spinifex is common on actively growing runners and plants along the seaward face of the foredune significantly reducing sand trapping.

- This is the first action to be tackled in the restoration of Smugglers Bay and is highest priority. ***Control of rabbits is essential before planting of most native plant species on dunelands and their control can often be the single best action to undertake on a degraded dune.***
- Methods for control of rabbits are reviewed by Unsworth (2005). A summary of recommendations relevant to Smugglers Bay for the control of rabbits is given in the Appendix.
- Pindone poisoning operations have proved effective for sustained control of rabbits in similar coastal dunelands as Smugglers, e.g., Te Henga Beach, west Auckland (contact Waitakere City Council and Auckland Regional Council); Bay of Plenty beaches (contact Environment BOP, Mount Maunganui).

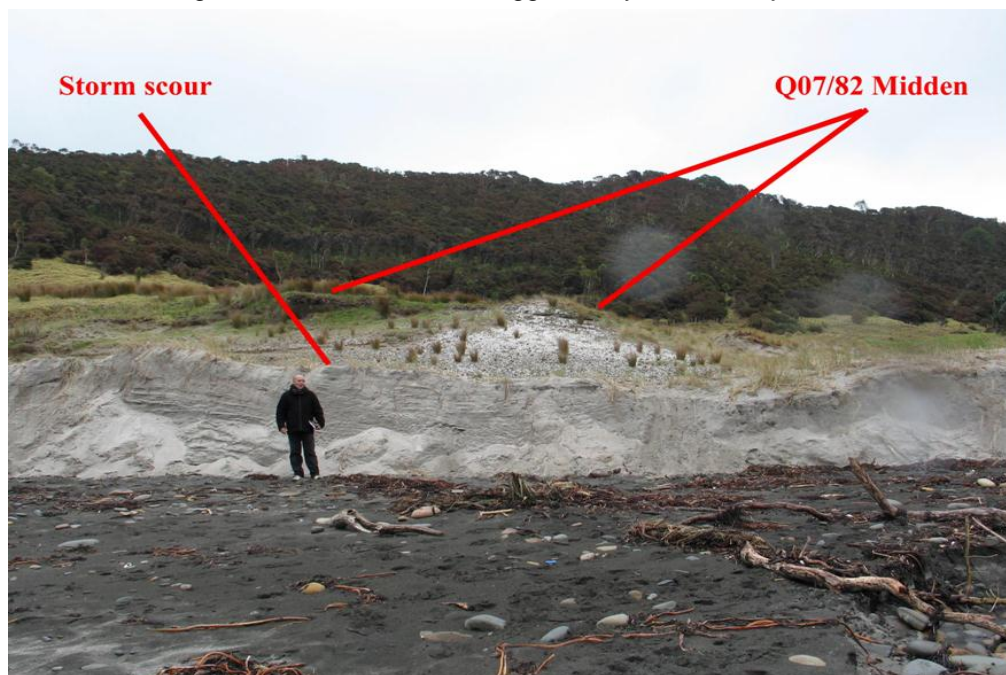
- *In 2007, a '100-year' storm event caused very serious damage to the Smugglers Bay midden (Figure 9). Site visits were undertaken by the DOC archaeologist (Jonathan Carpenter) and Clive Stone of the Ngatiwai Trust Board. With the support of Ngatiwai Trust Board, an Archaeological Authority was obtained, to carry out archaeological investigations of these midden before they suffered further damage.*

Figure 9: Site damage to midden Q07/82, Smugglers Bay, after a major storm in 2007 that caused

considerable erosion. Photograph taken in July 2007 and supplied by Maria Butcher.

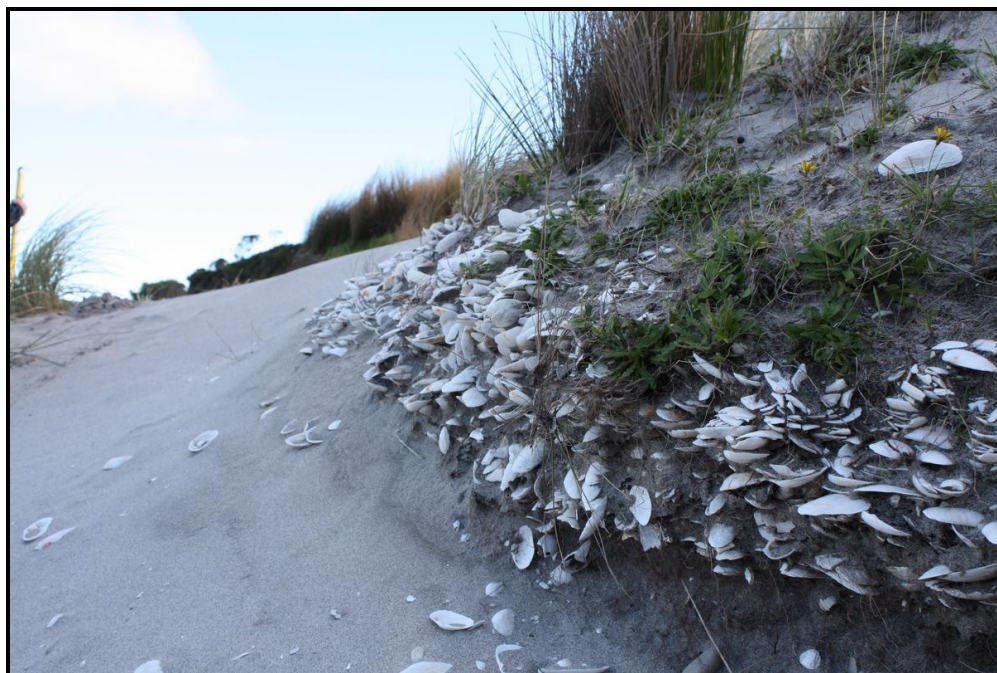
The two most conspicuous middens (Q07/82 & Q07/83) are currently being exposed by wind damage associated with blowouts largely due to lack of appropriate vegetation cover (Figure 10). In addition, an irregular foredune immediately seaward of the western midden (Q07/82) is allowing wind funnelling up the steep dune face creating a windswept zone deflating the midden site and depositing fresh sand landward. A restoration programme starting with revegetating the foredunes is likely to reduce damage to this and other middens on the dunes of Smugglers Bay.

Figure 10: Exposed archaic shell midden on a poorly vegetated dune at Smugglers Bay vulnerable to further erosion from onshore winds.

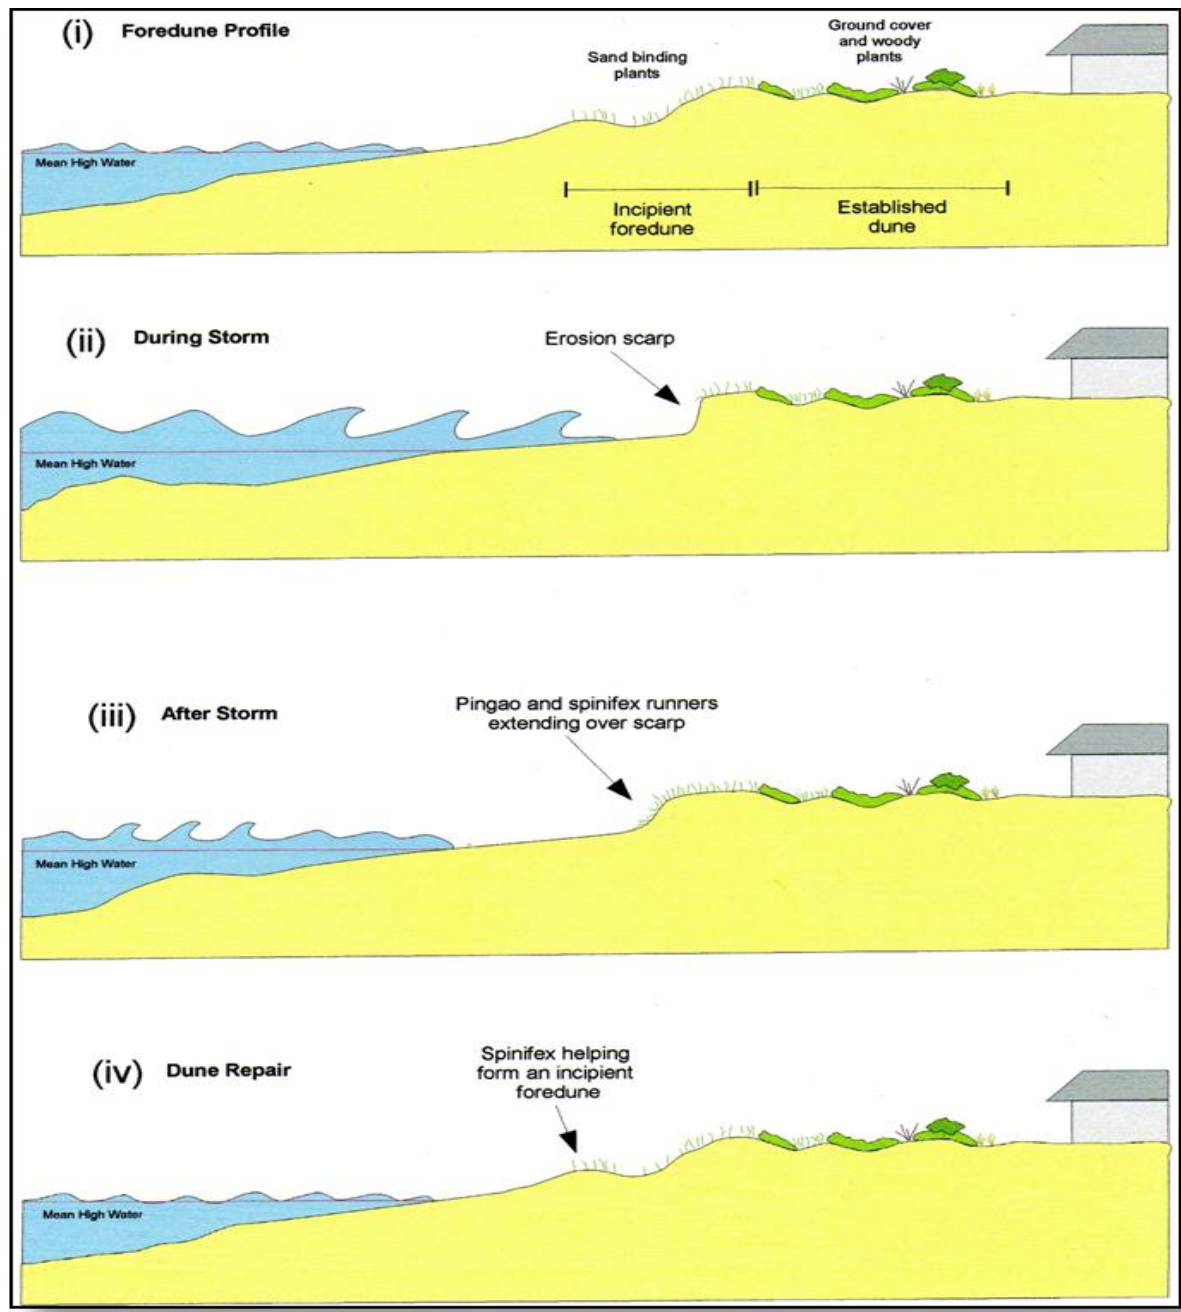
As in other beach and sand dune systems, the foredunes along Smugglers Bay are an integral part of the total beach system and are subject to these natural cycles of erosion and repair. These processes, sometimes referred to as “cut and fill”, are illustrated in Figure 11 and described as follows:

- iv. In extended periods without further dune erosion, the native sand binding grasses on the seaward face of the dune, particularly spinifex and pingao, gradually begin to extend down the eroded dune face – renewing the process of sand entrapment and gradually repairing the eroded dune face. The building of an incipient dune continues during this accretion phase to return the dune to a pre-storm profile

(Figure 11iv). This natural dune repair process is relatively slow and full recovery can take years after a period of severe dune erosion.

Figure 11: Natural cycles of dune erosion and recovery that occur on sandy beaches including pocket beaches like that of Smugglers Bay. The foredune profile (i) is cut back during a storm to create a steep scarp (ii). Following the storm, over the following months or longer, the native sandbinders spinifex and pingao extend over the scarp to trap sand blown off the beach (iii) and an incipient dune is eventually reformed (iv). Refer to the text for greater detail on each profile i - iv.

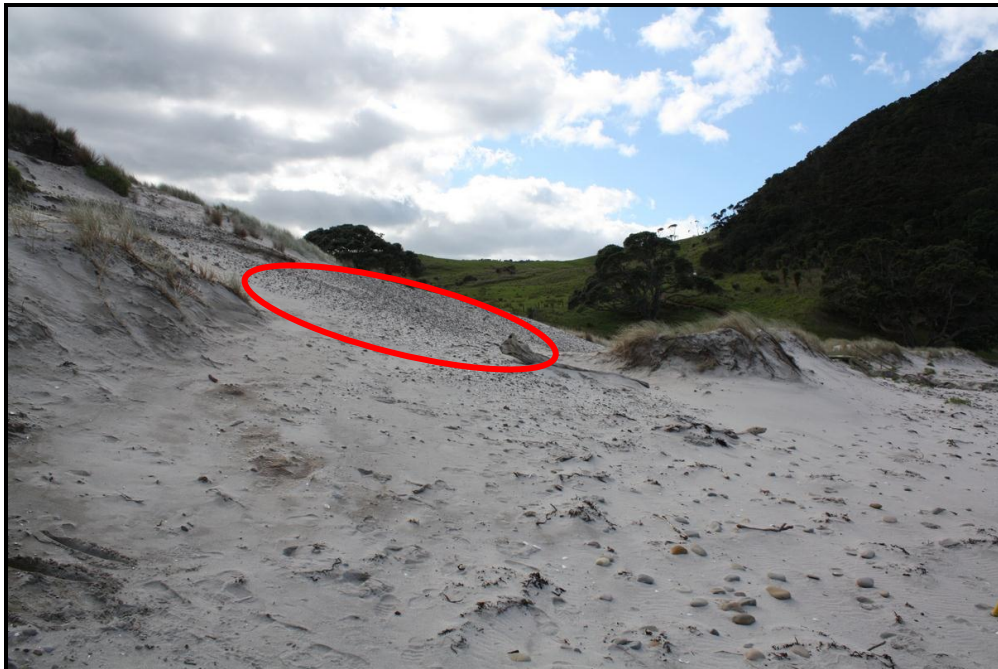
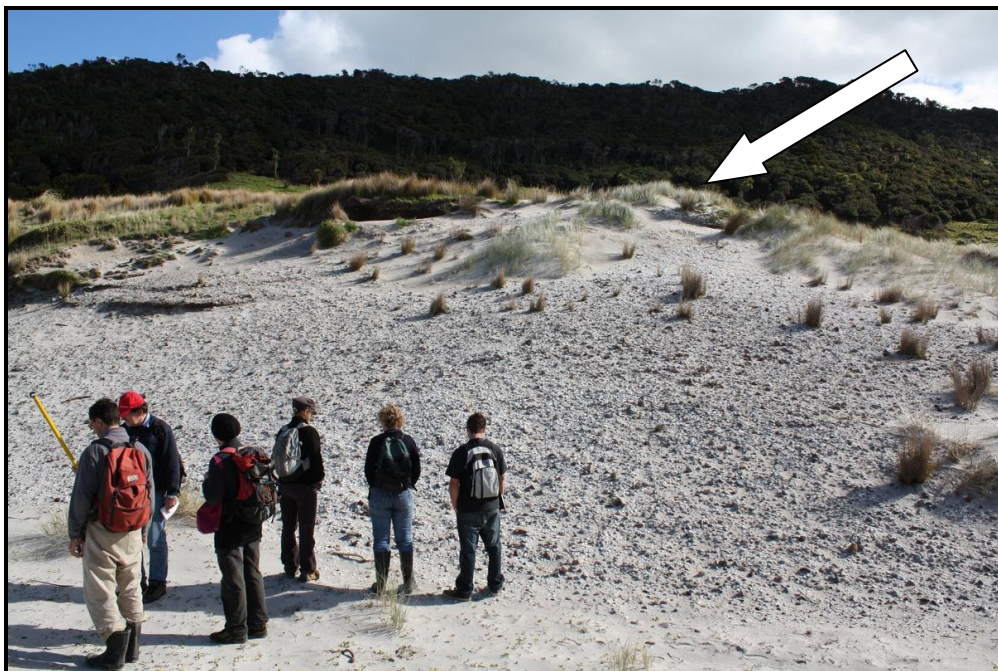
Figure 12: The features of the blowout at Smugglers Bay that is eroding midden Q07/82 toward the western end of the beach. The partially destroyed and degraded foredune (top) is allowing accelerated wind flow over the midden immediately landward (circled). This has left a typical deflation basin directly over the midden covered in a dense layer of shell and stone (lower). Further landward is the depositional zone (with healthy spinifex arrowed) of sand blown inland from the foredune and midden.

- Consult the Department of Conservation before any planting over the midden.
- Attempt to rejuvenate the single unthrifty pingao at top end of blowout and midden by adding a small quantity of sand around plant, applying a light dressing of urea fertiliser and controlling rabbits.

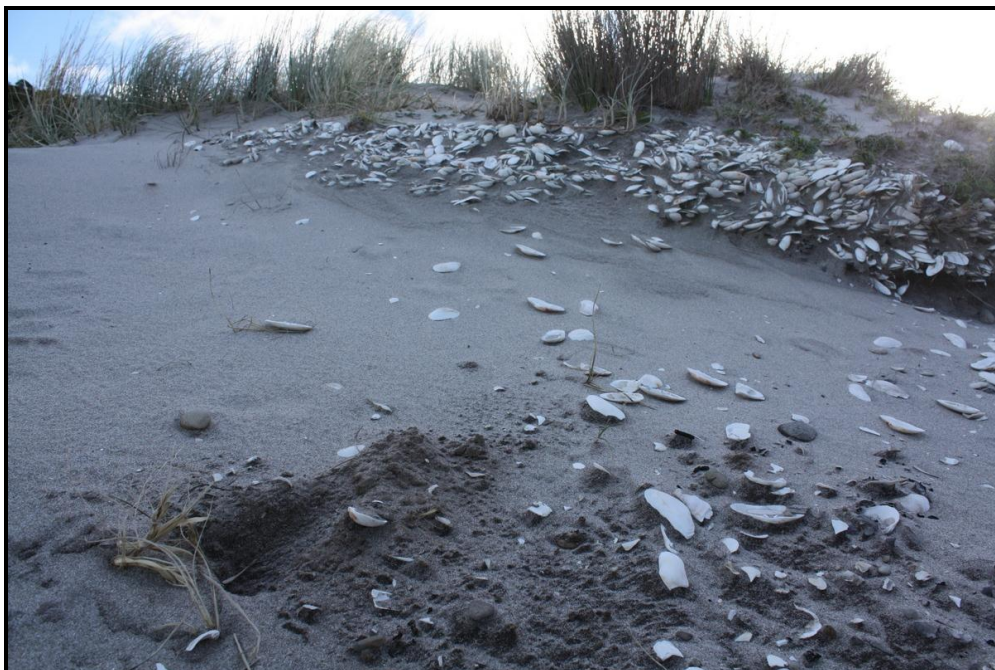
Figure 13: The effects of wind erosion of a poorly vegetated dune and rabbit burrowing on a midden site at Smugglers Bay.

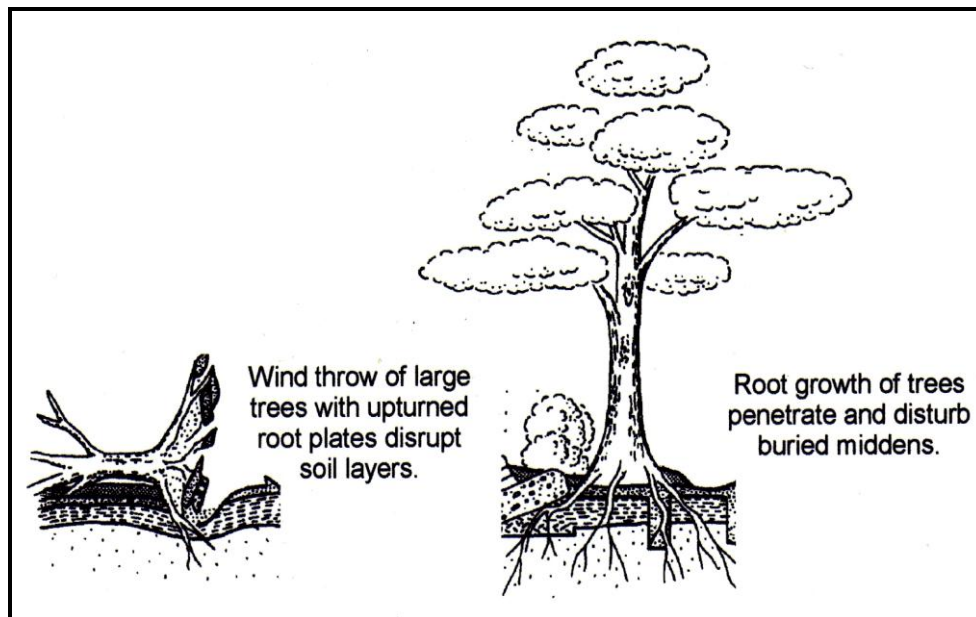
Figure 14: Effects of large trees on site stabilisation of archaeological sites such as middens (modified from Jones and Simpson 1995). Planting trees and shrubs on middens is therefore not recommended.

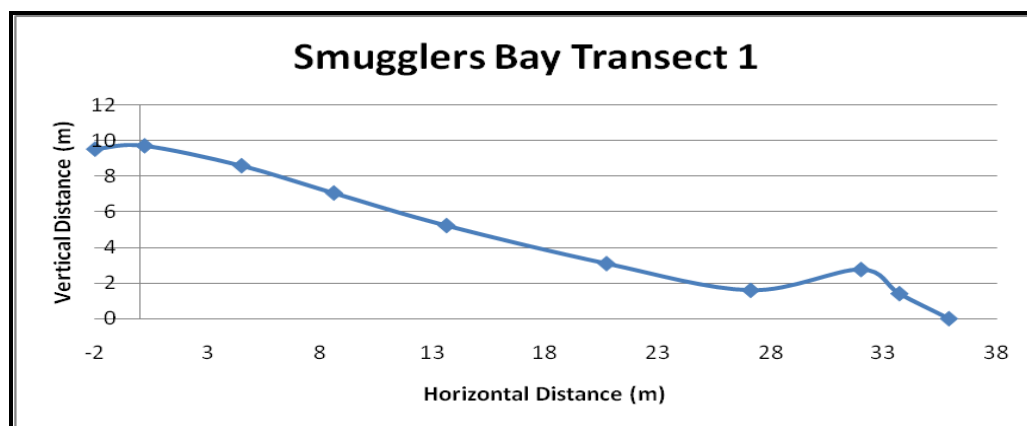
- Transect 1 (Figure 16) shows where the foredune occurs (at approx. 28-36 m horizontal distance) but just west of this transect is the blowout with no foredune that has led to erosion of the midden (at approx. 5-20 m on the slope).

Figure 16: Transect 1 through the centre of the midden (Q07/82) at the western end of the bay. The exposed midden, which is the deflation basin of a blowout, is located at approximately 5-25 m horizontal distance. Note that the foredune (at 28-35 m) is completely destroyed immediately west of this transect resulting in erosion of the midden.

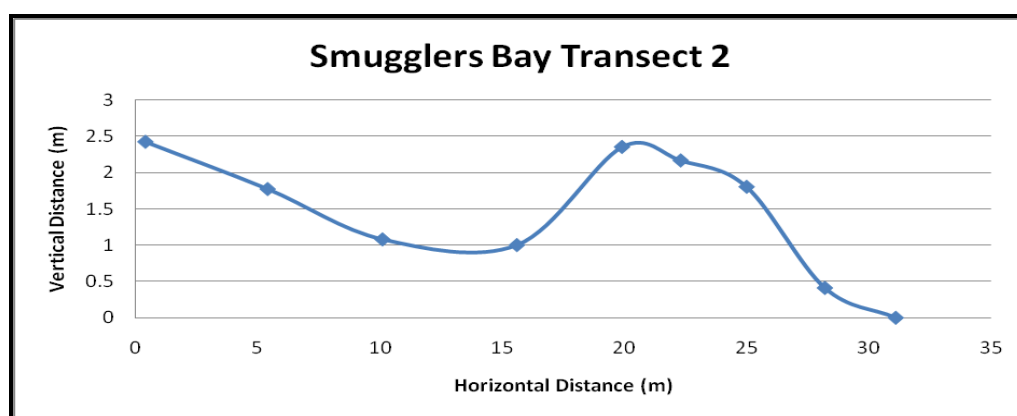
- 5 m wide foredune dominated by spinifex; evidence of erosion scarp from last storm but minimal regrowth of spinifex on seaward face due to rabbits and trampling by beach users; good example of a degraded foredune with lack of natural repair after storm cut.

- Extend knobby club rush to landward sites; consider small groups of harakeke in lower landward sites.
- Transect 2 from boardwalk to foredune toe (Figure 17); note steep seaward face of foredune from a previous storm cut (at approx. 25-28 m horizontal distance) which remains highly vulnerable to further erosion until a cover of native sand binders is achieved; if not restored, potential for the foredune to be destroyed as sand blown inland covering habitat landward.

Figure 17: Transect 2 immediately east of access and central stream. The foredune with steep foredune face (approximately 25-28 m horizontal distance) is poorly vegetated in native sand binders and therefore vulnerable to further erosion. The semi-stable swale (5-10 m) is sparsely vegetated.

- High priority for restoration of foredune by controlling rabbits, planting spinifex and pingao, and erecting signs and low-key fencing to reduce damage along foredune from beach users.

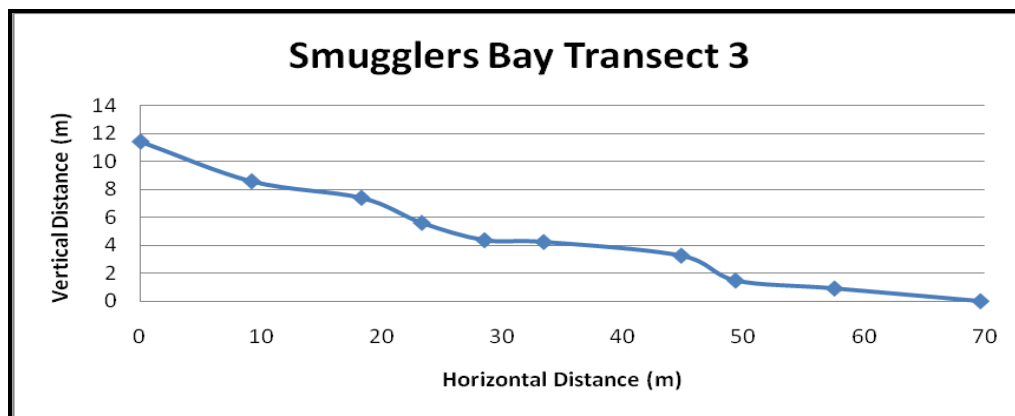
- Transect 3 from fenceline to foredune toe (Figure 18); note the remnant storm scarp in foredune (at 45-50 m); maintain flat area of low exotic grass beneath pohutukawa (at approx 30 m).

Figure 18: Transect 3 toward the eastern end from the fenceline (0 horizontal distance), pohutukawa with a dense ground cover of native spinach (0-20 m), to a part-vegetated foredune slope at near high water mark (45-50 m).

- Large blowout at western end semi-stabilised with scattered grasses; plant groups of spinifex and pingao along degraded foredune to fill gaps and encourage spread of vegetation over foredune faces; encourage natural regeneration of knobby club rush and pohuehue on semi-stable sites landward.

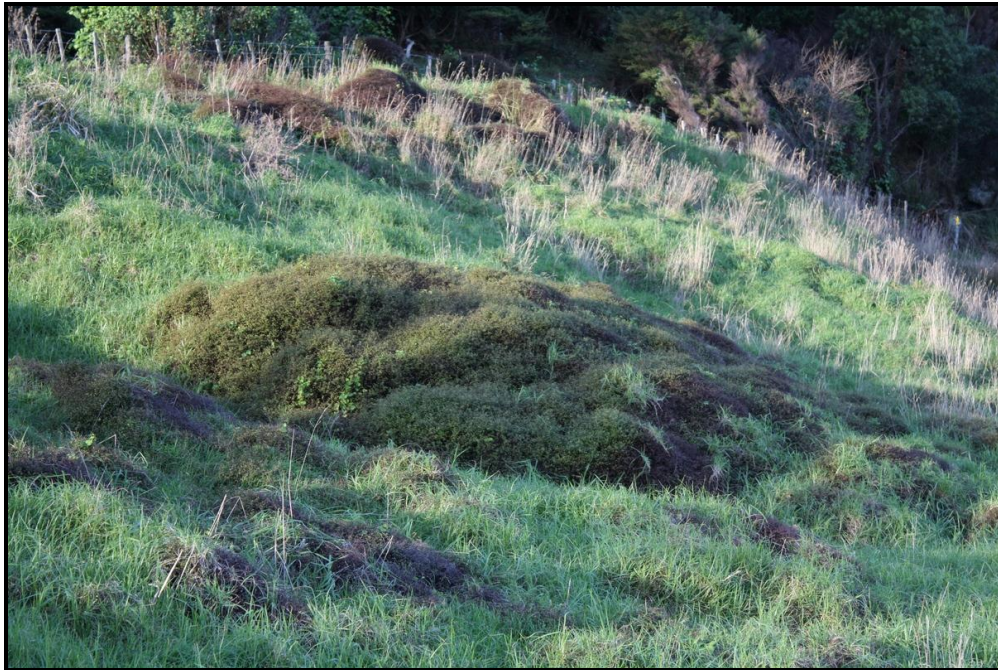
Figure 19: Dense mounds of vigorous pohuehue at the eastern end of the beach amongst rank grass. There is scope to trial grass-selective herbicide spraying around these mounds to reduce vigour of exotic grasses as a practical method for encouraging more rapid spread of pohuehue. This could also be trialled around established colonies of knobby club rush that also occur in this area.
