# Ohau Loop Phase 1

## Existing Status and Recommendations for Improvement

Manaaki Taha Moana: Enhancing Coastal Ecosystems for Iwi  
MTM Report No. 5  
November 2011

# ŌHAU LOOP PHASE 1: EXISTING STATUS AND RECOMMENDATIONS FOR IMPROVEMENT

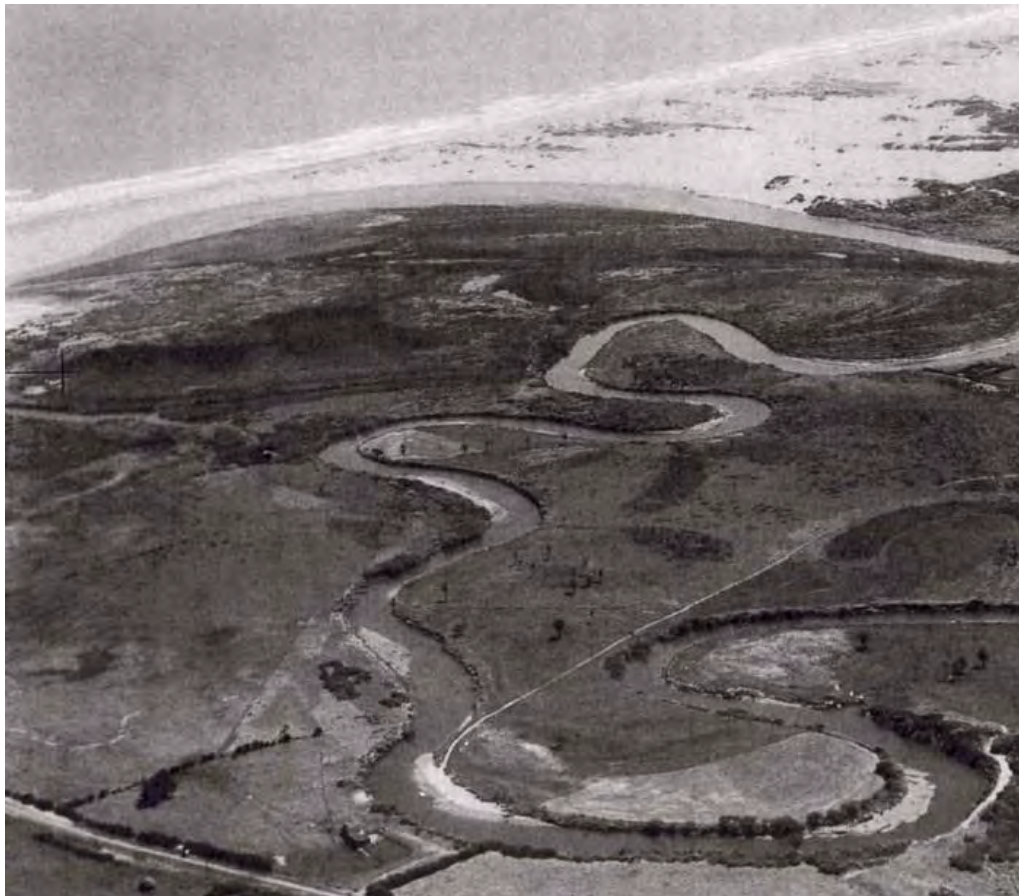
Figure 6. The Ōhau Loop in the 1940s before the cut was made (Smith 2007).

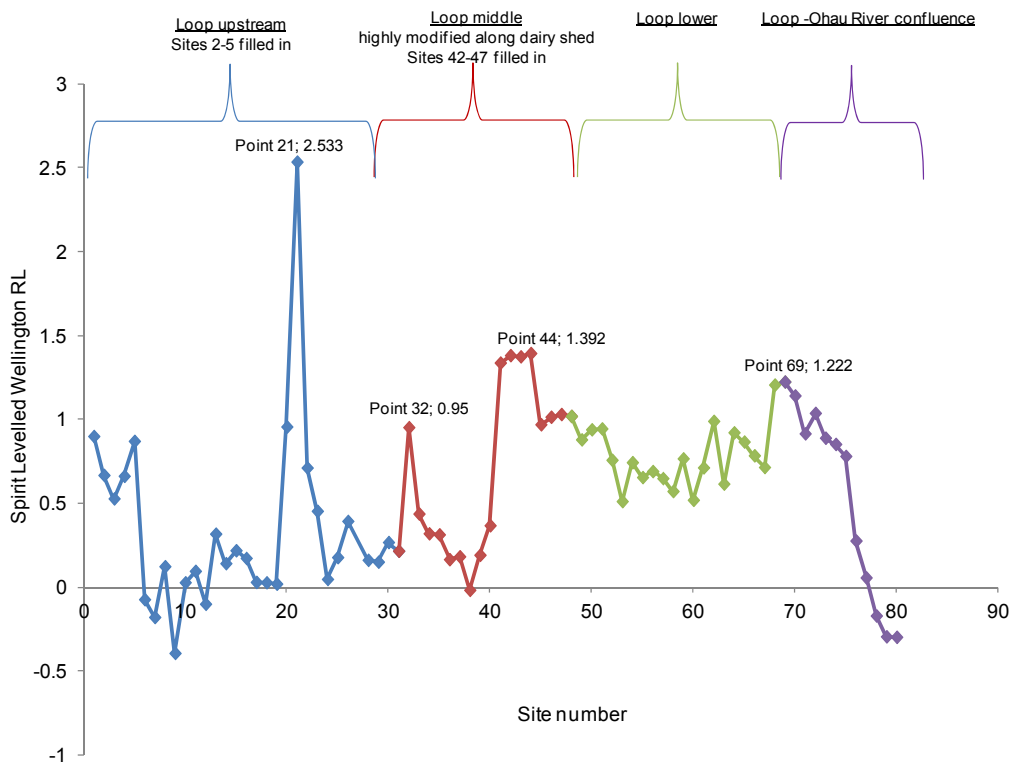
Figure 12. Location of 83 bed height stations (A) and their Right Level elevation (B). Elevations in metres.

The Loop lower section had the highest mean bed height recorded within the Loop (*i.e.*, 0.790RL), with a range from 0.509RL to 1.222RL. This part of the Loop had consistent water flow and was permanently inundated.

The Loop-Ōhau River confluence section had the second lowest bed height readings and particularly low values at points 78, 79 and 80 (-0.173, -0.297 and -0.3, respectively). No further bed height measurements were made in the Ōhau River because of high wind<sup>4</sup>. Thus more field work is required before precise bed height and gradient descriptions of the Ōhau River can be made.
