BEACH CHANGES BETWEEN NAPIER and CLIFTON

SOUTHERN HAWKE BAY

WATER QUALITY CENTRE PUBLICATION NO. 5

BEACH CHANGES BETWEEN NAPIER AND CLIFTON,
SOUTHERN HAWKE BAY

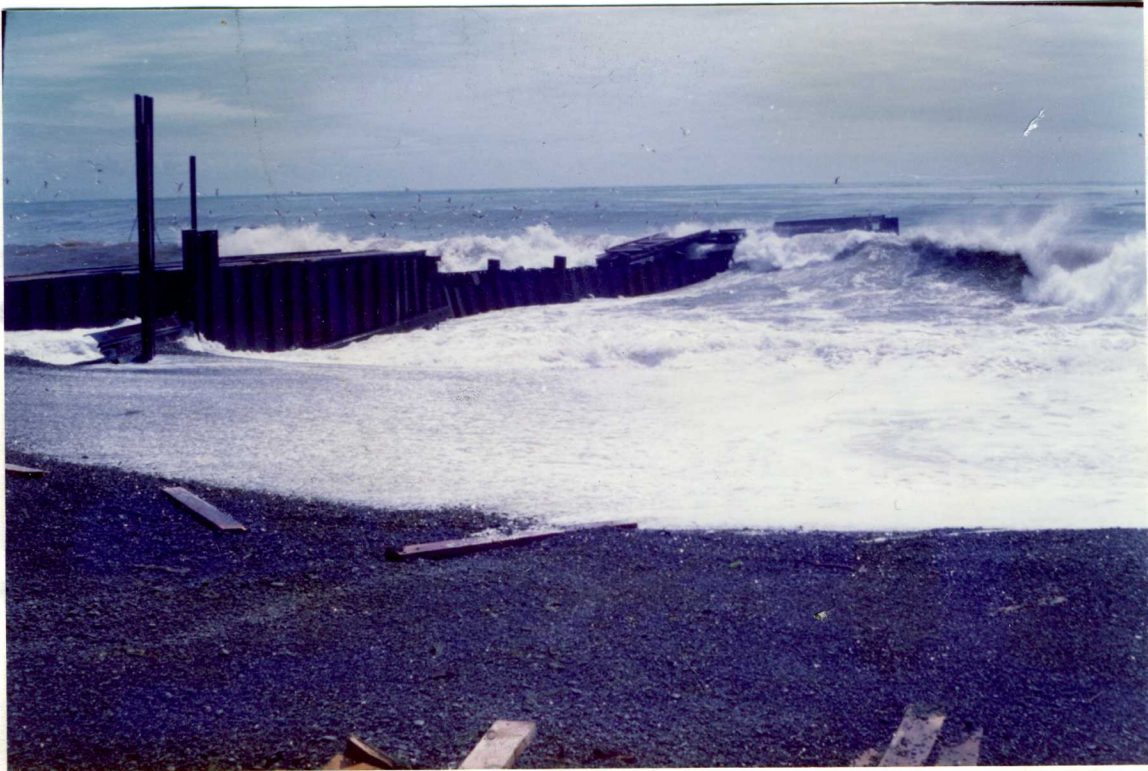
Plate 1 : Wave damage to sheet piling tunnel at the Hastings City sewer outfall, December-January 1979-80.

Beach erosion and damage to foreshore works can occur through two different circumstances. The most spectacular and best reported, are the infrequent, catastrophic events such as the storms of 1906, 1974 and the 'Wahine' storm of 1968. The less spectacular though often equally destructive process, is caused by two, or more, less severe events occurring in close succession. In these occasions the beach does not have time to recover from one event before the next arrives. For example, the partial destruction of the sheet piling groyne used for launching the Hastings sewer pipe was caused by two series of southerly waves which were generated by two depressions which developed on the east coast of the South Island over the Christmas/New Year period 1979-80. These two depressions caused waves in Hawke Bay of 1.0 m - 1.5 m from 30 December 1979 to 2 January 1980 and 1.5 m - 2.0 m from 5-8 January 1980. These two events eroded the lower beach face and undermined the sheet piling sufficiently for the longshore drift to push the structure out of alignment at the wave break point (Plate 1). Previous to this double event the structure had survived similar sized events with no damage. Any coastal protection scheme must consider the

effects of both infrequent large events and/or a succession of small events causing erosion to the works. Table 5 summarises the frequency distribution of the number of days between wave events in excess of 1 m for the period 1976 to 1980. The distribution is noticeably skewed with the modal class of 11-15 days separating events, which reflects the cyclonic pattern of weather typical of this latitude. The average period between events was 19 days.

The accretion observed at K4 from 1979 to 1980 appears to be related to the construction of the Hastings City sewer outfall at East Clive. The sheet piling launching tunnel acted like a groyne, prevented the northward drift of material, causing deposition to the south. Beach changes measured at East Clive from

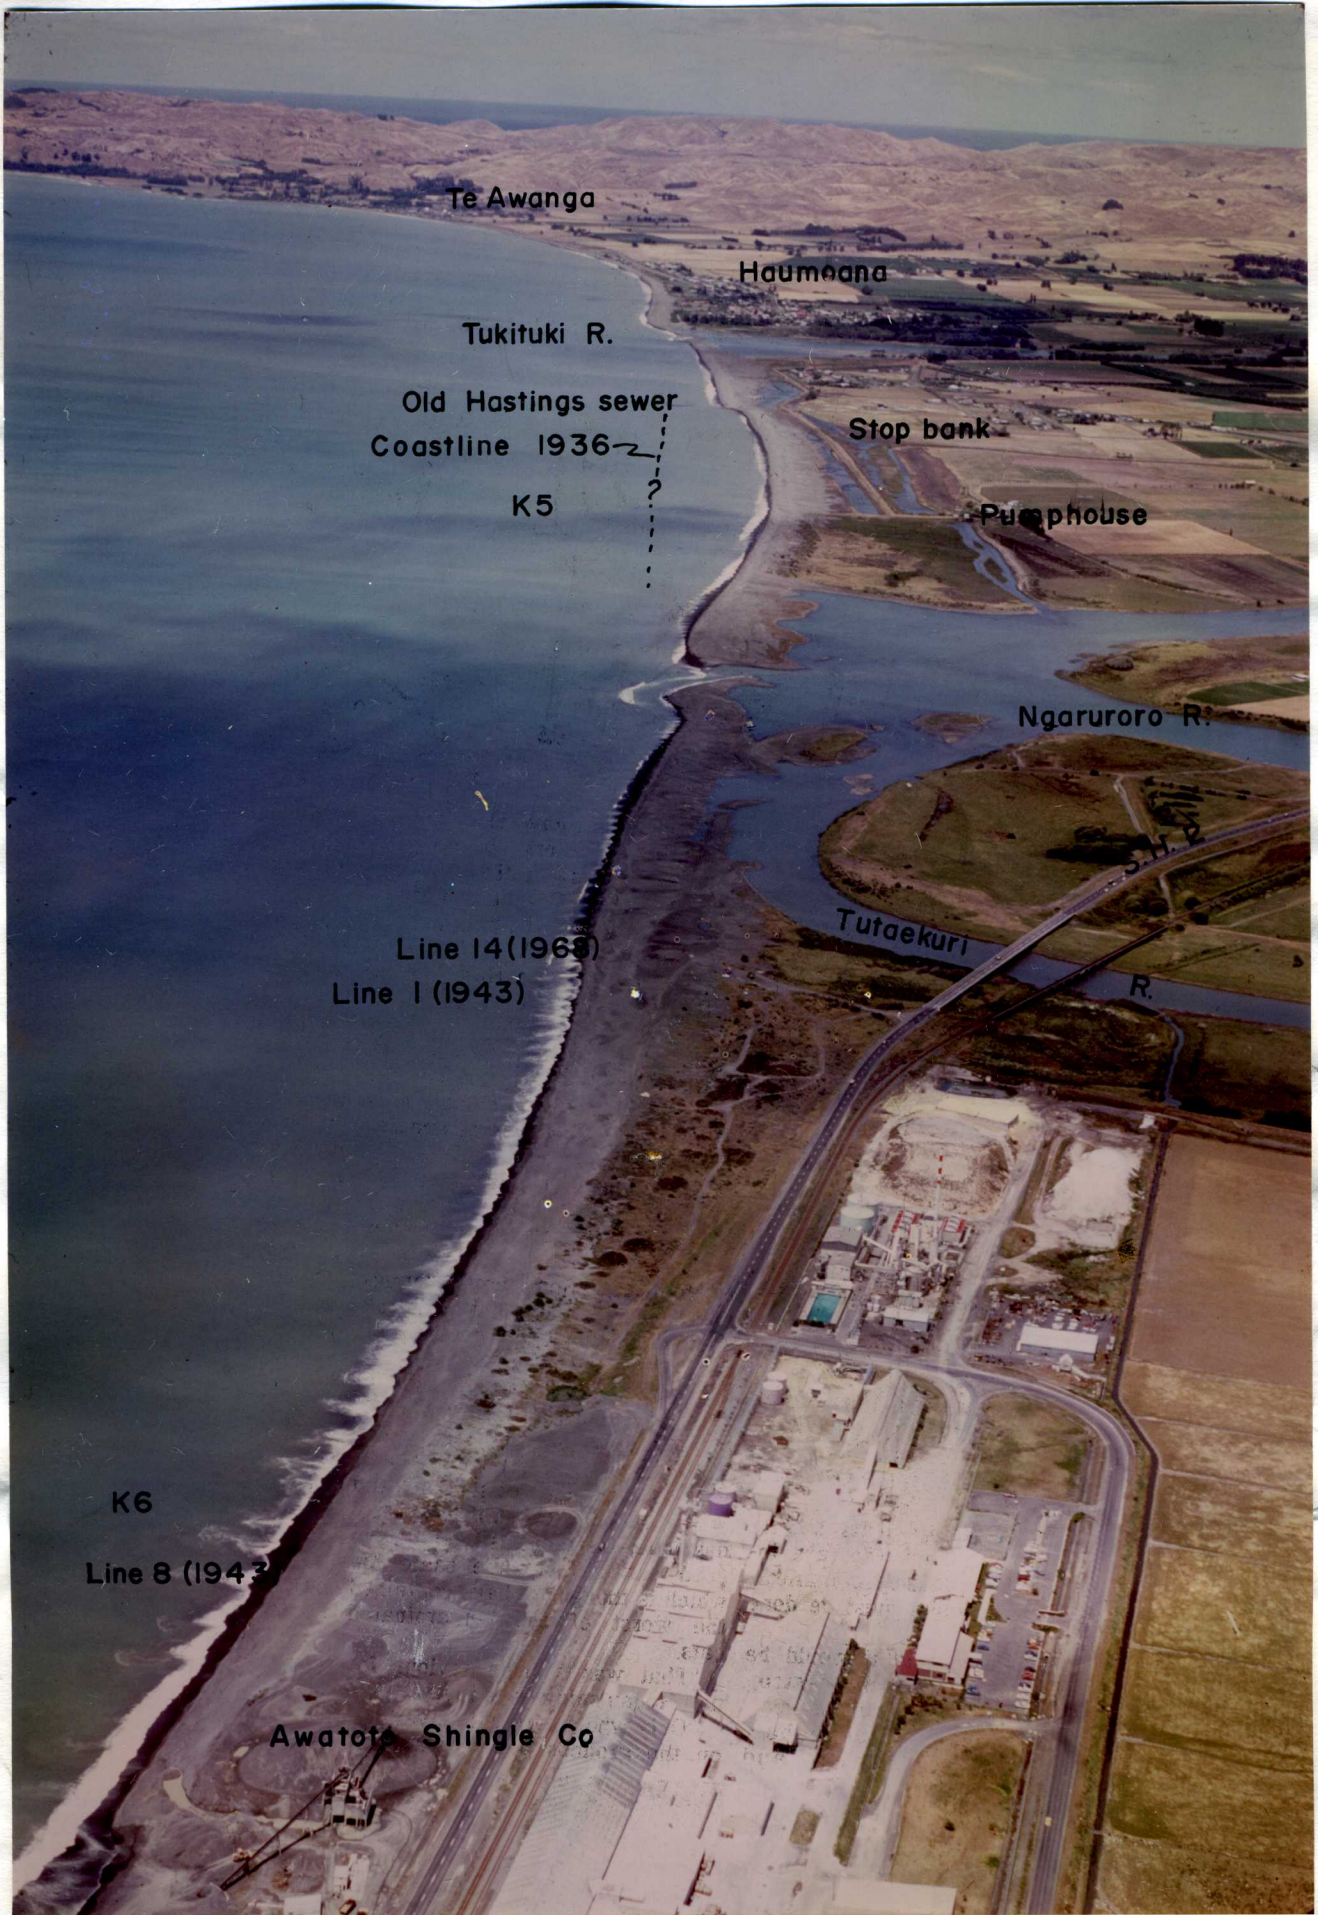
Plate 2 : Aerial view of the coastline from Awatoto to Te Awanga 1984
(Photo T M Hume).

The localised area affected by reduced progradation rates between 1948 and 1984, lines 6 to 10, is indicative a local process is causing the beach retreat. That lines 1-5, south of the extraction plant, do not show the effects of extraction may be explained by the periodic northwards migration of the river mouth which causes a slight bulge in the coastline (Plate 2).

An alternative hypothesis for the reduced progradation between lines 6 and 10 at Awatoto, is that it is the result of the Hastings City sewer outfall construction. As part of the construction a sheet piling tunnel was constructed to launch the pipe from the shore. This tunnel acted as a groyne, preventing the normal drift of material northwards and causing erosion of the beach from the construction site northwards to the southern side of the Ngaruroro/Tutakuri river's mouth. Continued northward migration of this undernourished beach form could possibly account for the undernourished conditions between lines 6 and 10. However, as the length of affected beach at Awatoto is only 500 m and the time lag is three years it is most likely that the Hastings City sewer construction is not the principle cause of the lack of progradation. Further, the rate of excursion distance retreat at line 8 (Figure 10) between 1980 and 1984 does not show a significant increase on that of 1975 to 1980. It is therefore unlikely that the construction work has had a significant effect on the beach conditions at Awatoto.

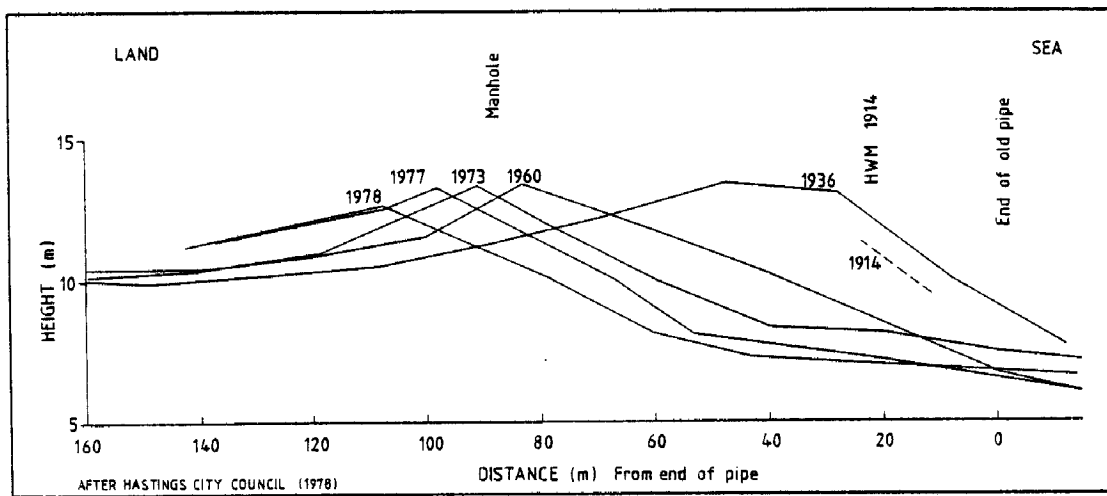
Figure 20 : Hastings City Council sewer outfall cross section 1914-1978.

Five surveys of the beach in the vicinity of the Hastings City sewer outfall, have been carried out from 1936 to 1978, which, together with a small section of a survey in 1914, provide a record of what has happened at East Clive over a longer period (Figure 20). From 1914 to 1936 a small amount of accretion occurred. Since 1936 the site has eroded, depositing a proportion of the beach

face material on the barrier backslope. The initial response to the relative changes in land and sea levels was, as could be expected, rapid averaging 1.1 m per year from 1936 to 1960. From 1960 to 1973, the rate reduced and averaged 0.6 m/year. Since 1973 the rate of retreat has again increased attaining 10 m/year for the 1977-1978 period. This latest increase in erosion rate suggests that some factor(s), other than the change in land levels associated with the earthquake, are stimulating erosion of the barrier in this area.

Only the beach at East Clive and along the foreshore adjacent to Clifton is there evidence of continuing erosion. The Hastings City Council cross sections at the sewer outfall do indicate an increase in the rate of coastline retreat since 1973 which may be attributed to increasing frequency of storm waves overtopping the barrier. The increased frequency of storms does not appear to have caused a change in longshore transport rate. Lindup's (1948) observations and the investigation at the mouth of the Tukituki River (1978-84) show no difference in sediment transport rates since the 1940s.
