**NORTHERN OHARIU FAULT:
Earthquake Hazard Assessment of a Newly
Discovered
Active Strike-Slip Fault in Horowhenua**

Prepared for

EQC

Research Foundation Project 97/263

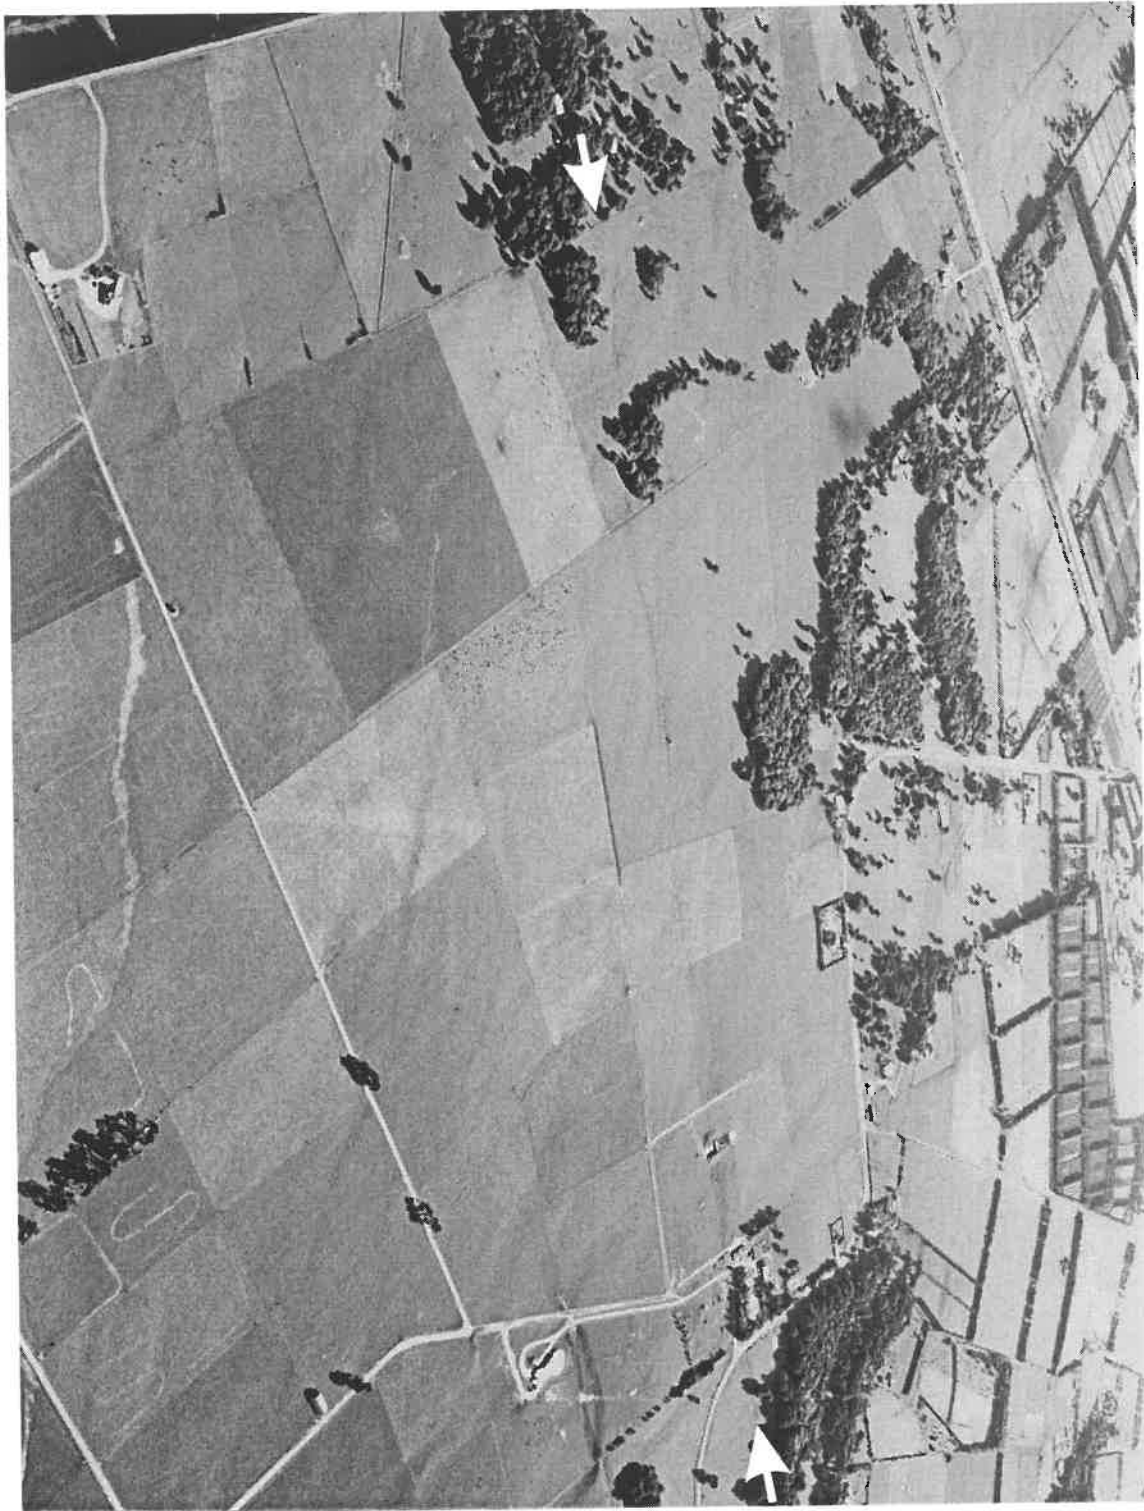
Fig. 4. Aerial photograph looking northwest across the northeast-trending scarp, 1-2 m high, of the Northern Ohariu fault, Te Horo/Old Hautere Road area. Bold arrows show the location of the fault which extends left to right across middle of photo. State Highway 1 runs diagonally across upper-left of photo, and Old Hautere Road is at upper-middle left. The extensive alluvial terrace in the photo that is displaced by the fault is predominantly Ohakean in age (about 10 000-15 000 years old).

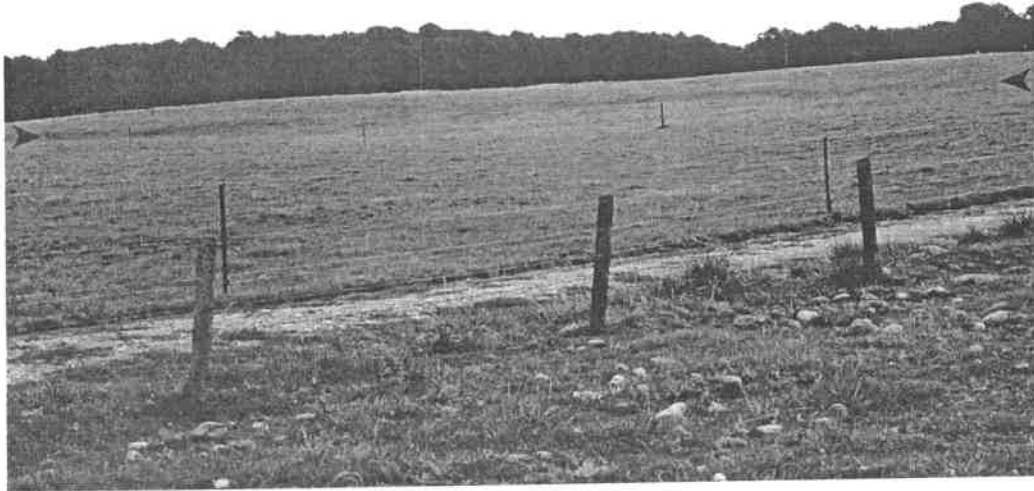
Fig. 5. Photographs looking northwest across the 1-2 m high, southeast-facing, scarp of the Northern Ohariu fault, Old Hautere Road area. Bold arrows show fault's location. Displaced alluvial terrace in photographs is Ohakean in age (about 10 000-15 000 years old). A) Photo taken about 300 m west-southwest of Old Hautere Road (grid ref. S25 909 437). Area shown in this photo is encompassed by that in Fig. 4. B) Photo taken about 200 m northeast of Otaki Gorge Road, between Otaki Gorge Road and the Otaki River (grid ref. S25 925 446).
Photo: R. Van Dissen, Institute of Geological & Nuclear Sciences.

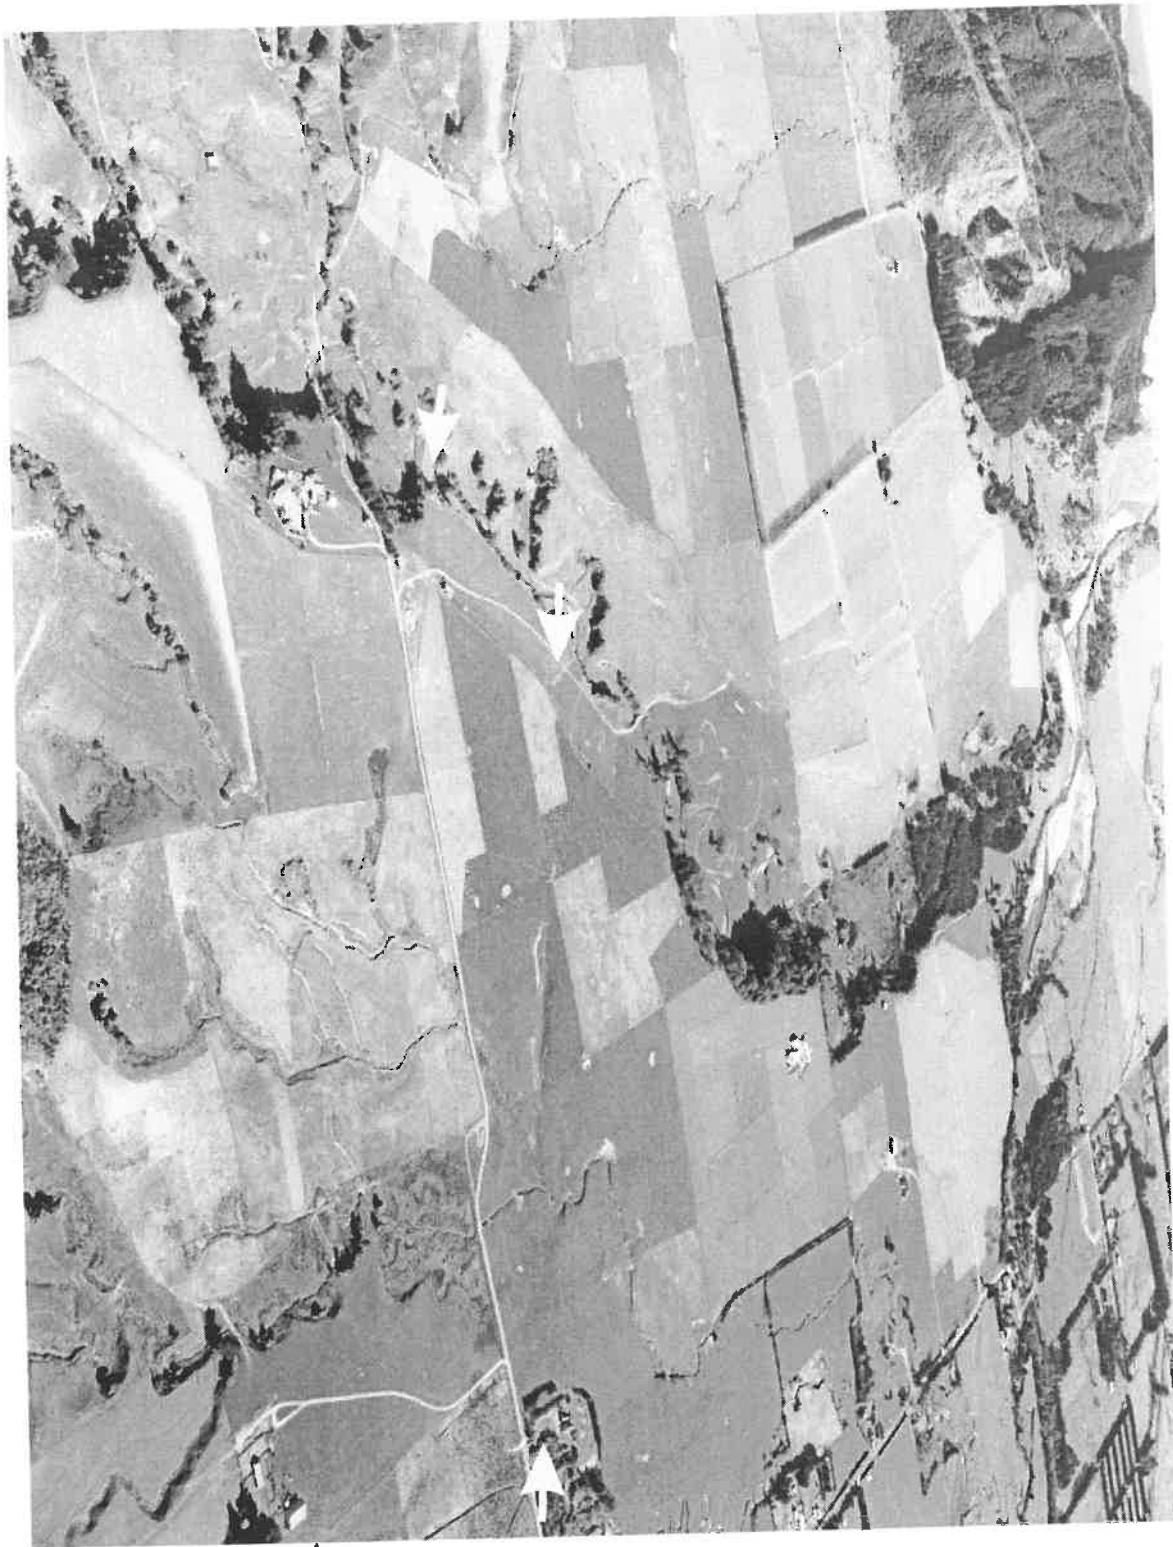
Fig. 7. Aerial photograph looking northwest across the small graben along the Northern Ohariu fault near Tangimoana Road. Bold arrows show the fault's location. Tangimoana Road extends across center of photo, and is slightly oblique to the fault. Muhunoa Road runs diagonally across upper-right of photo, and the Ohau River flows right to left across top of photo.
Photo: D.L. Homer, Institute of Geological & Nuclear Sciences (photo ref. CN 46625 A).

| Fig. 7 | S25 036555 | 11 | Degraded Ratan terrace just W of fault. Shannon silt loam on gravels at 1m. |

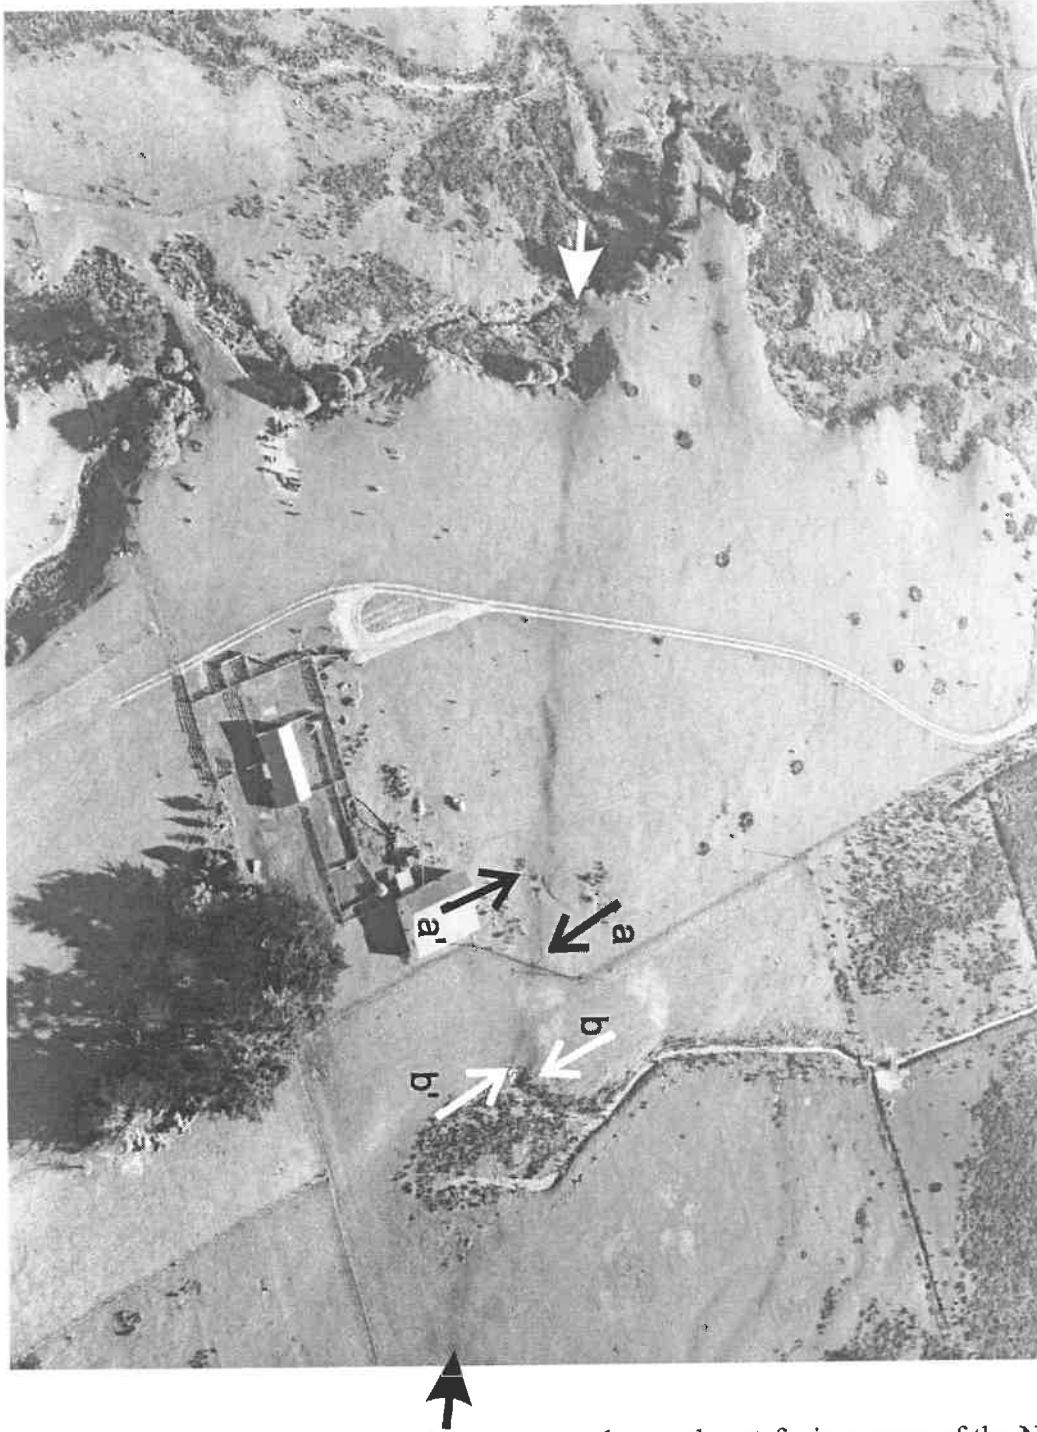
Fig. 8. Aerial photograph looking northwest across the southeast-facing scarp of the Northern Ohariu fault (grid ref. S25 039 555). Bold arrows show the fault's location. The faulted terrace in the centre of the photo is Ratan in age (ca 30 000-40 000 years), and the road in the upper left-hand corner of the photo is Tangimoana Road. The ca 10-20 m right-lateral displacement of an Ohakean age terrace riser (10 000-15 000 years) is denoted by a-a', yielding a lateral slip rate of ca 0.7-2 mm/yr. This, however, is a minimum rate for the fault as a whole because about 300 m to the northwest, off the photograph, there is the sub-parallel western strand of the fault for which a slip rate has yet to be determined. The ca 3 m right-lateral offset of the channel-wall of a small spring is denoted by b-b'. This may represent the amount of lateral displacement resulting from the most recent surface rupture displacement on this strand of the fault.

About 50 m northeast from the red woolshed, the eastern strand of the fault laterally displaces the channel-wall of a small spring by 3±1 m (b-b' of Fig. 8; site 1c of Table 1). This channel has been cut into an Ohakean age terrace, and is thus younger than the terrace. The size of the offset is the smallest observed along this portion of the fault, and may represent the amount of lateral displacement resulting from the most recent surface rupture displacement on the eastern strand of the fault.

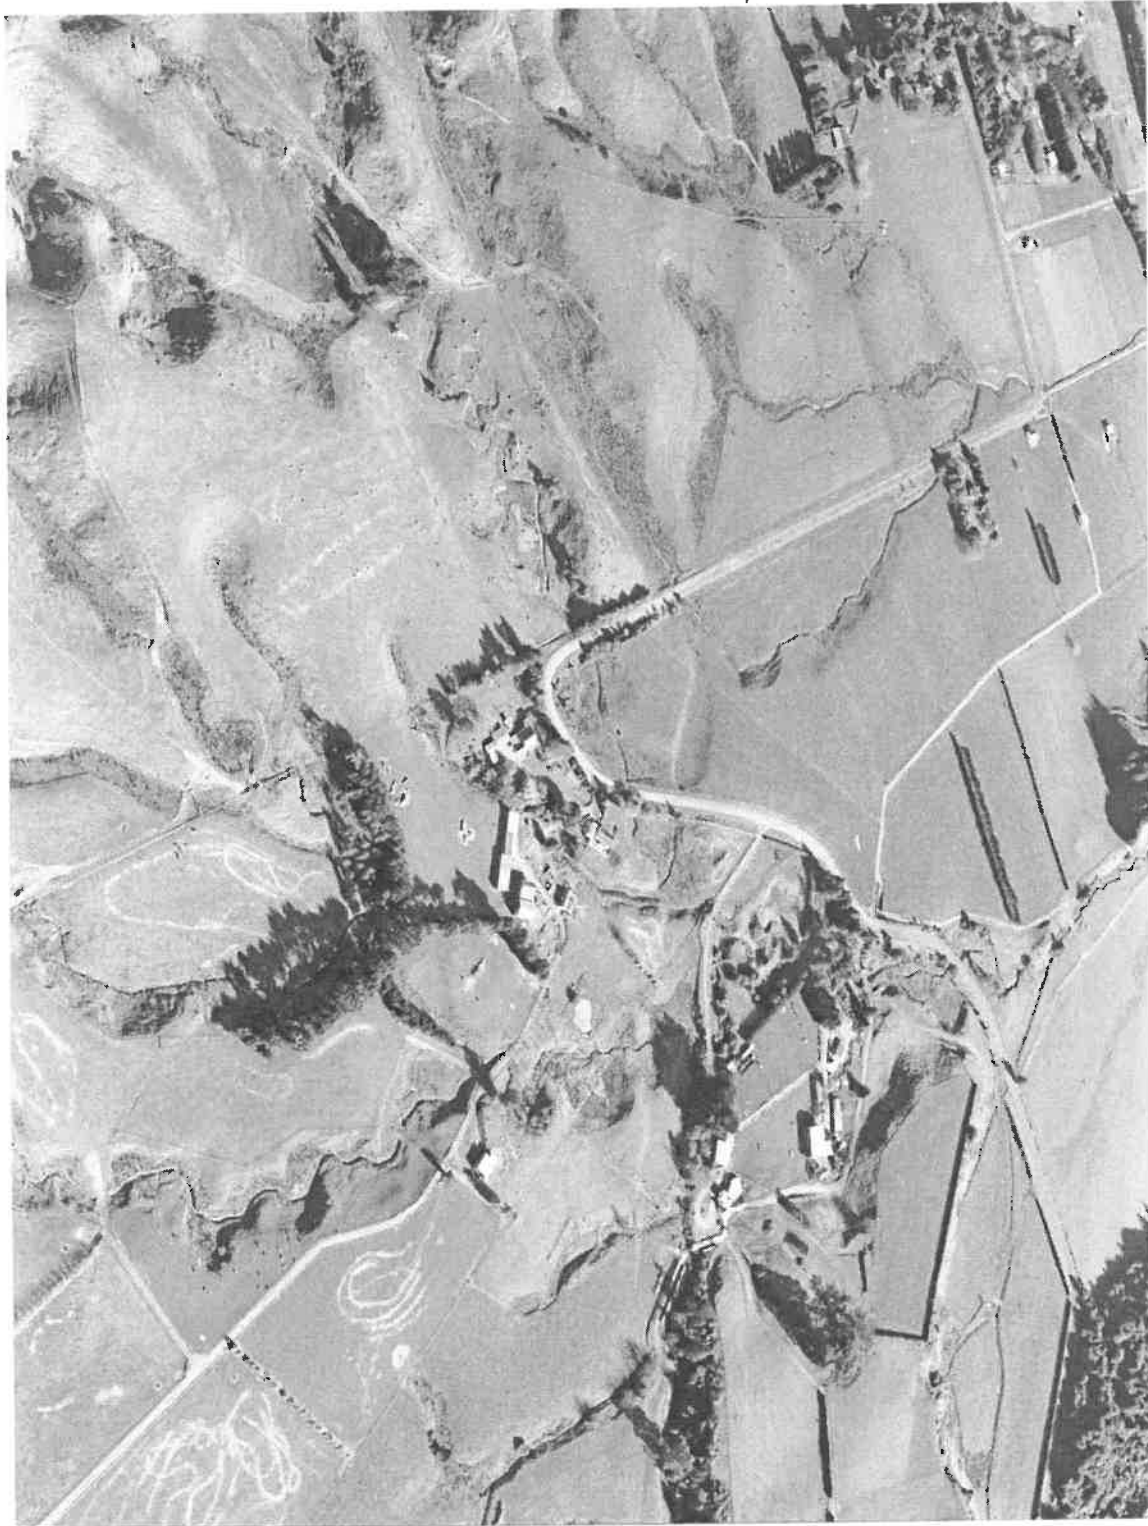
Fig. 9. Aerial photograph looking north-northwest across the northeast-trending Northern Ohariu fault (grid ref. S25 050564). Bold arrows show the fault's location. The main road in the photo is Florida Road. The displaced terraces in the photograph are Marton in age and younger (less than ca 140 000 years).

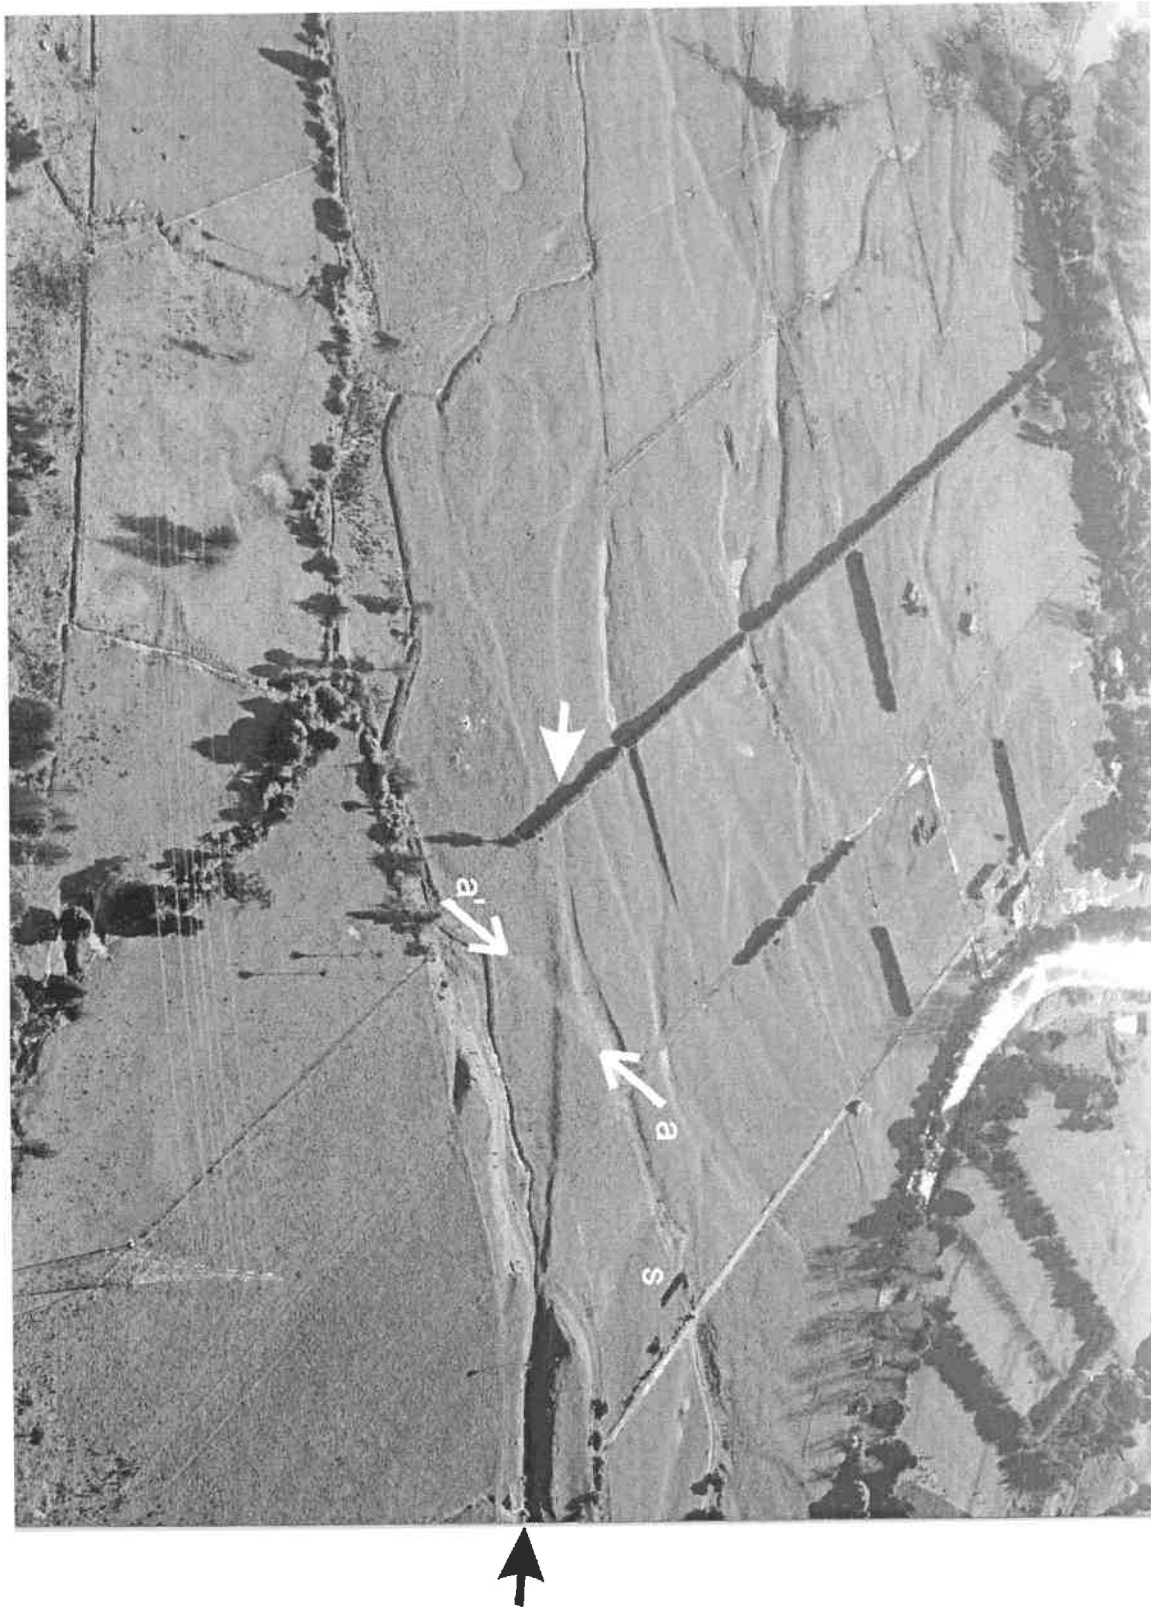
Fig. 10. Aerial photograph looking north-northwest across northeast-trending Northern Ohariu fault, Florida Road/Ohau River area. Bold arrows show fault's location. The 3.0-3.5 m net displacement of the young terrace riser is denoted by the arrows labelled a-a', and is interpreted to represent the amount of surface rupture displacement that occurred at this site during the most recent earthquake. "s" is location of silage pit discussed in text.
Photo: D.L. Homer, Institute of Geological & Nuclear Sciences (photo ref. CN 39576 17).

On the south side of the Ohau River, east-southeast from the end of Florida Road, a second site has been identified where a geologically young, metre-scale displacement can be measured (Fig. 10; site i of Table 1; grid ref. S25 067 571). This is the smallest, and presumably youngest, displacement that has yet been identified along the fault, and is taken as a measure of the amount of surface rupture displacement that occurred at this site during the most recent earthquake on the Northern Ohariu fault. Fig. 10 shows a young terrace riser (a-a') right-laterally displaced by the fault (arrowed) by 2.5-3.0 m, and vertically displaced by ca 1.5 m, northwest side up. This amounts to about 3.0-3.5 m of net displacement if a near vertical fault dip is assumed (at the four places along the fault where the dip of the fault can be measured, it ranges from about 75° NW to 75° SE). The age of this displacement can be estimated from the development of the soil exposed in the silage pit marked "s" on Fig. 10. The soil, developed on a faulted alluvial terrace surface, is a recent soil with a reasonably well developed Bw horizon, and its age is estimated at ≤ 5000 years. To the left of a-a' (i.e., to the southwest) there are younger terraces that do not appear to be faulted. These terraces are younger than the most recent movement on the fault, and the soil development on these terraces is suggestive of an age of several hundred years. Thus, at this site it is interpreted that the most recent surface rupture earthquake on the Northern Ohariu fault occurred within the last 5000 years and was associated with 3.0-3.5 m of net surface rupture displacement, and that the fault has not moved within the last several hundred years.

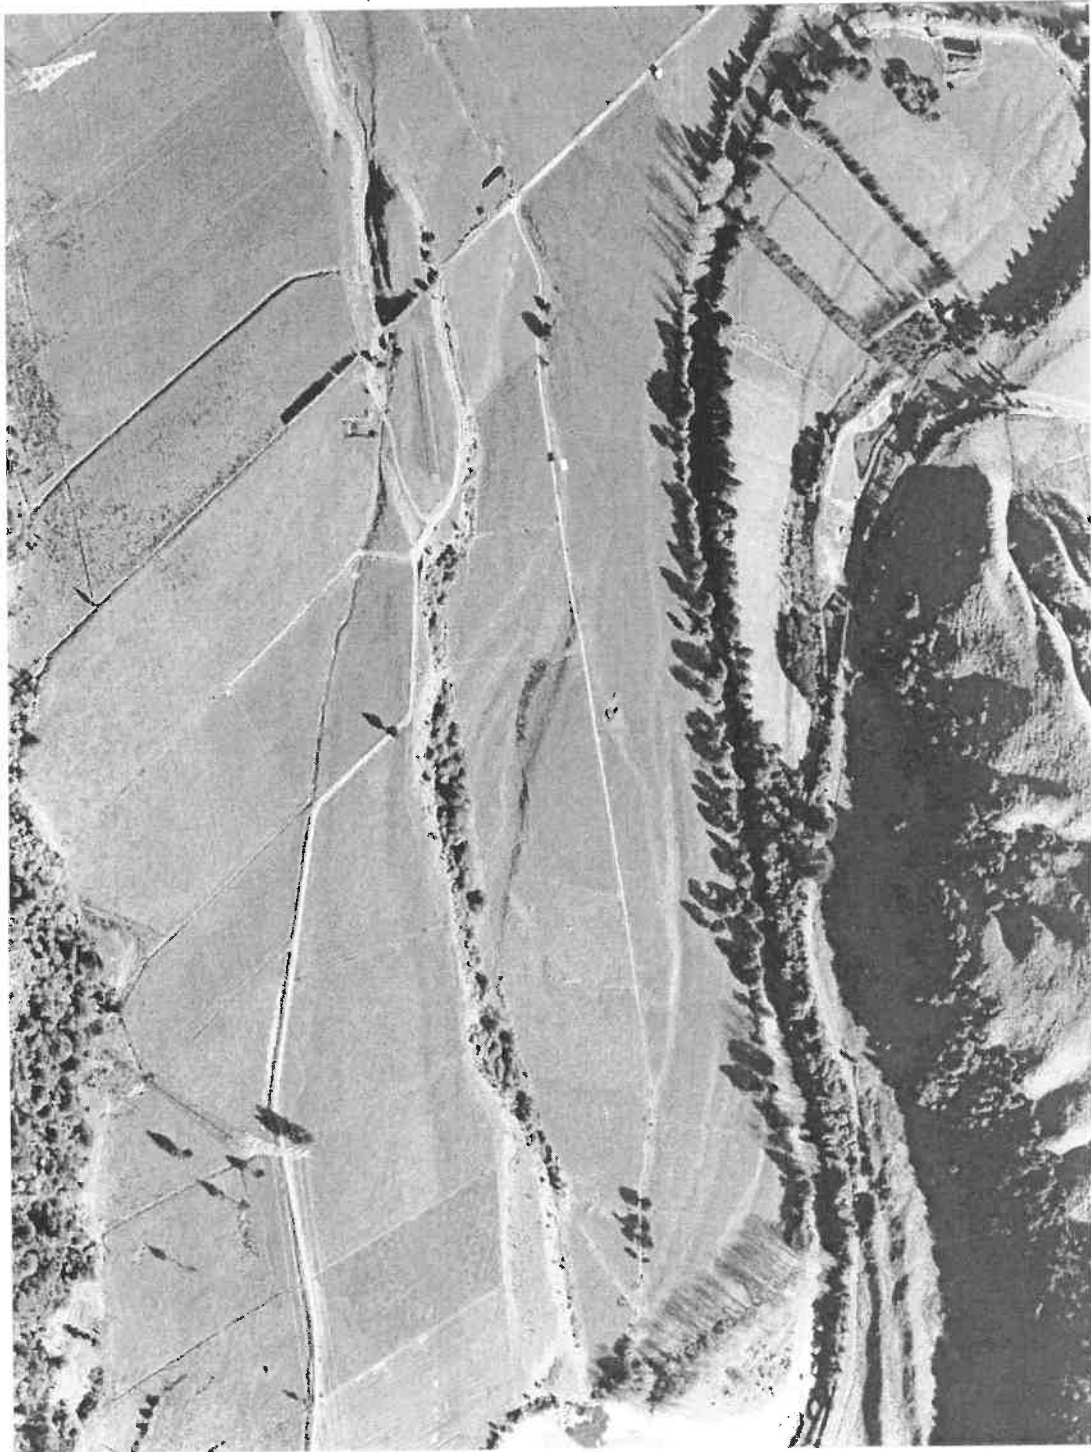
Fig. 11. Aerial photograph looking north-northwest across the ENE-trending Northern Ohariu fault (grid ref. S25 073 574). The bold arrows show the location of the fault. The river and road in the upper part of the photo are the Ohau River and Gladstone Road, respectively. The displaced alluvial terraces in the photograph are Ohakean age (10 000-15 000 years old) and younger. The photograph shown in Fig. 10 was taken just to the left (southwest) of this photo.

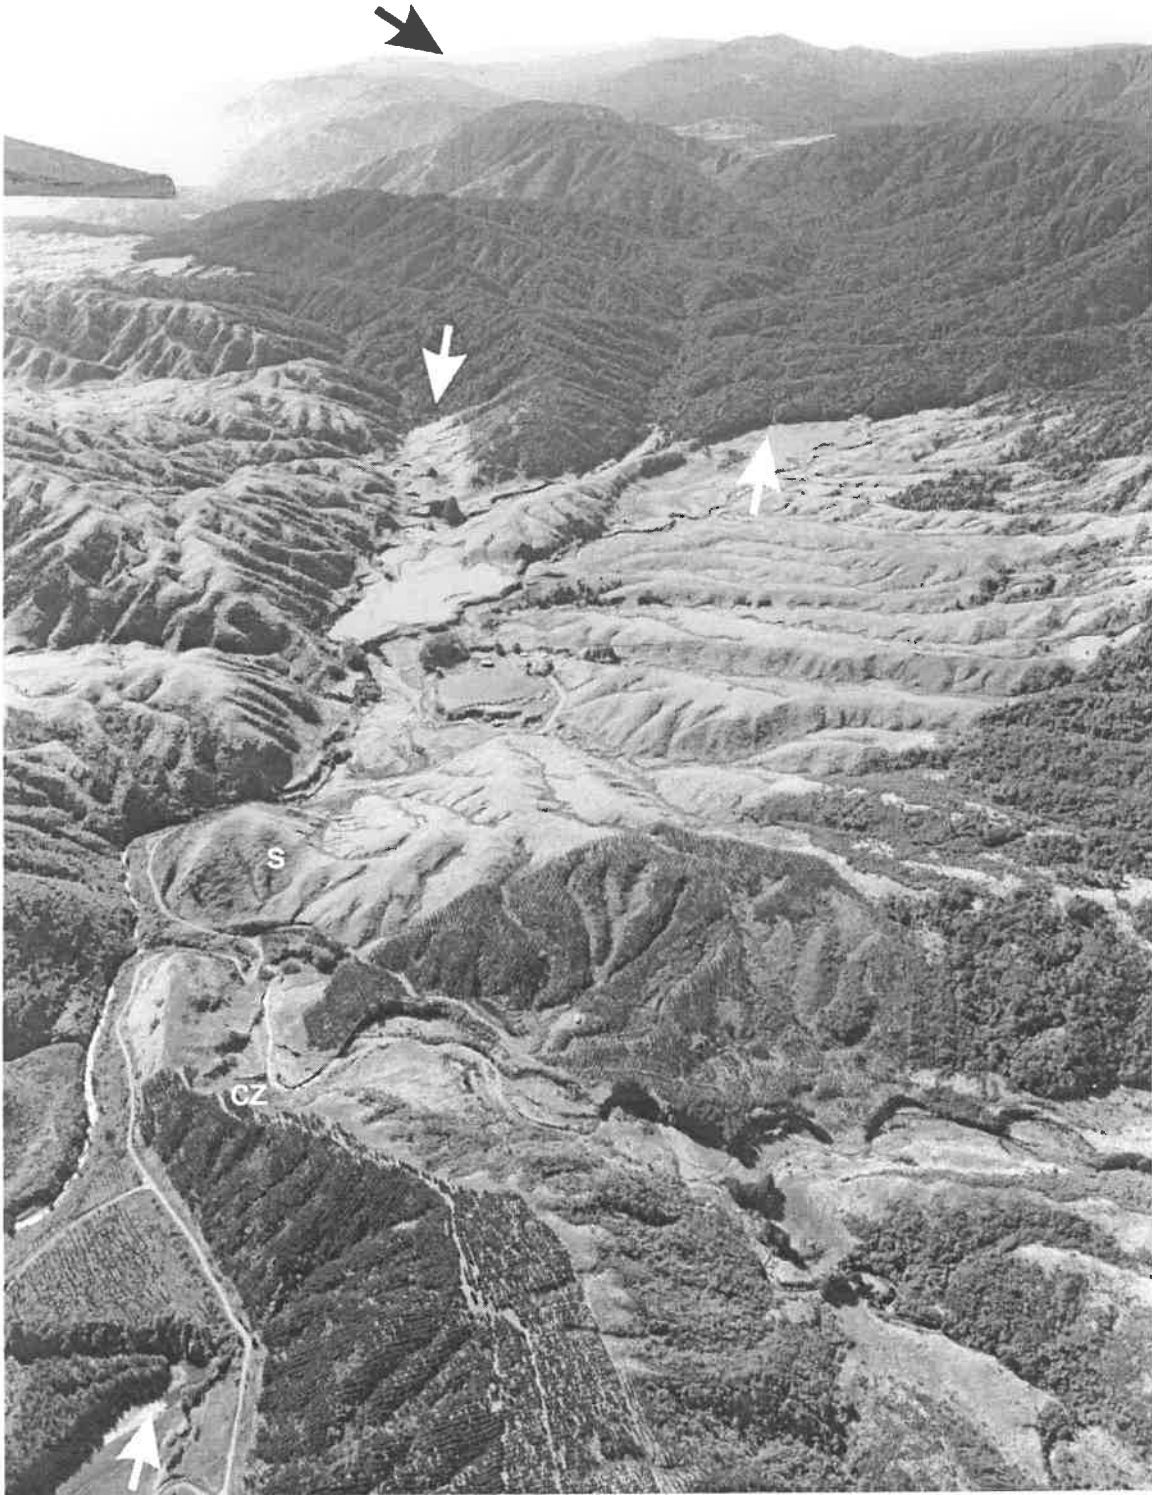
Fig. 13. Aerial photograph looking east-northeast along the Northern Ohariu fault, Makahika Stream area. Bold arrows show the locations of the fault traces. Makahika Stream flows top to bottom along left side of photo, and Makahika Station is located near the center. "cz" and "s" are locations discussed in text. The area shown in this photograph encompasses that shown in Figs. 14-16.

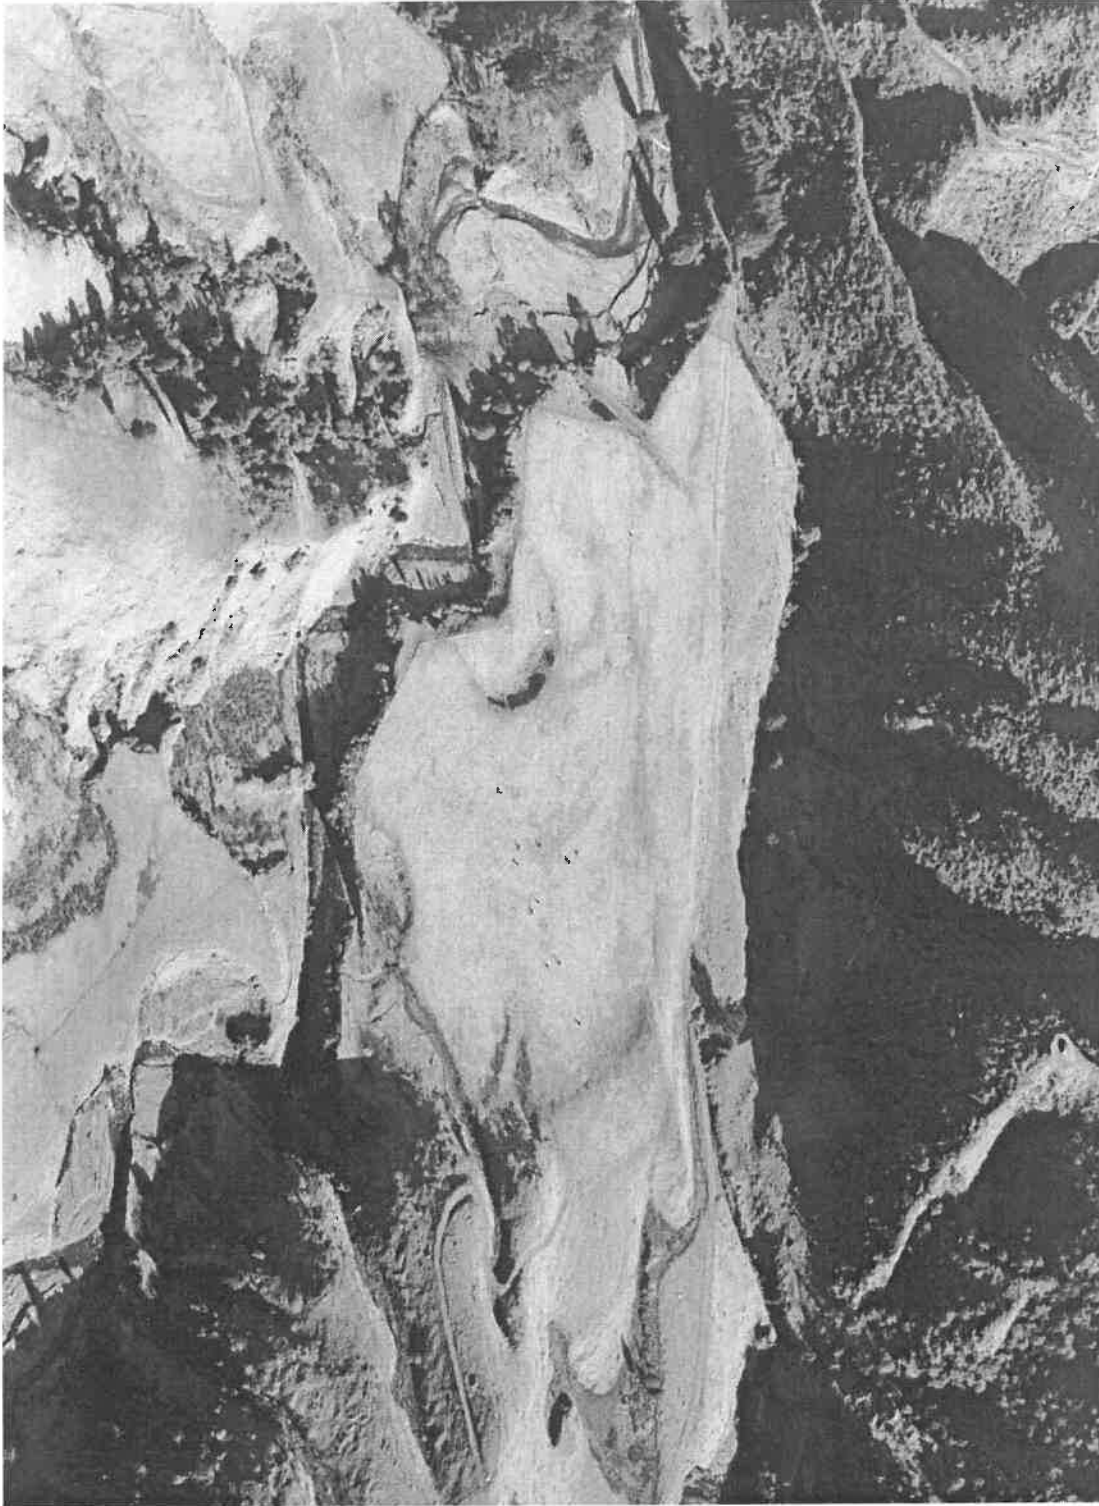
Fig. 14. Aerial photograph looking northwest across the ENE-trending mole-track scarp of the Northern Ohariu fault, Makahika Stream area (grid ref. S25 127 609). Bold arrows show the fault's location. The prominent displaced alluvial terrace in the photograph is Ohakean in age (10 000-15 000 years old). The area shown in this photograph is encompassed by that shown in Figs. 13 & 16.

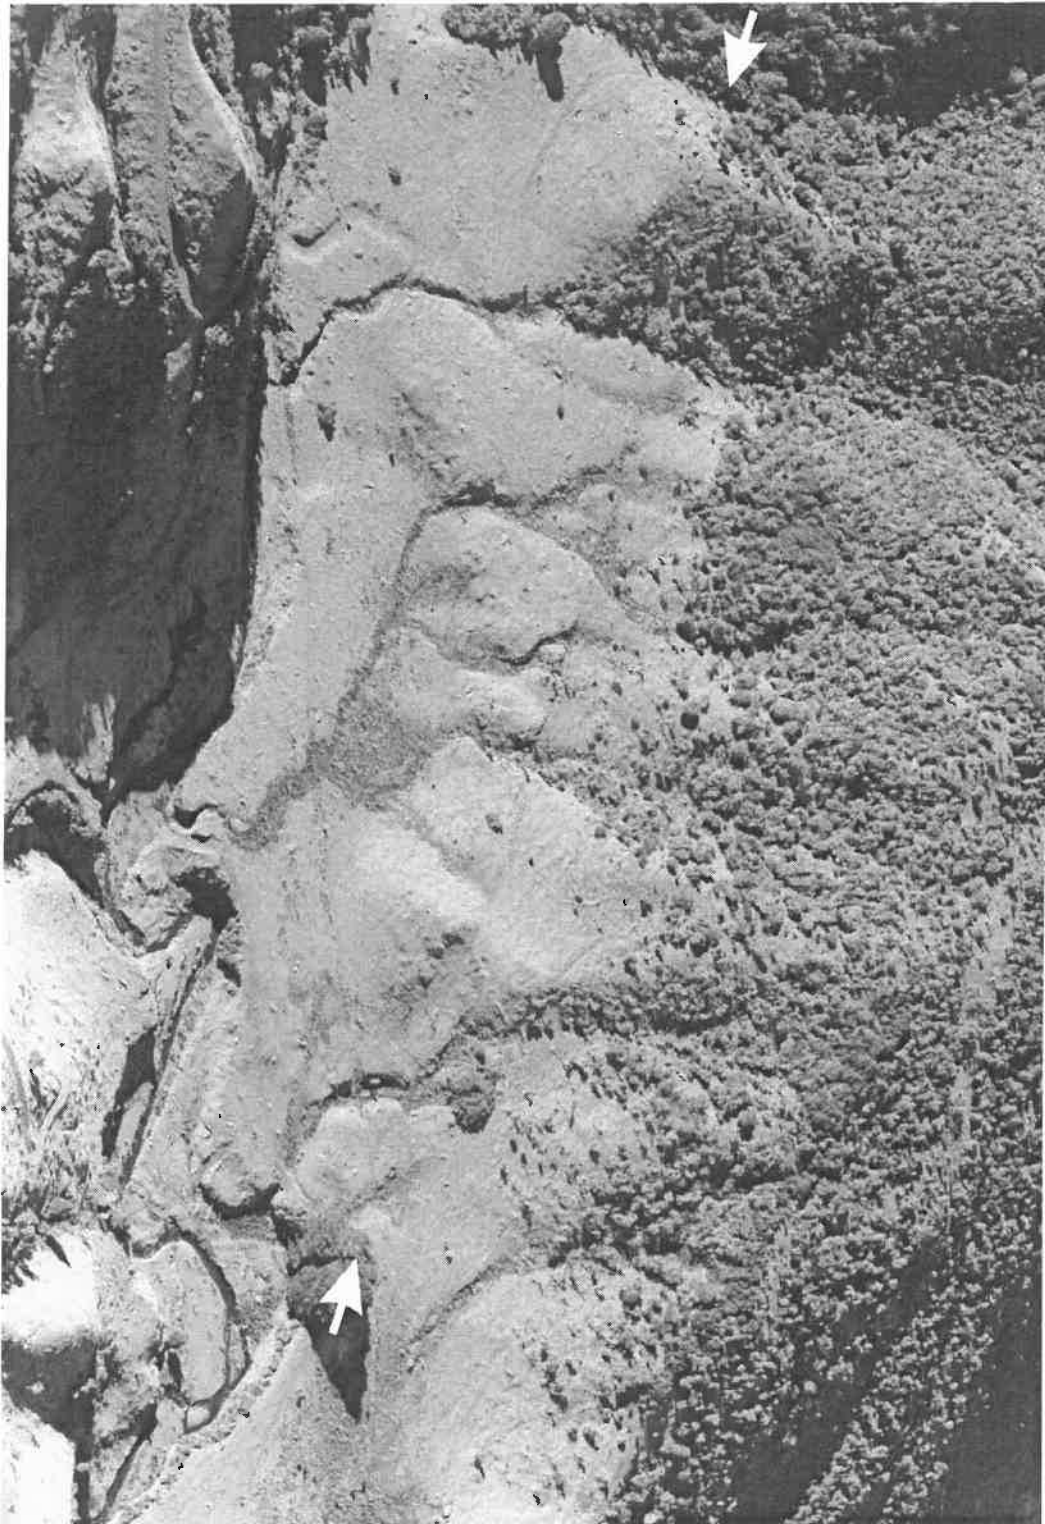
Fig. 15. Aerial photograph looking east-southeast across uphill-facing, bedrock scarp of the Northern Ohariu fault, Makahika Stream area (grid ref. S25 135 614). Bold arrows show the fault's location. Makahika Stream winds its way left to right across the bottom of the photo. *Photo: D.L. Homer, Institute of Geological & Nuclear Sciences (photo ref. CN 39624 13).*

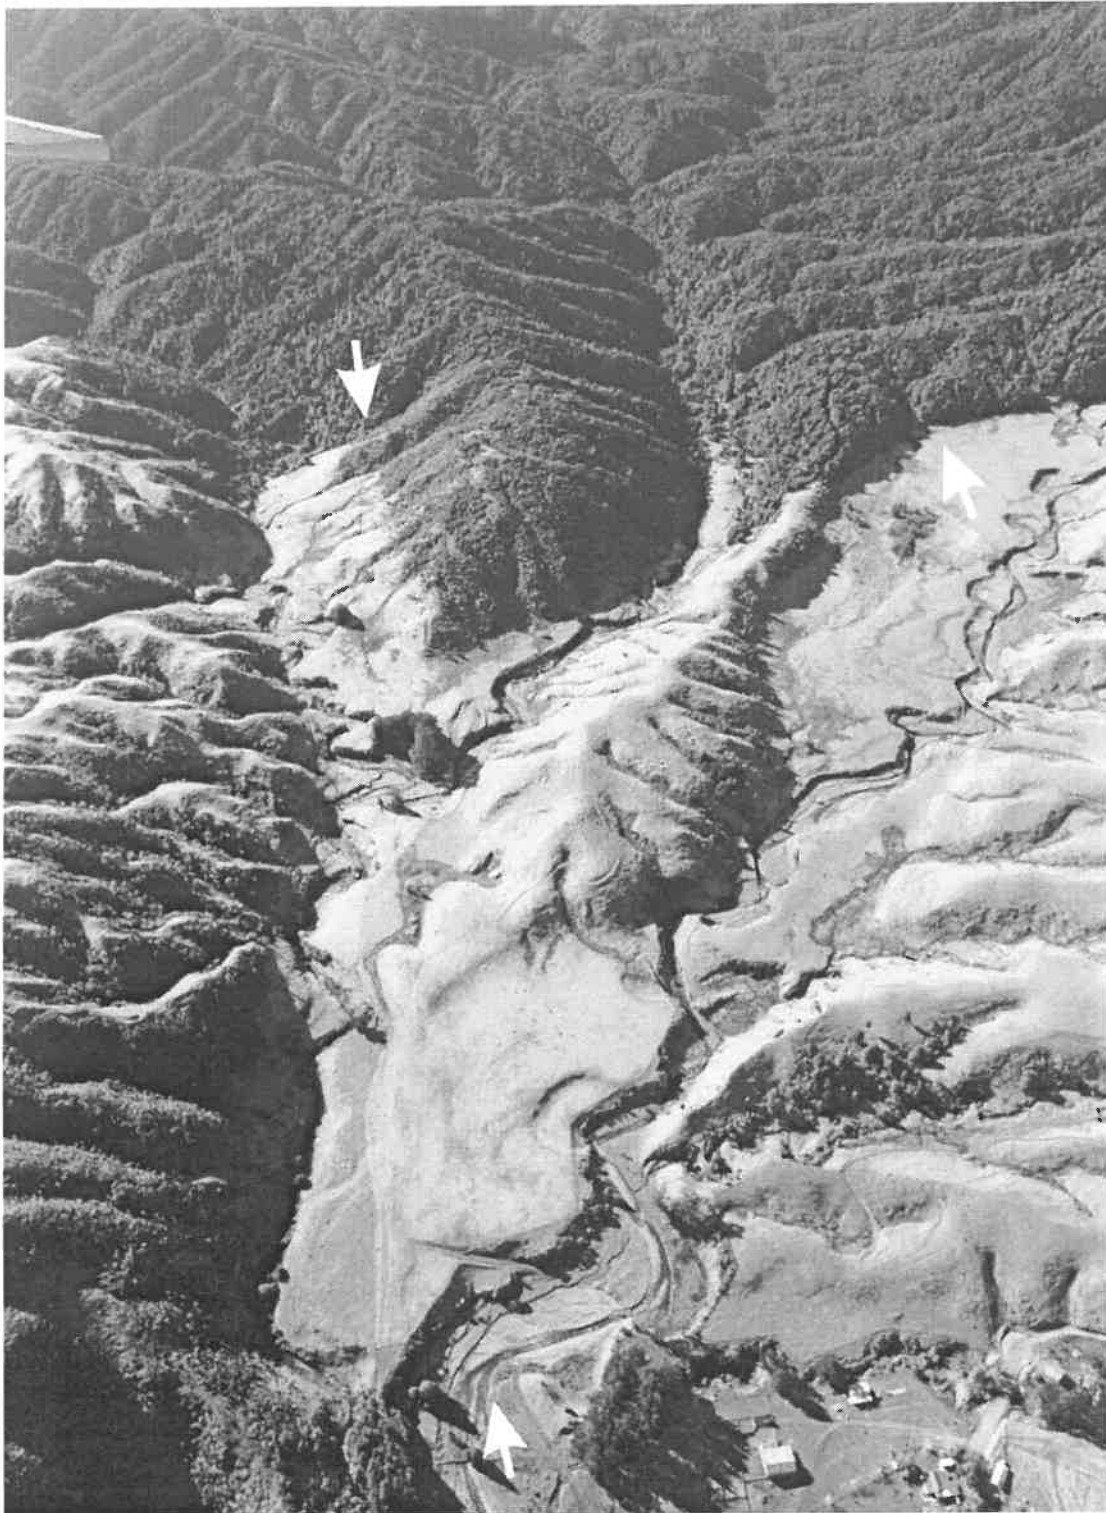
Fig. 16. Aerial photograph looking east-northeast along traces of the Northern Ohariu fault, Makahika Stream area. The bold arrows show the locations of fault traces. The prominent displaced alluvial terrace in the foreground is Ohakean in age, and is the same as that shown in Fig. 14. The forested ridges and valleys that are displaced by the arrowed fault trace in the upper centre-right of the photo comprise a dissected alluvial fan of Marton age (ca 140 000 years) or greater.
