# Annual coastal monitoring report for the Wellington region, 2007/08

GW/EMI-G-08/162

October 2008

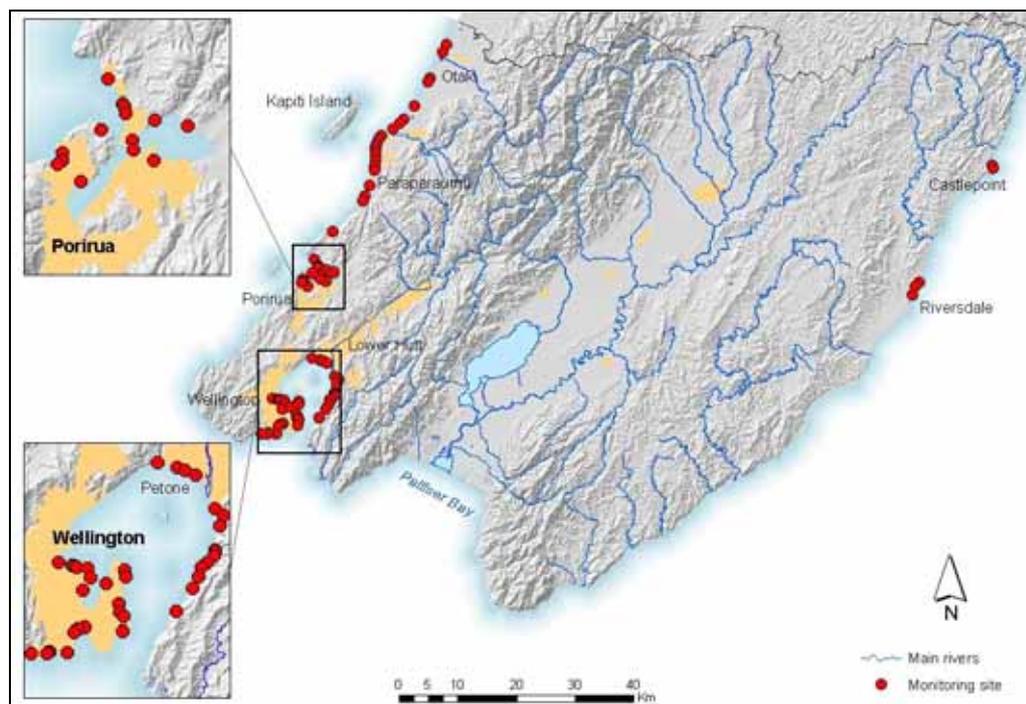
Figure 3.1: Coastal water quality sites monitored over 2007/08

Microbiological water quality was monitored at 77 coastal sites across the Wellington region over 2007/08 (Figure 3.1, Appendix 1), as follows:

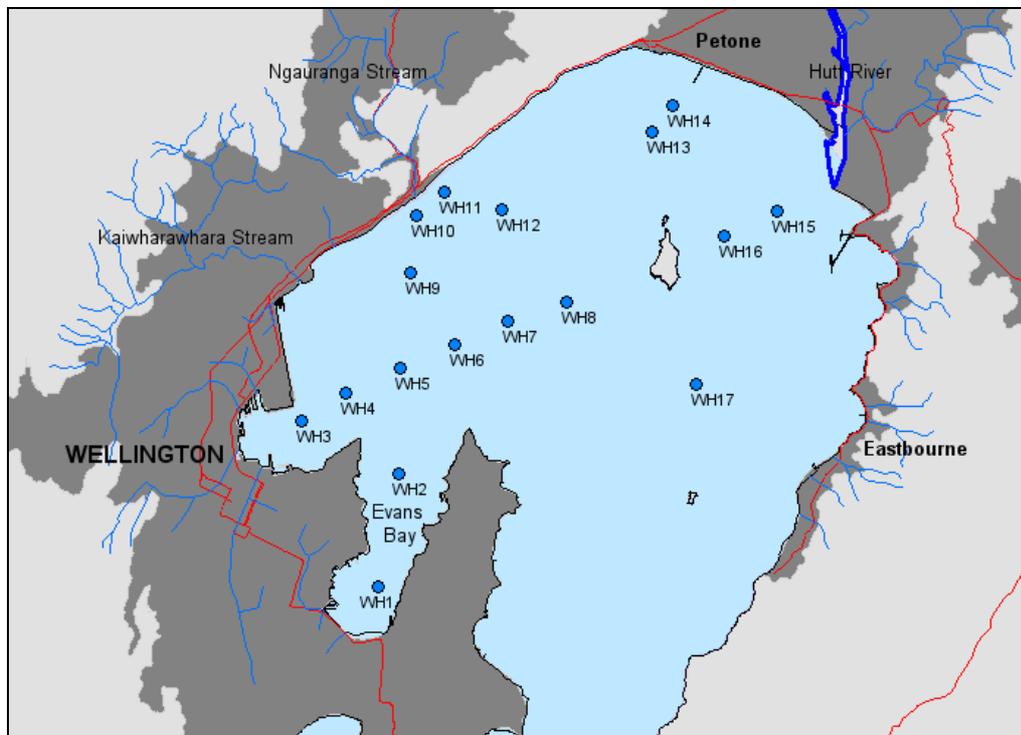
Figure 4.2: Map of Wellington Harbour showing the 17 sampling locations

Seventeen sub-tidal sites were sampled in Wellington Harbour over October–November 2006 (Figure 4.2 & Table A2.1, Appendix 2). The 17 sites selected provided good spatial coverage, making this investigation the most comprehensive assessment of surface sediment quality in the harbour since that undertaken by Stoffers et al. (1986). Although selected to assess the impacts of stormwater discharges, the sites investigated only target *far-field* effects rather than effects in areas close to the discharge points, reflecting Greater Wellington’s focus on the health of the wider harbour environment.

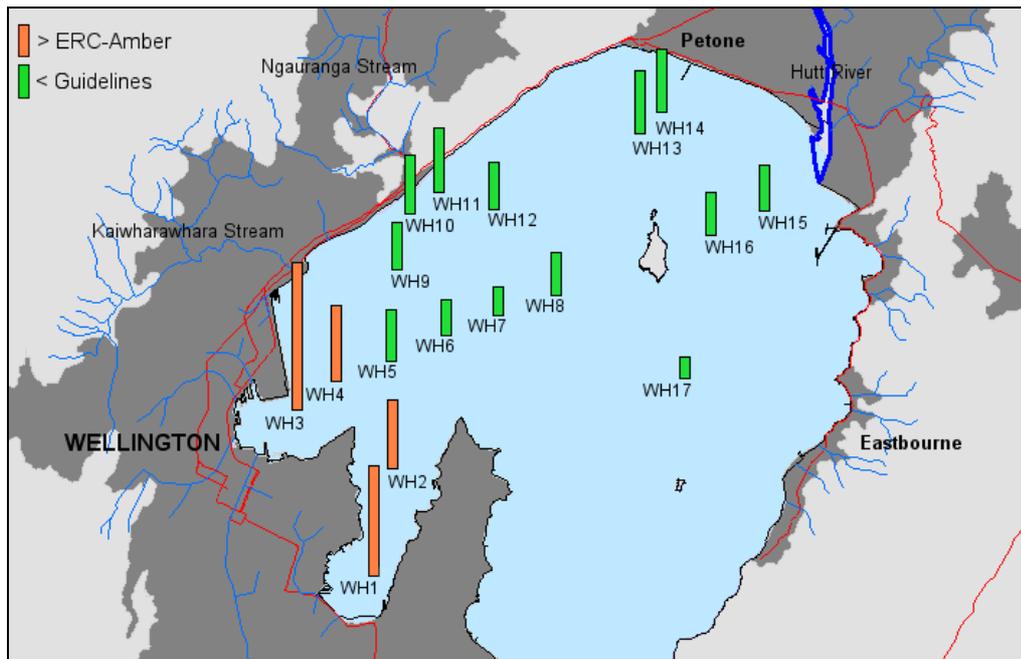
Figure 4.3: Relative concentrations of total copper in sediments of 17 sites sampled in Wellington Harbour in 2006, based on the <500 µm fraction of a single composite sample from each site

Concentrations of lead, mercury, and to a lesser extent copper and zinc (Figure 4.3), are present above sediment quality guidelines in the subtidal sediments of various parts of Wellington Harbour, especially those adjacent to Wellington City. Tributyltin (TBT) is only present above sediment quality guidelines at the entrance to the Lambton Basin and off Ngauranga, but its less toxic breakdown product dibutyltin is widespread. High molecular weight PAH compounds are above sediment quality guidelines in Evans Bay, and at the entrance to the Lambton Basin (Figure 4.4).

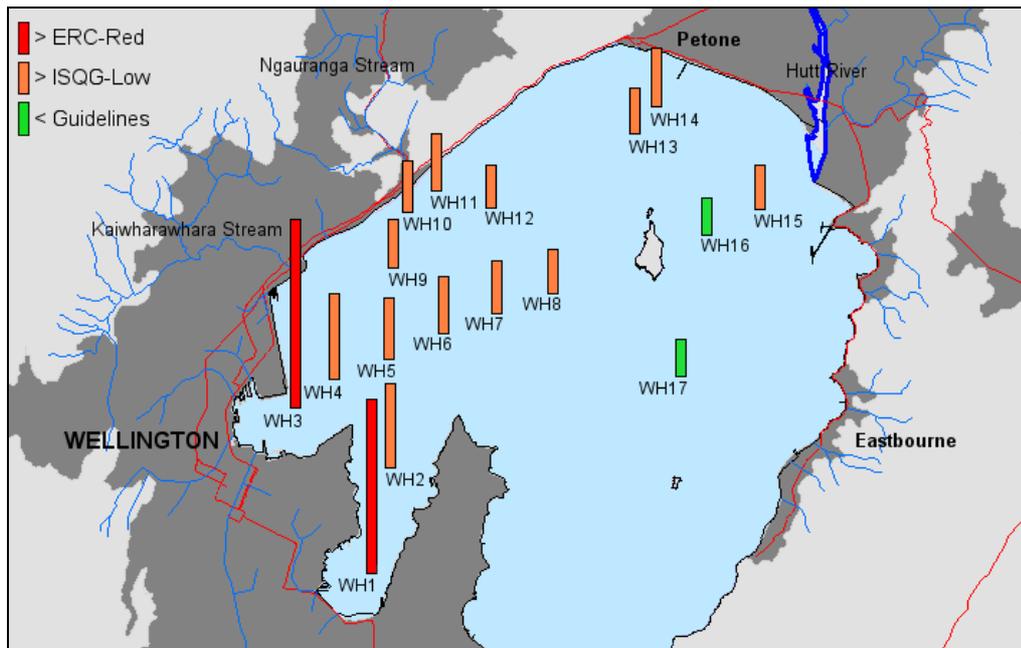
Figure 4.5: Mean concentrations of Total DDT in sediments of 17 sites sampled in Wellington Harbour in 2006, based on the <500 µm fraction of five composite samples from each site.

Of the 22 organochlorine pesticides analysed, only the insecticide DDT and its derivatives were consistently detected. Total DDT is present above sediment quality guidelines over much of the harbour (Figures 4.5 and 4.6), indicating that although its use in agriculture effectively ceased in the 1970s, and its use in urban areas was banned in the late 1980s, substantial sources remain in the environment.

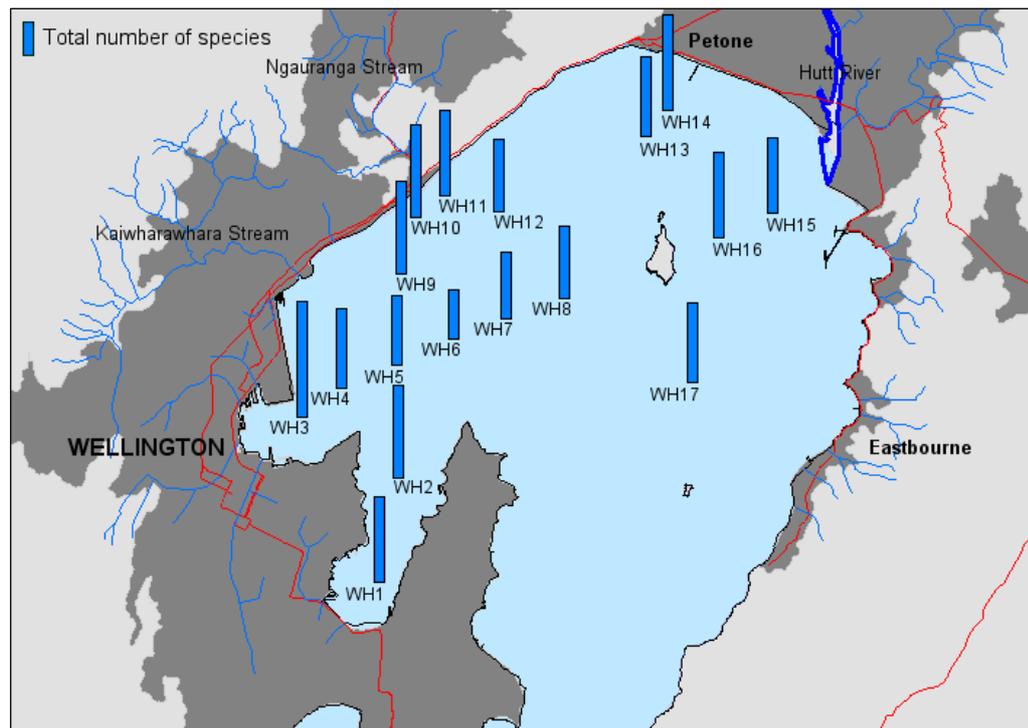
Figure 4.7: Number of species at each of the 17 sites sampled in Wellington Harbour in November 2006. Note that the scale used for the bars is unique to this map.

A total of 101 species were found in the benthic fauna samples collected in November 2006 (Figure 4.7), predominantly polychaete worms, crustaceans, bivalve molluscs and nemertean worms. The fauna present at the investigation sites can be considered as being variants of an inner harbour subtidal fine sediment community occurring in water depths >10 m. The principal species in this community were Sipunculida sp.#1, Tanaidacea sp.#1, *Theora lubrica*, *Labiothenolepis laevis*, *Cossura consimilis*, Paraonidae sp.#1, Phoxocephalidae sp.#1, Cirratulidae sp.#1, *Arthritica* sp.#1, *Maldane theodori*, *Aglaophamus macroura* and *Amphiura rosea*. The heart urchin *Echinocardium cordatum*, the bivalve *Dosina zelandica*, the rag-worm *Onuphis aucklandensis*, the bamboo worm *Asychis trifilosa*, or a combination of these species, most often dominated the biomass.

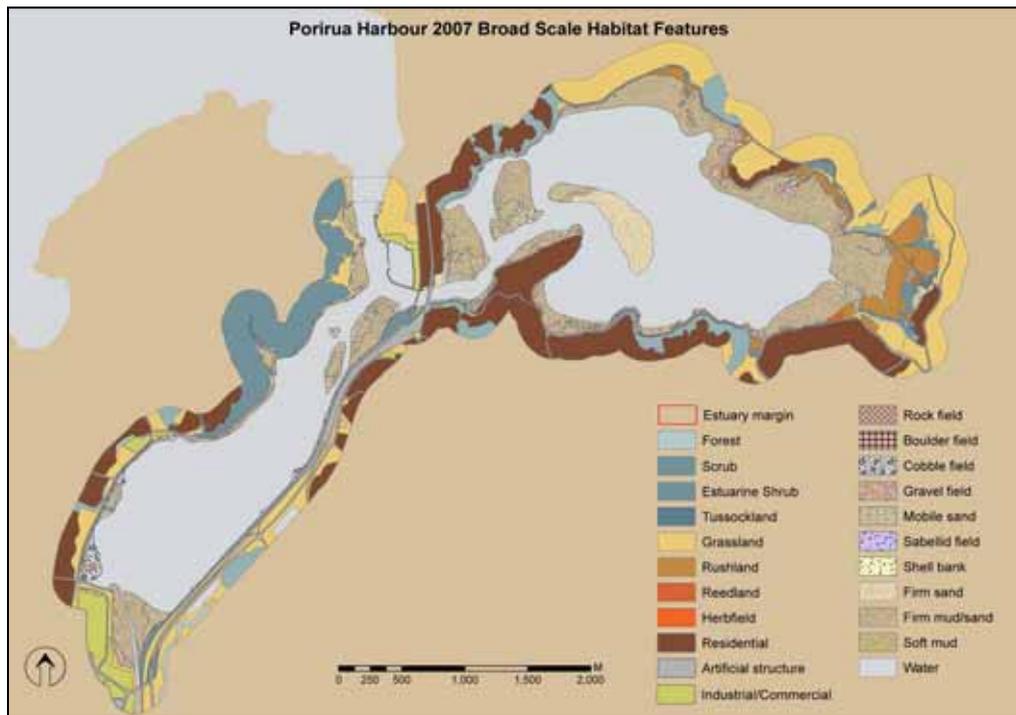
Figure 6.1: Summary of the broad-scale habitat (substrate and vegetation) features of Porirua Harbour, December 2007

The intertidal mapping (Figure 6.1) of Porirua Harbour showed:

- The majority of the intertidal area of both arms was dominated by unvegetated, firm muddy sands (122 ha in the Pauatahanui Arm and 33 ha in the Onepoto (Porirua) Arm). Soft muds occupied only 1.9 ha and 1.5 ha respectively.
- Saltmarsh vegetation was virtually non-existent in the Onepoto Arm but occupied 51 ha in the Pauatahanui Arm where it was dominated by wide beds of rushland. As the terrestrial influence increased, rushland transitioned through areas dominated by saltmarsh ribbonwood (*Plagianthus divaricatus*) and grassland.

- The whole harbour is moderately eutrophic (enriched), indicating a risk of nuisance macroalgal growth (e.g., sea lettuce). This was evident in the broad-scale macroalgal mapping results; approximately 70% of the intertidal area of each arm had macroalgal cover of at least 5%. Continued surveys of macroalgal cover are recommended.

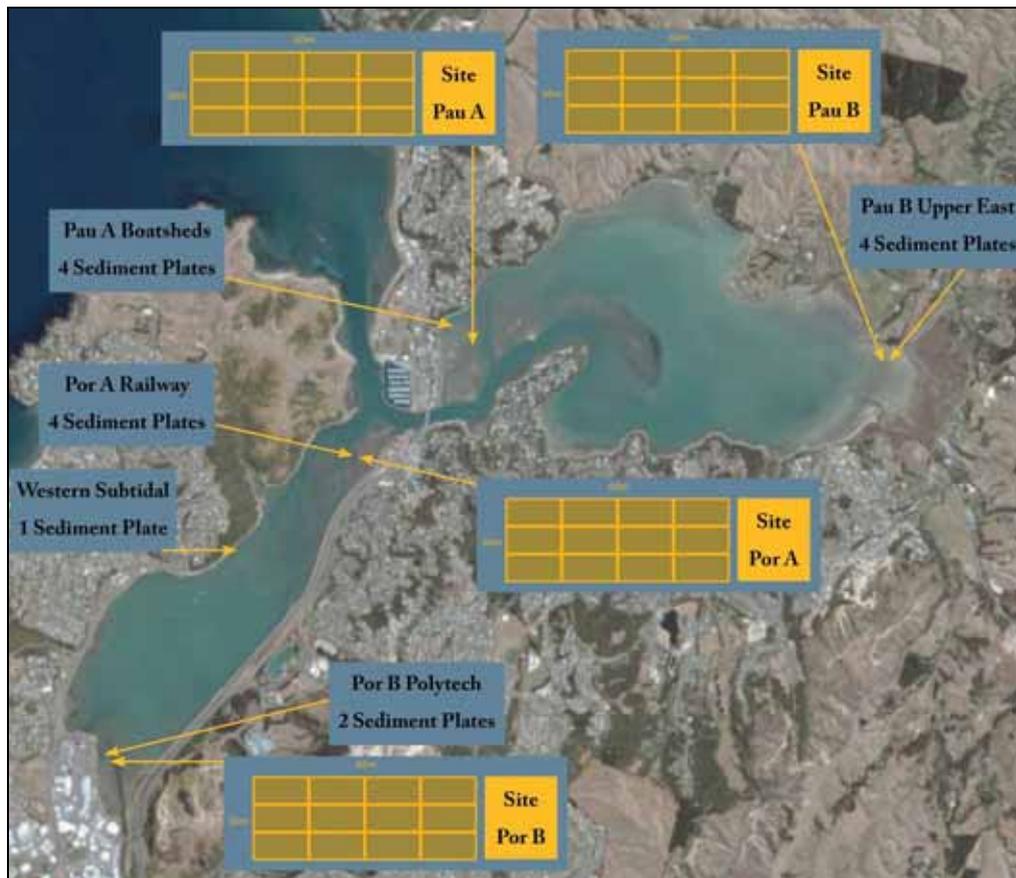
Figure 6.2: Location of fine-scale monitoring sites (with sampling plot layout) and sedimentation plates in Porirua Harbour

Fine-scale monitoring was undertaken at two intertidal sites within each arm of the Porirua Harbour in January 2008 (Figure 6.2 & Table A2.2, Appendix 2). This monitoring included assessments of 10 plots for sediment grain size, oxygenation (Figure 6.3), nutrient and organic content, contamination, and benthic (sediment-dwelling) flora and fauna. The methods used were based on an extension of the tools included in the National Estuary Monitoring Protocol (Robertson et al. 2002). One extension of the protocol was the installation of 15 sedimentation plates at selected intertidal and subtidal locations to enable long-term monitoring of sedimentation rates (Figures 6.2 & 6.4).

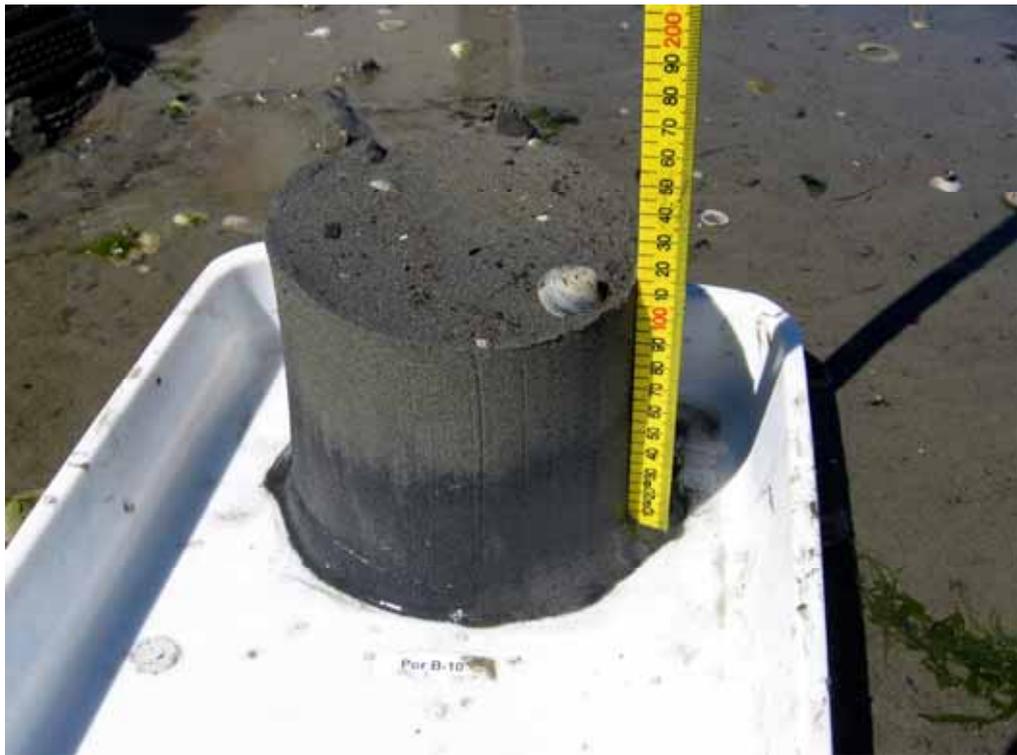
Figure 6.3: Measuring the depth of oxygenated sediment in a core sample from the Onepoto Arm of Porirua Harbour. The greater the depth of oxygenated sediment (indicated by the lighter-coloured surface layer), the better the conditions for the associated benthic flora and fauna.

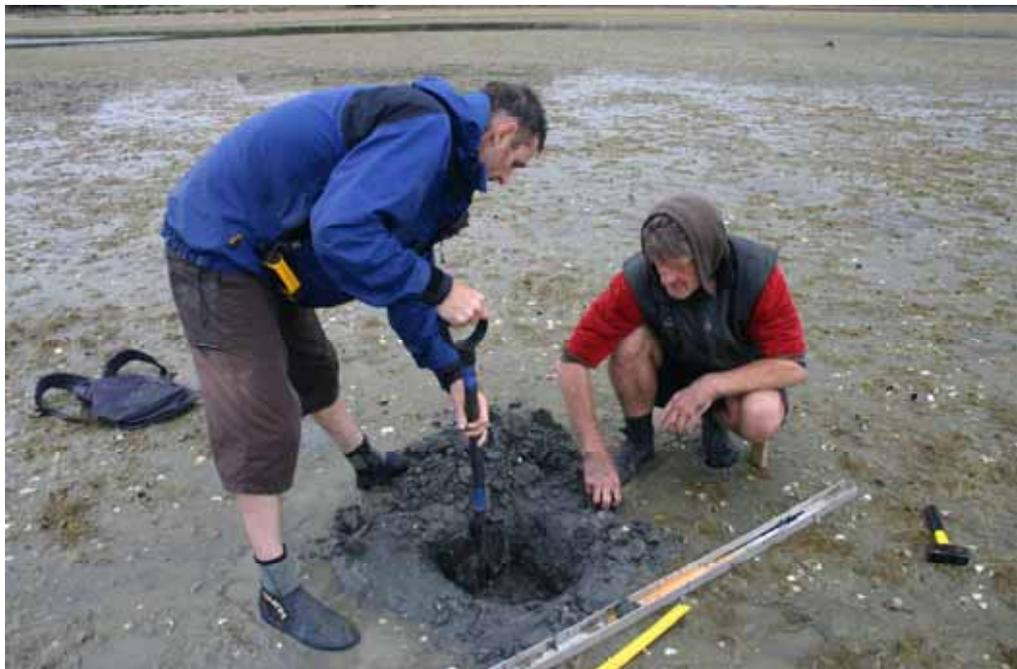
Figure 6.4: Installing a sedimentation plate in the Pauatahanui Arm of the Porirua Harbour. The depth to each sediment plate will be measured each year, allowing the sedimentation rate to be determined.

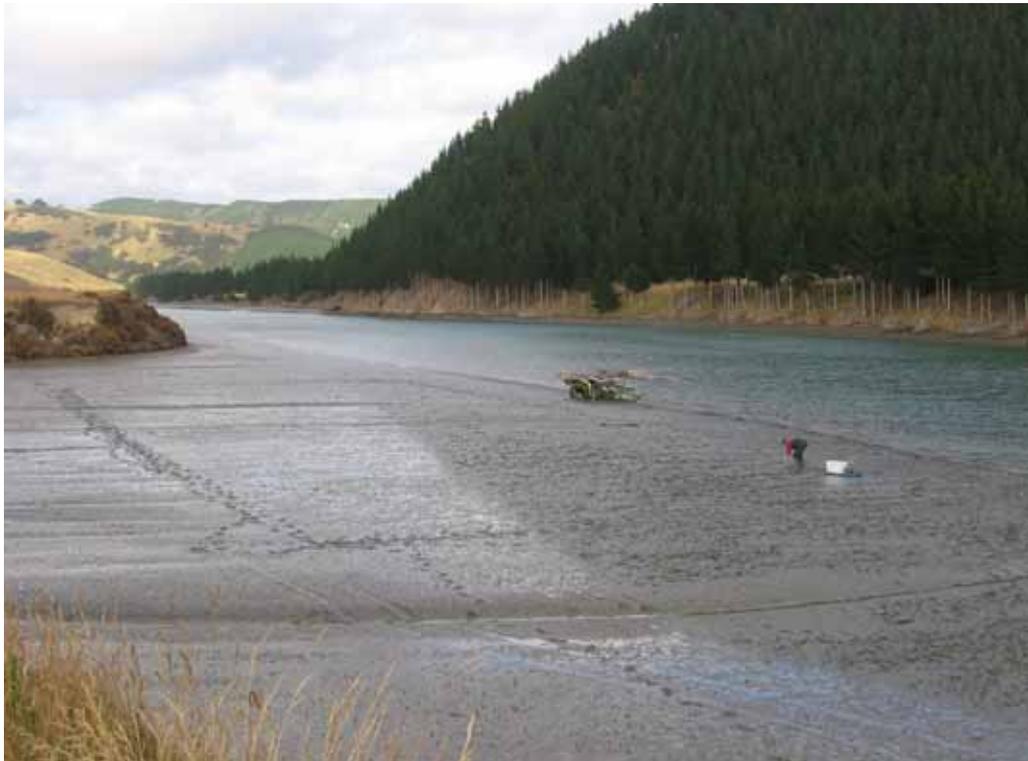
Figure 7.1: Whareama Estuary intertidal mudflats

Monitoring was undertaken at two sites located on the unvegetated intertidal mudflats (Figure 7.1 & Table A2.3, Appendix 2). Ten plots were sampled at each site, with assessments made of sediment grain size, oxygenation, nutrient and organic content, contamination (heavy metals and pesticides), and benthic (sediment-dwelling) flora and fauna. The fine-scale monitoring methods were based on an extension of the tools included in the National Estuary Monitoring Protocol (Robertson et al. 2002). One extension of the protocol was the installation of four sedimentation plates in muddy habitat in the lower estuary to enable long-term monitoring of sedimentation rates.

The results for the selected physical, chemical and biological indicators of estuary condition showed that the dominant intertidal habitat was generally in “fair” to “good” condition. Nitrogen, phosphorus and organic carbon concentrations were classed as low to moderate. Heavy metal concentrations were very low to low and pesticide concentrations were below laboratory detection limits. Of concern was the very muddy and poorly oxygenated nature of the sediments (70% mud) which create poor conditions for plants and animals. As a consequence of this (and possibly periodic exposure to low salinity), the condition of the biological community was classified as “slightly to moderately polluted”; the community was largely dominated by small subsurface deposit-feeding organisms that prefer moderate mud and organic enrichment levels (e.g., the bivalve *Arthritica* sp. and polychaetes *Heteromastus filiformis* and *Scolecopides benhami*).

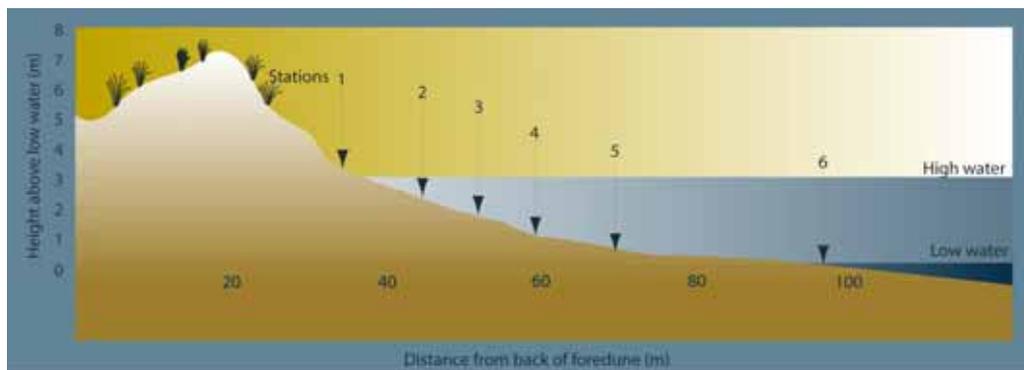
Figure 8.1: Cross-section of sampling transect at Castlepoint Beach

Monitoring was undertaken at two intertidal sites located towards the northern end of the beach, approximately 750 m south of the Whakatangi Estuary (Table A2.4, Appendix 2). Six stations were sampled along two transects 50 m apart (Figure 8.1), with assessments made of sediment grain size, sediment oxygenation and benthic (sediment-dwelling) fauna. Assessments of sediment nutrient and contaminant concentrations were not undertaken; there are no major nutrient inputs on semi-exposed beaches like Castlepoint, and the risk of toxic contamination is very low.
