Memo

To:	Richard Saunders, Lisa Wheeler, David O'Malley	Job No:	27226.002
From:	Richard Reinen-Hamill	Date:	2 December 2015
Subject:	Ocean Beach - Hold the Line Remedial Work Options

1 Purpose

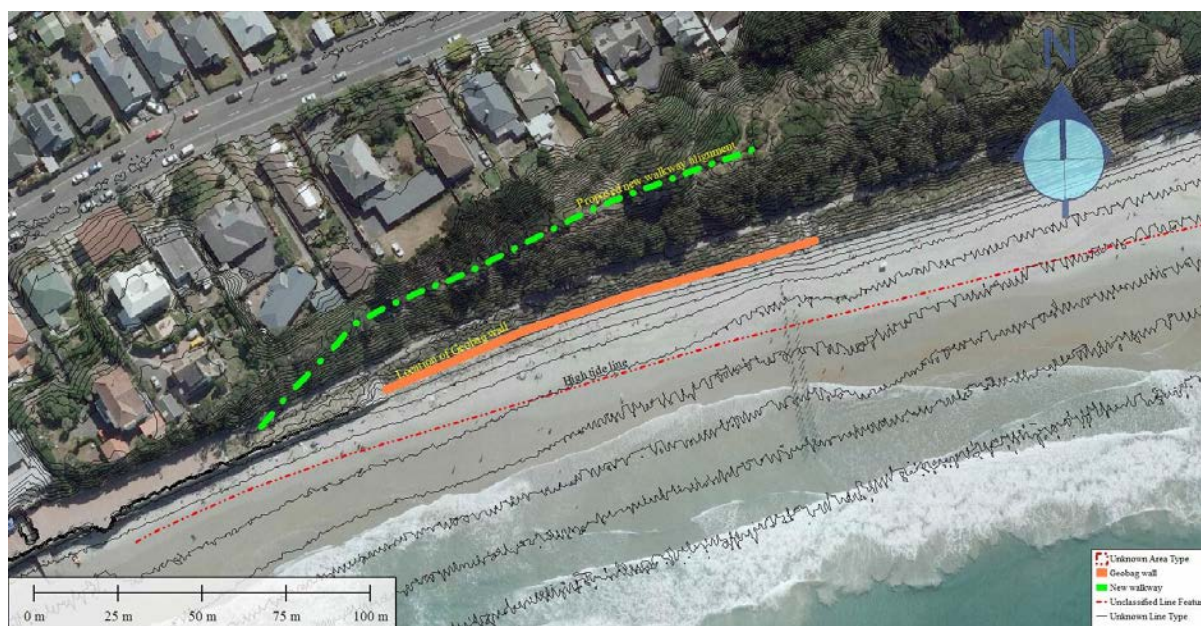
Figure 1 Showing the likely extent of the proposed geotube wall and the possible location of a relocated pathway

In the long term the plan for this area is to look at a combination of partial seawall extension or equivalent erosion protection system and managed retreat (T&T, 2011), with a short term goal of continuing the holding pattern. The present erosion has removed the existing walkway access adjacent to the geotextile bags, but where the reserve width is wider, it may be possible to relocate access further landward from the original path. We recommend that the holding pattern should provide protection to the narrowest parts of the reserve to reduce the risk of dune erosion affecting any new walkway access that is located more landward than the original position. To extend protection along the foreshore where the width of the reserve is less than 40 m would require the restoration and rebuilding of around 130 m of the backstop wall. If the footpath was to be relocated the backstop wall could be installed as far landward as possible, with dune planting of the slope above the crest of the wall to improve sand rebuilding properties. It is noted however, that there is the potential of erosion of the dunes to the east but as the reserve width is sufficiently wide, for the medium term it is proposed not to protect the dune. This is consistent with the longer term strategy.

Detailed design will need to be undertaken for the replacement of the existing geotube wall. This would include the requirement for additional survey to confirm levels of the existing foreshore and extent of rock debris. We note the geotubes originally used are no longer readily available and if it is determined to replace like with like these would need to be specially made. Two alternative

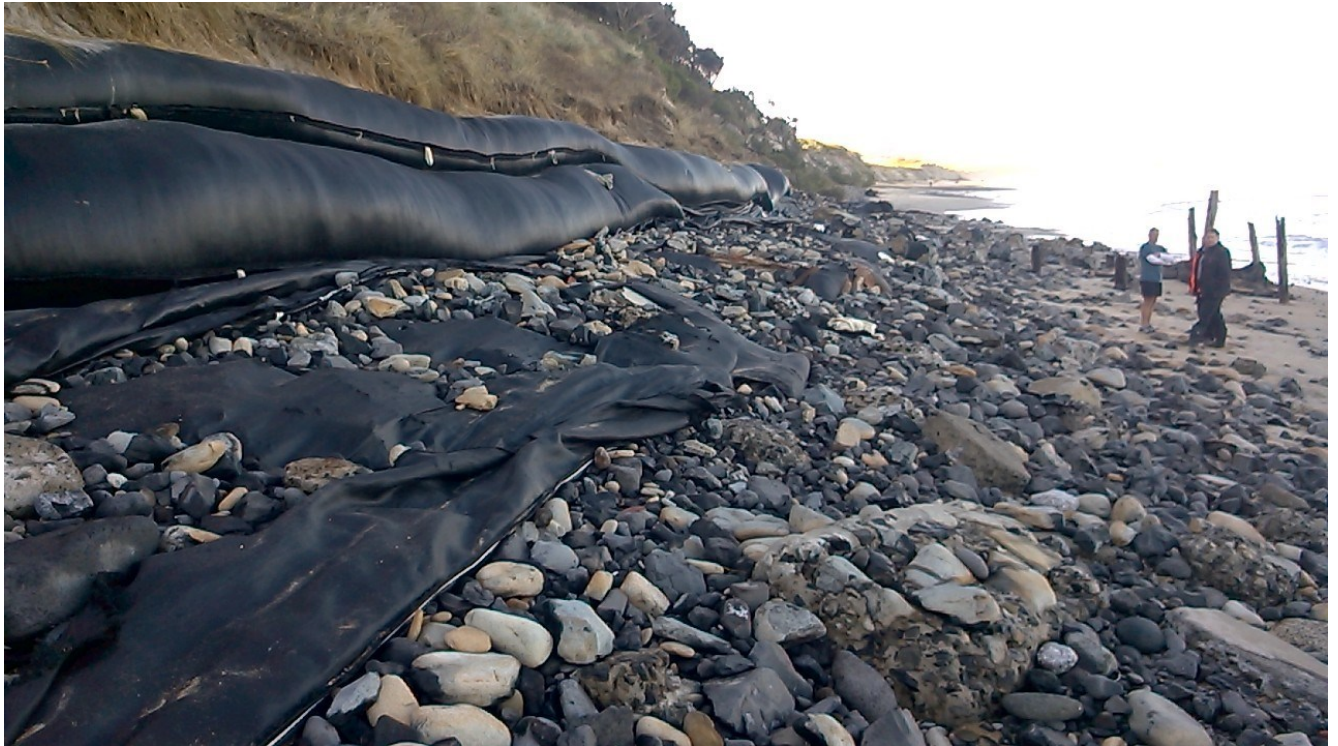
Photograph 1 Geotube backstop wall

- Immediately adjacent to the St Clair seawall extending all along the area where the geotube backshore wall is situated and a distance some 100 m to the east (*Photograph 1*).
- At the location of the reno mattress protection structure to the west of Moana Rua Road (*Photograph 2*).
- At the eastern end of the playing fields between Moana Rua Road and John Wilson Ocean Drive where there is an erosion scarp on the dune exposing construction debris and material on the dune face (*Photograph 3*).

The western 100 m has performed to retain the position of the dune toe. However, there is evidence of wave overtopping and scour above the crest of the bags and there are significant areas of the bags that have begun to split or abraded. It is likely that they will not perform adequately if beach levels remain low and storms occur and these bags should also be replaced.

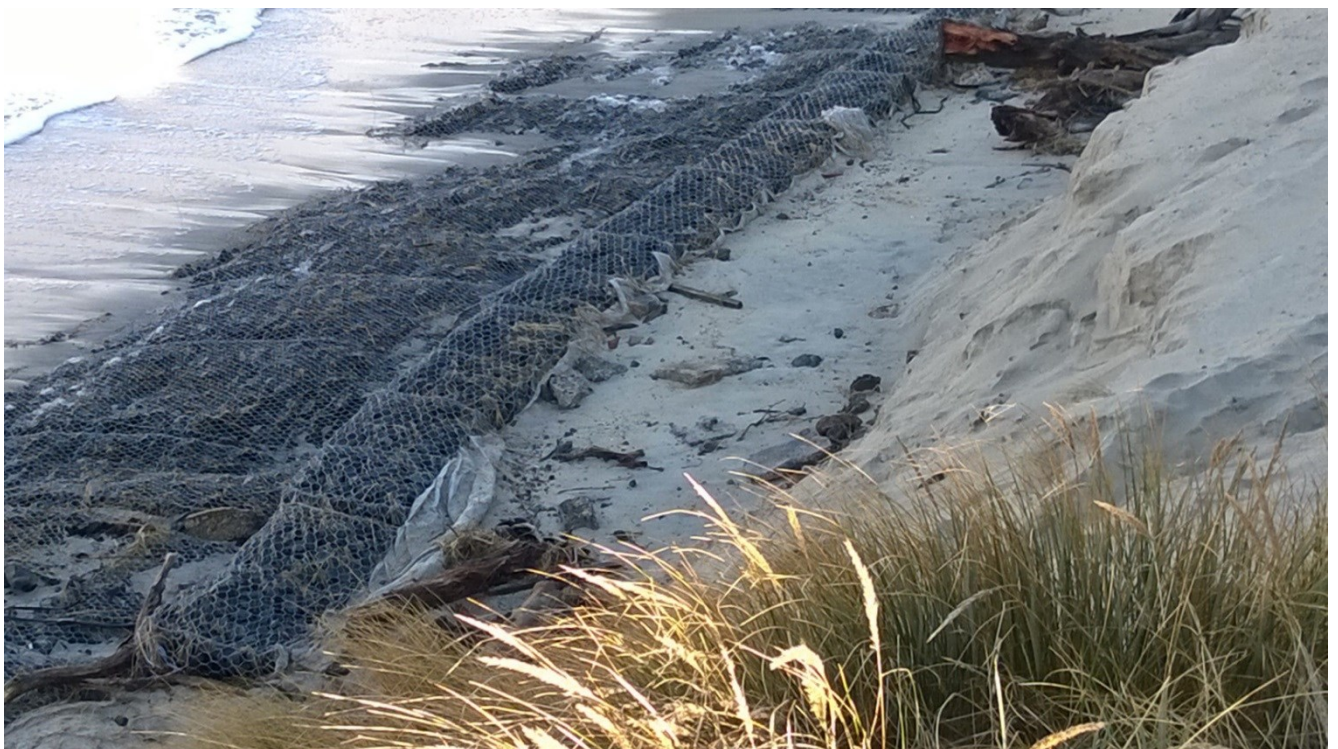
Photograph 2 Reno mattress toe

The geotube backshore wall is situated in Area 3 as identified in the T+T Options Report, Figure B1. The reno mattress toe protection has experienced overtopping and end scour and has many elements that are damaged. At this location the long term option was either a buried backstop wall or managed retreat or a combination of both. In the short term it was the continuation of the holding pattern.

If the reno mattress is required it will require a rebuild of this structure to continue to provide toe protection to the dune, although it is possible that the graded rock used may be able to be salvaged to refill the new baskets. We recommend a slightly more landward location of the structure be implemented to limit its extension into the beach system to improve its longevity by reducing its exposure. In addition, to improve the performance of the structure there should be a tie in detail comprising a landward return of the structure and at the crest the reno baskets should be returned landward at least 2 m and preferably 4 m to reduce overtopping scour.

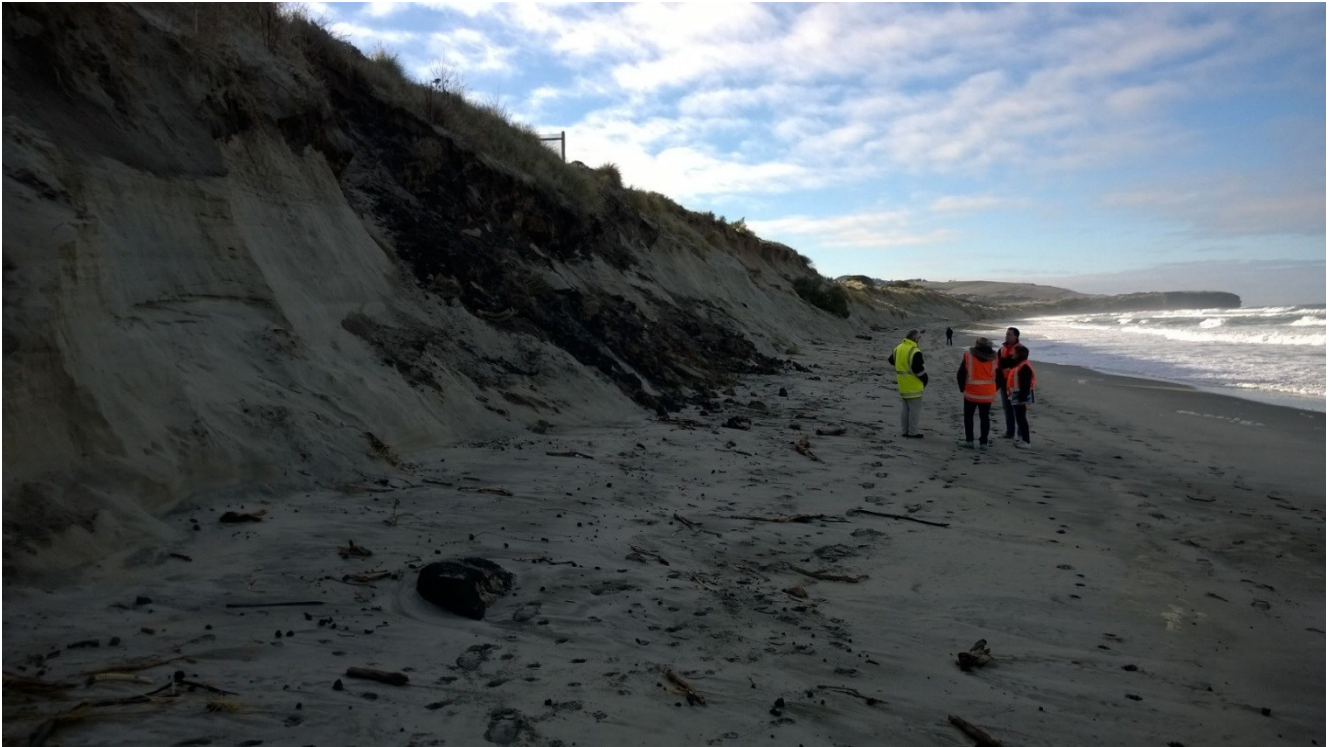
Photograph 3 Construction debris on eroded dune face

There are localised areas where construction debris is being eroded from the dune face. We recommend ongoing regular inspections and management of the debris, removing it from the upper part of the beach as it falls from the dune to the beach.

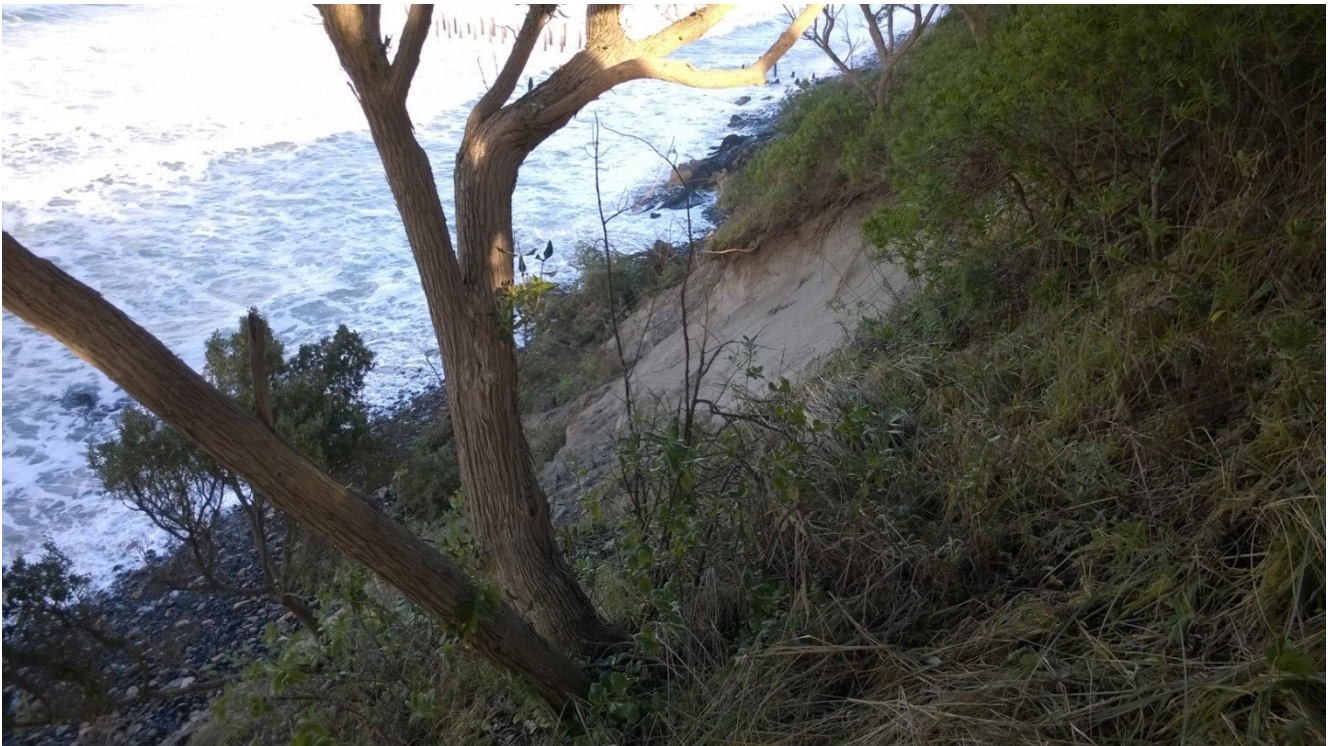
Photograph 4 Erosion of the dune face to the east of the geotube wall

At the eastern end of the geotube there is accelerated erosion of the dune toe resulting in erosion of the dune face, including loss of vegetation from the dune slope. This is a common feature at the end of seawalls as there is both a deficit of sediment supply from the protected area of the dune and edge effects focussing wave energy.
