Beach-front battles - repelling tides at Amberley

By GREGORY BENNETT, engineering officer, Hurunui District Council, Amberley

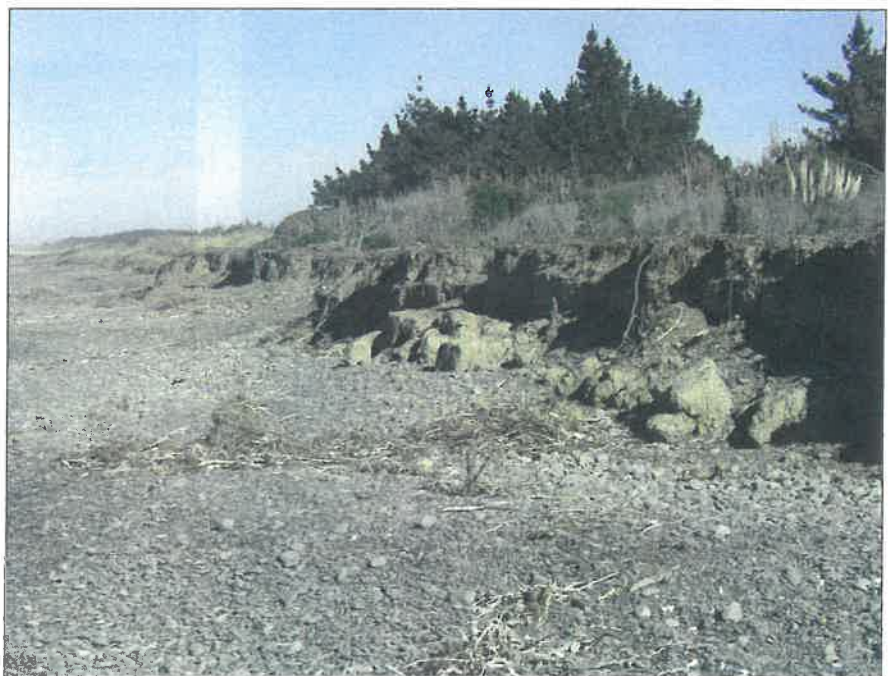
Erosion at South Crescent...rough seas take a toll on the beach front at Amberley.

During 1992 Pegasus Bay was subjected to three significant coastal storms, with the most intense being in August when snow was recorded at sea level in Christchurch. The waves at Amberley Beach inundated parts of the settlement and a civil defence emergency was declared. Parts of the beach settlement were evacuated. The beach profile survey conducted after the storm showed a 5m retreat of the beach crest.

At the request of property owners, the Hurunui District Council decided to build the beach crest up to 5m above MSL along the shore in front of South Crescent. A total volume of 4,800m³ of material was sourced from a nearby gravel pit. This re-nourishment has been successful in preventing further inundation, however, the erosion continued.

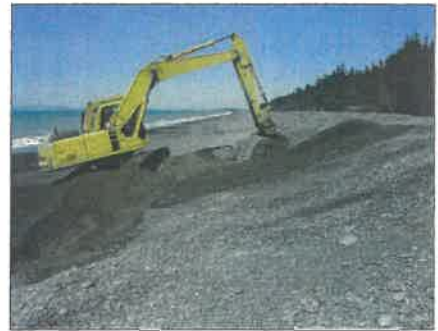
Repairing damage...a regular exercise at Amberley Beach over the years.

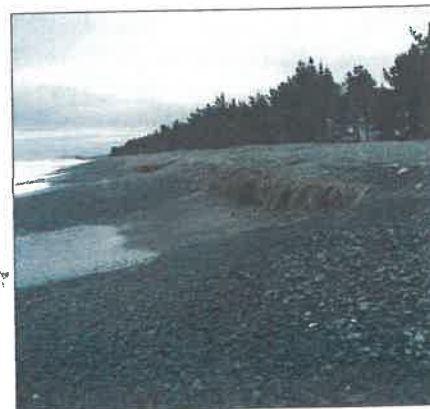
An exposed scarp and extensive scouring of the beach after the October 1993 storm.

During October 2003 there was a southerly storm that gave the re-nourishment a real test with waves washing right on top of the crest. The Banks Peninsula wave buoy, at the time, measured waves at 8m. If the foreshore were not increased in height the waves would have washed over, flooding the lower areas of the back-shore and possibly the road. The storm exposed some of the old beach scarp near the northern end of the

beach. This led to scouring as the energy of the waves being reflected by the scarp caused the beach material to be eroded and washed away. The existing marram grass contributed to this problem because its tight matted root structure was stabilising the old beach material. This phenomenon is typical of the problems caused by sea walls. Where the old scarp was not exposed, the re-nourished material coped well, with the loose nature of the gravel dissipating the energy of the wave.

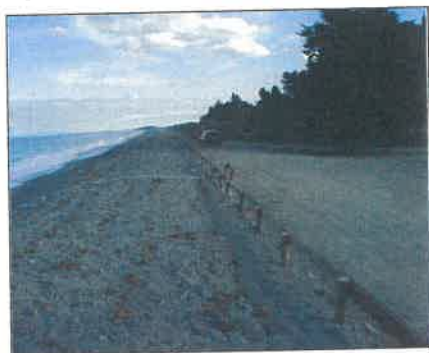
Looking good...Amberley Beach facing south from the carpark. A fence and a planting programme of native iceplants are among the improvements made.

The natural values and character of Amberley Beach have not been compromised. The material used to nourish the beach is essentially identical to the existing gravels. The invasive marram grass and dead pine trees have been cleared. A native planting programme has been instituted which aims to establish a coastal bush corridor along the foreshore.
