Department of Conservation Visitor Asset Management

Assessment of Environmental Effects for Castlepoint Walkway in the Castlepoint Scenic Reserve: U26007

July, 2008

Project Name
CASTLEPOINT CAUSEWAY TRACK REROUTE

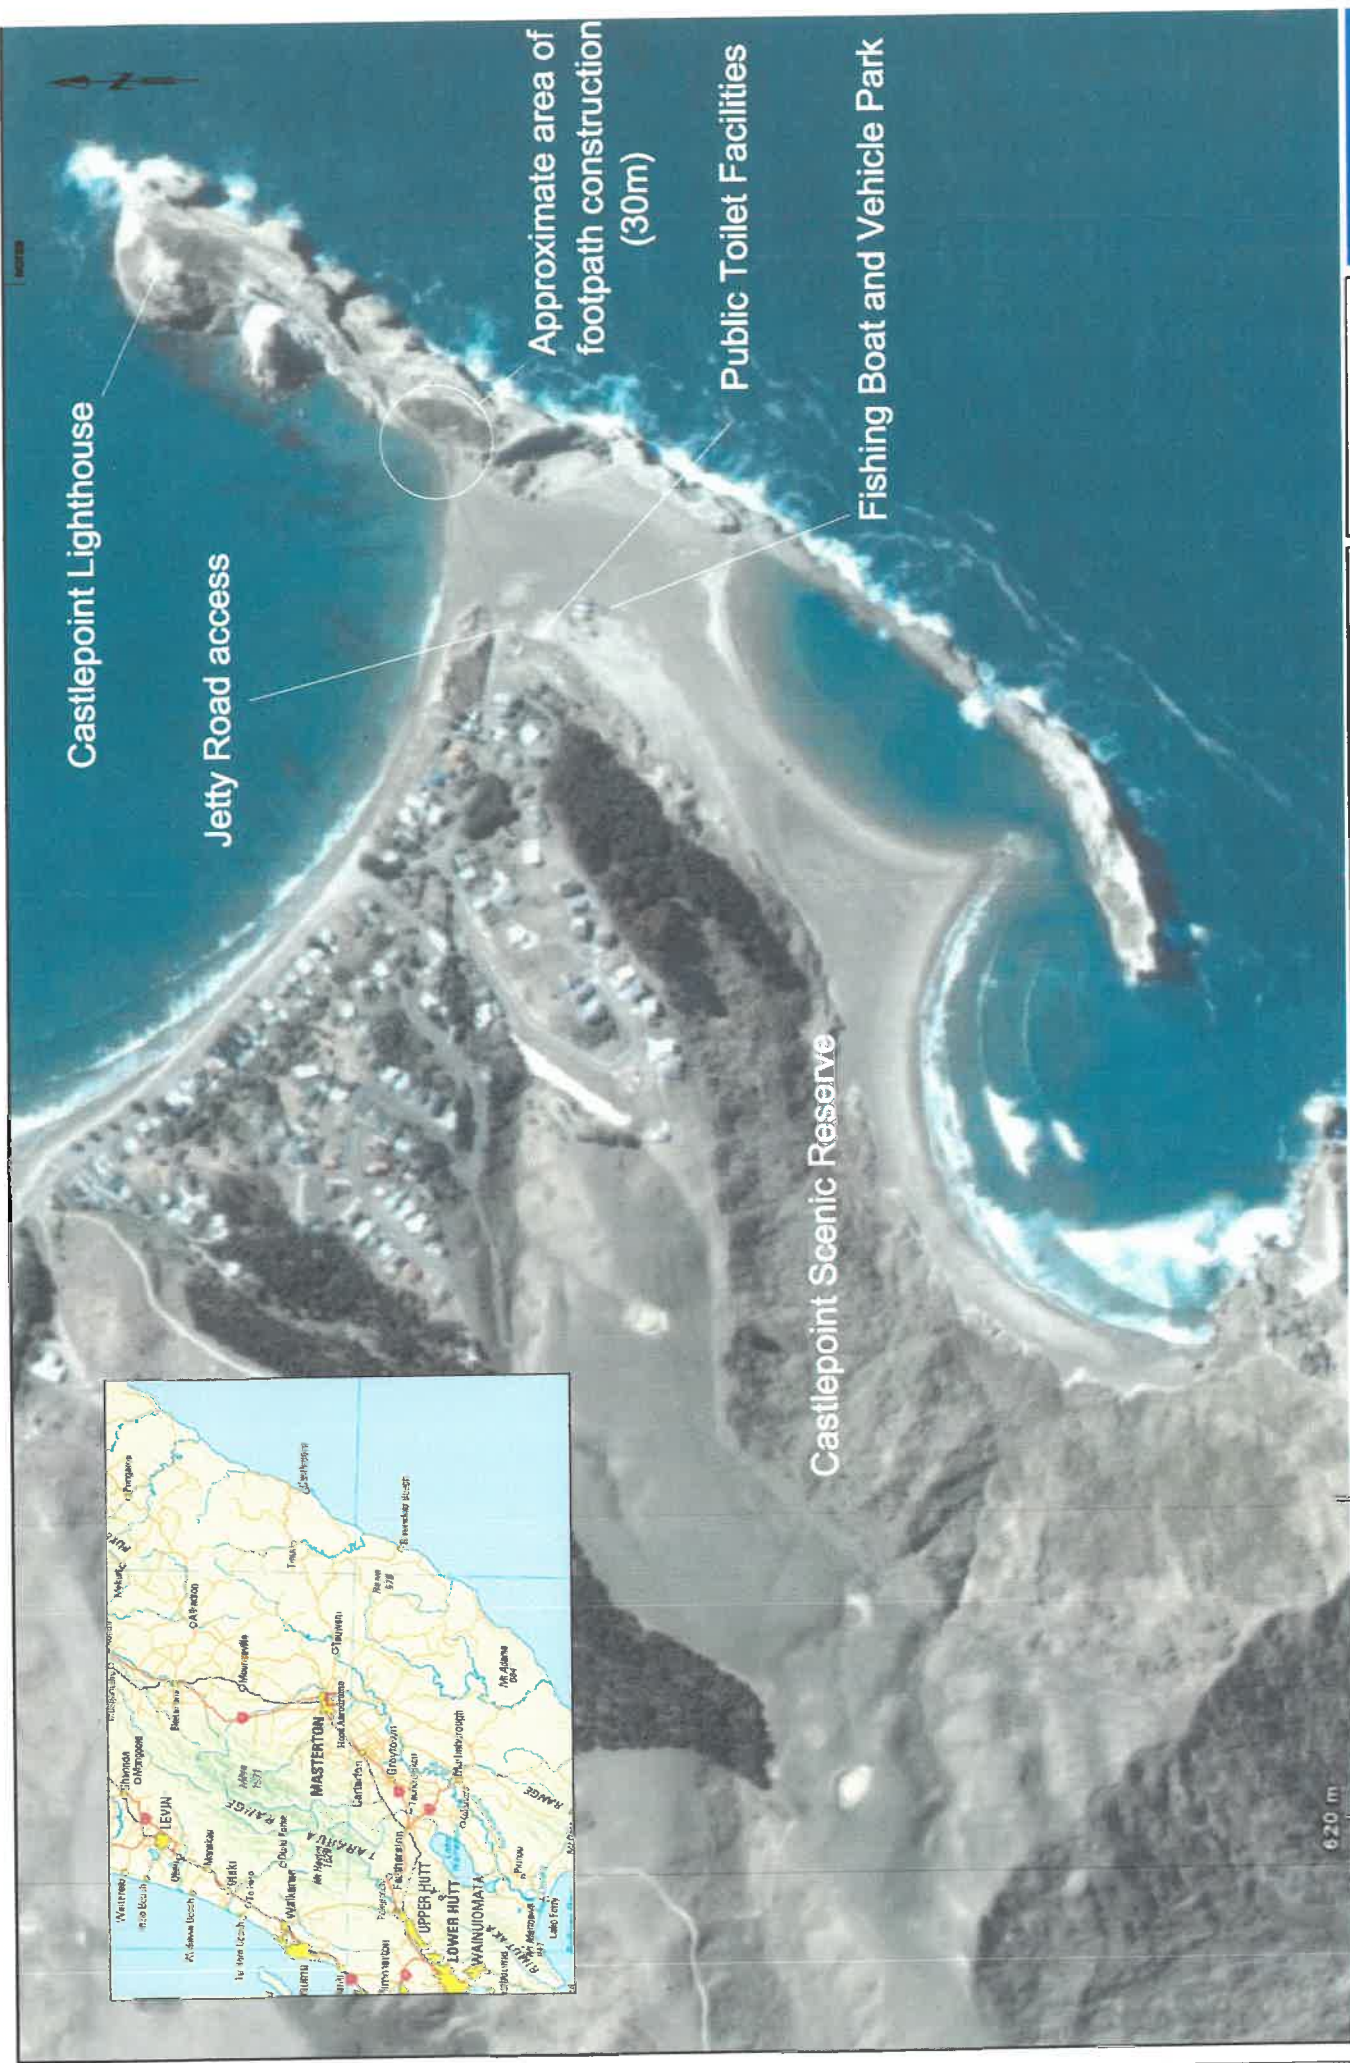
Castlepoint Lighthouse

Jetty Road access

Castlepoint Scenic Reserve

620 m

A site plan is attached as Figure 1 in Appendix 1.

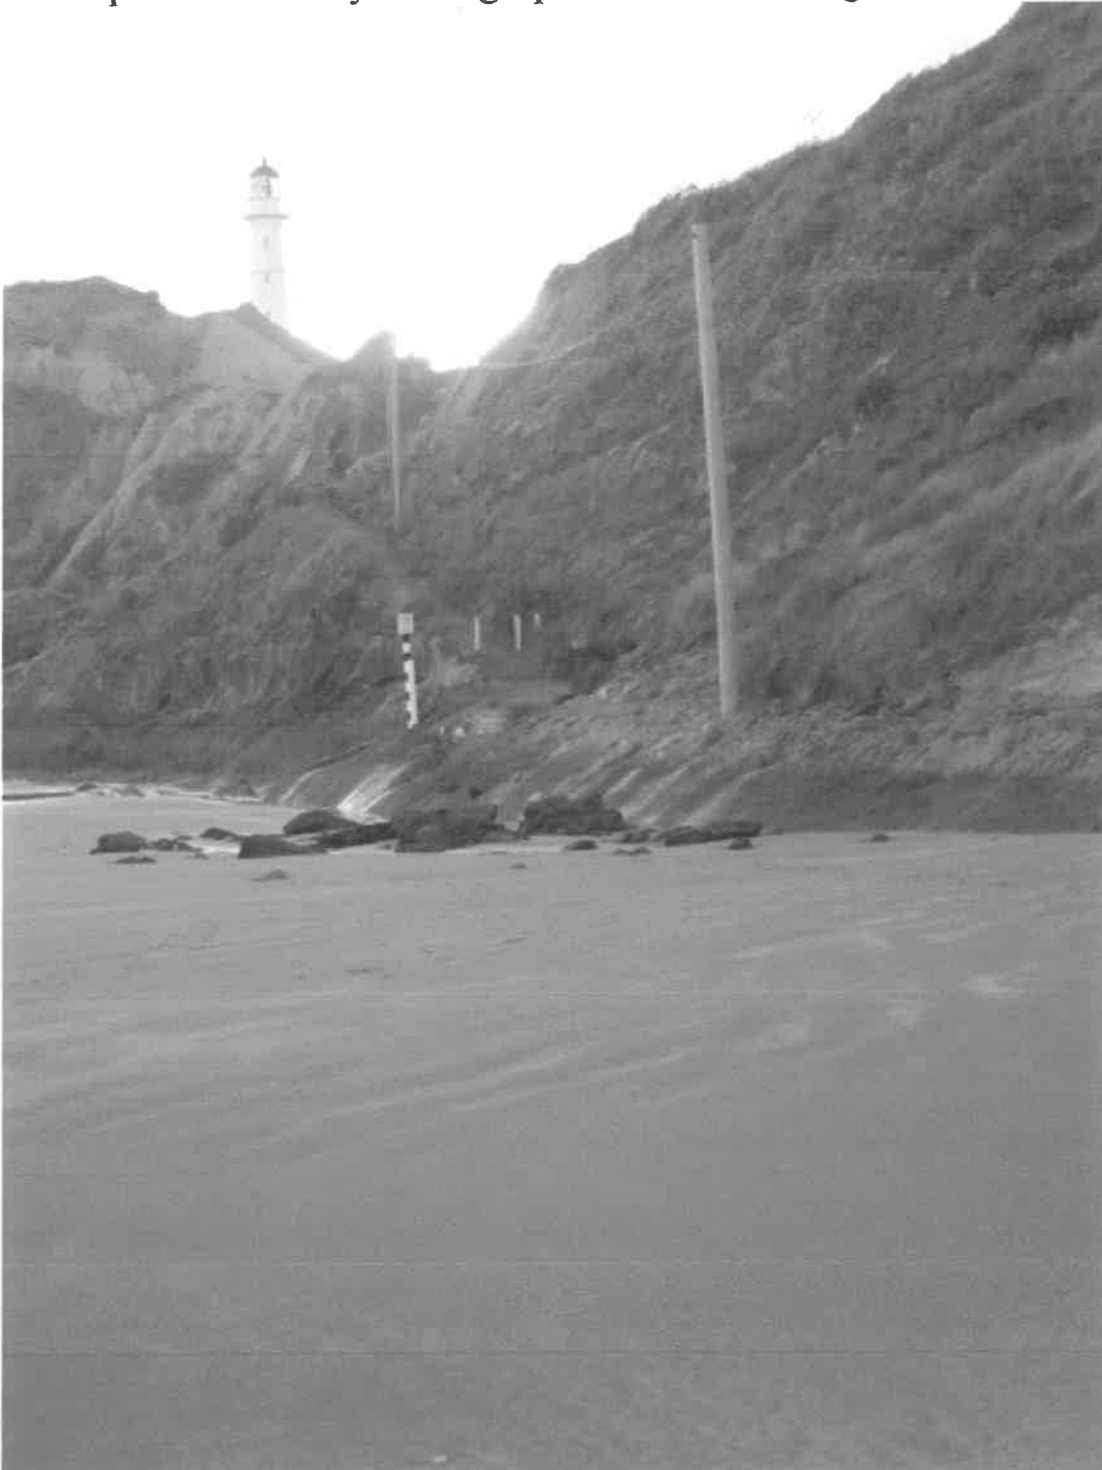
Figure 1: Photograph showing existing path and area where extension is to occur

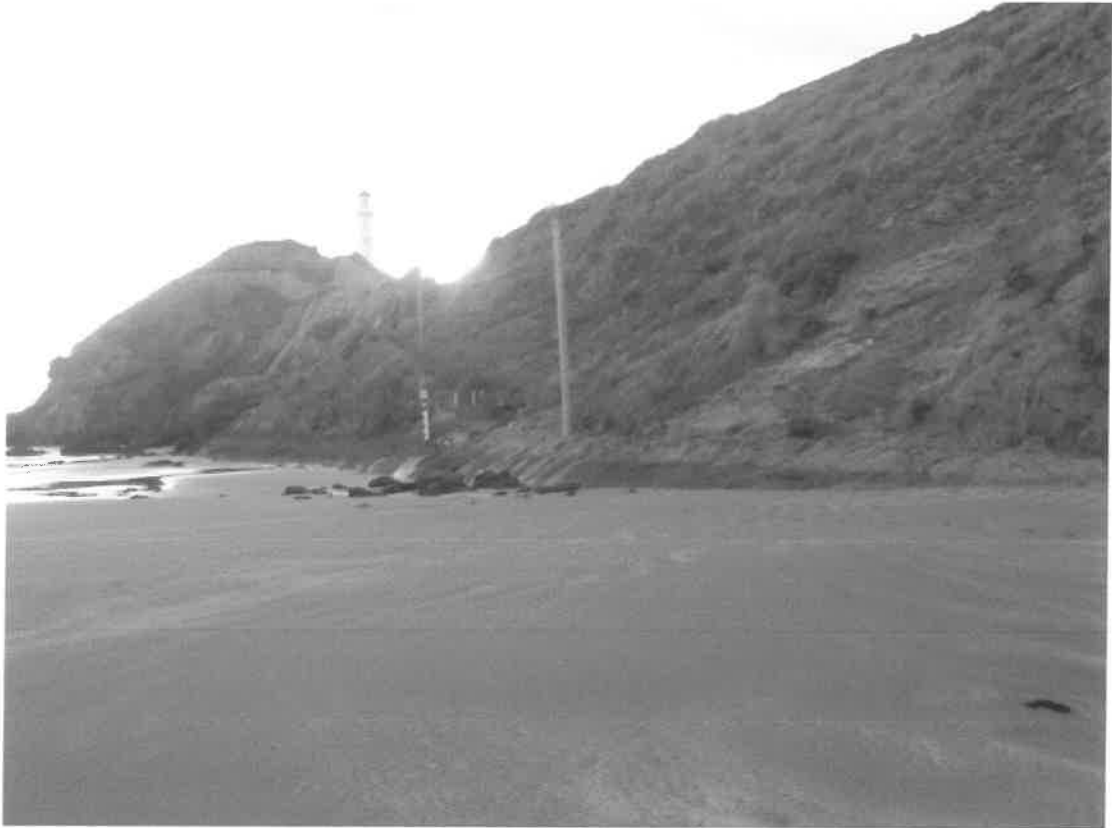
Figure 2: Photograph showing the existing path and extent of the proposed footpath extension

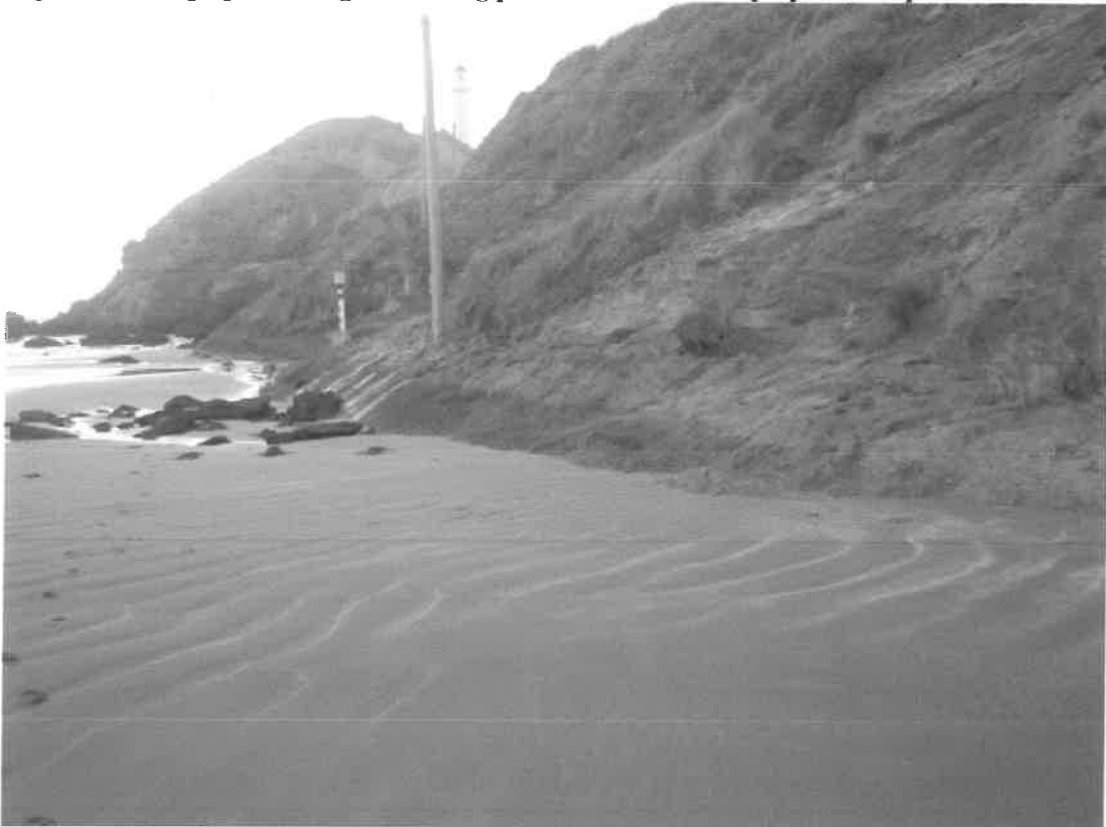
Figure 3: Photograph showing the approximate extent of the footpath extension

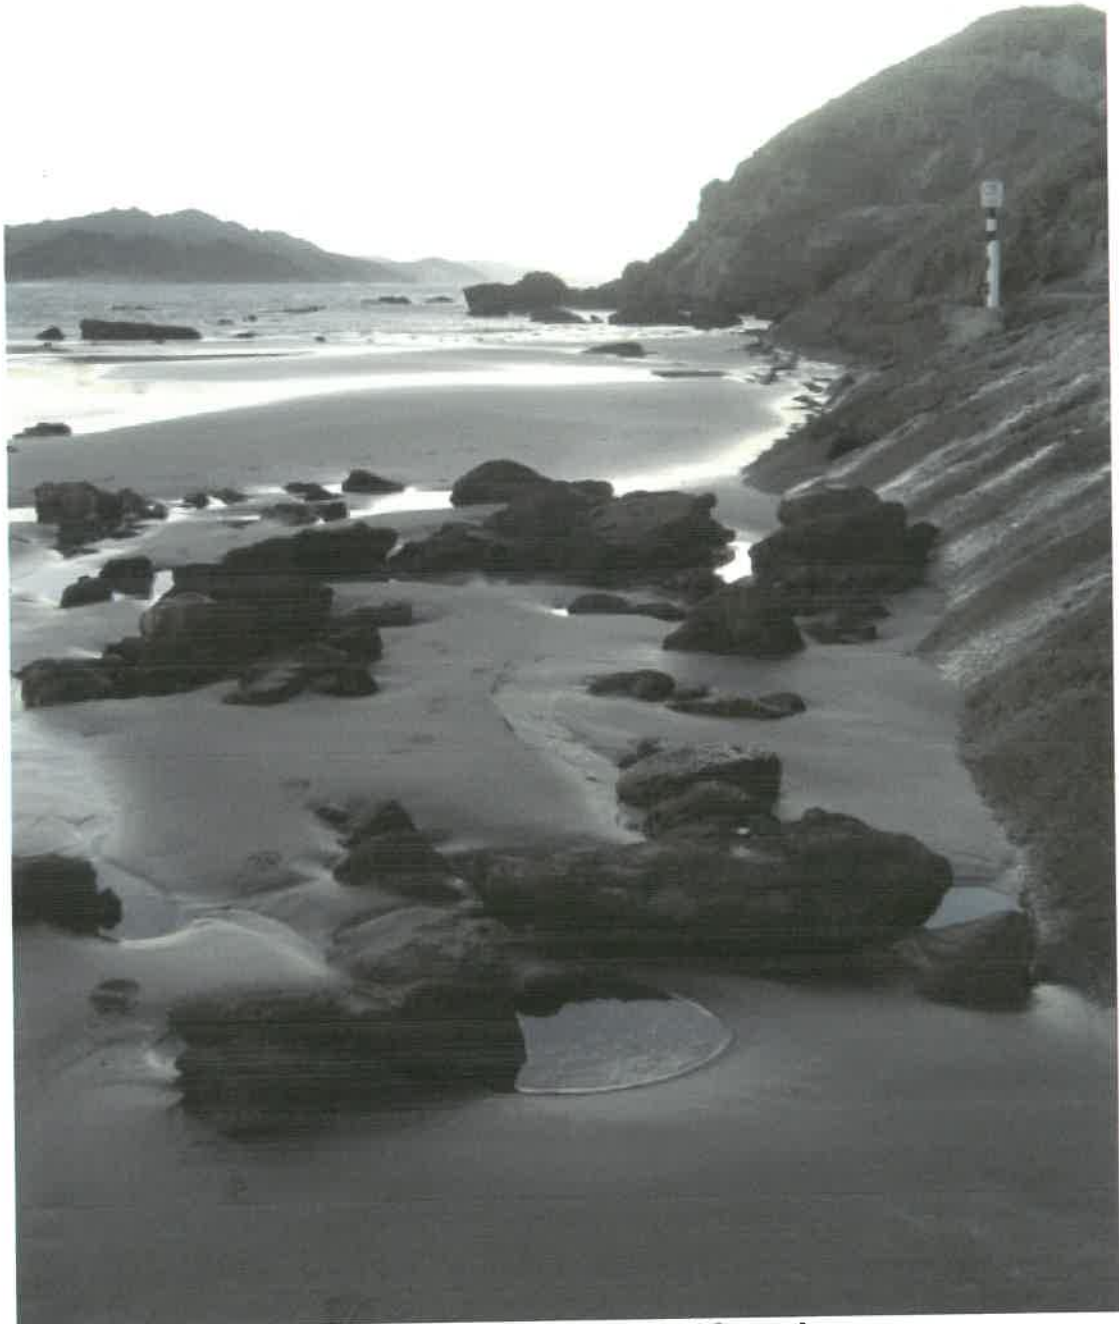
Figure 4: Environment immediately down slope of proposed foot path

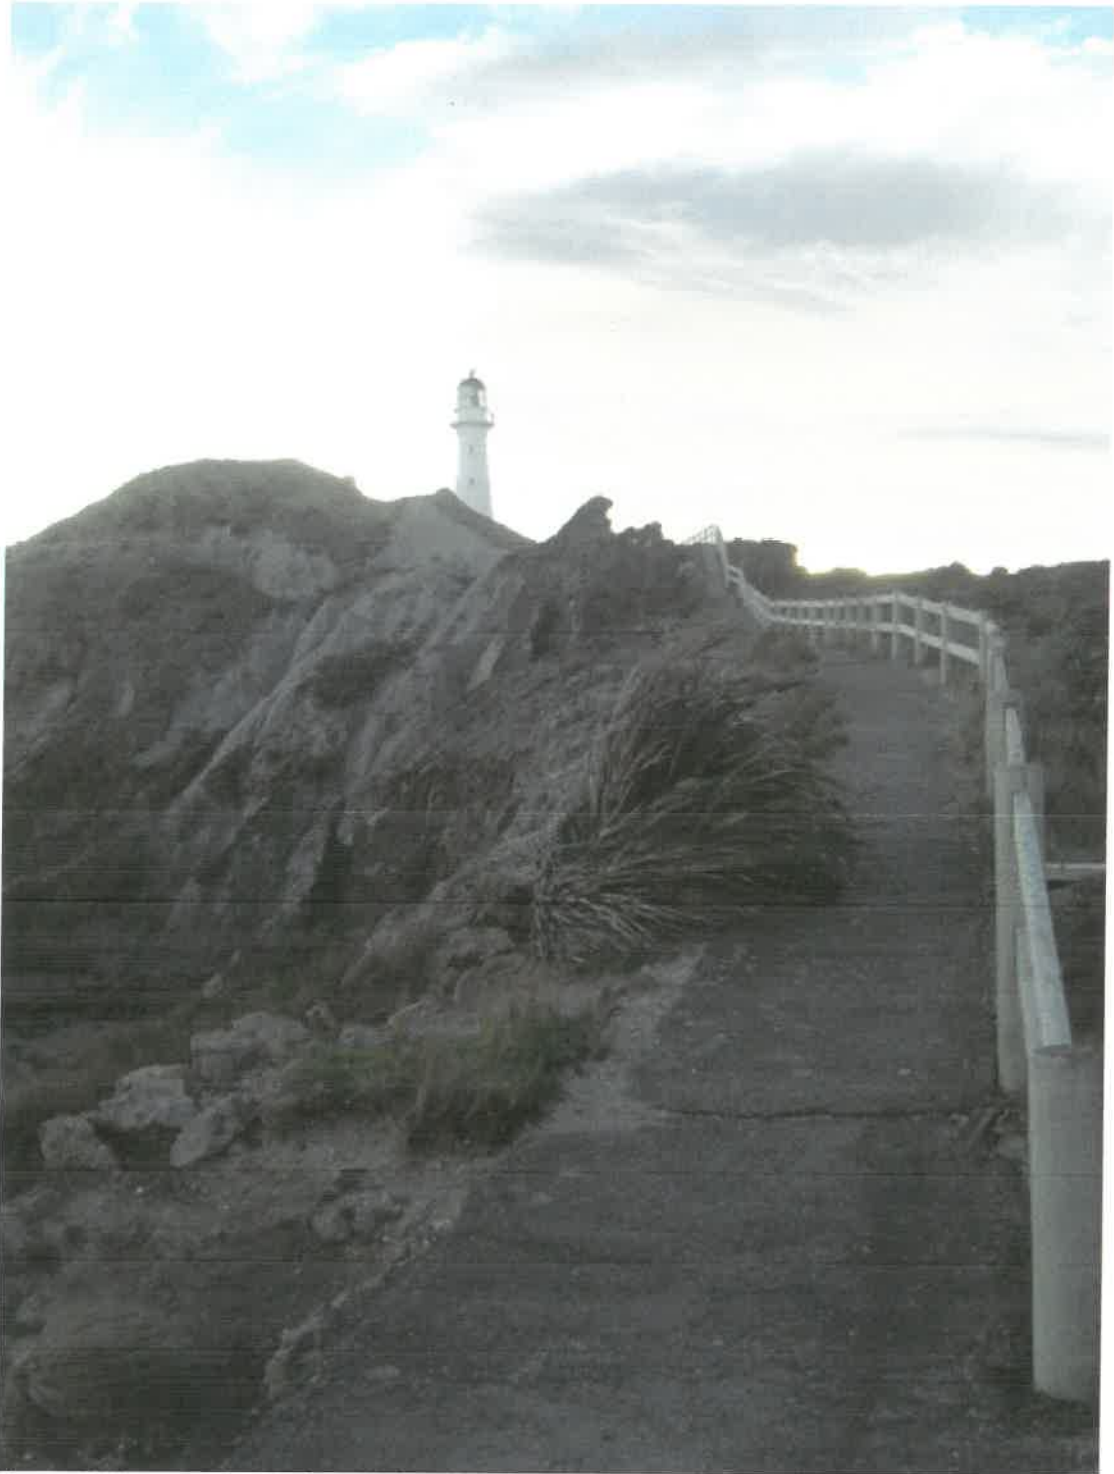
Figure 5: Photograph showing existing footpath

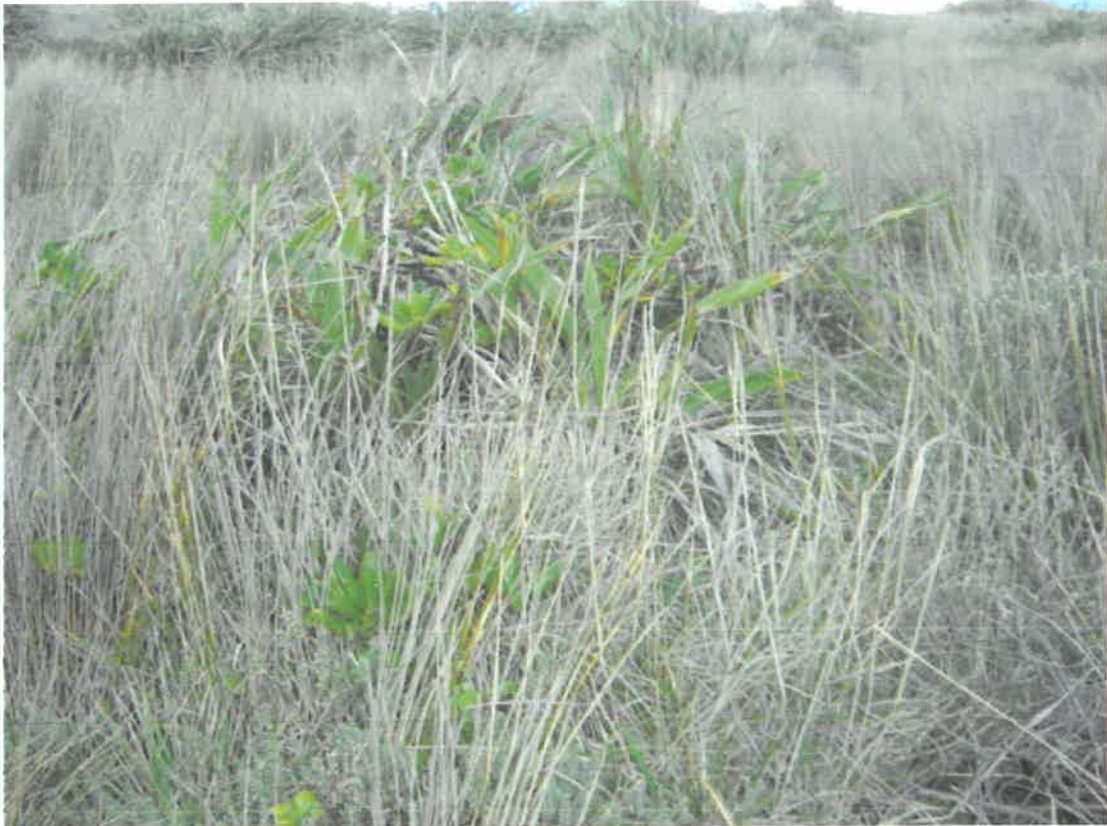
Figure 6: Photograph showing typical vegetation adjacent to the footpath

The area of particular relevance to this proposal is western side of Castlepoint reef fronting the sand dunes and Castlepoint Village. The vegetation in the immediate area is introduced marram grass and sporadic sand daphnes, sand coprosma and Castlepoint daisy. The proposed alignment of the foot path requires the removal of only one sand daphne. Different alignments of the path would require the removal of additional native plants.
