# **PATTERNS AND RATES OF SEDIMENTATION WITHIN PORIRUA HARBOUR**

**Dr Jeremy Gibb,  
Coastal Management Consultants Ltd**

**for  
PORIRUA CITY COUNCIL**

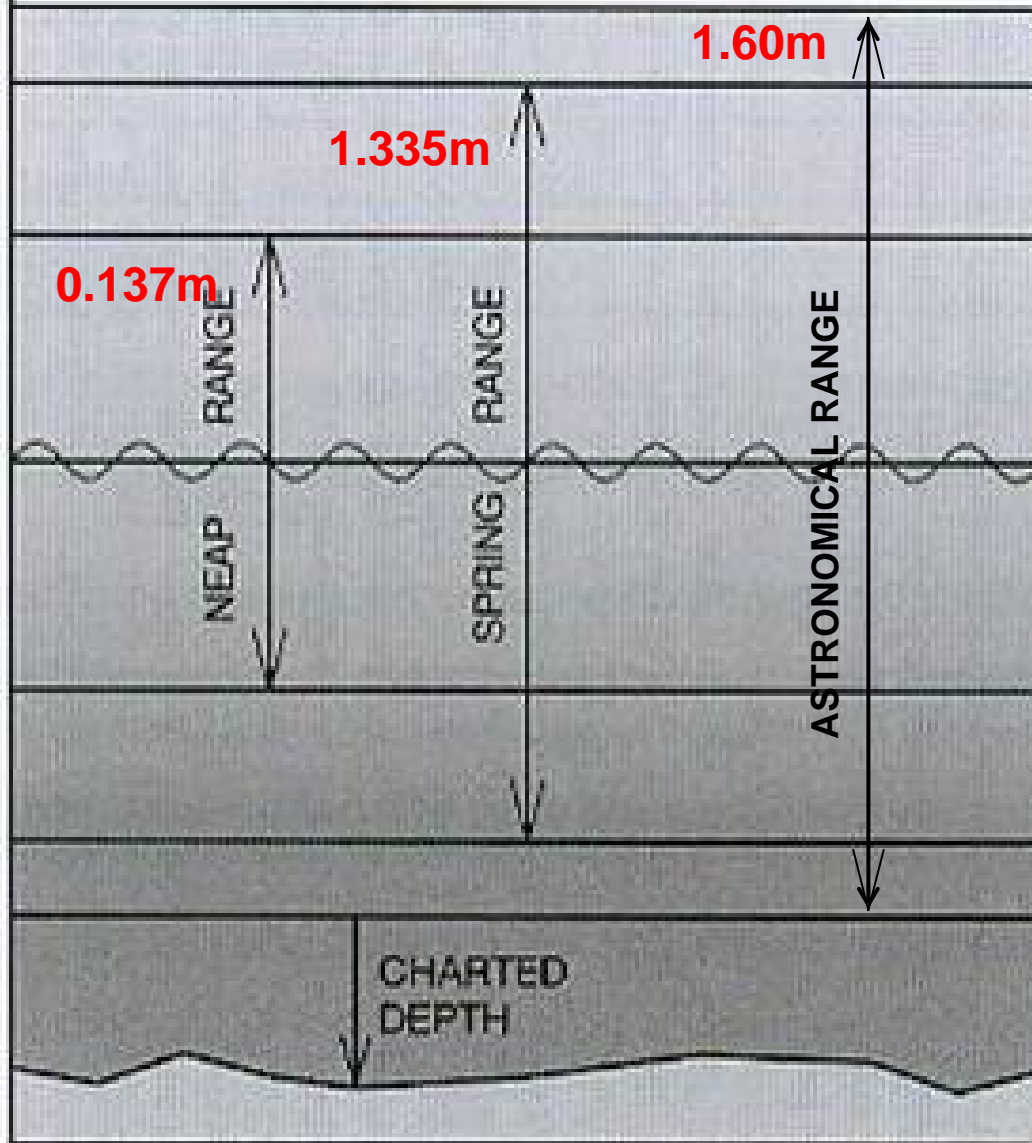
## 2009 MANA MARINA TIDES

Highest Astronomical Tide (HAT)  
Mean High Water Springs (MHWS)

Mean High Water Neaps (MHWN)

Mean Sea Level (MSL)

Mean Low Water Neaps (MLWN)

Mean Low Water Springs (MLWS)

Lowest Astronomical Tide (LAT)  
Chart Datum (CD)

(source: CMCL Report Fig 4, CR2009/1)

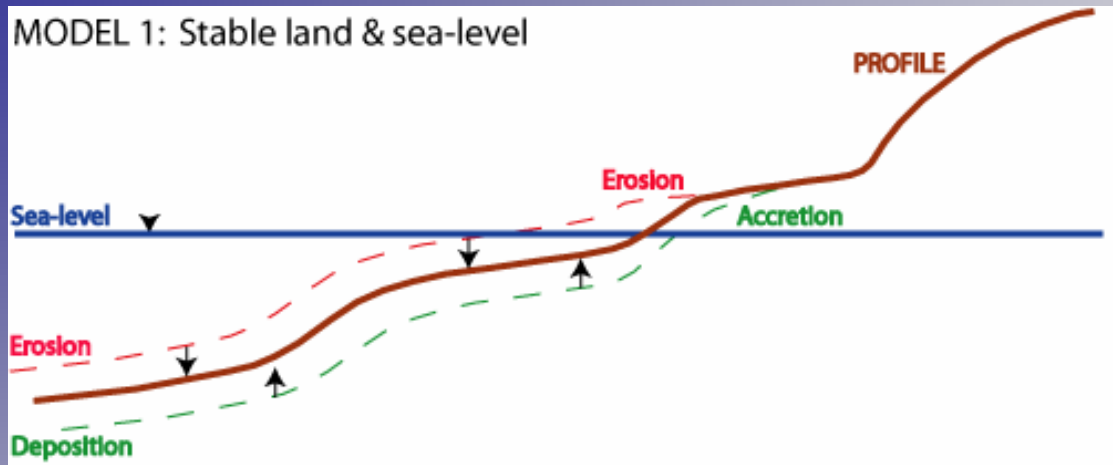
MODEL 1: Stable land & sea-level

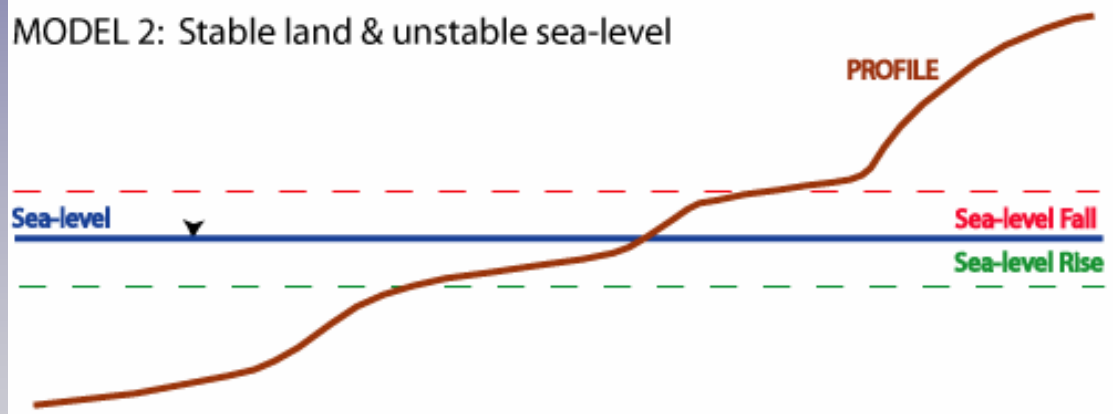
MODEL 2: Stable land & unstable sea-level

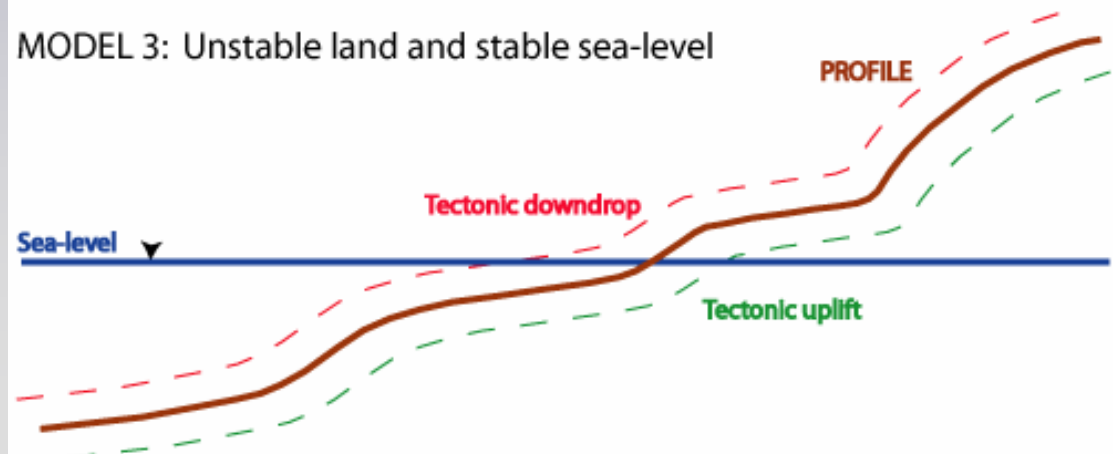
MODEL 3: Unstable land and stable sea-level

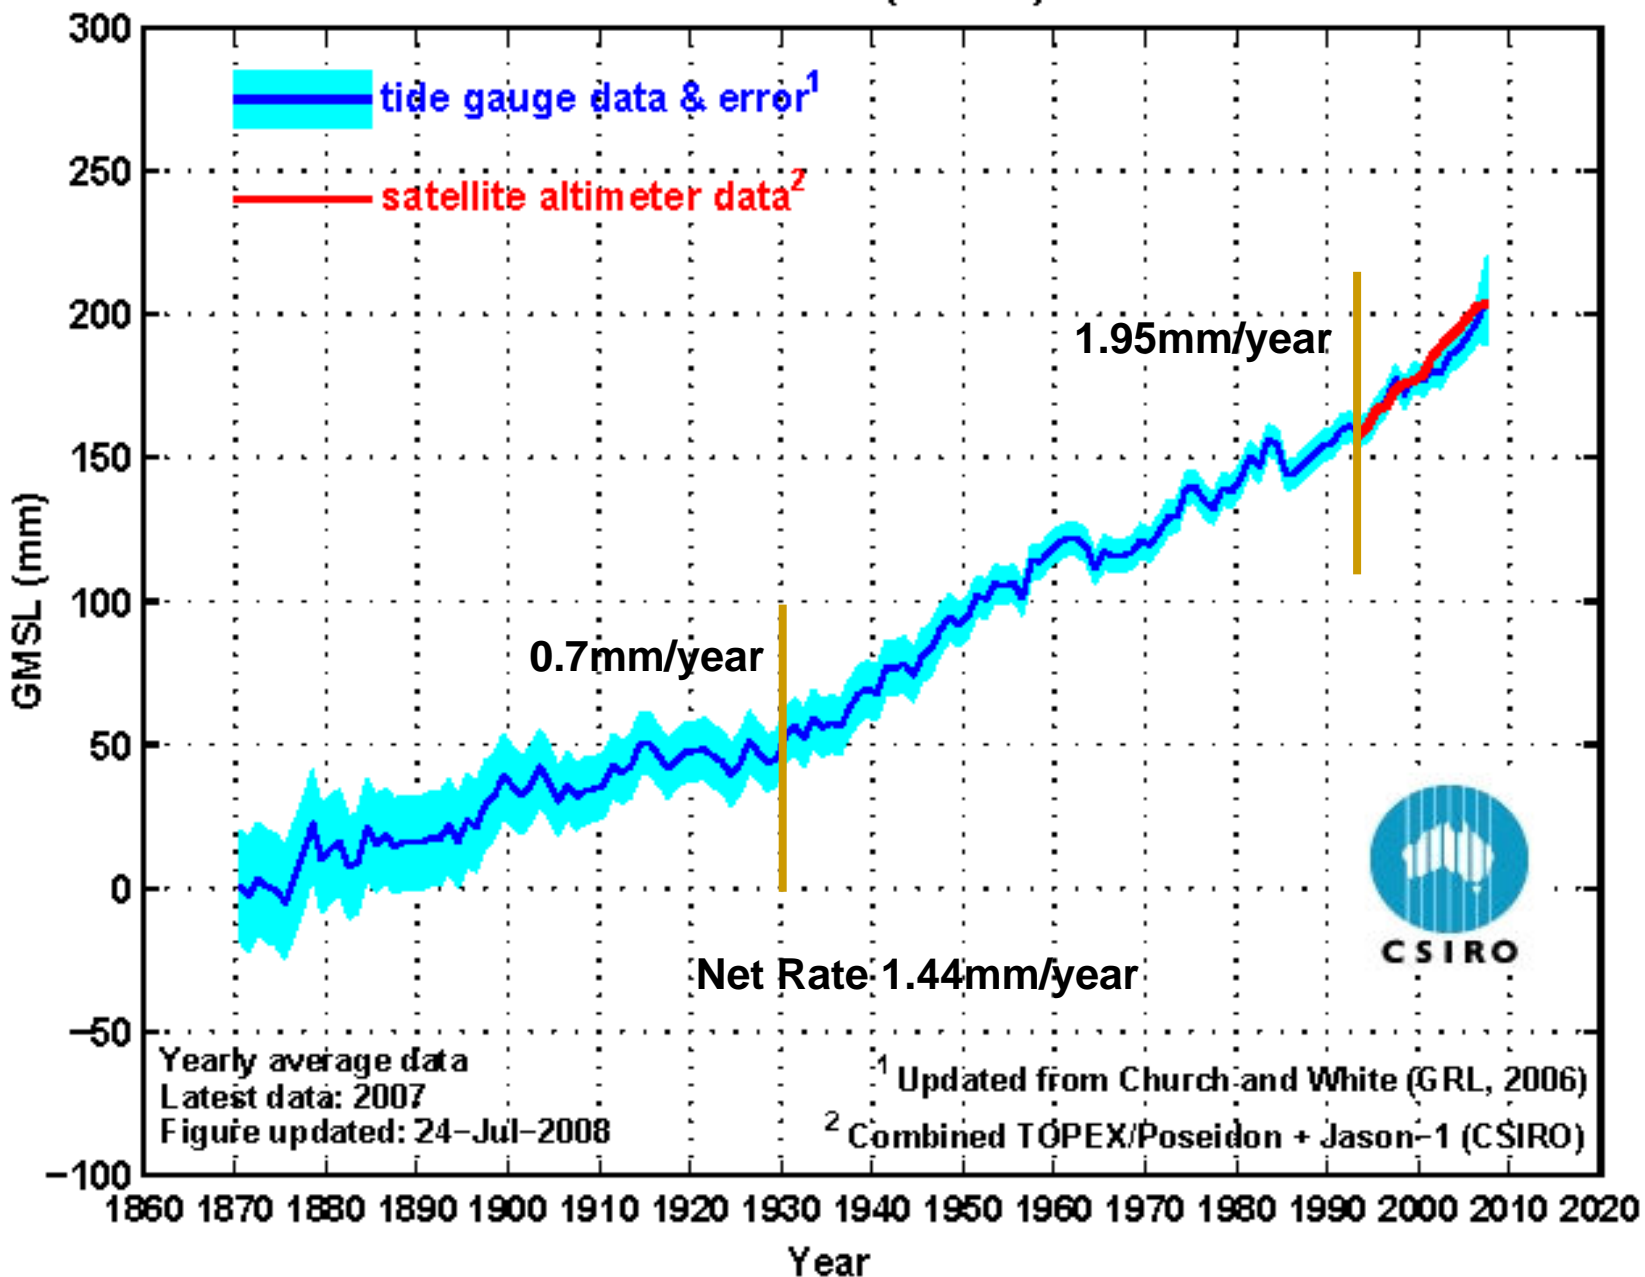
# Global Mean Sea Level (GMSL) – 1870 to 2007

(source: Church et al. 2008)

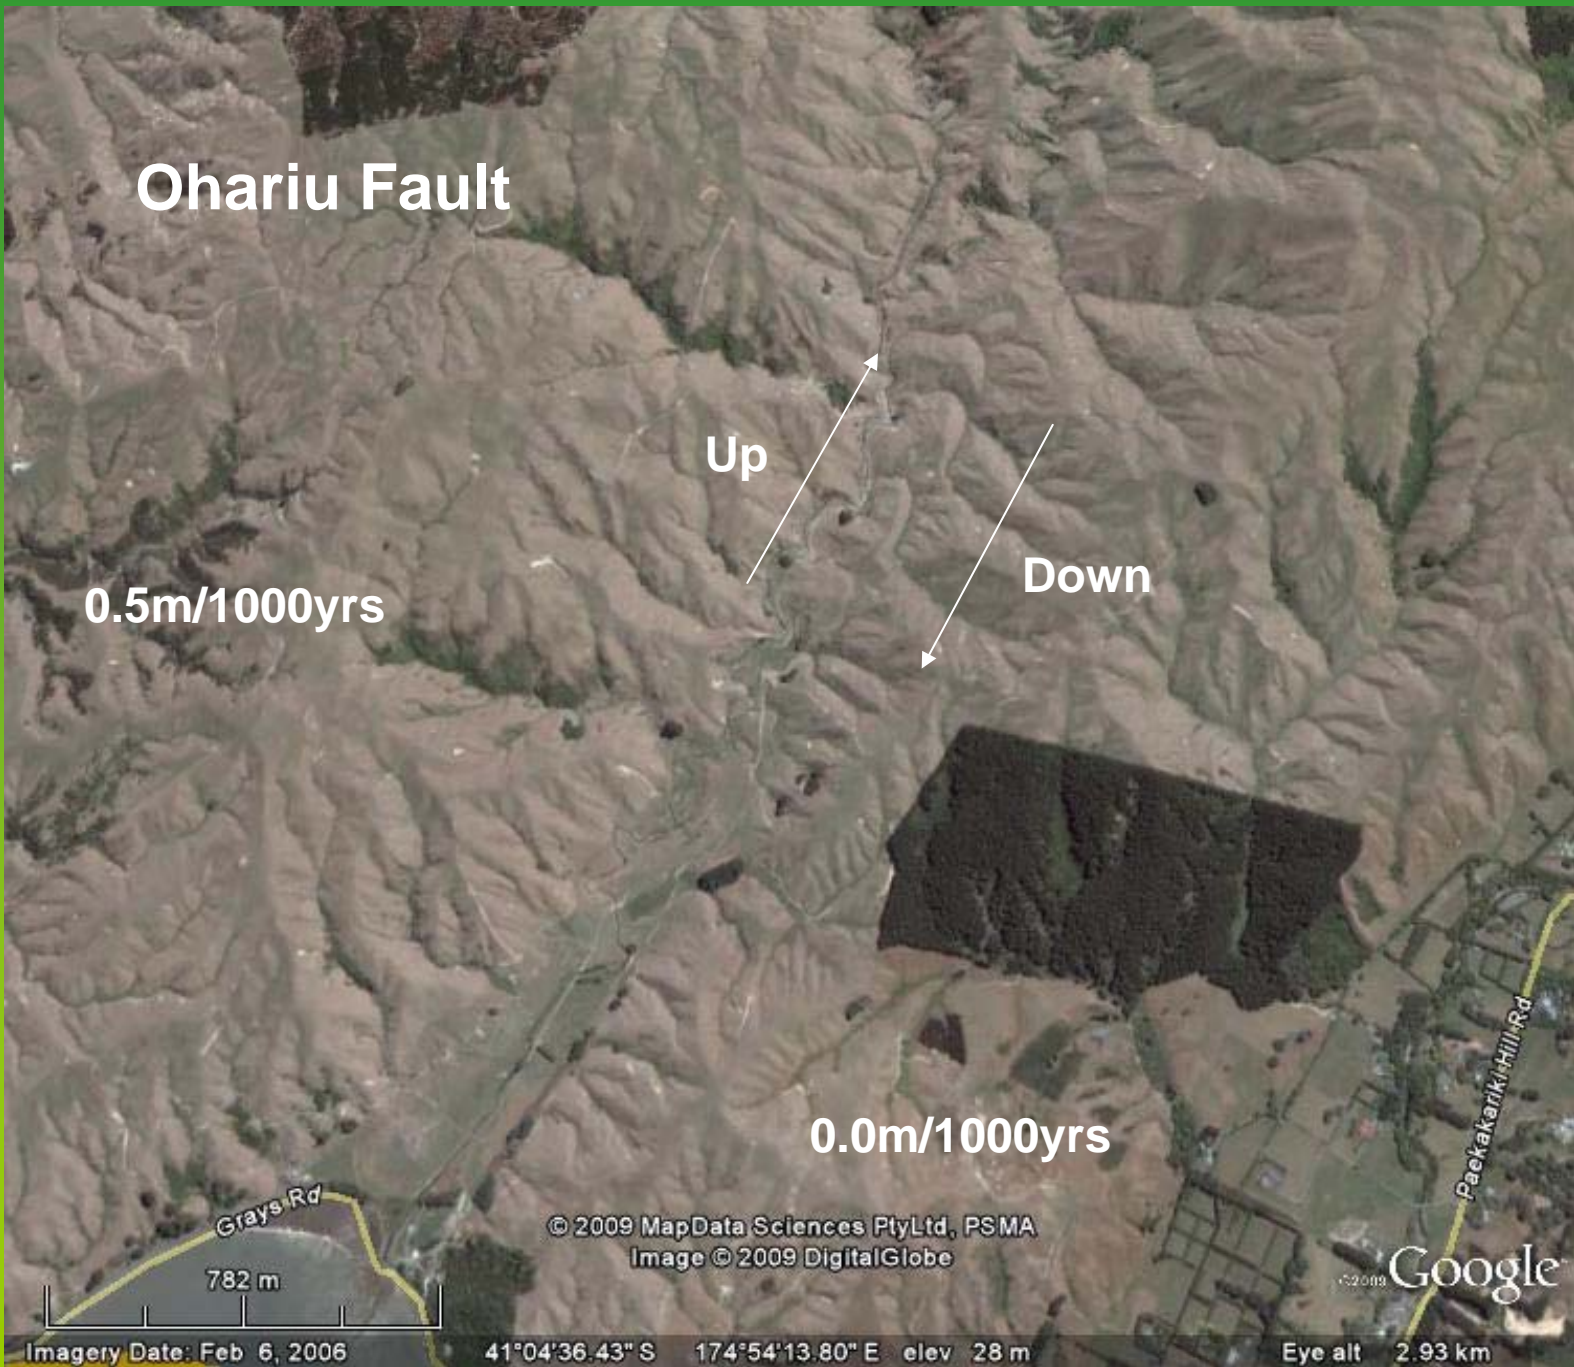
# Ohariu Fault

0.5m/1000yrs

Up

Down

0.0m/1000yrs

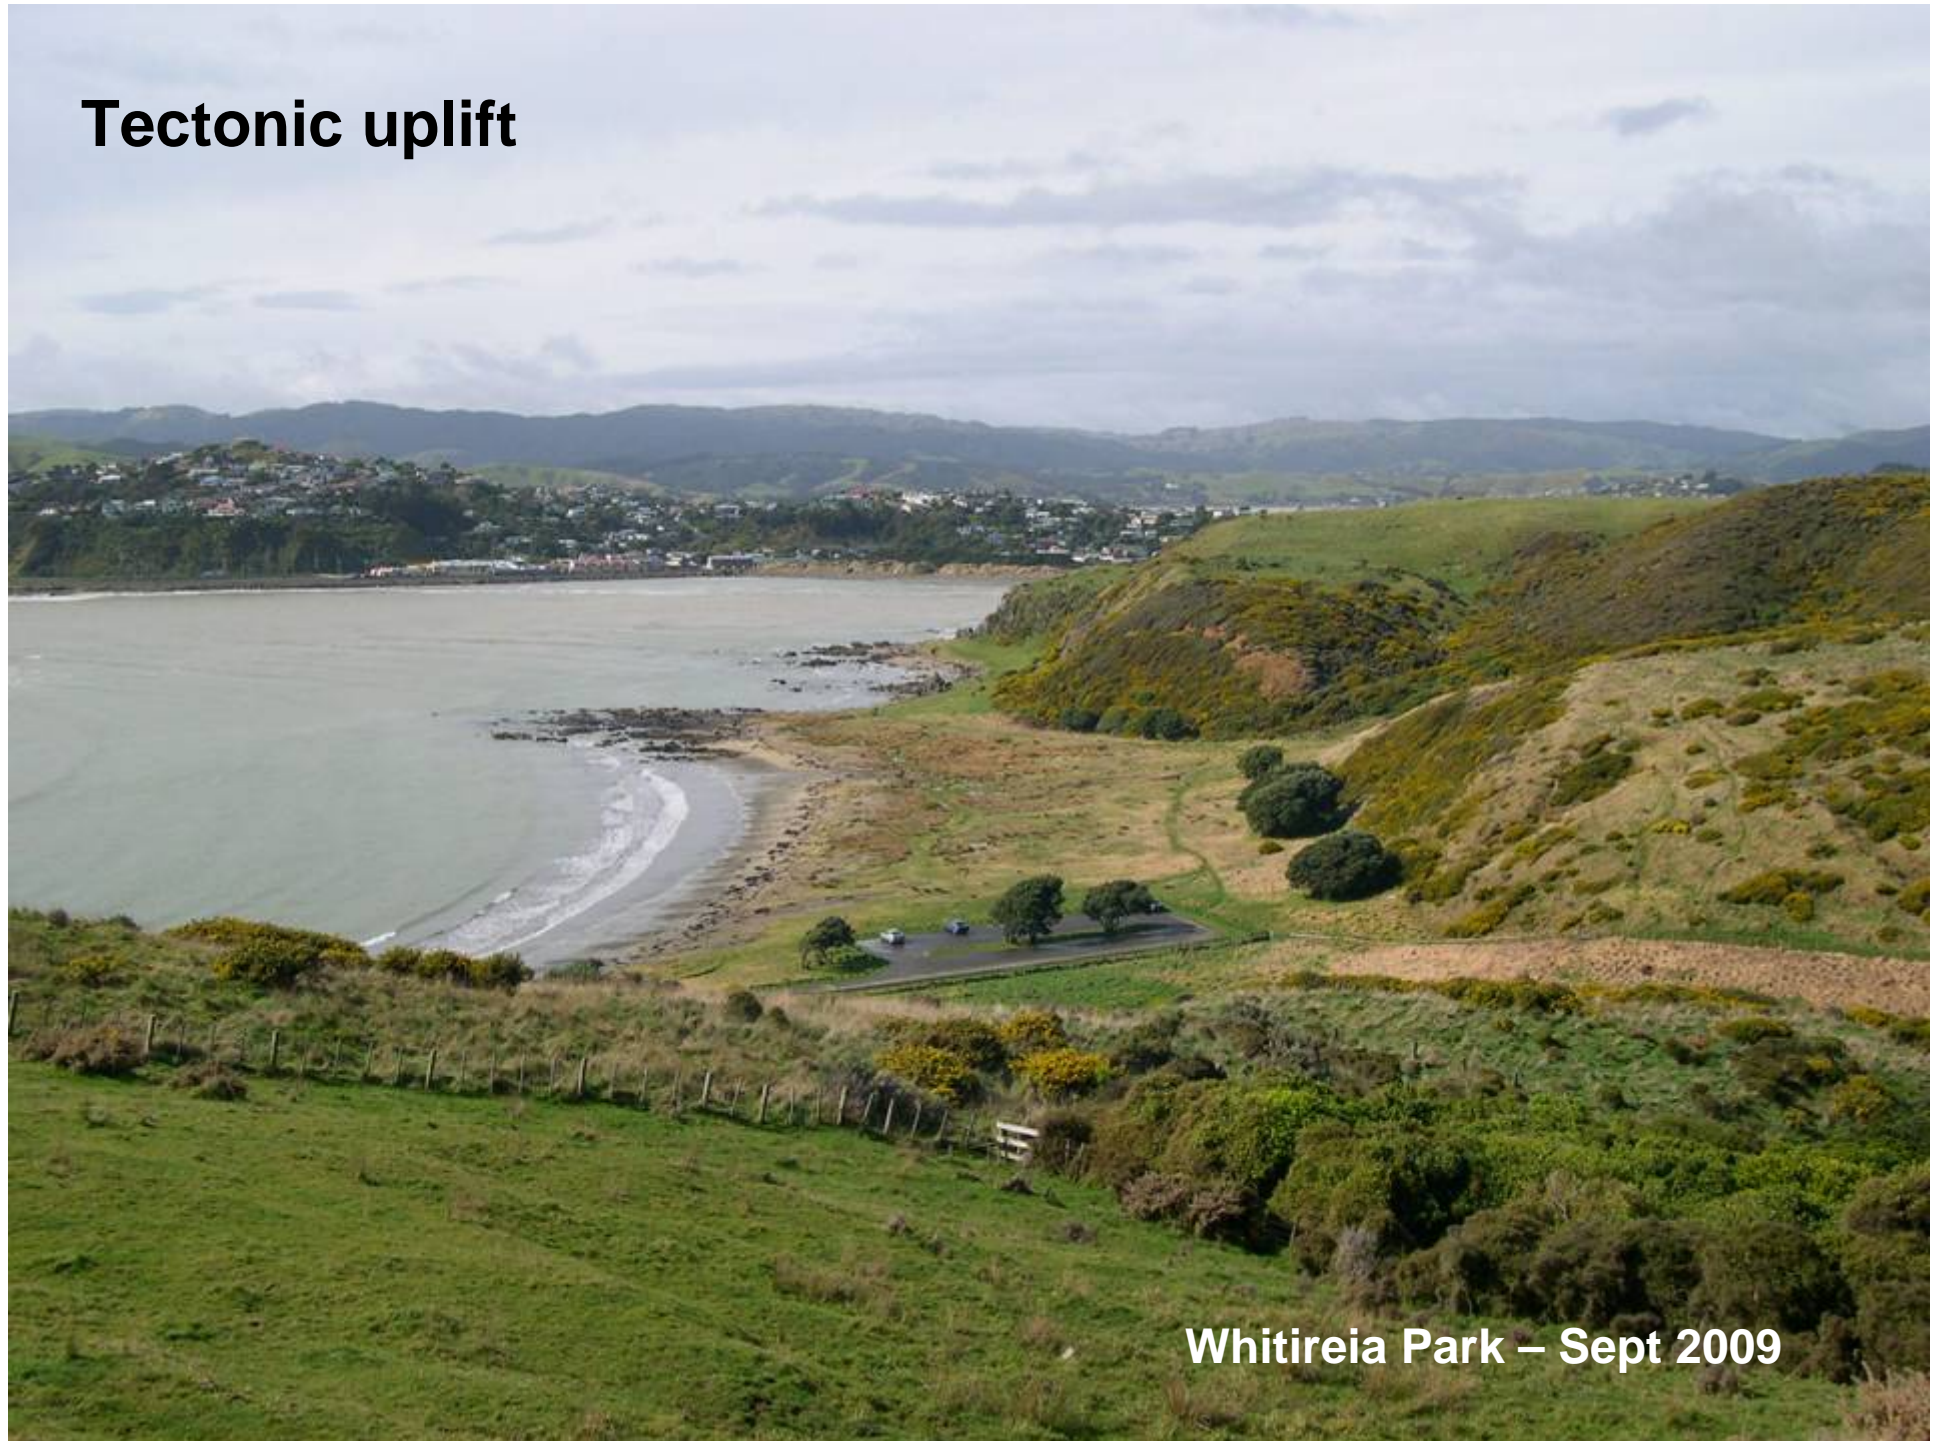
# Tectonic uplift

0.2m/1000 yrs

3.2ka

4.2ka

0.5m/1000 yrs
