Kapiti, Southwest, South Coasts and Wellington Harbour

Risk Assessment and Monitoring Recommendations

Prepared
for
Greater
Wellington
Regional
Council

September
2007

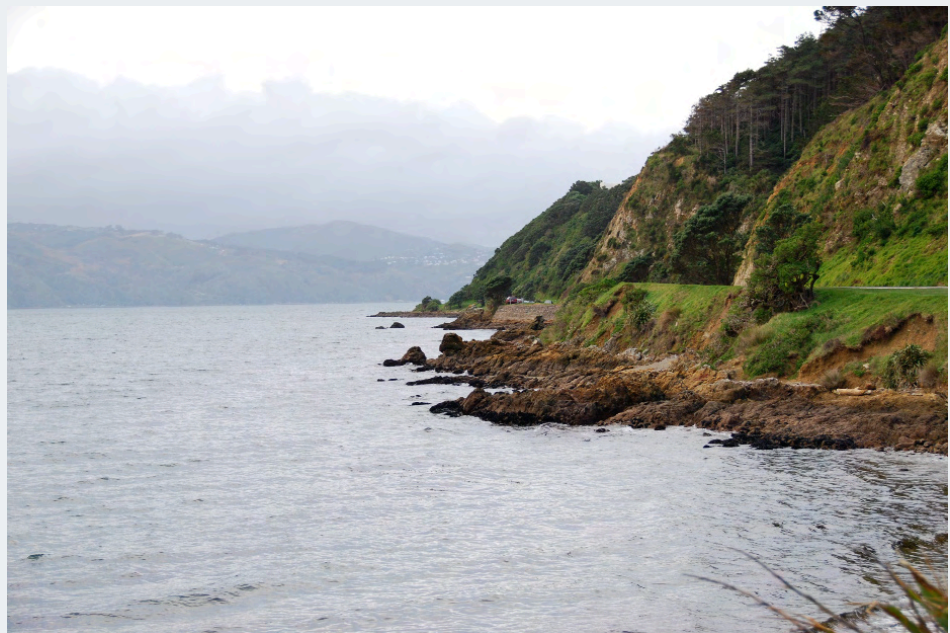
Wellington Harbour rocky shore near Shelly Bay

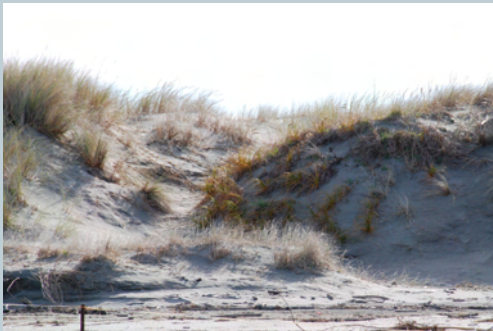
Erosion of dune face. and replanting (Waitohu)

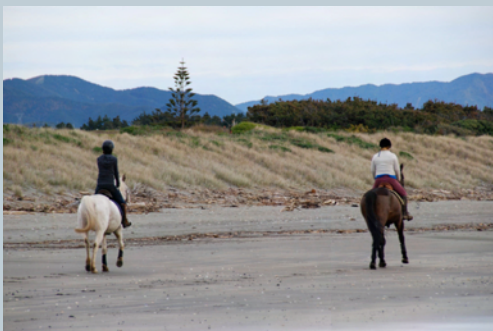
Spinifex foredune, marram near Peka Peka

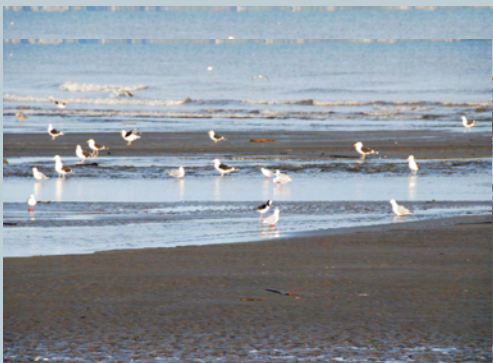
Birds eating shellfish at Ngarara mouth.

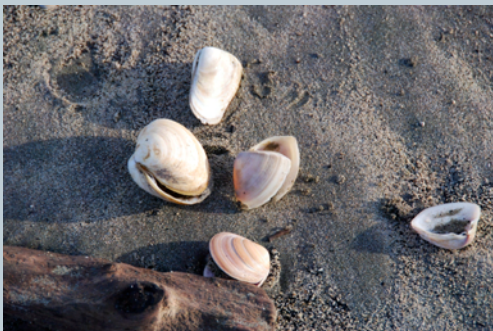
Pipi, dog cockle, *Mactra* and wedge shells common.

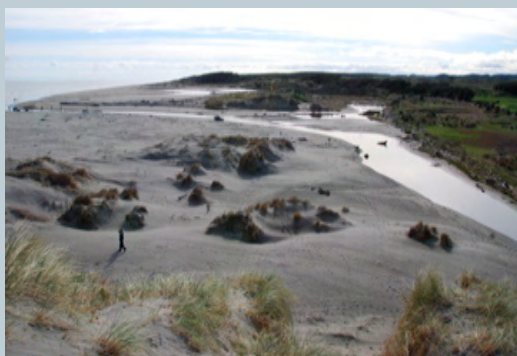
Estuary Type/Area	Tidal River Mouth
Catchment	54 km ² (forest, pasture)
Dairy cows	1560 cows
Nitrogen loading	Mod-High: 14-20 kg/ha/yr
Catchment geology	Greywacke, alluvium, peat
Saltmarsh (ha)	1-2ha (dunes on margins)
Salinity	Varies depending on mouth closure
Mean depth (m)	0.5-1m
Tidal flats	None (lagoon floods sand flats on beach berm)
Uses/Values	Fishing, swimming, birds, whitebaiting.

Waitohu Estuary and mouth

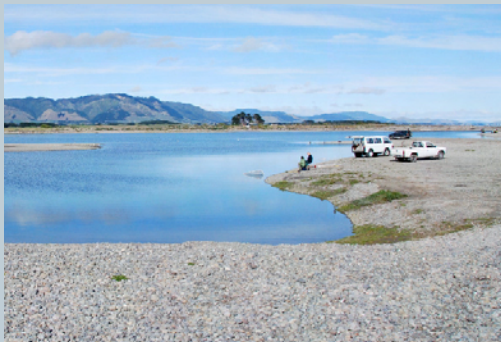
Estuary Type/Area	Tidal River Mouth
Catchment	348 km ² (native forest)
Dairy cows	1670 cows
Nitrogen loading	Low: 5-8 kg/ha/yr
Catchment geology	Greywacke, alluvium
Saltmarsh (ha)	1-3ha
Salinity	<5ppt
Mean depth (m)	1 to >2m
Tidal flats	None
Uses/Values	Fishing, swimming, birds, whitebaiting.

Otaki Estuary and whitebaiters

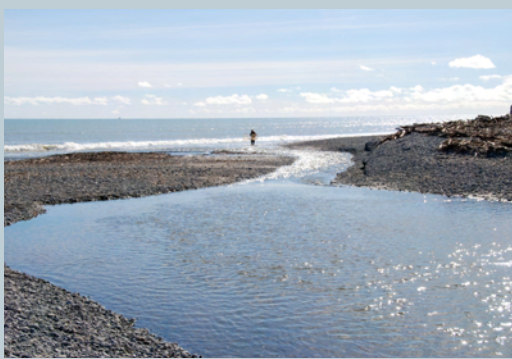
Estuary Type/Area	Tidal River Mouth
Catchment	53 km ² (intensive pasture)
Dairy cows	2020 cows
Nitrogen loading	High: 14-30 kg/ha/yr
Catchment geology	Greywacke, alluvium, peat, sand
Saltmarsh (ha)	<0.1ha
Salinity	Varies depending on mouth closure
Mean depth (m)	0.5m
Tidal flats	None (lagoon floods sand flats on beach berm)
Uses/Values	Fishing, swimming, birds, whitebaiting, picnicking, fossicking.

Mangaone Estuary and mouth

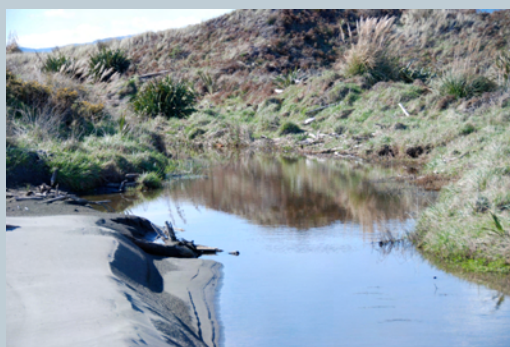
Estuary Type/Area	Tidal River Mouth
Catchment	15 km ² (intensive pasture)
Dairy cows	0 cows
Nitrogen loading	Mod - High: 14-20 kg/ha/yr
Catchment geology	Sand, greywacke, loess, peat
Saltmarsh (ha)	<0.1ha
Salinity	Varies depending on mouth closure
Mean depth (m)	0.5m
Tidal flats	None (lagoon floods sand flats on beach berm)
Uses/Values	Fishing, paddling, birds, whitebaiting, picnicking, fossicking.

Peka Peka Estuary just inland of beach

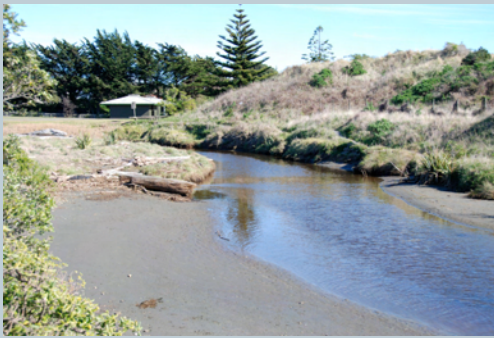
Estuary Type/Area	Tidal River Mouth
Catchment	15 km ² (intensive pasture)
Dairy cows	0 cows
Nitrogen loading	Mod - High: 14-20 kg/ha/yr
Catchment geology	Sand, urban, greywacke, peat
Saltmarsh (ha)	<0.5ha
Salinity	Varies depending on mouth closure
Mean depth (m)	0.5m
Tidal flats	None (lagoon floods sand flats on beach berm)
Uses/Values	Fishing, paddling, birds, whitebaiting, picnicking, fossicking, shellfish.

Ngarara Estuary and inland of beach

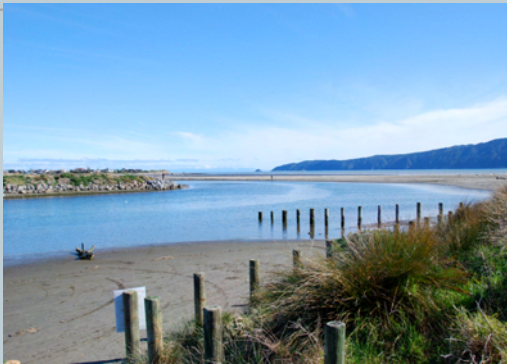
Estuary Type/Area	Tidal River Mouth
Catchment	149 km ² (native forest)
Dairy cows	0 cows
Nitrogen loading	Low 5-8 kg/ha/yr
Catchment geology	Greywacke, alluvium, peat, sand
Saltmarsh (ha)	10-20ha
Salinity	Varies depending on mouth closure
Mean depth (m)	1-3m
Tidal flats	Moderate (lagoon floods beach)
Uses/Values	Fishing, bathing, birds, whitebait, picnics, conservation, shellfish.

Waikanae Estuary

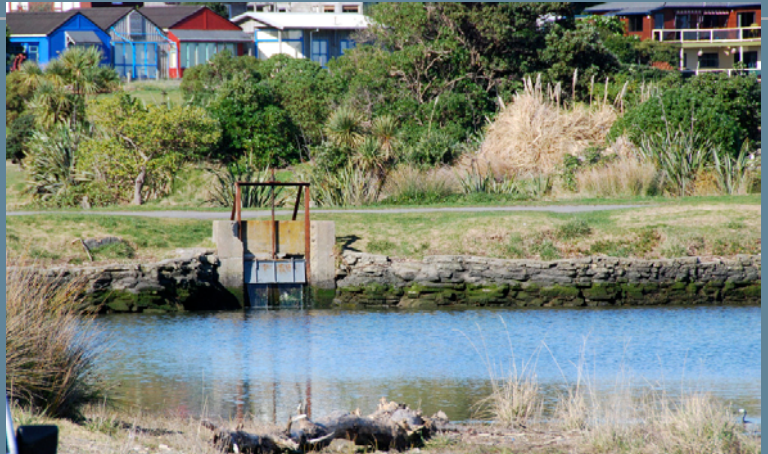
Waikanae Estuary, presence of floodgates limiting access to adjacent stream, and green algal mats in intertidal zone.

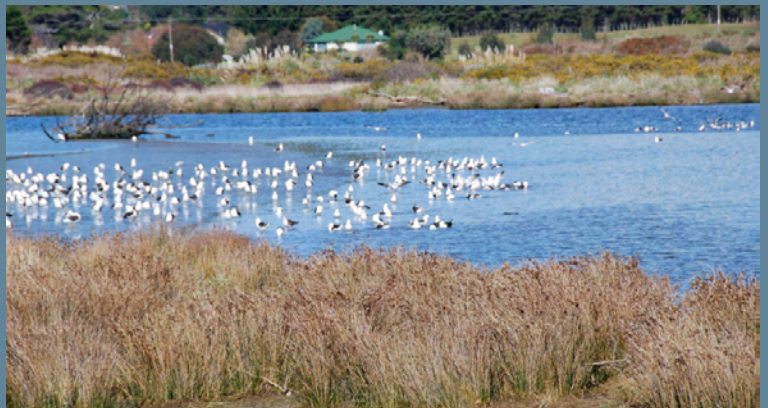
Waikanae Estuary, presence of salmarsh, and birdlife

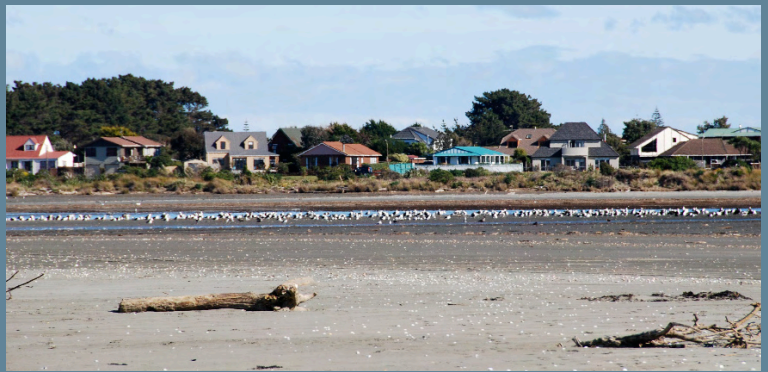
Waikanae Estuary, presence of tidal flats and dunes

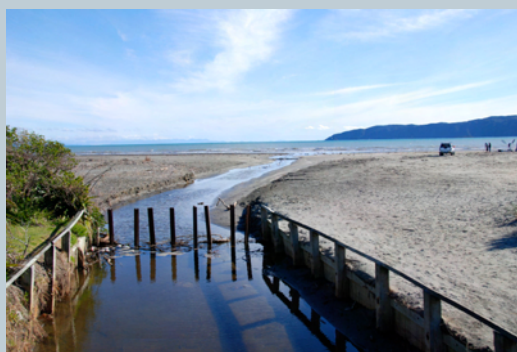
Estuary Type/Area	Tidal River Mouth
Catchment	17 km ² (urban)
Dairy cows	0 cows
Nitrogen loading	Mod : 8-20 kg/ha/yr
Catchment geology	Urban, sand
Saltmarsh (ha)	<0.1ha
Salinity	Varies depending on mouth closure
Mean depth (m)	0.5m
Tidal flats	None (lagoon floods sand flats on beach berm)
Uses/Values	Low

Tikotu Estuary

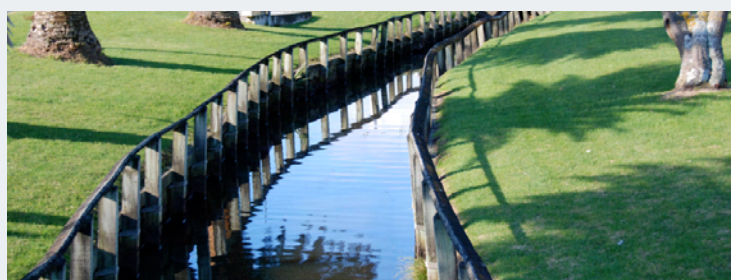
Tikotu Estuary

Salinities vary depending on the extent of tidal inflow. The water is humic stained, turbid and the sediments a soft sandy mud with signs of anoxic conditions. Given the dominant urban and intensive pastoral landuse, small catchment, absence of wetland filtering, water quality is expected to be fair to poor. Kapiti Coast District Council (KCDC) faecal monitoring data confirms high levels of faecal contamination. Estimated nitrogen (the major driver of eutrophication) loadings are moderate. Because the estuary is very small and dominated by freshwater inputs, its quality is expected to be similar to that of the stream for much of the time. However, the mouth constricts or closes periodically and therefore is susceptible to eutrophication (nuisance algal blooms, low oxygen and smelly black sediments), muddy sediments, low clarity and high disease risk to bathers. To minimise water quality deterioration and flood risk, the mouth opening is artificially managed.

Given these characteristics there is potential to improve habitat condition and diversity through management of landuse intensity in the catchment, margin revegetation and profiling, and weed control. However, because of the urban margins, roads, and walled channel, such improvements are likely to be difficult to achieve.

Issues	Monitoring	Management
Mouth constricts. Natural cycle of low to high water quality as degree of mouth restriction varies. Very low habitat diversity, water quality. Dunes built on.	<ul style="list-style-type: none"> Map intensive landuse (urban, high production pasture) in the catchment at 5 yearly intervals. 	<ul style="list-style-type: none"> Limit intensive landuse development and/or manage to ensure impacts don't degrade estuary WQ.

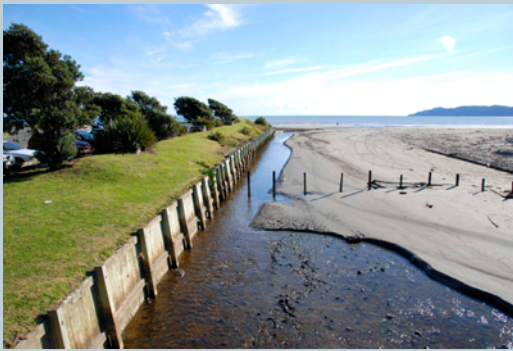
Estuary Type/Area	Tidal River Mouth
Catchment	12 km ² (urban, intensive pastoral)
Dairy cows	0 cows
Nitrogen loading	Mod : 8-20 kg/ha/yr
Catchment geology	Greywacke, loess, peat, urban
Saltmarsh (ha)	<0.1ha
Salinity	Varies depending on mouth closure
Mean depth (m)	0.5m
Tidal flats	None (lagoon floods sand flats on beach berm)
Uses/Values	Low

Wharemakau Estuary

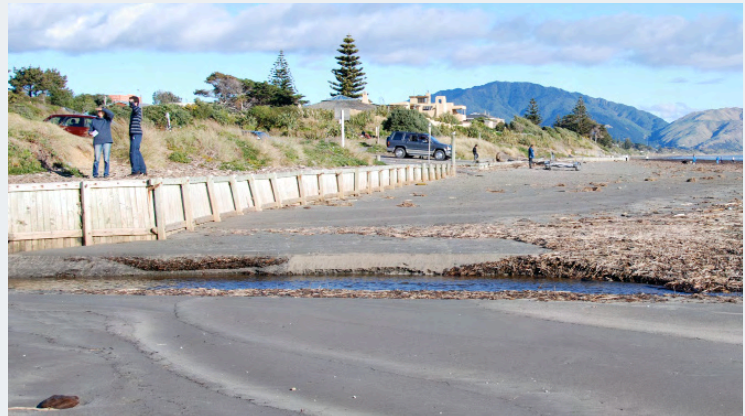
Wharemakau Estuary

Salinities vary depending on the extent of tidal inflow. The water is humic stained, turbid and the sediments a soft sandy mud with no signs of anoxic conditions. Given the dominant urban and intensive pastoral landuse, small catchment, absence of wetland filtering, water quality is expected to be fair to poor. Kapiti Coast District Council (KCDC) faecal monitoring data confirms high levels of faecal contamination. Estimated nitrogen (the major driver of eutrophication) loadings are moderate. Because the estuary is very small and dominated by freshwater inputs, its quality is expected to be similar to that of the stream for much of the time. The mouth constricts but the estuary is too well flushed to be susceptible to eutrophication or sedimentation.

Given these characteristics there is potential to improve habitat condition and diversity through management of landuse intensity in the catchment, margin revegetation and profiling, and weed control. However, because of the urban margins, roads, and walled channel, such improvements are likely to be very difficult to achieve.

Issues	Monitoring	Management
Very low habitat diversity, fair water quality. Dunes built on. Sea walls, beach erosion.	<ul style="list-style-type: none"> Map intensive landuse (urban, high production pasture) in the catchment at 5 yearly intervals. 	<ul style="list-style-type: none"> Limit intensive landuse development and/or manage to ensure impacts don't degrade estuary WQ.

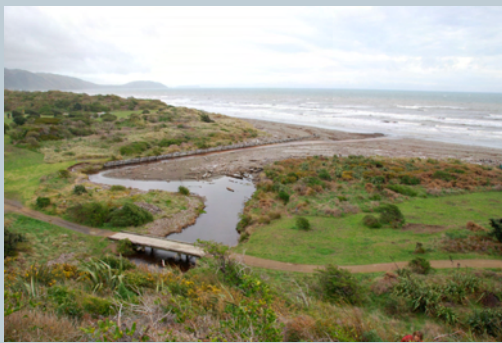
Estuary Type/Area	Tidal River Mouth
Catchment	16 km ² (intensive pasture)
Dairy cows	0 cows
Nitrogen loading	Mod 8-20 kg/ha/yr
Catchment geology	Greywacke, loess, peat, sand
Saltmarsh (ha)	1ha
Salinity	Approx 1km
Mean depth (m)	1m
Tidal flats	None (lagoon floods sand flats on beach berm)
Uses/Values	Fishing, paddling, birds, whitebaiting, picnicing, conservation.

Whareroa Estuary

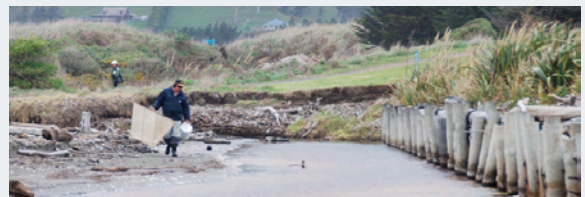
Whareroa Estuary

Salinities vary depending on the extent of tidal inflow. The water is humic stained, and the sediments a soft sandy mud with little sign of anoxic conditions. Currently the water quality in the stream is moderate (moderate nutrient and *e.coli* concentrations), reflecting the dominant high productivity pastoral landuse, small catchment, lack of significant wetland filtering. Estimated nitrogen (the major driver of eutrophication) loadings are moderate. Because the estuary is small and dominated by freshwater inputs, its quality is expected to be similar to that of the stream for much of the time. However, the mouth constricts or closes periodically which can cause lowered water quality for short periods. To minimise water quality deterioration and flood risk, the mouth opening is artificially managed.

Given these characteristics there is a good potential to improve habitat condition and diversity through management of landuse intensity in the catchment, margin revegetation and profiling, and weed control.

Issues	Monitoring	Management
Mouth constricts. Natural cycle of low to high water quality as degree of mouth restriction varies. Low-mod habitat diversity , water quality and dune vegetation deterioration.	<ul style="list-style-type: none"> Map intensive landuse (urban, high production pasture) in the catchment at 5 yearly intervals. Map dominant species cover and condition of salt marsh and dune vegetation at 5-10 yearly intervals. Identify hot spots for management. Map likely natural extent of estuary. 	<ul style="list-style-type: none"> Limit intensive landuse development and/or manage to ensure impacts don't degrade estuary WQ. Improve margin habitat incl. dune and weed management. Allow minimal earthworks to open mouth when required.

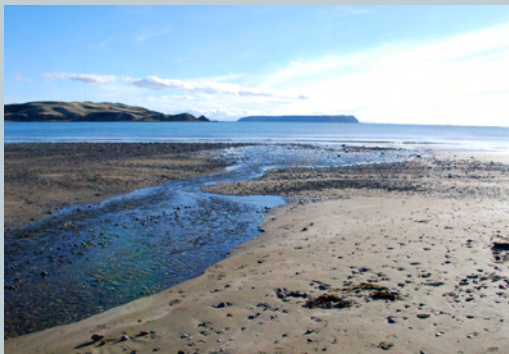
Estuary Type/Area	Tidal River Mouth
Catchment	9 km ² (urban, intensive pastoral)
Dairy cows	0 cows
Nitrogen loading	Mod : 8-20 kg/ha/yr
Catchment geology	Greywacke, loess, clays
Saltmarsh (ha)	<0.1ha
Salinity	Varies depending on mouth closure
Mean depth (m)	0.5m
Tidal flats	None (lagoon floods sand flats on beach berm)
Uses/Values	Low

Taupo Estuary

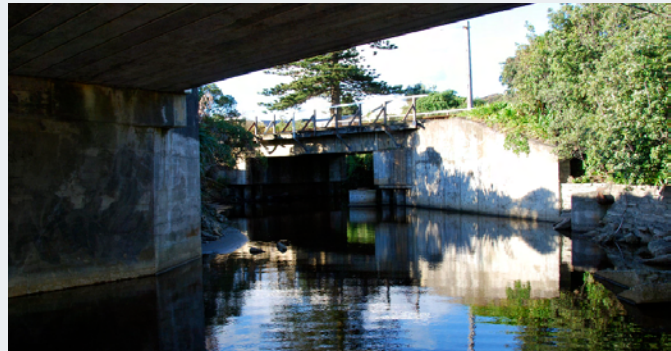
Taupo Estuary

Salinities vary depending on the extent of tidal inflow. The water is humic stained, turbid and the sediments a soft sandy mud with no signs of anoxic conditions. Given the dominant high productivity pastoral landuse, some urban and industrial use, small catchment, and presence of wetland filtering, water quality is expected to be fair to poor (Porirua City Council monitoring data indicates elevated faecal bacteria). Estimated nitrogen (the major driver of eutrophication) loadings are moderate. Because the estuary is very small and dominated by freshwater inputs, its quality is expected to be similar to that of the stream for much of the time. The mouth constricts at times, but the estuary is too well flushed to be susceptible to eutrophication or sedimentation.

Given these characteristics there is potential to improve habitat condition and diversity through management of landuse intensity in the catchment, margin revegetation and profiling, and weed control. However, because of the urban margins, roads, and walled channel, most of these improvements are likely to be very difficult to achieve.

Issues	Monitoring	Management
Very low habitat diversity. Fair water quality. Dunes built on.	<ul style="list-style-type: none"> Map intensive landuse (urban, high production pasture) in the catchment at 5 yearly intervals. 	<ul style="list-style-type: none"> Limit intensive landuse development (including industrial and/or manage to ensure impacts don't degrade estuary WQ. Encourage margin vegetation and reprofiling of banks.

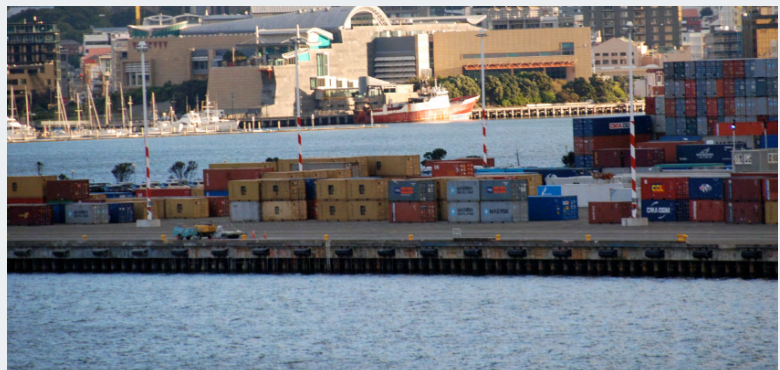
Wharves, Wellington Harbour

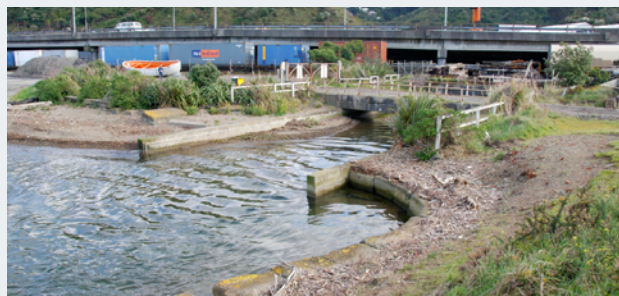
Kaiwharawhara Estuary

Issues	Monitoring	Management
Concrete channels. Low habitat diversity. Urban SW	<ul style="list-style-type: none"> Map intensive landuse (urban, high production pasture) in the catchment 5 yearly. Monitor potential toxicants in sediment. 	<ul style="list-style-type: none"> Limit intensive landuse development and/or manage to ensure impacts don't degrade estuary WQ.

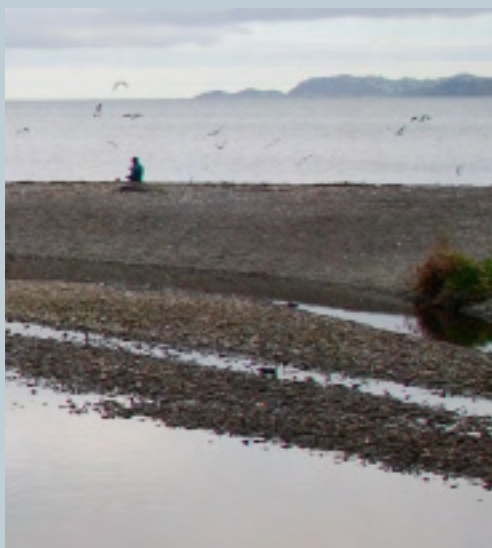
Korokoro Estuary
(Google)

Ecologically, habitat diversity is low, given the modified upstream channel, absence of tidal flats, and limited salt marsh vegetation. Such conditions provide poor habitat for native fish and tidal flat organisms.

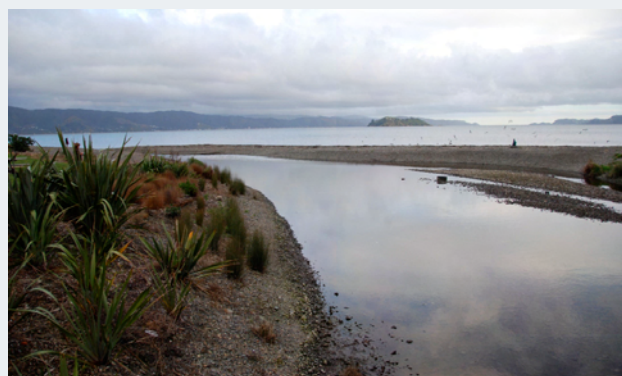
Korokoro Estuary

Salinities vary depending on the extent of tidal inflow. The water is clear and the sediments gravel and mud with little sign of anoxic conditions. Currently the water quality in the stream is likely to be good reflecting the dominant native forest landuse. Estimated nitrogen loadings are low-moderate. Because the estuary is relatively well flushed its quality is expected to be similar to the river. Estuary sediment quality is expected to be high.

Issues	Monitoring	Management
Concrete channels. Low habitat diversity.	<ul style="list-style-type: none"> Map intensive landuse (urban, high production pasture) in the catchment at 5 yearly intervals. 	<ul style="list-style-type: none"> Limit intensive landuse development and/or manage to ensure impacts don't degrade estuary WQ.

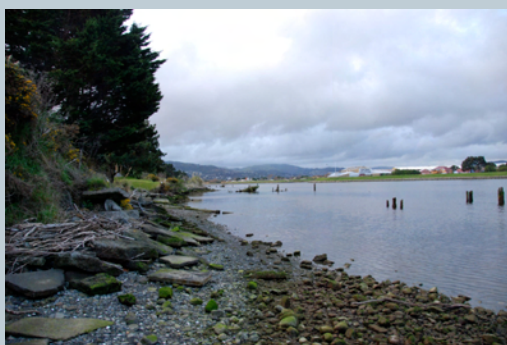
Hutt Estuary

Salinities vary depending on the extent of tidal inflow. The water is clear and the sediments a soft sandy mud with little sign of anoxic conditions. Currently the water quality in the stream is good (low nutrient and *e.coli* concentrations), reflecting the dominant native bush catchment. Estimated nitrogen loadings are low. However, because of the high volume, it is the major contributor of nutrients, sediment and contaminants to the estuary and harbour. Because the estuary is relatively well flushed its quality is expected to be similar to the river. Estuary sediment quality is good (low metals and moderate organic matter and nutrient contents).

Issues	Monitoring	Management
Water and sediment quality (particularly settling areas, e.g. stream mouths). Artificial rip rap estuary margins reduces habitat values. Loss of shallow areas for water to spread (wetland, tidal flat areas).	<ul style="list-style-type: none"> Map intensive landuse (urban, high production pasture) in the catchment at 5 yearly intervals. Broad scale mapping of sediment types, sed. rates, vegetation (5 yearly intervals). Fine scale monitoring of key intertidal sediment condition indicators. 3 years baseline, then review. Monitor disease risk in waters. 	<ul style="list-style-type: none"> Limit intensive landuse development and/or manage to ensure impacts don't degrade estuary WQ. Develop management plan to improve saltmarsh habitat, and area of tidal flats (explore options for reshape and revegetation of margins in certain areas).

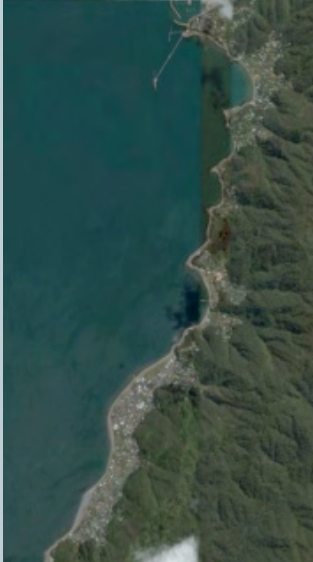
Lowry to Robinson Bay (Google)

- Existing condition of all rocky and beach habitat is expected to be generally "good" given its well flushed nature. Duneland is small but in good condition. The remaining vegetated areas between the road and the beaches and rocks have many weeds but are being actively managed.
