Managing and adapting to coastal erosion at Granity, Ngakawau and Hector

Prepared for West Coast Regional Council

January 2016

NIWA CLIENT REPORT No: HAM2016-009
Report date: January 2016
NIWA Project: ELF16202

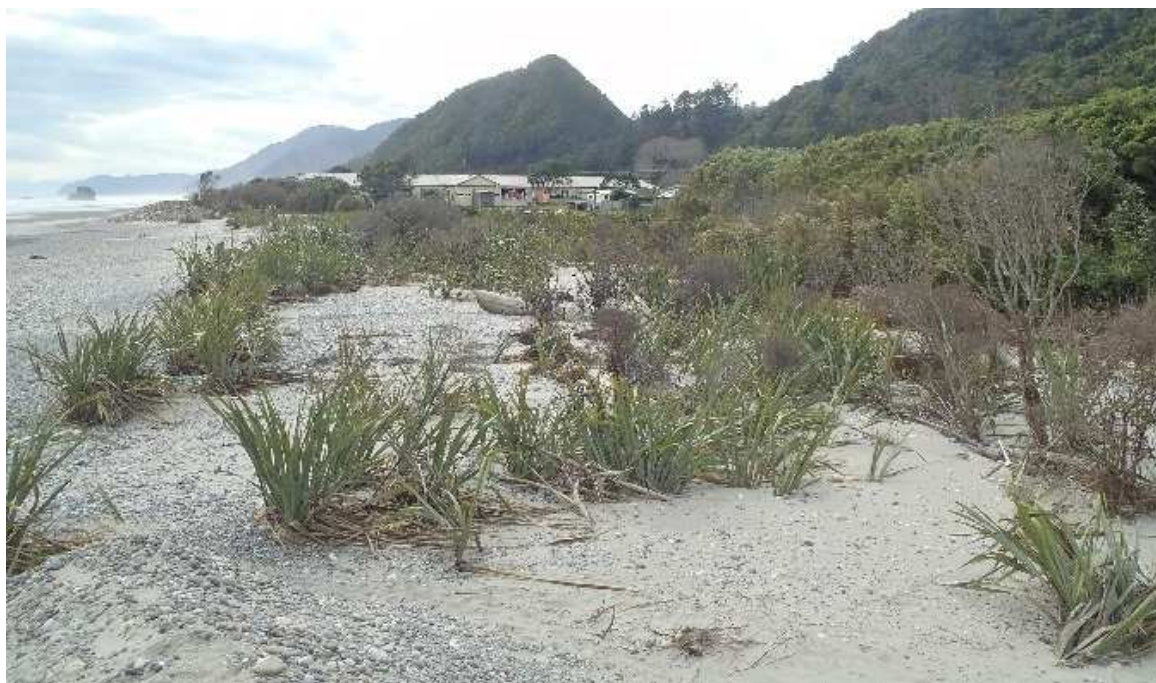
G1 - Along the southern section of Granity (from 50 Domain Rd to southern flank of Granity School) there are areas with small gravel bunds (one, two or none) created by BDC through drain clearance, fronting pond or vegetation (flax, bamboo) with private land immediately behind lagoon. The small bunds (<1 m above natural beach level) do not withstand significant wave action on a high tide and are periodically reformed through drain clearance. Regular overwash of water and sediment is apparent (Figure 3-2) and is causing the vegetation to die-back in various places. There is little sediment available for natural (or mechanical) rebuilding of a gravel barrier. However, the current dwellings are set back from the beach crest approximately 50 m along New Rd and at least 80 m along Domain Rd, many with small bunds along their boundary which is sufficient to allow natural beach retreat over the short term. The continued and regular drain clearance by BDC will aid beach recovery and prolong vegetation longevity by restricting overtopping during minor storms. Ceasing vegetation clearance and re-planting robust vegetation will also aid longevity.

Figure 3-2: Overwash of beach material through vegetation in absence of gravel barrier. Evidence of vegetation die-back within infilled lagoon. Photograph looking north along-beach towards school buildings (centre) from approximately 65 Domain Road, Granity. [22 September 2015].

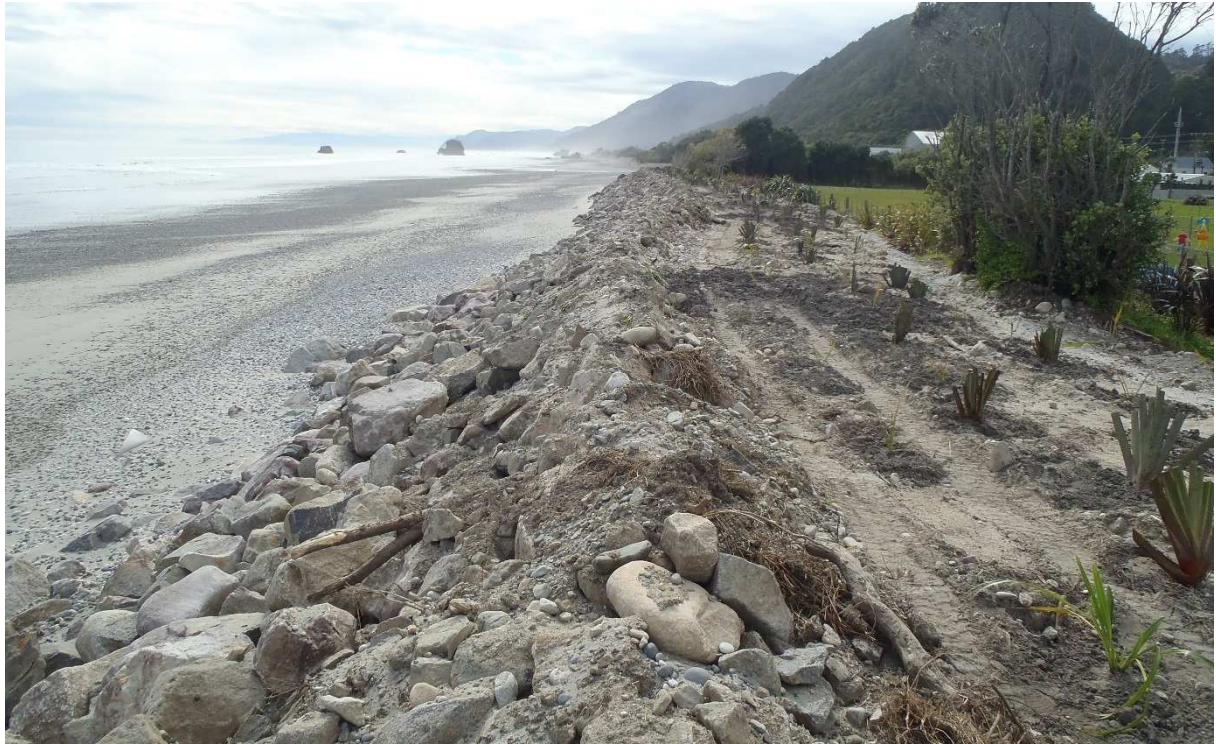
- However, the school revetment is poorly constructed and does not meet good practice for revetment design and construction. It is currently projected out about 5 m onto the active beach face and ‘sticks out’ compared to the adjacent natural storm berms and beach crest. This means the school structure has a shorter expected lifespan as waves regularly reach it even during minor storms or spring tides (waves during the last high-tide before the inspection were within 5 m horizontal distance or less than 1 m elevation from the structure toe, see Figure 3-3). Further, the revetment size (rock diameter, crest height) may not be sufficient to withstand large coastal storms intact, and there is evidence of waves outflanking the southern side of the revetment. This out-flanking erosion increases the risk to the school property and contributes to vegetation die-back (as per Figure 3-2). The level of protection provided by the revetment will improve slightly if the recently planted vegetation is able to permanently establish itself along the school revetment before an erosion event (see Figure 3-3). School buildings are within 20 m of the beach face. A sensible option for the school is to relocate buildings on site and rebuild the revetment to be in-line with the adjacent gravel berm barriers.

Figure 3-3: Recently constructed revetment at Granity school. Photograph looking north along-beach towards Torea Rocks (foreshore at upper left) from on top of revetment. [22 September 2015].

- A 200 m long rock revetment fronting Granity School with some tie-in extension at each end (e.g., Figure 3-3). This replaced the failing stopbank/revetment and was constructed in September 2015. Representative rock diameter is 0.3-0.6 m, with geotextile underlay, which is small for the wave climate although it may be an outer layer of small rock covering a larger rock core (which is not a recommended construction approach). Construction price was approximately \$750 per metre length (pers. comm P. Birchfield). This wall has not yet been tested in moderate storm conditions. The structures also sits out on the beach face compared to the adjacent beach berm and is thus more susceptible to wave attack. Larger rock armour is likely to be required to ensure the defence provides an adequate level of protection and service.

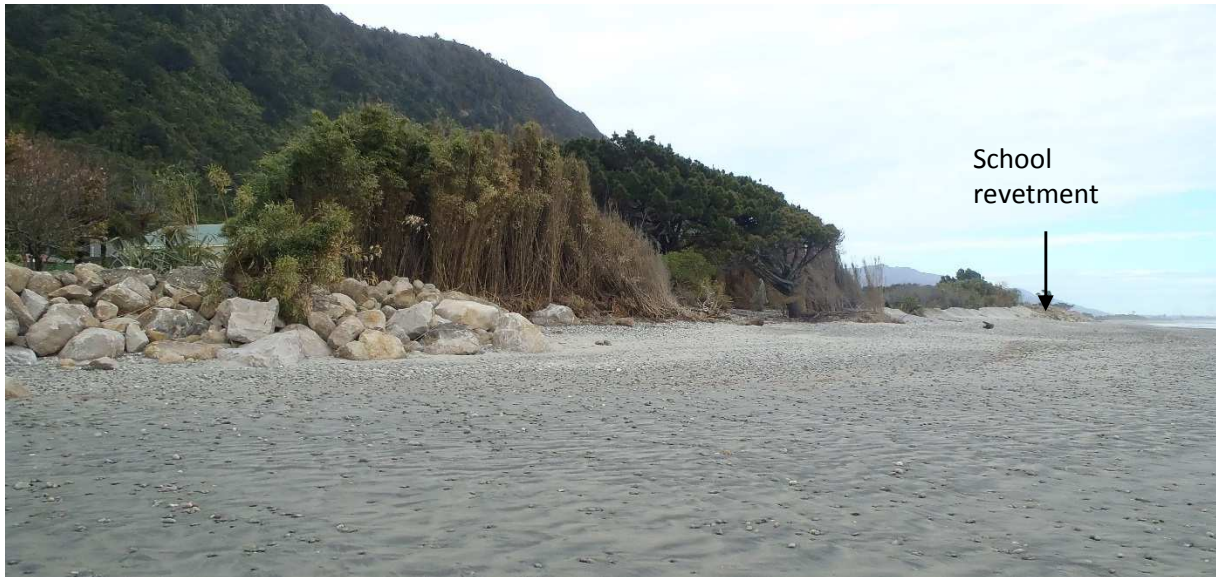
Vegetation die-back and overwash is also seen between the two revetments (Figure 3-4). However, the dwellings between the revetments are typically set back 50 m from the vegetation line and do not appear to be at critical risk. Filling the gap between the two revetments with a similar rock structure is a sensible option should the outflanking erosion threaten these dwellings.

Figure 3-4: Unprotected section of coastline between Granity Stream revetment (centre left) and Granity school revetment (centre far-right). Photograph looking south along-beach towards school from Granity Stream (100 Torea St, Granity). [22 September 2015].

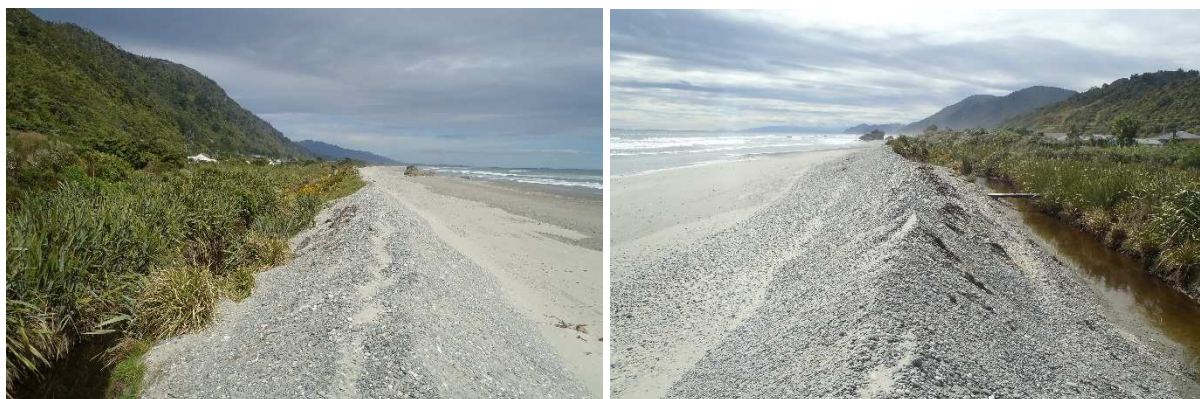
G3 - Along the stretch of coastline north from Granity Stream to Chair Rock, the beach is presently in a healthier state with a larger volume of gravel on the upper beach compared to adjacent beach sections. The gravel berm is regularly topped-up by BDC drain clearance (approx. 2.5 m above beach level at time of inspection) and there is a 40-60 m wide vegetation/swamp buffer to the dwellings (Figure 3-5). Barrier washover will still occur, particularly along sections where residents have cleared the natural vegetation up to the back of the beach crest.

Figure 3-5: Example gravel barrier and wide vegetation/swamp buffer between beach and houses between Granity Stream to south (left, not visible) and Chair Rock (right, visible at centre). Photographs looking south (left) and north (right) at about 138 Torea St. [22 September 2015].

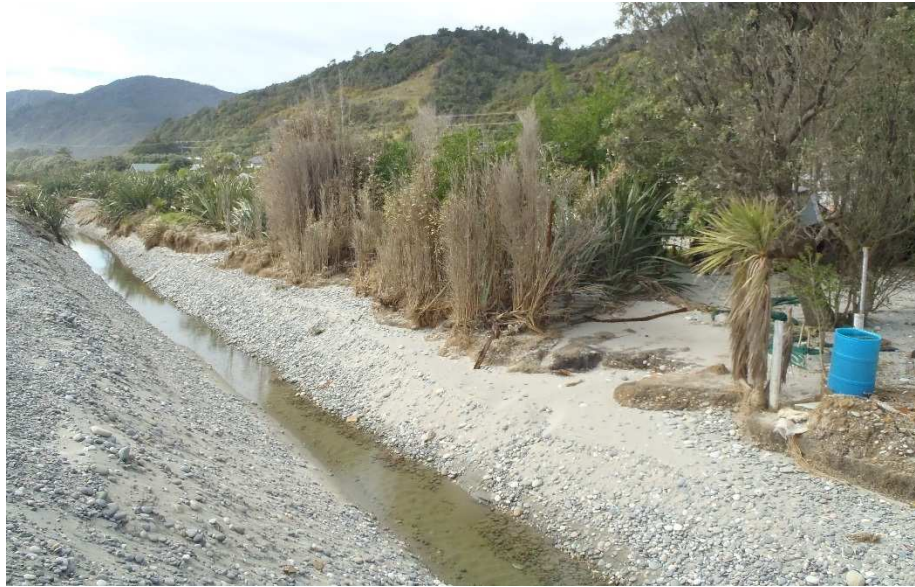
Given the low-lying nature of the land behind and the lowering of the beach crest that has occurred, overwashing and inundation of the land behind will become a more regular feature in the future. With this susceptibility, the diversion of Bradley Stream to an outlet behind Lover's Rock exacerbates this risk, and it will become increasingly difficult to maintain an open channel immediately behind the beach. However, simply opening up a direct outlet to the sea further south for Bradley Stream would result in lowering of the beach and the potential for considerable erosion adjacent to the outlet.

Figure 3-6: Overwash deposits and vegetation dieback behind mechanically cleared drain within private property. Berm approximately 1 m above beach level. Photograph looking northeast across diverted Bradley stream at approximately 155 Torea St, Granity. [22 September 2015].

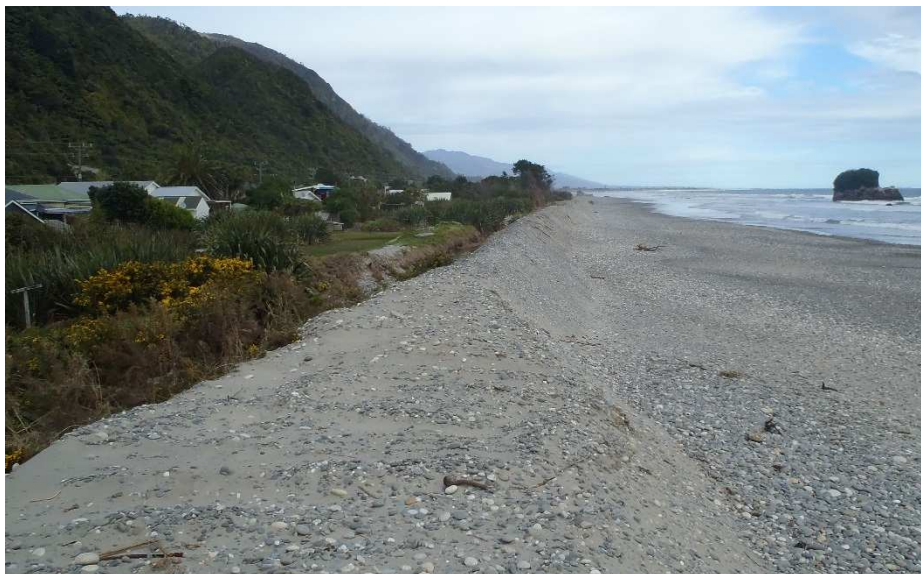
G4 - North along the Granity frontage from Chair Rock to Lover's Rock, including the northward diverted Bradley Stream, there is a gravel stopbank/bund composed of material cleared from drains by BDC (typically 1 m above beach elevation) with evidence of recent overwash deposits and vegetation die-back within the private property fences (Figure 3-6). These properties were most effected by the overwash and erosion during the 2006 storms (NIWA, 2007). Dwellings are typically set back 30-50 m from the beach face, with the buffer zone comprising flax swamp and fenced backyards (Figure 3-7). At various points along this stretch (notably 154 Torea St) vegetation removal and private vehicle access have lowered the berm height, increasing overwash and erosion. The beach is slightly wider, flatter and with a gravel component in the lee of Lover's Rock at the drain outlet, probably due to the wave sheltering from the nearshore rocks and to stream sediment supply.

Figure 3-7: Narrow and low mechanically created gravel berm with diverted Bradley Stream and low-lying buffer space between houses at 155-165 Torea St. Photograph looking south towards Chair Rock (centre right) from 164 Torea St. [22 September 2015].

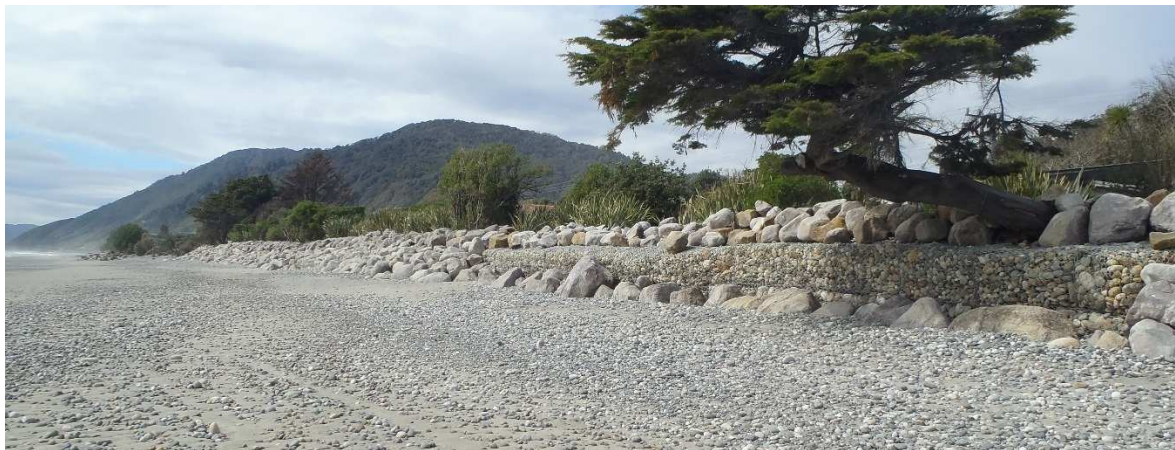
N1 - The privately built rock and gabion structure from 11 - 14 Main Rd (referred to as Merrett's wall, Figure 3-8, see also DTEC 2007) is an example of cooperative defence construction which has so far been successful in defending the properties and has a small gravel fillet beach at present. Merrett's wall also wraps around the south side of Morris Creek exit. The revetment size (rock diameter, crest height) is adequate for moderate storms, but is likely to be damaged by large coastal storms. The combination of rock and gabions is not good practice for revetment design/construction due to lack of gabions-rock interlocking when compared to rock-rock interlocking, along with the eventual corrosion and slumping of gabion baskets. There is evidence that the storms experienced have caused some undermining, outflanking and occasional overtopping. At the creek mouth, the streambed is infilling with sand and erosion of the upper foreshore has caused the shoreline to retreat on its northern side where several protection attempts have been made (Figure 3-9). This erosion and infilling will continue to cycle between streambed flushing by strong runoff events or large waves on a high tide and sediment accumulation by wind and wave coastal processes during lower wave conditions. Dwellings are within 5-10 m of the active beach face, behind the revetment and a narrow vegetation buffer.

Figure 3-8: Coastal defence "Merrett's wall" along 11-14 Main Rd, Ngakawau. Privately funded structure built in 2007. Photograph looking north east along Ngakawau frontage from 11 Main Rd, Ngakawau. [22 September 2015].

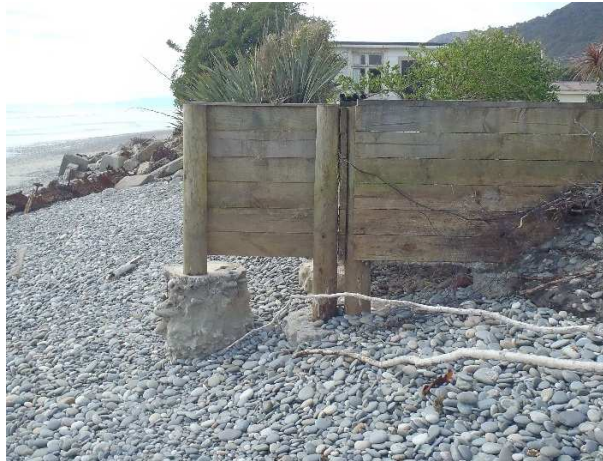
Figure 3-9: Erosion on northern side of Morris Creek exit showing proximity of houses (top centre) with eroding defences and nearby ad-hoc rubble defences (centre left). Photograph looking north from Morris Creek mouth at 14 Main Rd Ngakawau. [22 September 2015].

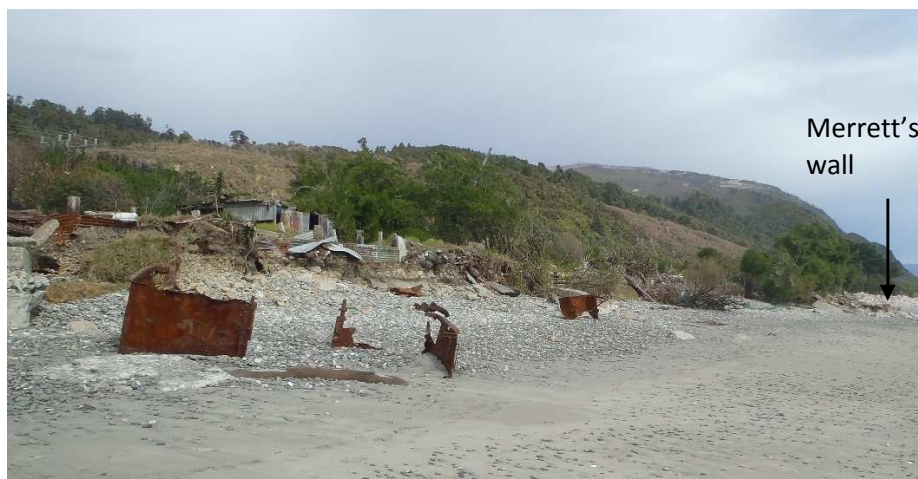
N2 - Various ad-hoc defences protect 15-20 Main Rd and extend 200 m north from Morris Creek, including dumped mining carts, reinforced concrete rubble and rocks (Figure 3-10). Generally this defence has been assisted by vegetation behind it to resist erosion. However, with low-lying land and little buffering vegetation behind the ad-hoc walls, the level of protection is low. Further, the ad-hoc nature of the rubble may have the adverse effect of stripping sediment from the beach face on immediately adjacent sections of coast. This section of Ngakawau frontage may require a cooperative seawall, similar to Merrett's wall, to increase the level of protection in the short to medium term as there is little or no backyard buffer space and no option to relocate dwellings further away from the beach.

Figure 3-10: Ad-hoc rubble and steel defences along Ngakawau frontage between Morris Creek and 21 Main Rd. Photograph looking south east toward Morris Creek (annotation). [22 September 2015].

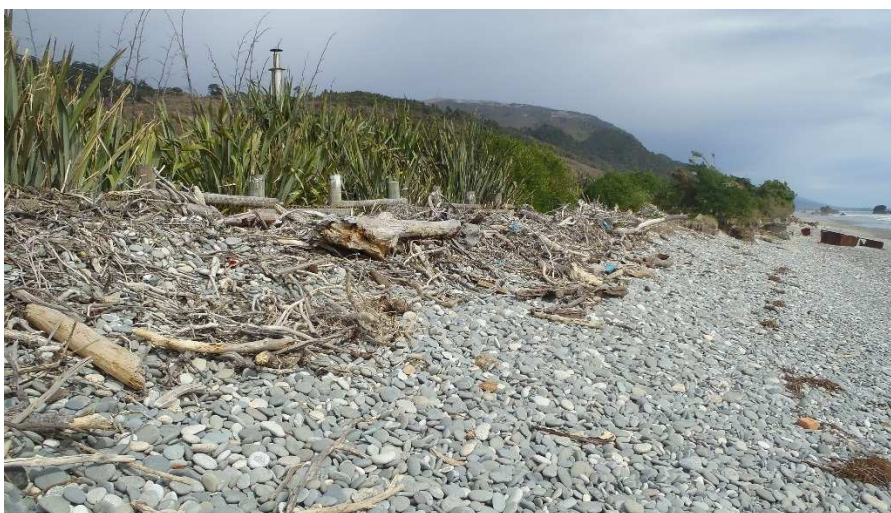
N3 - Immediately north of the dumped debris wall, at 25-26 Main Rd, Ngakawau, the post and rail fence with wire mesh along property frontages is acting as a buffer to minor storm erosion by accumulating a wedge of driftwood and beach material, increasing the beach crest height by 0.5 m (Figure 3-11, note top of fence is 0.8 m above ground level behind the fence). This defence is effective because there is currently enough sediment and driftwood to accumulate at this point along the beach, plus the thick vegetation buffer behind the fence also intercepts overwash flows. However, the beach face is over-steepened and without substantial fence foundations it is unlikely to be an effective medium-long term defence against erosion during large storms. The fence is unlikely to survive if the sediment regime changes to be in deficit (such as 300 m south at 18 Main Rd on the north side of Morris Creek, Figure 3-9). A dwelling at 25 Main Rd is within 5 m of this fence (chimney visible in Figure 3-11), and could be relocated towards the road if erosion encroaches past the fenceline and vegetation buffer.

Figure 3-11: Accumulated driftwood and beach material in front of fence creating storm buffer and increasing elevation of beach crest. Ad-hoc dumped material visible 100 m along-beach. Photograph looking southeast. The visible chimney is at 25 Main Rd, Ngakawau. [22 September 2015].

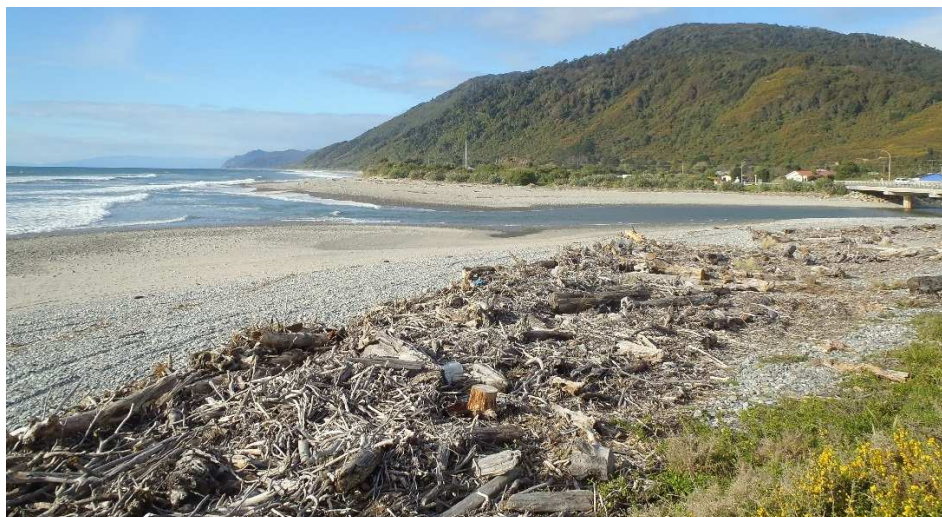
N4 - The sole abandoned building on the seaward side of the road near the Ngakawau River bridge (28 Main Rd, Ngakawau) is currently fronted by a wide beach with dumped concrete rubble and well-established vegetation behind the active beach face (Figure 3-12). This stretch of coastline appears to be currently accumulating beach material and is relatively healthy. The Ngakawau River contributes to the sediment supply along this stretch and at times the river bar reduces the wave energy and increases the sediment longevity – although the shoreline change rates are more variable because of the river mouth dynamics (NIWA, 2007). A resource consent has been granted at this location to construct a 50 m long rock groyne extending perpendicular offshore from 28 Main Rd, Ngakawau (WCRC consent RC08175). Single (2009) considers the groyne is unlikely to prolong or cause significant adverse effects on the coastal environment of the nearby shore and river mouth. This side of the river mouth is currently accreting (i.e., building the erosion buffer) therefore constructing a groyne for land protection seems redundant at this time. Further, combined with the current deficit of sediment causing erosion on the Hector side (see Section 3.3 below), and considering that the

effect of a groyne would be to trap and prevent northward sediment drift, there are potentially adverse effects from such a structure. In the long-term and as seen historically, the shoreline around the river mouth will experience episodic erosion and accretion in response to sediment, coastal and fluvial interactions, irrespective of groyne placement.

Figure 3-12: Wide upper beach face, accumulating sediment and driftwood with advancing vegetation on the southern bank of the Ngakawau River mouth. Photograph looking north across the Ngakawau River mouth from frontage of 28 Main Rd, Ngakawau. [22 September 2015].

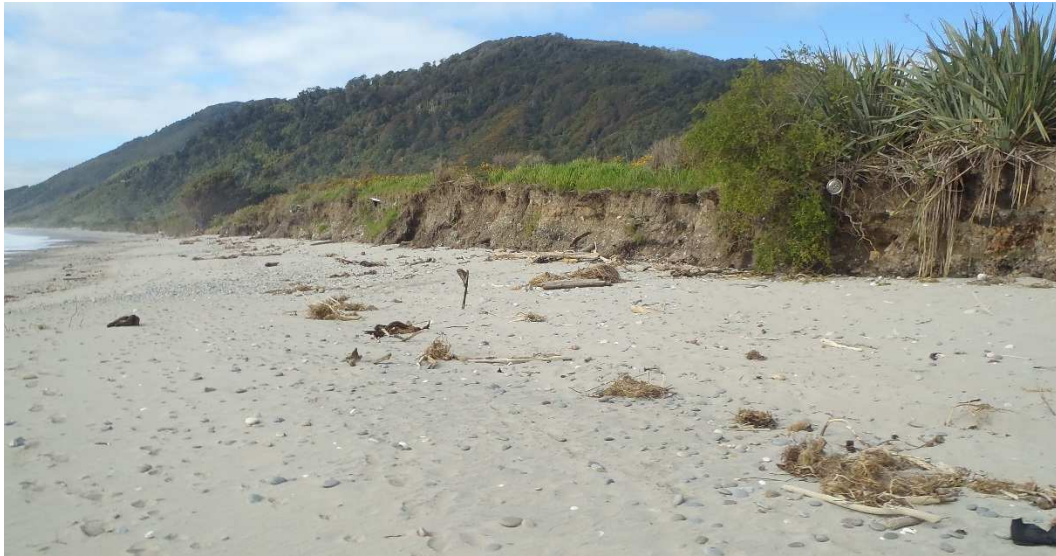
H1 - The coastline from the northern bank of the Ngakawau River to Corbett St is relatively wide and sandy but currently is experiencing a deficit of sediment with current erosion scarps up to 2 m above beach level (Figure 3-13) and extending for 300 m south from Corbett St to the river mouth. This retreat into sand/gravel berm/dunes would appear to be an episodic occurrence as indicated by the old building rubble exposed at the base of the eroded beach scarp which indicates the shoreline has been landward of its current position within the last 100 years. This area was also mentioned as an old dumping ground by the Charming Creek Tavern publican and patrons – if this is confirmed, then the councils may want to intervene and prevent landfill material making its way onto the beach face. This loss of sediment on the north of the river mouth appears to be offset by a gain on the southern side (Ngakawau side, see Section 3.2). This fluctuating pattern of erosion/accretion on the north/south bank is natural and is expected to occur at some point in the future in response to wave and river driven sediment transport. The current shoreline retreat will continue into the future but it will not threaten adjacent dwellings which have at least 100 m of vegetated setback buffer.

Figure 3-13: Erosion scarp of retreating shoreline along the southern Hector frontage (north of Ngakawau River mouth). Note old building rubble was exposed near the base of the scarp. Photograph looking north from opposite Greenfield St, Hector. [22 September 2015].

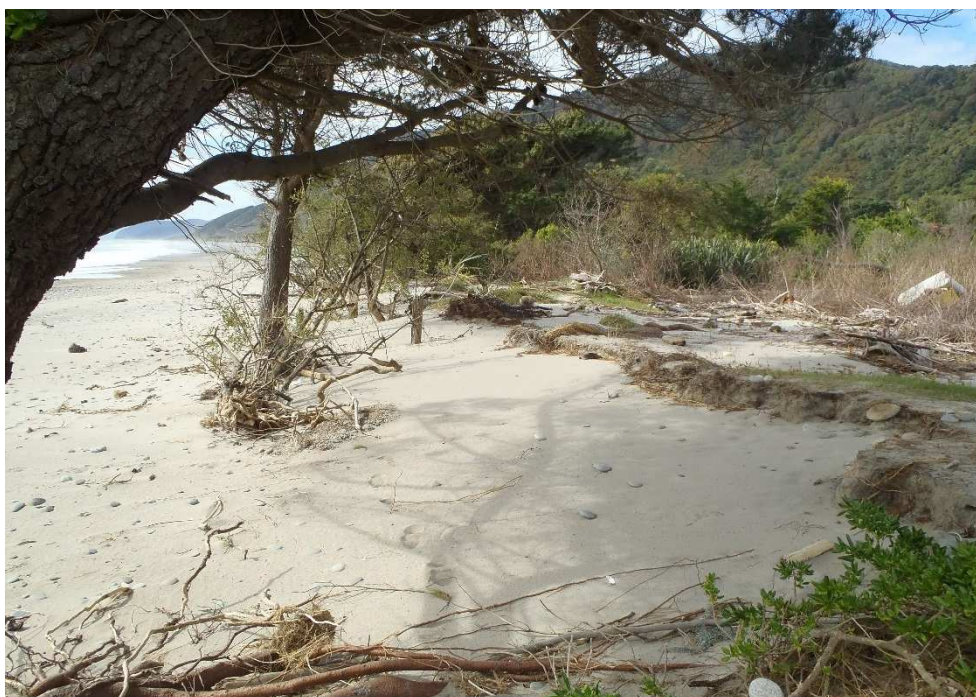
H2 - North along the beach front from Corbett St to 25 Main Rd, Hector, the backshore is low lying and sparsely vegetated without any substantial dune or defence structure to resist erosion. This has allowed the beach crest or erosion scarp to advance inland through the foremost tree barrier, washing sand into the vegetation buffer and causing large patches of die-back (Figure 3-14). This pattern continues for 300 m north and is evidence of the deficit of beach material along the Hector coast. Dwellings are set back by 20-50 m, within and behind vegetation buffers, although several outbuildings are within 10 m of the active beach face (e.g., 3, 7, 21 and 23 Main Rd) and vegetation has been cleared in places. Episodic shoreline retreat is likely to continue for some time with little resistance from beach material or a thick vegetation buffer.

Figure 3-14: Beach crest retreating within vegetation buffer and evidence of windblown and overwashed sand in low-lying backshore causing vegetation die-back. Photograph looking northeast from Corbett St beach access. [22 September 2015].

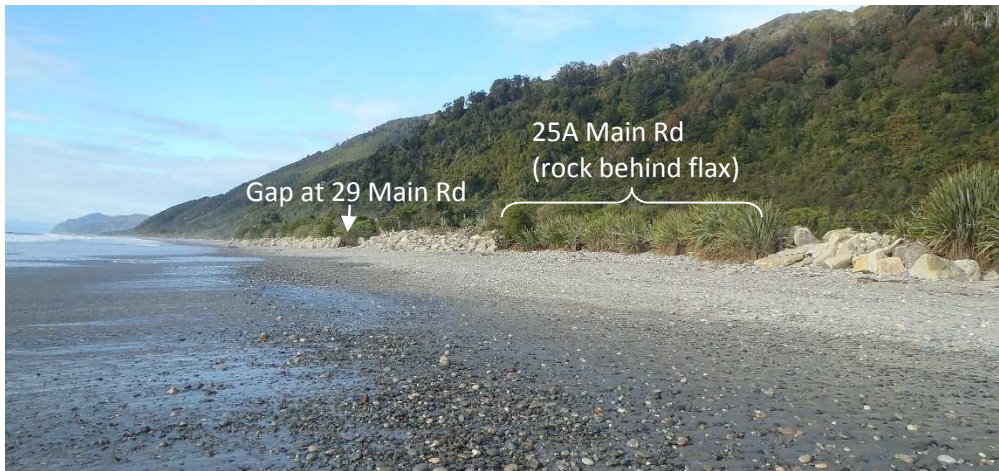
H3 - Along the northern Hector frontage from 25 to 37 Main Rd, beach erosion is predominantly defended by a private rock revetment (Figure 3-15). The beach profile is flattening to the same degree as the southern Hector, but beach crest retreat has been halted by the structure where present. However, there are gaps between revetment structures which are clearly susceptible to erosion and have had ad-hoc attempts to mitigate this (Figure 3-16). Completing the revetment by filling the gaps (approximately 70-80 m length) would present a single line of defence and is recommended to prevent future out-flanking erosion from threatening the properties which are currently defended. The revetment size (rock diameter, crest height) is adequate for moderate storms but is likely to be damaged by large coastal storms. There is evidence that the storms experienced have caused some undermining, outflanking and overtopping of the structure.

Figure 3-15: Intermittent defensive structure along beach at north Hector from 25A - 37 Main Rd. Gaps in beachfront revetment at 25A and 29 Main Rd. Note 25A has a small defensive line of rock behind beach front flaxes (annotation). Photograph looking north east from 25A Main Rd, Hector. [22 September 2015].

- Gaps in the beachfront revetment at northern Hector should be filled (total length 70-80 m) to provide a continuous line of defence and eliminate out-flanking erosion within already defended sections.
- Tie-in or wrap-around walls are recommended for the southern edge of Granity school to reduce outflanking erosion and wash-around sediment deposition which is causing vegetation die-back and reducing the level of protection.
- Gabion- basket backstop defences and aggressive replanting along the private property boundaries of northern Granity frontage from Chair Rock to Lovers Rock are recommended to reduce the impact of storm washover events.
- While not a new task, the Buller District Council should continue to clear the back-shore drains and re-form the narrow beach berm to allow drainage of any overwash flows and allow sediment to reach the active beach face through stream flow.

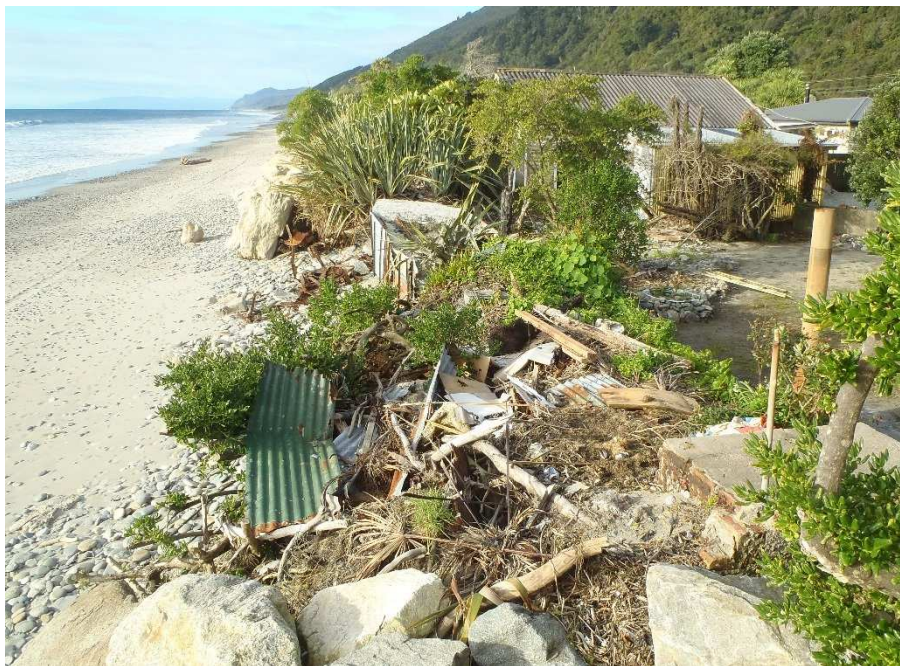
Figure 3-16: Ad-hoc defensive filling of 20 m wide gap in existing revetment at 29 Main Rd, Hector. Photograph looking north from 29 Main Rd, Hector. [22 September 2015].

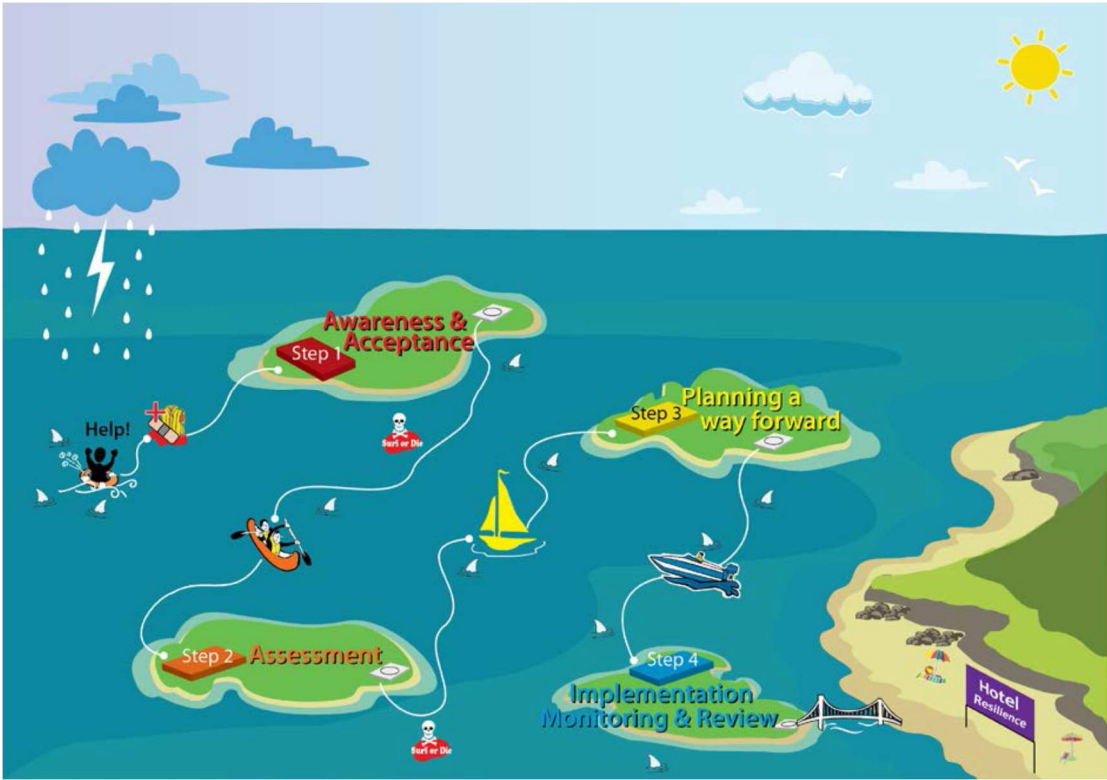
Figure 4-1: Illustration of Pathways to Change – 4 steps on the coastal adaptation journey. From Britton et al. (2011, Figure 3.1).

A schematic of the adaptation pathway for coastal change is illustrated in Figure 4-1 and Table 4-1.

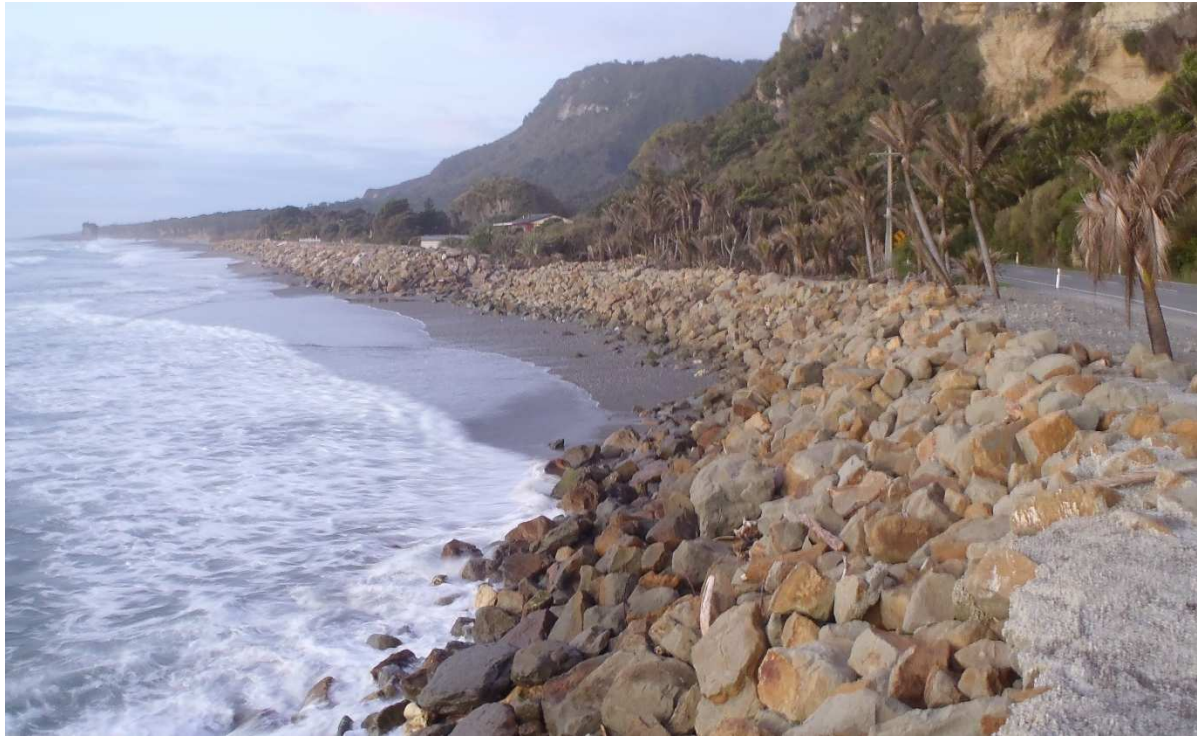
Figure A-1: Larger-scale rock revetment for coastal defence at Punakaiki. Defence constructed to protect both SH6 (visible centre right) and township. Photograph looking north towards Punakaiki township. [22 September 2015].

Large-scale rock revetments are another an option for the coastline, but to be an effective engineering solution for the medium-long term they need to be on the scale as the recently constructed Punakaiki revetment (see Figure A-1, Appendix A). Such a structure along the Granity, Ngakawau and Hector frontage would be prohibitively expensive (construction and ongoing maintenance), and if constructed from Granity to Hector it would likely cause other adverse environmental impacts on adjacent sections of shoreline.

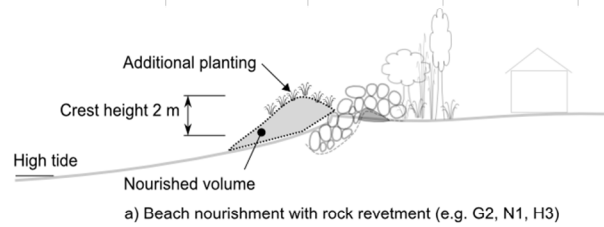
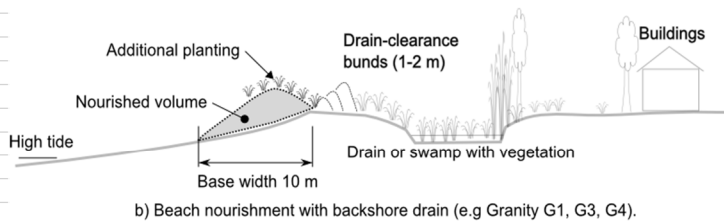
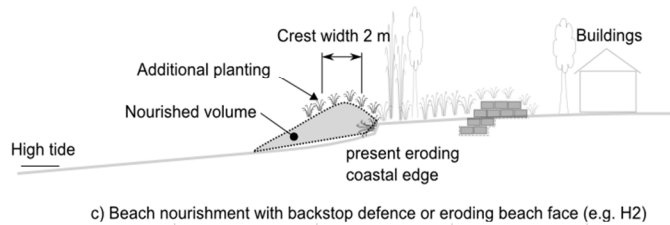
3 Beach nourishment to buy time or extend life of defence (e.g. G1, G4, N1, N2, N3, H3)

Beach nourishment material	height (m)	width, base (m)	width, crest (m)	Cross sectional area (m ²)	bulk density (kg/m ³)	22.8 Nourishment volume (m ³ /m length) (Well-sorted mixed sand/gravel with similar size grading and composition to beach material but NOT sourced from active beach face.)	
	2	10	2	12	1900	-	-

Volumetric material estimates for a typical rock revetment, gabion backstop wall or beach nourishment defences relevant for each frontage section have been established to aid community/Council decision making through eventual cost-benefit analysis. All recommendations are subject to change when critical risks arise from coastal storm events which cause large or severe erosion, inundation and overtopping.
