Piha South Road Reserve

Dune Management

Review and Proposed Management Plan

Prepared for Auckland Council

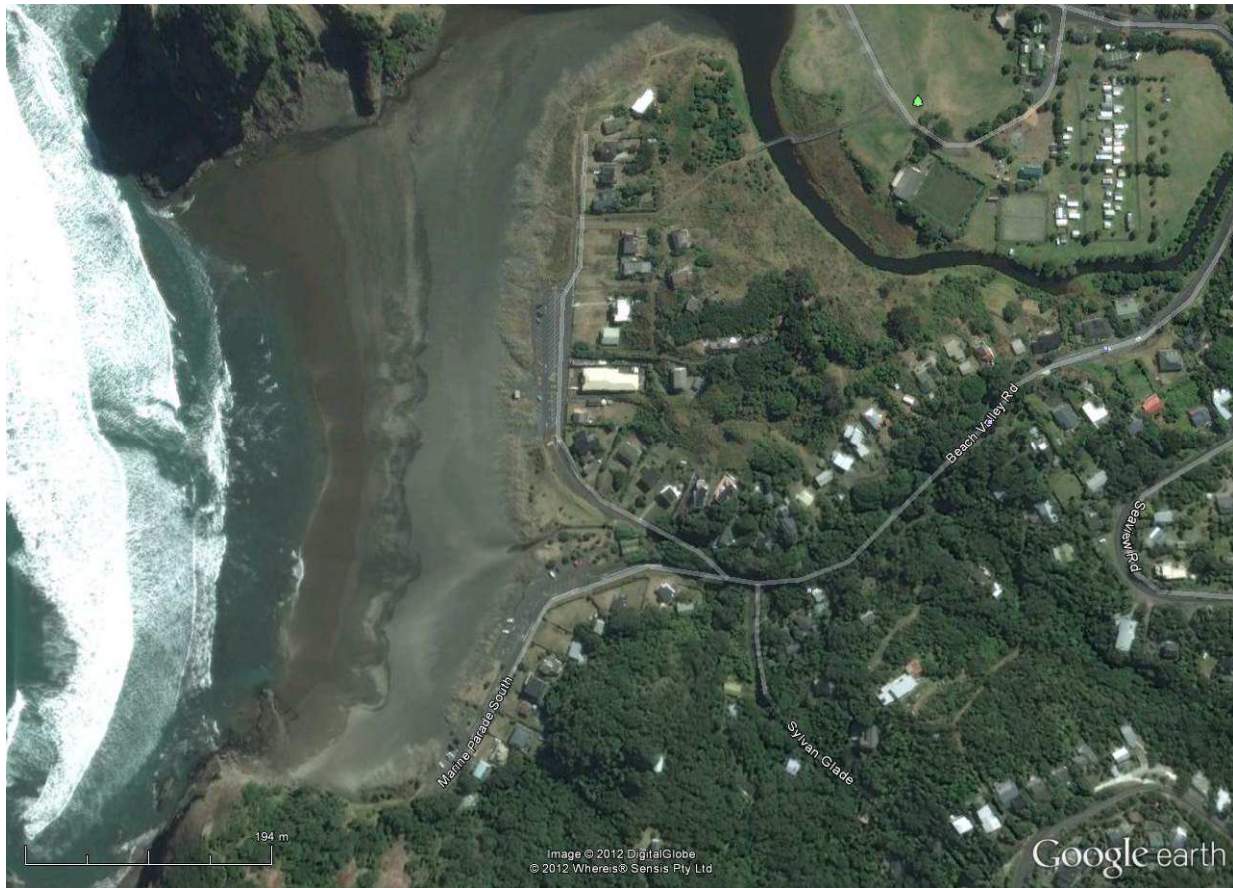
Figure 1: Area of Piha Beach relevant to this review

The area of Piha Beach relevant to this review is the area extending from the dunes on the southern side of Piha lagoon to the south end of Marine Parade (Figure 1). It includes:

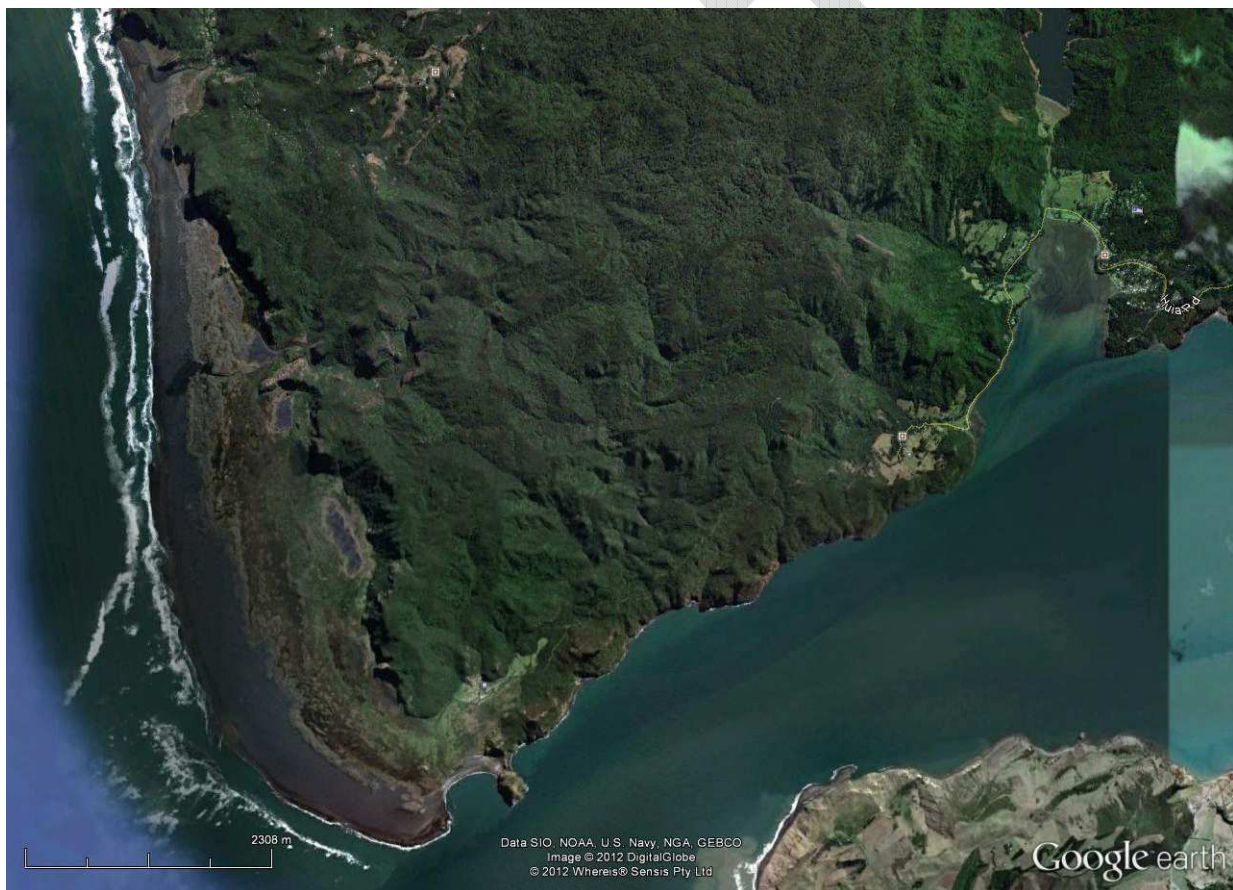
Figure 2: Sand accumulation at Whatipu

The very large volumes of sand which have accumulated at Whatipu over this period are evident in aerial photographs of this area (Figure 2). Prior to this accumulation the shoreline lay along the rocky cliffs behind.

In fact, the volumes of sand trapped in dunes are small relative to the volumes which have caused the noted beach advance. As noted earlier, NIWA estimated that shoreline advance between 1960 and caused the volume of sand above mean sea level (i.e. about midway between high and low tide) to increase by only about 700,000 cubic metres. The total volume that accumulated in the dunes over the same period is obviously only a part of this. If this total volume were to be dug up and placed seaward of the beach, it would cause on average less than 1 m shoreline advance along the full 2.6-2.7 km length of Piha Beach. In contrast, as noted earlier, calculations using beach nourishment formulas indicate that something in the order of 60 million cubic metres (quite possibly more) was required to cause the observed shoreline advance. The source of that sand is visibly obvious (Figure 2).

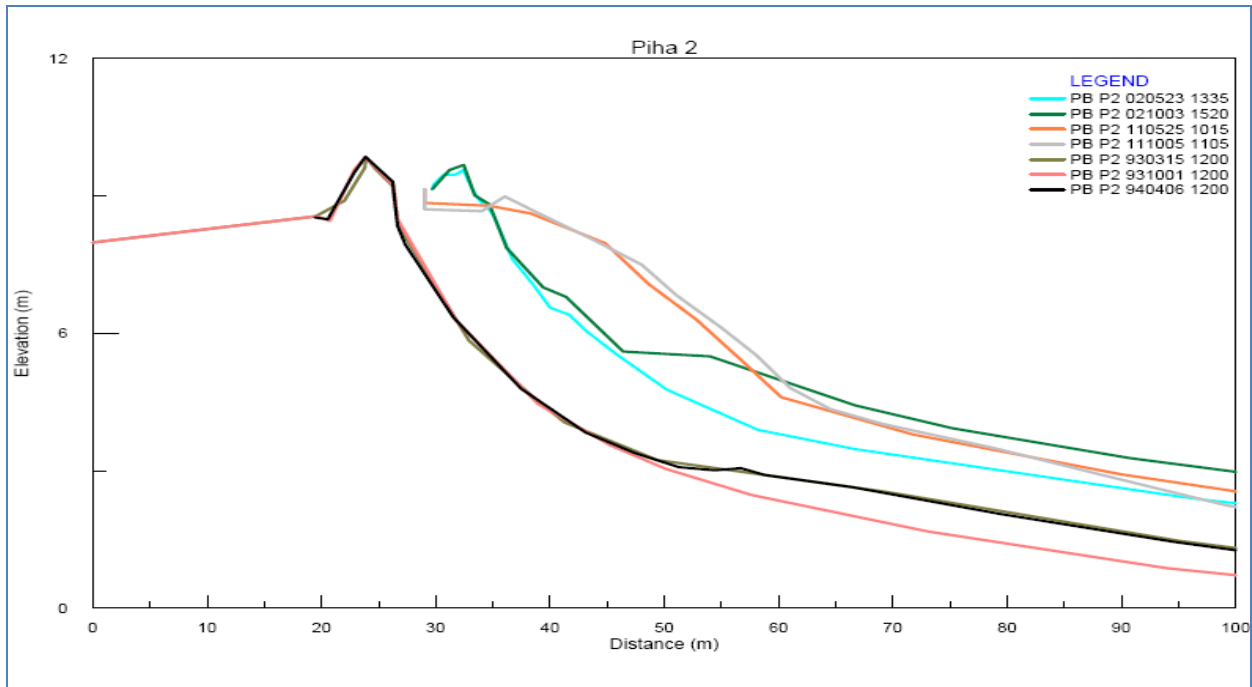
Figure 3: Selected surveys conducted at Auckland Council beach profile site Piha 2 (top) showing progressive shoreline advance over time since surveys commenced in 1993. The most landward profiles are from 1993 and 1994; the mid profiles from 2002 and the most seaward profiles date from May and October 2011. The beach profile monitoring site is located near the surf club as shown in the location map (bottom) – where it is labelled “Profile 2”.

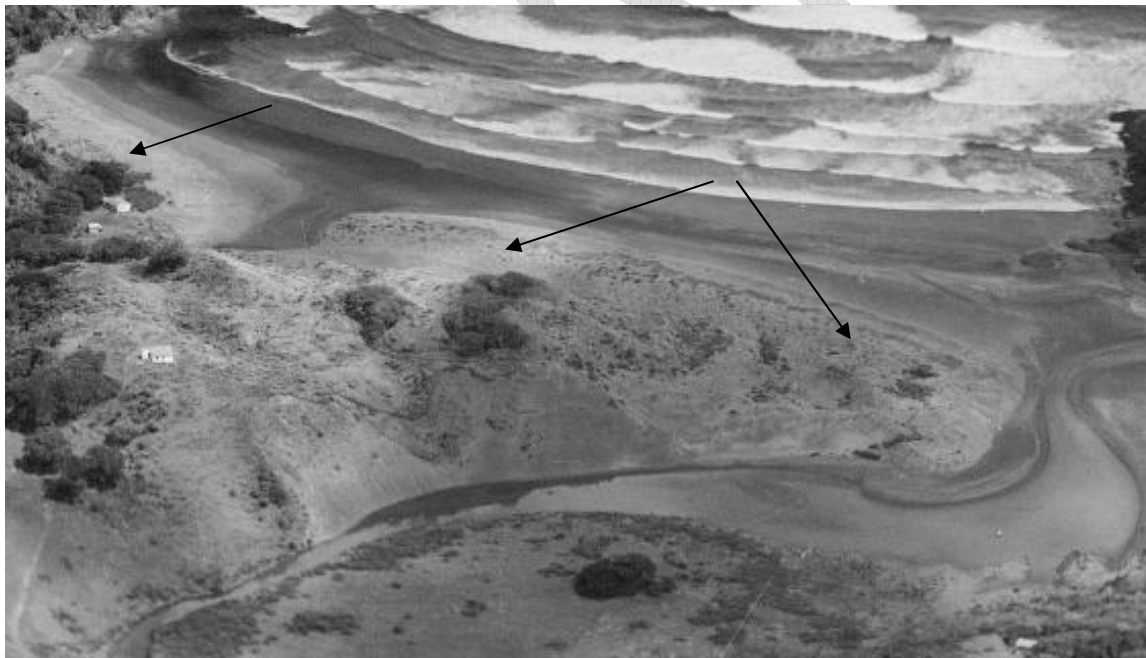
Figure 4: Photograph of Piha Beach dating from the early 1930's showing areas of natural dunes (arrowed) – also evident in earlier photos. (Photograph from Alexander Turnbull Library).

The photos indicate a relatively extensive cover of spinifex over the dune areas and patches of darker vegetation further landward, with little to no evidence of human damage (Figure 4).

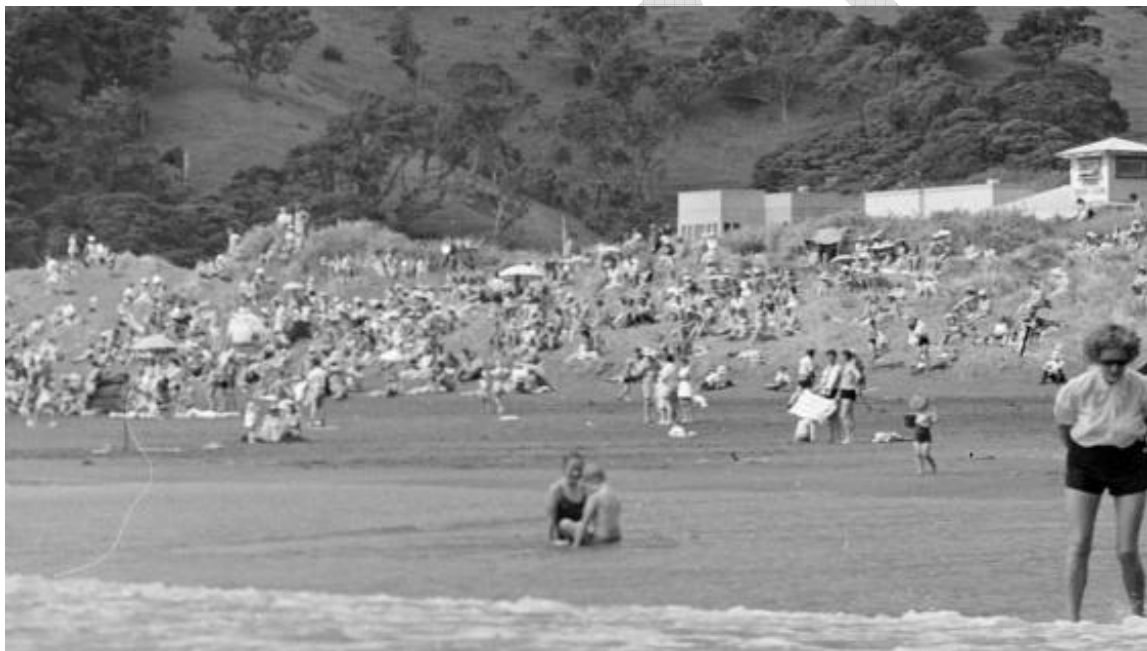
Figure 5: Photograph of area in front of the former surf club. Note people sitting all over the seaward face of the frontal dune, damaging the sensitive native sand trapping vegetation. (Photograph from Alexander Turnbull Library).

For instance, in the vicinity of the surf club, early subdivision extended seaward over the natural dunelands reducing the width of natural dunes further seaward. Photographs from the 1940's show poorly managed human use, with intense human pressure on the critical sand trapping vegetation on the seaward dune face (Figure 5)

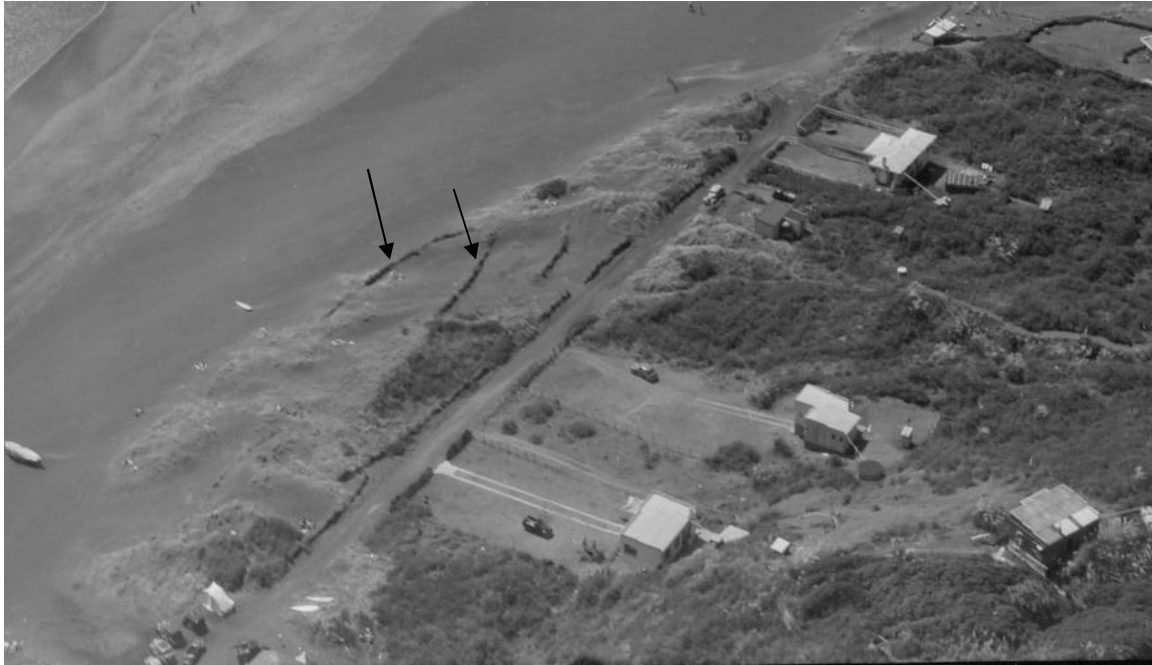
Figure 6: Photograph of Piha taken in January 1951 to the immediate north of the surf club showing brush fences (examples arrowed) erected to control wind erosion. (Whites Aviation photo – from Alexander Turnbull Library).

By the 1950's, photos indicate that human disturbance of vegetation and consequent wind erosion was common with widespread use of brush wind break fences to minimise wind erosion and windblown sand (Figure 6).

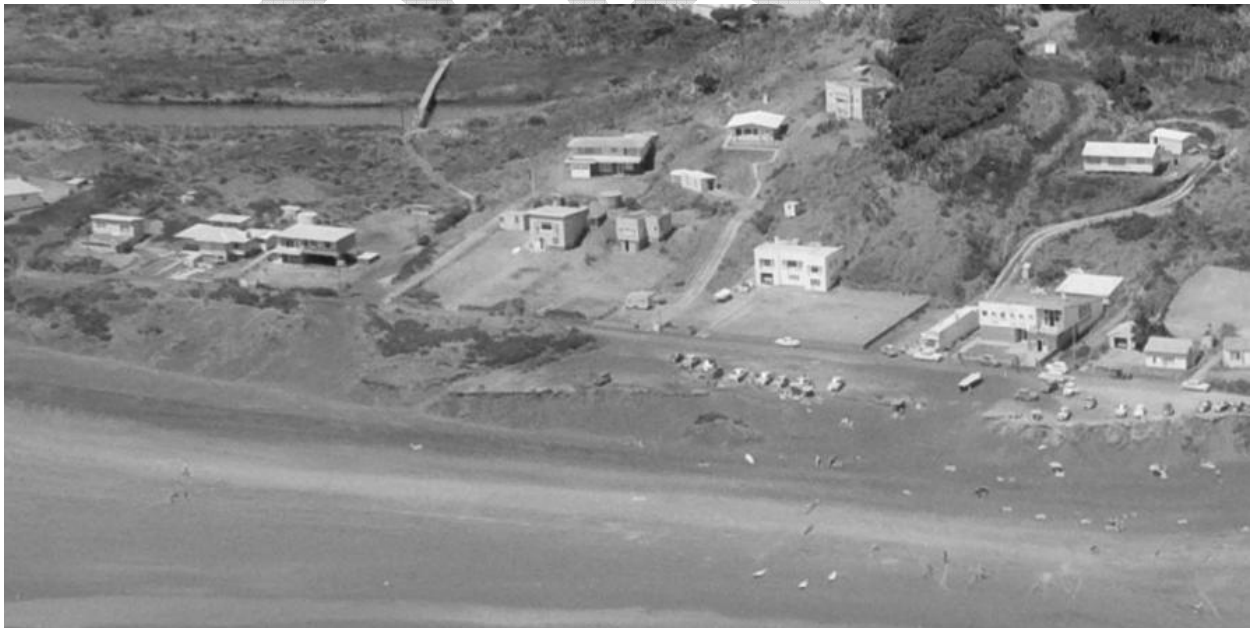
Figure 7: Photograph from 1963 showing area of Piha fronting surf club and areas to the north. Note that dunes fronting the surf club have now been levelled to create a car park and the dune face seaward of this car park is now largely devoid of vegetation. (Whites Aviation photo – from Alexander Turnbull Library).

In the mid 1950's, levelling of dunes in front of the surf club began to create car parking and this area was progressively extended into the 1960's (Figure 7).

Long term residents advise that clay fill was also placed extensively over these areas at this time (Helen Pearce, pers. comm.). The car parks also encroached seaward, significantly further reducing the width of natural dunes seaward of the car park. The poor management of beach access resulted in the dune face seaward of the car park being largely devoid of vegetation at this time (Figure 7)

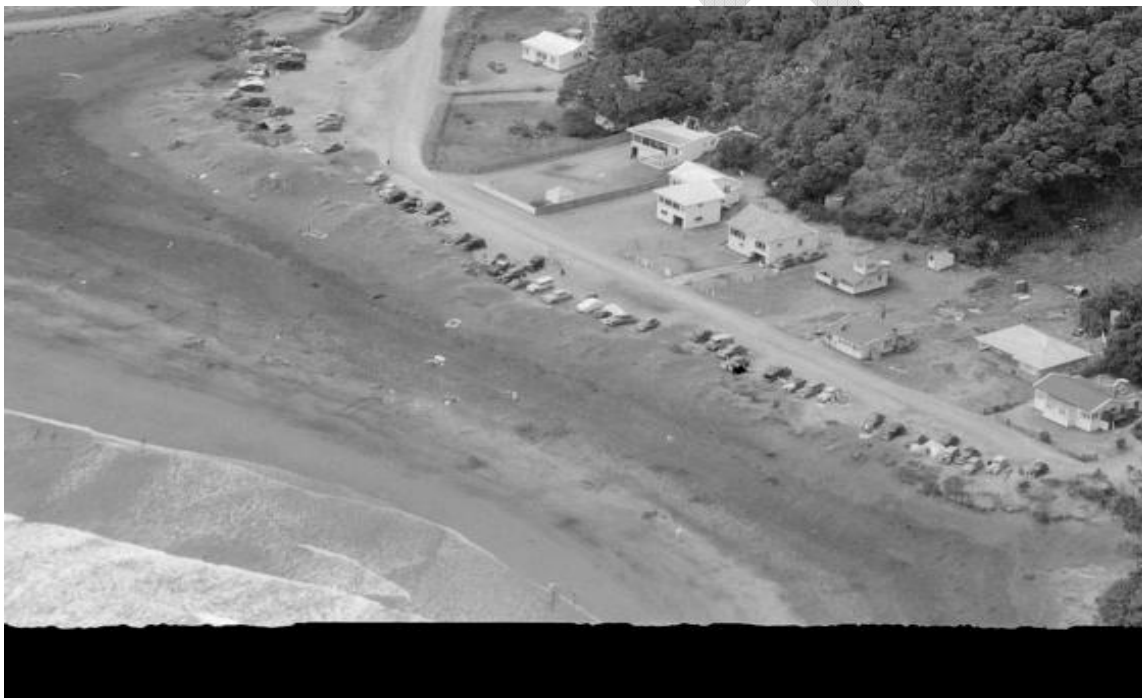
Figure 8: Photograph of southern car park area dating from January 1963.

Parking occurred along the full length during high use periods and access to and from the beach was unmanaged – resulting in extensive disturbance of sand trapping vegetation on the seaward dune face by the early 1960's (Figure 8).

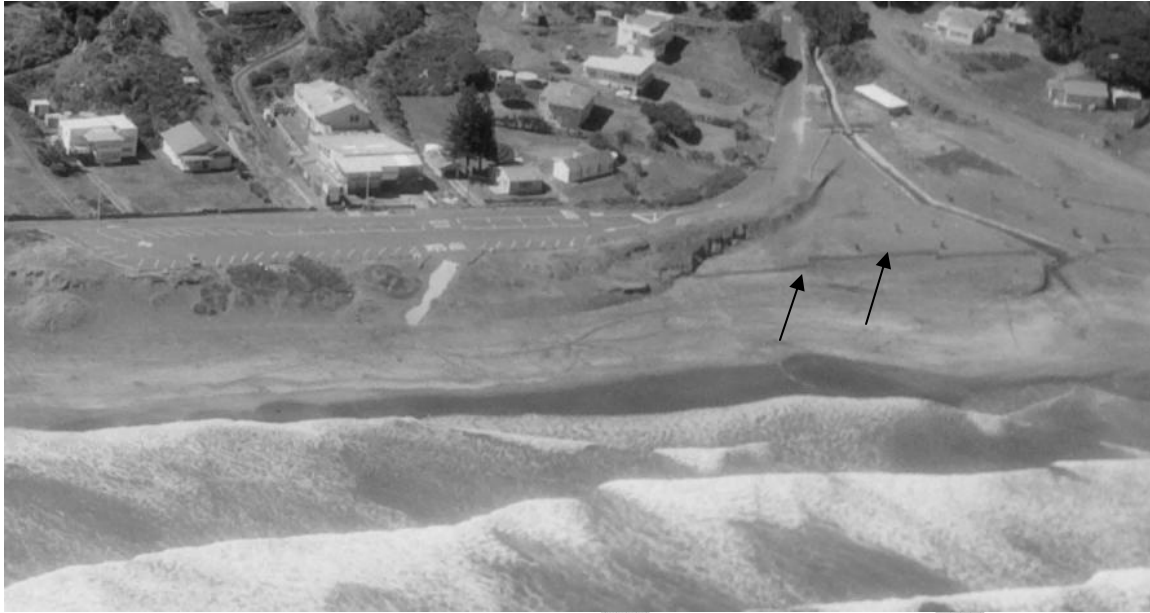
Figure 9: View of surf club car park and Moana Stream entrance area in 1985. Note the concrete stream training works in the Moana Stream and the placement of sand trapping fences (arrowed) to create dunes on the immediate northern side of the former embayment.

In the mid 1980's, the Moana Stream entrance was also significantly modified – including training the stream with a concrete-lined channel (Figure 9), reclamation of the former embayed stream entrance and construction of dunes across the head of the former embayment (these dunes often referred to locally as the “artificial dunes”). The modification of the Moana Stream entrance was controversial and was subsequently deemed unnecessary by the Turner decision.

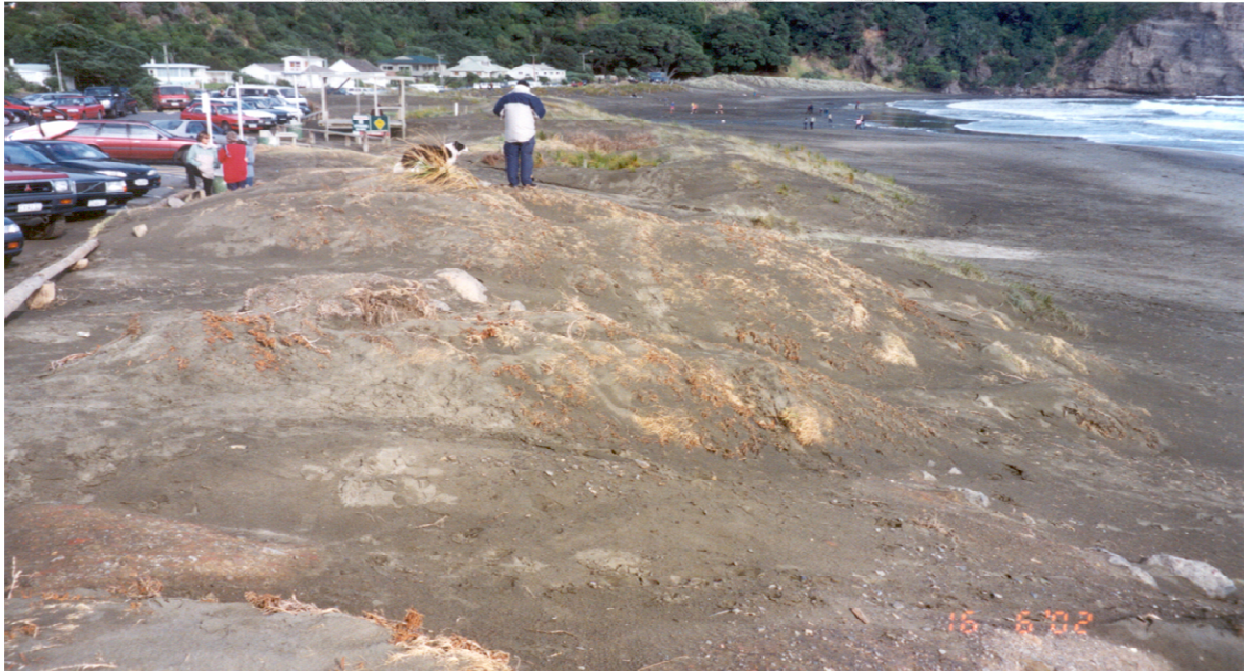
Figure 10: Area in front of surf club (undated but circa 2003) - before commencement of Coastcare dune restoration works. (Auckland Council photograph)

By the early 2000's, the high use area in front of the surf club was still seriously damaged with exposed clay fill and very little native sand trapping vegetation (Figure 10).

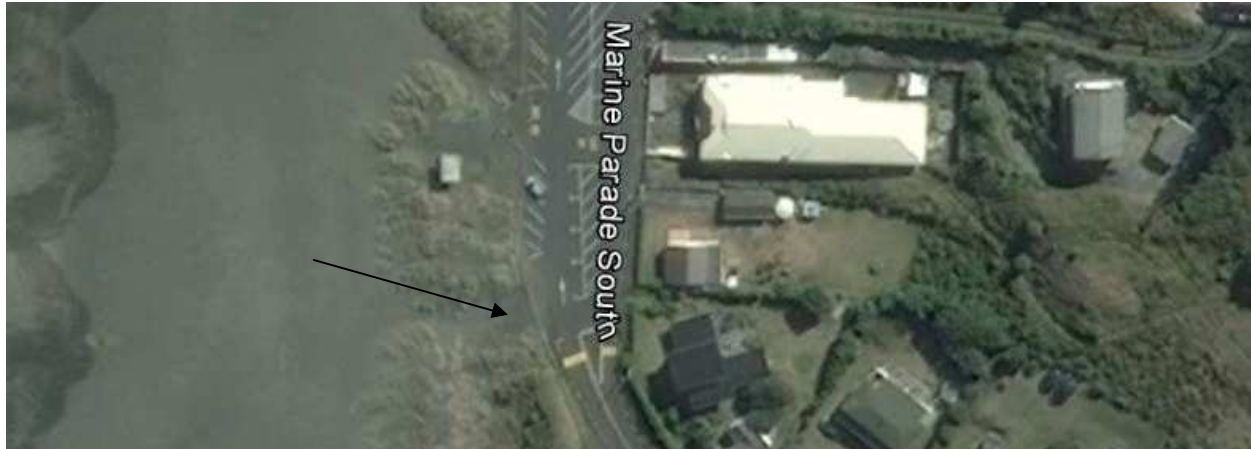
Figure 11: Location of informal accessway (arrowed) at the southern end of the surf club car park. It is recommended that this accessway be formalised and defined.

- iv. An additional defined accessway be established at the southern end of the surf club car park (as arrowed below in Figure 11) where an informal accessway presently exists.

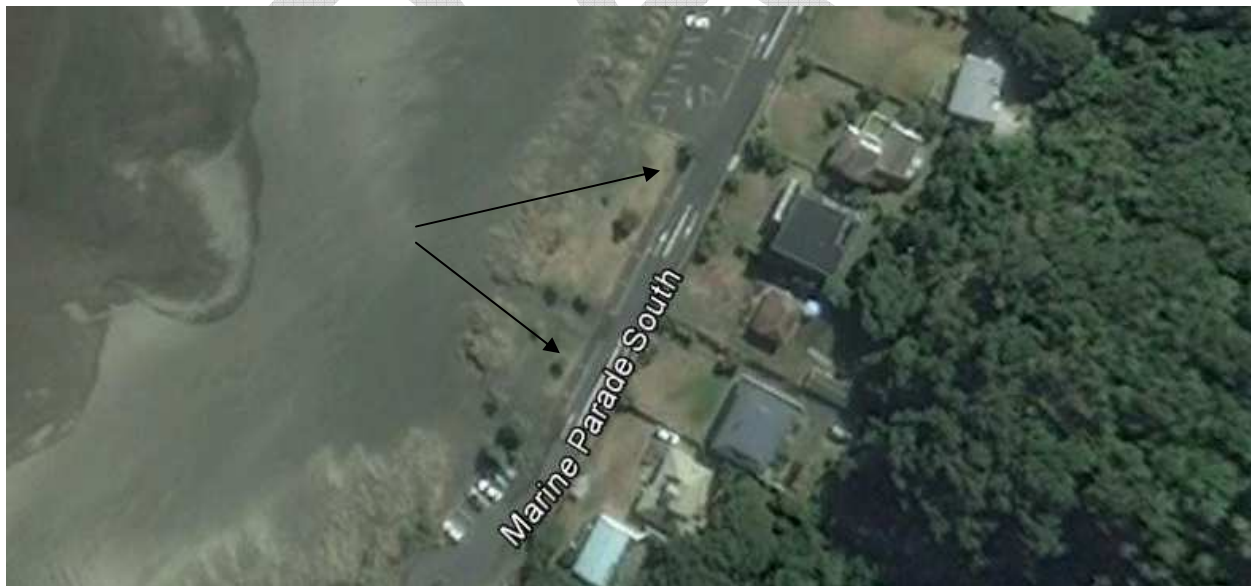
Figure 12: Grassed area behind spinifex zone at western end of the southern car park. This area provides an important grassed elevated viewing area and could readily be levelled to improve suitability for use.

In terms of more immediate action, the existing grassed area at the western end of the southern car park (arrowed in Figure 12) is already extensively used and could be enhanced for use in the near future. For instance, ground levels are presently irregular and the area could be leveled to improve it for recreational use. There are also existing small pohutukawa here that will in time provide useful shade – though they may need to be managed (e.g. periodically opened up with careful pruning) to maintain views from landward.

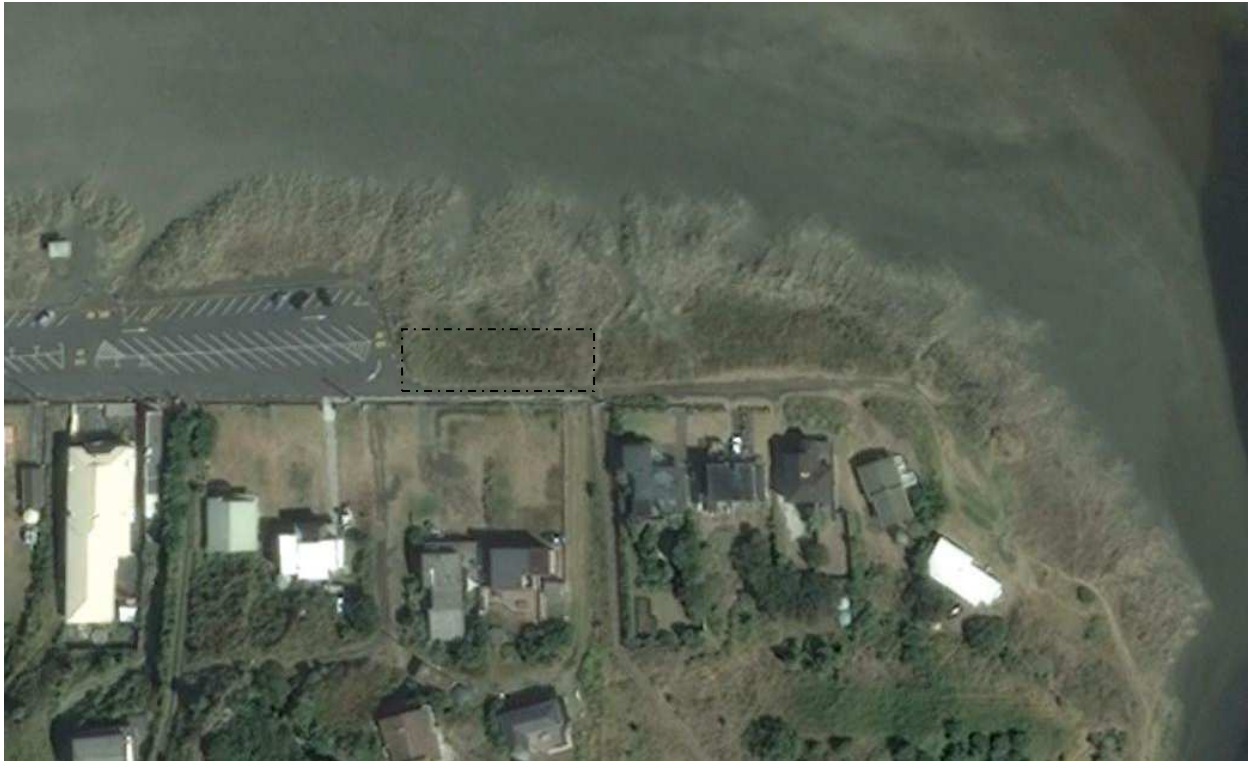
Figure 13: dashed line outlines backdune area to the immediate north of the surf club car park within which a grassed viewing area could potentially be established – subject to appropriate design and consultation.

There are also elevated backdune areas to the immediate north of the surf club car park where quite extensive elevated grassed areas could potentially be established, while still maintaining wide spinifex zones (at least 30 m) to seaward (Figure 12). An advantage of this area is that it is not only immediately

adjacent to the surf club car park but also borders the beach access from the Domain. However, any future development of elevated grassed viewing area in this location would require appropriate design and consultation. Additional beach accessways might also be required.
