Review of Existing Multi-Functional Artificial Reefs

Abstract

Costs, benefits and performance of existing surfing and multi-functional artificial reefs have varied considerably. This paper compares details of the 6 reefs completed or under construction to determine the total costs and performance as well as construction issues. The investigation was undertaken as part of the design and construct contract for a multi-functional artificial reef project.

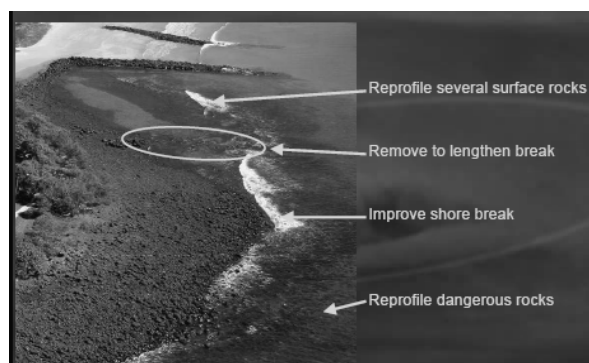
Figure 1 Bargara Reef Phase 3 [Source: Greg Redgard]

No modeling was carried out. Local knowledge was used to relocate / break boulders that were observed to be adversely impacting on the break. These boulders were also used to fill holes to further improve the wave quality for surfing. The initial works were monitored on the “full scale model” and additional works have been “designed” [Figure 1]. [Redgard, 2006]

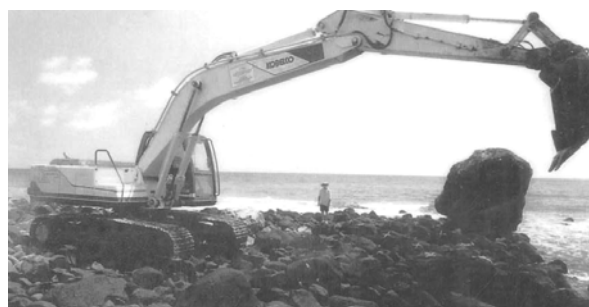
Figure 2 Excavator moving boulders at low tide (Source: Greg Redgard)

The rocky headland was groomed at low tide using a large excavator to move the existing basalt boulders (Figure 2). No additional materials were required to be imported. The rock volume moved is very difficult to estimate, but is approximately 300m³.

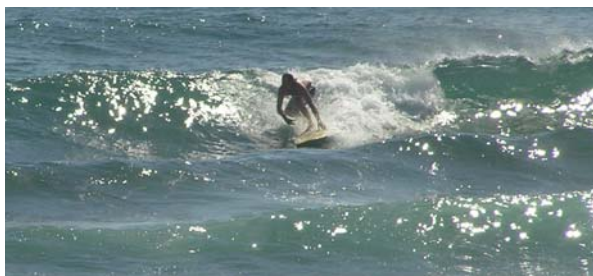
Figure 3 Surf at Bargara (Source: Greg Redgard)

No scientific monitoring has been done. It is obvious, however, that the work is producing an improved and safer, longer point break [Figure 3] near high tide with swells of over about 1m and light and / or offshore winds. The number of surfable days is relatively low, but expectations of the surf quality do not appear unrealistic and it is seen as successful in improving the surf quality and increasing the number of surfable days. (Redgard, 2006)

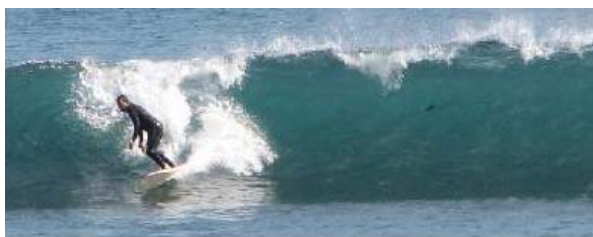
Figure 6 Surf at Cables

Monitoring of the reef has been carried out by Bancroft [1999] and Pattiaratchi [2003]. They concluded that the reef was performing according to design, with swell as low as 0.5m breaking on the reef in low tides. In 1999, the reef was considered to be “surfable” 142 days of the 178 days it was breaking. (Figure 6)

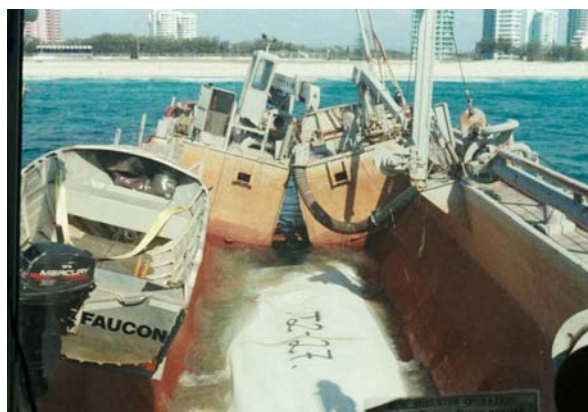
Figure 8 Placing containers from a split hull hopper dredge at Narrowneck

ICM developed the construction methodology and the contract was awarded to local firm McQuade Marine. The reef was constructed using over 400 mega sand-filled geotextile containers supplied by ELCO Solutions [then SoilFilters Australia], filled, and dropped into place using a hopper dredge, Faucon [Figure 8].

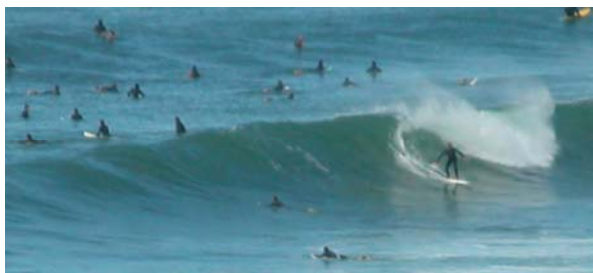
Figure 9 Surf at Narrowneck (Source ICM)

Wave breaking occurs $\sim 50\%$ of the time – generally for waves $> 1\text{m}$ at MLWS and $> 1.8\text{m}$ at MHWS. Good surf [Figure 9] is experienced regularly on the reef when wind, waves and tides are suitable. It is noted that the surf very rarely looks like either the numerical or physical models as there is often multi-swell / wave conditions and wind factors. When there is a clean swell without wind, the modeling is replicated in the real world.

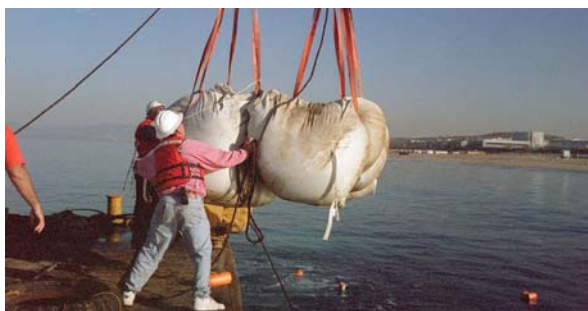
Figure 11 Placement of sandbags at Pratte's

Two types of woven geotextiles were used – polyester and polypropylene. For safety and budget constraints, the reef was designed and constructed of ~14t sandbags that could fit snugly into the back of a standard tip truck tray. Once filled, they were loaded onto the barge and towed to site to be placed by a barge-mounted crane [Figure 11]. Final reef volume was only ~1,350m³.
