The first 10 days (1 to 12 September 2008) of construction of a marina at Whangamata.

INTRODUCTION

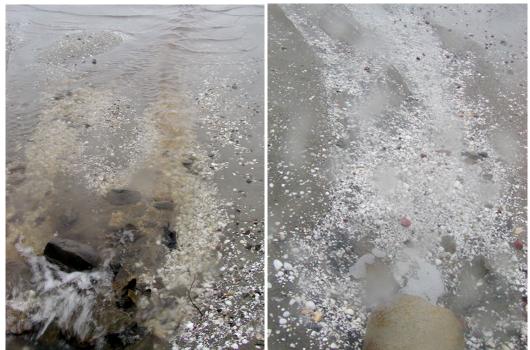
There has been a swell running during this time with surfers using the Bar. Unacceptable amounts of land based sediment from these works left the site from the 2nd to the 9th September. On the 5th and 6 th of September the surfers at the Bar could not see their feet when sitting on their boards. SPS monitors believe this was a breach of the turbidly clauses of the Marina Society's consents, both in the strength of turbidly and the distance travelled.

These photos were taken at the same time 20 meters apart in the rain of 8 September 2008. On the left the drain of the marina society "silt pond", on the right the slipways carpark and roading stormwater drain.
