# Eastern Seaboard Coastal Management Plan:

Coastal Strategy for the Tairua, Pauanui and  
Whangamata Ocean and Estuarine Shorelines

**Thames Coromandel District Council**

**July 2015**

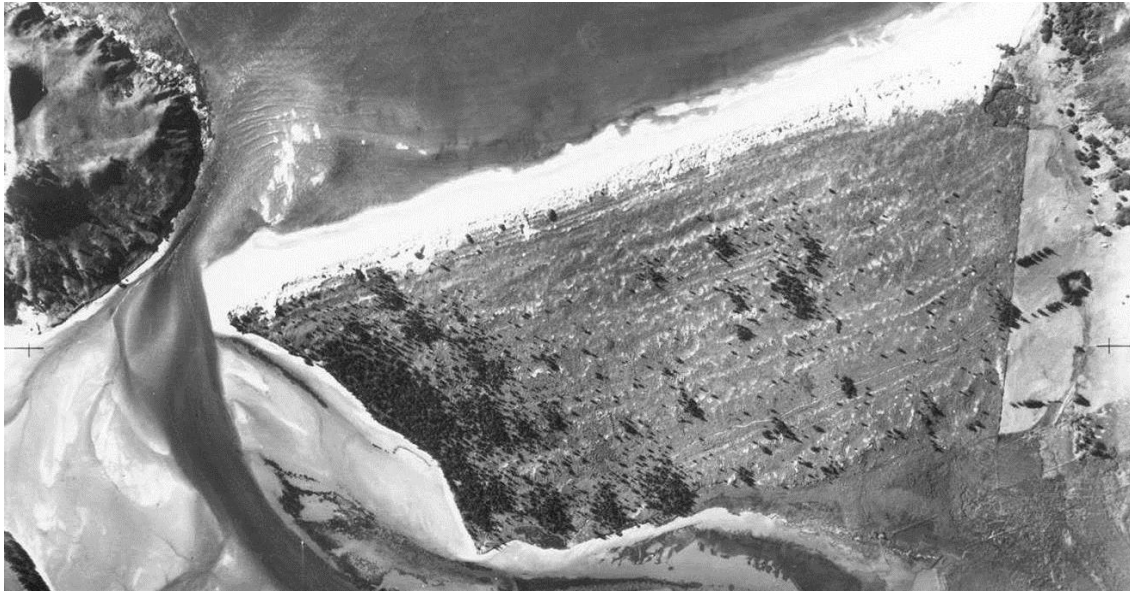
Figure 1: View of Pauanui in the 1940s showing the old shore parallel dune ridges formed as the shoreline advanced seaward over the last 6000-7500 years ago.

The Whangamata and Pauanui shorelines have advanced by approximately 1.2 km and 1.0 km respectively over the last 7000-7500 years; forming wide sand dune plains (e.g. Figure 1) on which the townships are now built. Dune building initially occurred very quickly but slowed over time and is now negligible (< 5 m per century). Most of the sand for the ocean beaches has moved onshore from the continental shelf, and there is little ongoing contribution from the catchment. In simple terms, the ocean beaches already have most of the sand they are going to get.

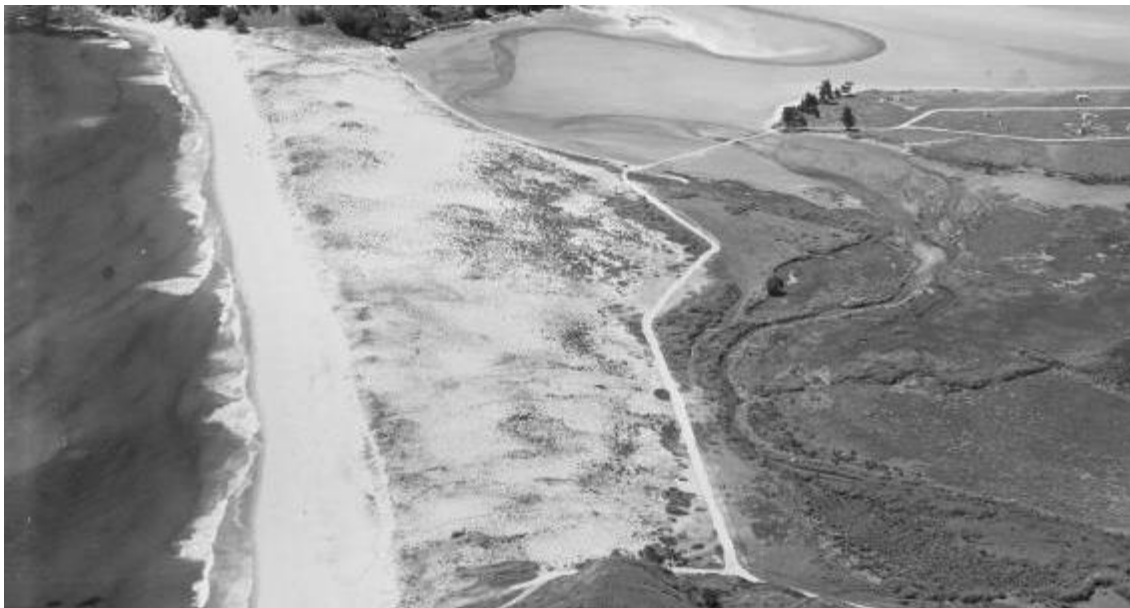
Figure 2: View of Tairua Ocean Beach in January 1953 prior to development showing width of dunes landward of the beach

The dunes at Tairua Ocean beach are narrower than at the other beaches (typically <250 m). Dating indicates that the beach had largely formed by 4000 years ago and the shoreline has not significantly advanced since then. The fact that the shoreline has been in much the same position for a long period of time has resulted in wide high dunes (Figure 2).

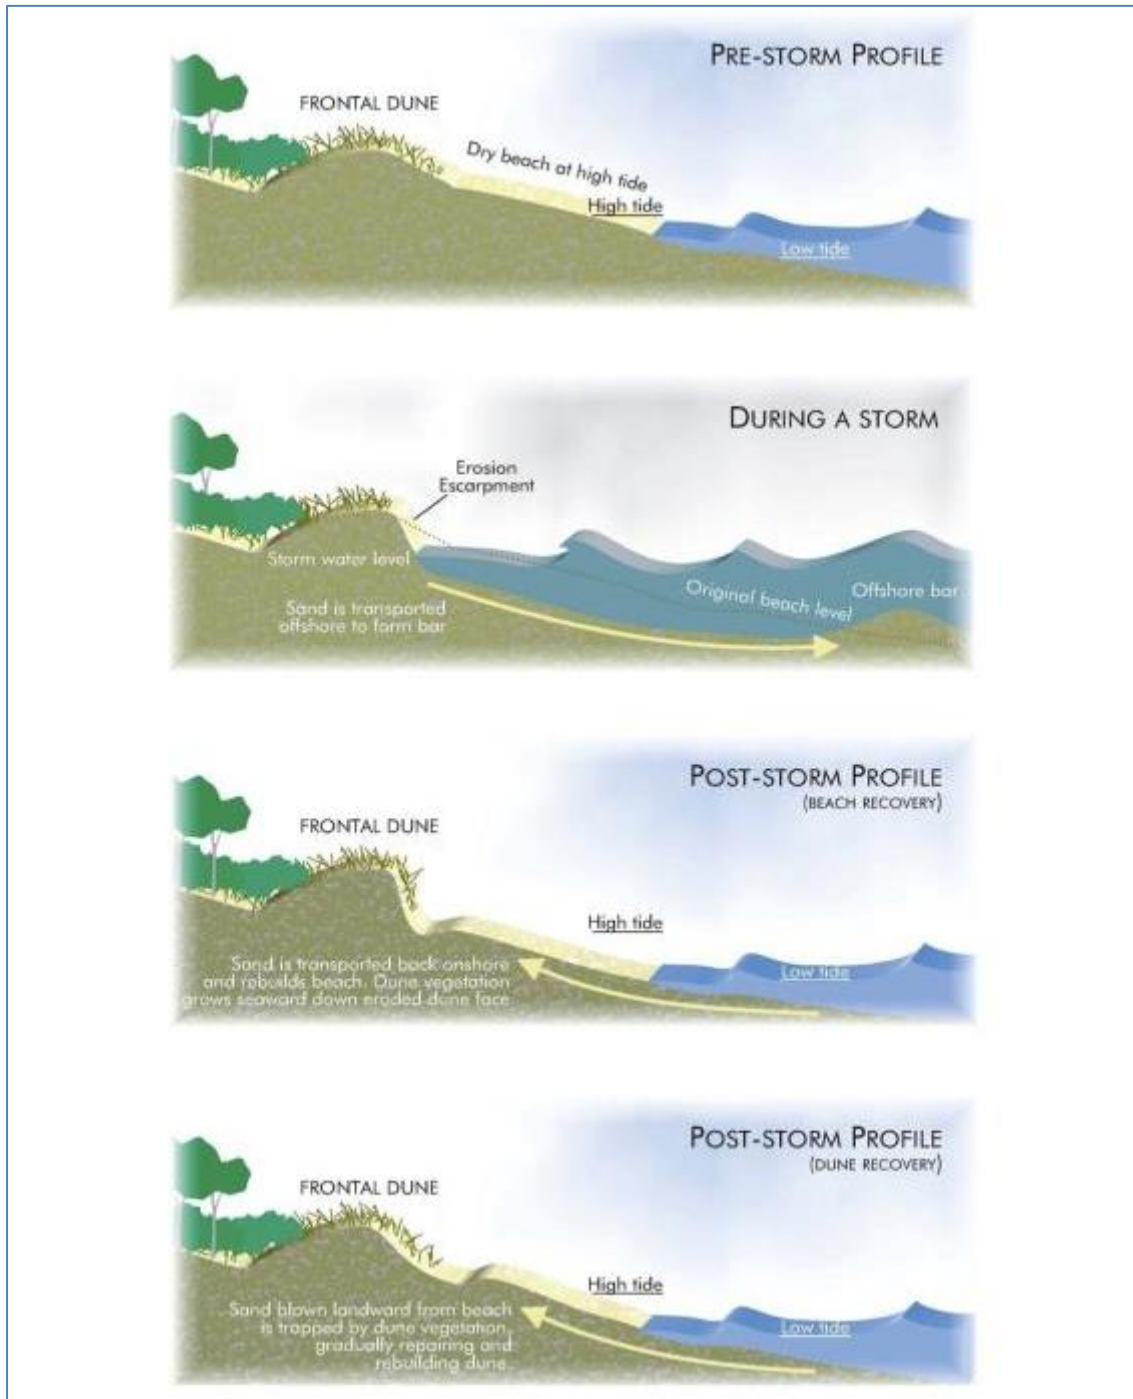
Figure 3: Schematic illustration of the process of storm erosion and subsequent beach and dune recovery. Understanding this process and decadal shoreline fluctuations is critical to understanding and managing coastal erosion on ocean beaches (see text for discussion)

- During storms, sand is eroded from the beach and dunes and moved offshore (see second diagram in Figure 3. Sometimes, storms also move the sand alongshore. This is particularly common at Tairua where storm waves arriving from one direction can cause erosion at one end of the beach and build up at the other.

- Once the erosion is over, sand gradually moves back onshore under more gentle waves and rebuilds the eroded beach (see third diagram in Figure 3). This beach repair process can occur in several weeks after an isolated storm event but the eroded beach state may persevere for some time during an extended erosion period.

- Dune repair occurs when native sand trapping plants grow down the eroded dune face and trap windblown sand (bottom diagram in Figure 3). This natural repair process depends completely on native sand trapping vegetation, particularly spinifex and pingao. After severe dune erosion, natural repair can take some years. Erosion occurs rapidly during storms, which means it is much more noticeable to human observers than the much slower process of shoreline recovery.

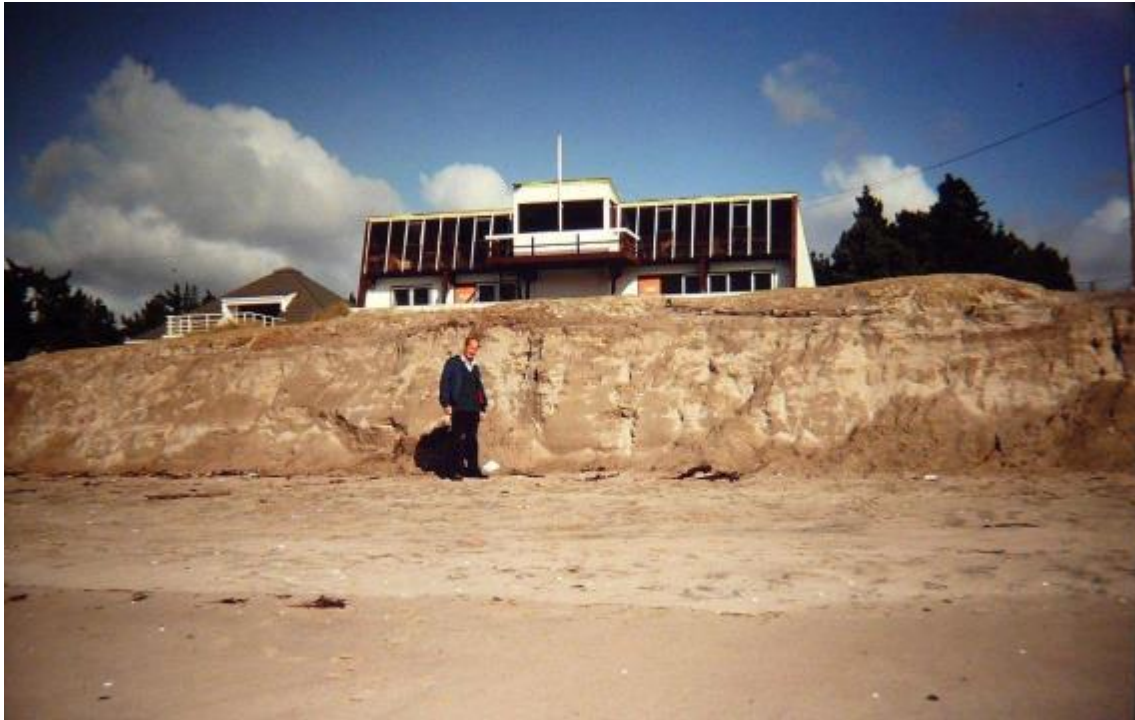
Figure 4: View of south end of Esplanade Drive near the surf lifesaving club showing severe dune erosion which occurred during a storm in July 1978. (Photo provided by Mr. Ray Madden).

A number of storms in the 1970s caused progressive erosion fronting Esplanade Drive, which reached a maximum in a major coastal storm in July 1978. Figure 4 shows a view of severe erosion in this area following the 1978 storm. At the southern end of the Esplanade Drive, the erosion reached the grassed reserve behind the dune and to within 2-4 m of the sealed road and car park.

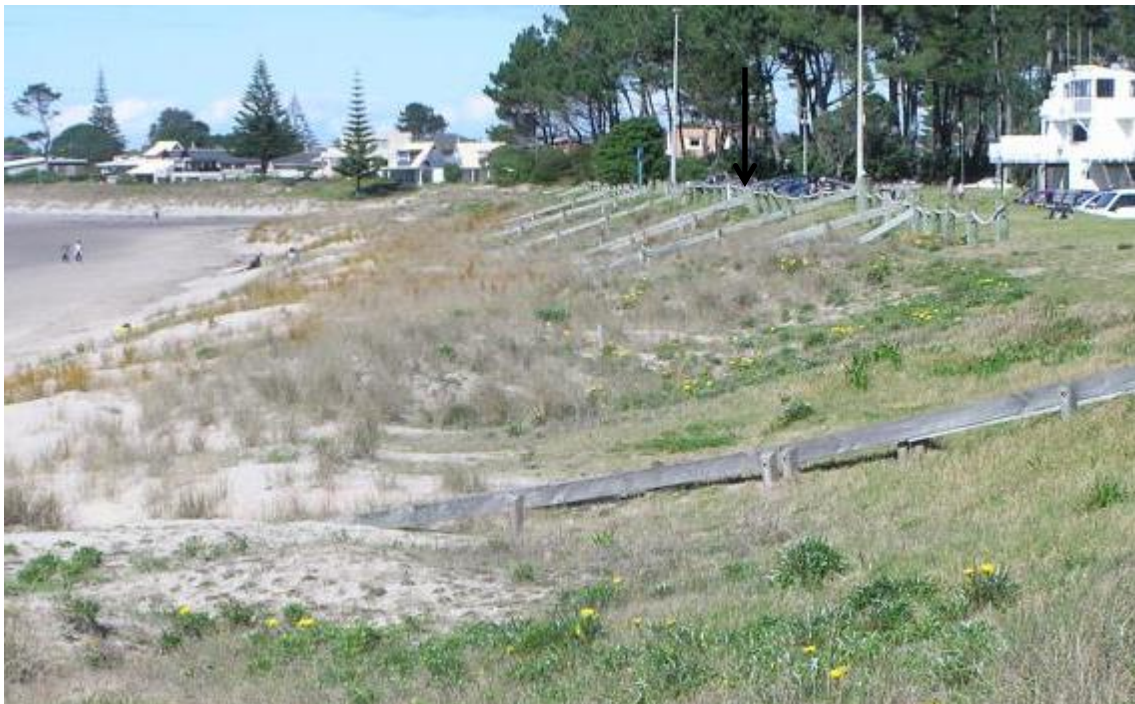
Figure 5: View of the south end of Esplanade Drive in August 2009 after a sustained period of dune building lasting several years (Photo: J Dahm). The 1978 erosion extended up to 2-3 m landward of the rope and bollard fence evident on the landward side of the dune.

In contrast, Figure 5 shows a view of the southern end of Esplanade Drive in August 2009, following a period dominated by dune repair and seaward dune advance lasting over 10 years. At this time, the seaward toe of the dune was located up to approximately 15-17 m seaward of the 1978 erosion scarp.

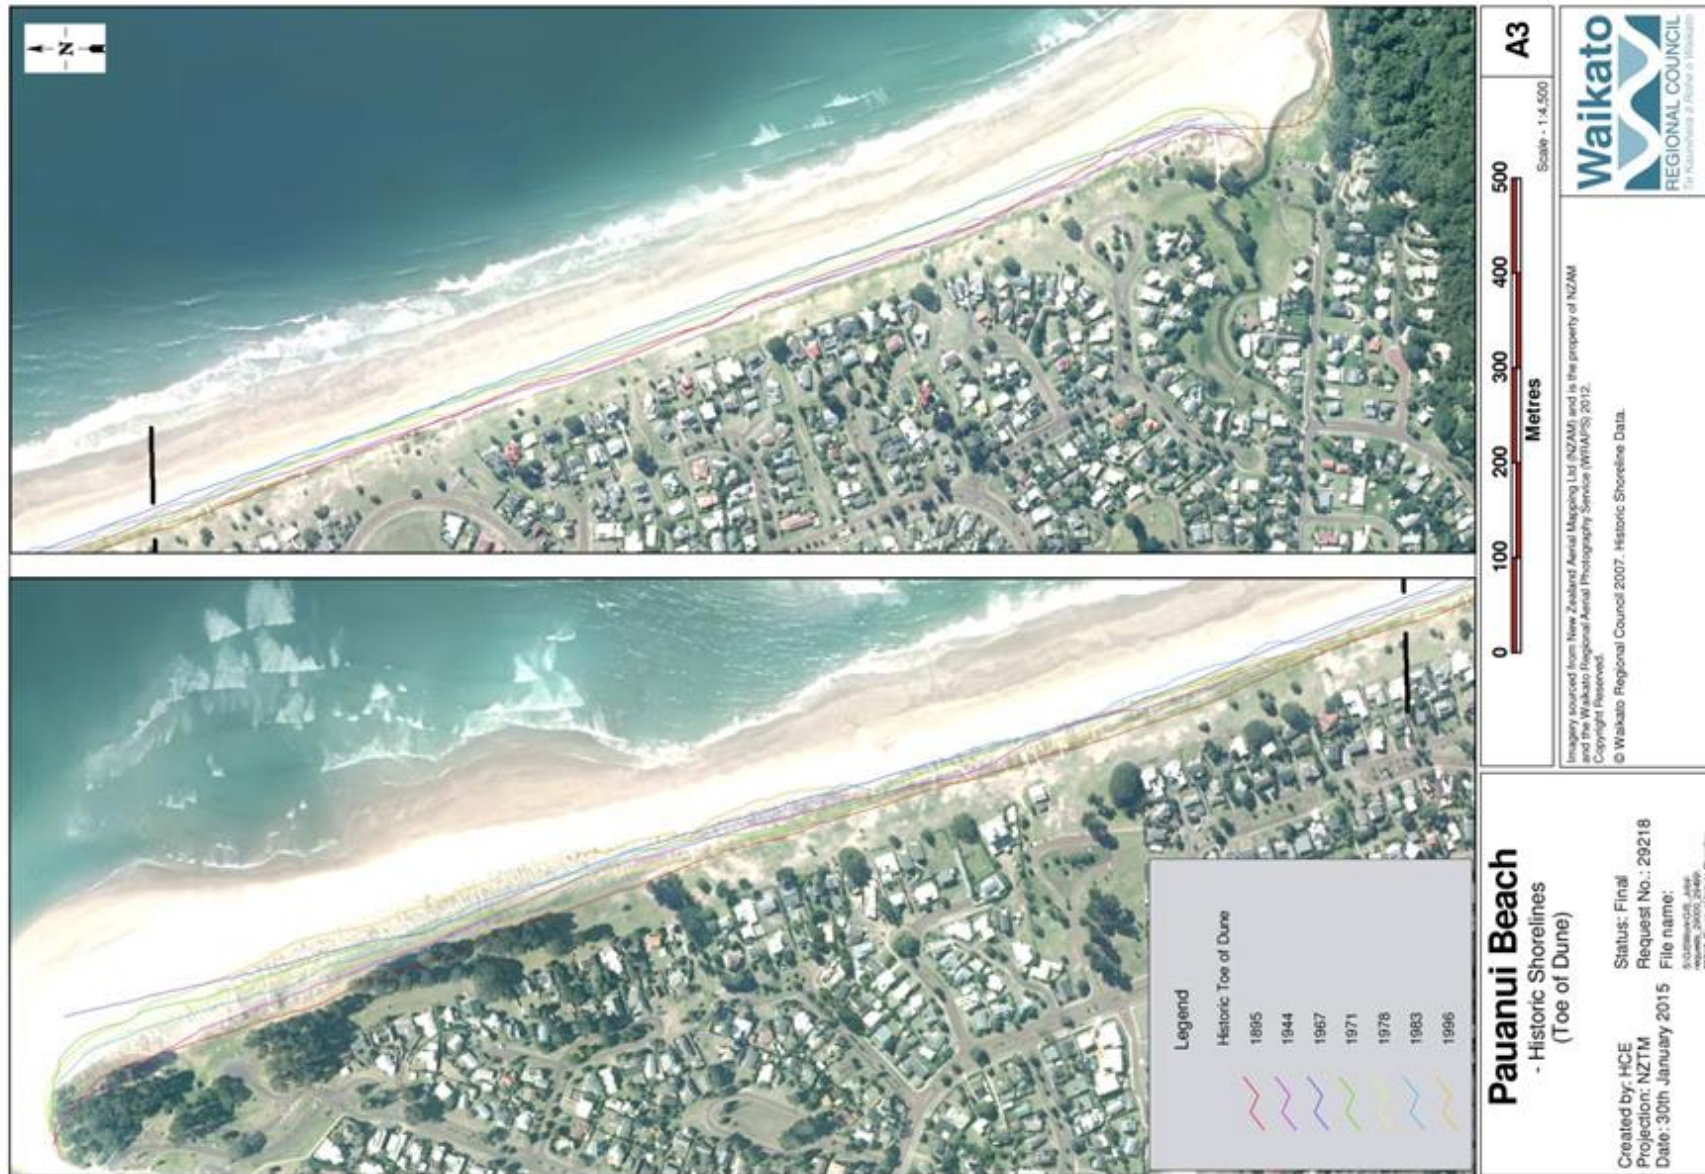
Figure 6: Shoreline fluctuations along the southern (top) and northern (bottom) ends of Pauanui Ocean Beach – as mapped from historic surveys dating from 1895 to 1996 and historic aerial photographs from 1944 to 1983. The mapped shorelines show the dune line at each date - except for the most seaward shoreline which was surveyed in 1962 and fixed high water mark.

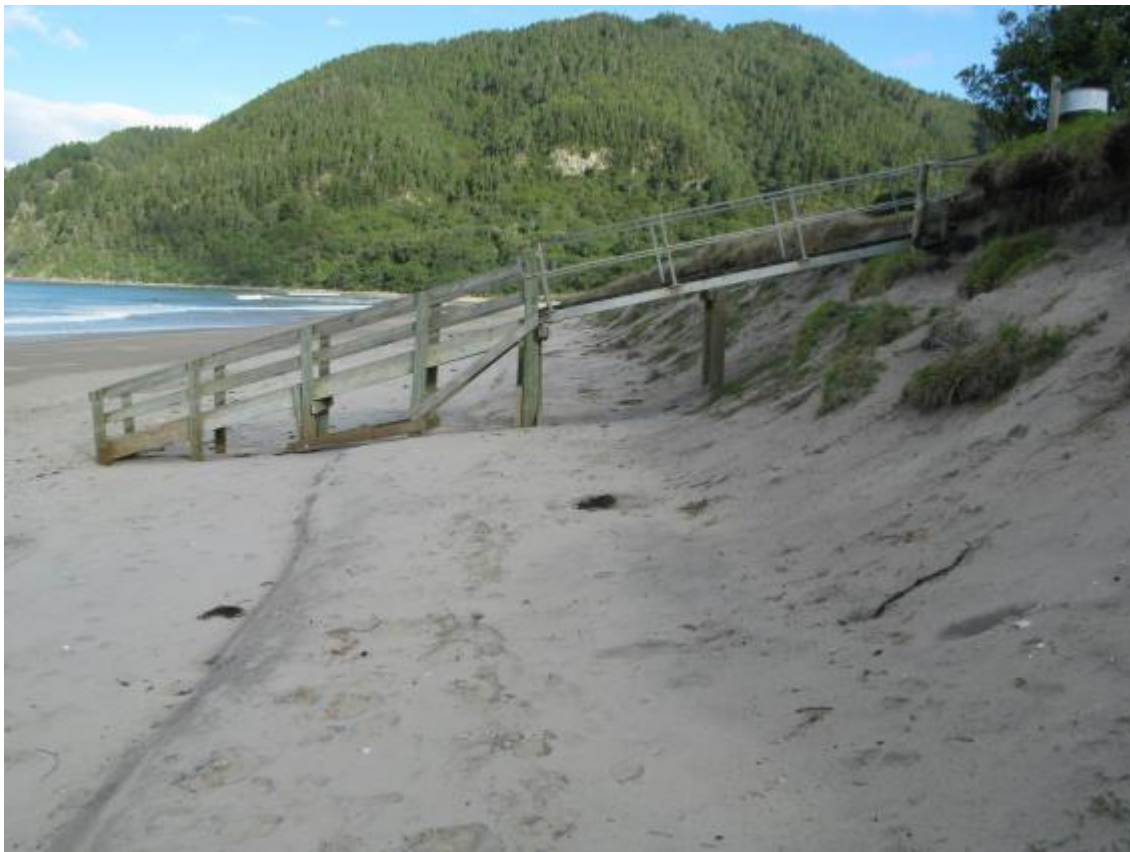
Figure 7: View of beach accessway 9 located towards the southern end of Pauanui Beach in 2012. In 2009, the seaward edge of the dune toe was approximately 8m further seaward. These changes are typical of the natural shoreline fluctuations which occur over time and the erosion will naturally recover.

Figure 7 shows a view of Accessway 9 (located towards the southern end of the beach) in 2012 after about 8-9 m of erosion between 2009 and 2012. Prior to the erosion, the dune reached near the end of the beach accessway. As with earlier cycles, this recent erosion is temporary and will eventually give way to a period of natural dune repair. These cycles of beach and dune erosion and recovery are perfectly natural and do not require human intervention as long as there is enough width of naturally vegetated dune to provide for natural dune repair.

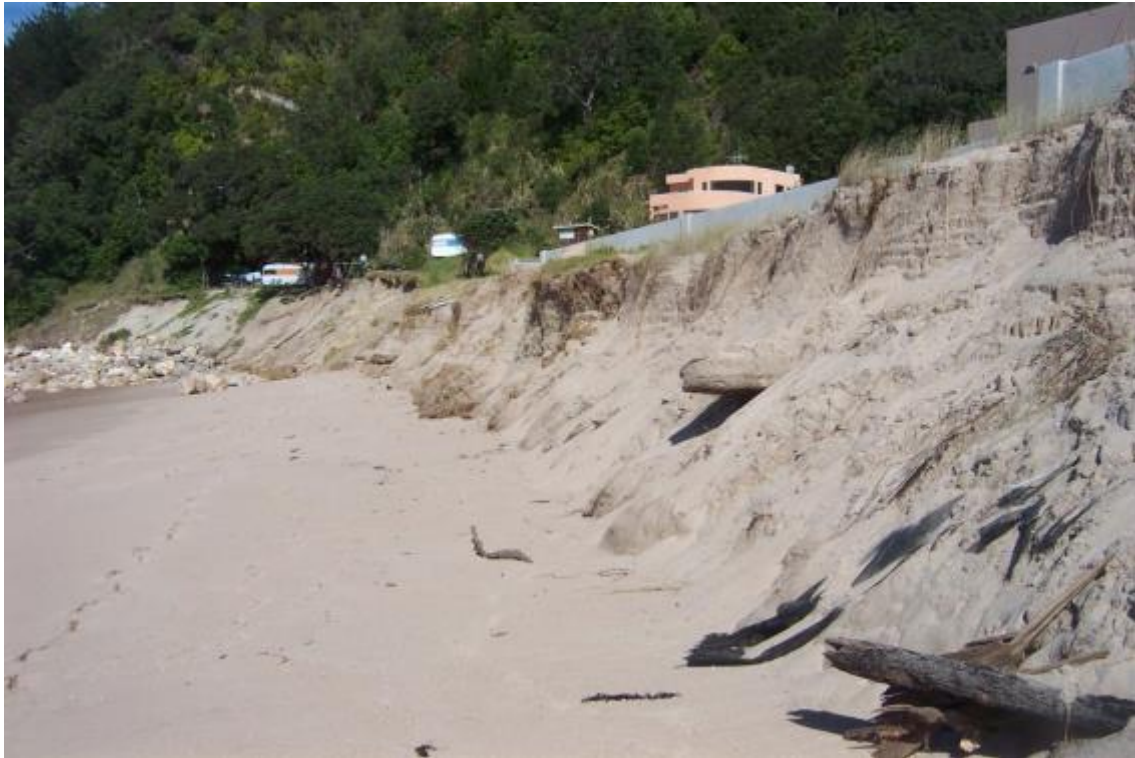
Figure 8: The south end of Tairua Ocean Beach following severe erosion in 2003.

The extreme southern end of Tairua Ocean Beach was eroded severely in August 2003 (Figure 9). The bottom photo shows the same area in 2014 after natural and human-assisted dune repair (Figure 9). The seaward edge of vegetation on the repaired dune is approximately 10-12 m seaward of the 2003 eroded dune toe.

Previous studies show that severe erosion also occurred in this area in 1978 and 1988, but the 2003 erosion is the worst since at least the 1940s. There is some evidence that even more severe erosion may have occurred earlier in the 1930s – possibly in 1936 when two major storms occurred within a few weeks of each other. Each of these earlier erosion events was also followed by natural dune repair.

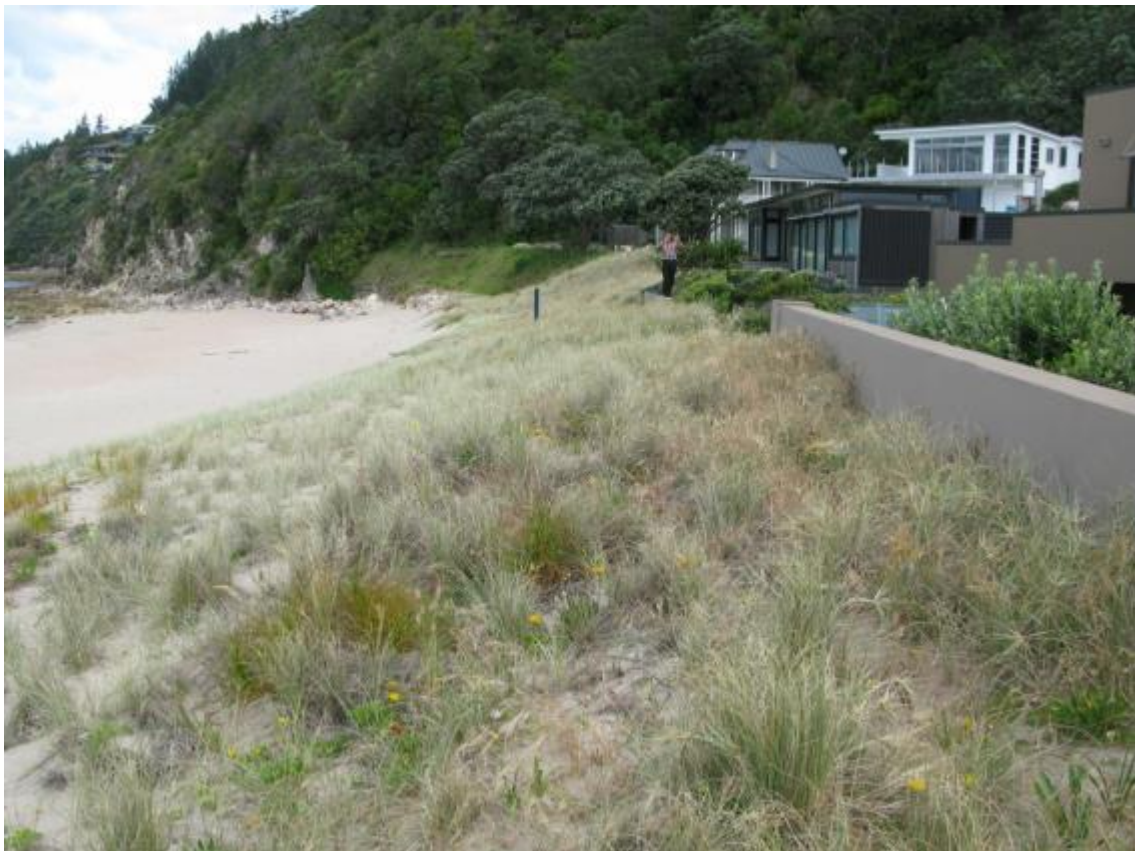
Figure 9: The south end of Tairua Ocean Beach after dune repair (2014).

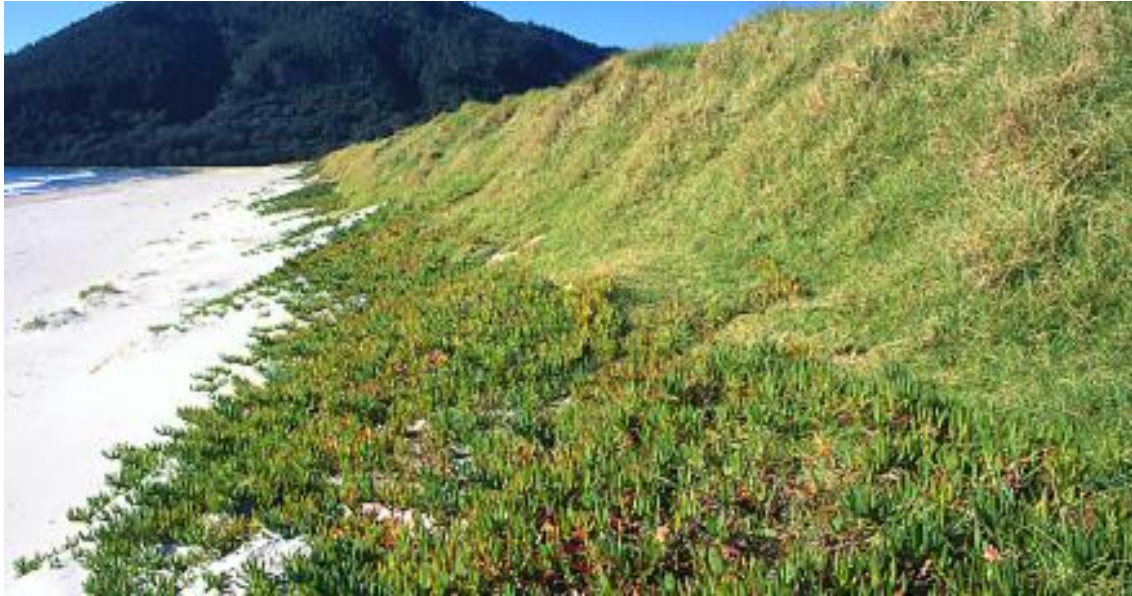
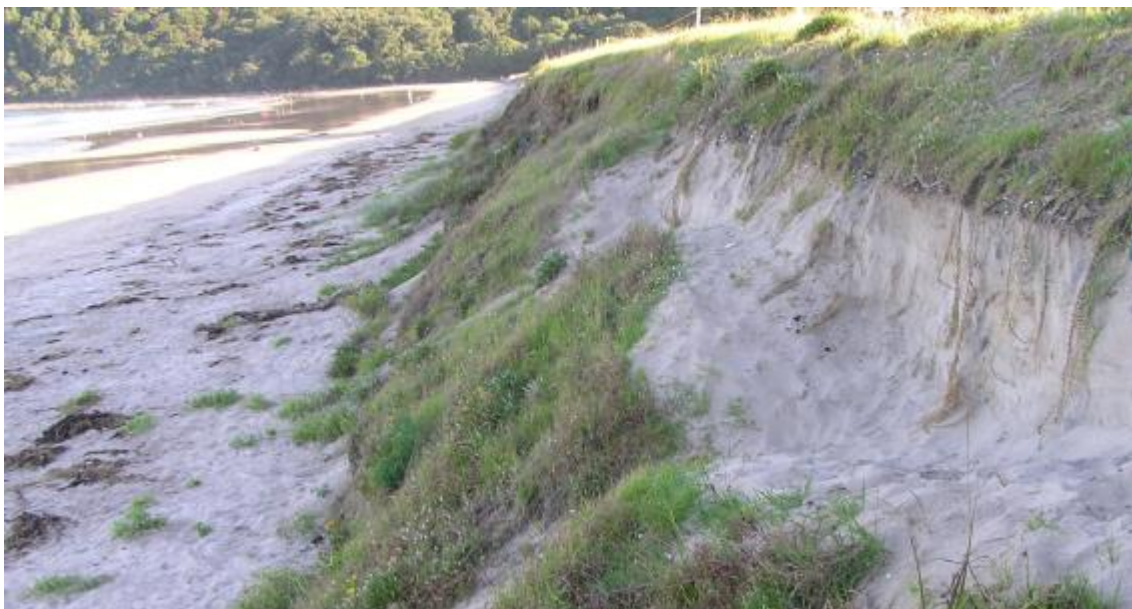
Figure 10: Views of southern Pauanui foreshore in early 2000s prior to dune restoration showing absence of native sand trapping dune vegetation such as spinifex. The seaward dune face is dominated rather by exotic vegetation that is not as effective at natural dune building and repair. Note the perseverance of the steep dune face from historic storm erosion due to the absence of natural dune repair processes - despite nearly two decades since the previous major storm erosion events (1978 and 1985).

other native dune vegetation needed for natural sand trapping largely stopped natural dune repair in this area. As a result, little natural dune repair occurred after severe erosion in 1978 and 1985, with the erosion scarps still clearly visible in the early 2000s. In this area the scarp had become vegetated with exotic species, which are not as effective as spinifex in natural sand trapping and dune repair (Figure 10).

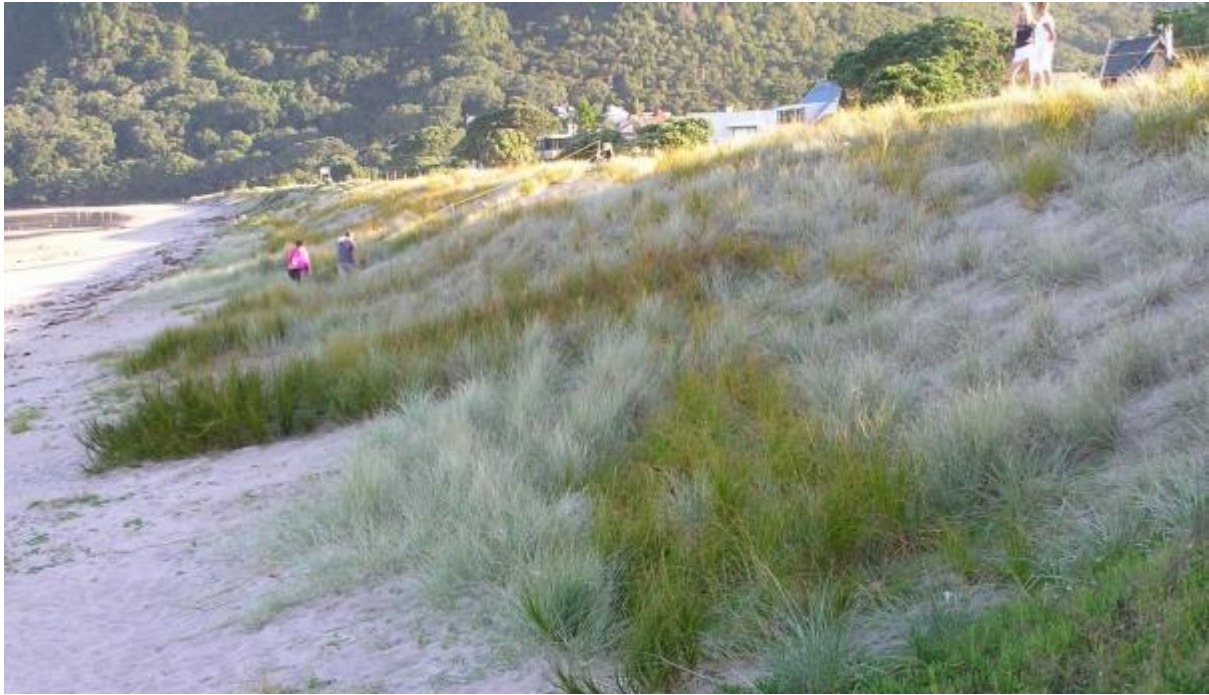
Figure 11: View of southern end of Pauanui in 2006 following reshaping of dune face and restoration of native sand trapping vegetation. Note how the native vegetation extends down the seaward face and onto the beach during accretion phases – actively trapping windblown sand and repairing the eroded dune face.

Subsequent dune restoration with native sand-trapping vegetation resulted in significant sand trapping and dune repair over a narrow width along the seaward face of the dune (Figure 11). However, the dune restoration was only undertaken over a narrow width as there was public resistance against the loss of grassed reserve. As a result the restored area was largely lost in the recent erosion phase (Figure 12; see also Figure 7).

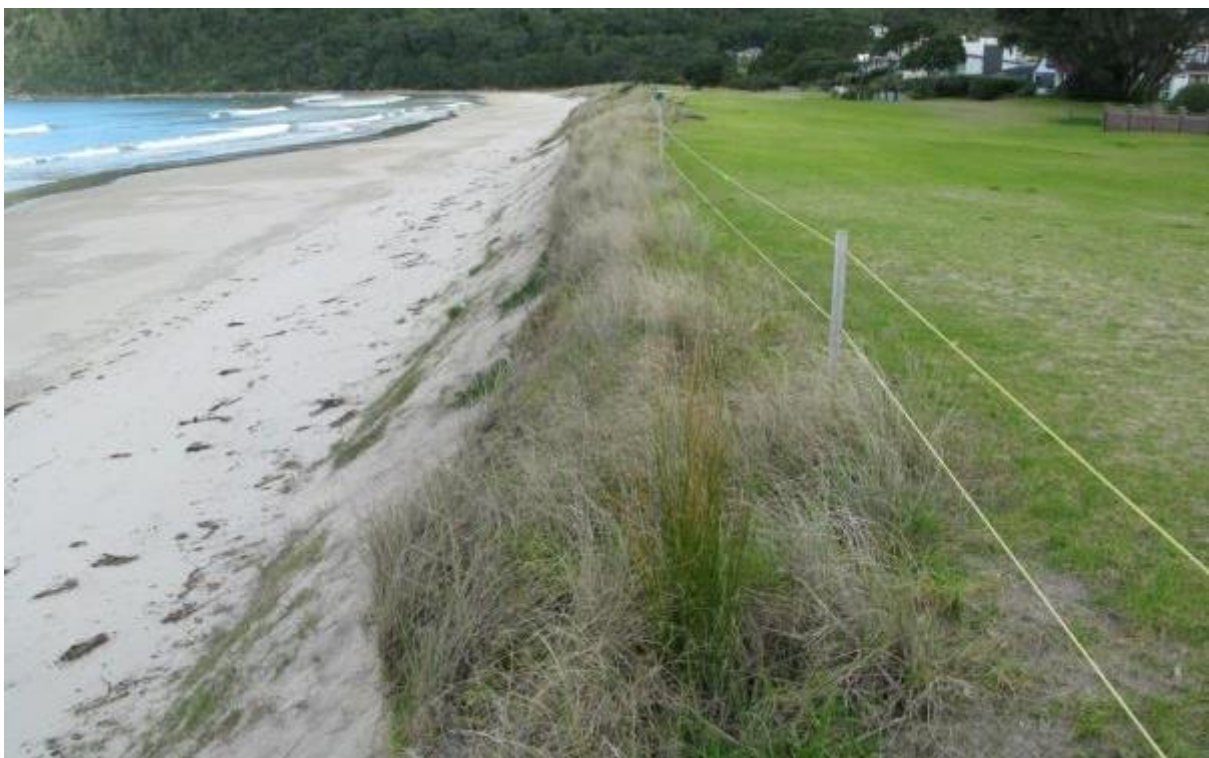
Figure 12: View of restoration area on southern Pauanui foreshore after period of dune erosion (in 2009 and following years). The narrow width of the restored native dune vegetation has largely been lost to erosion – with about 1m width remaining. This indicates the importance of having a natural dune of sufficient width to absorb the worst likely storm erosion. Otherwise, replanting has to occur after the erosion before natural dune repair can commence.

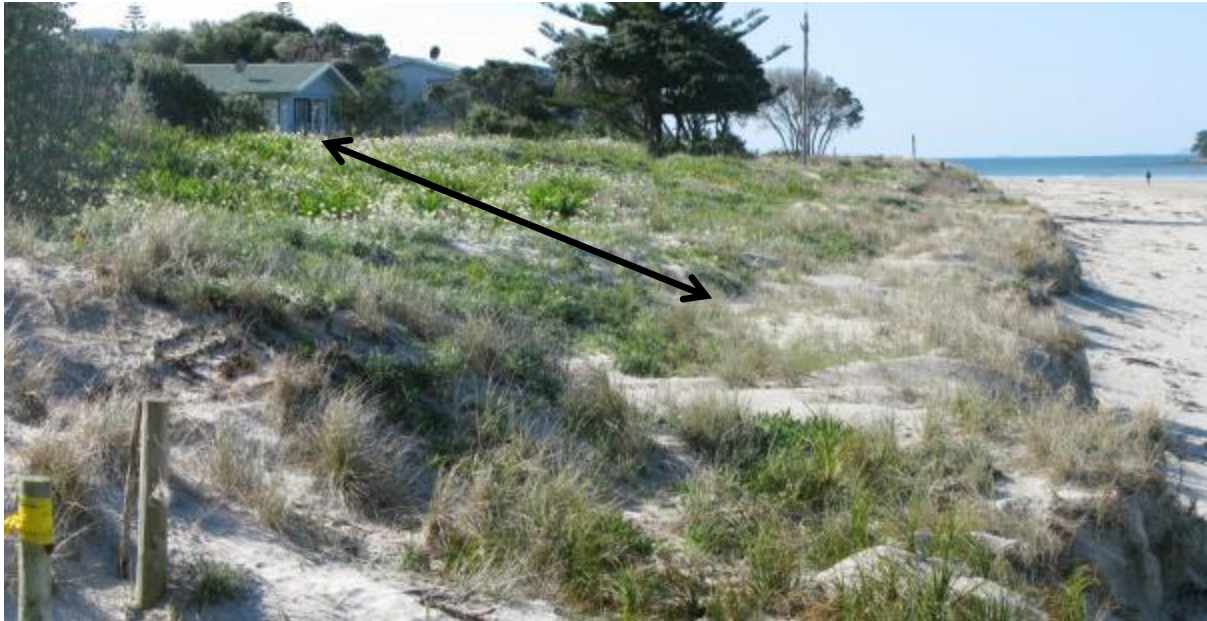
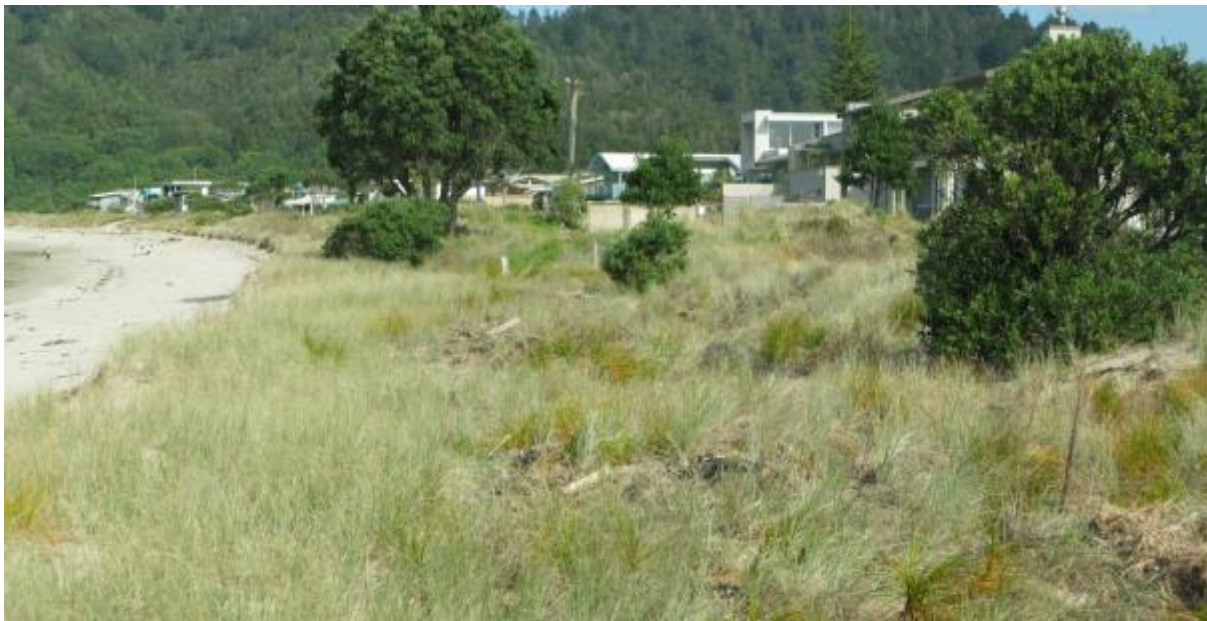
Figure 13: Views to the north (top) and south (bottom) of Island View Reserve at Whangamata. Note in the top photo how the seaward advance of exotic species (arrowed) has resulted in only a narrow width of spinifex and other native sand trapping vegetation being left to seaward. This narrow zone could be completely lost during severe erosion, preventing natural dune repair once the erosion phase was over. In contrast, the area to the south of the Island View reserve retains a wide zone of native sand trapping vegetation (spinifex and pingao).

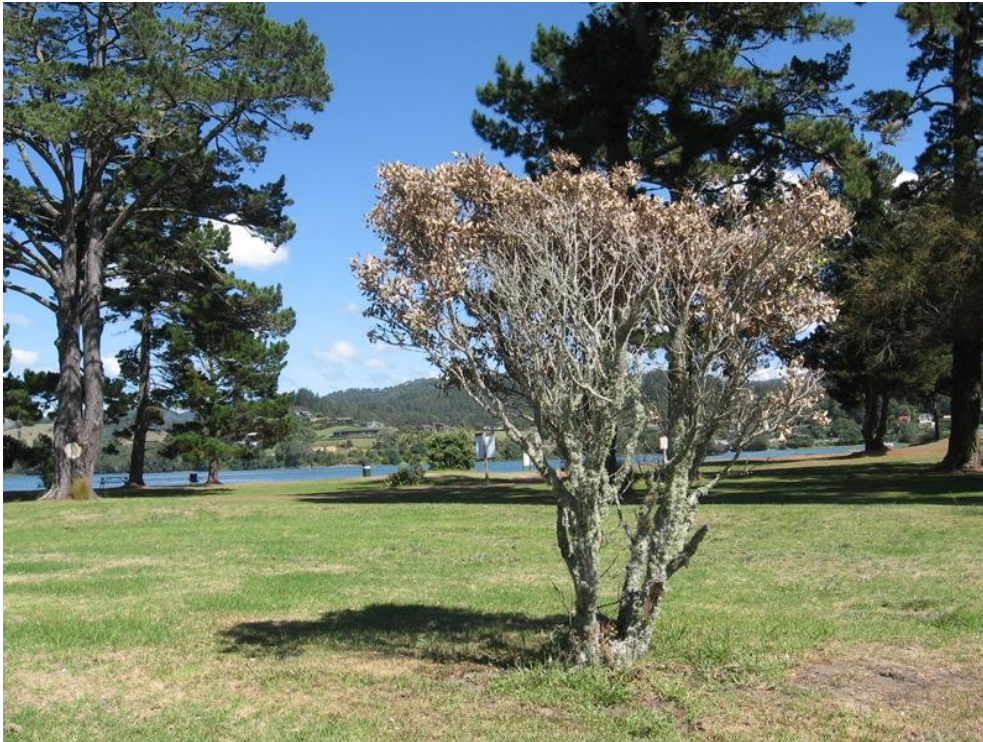
Figure 14: A poisoned pohutukawa at Pleasant Point, Pauanui. Vandalism of young trees makes it very difficult to develop succession planting to provide amenity and shade in the future.

A further issue noted at all three sites was the lack of beach shade on the beachfront reserves – with limited trees in many areas. Council staff also noted that there were serious ongoing issues with trees and shrubs on reserves being killed or extensively (and usually very poorly) pruned to enhance views from properties to landward (e.g. Figure 14). Thames Coromandel District Council bylaws exist to protect vegetation and structures on Council reserves, and any act that damages trees is in violation of Bylaw 1706 (see Appendix F). A strategic approach to this issue may also be required if the existing issues continue.

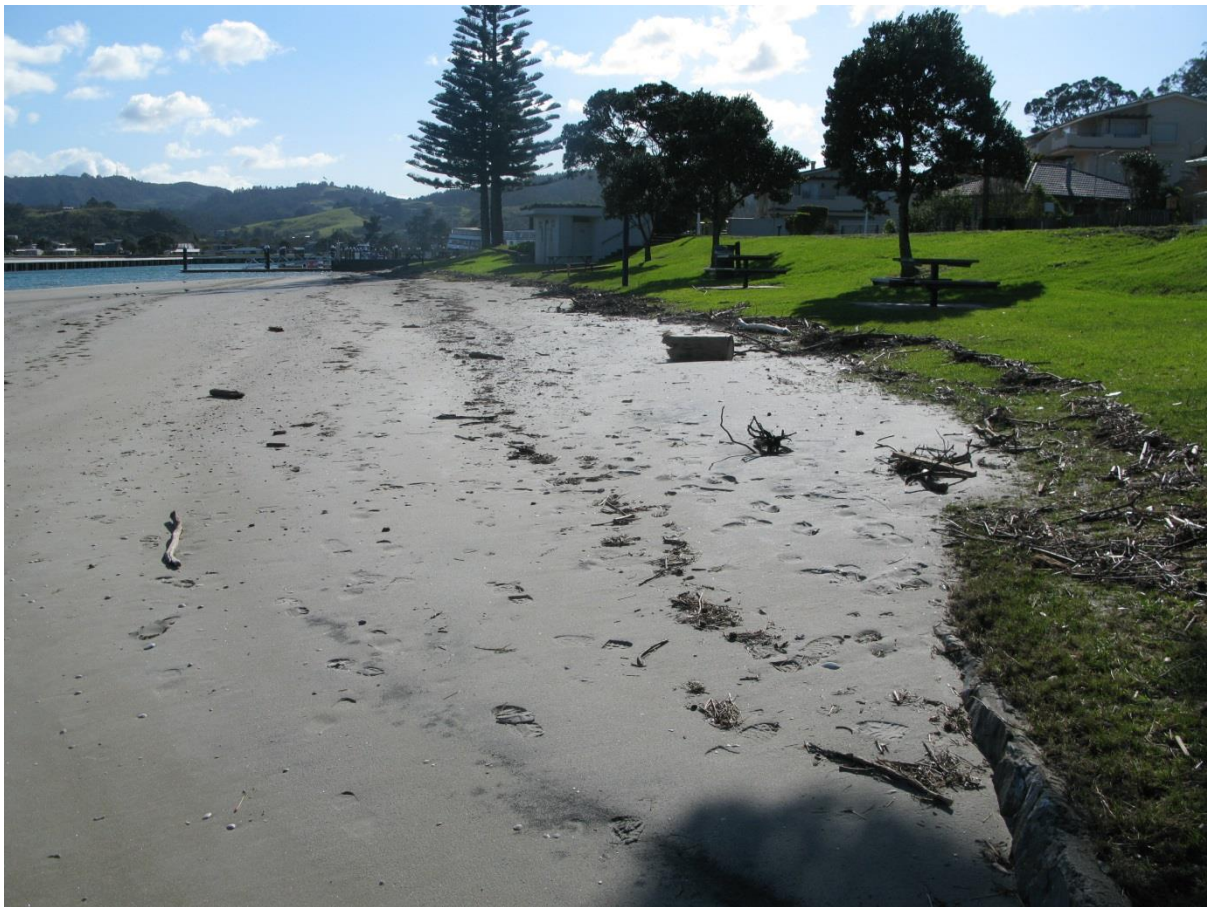
Figure 15: Esplanade beach, Tairua Harbour. Recent beach nourishment has significantly raised the beach level and improved the amenity value of the area.

The beach has recently been nourished with material from the dredging of the adjacent marina, and this has greatly reduced the height of the existing seawall, improving the ease of access and increasing the width of beach for recreational use. **Beach amenity should be retained with occasional nourishment as required.**

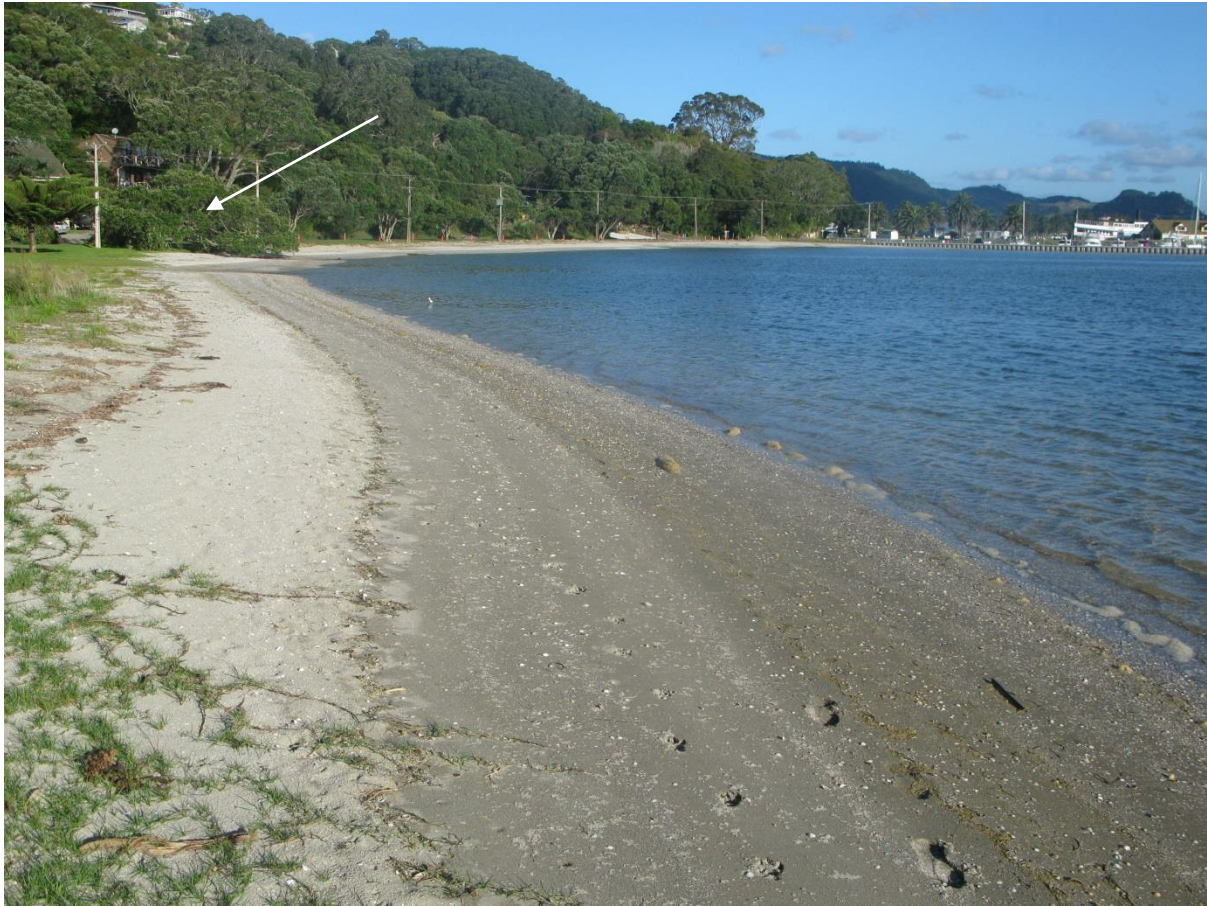
Figure 16: Paku Bay showing enhancement of the natural and amenity values by recent beach nourishment. The large pohutukawa tree near the centre of the beach (arrowed) is culturally significant and the nourishment has also enhanced protection of this tree which had been undermined by erosion and collapsed across the beach.

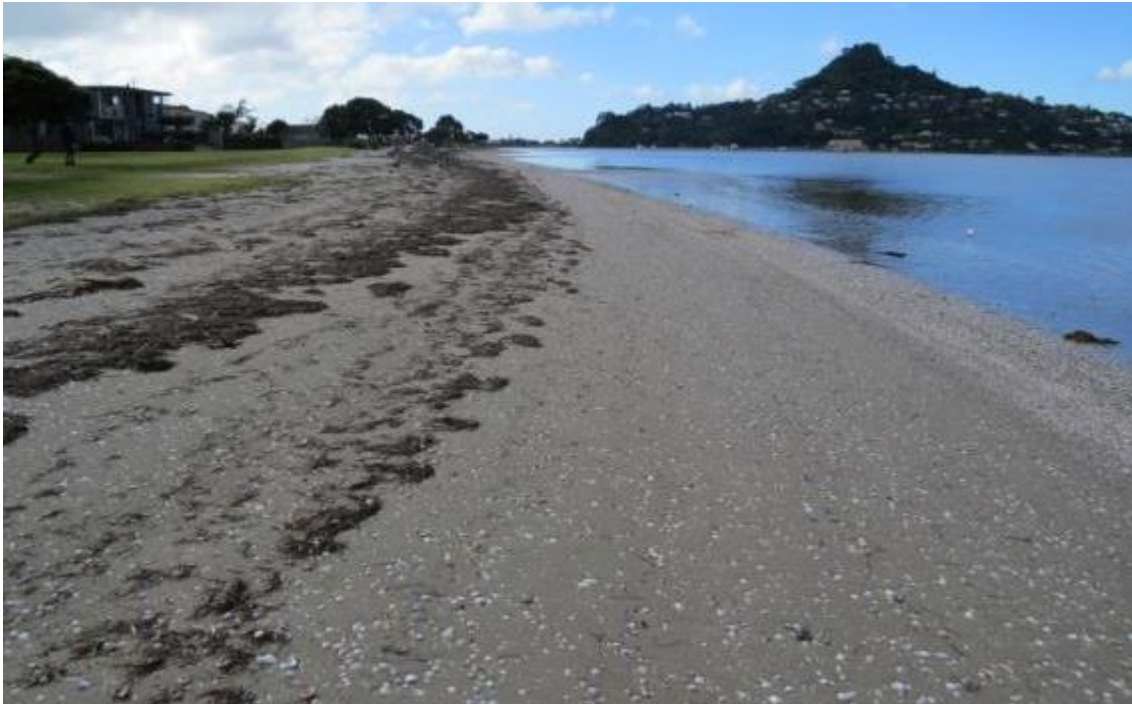
Figure 17: Manaia Road Beach following nourishment in 2014.

Recent nourishment using sands dredged from the Tairua Marina in 2014 has enhanced the beach width and provided increased erosion protection for the grassed reserve and flood embankment along most of the shoreline (Figure 17). The nourishment has also enhanced beach amenity and has generally received very positive feedback from the community and owners of adjacent properties. The nourishment however did not extend to the eastern end of the beach because owners of the adjacent (and particularly low-lying) properties were concerned that it may aggravate blocking of public and private stormwater outlets in this area.

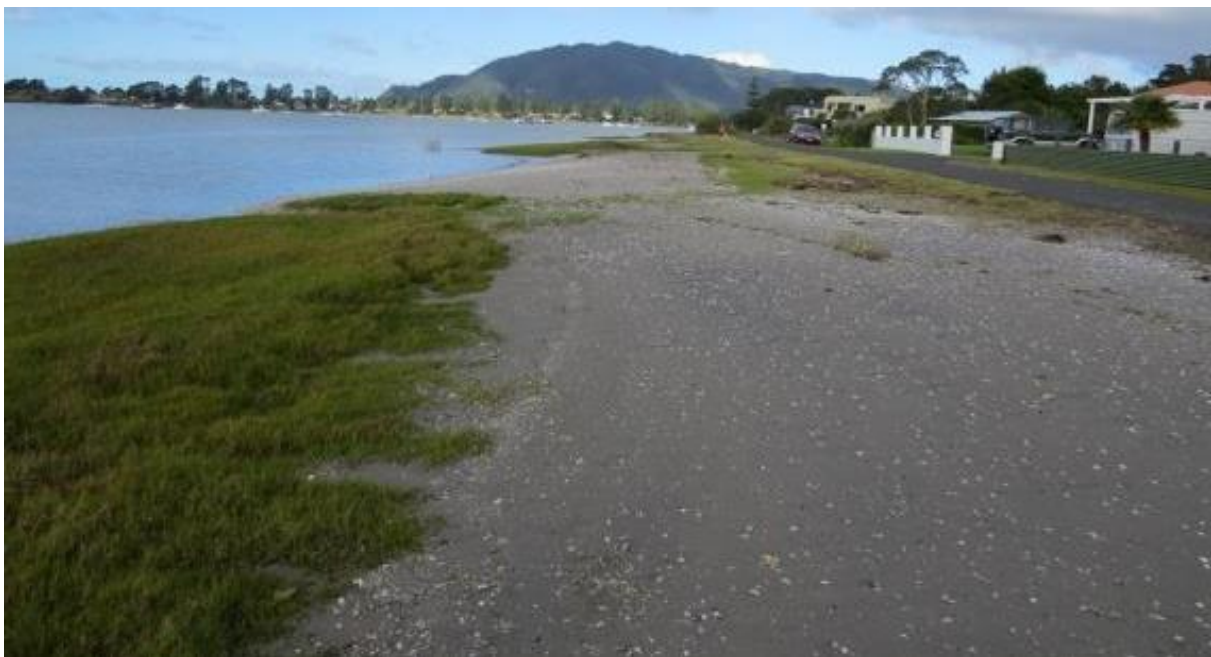
**Figure 18: Shoreline at northern end of Bay View Terrace showing successful beach nourishment. Note that the beach is however gradually being covered by saltwater paspalum.**

The beach is however being impacted by salt water paspalum which if left unchecked will eventually cover the beach. **Salt water paspalum should be controlled** to maintain and enhance amenity values of the beach.

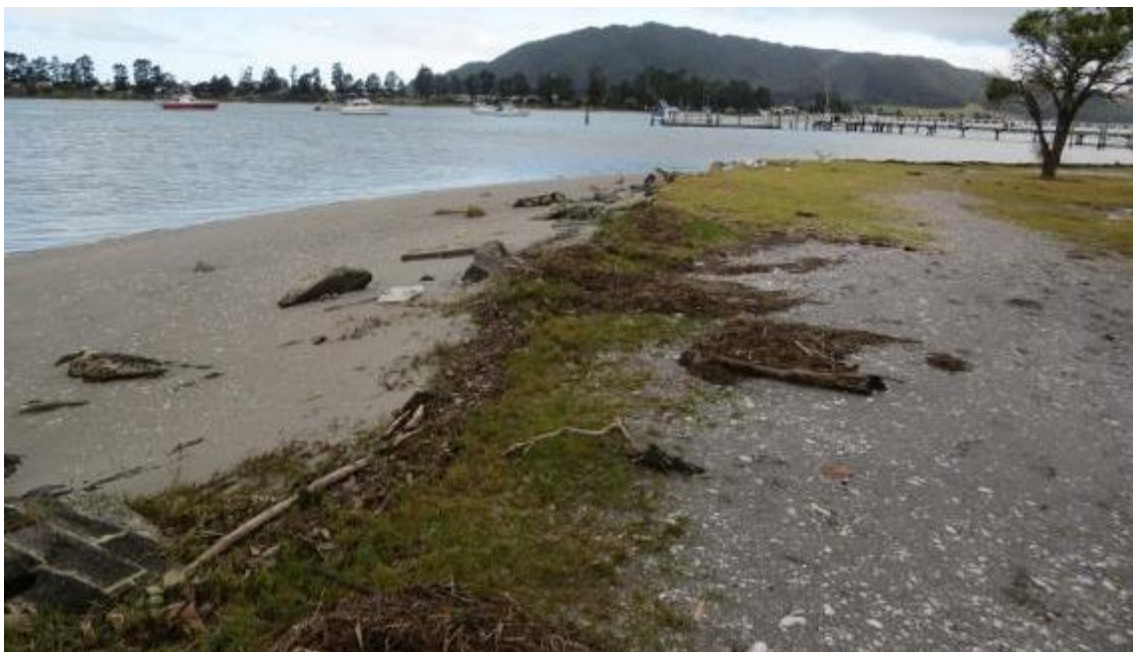
Figure 20: Rocks and remains of structures near Mary Beach. Removal of these materials would improve public safety and amenity, as well as the general appearance of the area. It is likely that erosion in this area can be successfully managed using beach nourishment as required.

In the area closer to Mary Beach, the shoreline contains various rocks and rubble which are currently serving little to no purpose and are unsightly and a potential safety hazard (Figure 20). We recommend that the rocks and rubble are removed and the area can be managed using beach nourishment if required. Some of this area will also be part of the upcoming redevelopment of Mary Beach wharf facilities.
