# Eastern Seaboard Coastal Management Plan:

Coastal Strategy for the Tairua, Pauanui and  
Whangamata Ocean and Estuarine Shorelines

**Thames Coromandel District Council**

**July 2015**

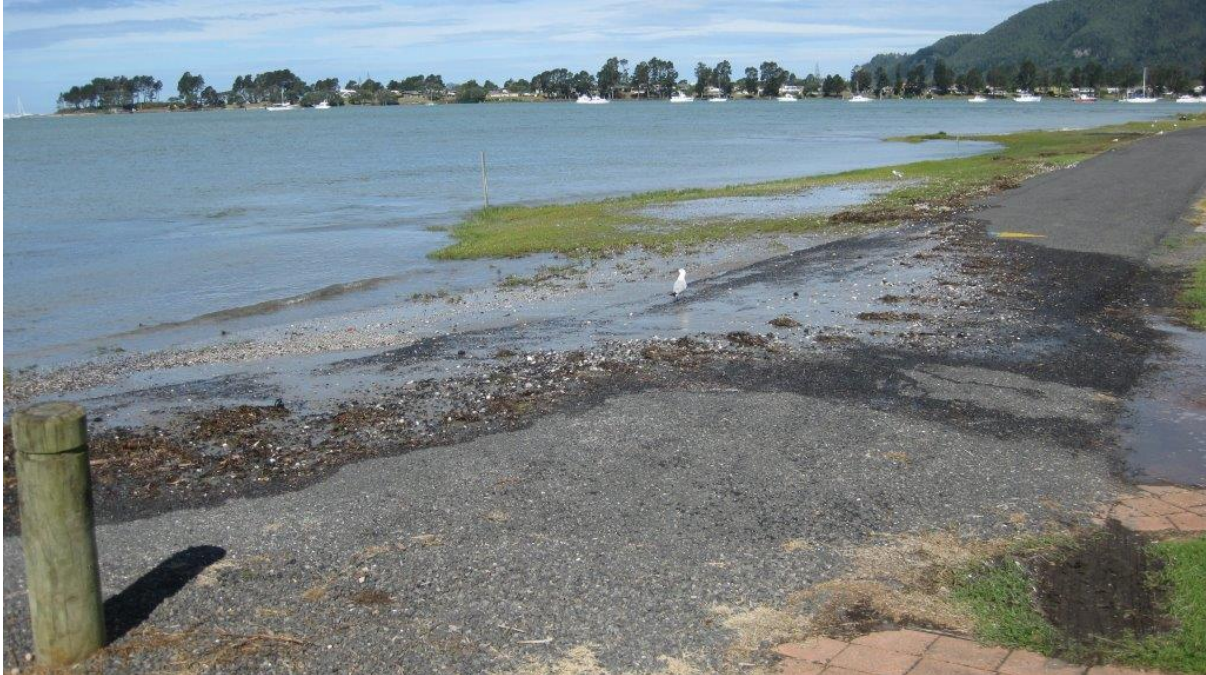
Figure 21: Recent (16 March 2015) flooding of Bayview Road.

The low-lying shoreline, including the public reserve, footpath and lower areas of Bayview Terrace are occasionally inundated by sea flooding associated with periodic storm-elevated sea levels and occasional wave overtopping (e.g. due to longer period swell wave energy propagating through the entrance into the lower estuary, Figure 21). The flooding generally does not cause serious issues but can carry significant debris onto the road, footpath and grassed reserves. Over time, it may be practical to gradually lift the beach and back-beach areas with nourishment to reduce these sea flood episodes.

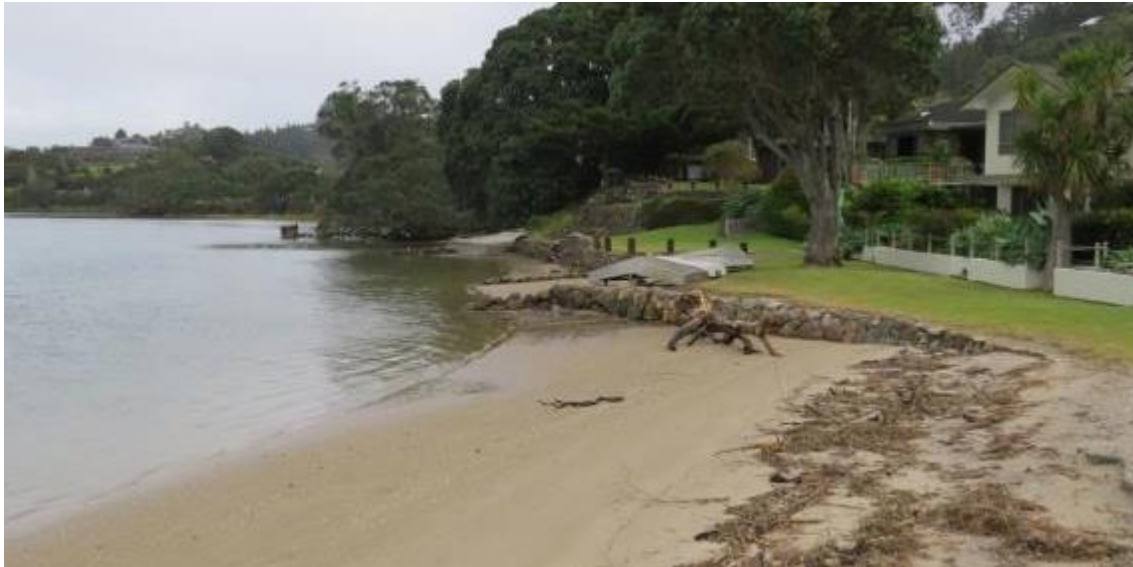
**Figure 22: Shoreline at eastern end of Petley Parade. Note that the boundary of the public reserve is approximately where the white fence is in the foreground. The old block seawall was privately constructed, but lies on council reserve land.**

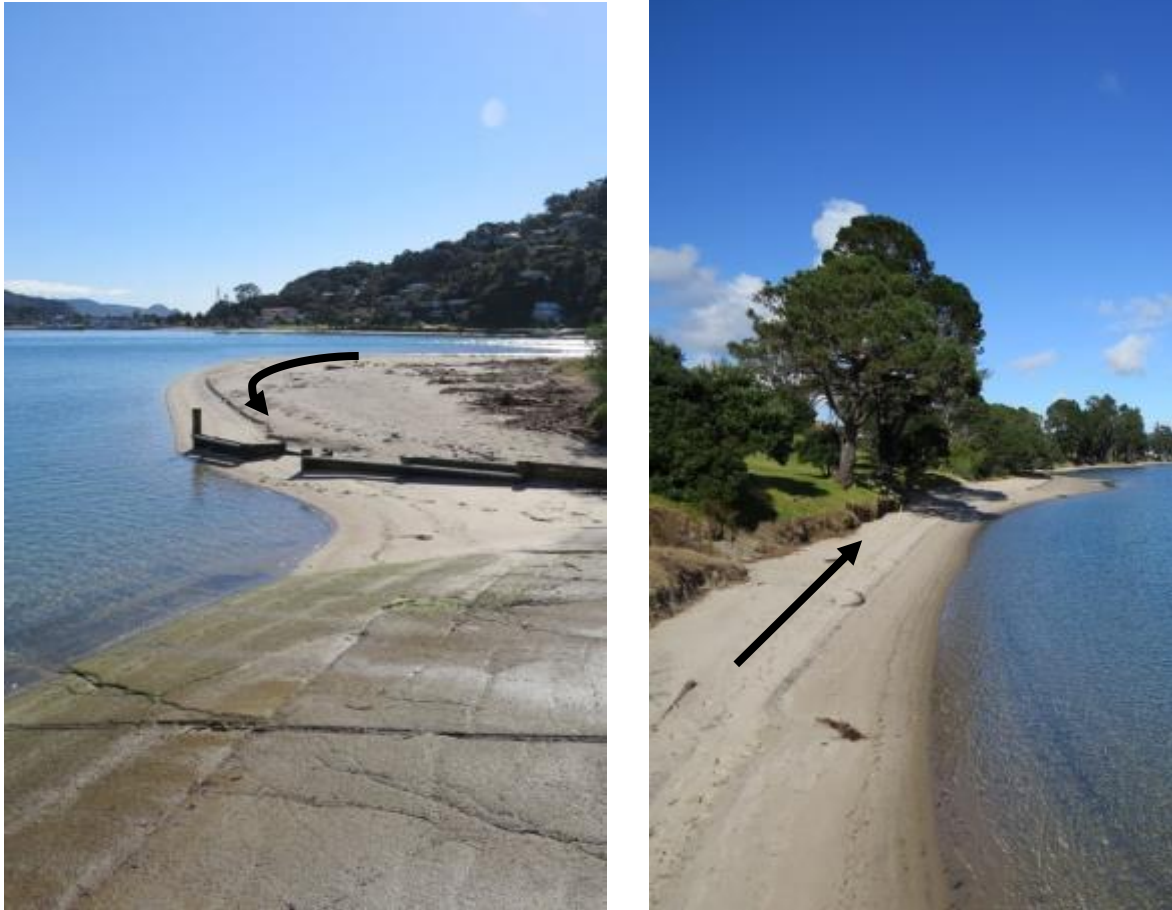
**Figure 23: Sediment accumulation on eastern side of Pauanui Wharf boat ramp (left), and eroding beaches to the west (right), where sediment should be placed. Arrows indicate dominant natural direction of sediment transport.**

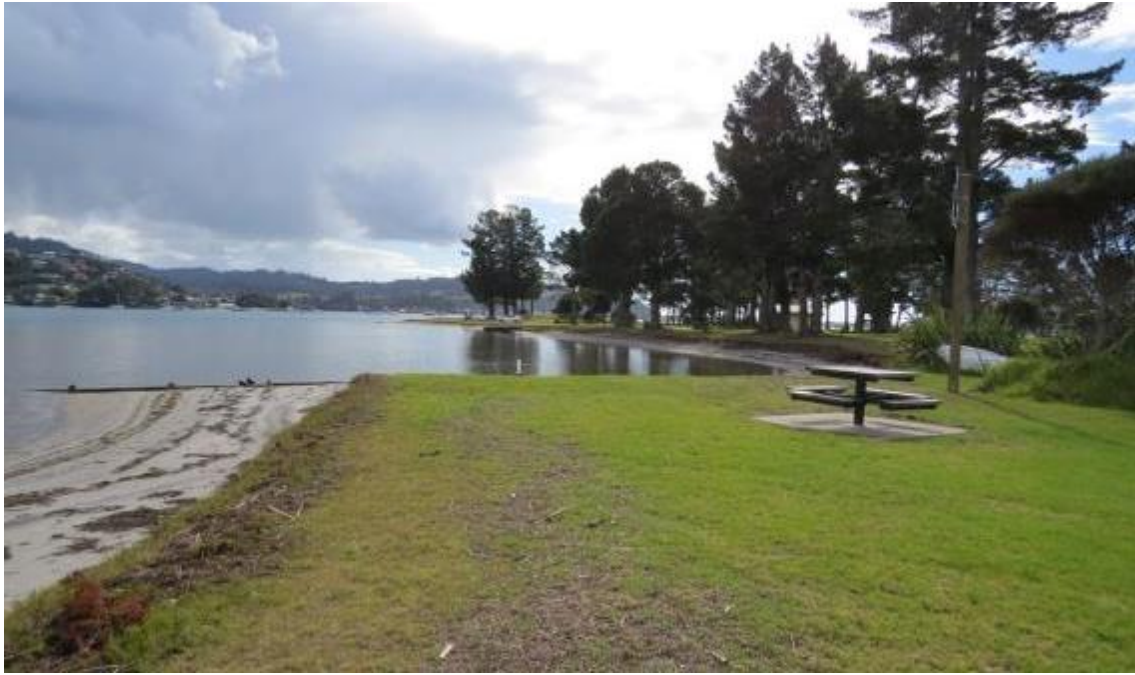
Figure 24: Minor beach erosion south of Pleasant Point. The shoreline here is partly impacted by the groyne shown in the left foreground, which has restricted northwards sediment supply to the reserve.

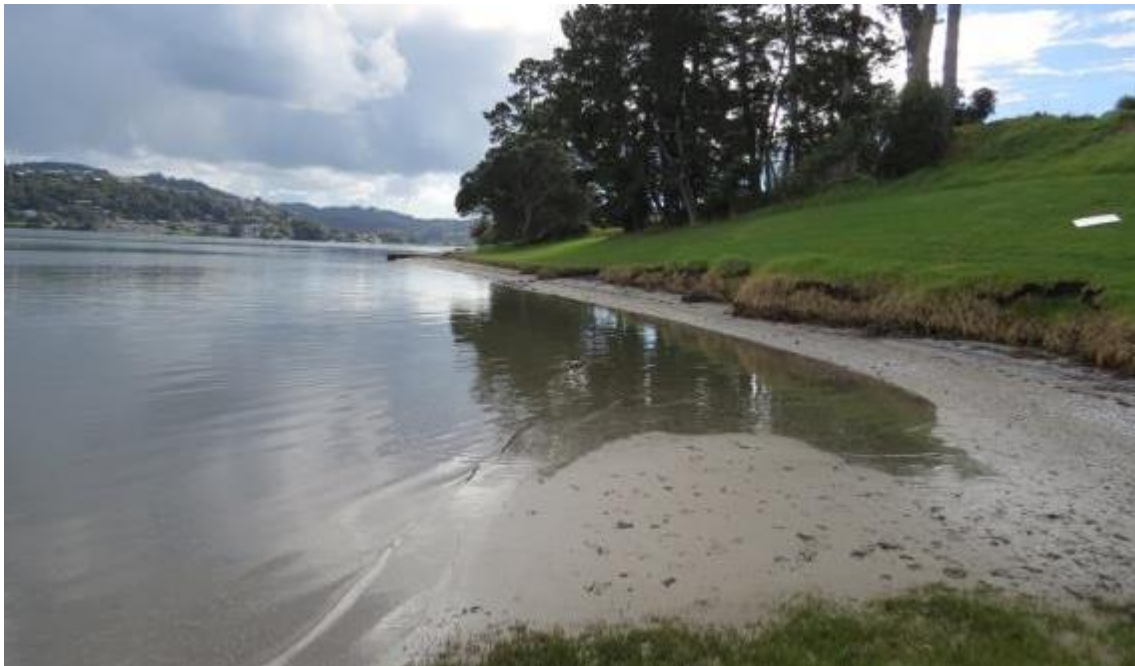
Figure 25: Area of past beach nourishment between Pleasant Point and Ajax Head. The sloping grassed reserve was constructed using dredged material from construction of the Waterways access channel in the 1990s. Monitoring indicates that the placed sediment performed well and much of the placed sediment is still present, even though slow erosion is occurring.

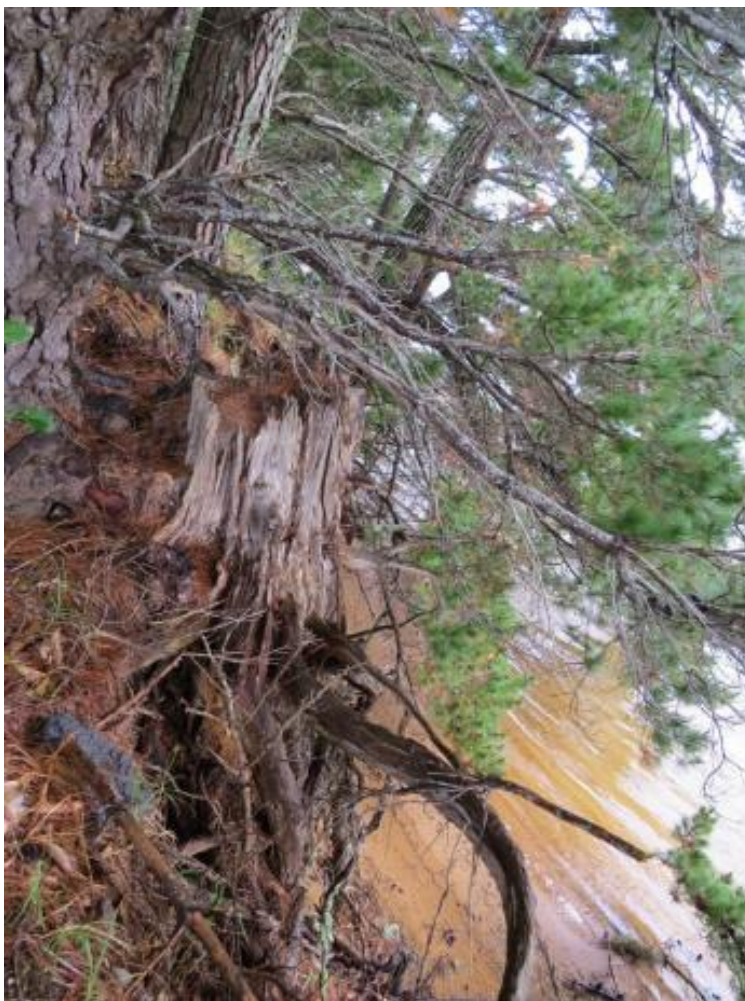
Figure 26: Erosion of the bank at Tangatarori.

At Tangatarori, slow erosion of the bank is undermining large pine trees on the Council reserve and private development (Figure 26). Historical aerial photographs suggest the erosion is very slow.

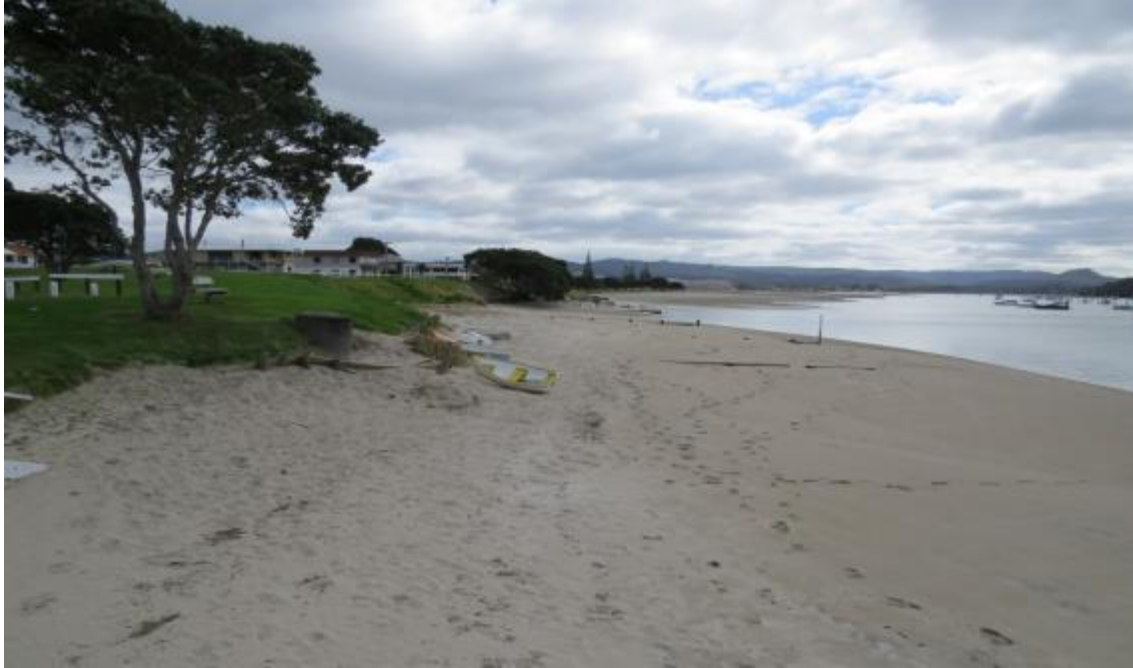
Figure 27: The shoreline immediately upstream from the Whangamata Wharf. The beach is presently in an accreted condition with the groynes buried. This relates to a natural pulse of sand passing through the area and the groynes have not played a significant role.

In the past, erosion in this area has led to construction of wooden groynes in places along the shoreline in an attempt to protect the grassed reserve and Beach Road (Figure 27 and Figure 28). There is some limited evidence of sediment accumulation against the groynes at times, but in general it appears the groynes have only had minor beneficial effect. For instance, some of the groynes (especially nearer the wharf) are completely buried during pulses of accretion (e.g. Figure 27); this burial due to natural sediment pulses and not to sediment trapping by the groynes. Past experience also suggests the groynes are not adequate to protect the shoreline during the periods of most severe erosion. Nonetheless, we recommend that the **existing groynes** be left in the interim until it has been more firmly established that are of little use, at which time they could be removed.

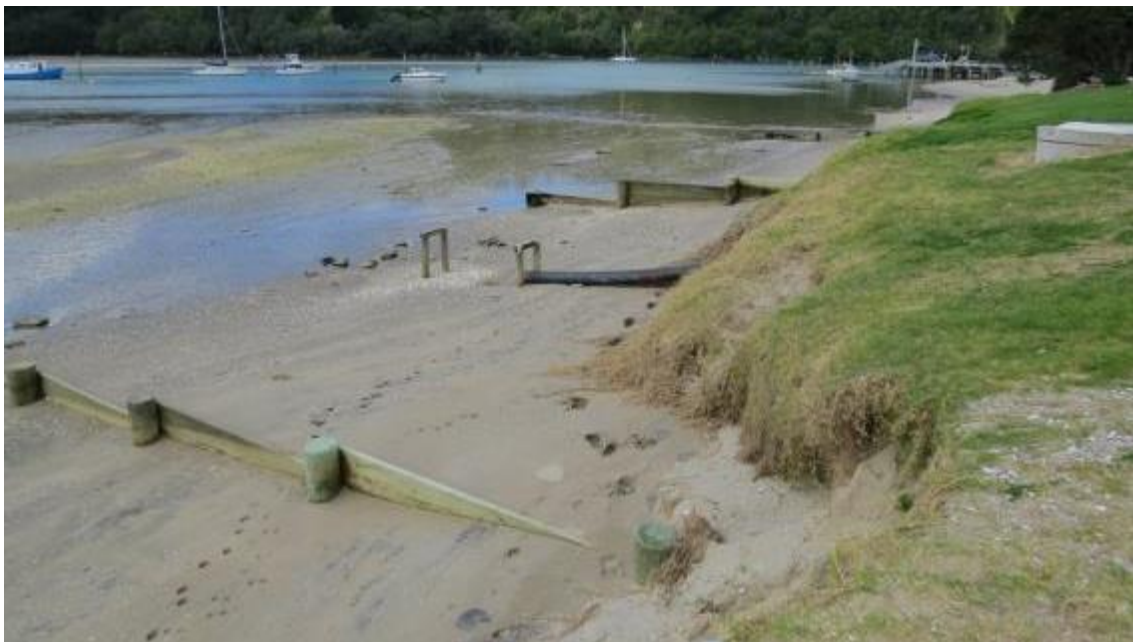
Figure 28: The shoreline adjacent to Beach Road, between Bond and Rutherford Roads. Erosion in this area can be severe at times and may threaten Beach Road in the future.

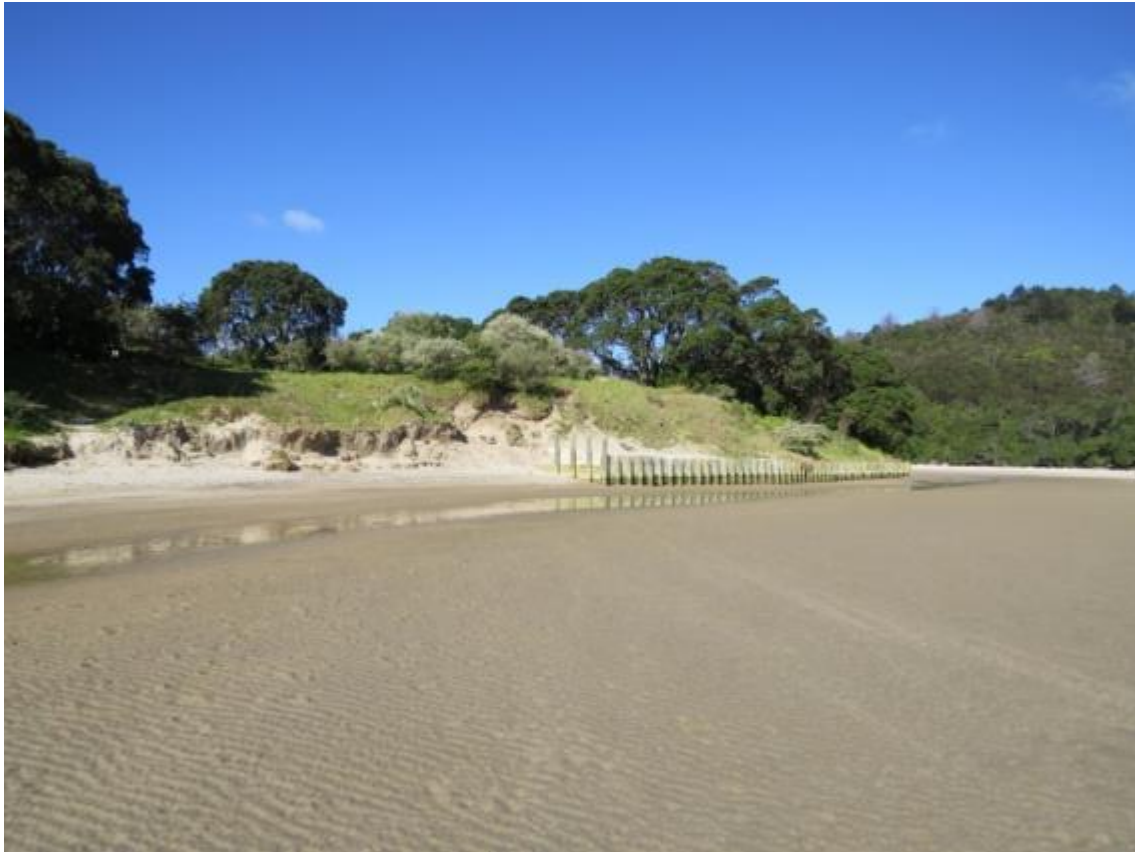
Figure 29: Wooden wall protecting the estuary shoreline of Otahu Point historic reserve at the entrance to Otahu estuary.

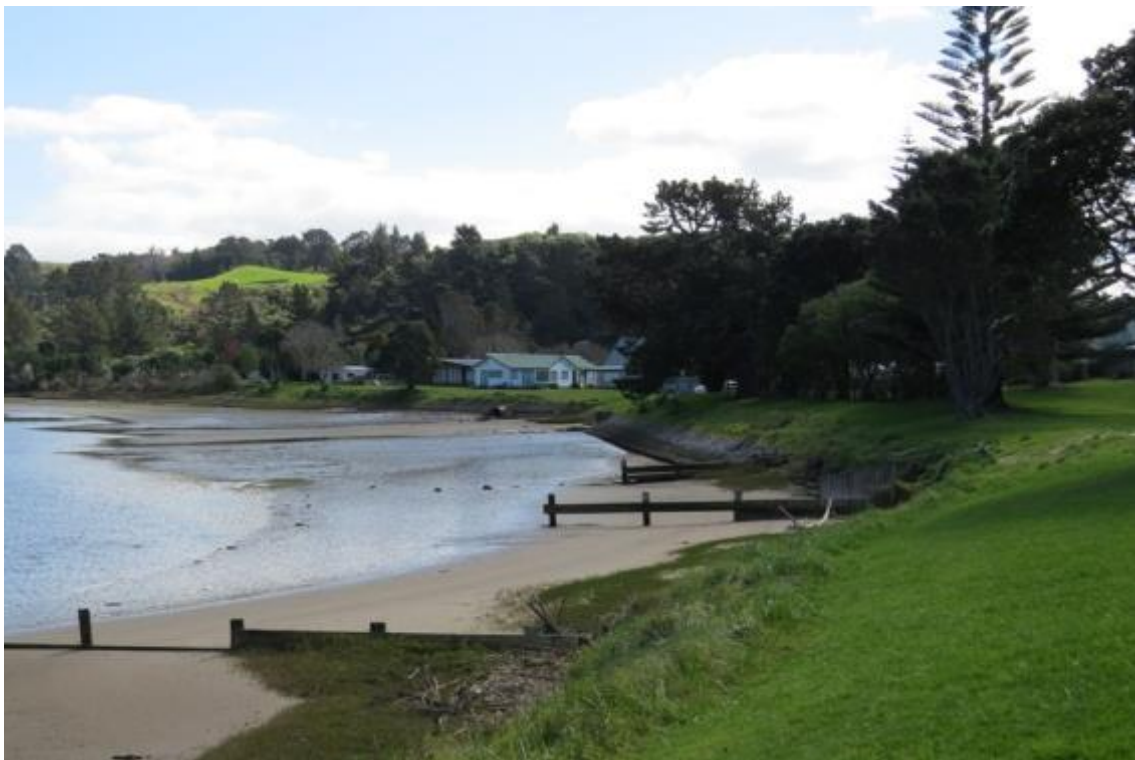
Figure 30: Shoreline protection works in Otahu Estuary, east of Kotuku Street. The gabion basket wall in the background is beginning to deteriorate.

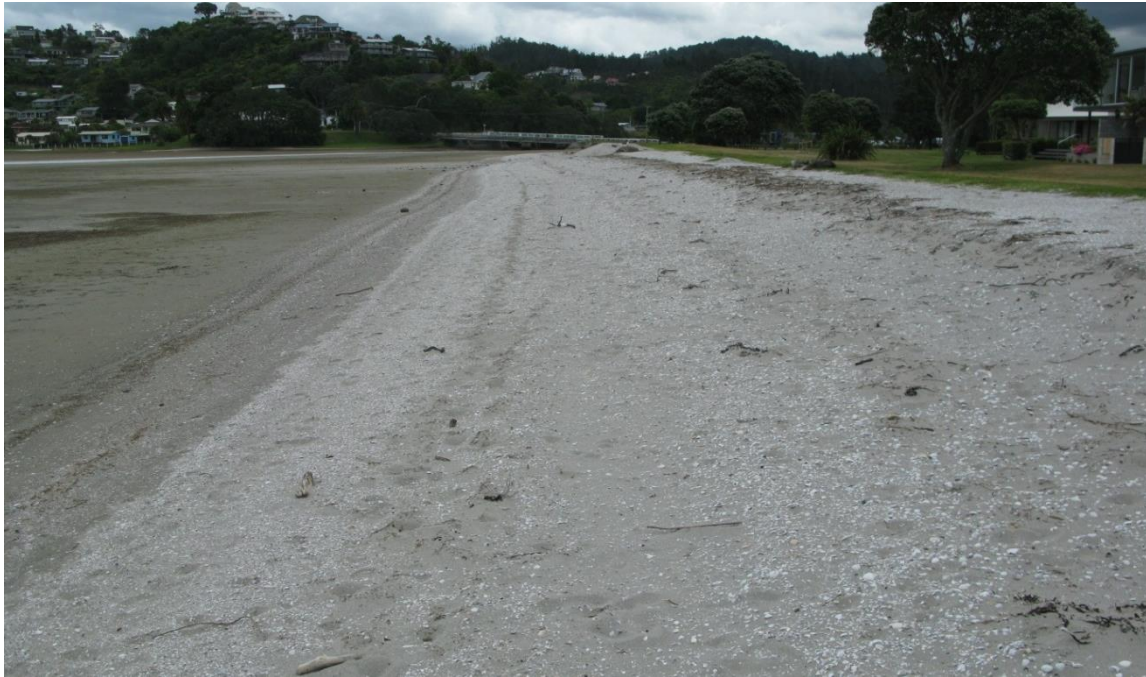
Figure 32: Sediments from the Tairua Marina development have been used successfully to enhance the beach at Manaia Road.

As discussed above, most estuary beaches in Tairua can be managed successfully using the ongoing supply of suitable sandy sediment from maintenance dredging. The same approach could be used at sites in Whangamata and Otahu estuaries, but the supply of suitable sand is likely to be much less.

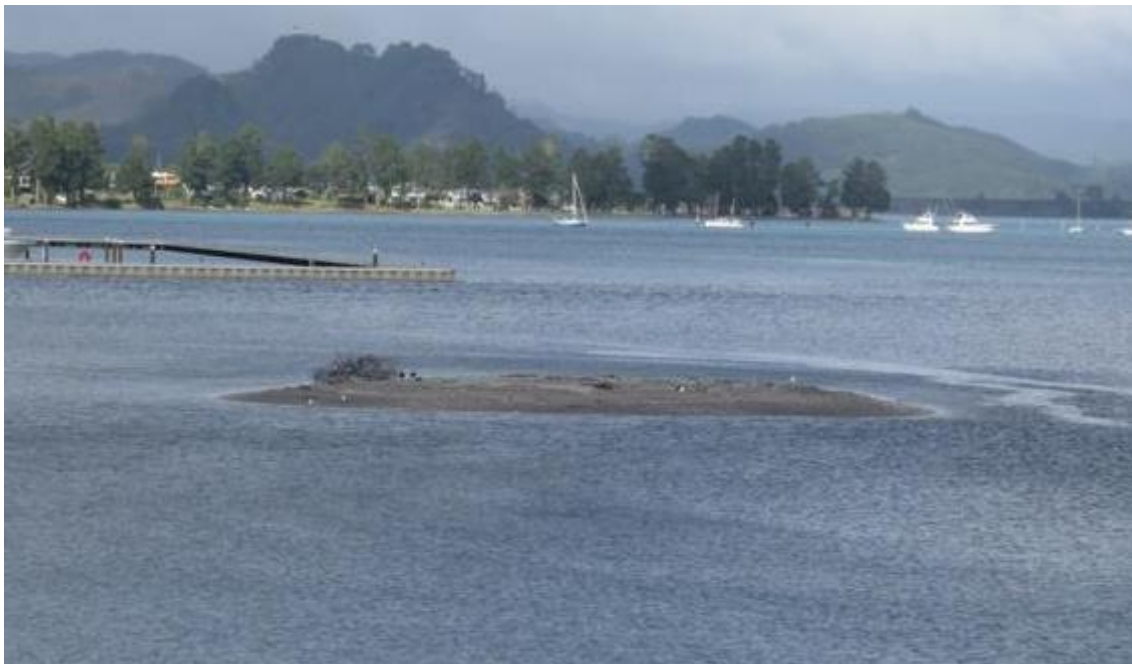
**Figure 34: High tide bird roosting island in Paku Bay.**

There are very few safe roosting areas for wading birds at high tide in Tairua and Whangamata. Mainland sites are frequently disturbed by human activity and particularly dogs. There is potential to create more high tide roosting areas in the form of low chenier (sand and shell) islands within the estuaries, such as those created in Paku Bay as part of the Tairua marina development (Figure 34). This can be achieved by slightly increasing the elevation of existing sand/chenier ridges so that they remain exposed at high tide.
