Guidelines for
**Managing Mangrove
(Mānawa) Expansion**
in New Zealand

To provide guidance on the best techniques to manage mangrove expansion, while maintaining the ecological integrity of estuaries and harbours.

Lundquist, C., Carter, K., Hailes, S., Bulmer, R. (2017) Guidelines for Managing Mangroves (Mānawa) Expansion in New Zealand. *NIWA Information Series* No. 85. National Institute of Water & Atmospheric Research Ltd. <http://www.niwa.co.nz/managingmangroveguide>

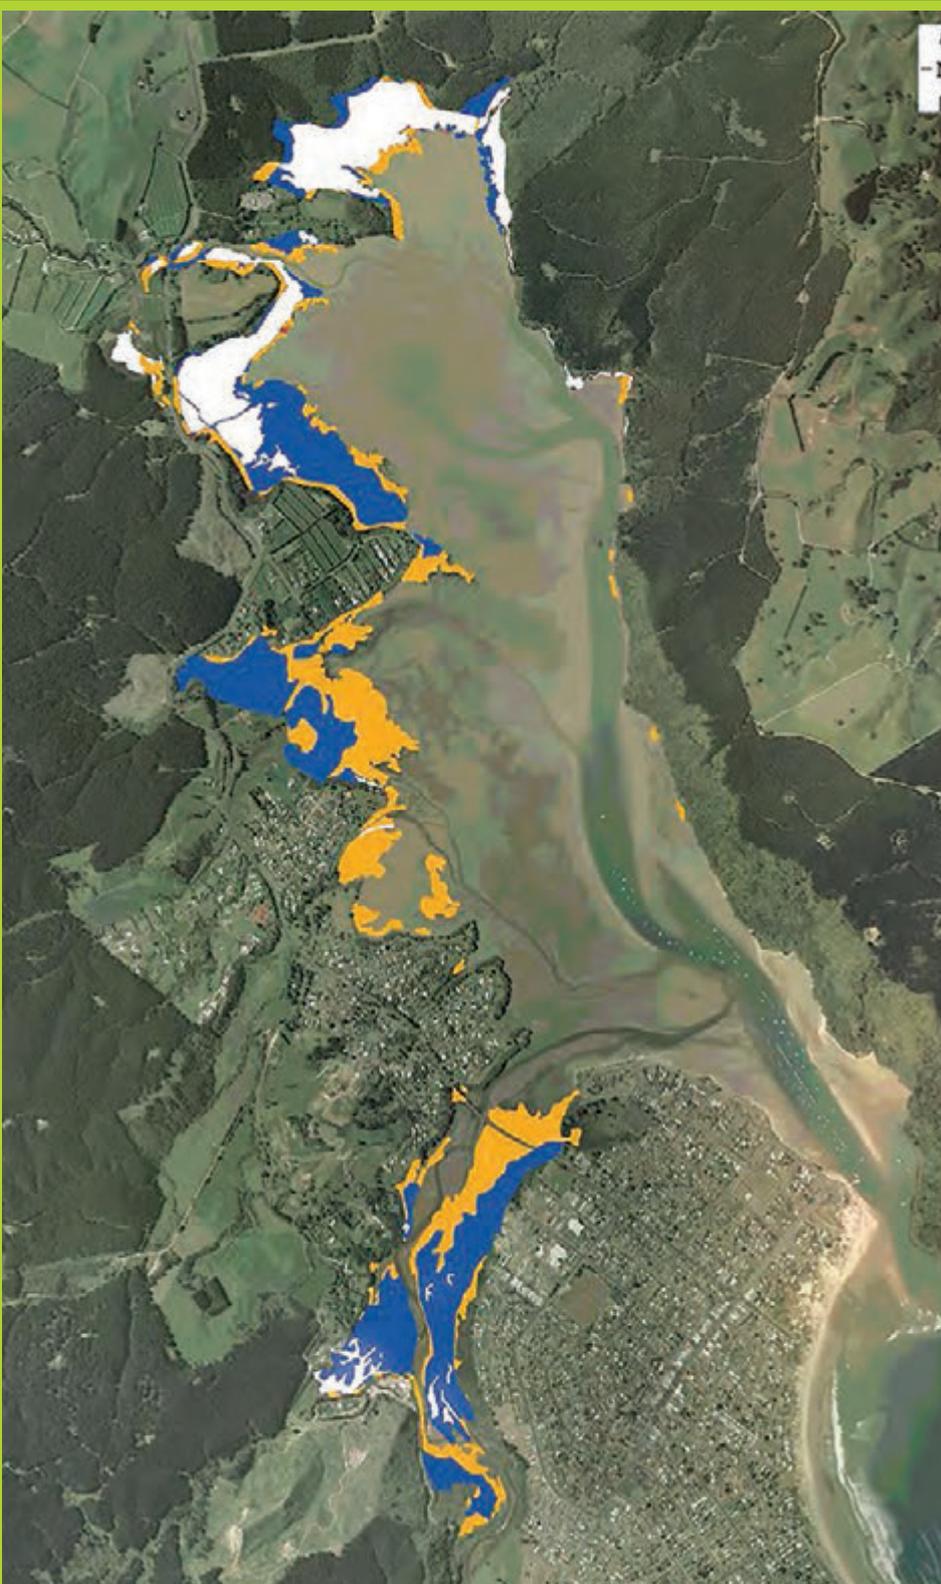
Figure 1: Aerial view of Whangamata Harbour and the extent of area occupied by mangroves in 1944 (white), 1978 (blue) and 2002 (orange). Figure: Waikato Regional Council.

Over the past half century, mangroves have expanded in extent in New Zealand, mainly seaward across tidal flats (for example in Whangamata Harbour, Figure 1).

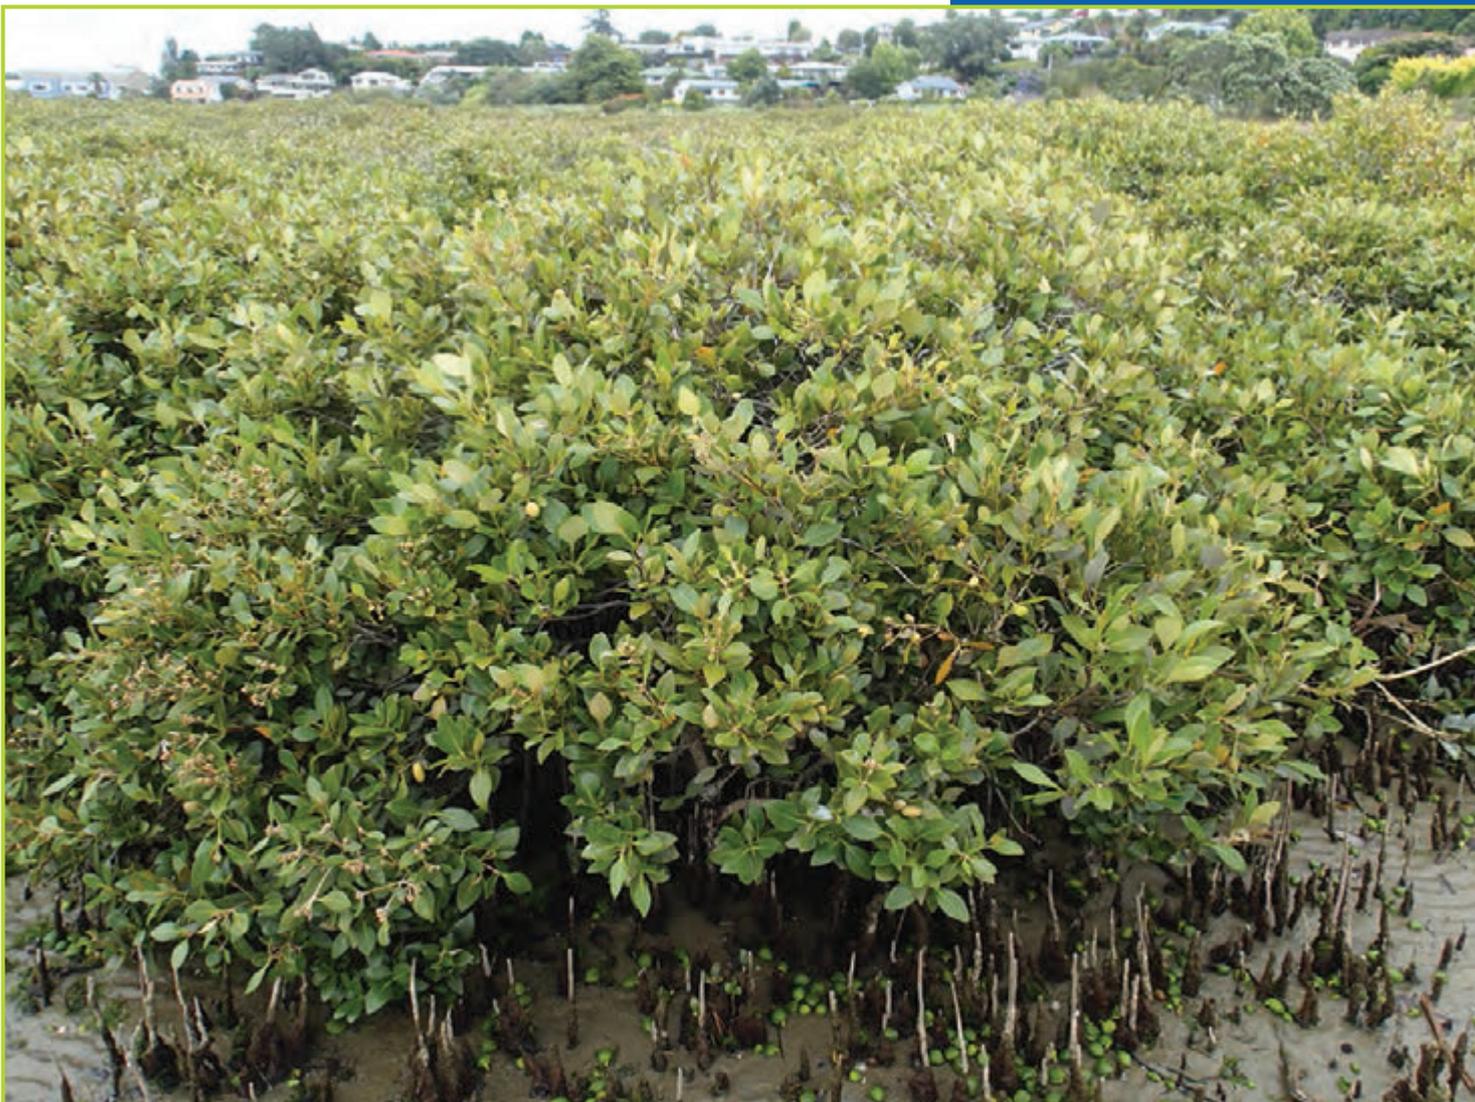
Figure 2: Ecosystem services provided by coastal mangroves in New Zealand. Figure: Max Oulton.

Mangroves provide many physical and ecological functions in New Zealand estuaries. Mangroves provide a buffer zone and protection from erosion of the coastline. Policy 26(2) of the New Zealand Coastal Policy Statement recognises the potential for mangroves to provide a natural defense against coastal hazards.

Ecologically, mangroves provide energy and organic matter in the form of leaf, seed and woody debris to the environment which is incorporated into the foodweb, thus supporting a diversity of animal life including both estuarine and terrestrial fauna and flora.

Mangroves and other coastal vegetation also have an important role in sequestering carbon, and are, therefore, important in contributing to New Zealand's international role in mitigating against climate change.

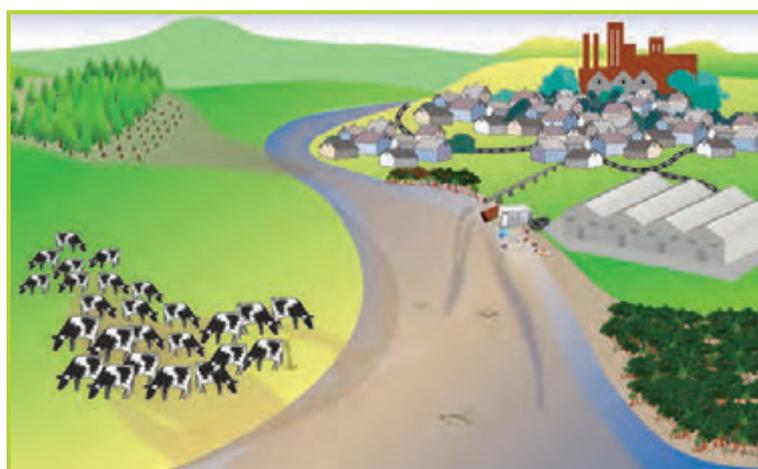
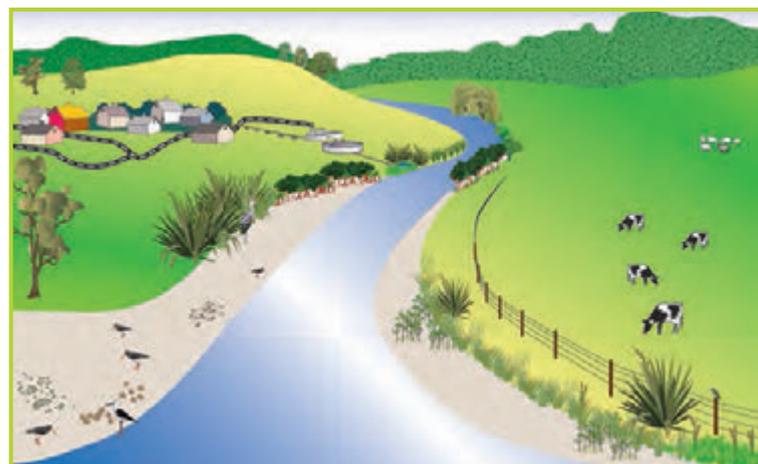
A. High intensity development

B. Low intensity development

Figure 3: Illustration of the impacts on estuaries and waterways when the surrounding land is highly modified (Scenario A, top) and less modified (Scenario B, bottom). Figure: Max Oulton.

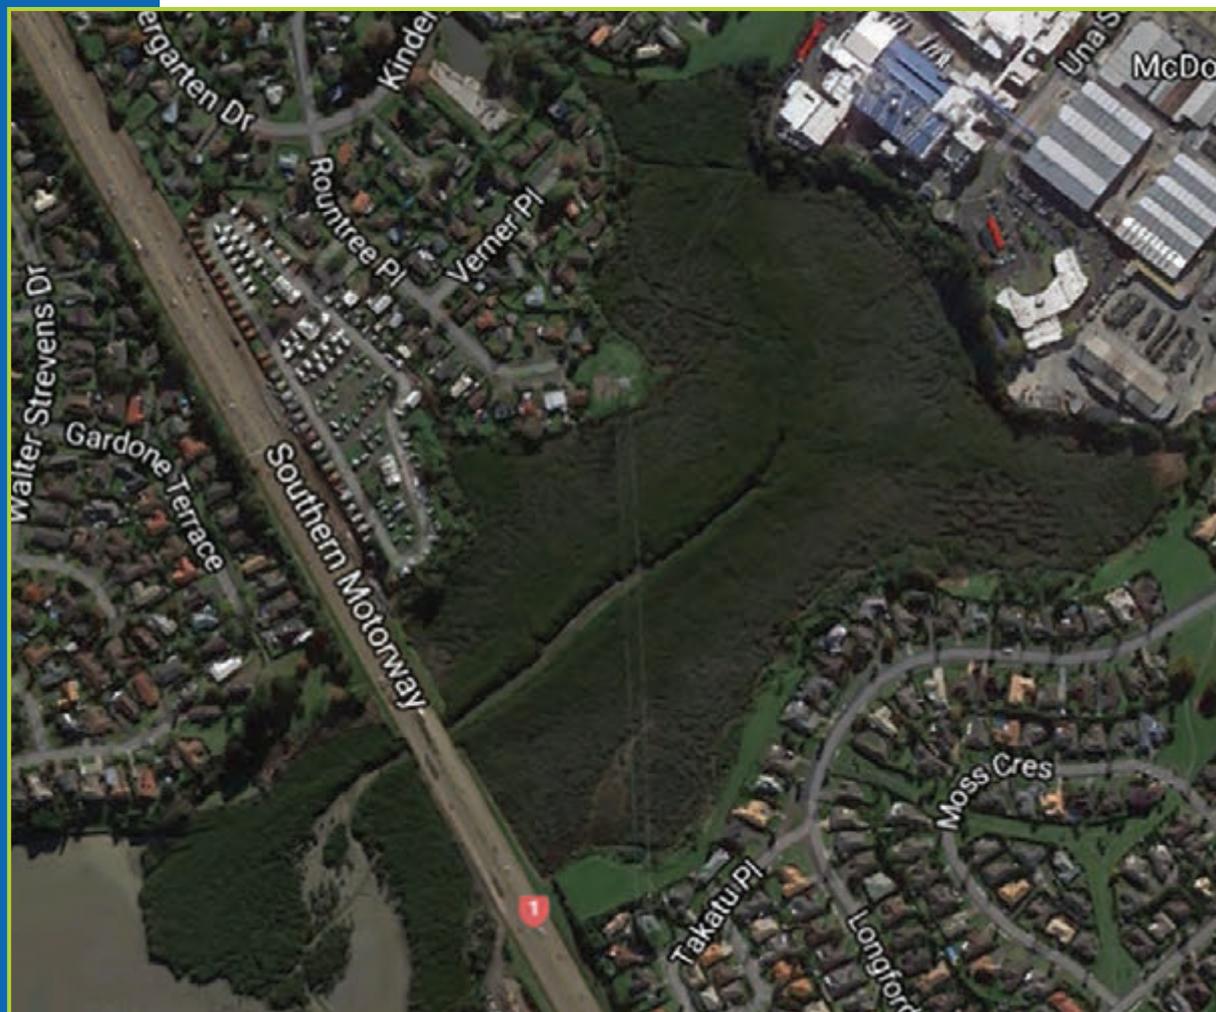
Figure 4: Illustration of tidal inlet with restricted flow due to causeway construction, resulting in mangrove colonisation, Pahurehure Inlet, Auckland. Figure: Google Maps.

The construction of causeways and other large structures changes the hydrodynamics of estuaries, and often results in a slowing of water flow through certain areas. This creates low-flow areas that facilitate the deposition of muddy sediments that are more suitable for mangrove establishment.

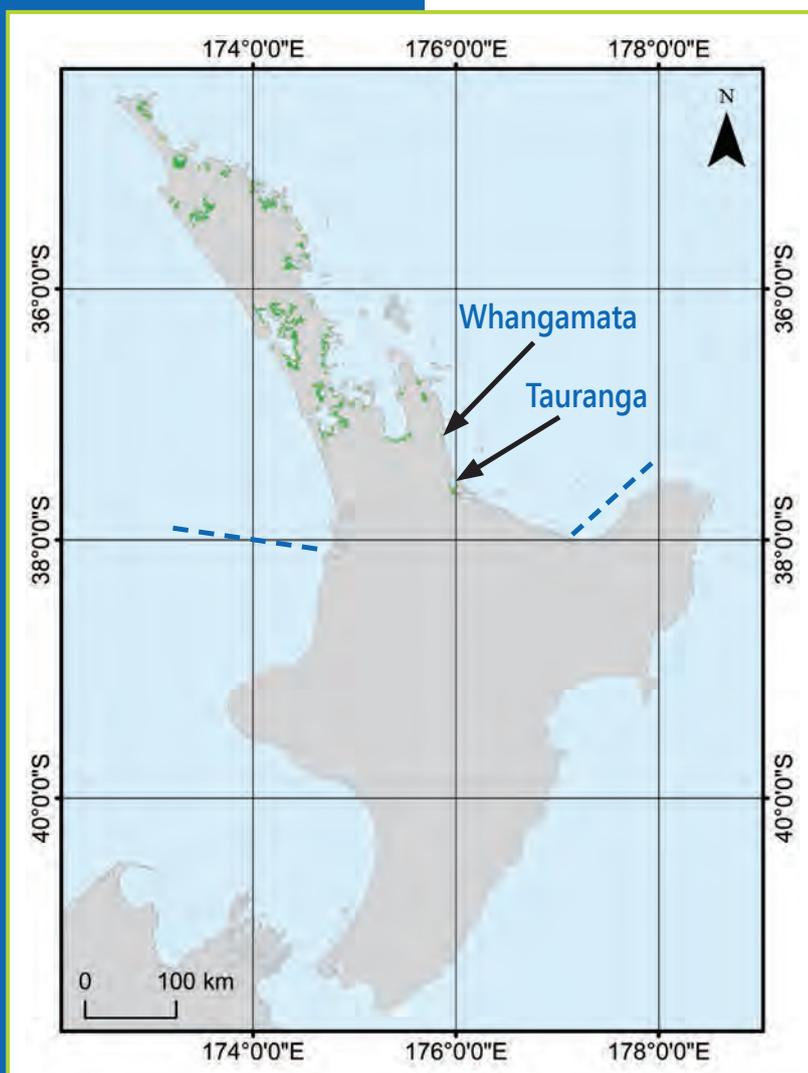
Figure 5: The current distribution of mangroves in New Zealand, showing the southern natural limit at Kawhia Harbour on the west coast and Ohiwa Harbour on the east coast (Morrisey et al. 2007).

New Zealand mangroves occupy North Island estuaries north of 38°S. The southern limit is likely determined by a combination of seawater temperatures, frequency and severity of frosts, and lack of suitable habitat, in addition to being limited by seed dispersal and distances between suitable habitats (Morrisey et al. 2007, 2010).

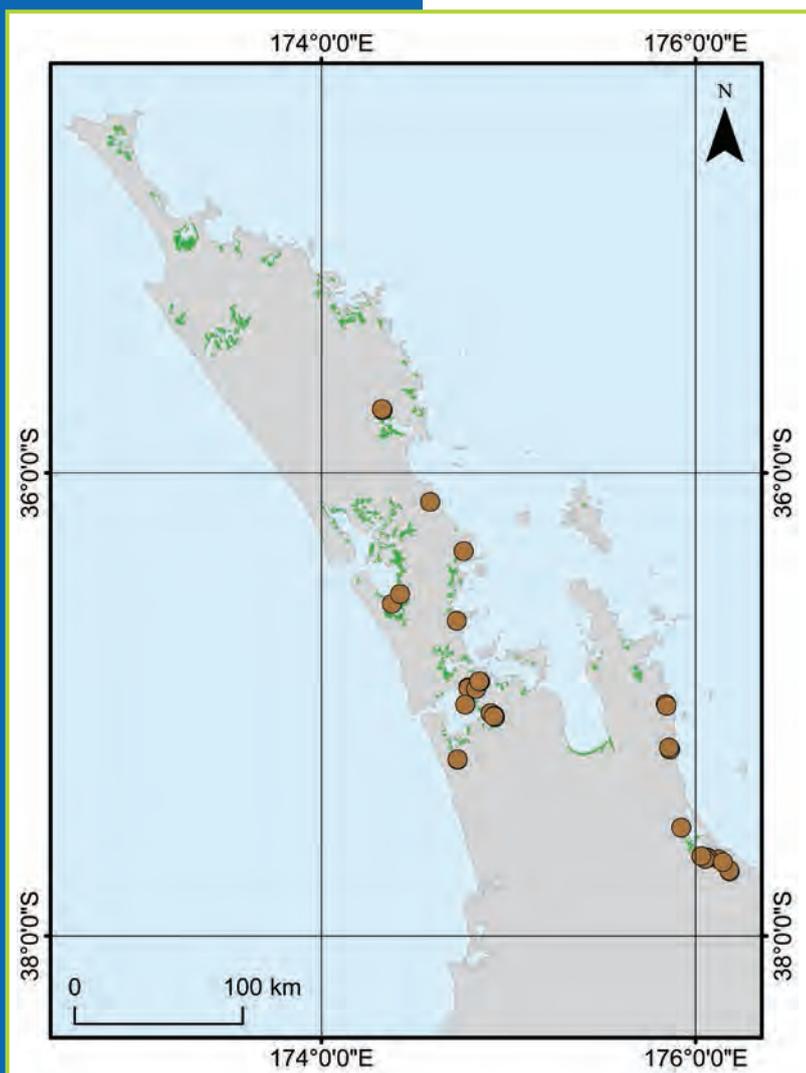
Figure 6: Map showing the location of ~40 removal sites surveyed by NIWA.

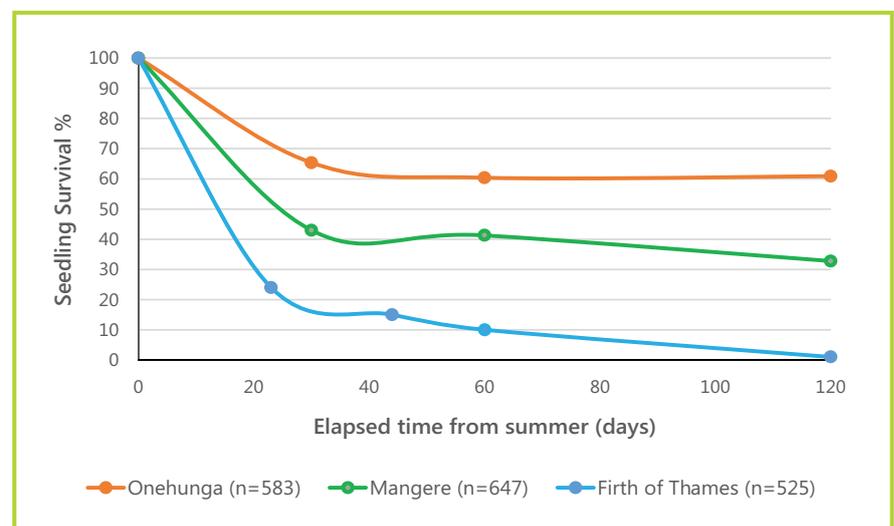
Figure 8: The percentage of mangrove seedlings surviving at three sites: Firth of Thames, Onehunga and Mangere, Manukau Harbour, Auckland.

The proportion of seedlings that survive differs between sites. Some exposed locations have low survival (e.g., Firth of Thames), while at other sheltered locations (e.g., Mangere, Onehunga) between 30% to 60% of seedlings survive through to the winter months.

This method is appropriate for all estuary types where access is relatively easy by foot or using a small boat. Most mangrove seeds disperse and colonise during summer months, and a large proportion of seedlings do not survive early autumn (Figure 8).

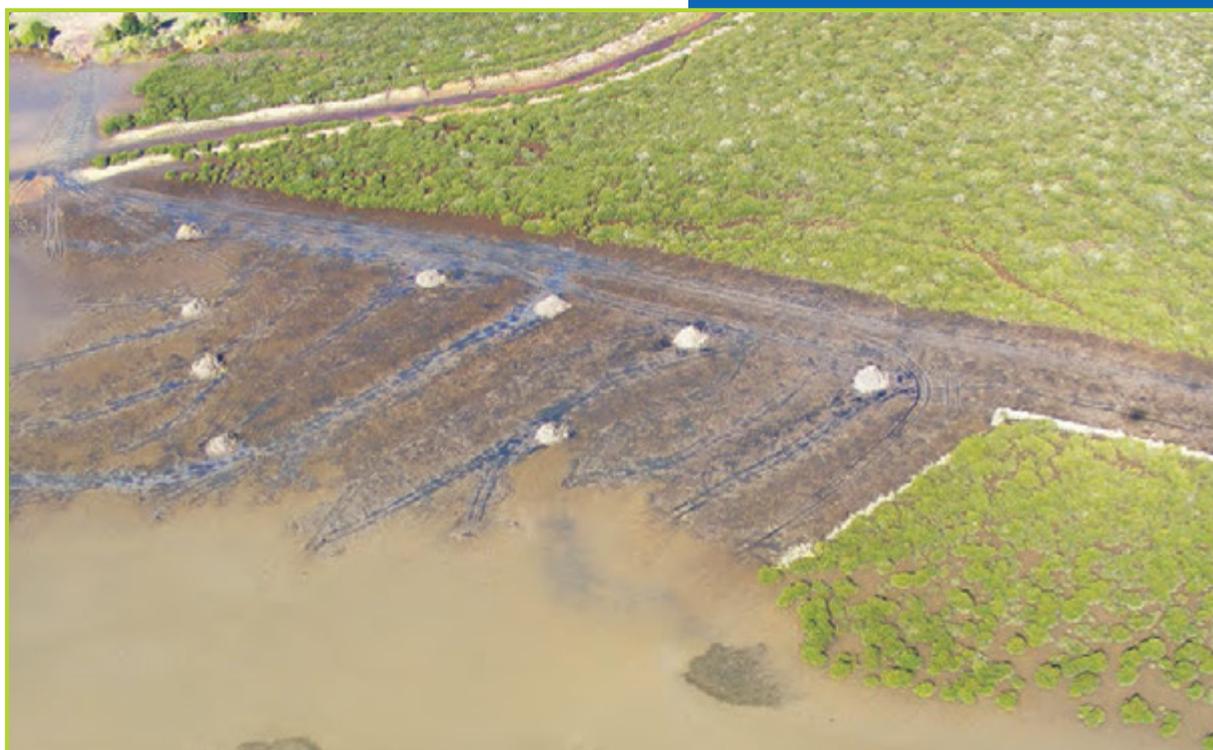
Tracking seen in Whangamata Harbour following mechanical removal, emphasising minimisation of tracking disturbance. Photo: Emily O'Donnell.

In Whangamata Harbour, a new mechanical method was trialled, attempting to reduce the impacts that had previously been observed in mechanical removals. Here, tyre track disturbance was actively minimised during removals by limiting tracking to around 10-20% of the removal site. Fewer adverse impacts were observed in terms of the amount of anoxic sediment, macroalgal blooms, and bacterial blooms.

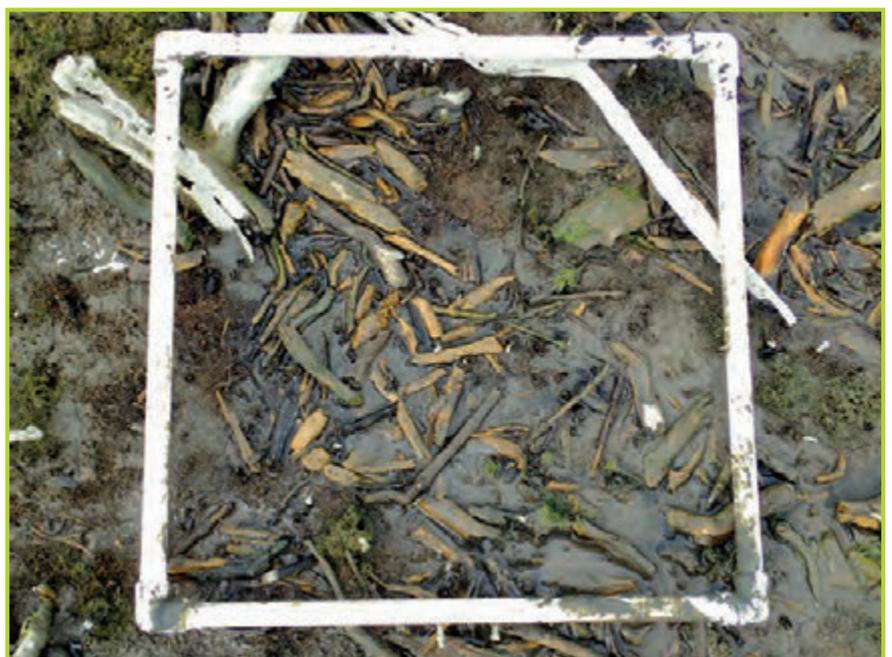
Mangrove mulch remaining on the seabed after mechanical removal at Welcome Bay, Tauranga. Photo taken in 2013, approximately three years after removal.

Post-removal monitoring and observations have revealed that the mulched material often does not get washed away and decomposes slowly, resulting in long-term adverse impacts which have been observed to continue at least five years after removal.

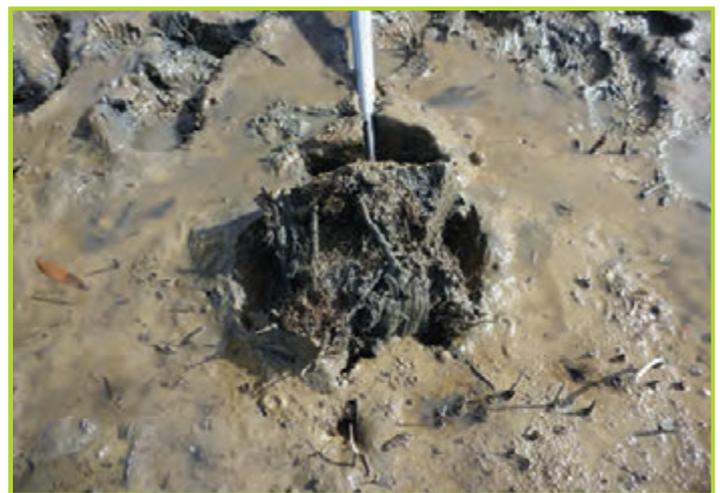
Moanaanuau Estuary, Whangamata Harbour. Remaining underground root biomass in 2010, approximately five years after clearance.

Methods for removing below-ground biomass have been trialled where the main stump and surrounding dense root material were removed using a digger. Main stump removal has been used in both mechanical (e.g., Whangamata) and manual removal consents (e.g., Onehunga). However, due to the fine and soft nature of the root material, root extraction is largely unsuccessful and results in considerable sediment disturbance.

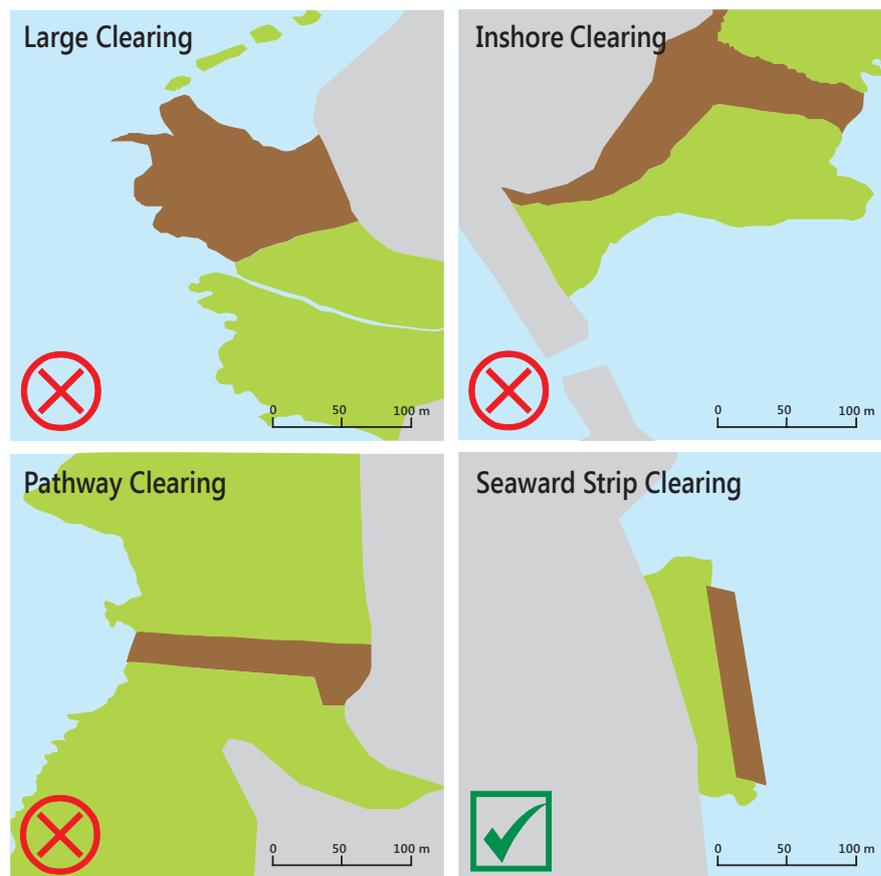
Figure 9: Schematic representations of three clearances that are not recommended (red cross) and a thin strip on the seaward boundary which is most ideal (green tick).

Strip clearances on the shoreward side of a mangrove forest have limited flow and are slow to recover. Strip pathways through the middle of mangrove forests are rapidly recolonised by seeds from neighbouring trees. Large clearances are also slow to recover.

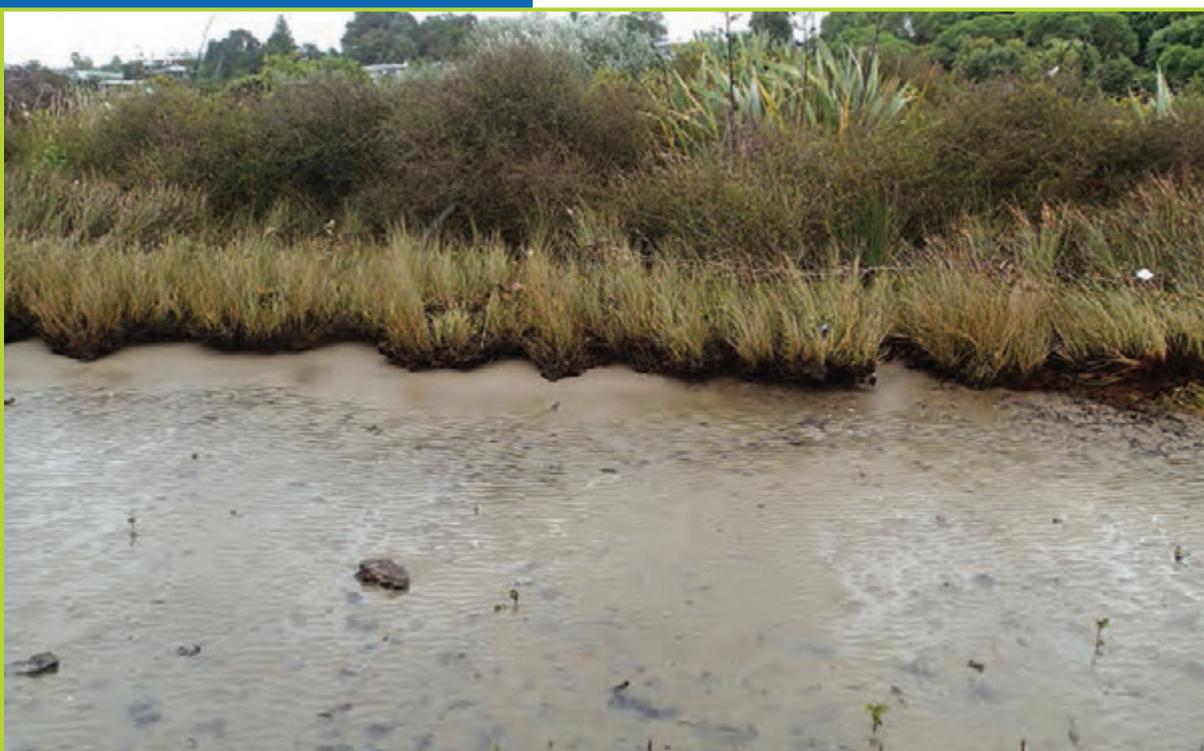
Waikareao Estuary, Tauranga, January 2016. Gradual erosion of saltmarsh where mangrove buffer was removed in 2010.

In other locations, such as Waikareao Estuary in Tauranga, a gradual seaward erosion of saltmarsh was observed following removal of the mangrove buffer. In the Manukau Harbour, mangroves were mulched, and mulch was transported by wave action to the shore, smothering adjacent saltmarsh habitat. Anoxic sediment and nutrient release resulting in algal blooms were also observed in Tauranga following mechanical mulching of mangrove. Despite concerns prior to removals, adjacent shellfish beds appeared unaffected by the mangrove removals (Lundquist et al. 2012).

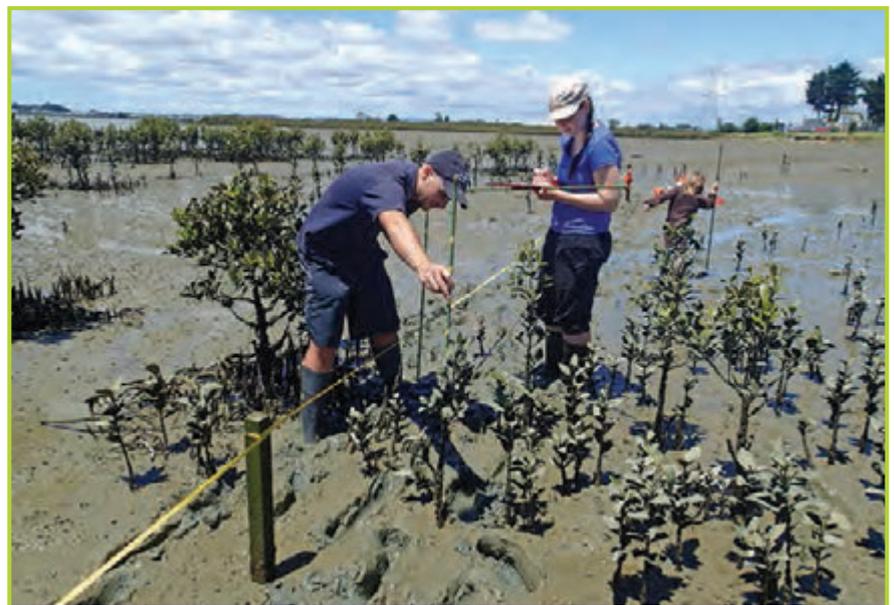
Transect line measuring seedling colonisation and growth rates at Mangere Inlet, Manukau Harbour.

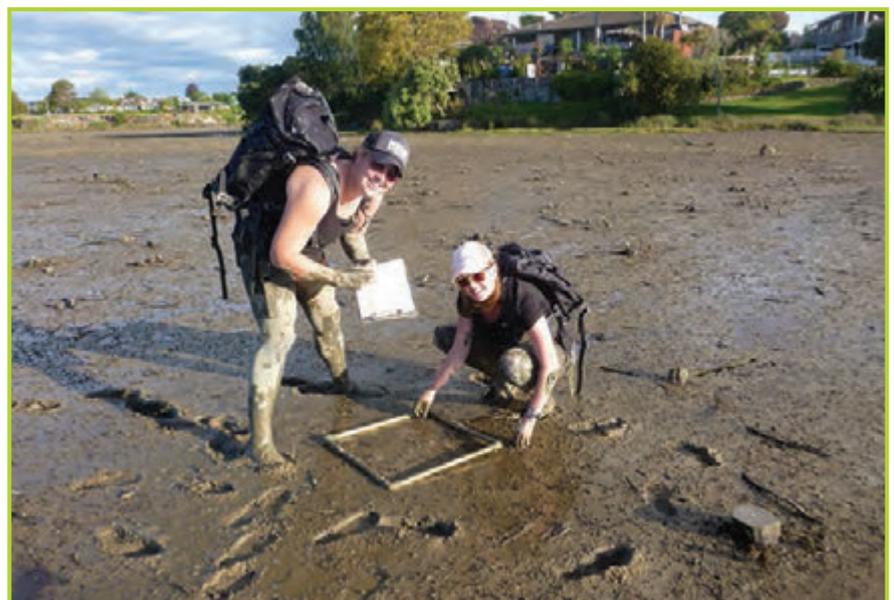
Monitoring to measure recovery of sediments and decomposition/erosion of mangrove roots (below-ground biomass) at Pahurehure Inlet, Manukau Harbour.

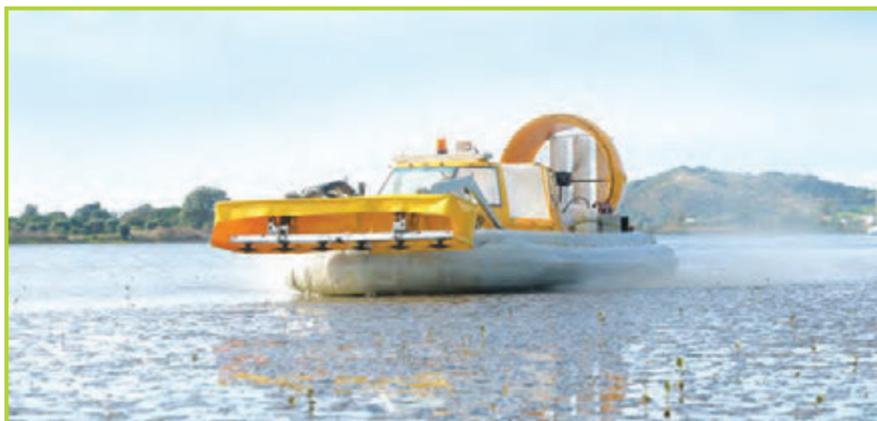
Mangrove hovercraft mower in Athenree Estuary. Photo: Bay of Plenty Regional Council.

An innovative, purpose-built hovercraft mower has been designed, constructed and certified for use in the Bay of Plenty. The hovercraft, which is designed to minimise surface disturbance to the estuary, is now ready to be put to the test through 11 estuaries within Tauranga Harbour. With promising test runs in two estuaries so far, it is expected that the hovercraft will prove a successful seedling management method throughout Tauranga Harbour.
