Waituna Lagoon 2007

Broad Scale Habitat Mapping and Historical Sediment Coring

Prepared
for
**Environment
Southland**
October
2007

Leigh Stevens and Barry Robertson

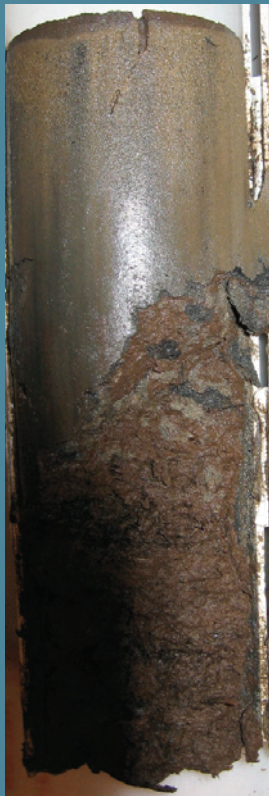
Figure 5. Waituna Lagoon sediment core.

To age sediment using radio-isotopes and calculate recent sediment deposition to ~100 years before present, a historical sediment core was taken from soft subtidal muds in Waituna Lagoon on 11 March 2007 (Figure 5). The core was collected by slowly inserting a 1m long, 10cm diameter PVC pipe into the lagoon muds, measuring core compression, then removing the pipe (and intact core) from the lagoon bed and transporting it upright on a canoe to the lagoon margin for processing. From here, the PVC pipe was laid horizontally, split in half, the core photographed, and then cut into 2cm slices. Each slice was described, bagged and labelled. Samples from representative depths were selected based on the visual character of the core (e.g. changes grain size/texture/colour/biota) for analysis at the National Radiation Laboratory, Christchurch for the following:

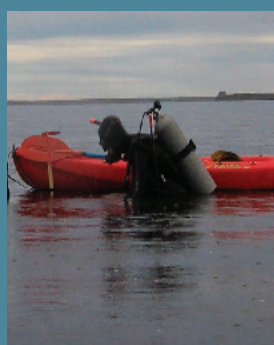
Sediment plate deployment in Waituna Lagoon.

A total of four sedimentation plates were buried near the edge of the soft mud sediment plume offshore of the mouth of Waituna Creek, ~15m apart on a straight line transect between a maimai and a large cabbage tree (Table 4 and Figure 1). This site was chosen to represent the sedimentation rates in the area with the greatest expected stream sediment input. The depth of the plate below the sediment surface and the plate locations are shown in Table 4. It is proposed that the depth of the plates to the surface will be next measured in 2008 and annually thereafter.
