**Waituna Lagoon Management Study  
Stage One**

**Urgent Measures Report**

**July 2011  
Final Report**

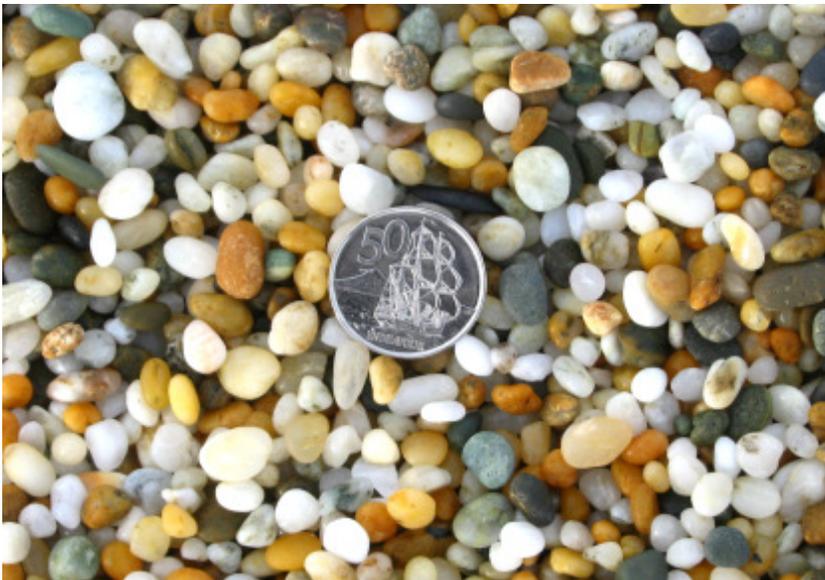
**Figure 2.1: Typical beach surface material – 6 to 8 mm median diameter gravel of variable depth.**

The barrier beach is composed of well-sorted and well-rounded fine grained gravel of median diameter of 6 to 8 mm: locally described as pea gravel (Figure 2.1). The material is non-cohesive, highly mobile and maintains only very low angles of repose. Very brief inspection indicated the occurrence of interstitial coarse sands within 100 mm of the surface (Figure 2.2). The surface material at the lagoon side of the barrier is of similar size as that of the ocean side but less well sorted. The surface material is overwashed by wave overtopping events during heavy storms at high tides.

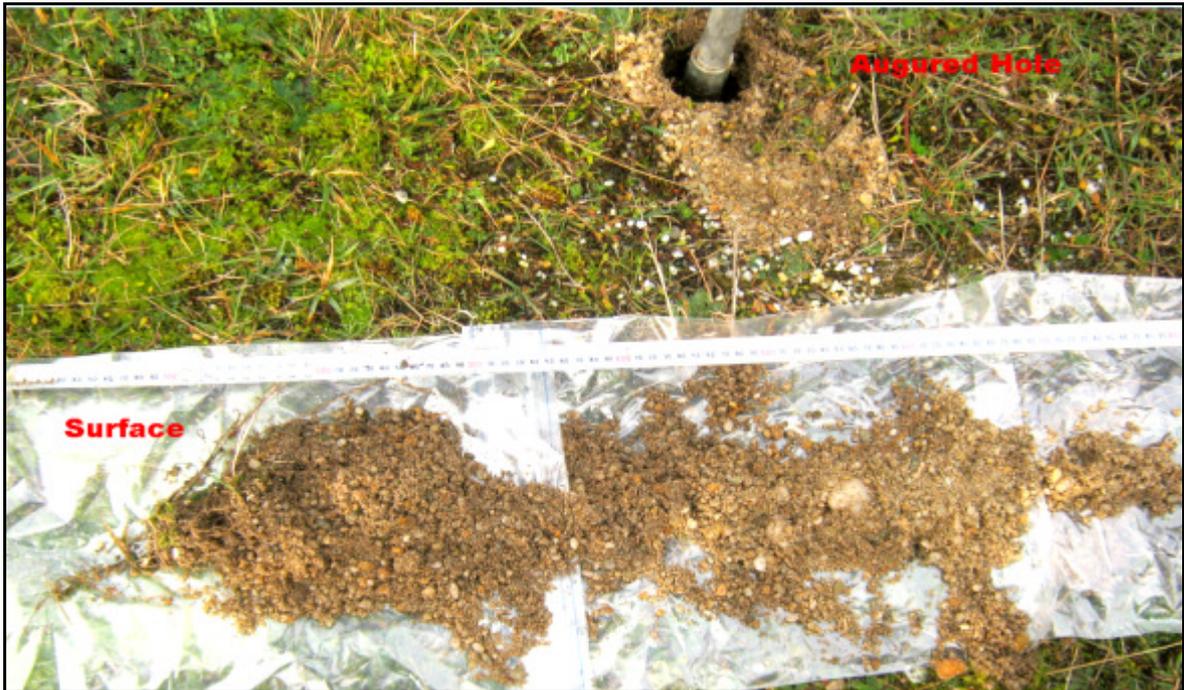
Figure 2.2: Typical sub-surface sediment sample at lagoon side of the barrier adjacent to Charlies Bay showing gravel in sand matrix.

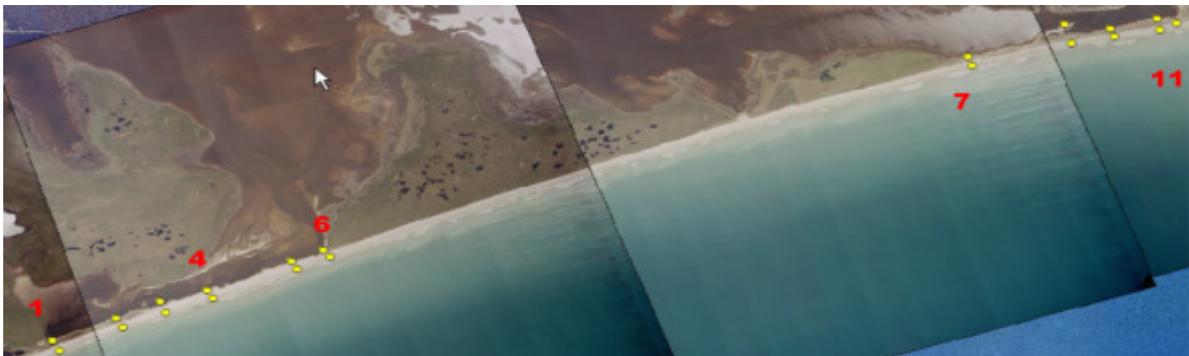
Figure 2.3a: Location of East and West Cross Sections (Environment Southland and Department of Conservation Data 2009)

Eleven cross-sections of the barrier along the lagoon coast are shown in Figure 2.3a & b. The general absence of berm/dune features indicates that the barrier is occasionally overwashed by wave runup. The foreshore slope varies from 1 in 8 to 1 in 16. The slope varies according to incoming sea state. It is noticeable from Figure 2.3b that the beach is quite uniform along its 9.3km length, with the crest height only varying by about 1.5m, and the width (measured at the 2.0m elevation) varying from about 50m to 75m.

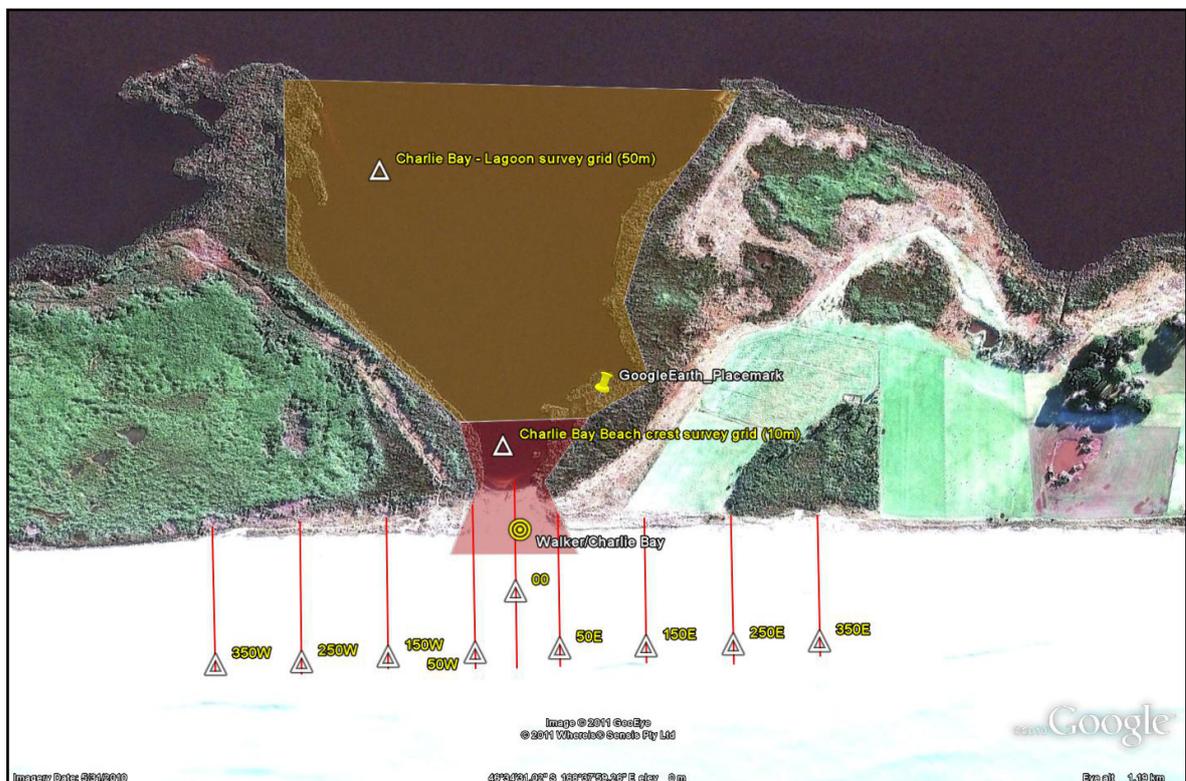
Figure 2.4a: Location of beach sections and required survey data at Charlies Bay

Further beach profile data was extracted from LiDAR data at the locations indicated in Figure 2.4a, covering the Charlies Bay area. The beach profiles are shown in Figure 2.4b.

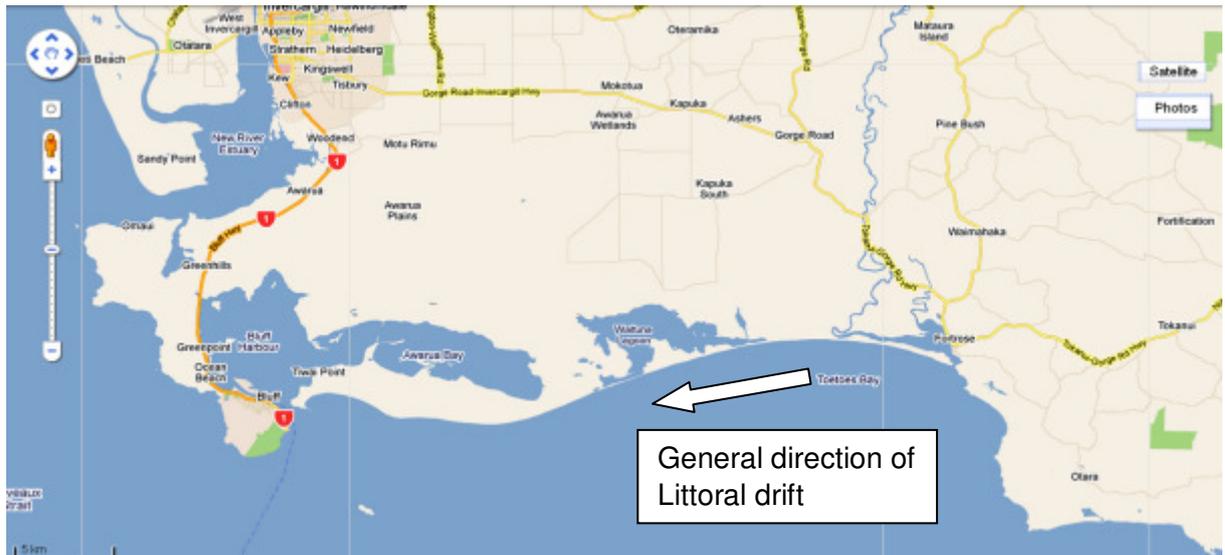
Figure 2.5: Map of coastal form around Waituna Lagoon showing direction of littoral drift

Figure 2.5 shows the plan form of the coast at Toetoes Bay. This area lies in the shadow of the Stewart Island from the predominant Southern Ocean swells. It suggests the net littoral drift is from the east to the west. The main source of sediment is likely to be gravel beds in the eastern Foveaux Strait and Toetoes Bay and the nearby cliff to the east. From time to time, the direction of the drift may reverse in accordance with the direction of local incoming waves, but the source of sediment from the west is limited. This means that outlets in the east are likely to close more quickly.

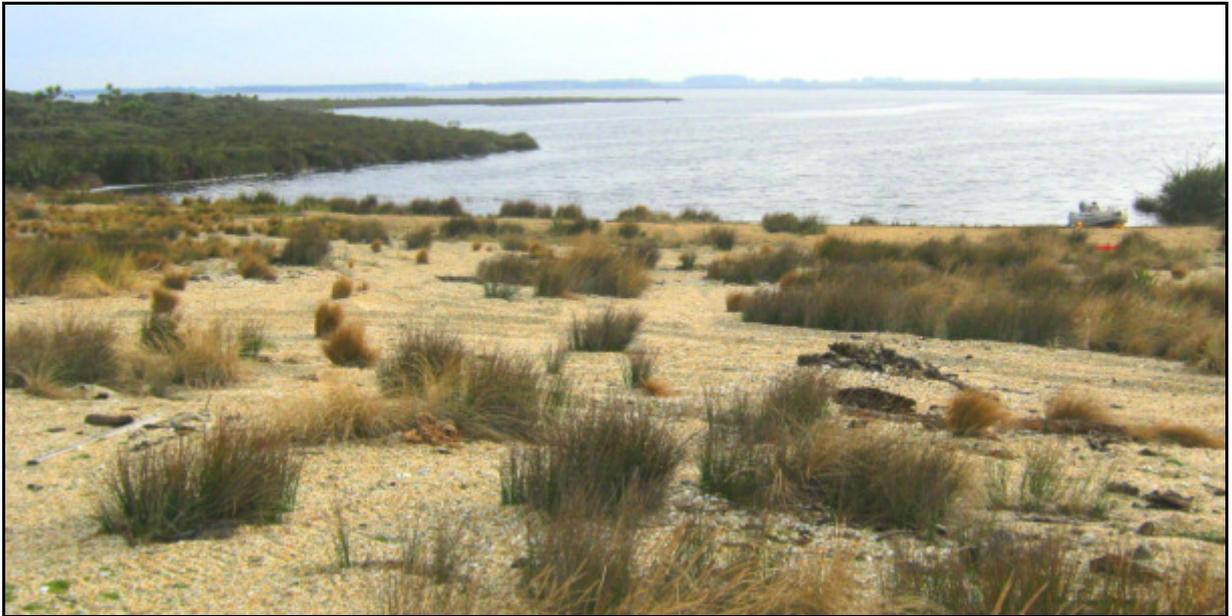
*Figure 6.1: Charlies Bay. Last opened in 1995. Barrier fully reclaimed and partially covered with vegetation in May 2011.*

The preferred option is to create a breach in the beach at Charlies Bay (Figure 6.1). This should be undertaken at the end of July or soon after. This offers the best option to balance the need for good flushing and the risk of disturbing *Ruppia* beds. It is centrally located in the elongated eastern region and should produce a good flush to the lagoon as a whole, with a significantly more active flushing of the critical eastern end.

Charlies Bay has been chosen as it is reasonably central and should produce good lagoon flushing, but far enough from the main *Ruppia* beds to avoid direct root damage. It also has an increased probability of a short opening period due to the increased beach width and the action of littoral drift.
