Waituna Lagoon Mechanical Opening Site Assessment

Report prepared for Environment Southland, 8th February 2013

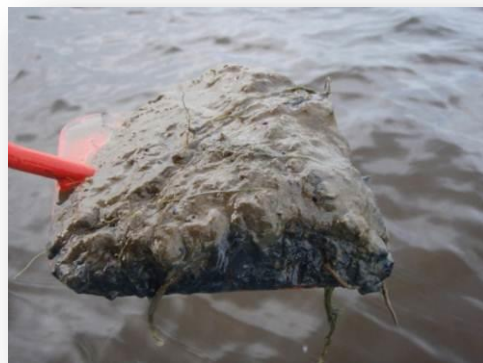
Figure 3: Typical sediment conditions in the northern part of Walker's Bay

Environment Southland (ES) has a long term water quality monitoring site in the middle of Walker's Bay at 2171691E, 5394136N. ES has also been undertaking sediment quality monitoring at this site since 2009 . Sediment quality at this site is often degraded with elevated sediment anoxia represented by shallow RPD layers 1-3 mm, and often thick black muddy sediments (ES monitoring data, 2011).

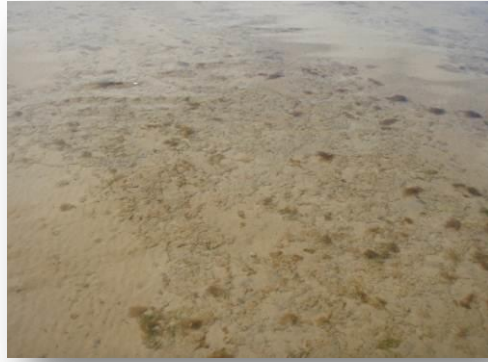
Figure 4: The central elevated basin of Walker's Bay, February 2011. The lagoon had been opened at this location for 5 ½ months.

Note: the smothering of *Ruppia* seedlings by marine sand and tufts of *Bachelotia anterillium* appearing.

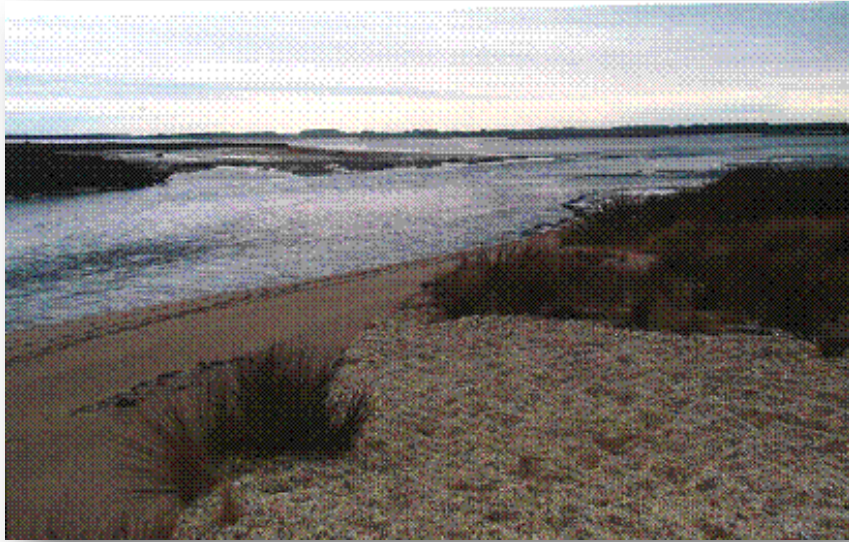
Figure 5: The weir-like terrace and eroded mudstones in the bathymetry of Charlie's Bay

Subsequent surveying and diving of the bay revealed all of the soft to very soft muds had been removed down to the now exposed mudstone (Environment Southland survey and dive data, 2011 & 2012). Currently, the outer parts of the bay are between 0.5- to 0 MSL then rise up to 0.25 MSL, this slight crest created a weir-like structure during the July opening (Figures 5 and 6).

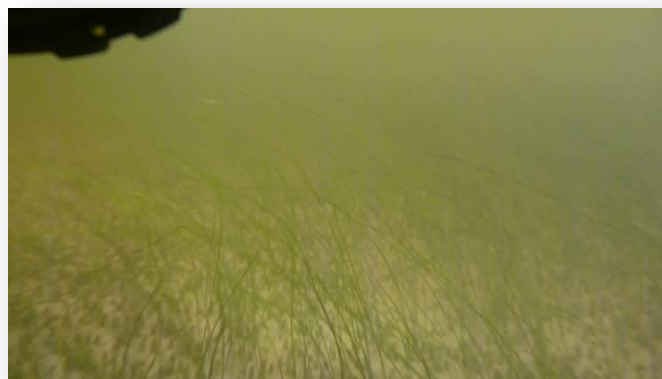
Figure 7: *Ruppia* seedlings (10cm) recovering in Charlie's Bay post-opening

The shallower and sheltered edge of the bay did start to show some recovery after the opening (Figure 7). By late 2011 and early 2012, the bay was showing good sign of growth with *Ruppia polycarpa* at 20-60% and about 10-30 cm long.

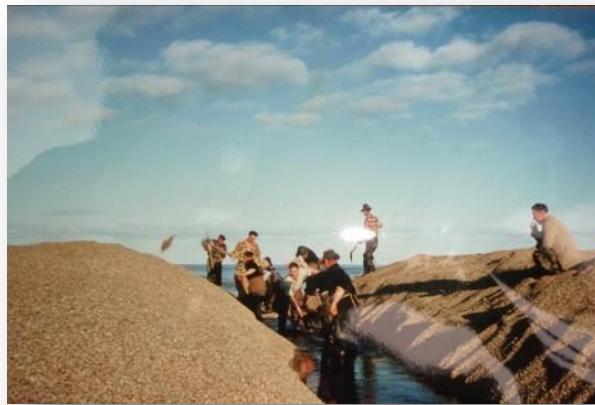
Figure 9: Local farmers and community members shovelling out the Far Eastern End in 1954. Photo courtesy of Ray Waghorn.

for 18 days (Figure 9). Anecdotal evidence suggests that a moderate wind from the west is required to push the lagoon flow towards the opening, and a spring tide to create the largest flush at this location. LWCA members suggest a very large opening event can be created here as the potential head gradient is larger than the other locations (see Figure 21 for barrier slopes).

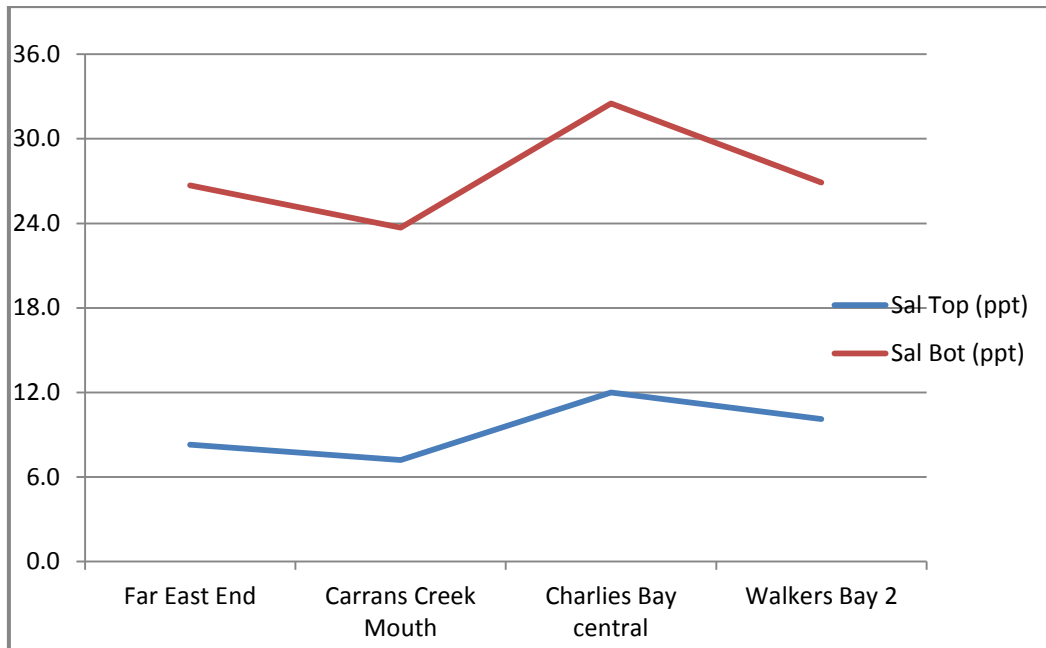
Figure 10: Salinity spot measurements (ppt) across Waituna Lagoon on 5th August 2011

The effects of bottom water salinity ingress between the western and eastern parts of the lagoon can be seen in Figures 10 and 11. When the lagoon was opened at Charlie's Bay, salinity was moderately high (15.0 to 32 ppt) between early and mid-August, but was highly variable due to the localised input of Carran Creek via Little Lake. High levels of salinity between 15-33 ppt were evident even in the Far Eastern End of the lagoon. The spot measurements undertaken by DOC scientists (Figure 10) clearly show salinity stratification in the deeper eastern end of the lagoon. Wind speeds over this period (recorded at the Waituna Lagoon hydrological site) were generally low in the order of 0-5 m/s and predominantly from the northern quarter. Wind from this direction reduced the fetch in eastern and central parts of the lagoon so wind mixing was reduced. In all likelihood the only mixing occurring was from the small tidal amplitude in the lagoon. Upon lagoon mouth closure on the 18th August 2012, salinity ranged from 10-15 ppt and within 6 weeks levels had dropped to below 8 ppt where it slowly decreased to 5 ppt by the 15th November 2012.

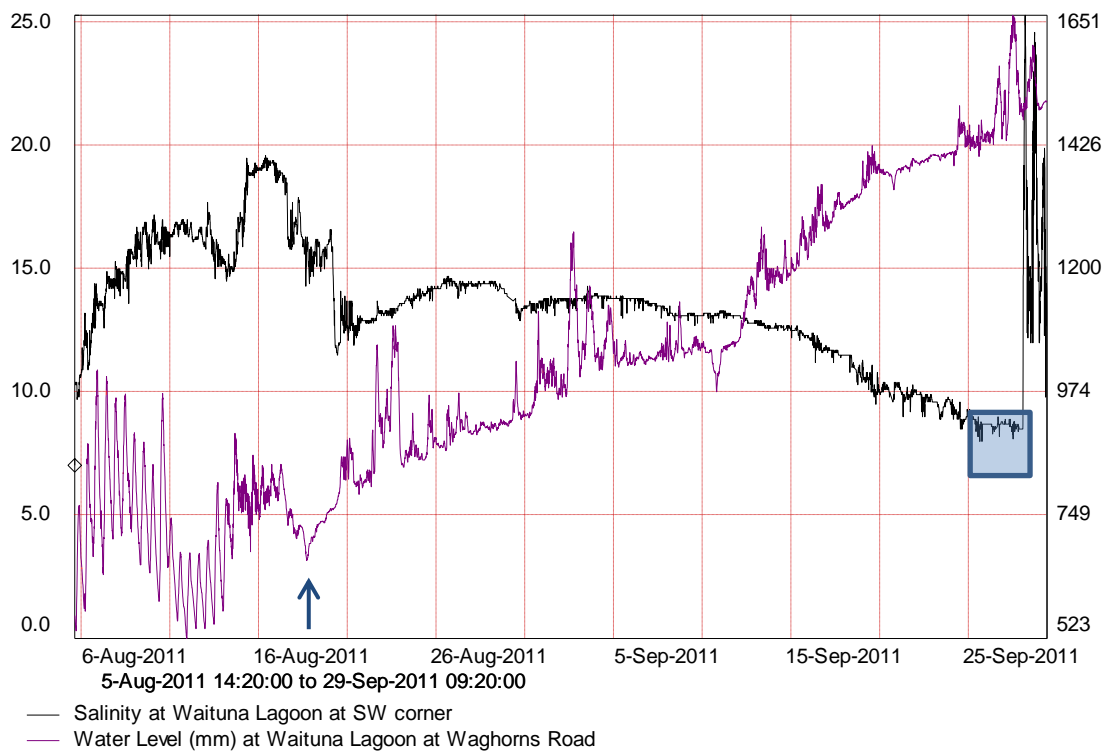
Figure 12: Walker’s Bay salinity profile and Waghorn Road water level.

Arrow denotes lagoon closure date on 18th August 2012 (Charlie’s Bay opening).

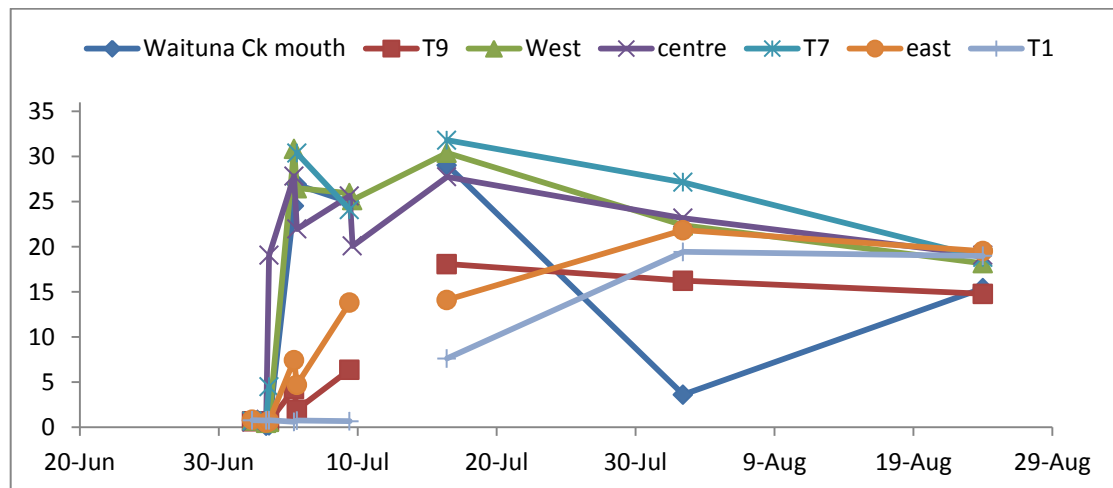
Figure 13: Salinity spot measurements across Waituna Lagoon pre-2nd July opening to 24th August 2012.

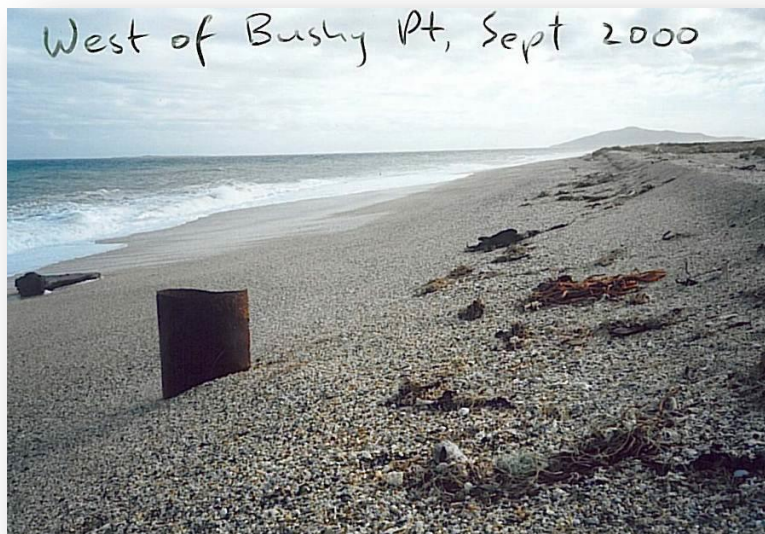
Figure 15: Waituna – Bushy Point beach facing west towards Bluff Hill, 2000.

Observations by ES staff over the last two years have recorded a large accumulation and movement of gravels, particularly on the coast immediately east of Waituna Lagoon towards Bushy Point (Bradley D, personal observations, 2010-2012). The photos series in Figures 15-19 clearly show the increases in gravel east of Waituna Lagoon, and the movement from east to west as demonstrated by removal of material around the pipe which increases towards the further west Bushy Point light house. These rates of gravel movements and accumulation may help explain the quick lagoon mouth closures in the last two years. Sea conditions over the period of the opening this year, were dominated by calm seaS and winds from the Southern quarter. Winds and swell from this direction are aligned with the dominant longshore drift in Toetoes Bay, which would have enhanced gravel movement along the coast past the LAGOON mouth.

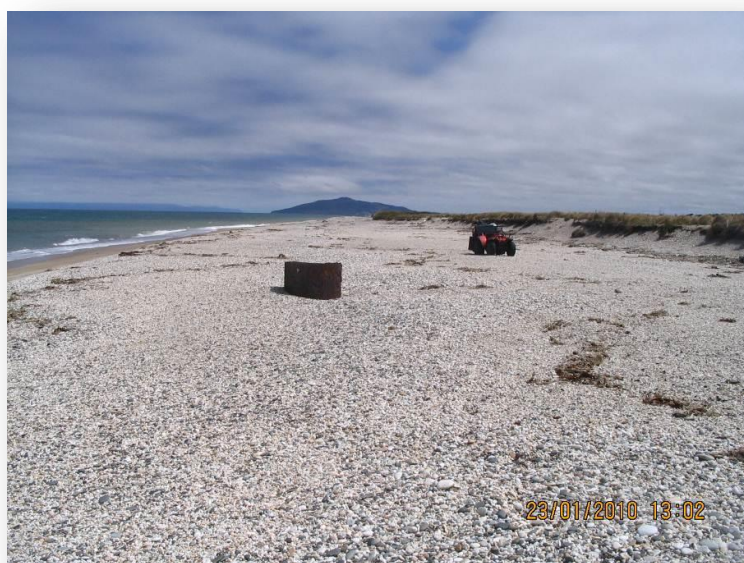
Figure 16: Waituna – Bushy Point beach August 2011 showing the massive aggradation around the steel pipe.

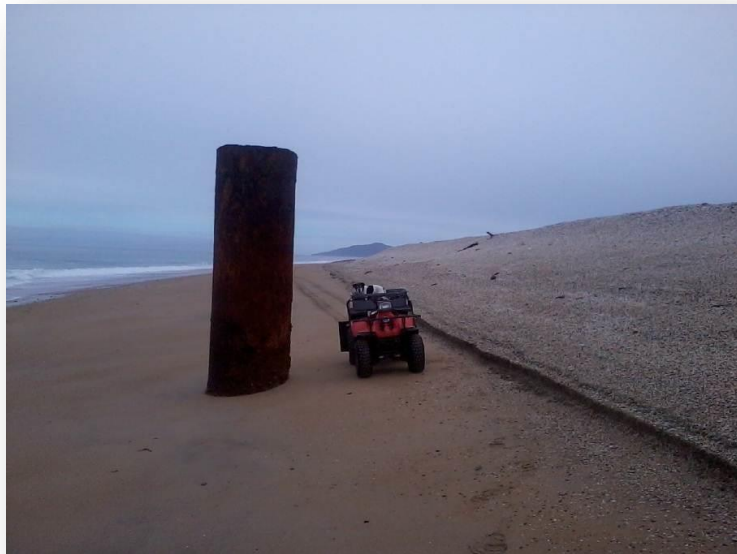
Figure 17: Waituna – Bushy Point beach August 2011 showing the removal of material west along the beach towards the Bushy Point lighthouse.

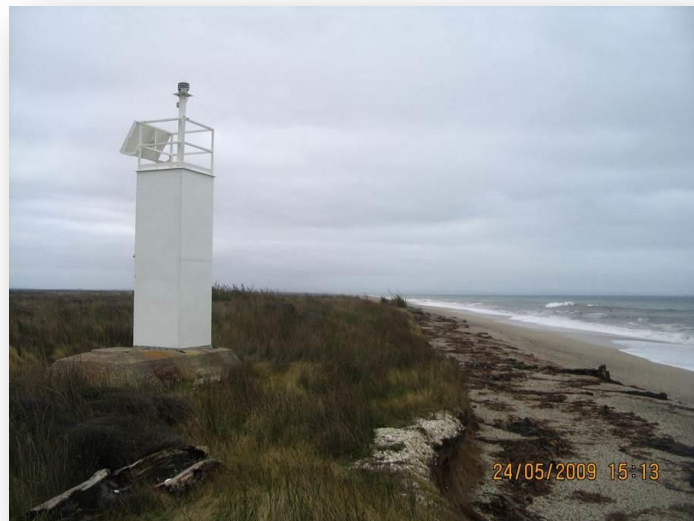
Figure 18: Bushy Point lighthouse foreshore facing east towards Waituna Lagoon, May 2009.

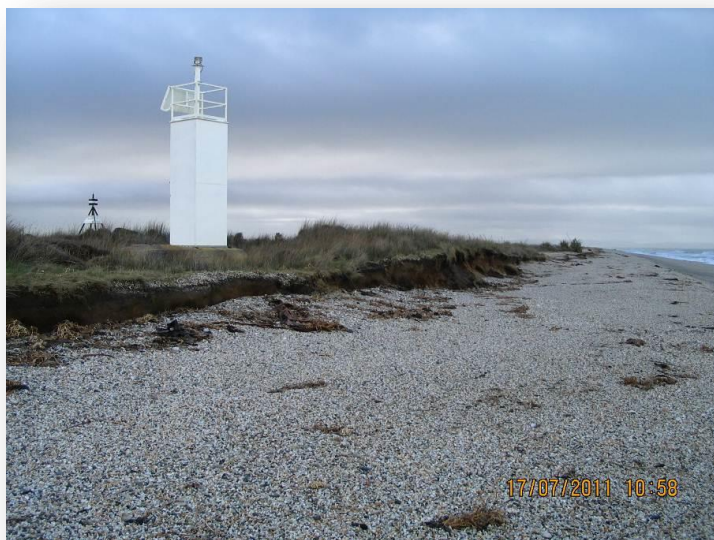
Figure 19: Bushy Point lighthouse foreshore facing east towards Waituna Lagoon, July 2011 showing the gravel accumulation on the upper beach.
