## MORPHOLOGICAL STABILITY OF PAUATAHANUI INLET, PORIRUA HARBOUR

J. IRWIN

Vertical aerial photographs made over a 31-y period (1942-73) show only a few small changes in channel and bank morphology of the inlet; the changes apparently occur more slowly than in the Avon-Heathcote Estuary.

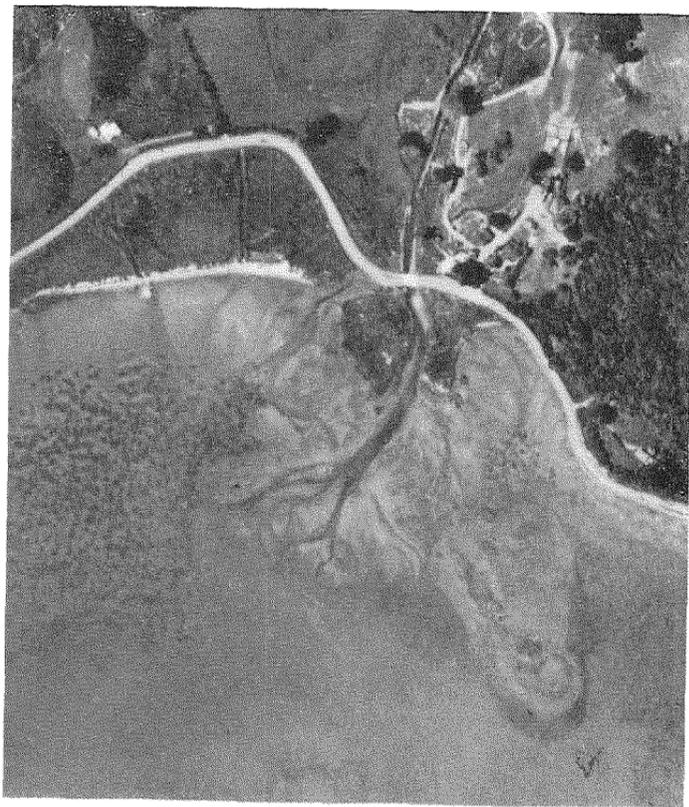
FIG. 3—Mouth of Kahao Stream, Pauatahanui Inlet, showing (*left*) south-west and south trending channel over tidal area, 17 March 1942, and (*right*) south-west trending channel with bird-foot effect over tidal area, 20 November 1968.

A very small-scale bird-foot effect developed at the end of the channel after 1958, when the channel divided at the end into two branches. By 1966 a third branch had formed, and in 1968 four branches, two with divided ends, are visible (Fig. 3). The total length of the channel over the mud flat area is approximately 130 m, of which the outer 70 m shows the bird-foot effect.

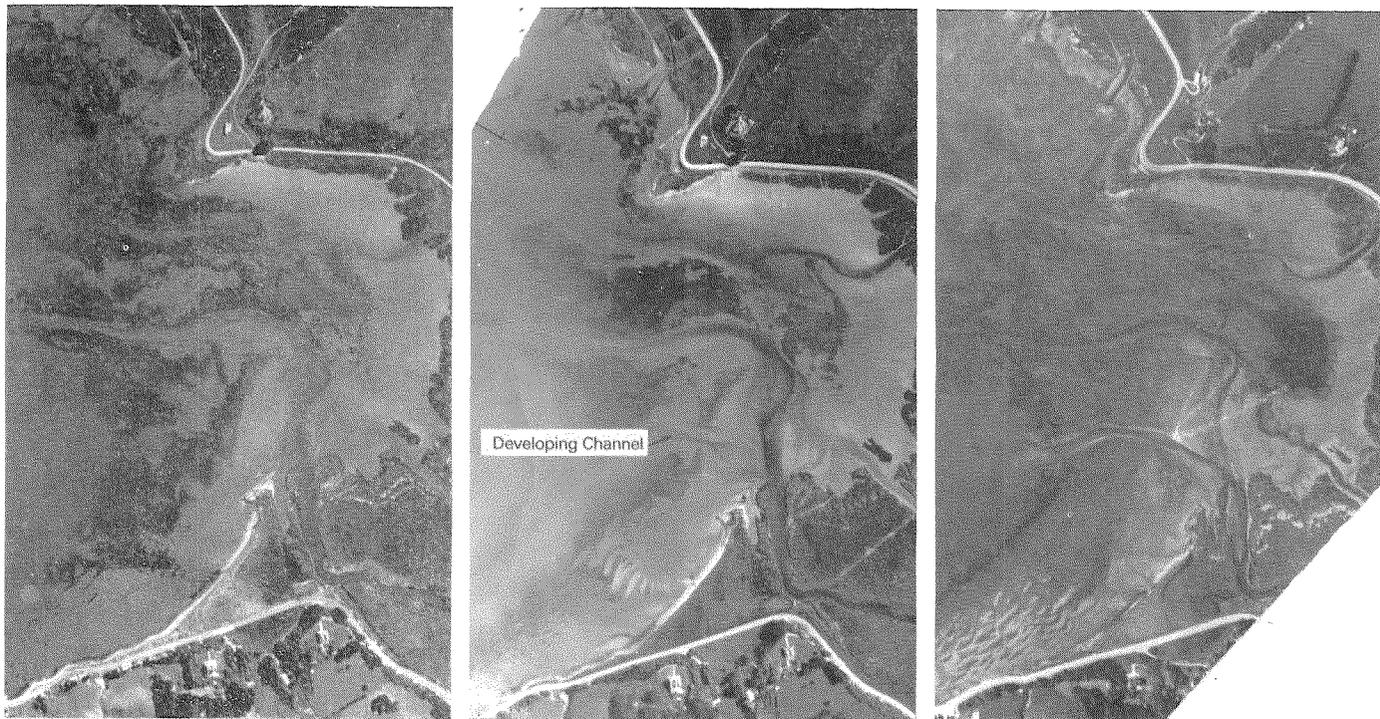
FIG. 5—Mouth of Pauatahanui Stream, at east end of Pauatahanui Inlet, showing (*left*) single channel over tidal area, 17 March 1942, (*middle*) single channel over tidal area but indications of west-flowing branch developing near mouth, 13 November 1947, and (*right*) second, west-flowing channel developed near mouth, 20 November 1968.

This stream enters at the eastern end of the inlet. In 1942 the main channel flowed for approximately 160 m northward on to the mud flat area thence nearly due west for 280 m. Over the 31-y period this stream channel shows little change in width or direction except for the development of a west-flowing branch where it enters the mud flat area. Figure 5 shows this channel is absent in 1942, but has joined the main channel by 1956, and appears the most prominent by 1968.
