Geotechnical and Coastal Hazards Topic Report

Warkworth Structure Plan

March 2018

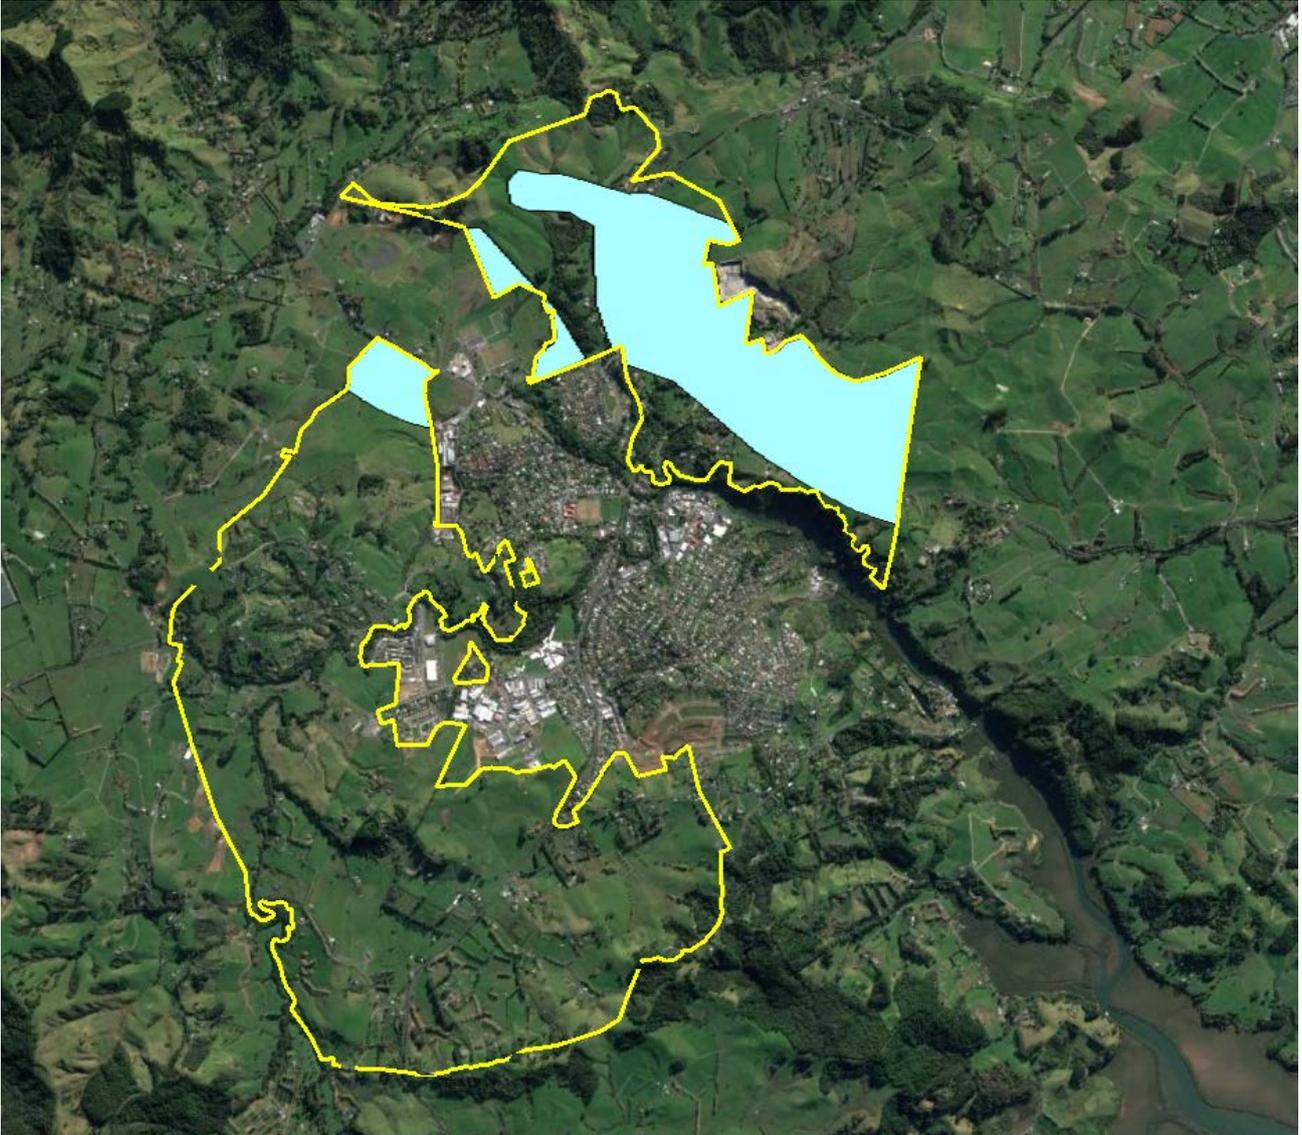
Figure 5: Inferred distribution of Mahurangi Limestone within the study area boundaries. Note that these are slightly different from the mapped distribution shown in Figure 3 as they take into account additional data from boreholes and other sources.

Almost all of the Allochthon materials immediately underlying the study area are believed to be Mahurangi Limestone, except under the Warkworth Golf Course.

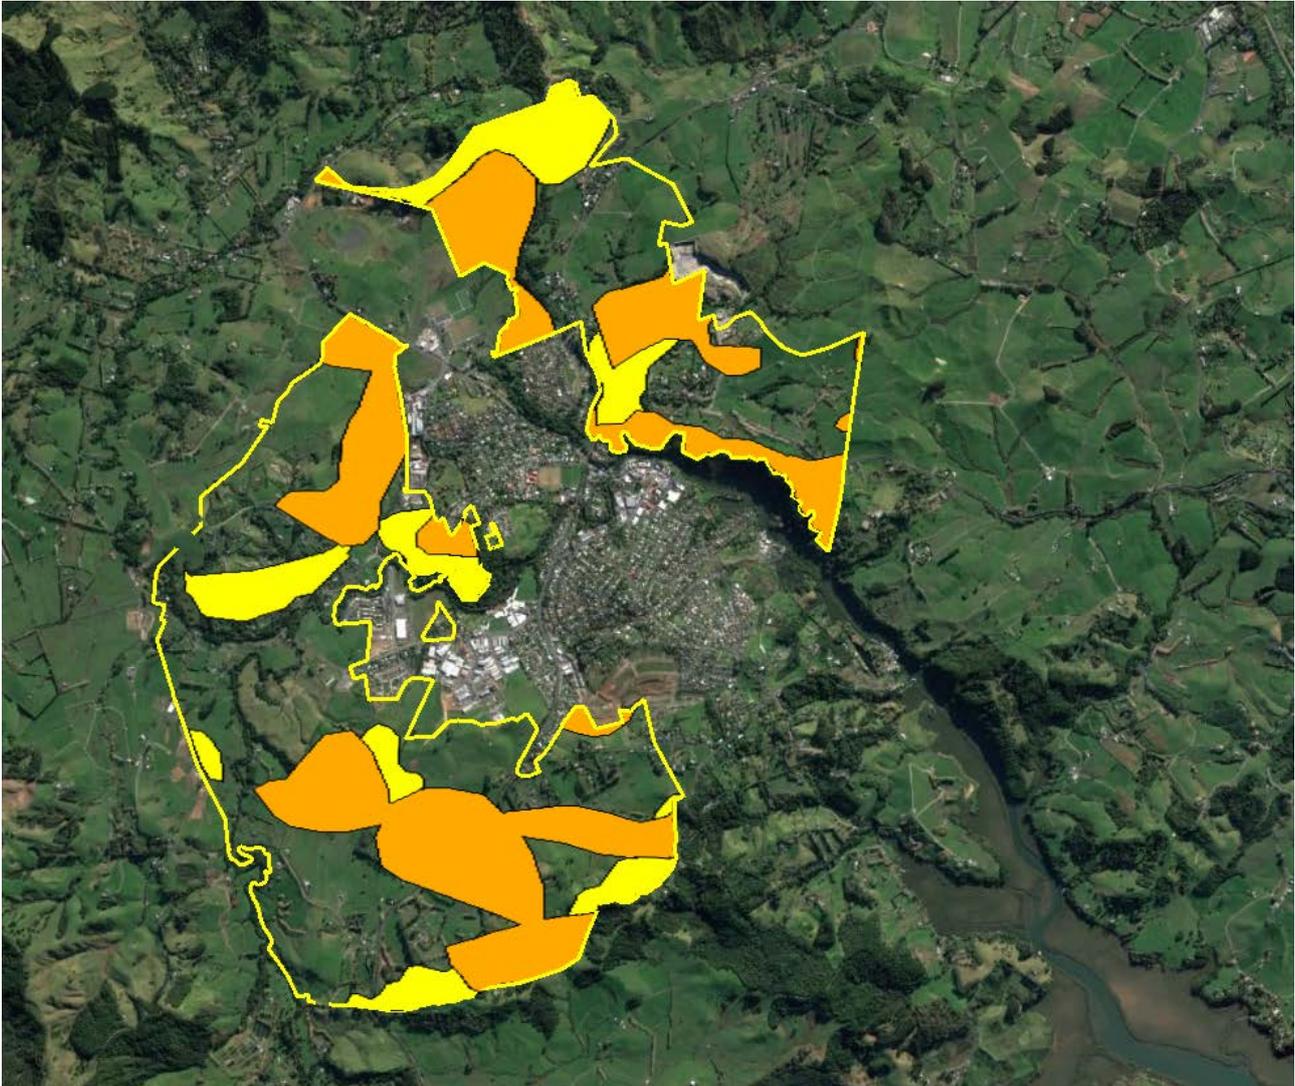
Figure 9: Mapped distribution of high (orange) and medium (yellow) risk areas for slope instability

The Auckland Council Slope Instability Hazard Map (Williams A. L., 1996) shows that a significant portion of the study area is considered a High hazard² for general slope instability.

Given the relatively low accuracy of the study on which Figure 9 is based, a geomorphological desk study of the area has been undertaken to assess the distribution of identifiable landslides within the area, and the data in Figure 9 has not been used in the definition of development premiums for the study area. The data used in the development premiums is presented in Figure 10
