**Beach profile surveys and morphological  
change, Otago Harbour entrance to Karitane**

**May 2014 to June 2015**

Port Otago Ltd

September 2015

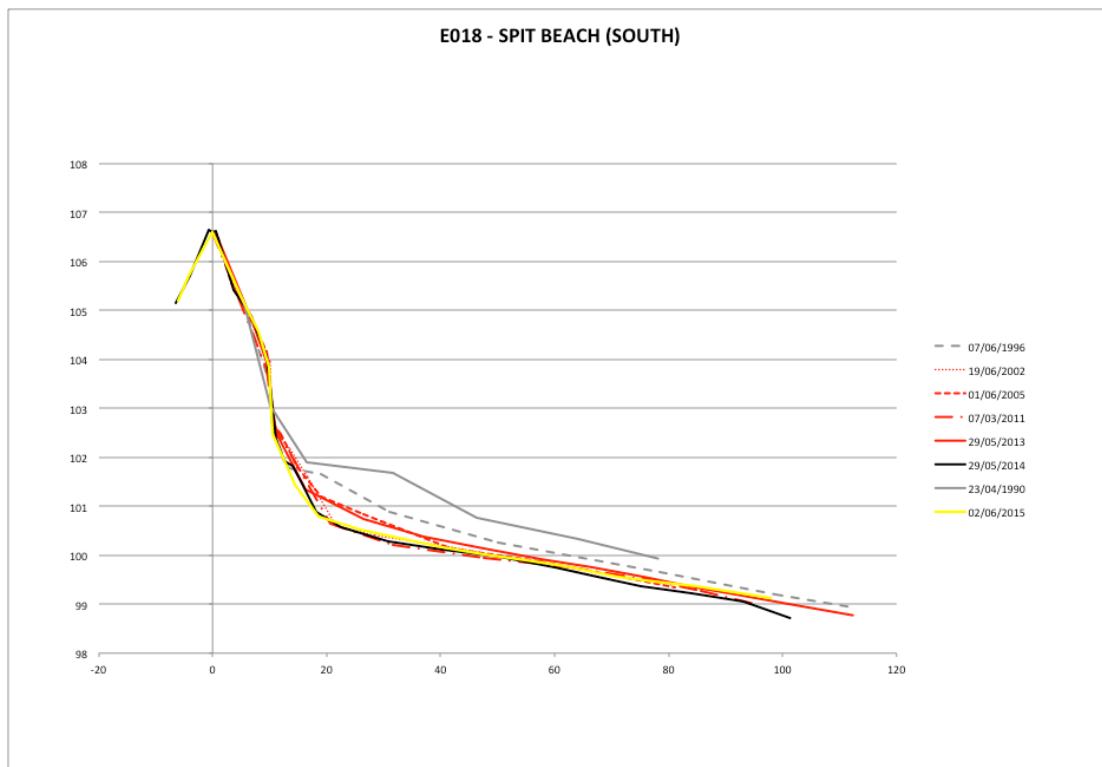
Figures 2.1 and 2.2 present overlay surveys of profiles EO18 and EO19 representing Aramoana Beach. The main change between the 2014 and 2015 surveys is retreat of the face of the dune in the southern part of the shore and deposition on the foreshore. There is greater change along the southern part of the shore than to the north. This type of change is indicative of storm erosion of the dunes and subsequent deposition and recovery. The build up along the base of the dunes is a precursor to development of a small foredune. Vegetation takes hold in this area and stabilises the sand helping the dune system recover and have sand available as a buffer to release during the next large storm. This type of change is within the longer-term envelope of change since 1990.

**Figure 2.1** Over-lay surveys of Profile EO18 located at the southern end of Aramoana Beach, approximately 50 from the Mole

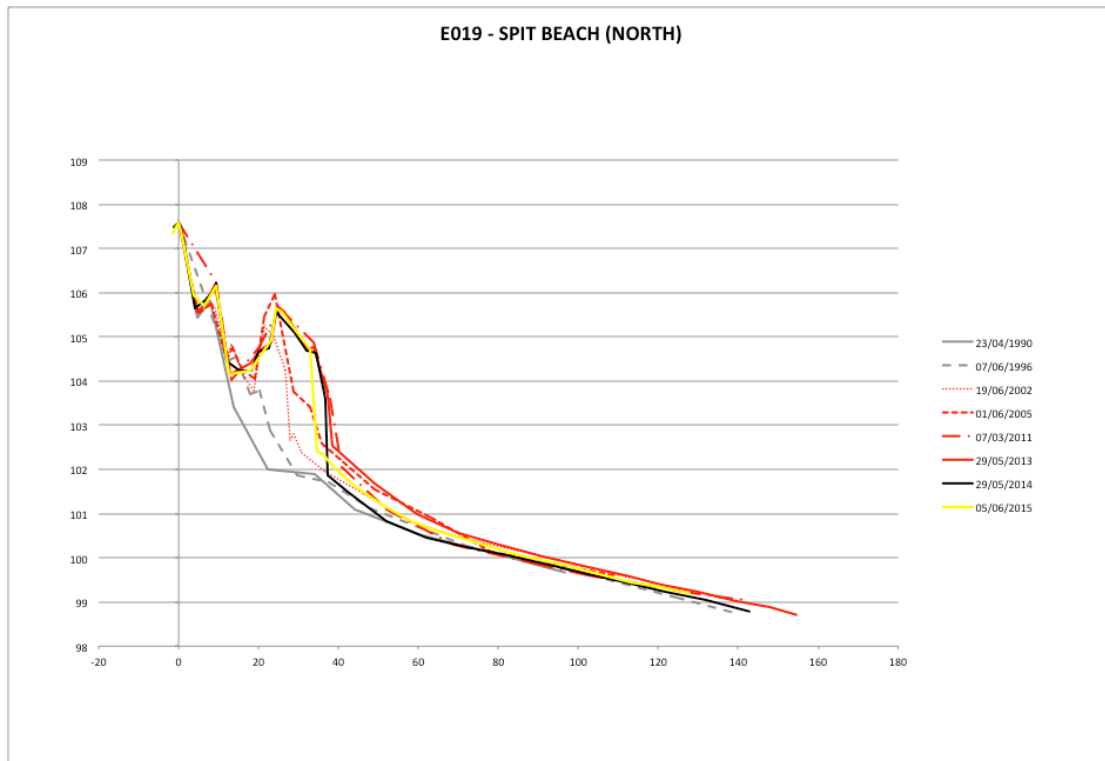
**Figure 2.2** Over-lay surveys of Profile EO19 located at the northern end of Aramoana Beach

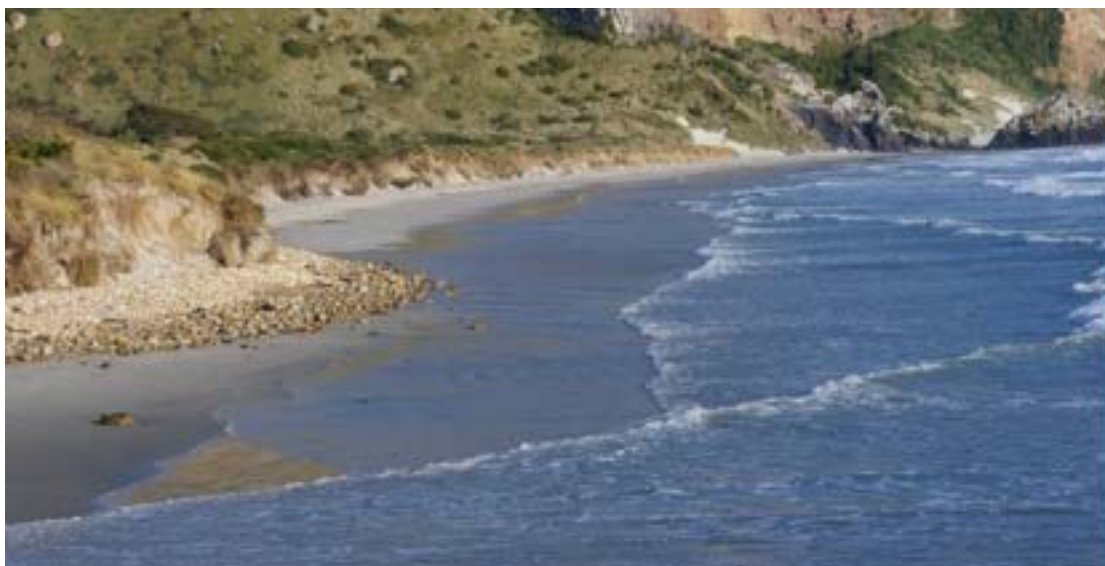
Figure 2.3 shows the foredune at Aramoana in September 2014. The face of the dunes is very steep, and the vegetation has died back. This is evidence that the dune has been subject to storm wave erosion. However the foreshore appears well nourished. This is indicative of accretion, and an overall indication that the beach has eroded during a storm, but recovered subsequently. The straight line of the storm erosion along the backshore shows that there is no focused area of erosion except where the waves are influenced by the presence of the Mole.

**Figure 2.3** View along Aramoana Beach from the Mole, September 29 2014.

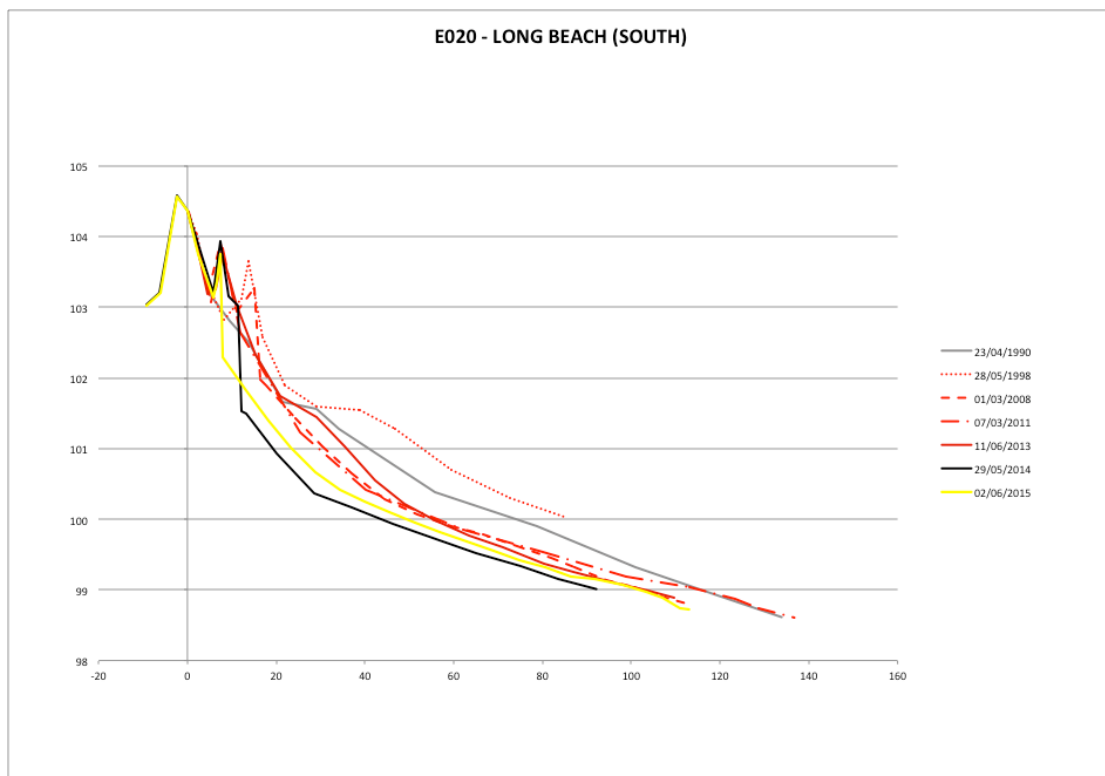
Figures 2.4 and 2.5 show the surveys of profiles EO20 and EO21. Change since 2014 is similar to that at Aramoana, with erosion and retreat of the seaward face of the dunes but an increase in the level of the beach surface across the foreshore. This is indicative of a large storm and systemic erosion in Blueskin Bay and subsequent recovery from storm erosion. There appears to have been recovery of the beach sediment at the base of the dune scarp and a net recovery to the beach volume since May 2014

**Figure 2.4** Profile of Long Beach as represented by survey line EO20, the southern most profile of Long Beach

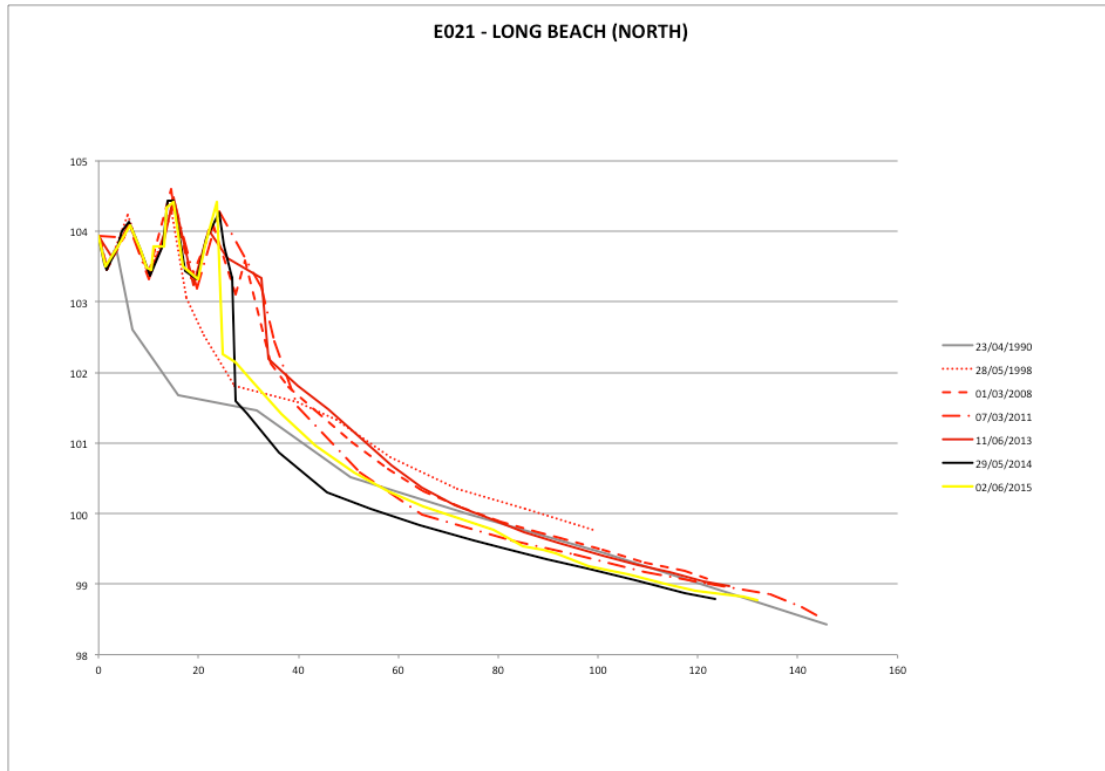
**Figure 2.5** Profile of Long Beach as represented by survey line EO21, the northern most profile of Long Beach

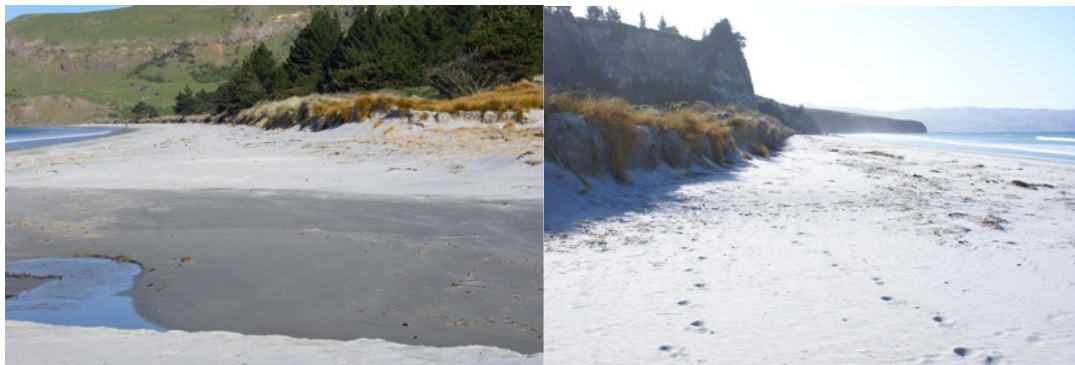
Figure 2.6 shows views along Long Beach from the main beach access point. The eroded dune scarp is readily apparent, with newly deposited sand along the base identifiable by the deep footprints showing the softness of the surface of the beach. In all, the beach shows recovery from the large storms prior to the 2014 survey, and the changes are within the envelope of change measured since 1990.

**Figure 2.6** Views to the south and north from the main beach access point to Long Beach, September 2014.

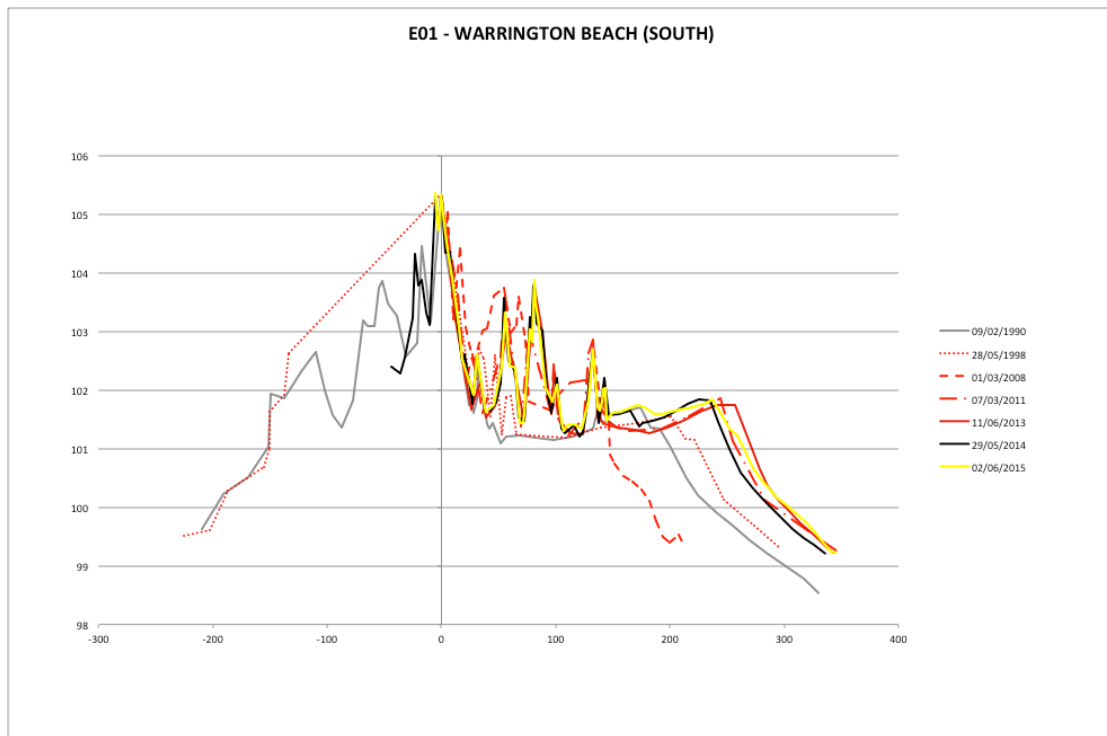
Figures 2.7 and 2.8 show representative profiles of the spit including the wide area of dunes. Apart from some growth in height of the middle dune complex, the main changes to the profiles since 2014 are seaward of the main dunes. The primary dune at the southern end of the spit appears to have contributed sand to the second row of dunes, but has grown in volume with seaward accumulation of sand. The level of the beach surface is also higher than in 2014. However there is not as much dune volume as shown in the 2013 survey. The northern section

shows similar seaward growth of the dune and deposition to the beach surface, with a similar profile to that of 2013. These changes are consistent with continued recovery of the upper foreshore after storm erosion.

**Figure 2.7** Profiles of Warrington Spit Beach as represented by survey line EO1 at the southern end of the spit

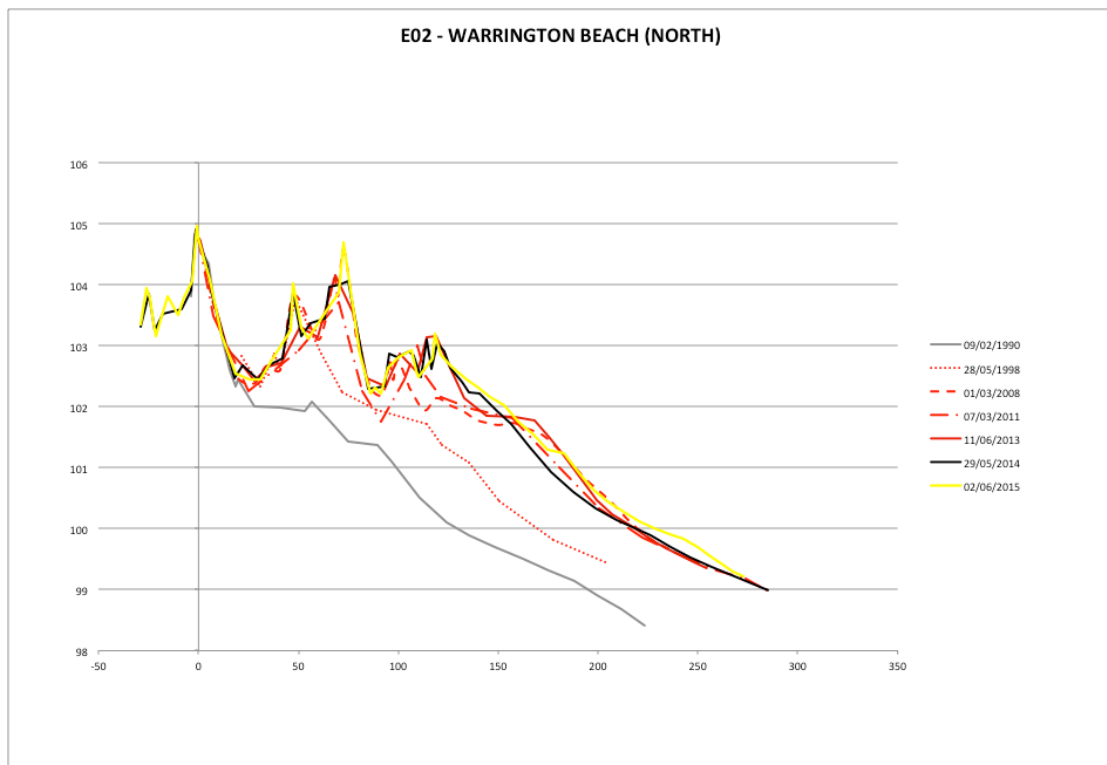
**Figure 2.8** Profiles of Warrington Spit Beach as represented by survey line EO2, the northern most profile of the beach

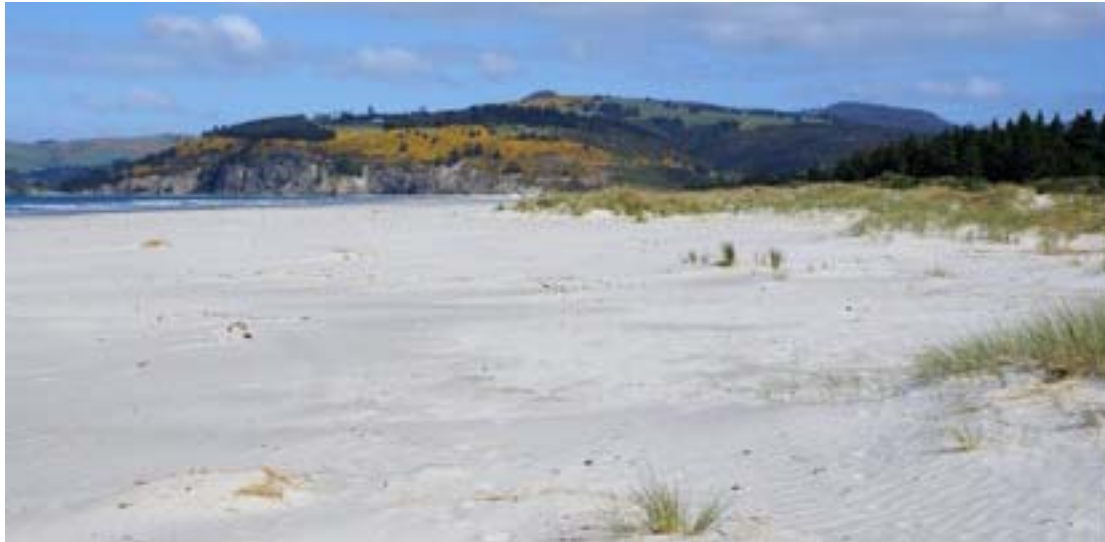
Figure 2.9 shows the development of embryo dunes near the northern end of Warrington Spit. This is an area of long-term progradation, with low dunes and sparse vegetation cover as the limit of the dune extent progresses seaward. The dune system in this area is fragile but vegetation growth will help to stabilise the dunes.

**Figure 2.9** The low prograding dunes at the northern end of Warrington Spit

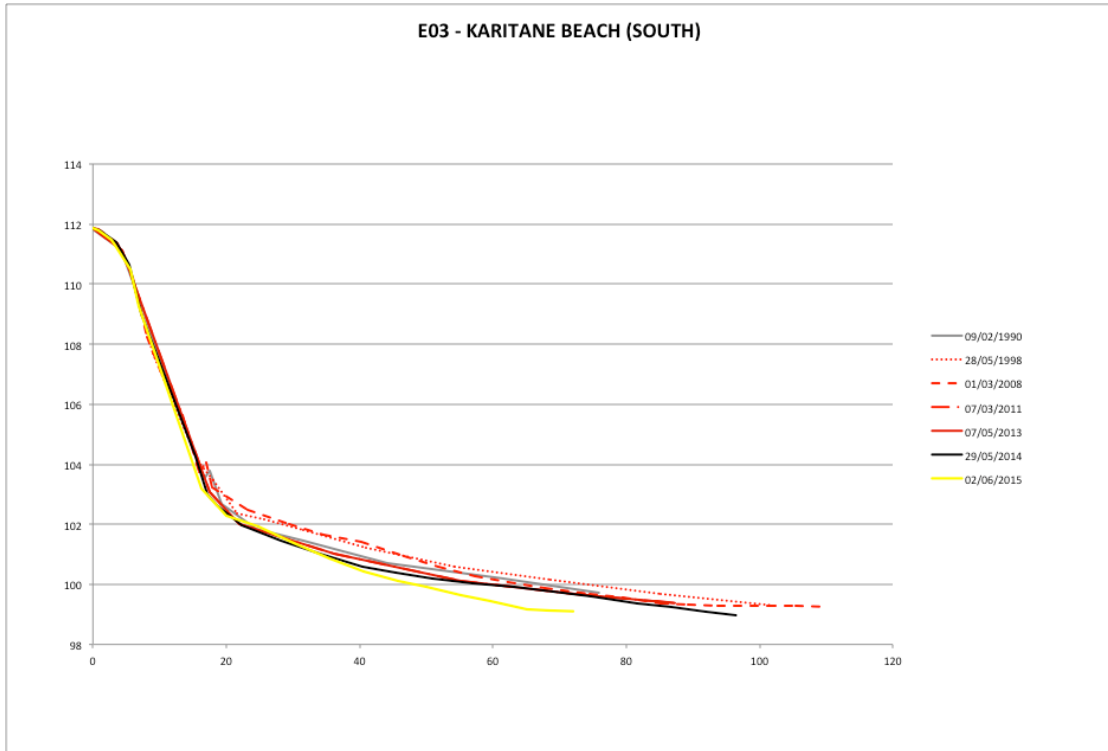
Figures 2.10 and 2.11 show the surveyed profiles (E03 and E04), while Figure 2.12 shows the beach adjacent to and north of the beach profile E04. The beach surface at the southern site is lower than in 2014, and is lower than any of the previous surveys. It is likely that this is a result of recent processes rather than an indication of long-term erosion. However with changes to the land-use in the backshore there is potential for increased hazard in this area. The northern section of the beach appears to have accreted since 2014. These changes may be indicative of movement of sediment along the shore from south to north in response to recent wave action. It is likely that there is beach sediment transport in both directions along this stretch of shore as a result in variations in the direction of wave approach.

**Figure 2.10** Profiles of Karitane Beach as represented by survey line EO3 near the middle of the beach

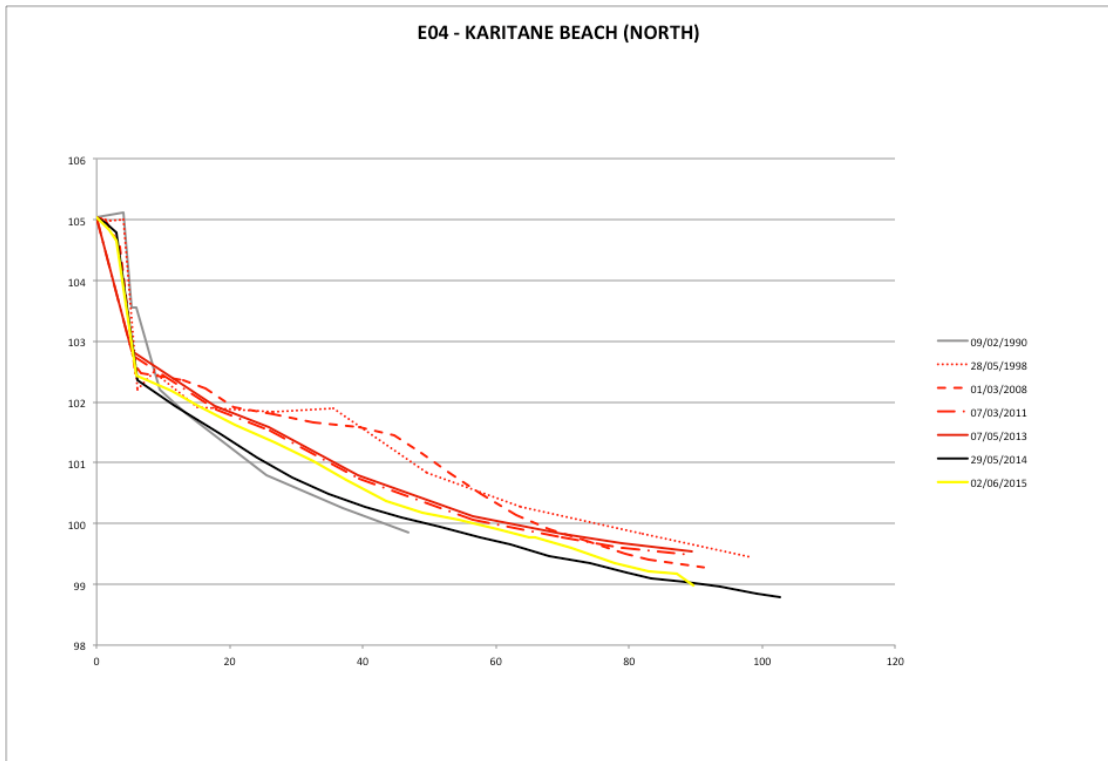
**Figure 2.11** Profiles of Karitane Beach as represented by survey line EO4 near the northern end of the beach

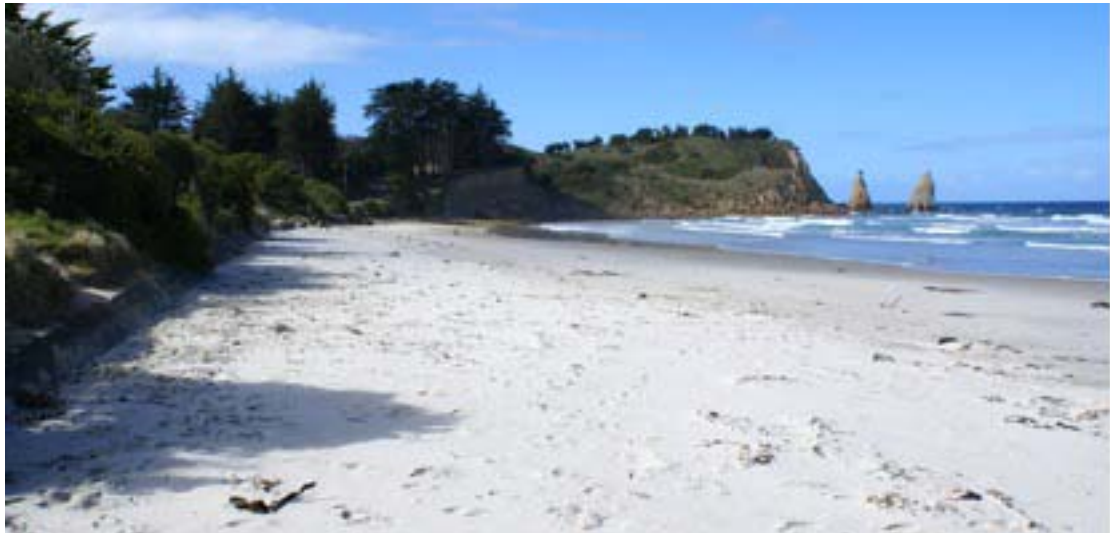
**Figure 2.12** Karitane Beach, looking north from survey site E04. Note the seawall at the base of the backshore (September 2014)

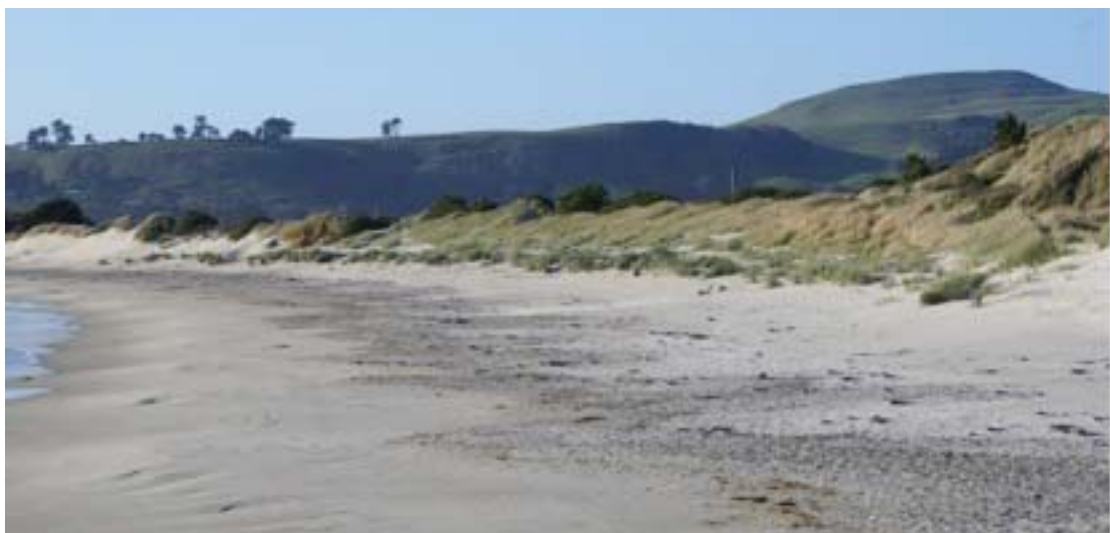
Figure 2.13 shows the northern end of Shelly Beach as of September 2014. Figure 2.14 shows the profile at Peg 250, a site north of the middle section of Shelly Beach. The main difference between the 2014 and 2015 surveys is loss of sediment from the upper section of the beach. This is similar to the type of change evident between the 2013 and 2014 surveys. There continues to be deposition of sand to the dune system, with an increase in the volume of the main dune. It is possible that the small seaward dune evident in Figure 2.13 has undergone some erosion between September and the survey (August 2015), but the overall, long-term health of this beach is likely to continue to be augmented by deposition of dredged sediment in the nearshore.

**Figure 2.13** View south along Shelly Beach from the Mole. The survey line at Peg 250 is approximately at the extreme left of the photograph.

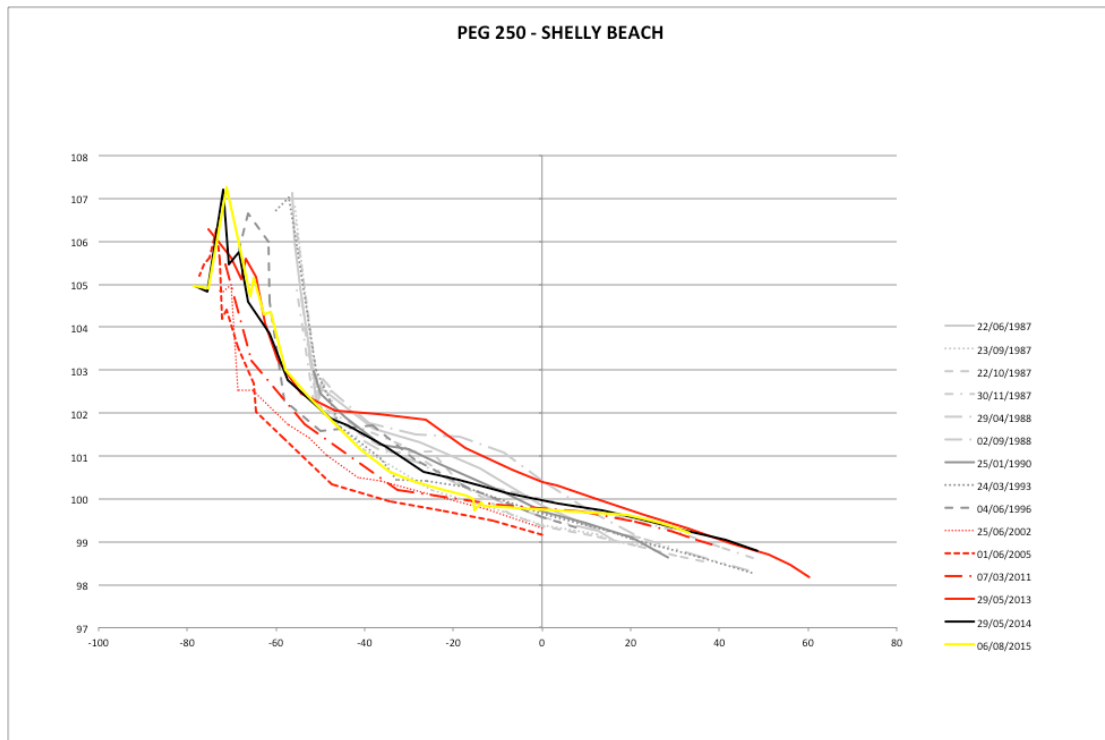
**Figure 2.14** Profiles of Shelly Beach as represented by survey line Peg 250
