## **ENGINEERING DESIGN STATEMENT PREPARED BY TONKIN AND TAYLOR**

### **Homeowners Wall - Coastal Erosion Protection**

In our January 2016 report, Tonkin & Taylor Ltd (T+T) presented a seawall concept design involving reconstructing the existing seawall (with the possibility of selecting a new alignment). Further to that report T+T have been requested by the Homeowners, to consider an option which doesn't require removal of the existing seawall. We have now evaluated this, and this report presents a concept which involves leaving the majority of the existing seawall structure in place. This is achievable by strengthening the seaward face of the seawall with additional larger rock armour, sized to withstand a 100 year return period storm (1% AEP) allowing for storm surge and predicted sea level rise over the next 40 years, (note that this does not mean that the design waves will occur only once in 100 years, these conditions or worse could occur at any time and more frequently than once in the life of the seawall).

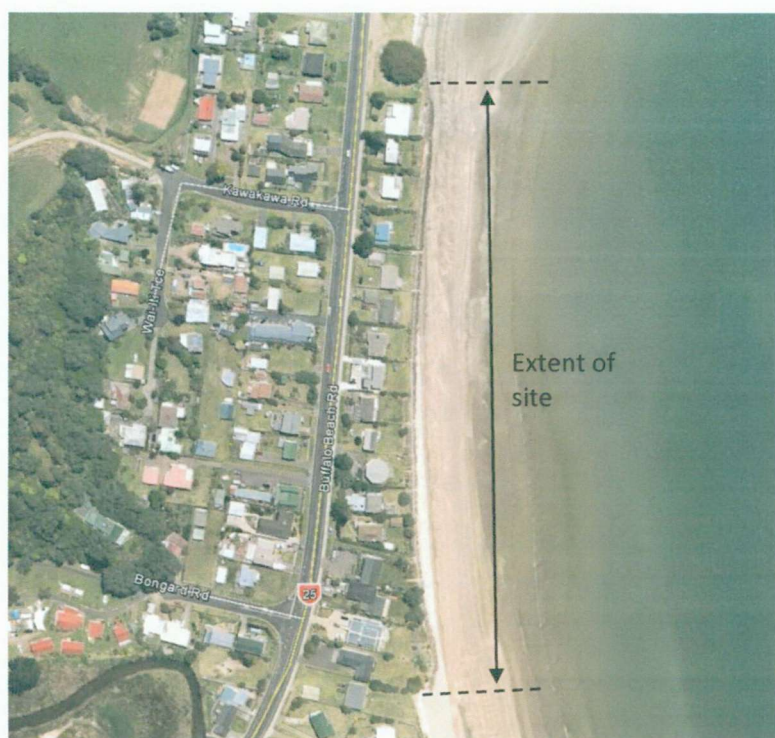
Figure 1-1: Site location plan

The site of the proposed coastal erosion protection structure is located at the northern end of Buffalo Beach. The site is bounded by Buffalo Beach Road/State Highway 25 to the west and the coastal marine area (CMA) to the east. Residential housing is located immediately landward of the site. Figure 1-1 provided below identifies the location of the proposed coastal erosion protection structure.

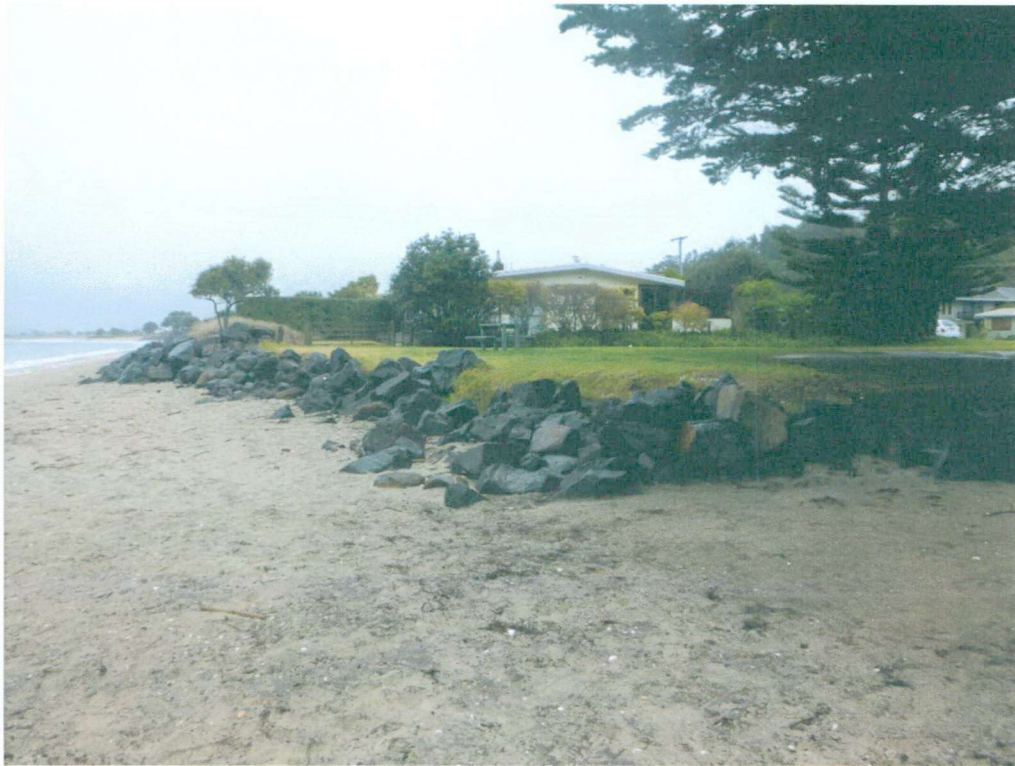
*Photo 1: existing structure in Macrocarpa Reserve – administered by Thames-Coromandel District Council.*

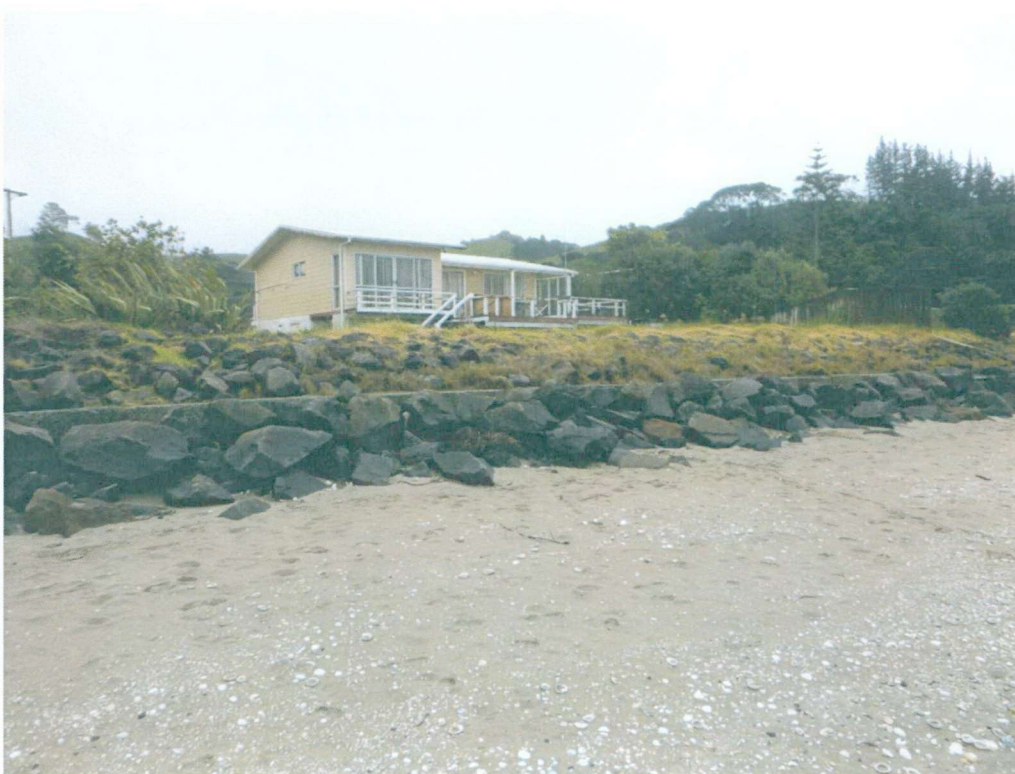
*Photo 2: Typical profile for northern end of existing coastal protection structure*

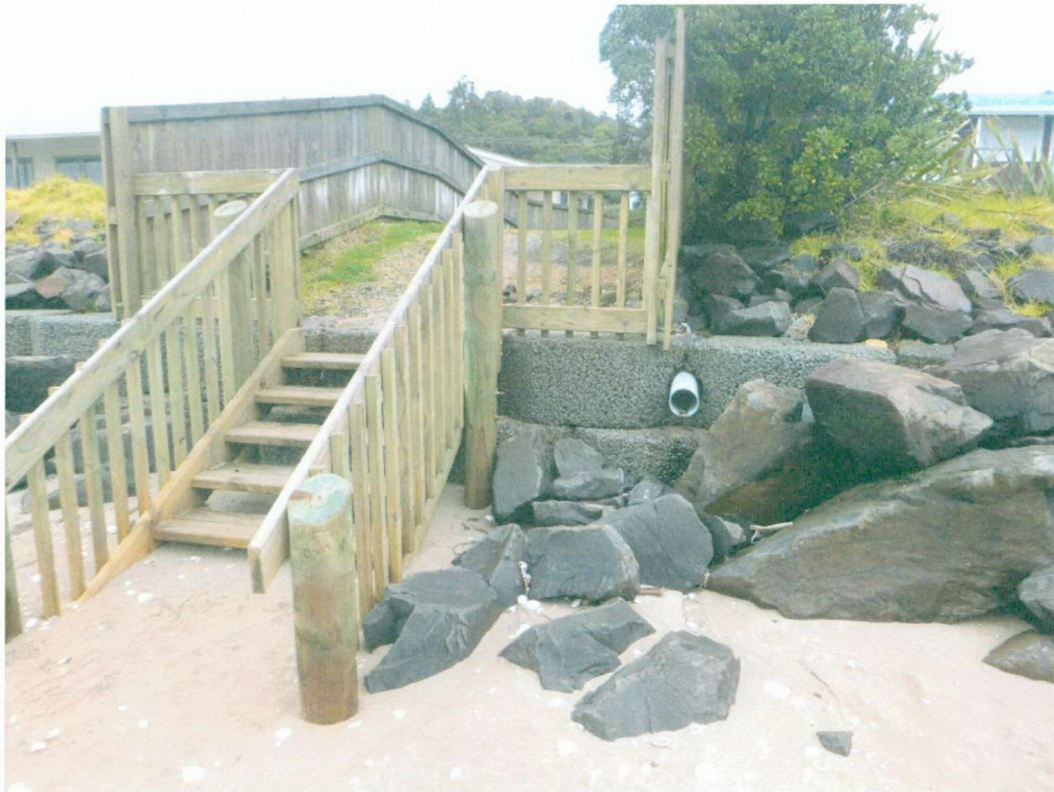
*Photo 3: Existing public access structure*

- **Access Structures:** a number of access structures exist along the length of the erosion protection works. These structures have been made from either concrete, timber or grouted rock.

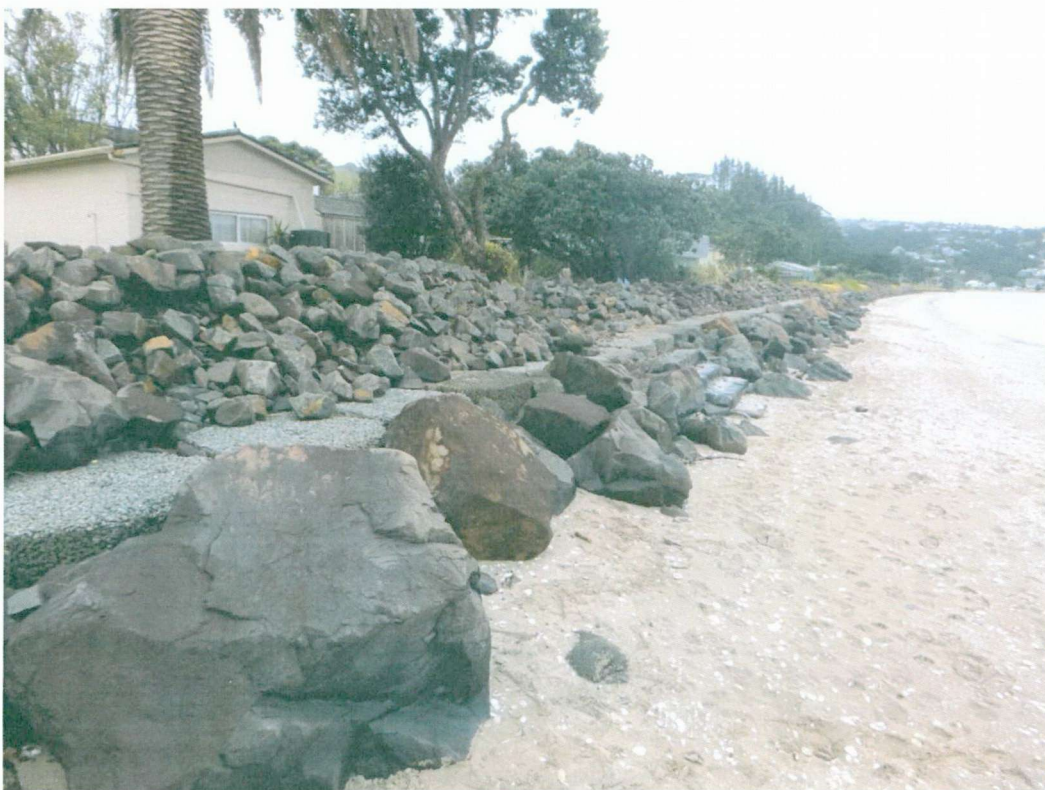
*Photo 4: Typical section through central area.*

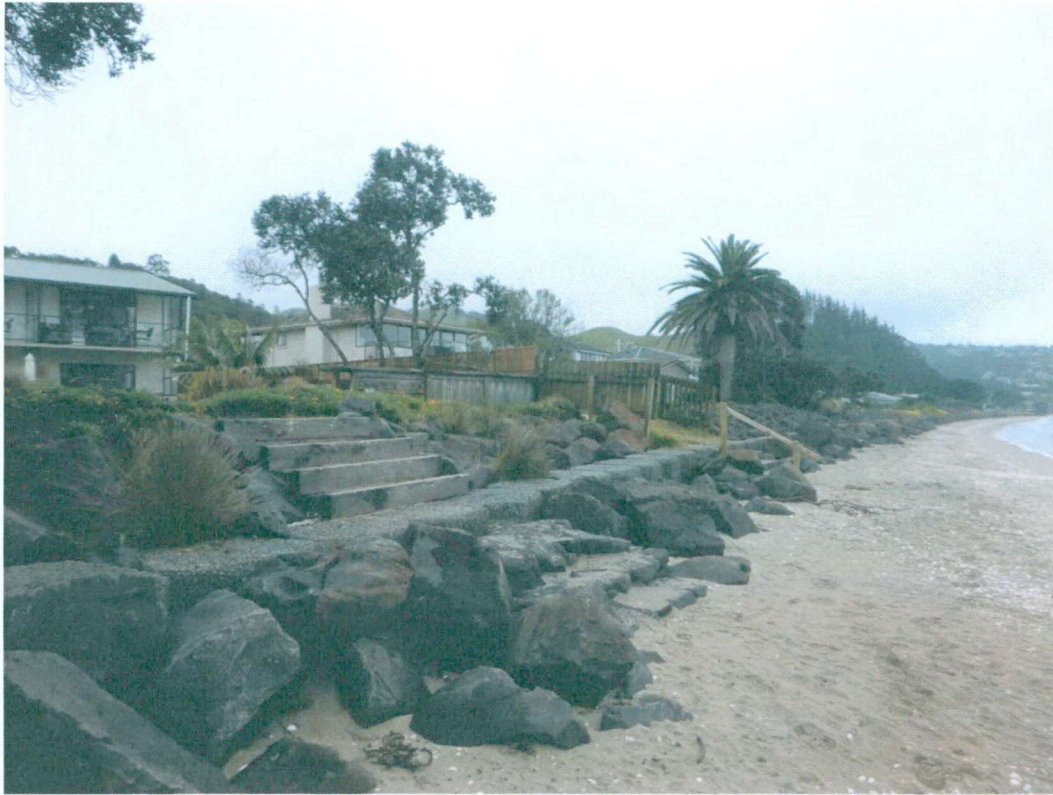
*Photo 5: Typical section at southern end of the existing structure*

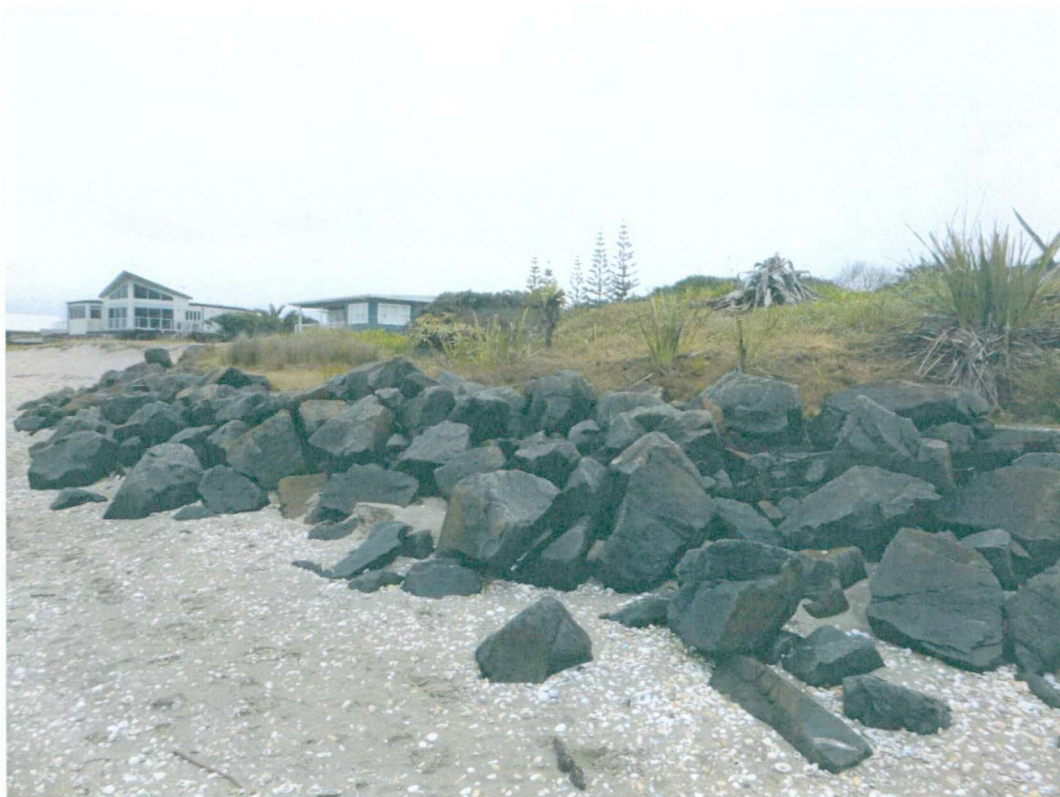
*Photo 6: Southern extent of existing structure – showing landward retreat for unprotected area*

The RMS survey (2014), shows the beach to the south of the seawall has eroded back to the point where the southern end of the seawall is exposed and is outflanked, with a risk of erosion behind the seawall. At the time of our July 2016 inspection, Council appeared to have recently completed beach dune regrading and planting in this area, and seawall outflanking was not evident to the extent indicated by the RMS survey.

Assuming the end of the seawall was originally constructed with the end buried slightly behind the adjacent beach dune, then it appears that the beach may be in a slow state of erosion in the area south of the seawall, although we haven't completed a detailed study of beach changes as part of this project.

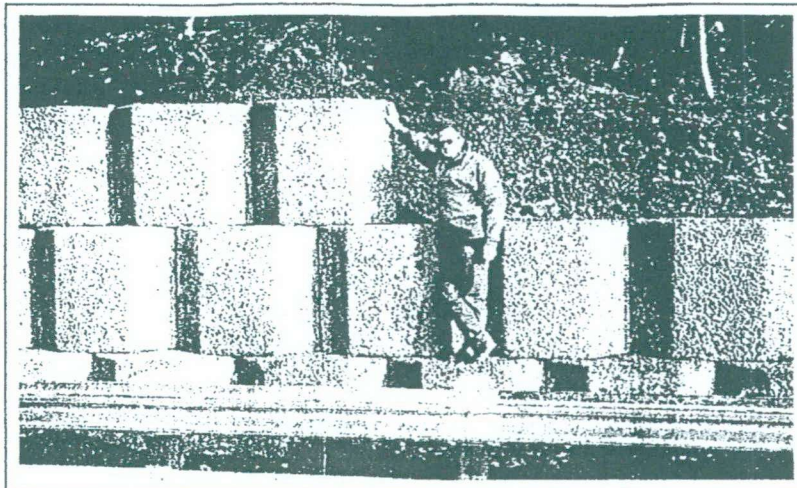
The MassBloc™ (pat. approved) is a manufactured permeable concrete block, precast in a variety of sizes and colours. Blocks in place have the ability to interlock using the lip cast into the base of each standard unit. This

interlock area extends from the rear surface by a distance of 150 millimetres and serves to lock the block to blocks placed below. The rough exposed concrete surfaces of the block aid the resistance to shearing forces by increasing the friction between units.

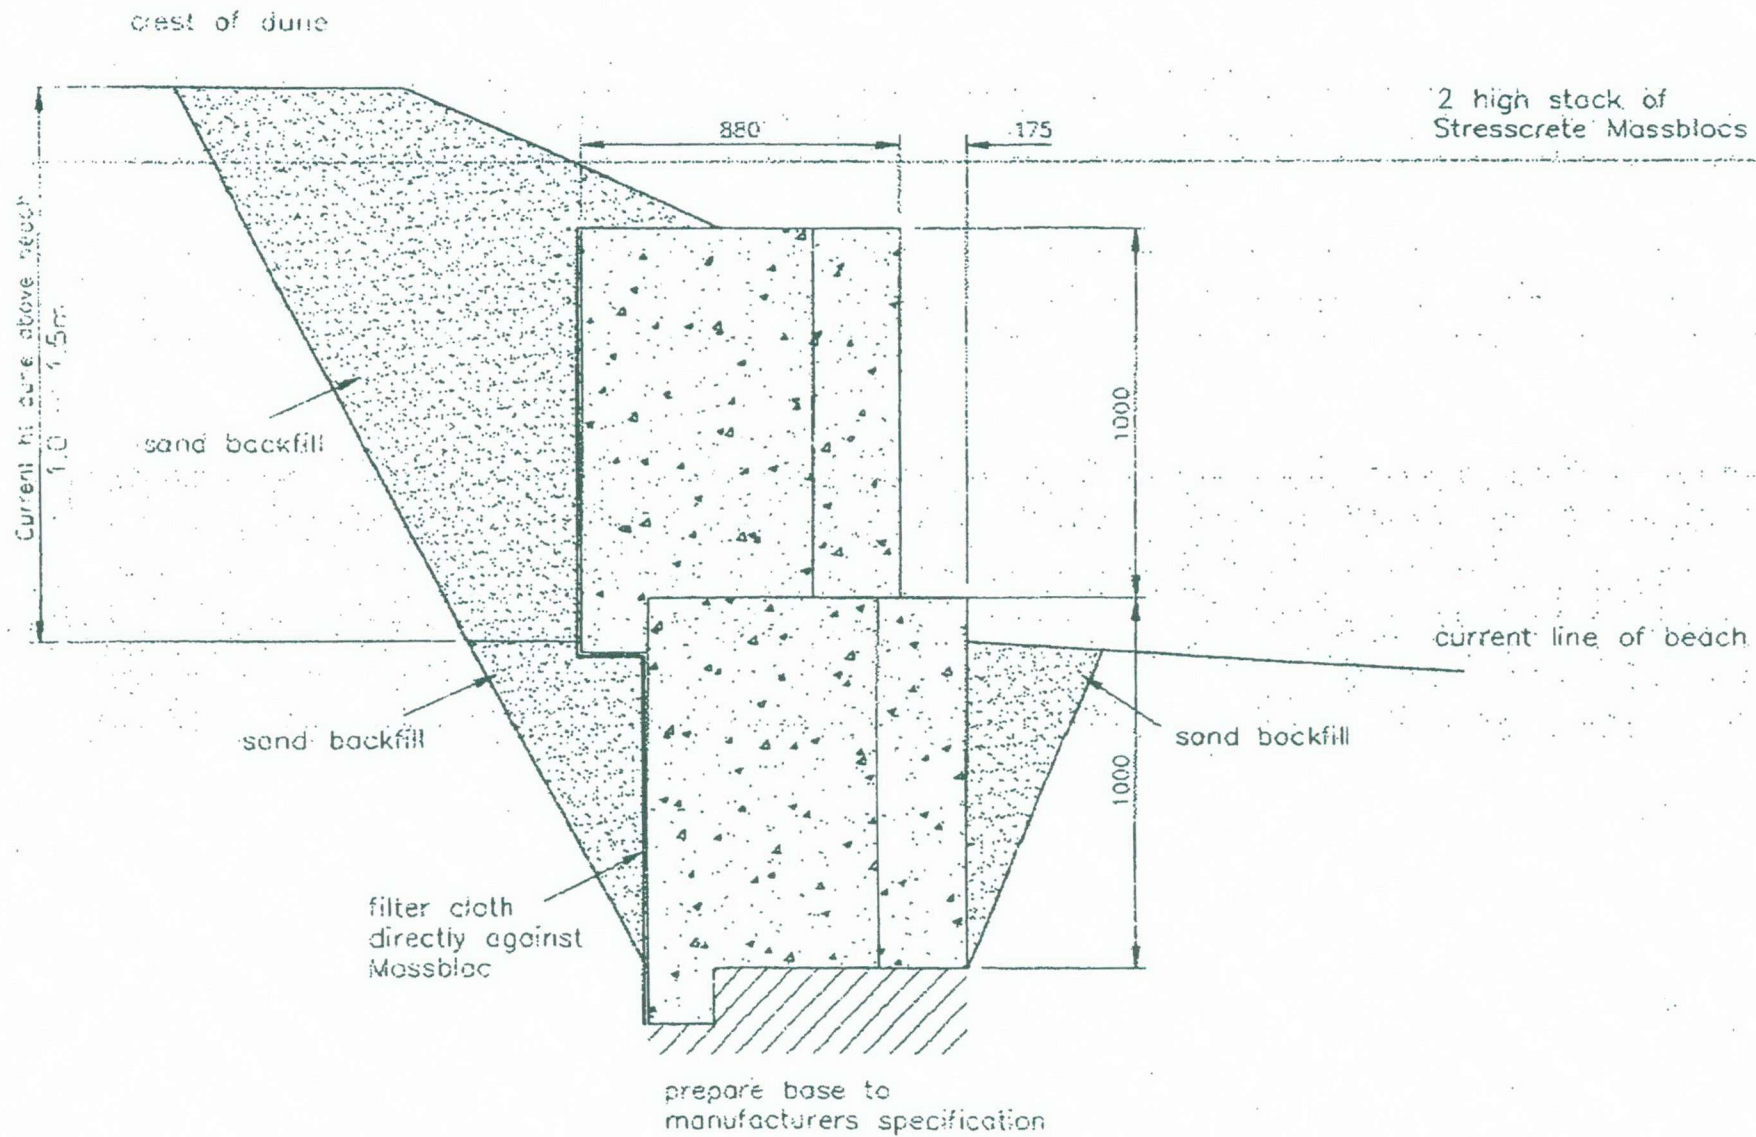
Typical section through sea-wall  
 Area D, Buffalo Beach  
 2k46(section)

As discussed above, information on the existing seawall construction was provided to T+T at our March site meeting by the Homeowners representatives. Details of the existing seawall are attached in Appendix C, and include B. F. Bolt and Associates drawings of the Massbloc wall, together with a series of 12 photos taken during the wall construction. Key details of the construction include the following:

- The Massbloc wall is a minimum 2 units high, however in the central and northern section where the beach was lowest, this height was increased to 2.5 units high. This is shown in the photos and the half units were observed in our recent site inspection. Based on this evidence we believe the Massbloc wall is 2.5m high in the central and northern sections, and 2m high for the southern section.
- The seawall survey (refer Appendix A), surveyed the top of the Massblocs generally at an elevation of +2.5m AVD-46 (Auckland Vertical Datum 1946). This implies that the toe of the Massbloc units are at RL 0.0m AVD-46 for the central and northern sections of the wall, and at +0.5m AVD-46 for the southern section of the wall.

- The design drawings and the construction photos both show a geotextile behind the wall and extending up above the height of the Massblocs to close to the elevation of the ground above the Massblocs.

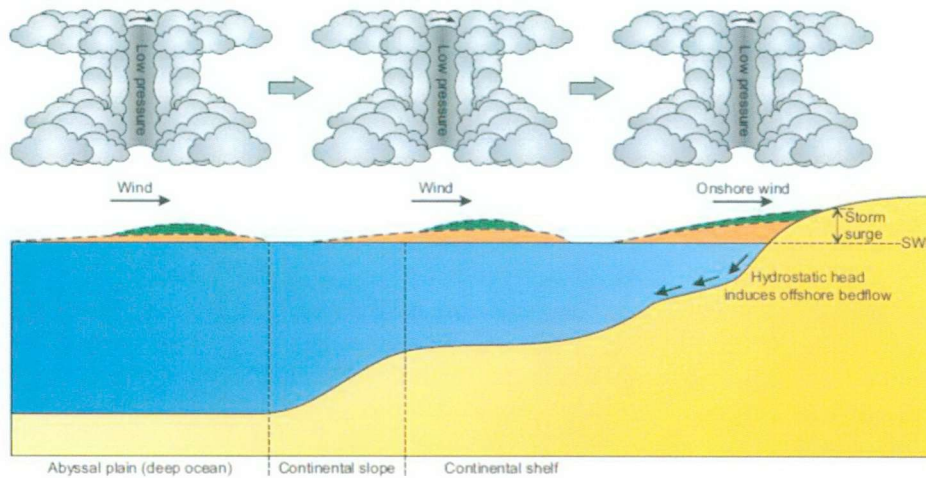
Storm surge, results from the combination of barometric setup from low atmospheric pressure and wind stress from winds blowing along or onshore, which elevate the water level above the predicted tide (Figure 1-1). The combined elevation of the predicted tide and storm surge is known as the storm tide. Storm tide estimates for Whitianga were derived by performing a Monte Carlo simulation using recorded annual maximum sea levels provided by NIWA (Figure 1-2). These storm tide values including astronomical tide, storm surge and fluctuations in mean sea level are shown in Table 1-2 with respect to mean sea level at Whitianga and AVD-46. Consideration of a 1% AEP event for assessment of coastal flooding is considered industry best practice (Ramsey et al., 2013). There is a 39.3% chance of such an event being exceeded over the next 50 years and 63.2% chance over the next 100 years.

Figure 1-1 Processes causing storm surge (source: Shand, 2010)

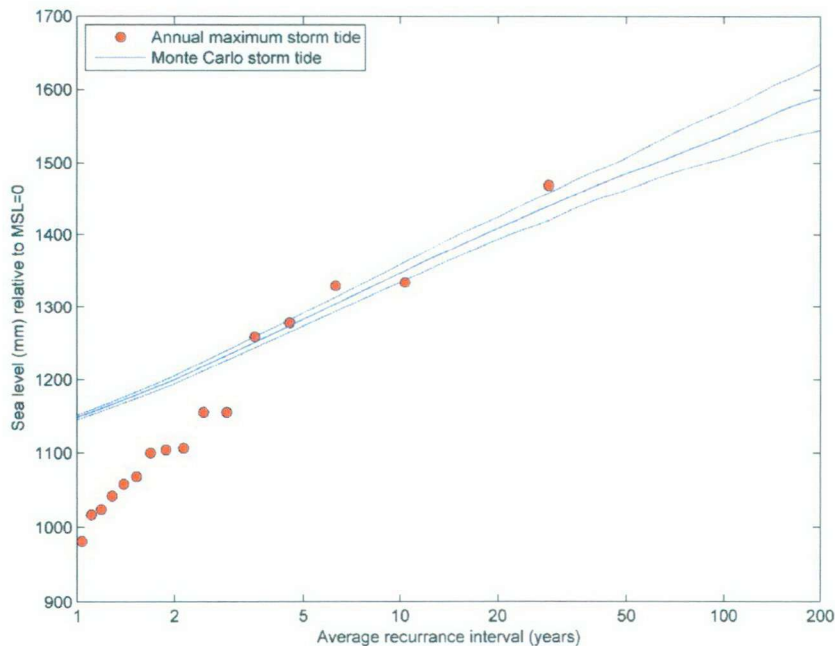
Figure 1-2 Storm tide for Whitianga (source: NIWA, 2014)

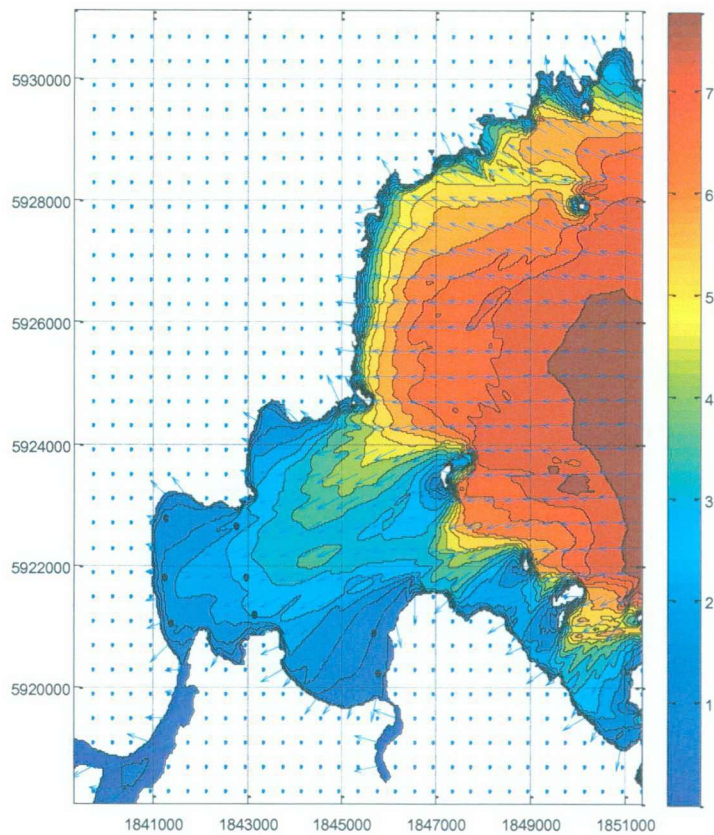
The model domain was constructed using bathymetry sourced from the LINZ Nautical Charts. Bathymetry maps of the central eastern part of the Coromandel peninsula (regional grid) and Mercury Bay, including Buffalo Beach (nested grid), have been generated. A 1% AEP significant wave height of 7.1 m and peak period of 11 seconds has been adopted as model boundary conditions based on wave data analysis by NIWA offshore of Mercury Bay. Winds are based on the yearly 1 hour wind speed from AS/NZS 1170.2:2011. Winds and waves from the north to southeast were tested with conditions from the easterly direction found to result in largest waves conditions at Buffalo Beach.

Figure 1-3 SWAN output for Mercury Bay for a 100 year ARI event from the East.

The SWAN model predicts a nearshore wave height of 2.15 m at the 5 m depth contour offshore of Buffalo Beach for a 1% AEP easterly event. Wave set up has been assessed based on the methods described within the Coastal Engineering Manual (CEM, 2006), with the resulting estimated wave set-up being 0.6m.

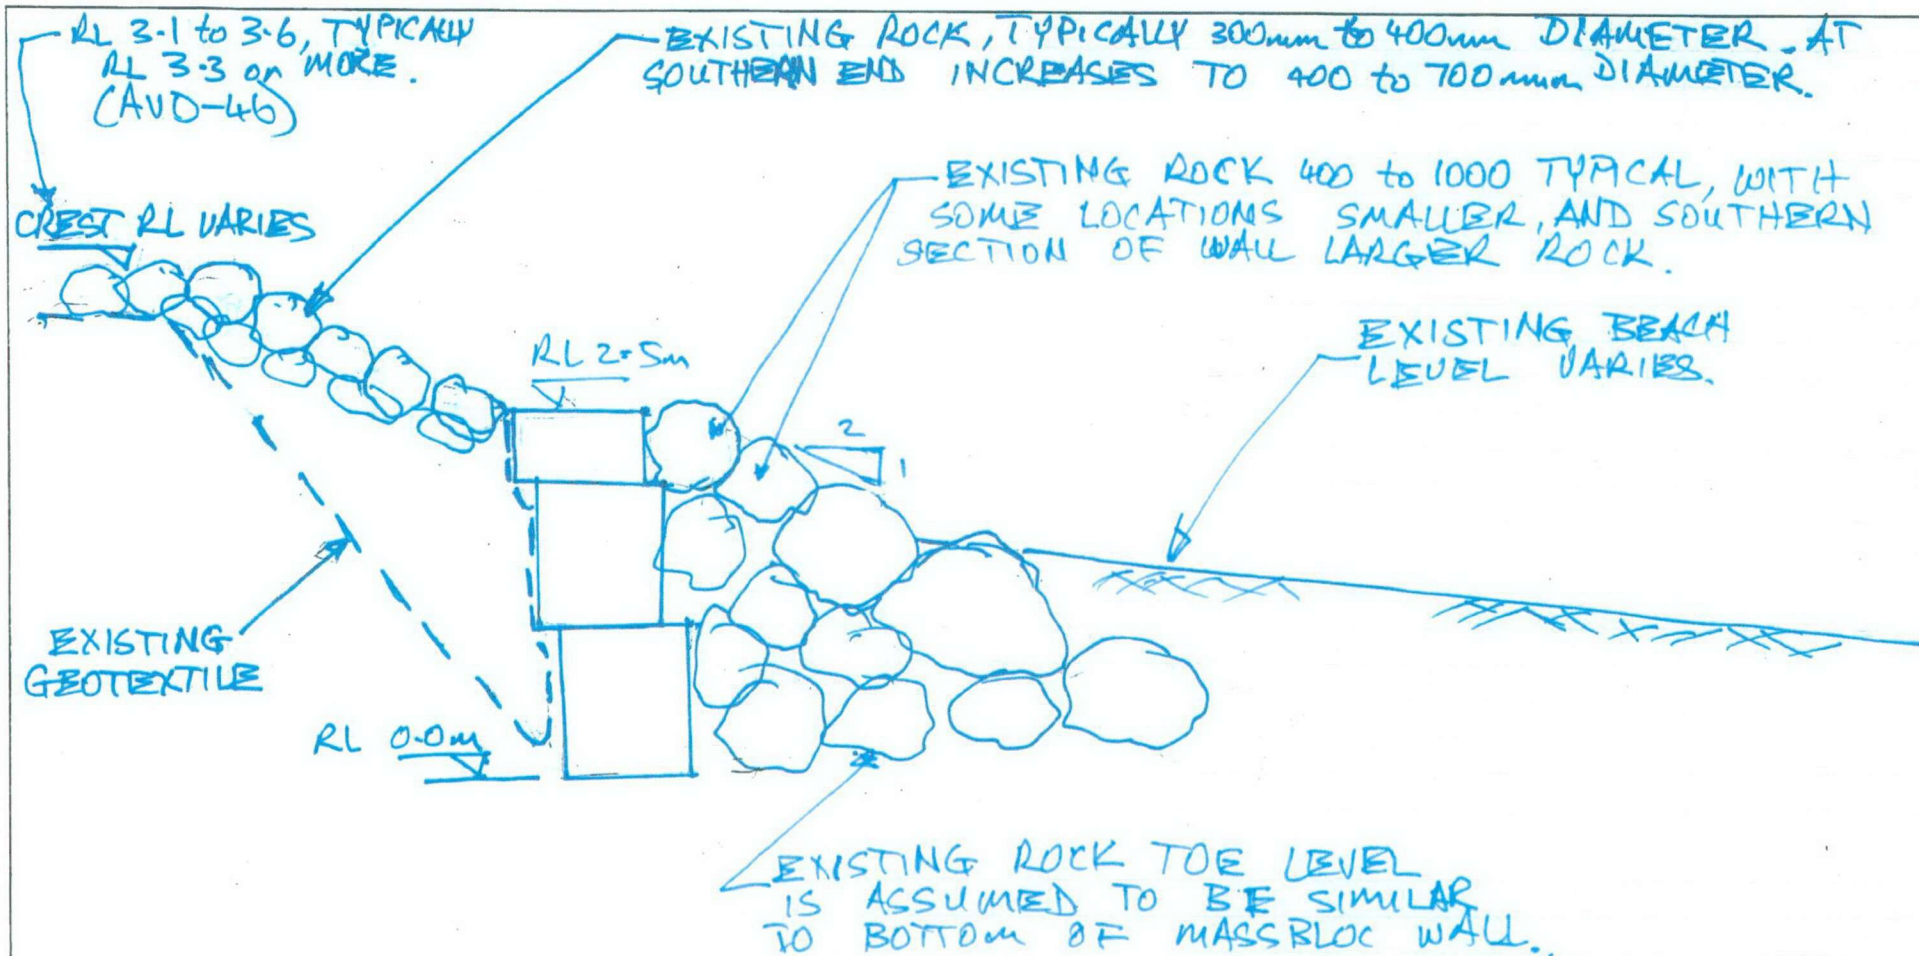
Office: **AK**  
Job No: **851872**  
File:  
Sheet No. **SK01**

TYPICAL EXISTING WALL CONSTRUCTION

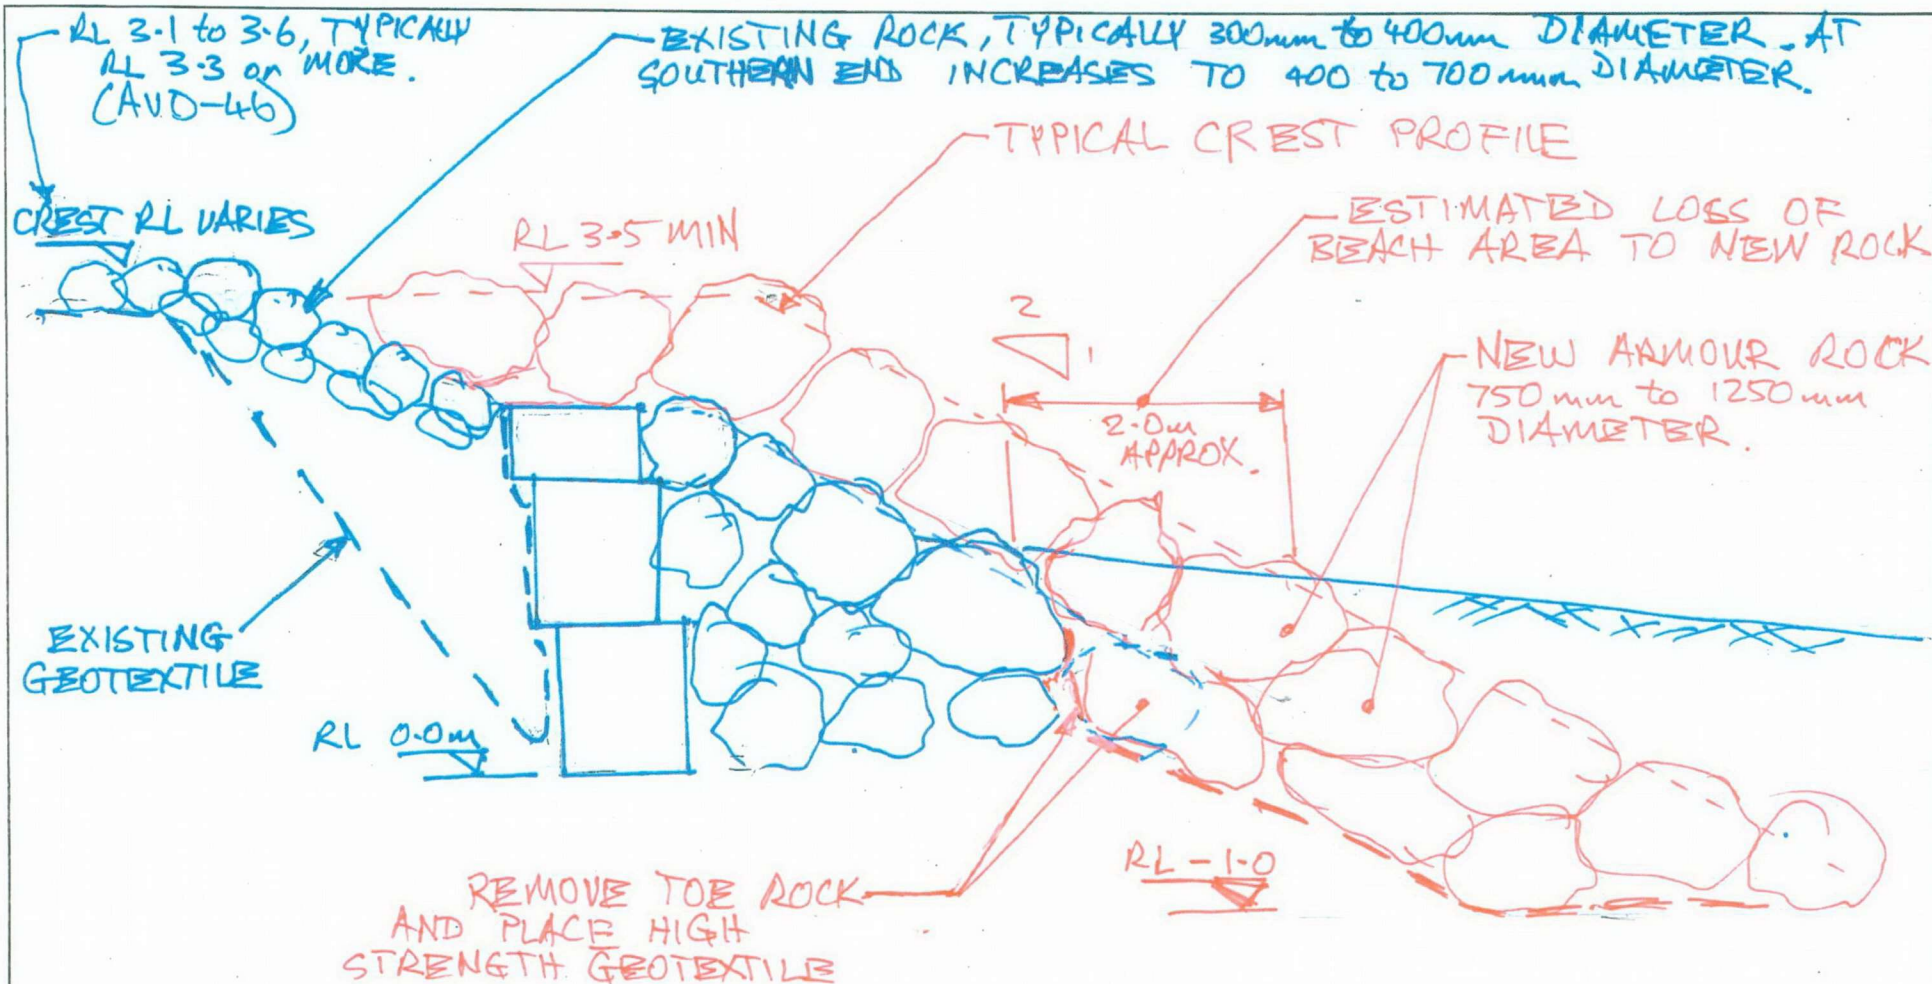
PROPOSED SEAWALL UPGRADE WORKS  
OPTION A: EXISTING WALL REMAINS.

Typical sketch cross-sections of the option to strengthen the existing seawall are included in Appendix E. The proposed seawall upgrade works involve placing additional larger armour rock over the outer face of the existing seawall. This larger armour provides protection against larger waves anticipated to occur during extreme storm events and allowing for future sea level rise, and also has the benefit of reducing wave overtopping during extreme storm events.

Two options have been presented, with the difference between the two options being that Option A simply encases the existing seawall in larger rock, whereas Option B includes installing additional geotextile layers beneath the existing rock armour to provide greater protection against sand being eroded through the existing rock armour, during extreme storms when the beach levels are low.

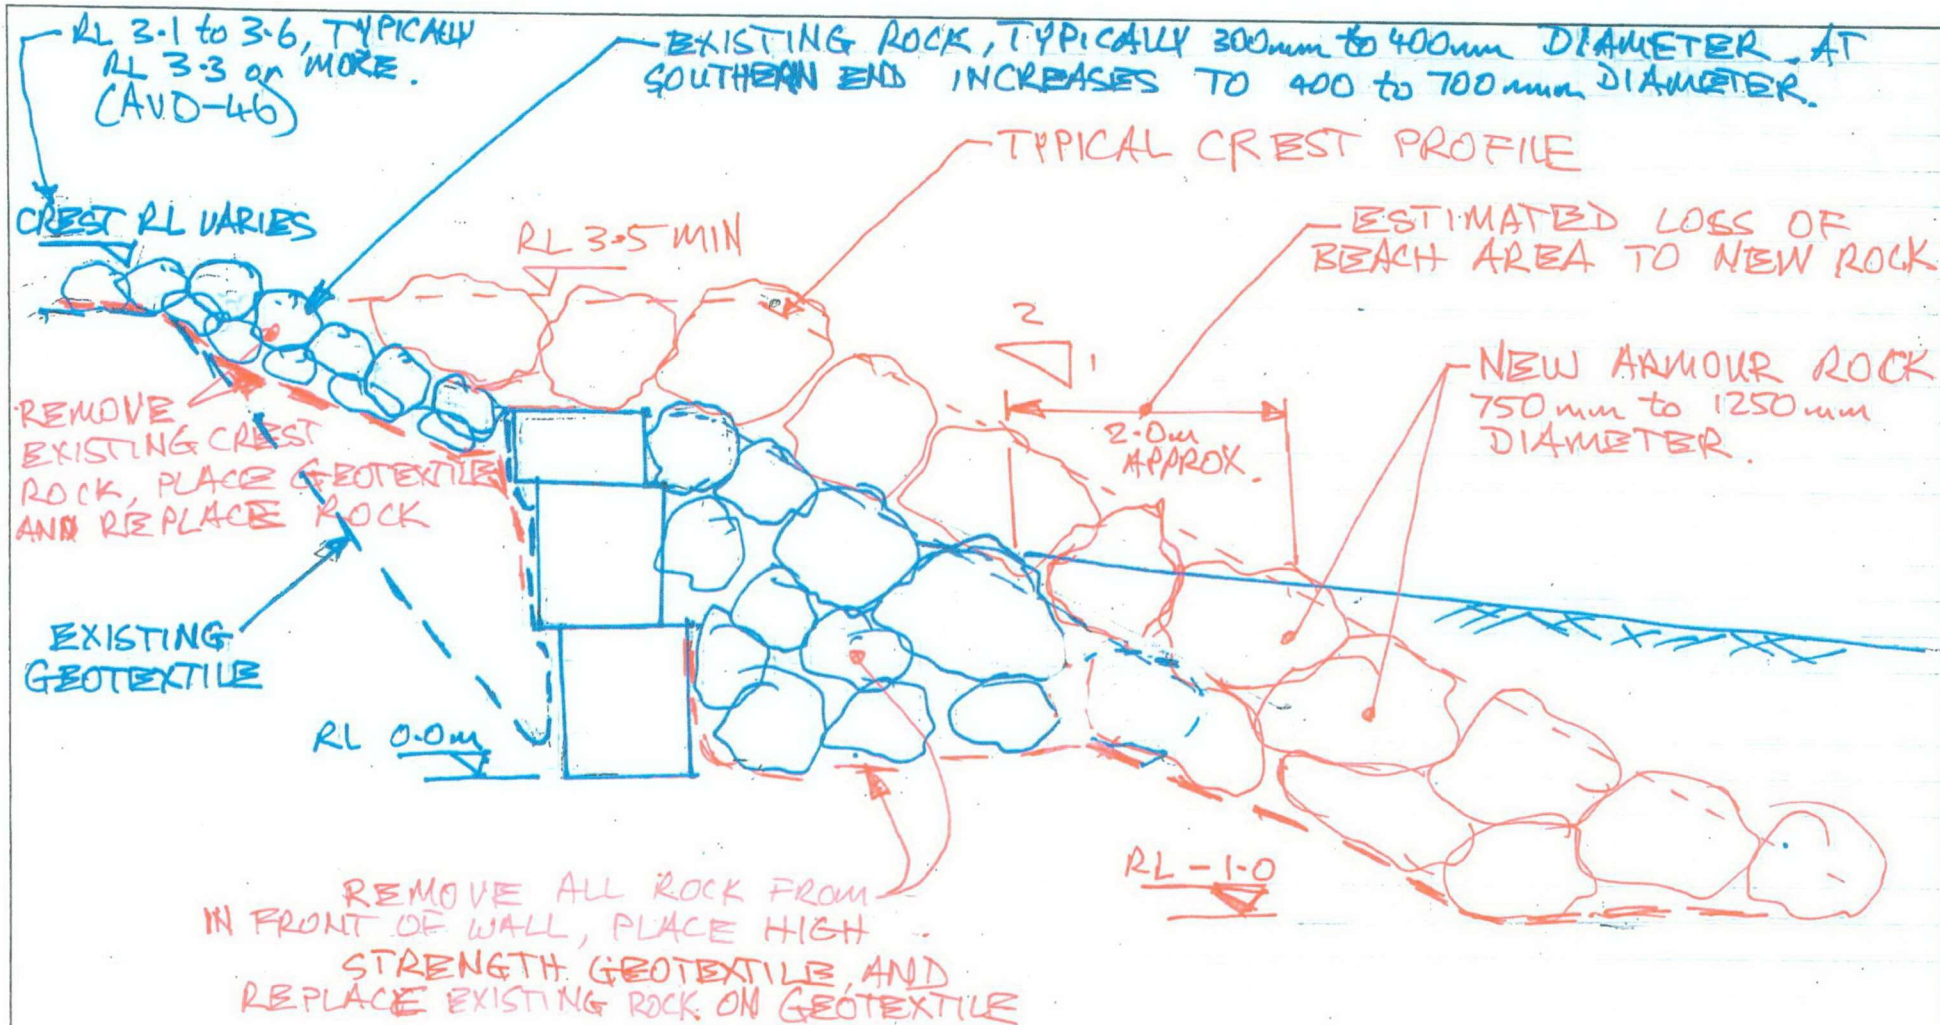
Office: **AL**  
Job No: **851872**  
File:  
Sheet No. **SK 03**

## PROPOSED SEAWALL UPGRADE WORKS

### OPTION B: PLACE ADDITIONAL GEOTEXTILES

We understand that the existing toe armour has settled during storms in the past. The placement of a geotextile beneath the existing rock, will assist in reducing any future settlement, however we do not have any information on the level of the underside of the existing toe rock, so do not know if any future settlement risk still exists. If Option A is selected by the Homeowners, there may be a need to top-up the Armour rock crest level in the future with additional rock, if settlement occurs. This could be done as a maintenance activity in the future if and when required.
