**Options assessment for  
shoreline erosion - Maketu  
Surf Club Car Park**

**Prepared for**  
Western Bay of Plenty District Council

**Prepared by**  
Tonkin & Taylor Ltd

**Date**  
May 2016

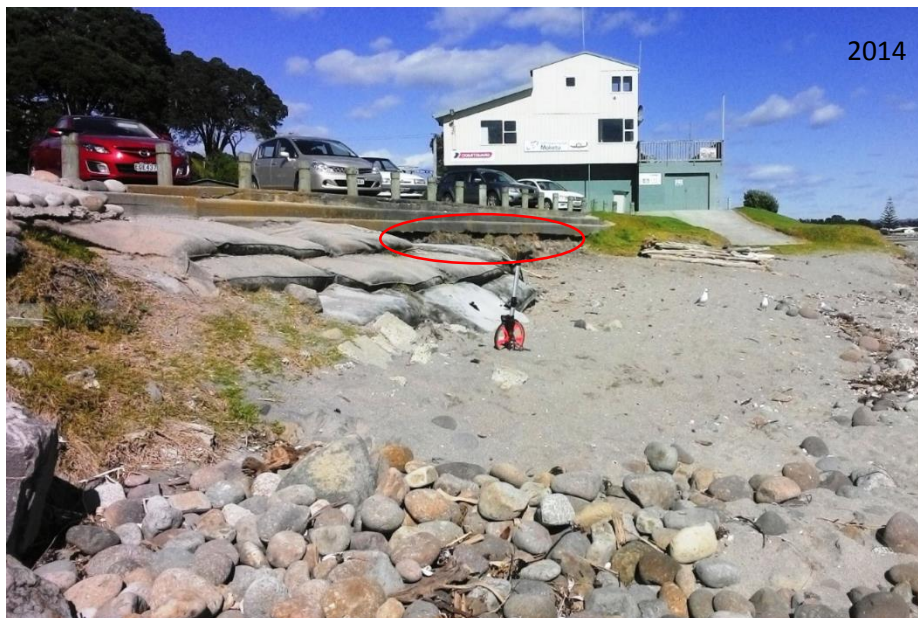
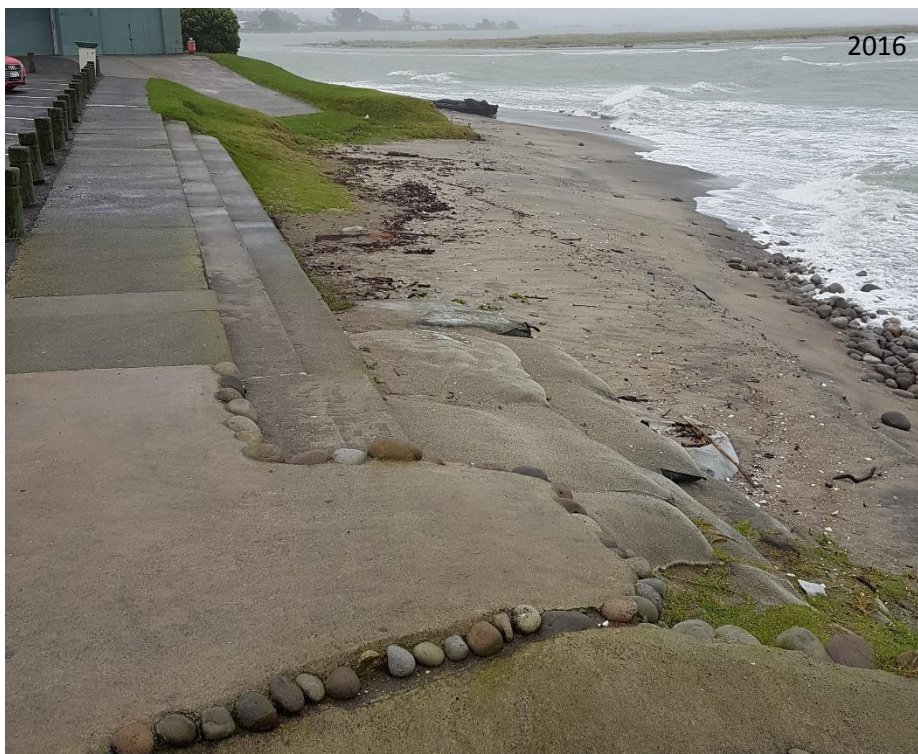
*Figure 1.2: The access structure, carpark, GSC and surf club in 2014 and 2016. The area where erosion has been identified by the Community Board is visible at the toe of the access structure in 2014 (see red circle). Source: WBOPDC 2016.*

The beach and the car park are segregated by a set of concrete steps (“access structure”) and a few geosynthetic sand containers (“GSC”) (refer Figure 1.2). The access structure and GSC serve two purposes. One purpose is to provide access between the car park and beach. The second purpose is to mitigate the effects of coastal erosion on the assets located behind the structures. We understand that these structures were constructed approximately 13 years ago.

During the annual coastal structures inspections it was noted that coastal erosion at the site was beginning to undermine the access structure, with the gabion basket foundation of the structure partially exposed. A rock revetment was discussed with community representatives as a potential option for addressing the erosion issue and these representatives expressed concern with such a structure being established on site. Therefore, the WBOPDC is considering coastal management options for the site to ensure the beach is preserved and community assets, including the access structure and car park, have a degree of resilience to current and future coastal erosion.

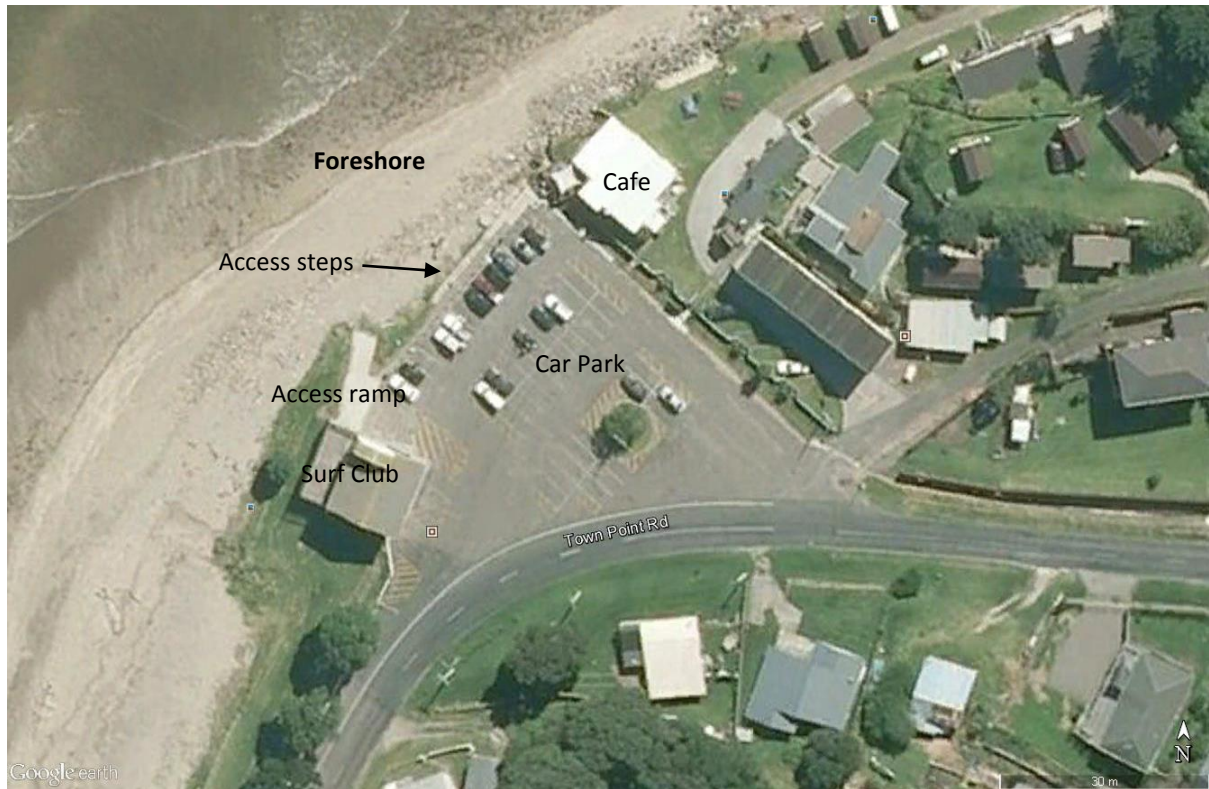
Source: Google Earth Pro 2016

Figure 2.1: The site and key features in 2011.

The area where there is an issue with coastal erosion periodically undermining the access structure extends for approximately 35 metres between the surf club access ramp and café (refer Figure 2.1).

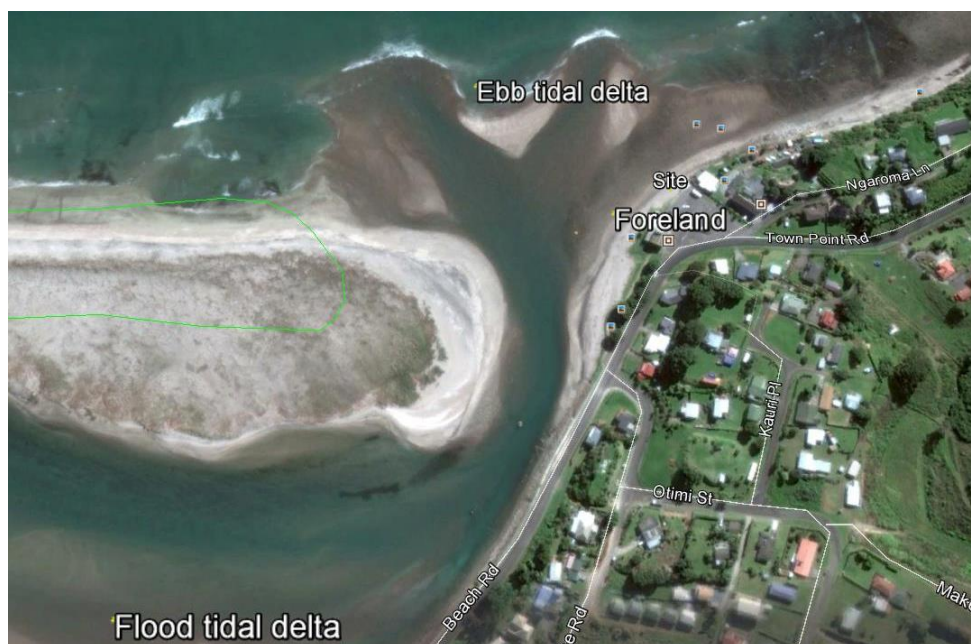
Figure 2.2: Morphology of the Maketu Estuary mouth 2015. Note the location of the ebb and flood tidal delta are indicative only and relate to their location at the time the aerial photography was flown. Source: Google Earth Pro 2016.

Aerial photography from the early 2000s to present day has been analysed and general observations suggest that the shape and location of the ebb tidal delta and the exit channel fluctuate, as expected in these types of systems. It appears that the rounded foreland, which the surf club is situated on, remains constant even with the varying morphology of the estuary and periodic repositioning of the ebb tide delta (see Figure 2.2).

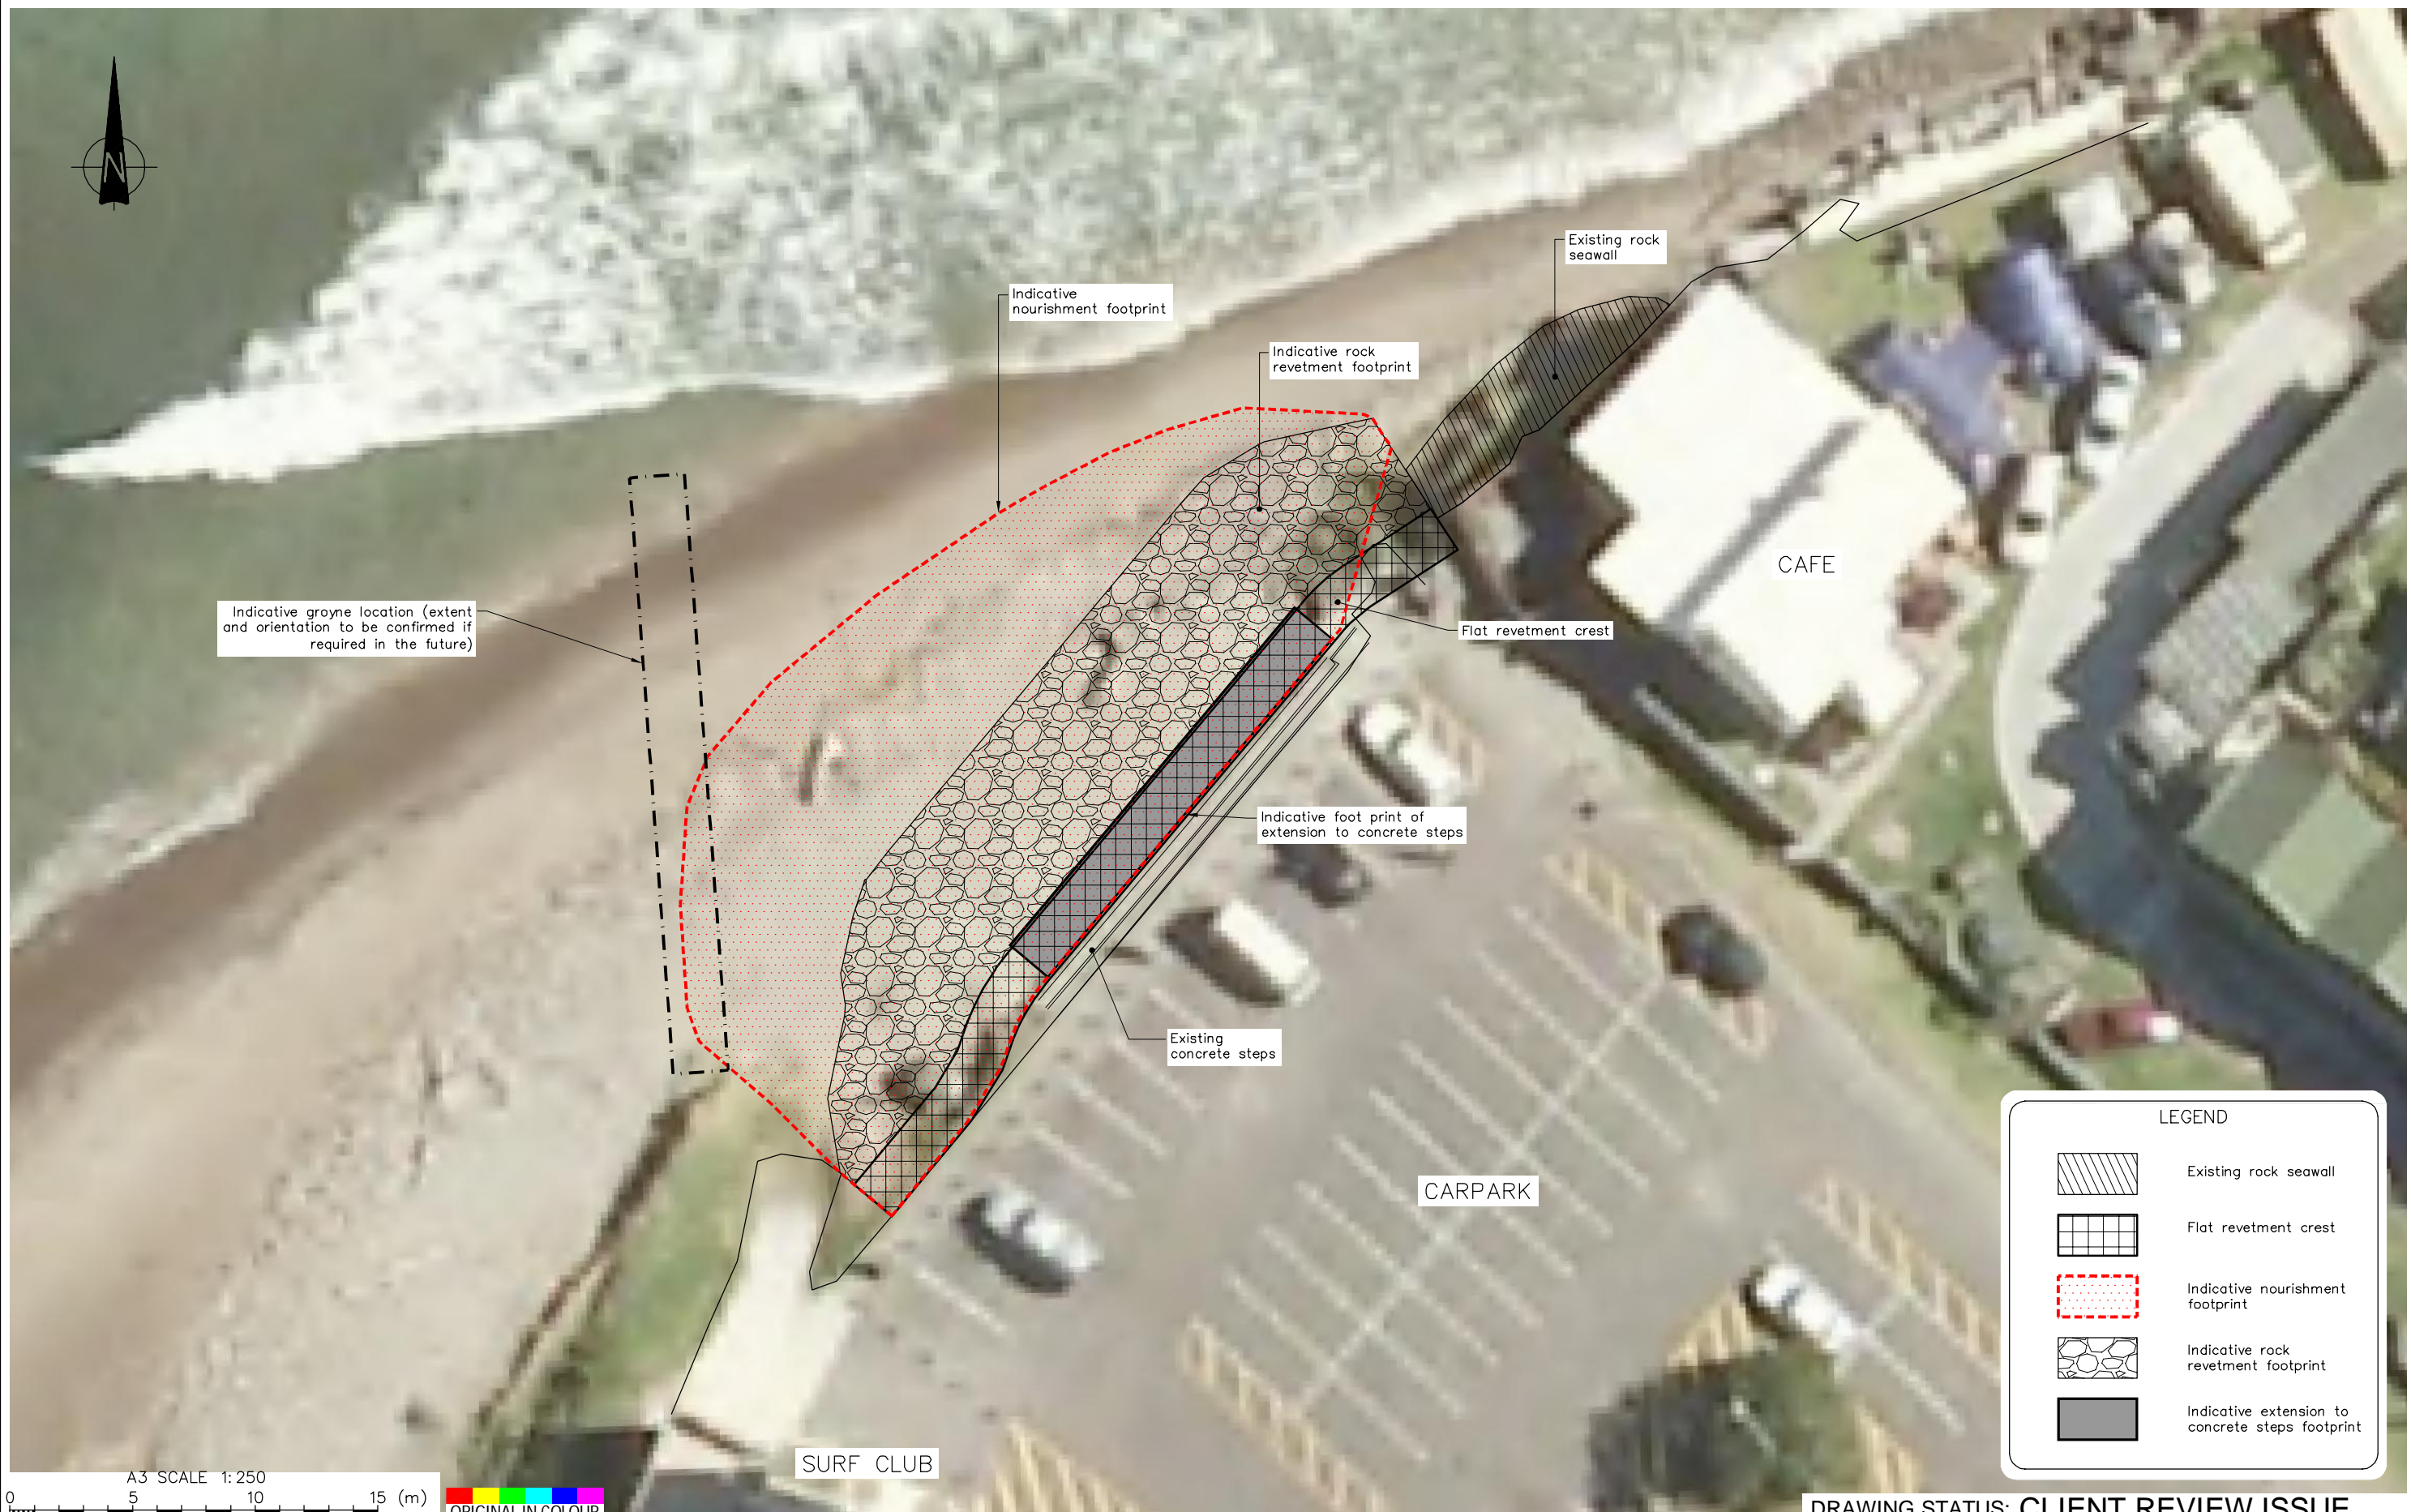
CLIENT PROJECT	WESTERN BAY OF PLENTY DISTRICT COUNCIL	
TITLE	MAKETU SURF CLUB CAR PARK COASTAL EROSION	
TITLE	POTENTIAL MANAGEMENT OPTIONS	
TITLE	Layout Plan	
SCALES (AT A3 SIZE)	DWG. No.	REV.
1: 250	85 1735.2200-01	1

## **Appendix A: Concept plan of the proposed options**

The preceding sections of this report set out the most relevant environmental factors in terms of shaping which potential management options are likely to be viable and which option(s) may be the preferred option. Other factors need to be considered in the development, discussion and selection of options for implementation including cost, design life, multiple use potential and aesthetics. An outline of the potential coastal management options available for implementation at the site to address the periodic lowering of the beach profile and exposure of the foundations of the access structure is presented in Table 3.1 below. The drawing contained in Appendix A provides an indicative location and extent of the options.

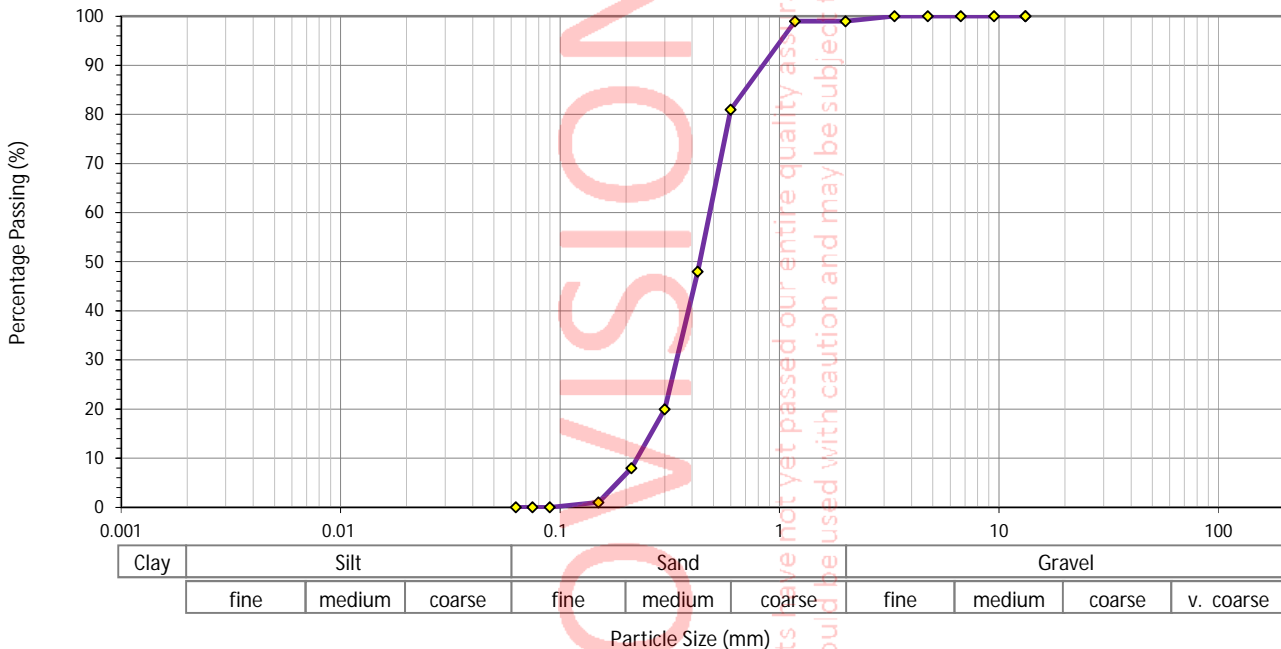
DETERMINATION OF THE PARTICLE SIZE DISTRIBUTION - NZS 4402:1986 - Test 2.8.1 (Wet Sieve)

LOCATION	ID	Maketu		
	Description	N/A		
	Data	N/A		
SAMPLE	Geotechnics ID	GEOT201605090	Date Received	5/05/2016
	Reference	S1	Depth	0.00m
	Description	Fine to coarse SAND, trace shells; grey. Dry.		
SPECIMEN	Reference	1	Depth	N/A
	Description	N/A

Sieve Size (mm)	Percentage Passing (%)	Sieve Size (mm)	Percentage Passing (%)	Sieve Size (mm)	Percentage Passing (%)	Sieve Size (mm)	Percentage Passing (%)
150	-	26.5	-	4.75	100	0.300	20
100	-	19.0	-	3.35	100	0.212	8
75.0	-	16.0	-	2.00	99	0.150	1
63.0	-	13.2	100	1.18	99	0.090	0
53.0	-	9.50	100	0.600	81	0.075	0
37.5	-	6.70	100	0.425	48	0.063	0

Samples of the sediment at the site were collected and analysed, both visually and within a laboratory for Particle Size Distribution (PSD). The analysis confirms the following:

- The sediments are coarse with shell and wood fragments visible.
- In terms of the Wentworth Scale the sediment is classified as “medium to coarse sand”.

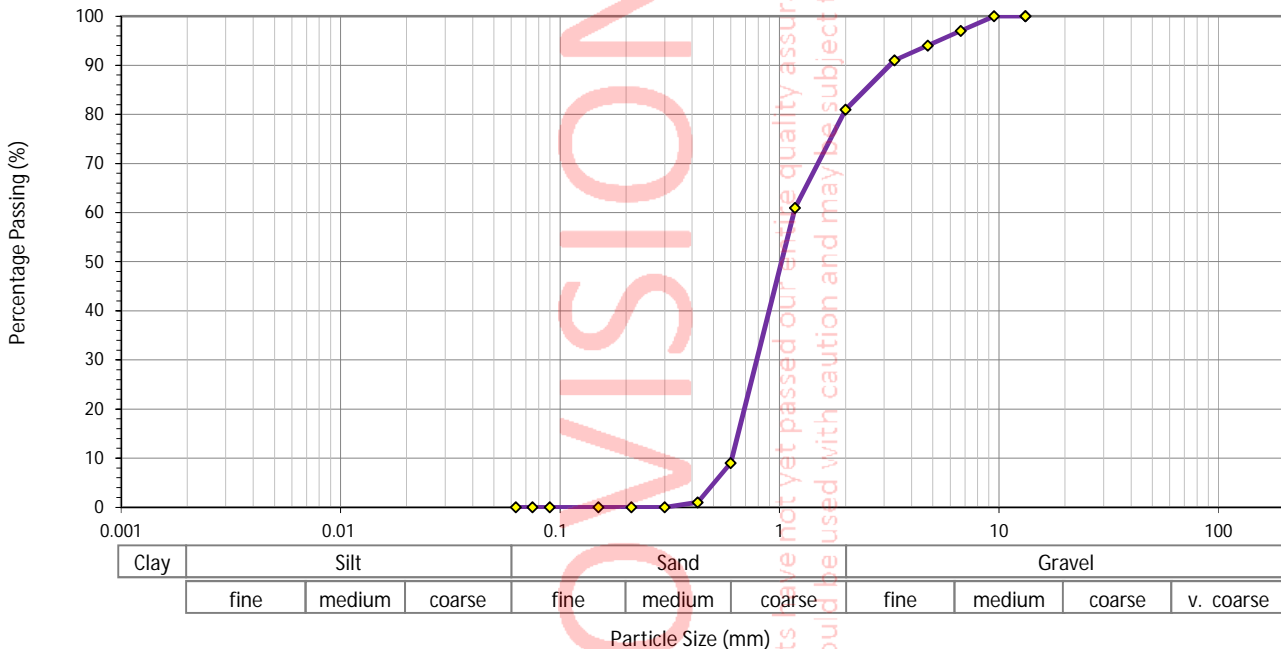
DETERMINATION OF THE PARTICLE SIZE DISTRIBUTION - NZS 4402:1986 - Test 2.8.1 (Wet Sieve)

LOCATION	ID	Maketu		
	Description	N/A		
	Data	N/A		
SAMPLE	Geotechnics ID	GEOT201605091	Date Received	5/05/2016
	Reference	S2	Depth	0.00m
	Description	Medium to coarse SAND, trace shells; dark brown. Moist.		
SPECIMEN	Reference	1	Depth	N/A
	Description	N/A

Sieve Size (mm)	Percentage Passing (%)	Sieve Size (mm)	Percentage Passing (%)	Sieve Size (mm)	Percentage Passing (%)	Sieve Size (mm)	Percentage Passing (%)
150	-	26.5	-	4.75	94	0.300	0
100	-	19.0	-	3.35	91	0.212	0
75.0	-	16.0	-	2.00	81	0.150	0
63.0	-	13.2	100	1.18	61	0.090	0
53.0	-	9.50	100	0.600	9	0.075	0
37.5	-	6.70	97	0.425	1	0.063	0

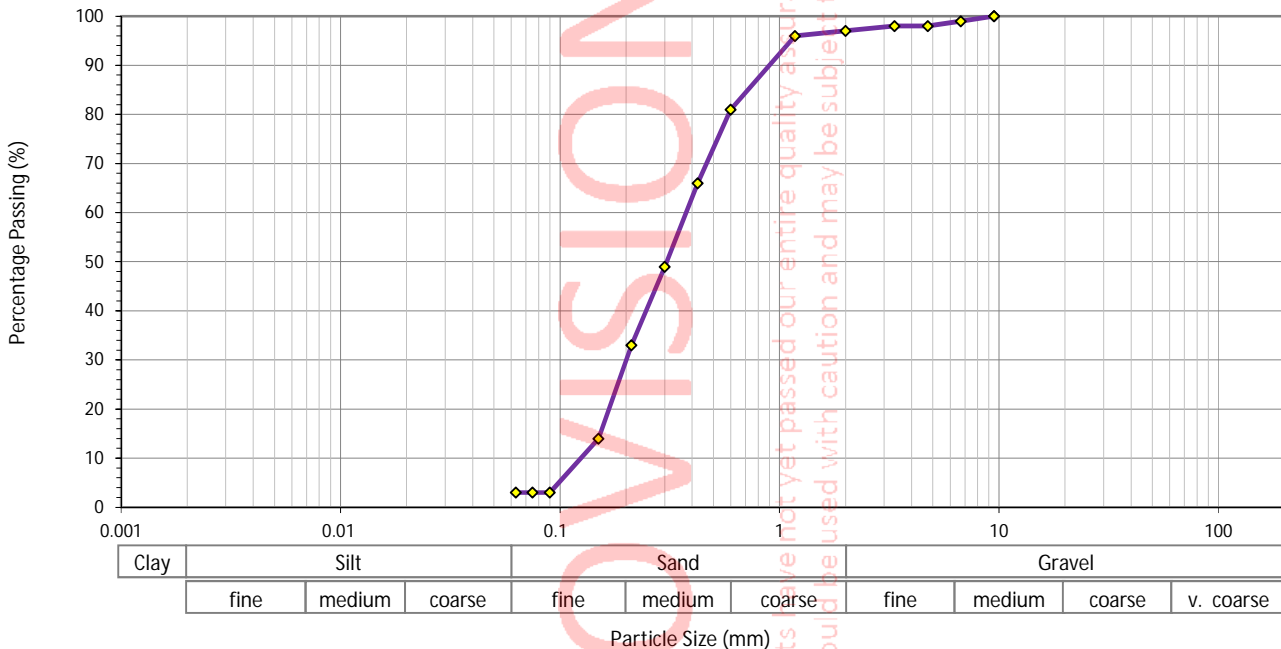
DETERMINATION OF THE PARTICLE SIZE DISTRIBUTION - NZS 4402:1986 - Test 2.8.1 (Wet Sieve)

LOCATION	ID	Maketu		
	Description	N/A		
	Data	N/A		
SAMPLE	Geotechnics ID	GEOT201605092	Date Received	5/05/2016
	Reference	S3	Depth	0.00m
	Description	Fine to coarse SAND, trace shells; dark grey. Wet.		
SPECIMEN	Reference	1	Depth	N/A
	Description	N/A

Sieve Size (mm)	Percentage Passing (%)	Sieve Size (mm)	Percentage Passing (%)	Sieve Size (mm)	Percentage Passing (%)	Sieve Size (mm)	Percentage Passing (%)
150	-	26.5	-	4.75	98	0.300	49
100	-	19.0	-	3.35	98	0.212	33
75.0	-	16.0	-	2.00	97	0.150	14
63.0	-	13.2	-	1.18	96	0.090	3
53.0	-	9.50	100	0.600	81	0.075	3
37.5	-	6.70	99	0.425	66	0.063	3
