Coromandel Beaches - Coastal Hazards:

Review of Primary Development Setback at Selected Beaches

Thames Coromandel District Council

October 2009

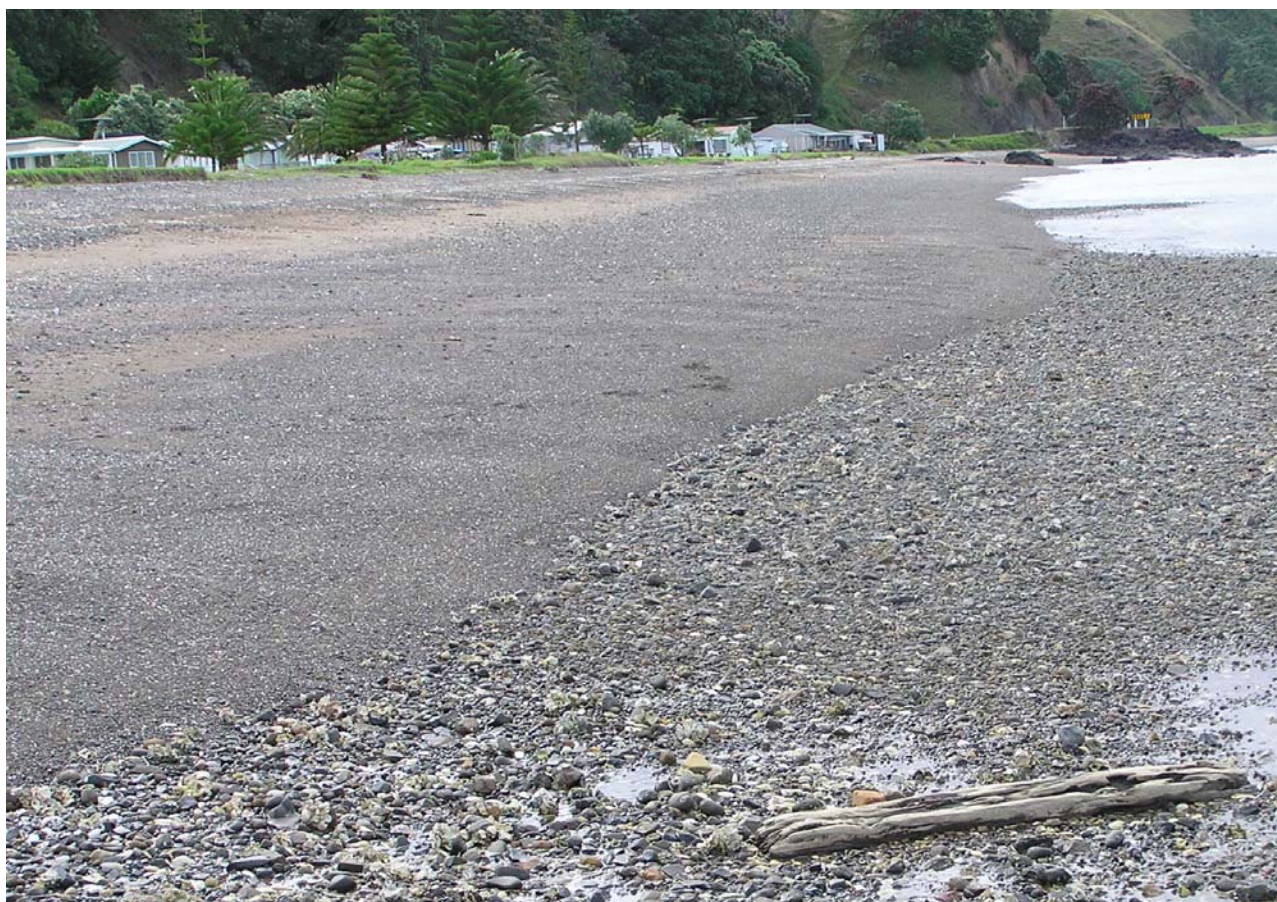
Figure 2: Example of the mixed sand and gravel beaches which tend to characterise the foreshore of the Thames Coast deltas

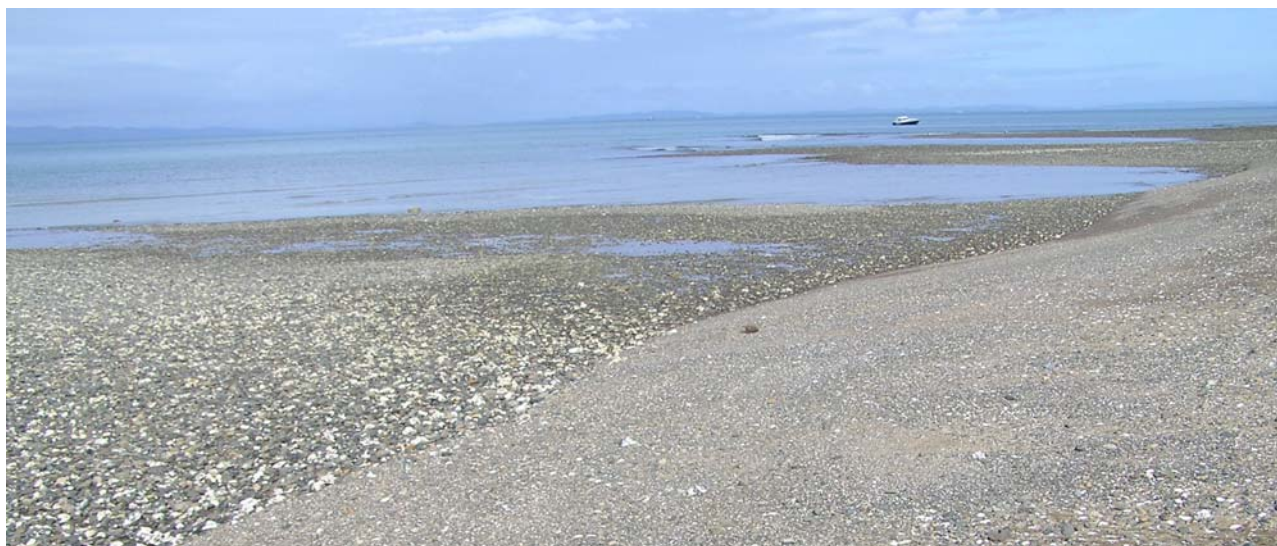
Figure 3: Rock and shell-lagged intertidal flat at Waikawau, typical of the low intertidal flats seaward of the Thames Coast deltas. This photo taken at mid tide also shows the shore-perpendicular swash bars and intervening swales that often characterise these areas.

The intertidal and subtidal flats seaward of the beaches are often lagged with large rocks and coarse gravels in areas close to the river entrance (Figure 3). Swash bars are common over these intertidal flats, often shore perpendicular (Figure 3). Sands and fine gravels winnowed by wave action are also commonly evident as low onshore migrating swash bars. Sediment size over the intertidal flats generally decreases with distance from river entrances and the flats can be relatively sandy in some areas.

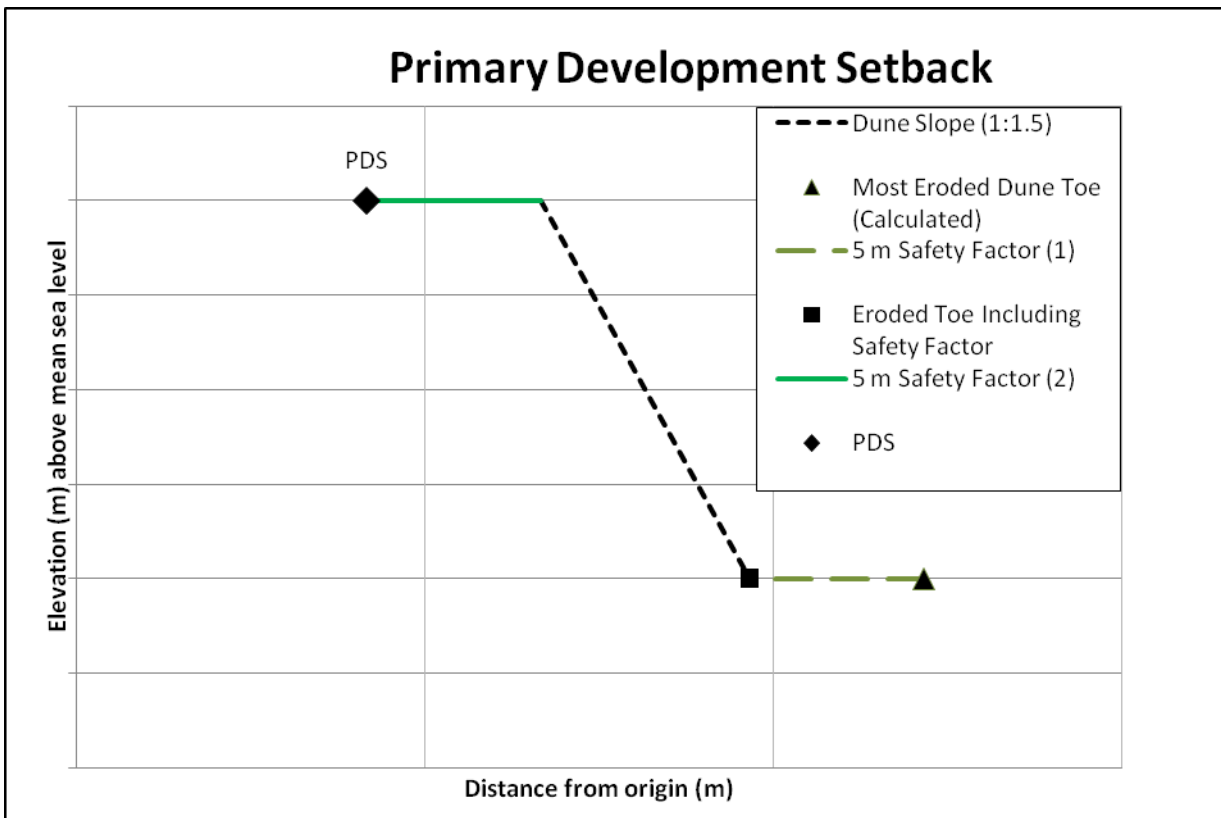
Figure 5: Key parameters including safety factors used to calculate revised PDS (see text for explanation)

A second 5 m safety factor was applied after calculation of the dune slope adjustment to ensure the safe location of new dwellings for periods of at least 50 years. We believe this factor is required to ensure a useful dune buffer is retained following the most severe erosion likely. In essence, this safety factor is intended to ensure that not only are the dwellings safe but owners also feel safe. It also ensures sufficient space for dune restoration work if required (e.g. dune enhancement with beach scraping; planting to encourage dune recovery; etc). We do not believe it is appropriate to have a setback (and therefore potentially a dwelling) located right on the line of the worst estimated erosion. Owners would not feel safe even if they were – probably resulting in increased demand for seawalls following severe erosion. In our judgement, an allowance of 5 m for this factor is the minimum reasonable provision. For instance, following erosion of July and August 2008 at Whangapoua, considerable concern was expressed by landowners with dwellings within 5-7 m of the top of the erosion crest. A safety factor of 10 m would be more ideal to provide for these concerns at many sites but would result in further restriction on property use. However, the lesser 5 m allowance is probably adequate. For instance, the experience at Whangapoua was that landowner concerns were able to be resolved without recourse to seawalls and there was sufficient space for required dune restoration. Nonetheless, the adequacy of the lesser (5 m) safety factor proposed is a matter Council should review in the light of future experience, increasing further if required.

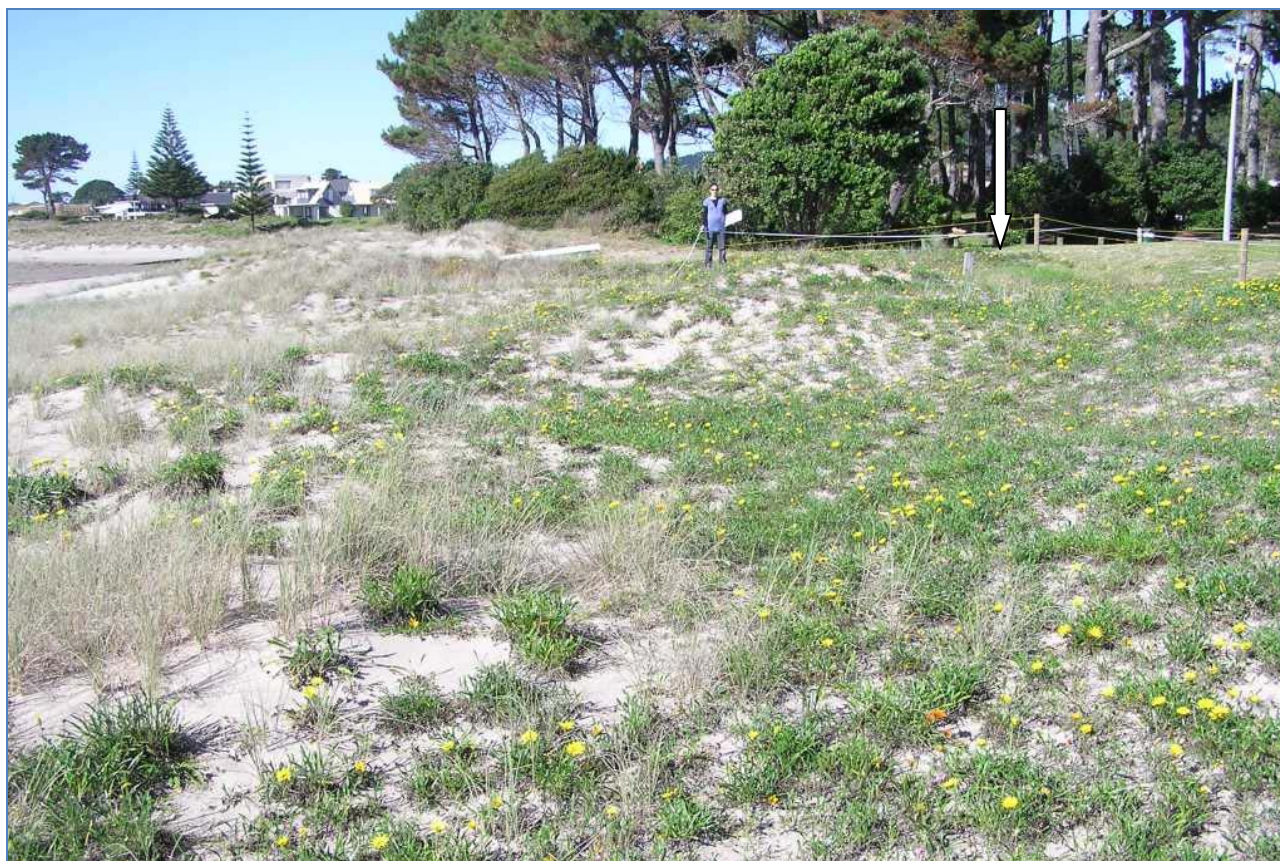
Figure 7: Photo showing approximate location of y-intercept at CCS56, close to the Whangamata Surf Club. Note relatively large trees immediately south of the profile growing on a line seaward of the calculated erosion.

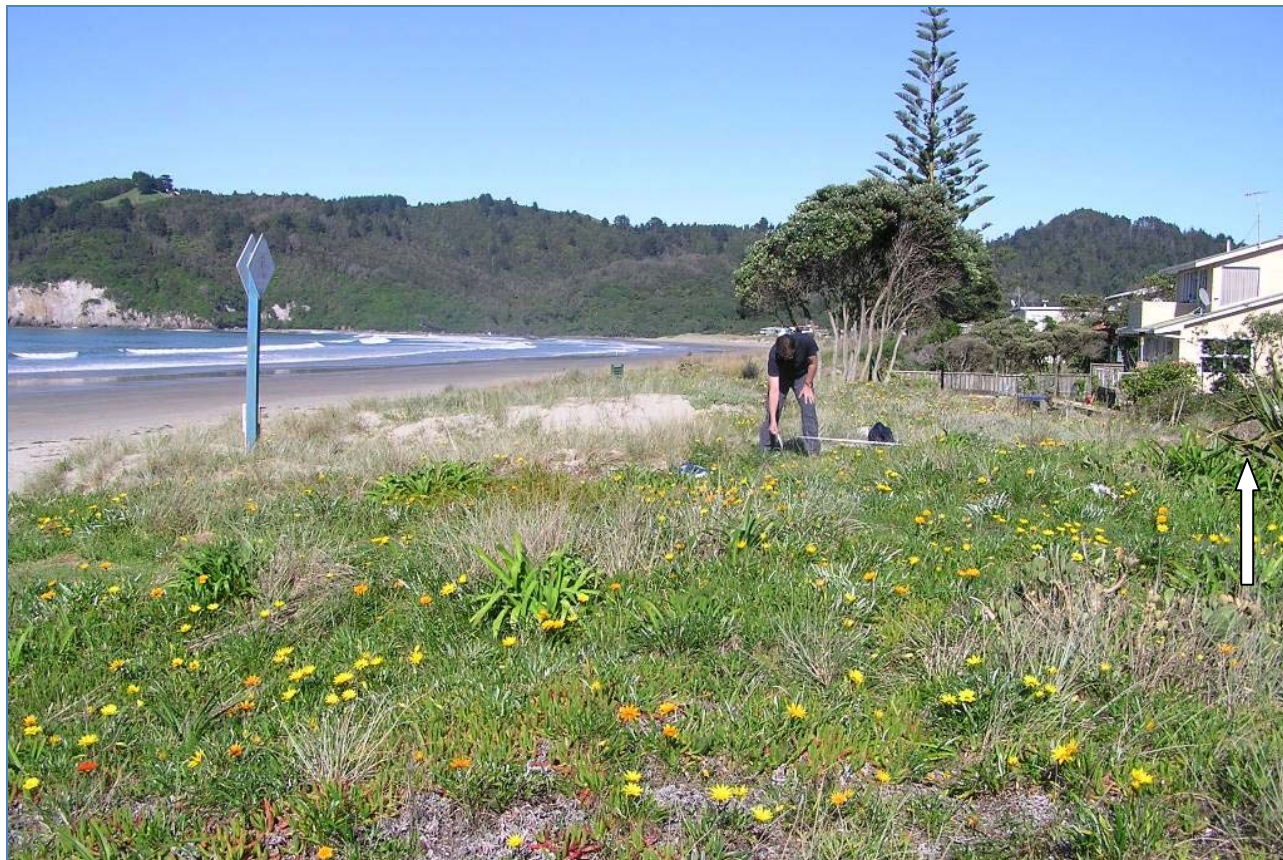
Figure 8: Approximate location of worst estimated erosion at ground level (arrow) at Whangamata beach profile site CCS57.

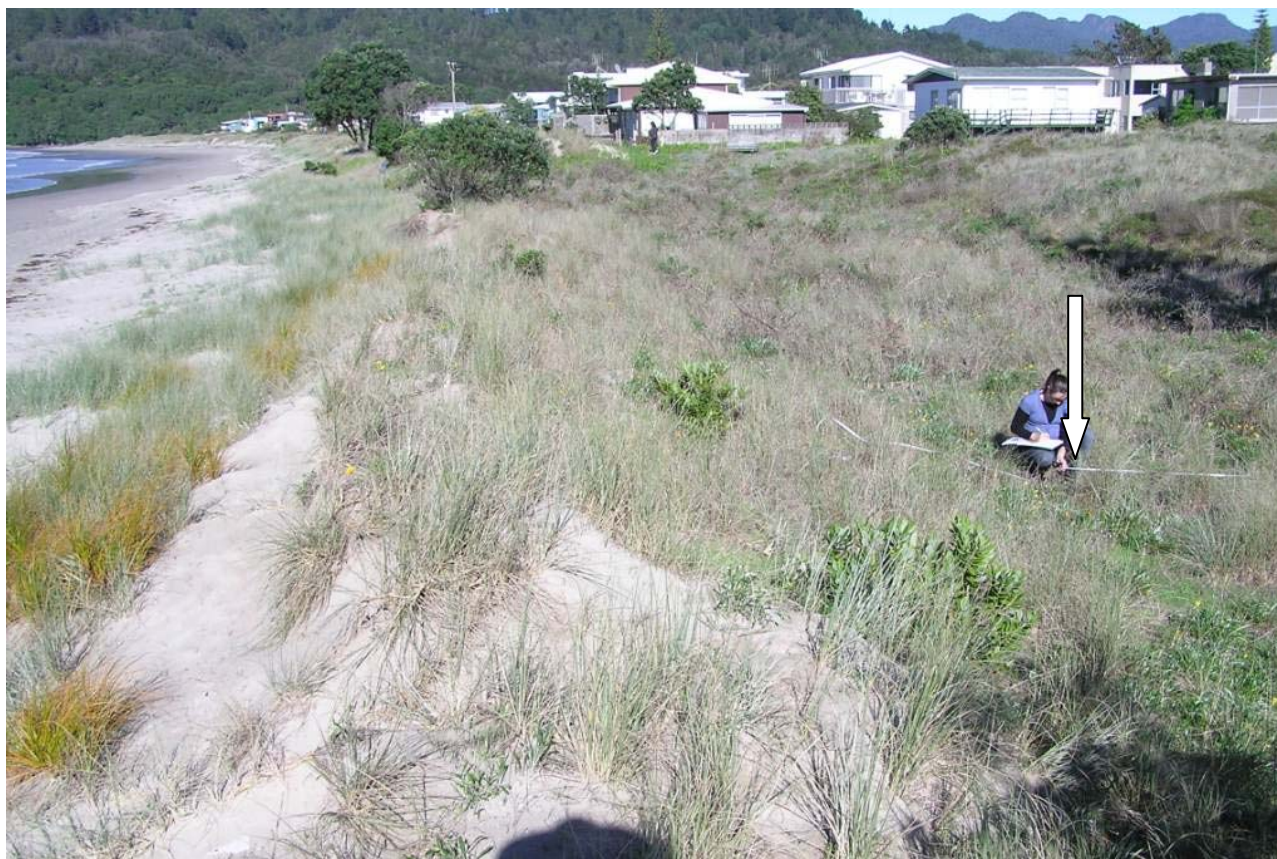
Figure 9: Approximate location of most severe likely erosion (at ground level) as estimated from beach profile data at site 57/3 (arrow). The calculated erosion is in the swale behind the frontal dune and approximately 5 m landward of the dune crest, which is location of the most severe observed erosion at this site (2003). Note large Pohutukawa in background, known to have been threatened by erosion in 2000.

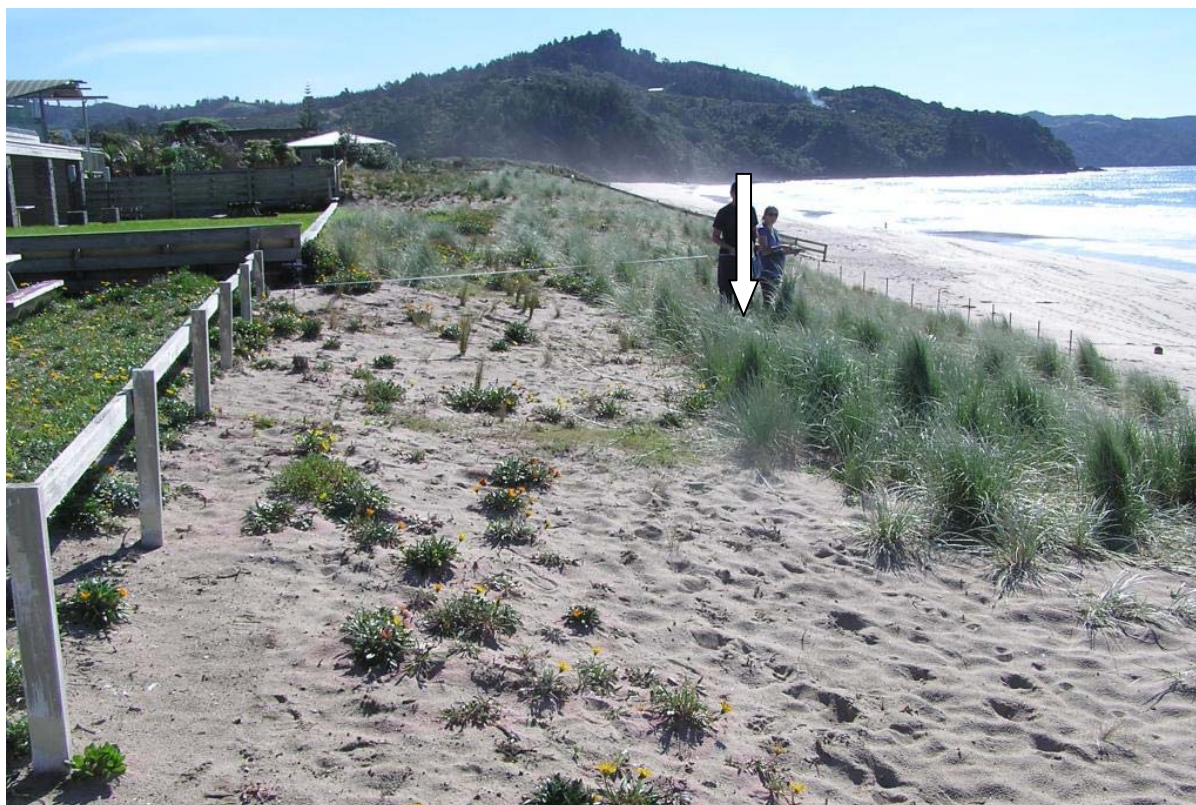
Figure 10: Calculated worst estimated erosion at ground level (arrow) at CCS36.

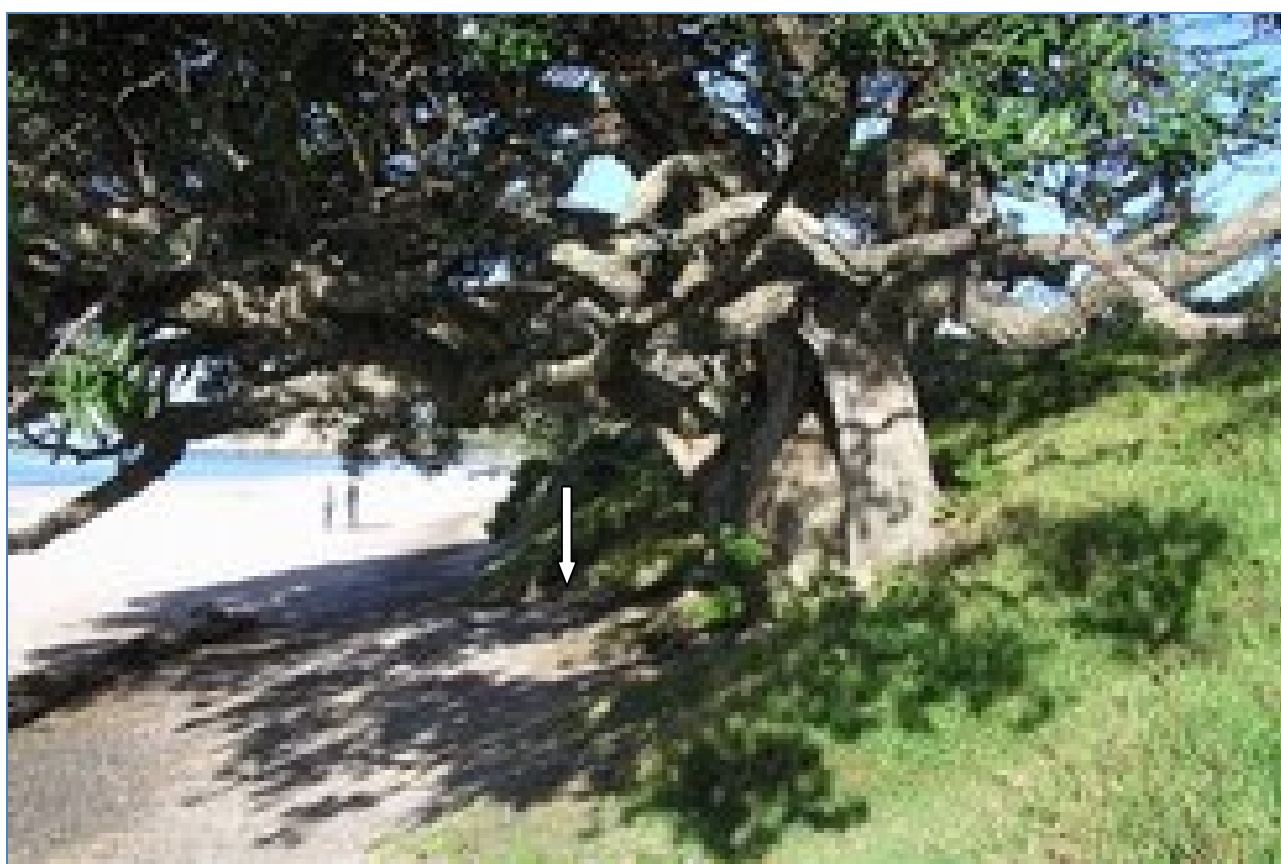
Figure 12: Old pohutukawa tree rooted in consolidated materials (arrow) at the base of the current dune, immediately north of beach profile site CCS32. This and other trees lie on a line seaward of erosion estimates from beach profile analysis.

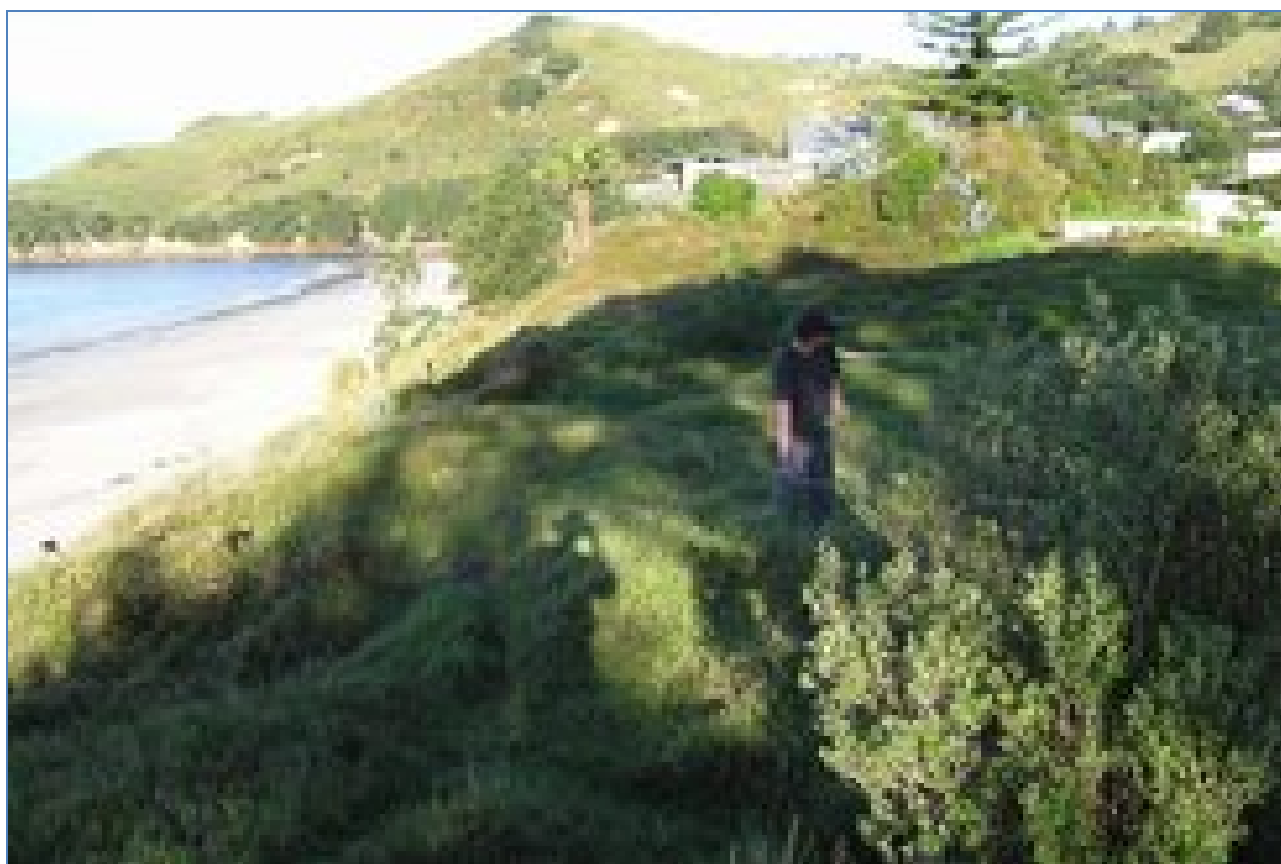
Figure 13: Worst estimated erosion at ground level at the south end of Hahei Beach (CCS33).

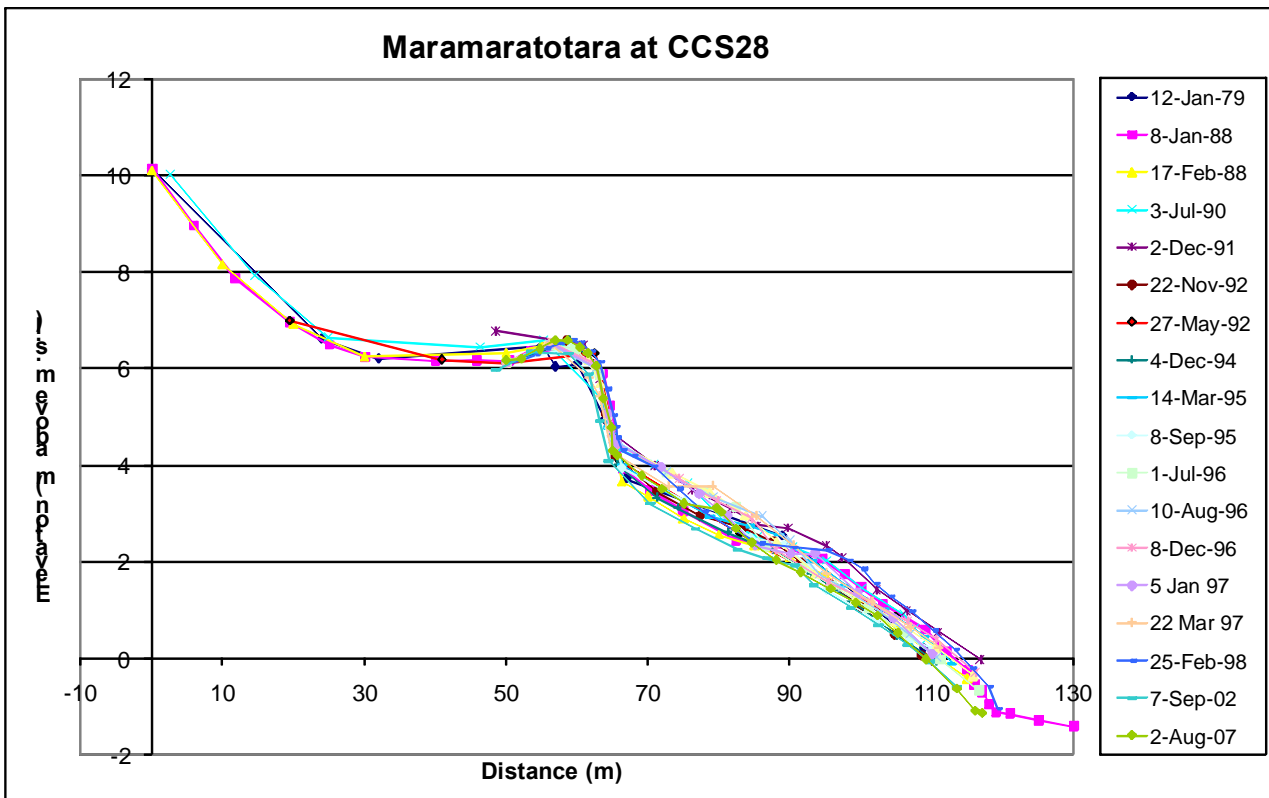
Figure 14: Duneline change recorded at CCS 28

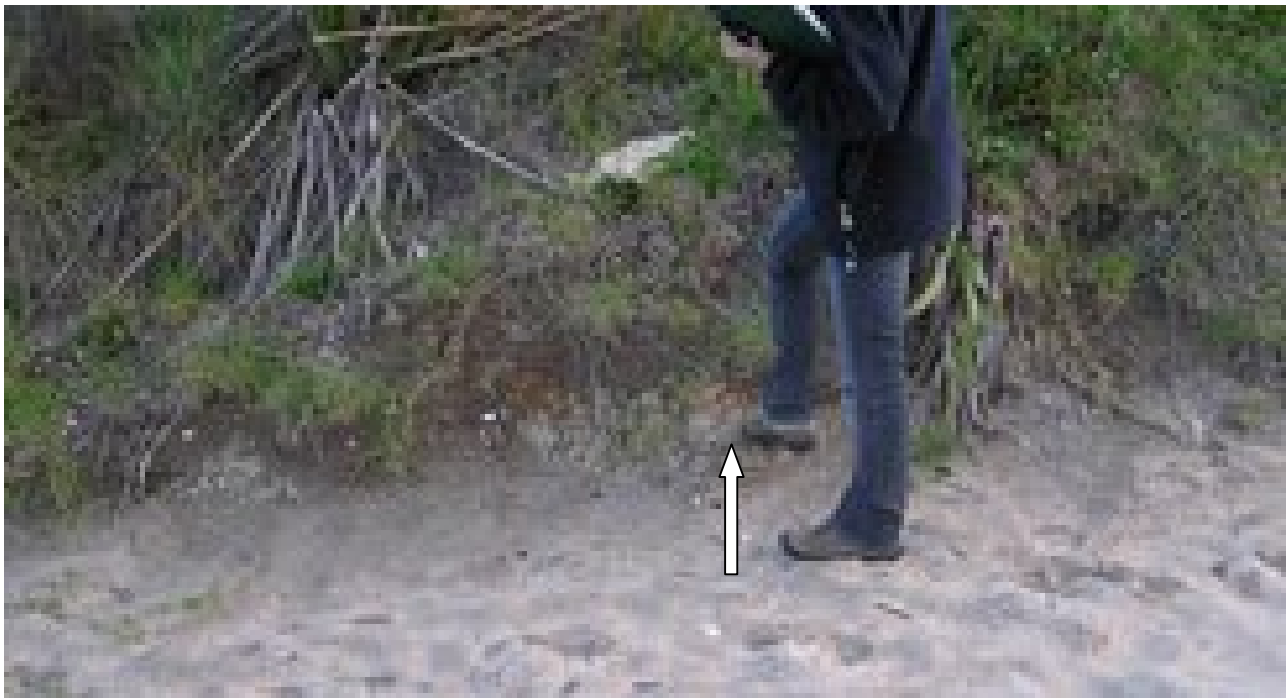
Figure 15: Erosion resistant material exposed in bank behind beach in the vicinity of profile site CCS28.

Field inspections indicated that the reason for the limited duneline fluctuations relates to erosion-resistant materials along the back of the beach. These consolidated materials were observed at the base of the current bank at the beach profile site (Figure 15) and exposed at the base of a large Pohutukawa to the south of the site. Field inspection also confirmed that the relatively high “dune” at the southern end of the beach consists of thin veneer of Holocene sands over more erosion resistant materials. The presence of large pohutukawa rooted on the bank all the way along the back of the beach further confirms the presence of erosion resistant materials.

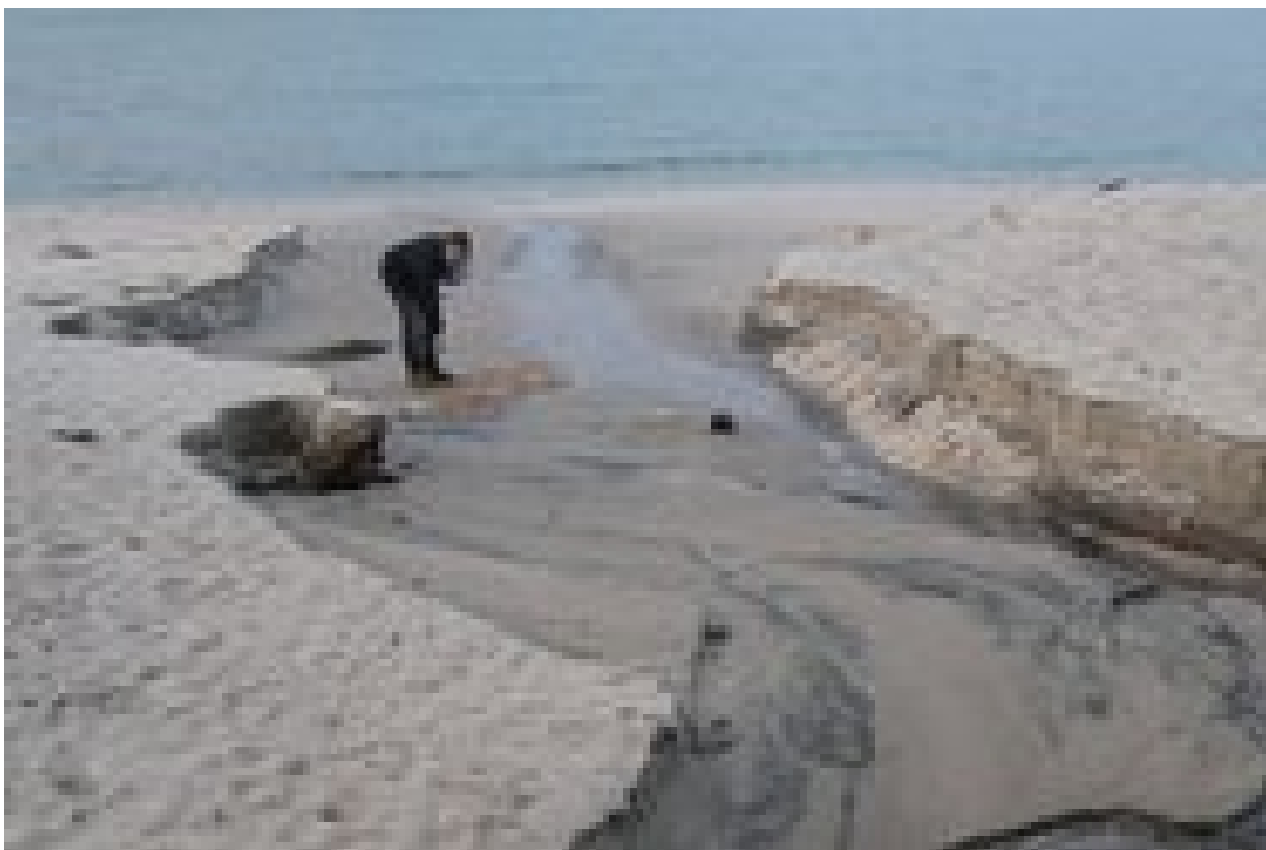
Figure 16: This creek bed at the southern end of Maramaratotara Beach contains erosion resistant materials under a thin layer of sand.

The erosion resistant materials outcrop in the beach within the bed of the second small creek south of the site (Figure 16) and several holes dug in the beach also found the materials underlying the beach sands. These outcrops relate to a shore platform formed by cliff erosion – probably before the Holocene sands were emplaced; though rare and severe storms do also expose the underlying materials at the back of the beach and may result in ongoing (very slow) retreat of the bank (probably at rates of less than 1 m per century given the rarity of such erosion events at this site).

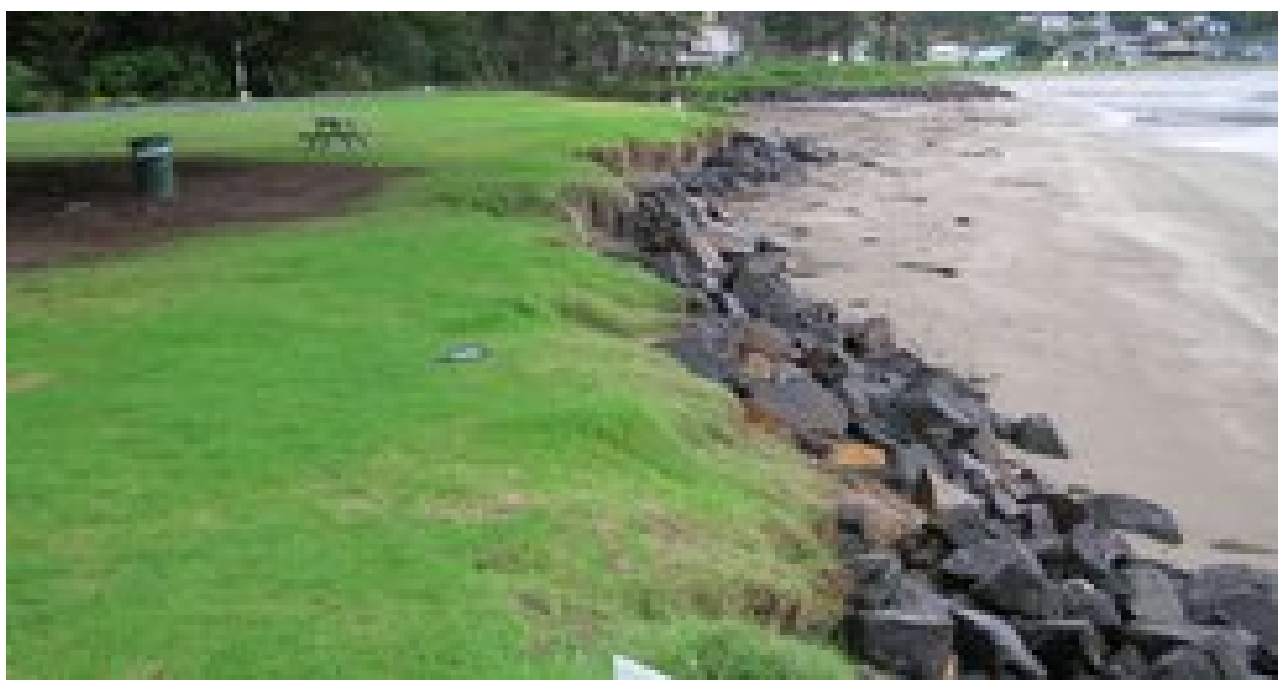
Figure 17: View in vicinity of CCS 25 (line of profile is approximately indicated by the tape measure evident centre-left). Tarapatiki Stream is evident in the middle background. The shoreline behind the photographer consists of a rock and concrete mass block seawall extending approximately 350 m alongshore (fronting private beachfront properties). The wall holds the shoreline seaward of the natural shoreline position with a high tide beach only rarely occurring. There are significant end

effects at both ends of the wall during storms.

It is clear from field observations that shoreline change at beach profile site CCS25 is influenced by stream effects, end effects, armoring structures and fill placed following a period of erosion in July 2000 (Figure 17).

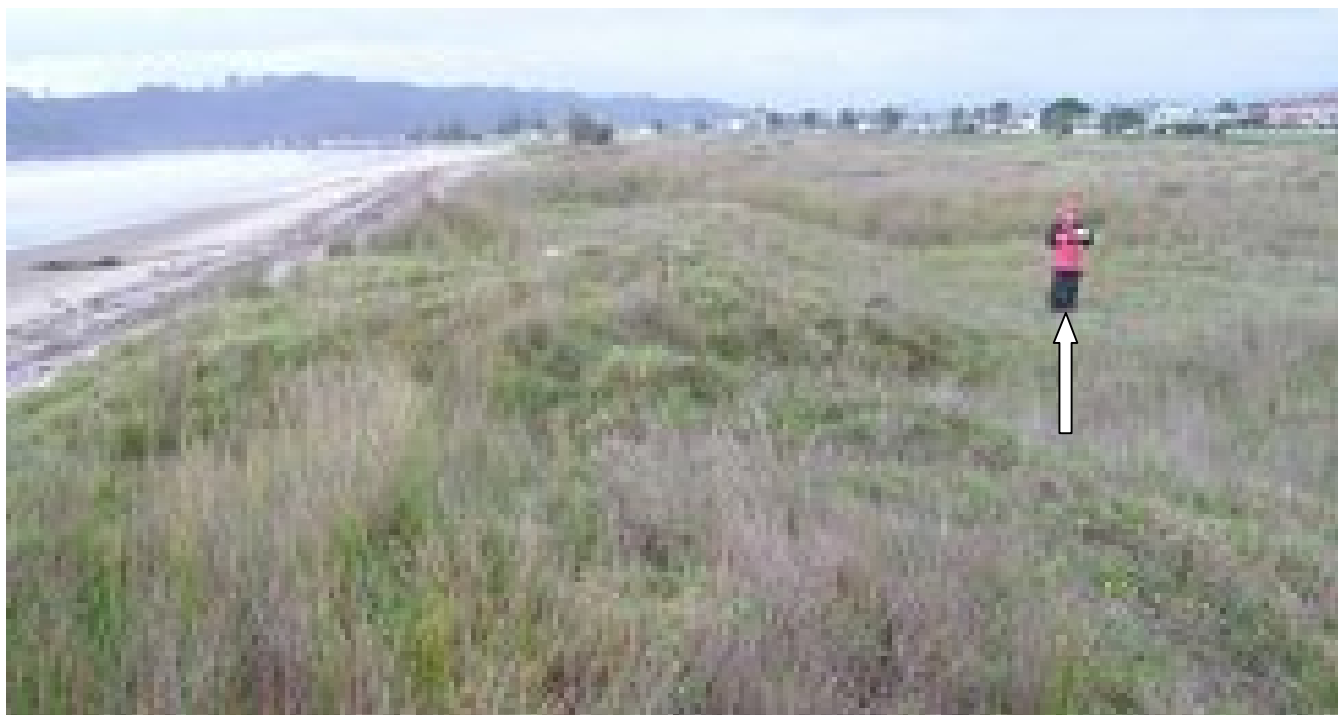
Figure 18: Photo taken at Buffalo Beach profile site CCS25/1. Person (and arrow) at the approximate location where the worst estimated erosion intercepts ground level.

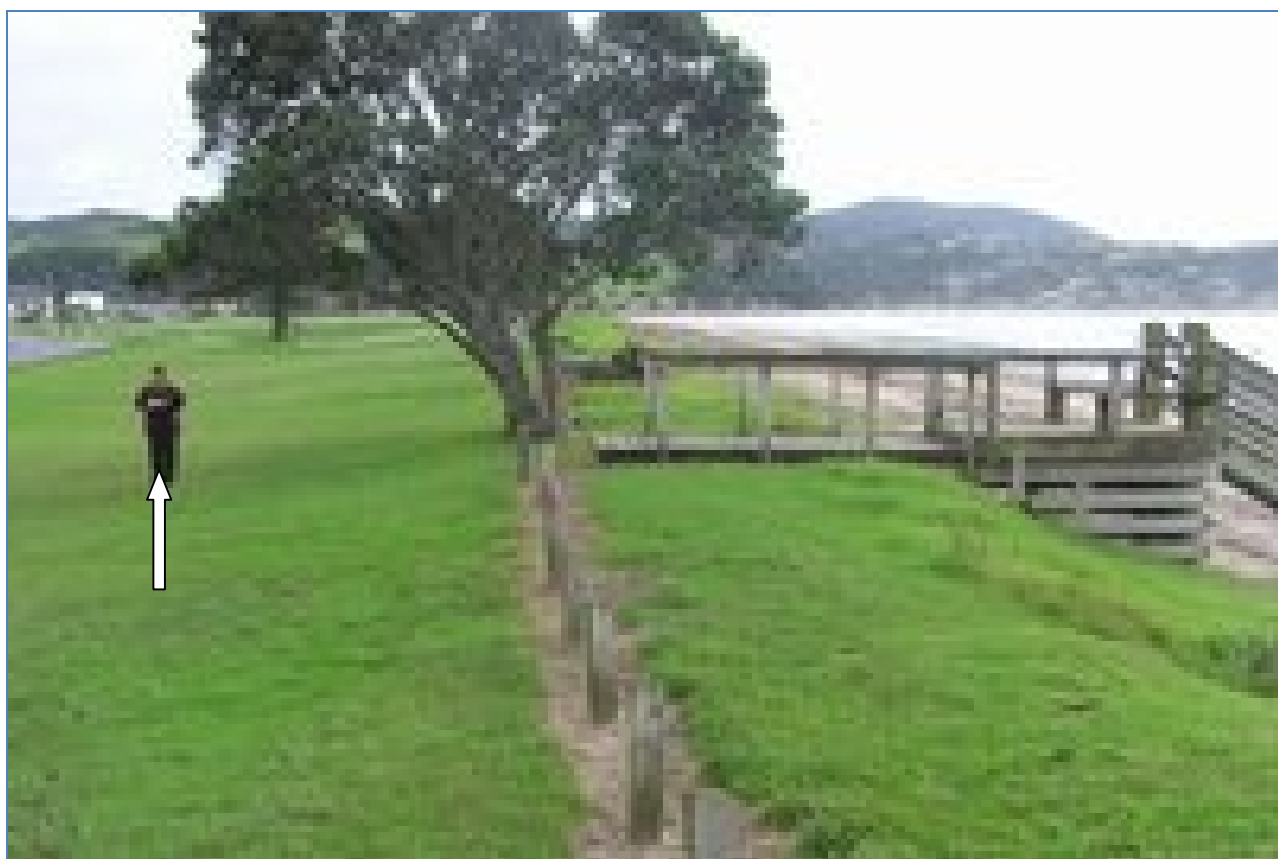
Figure 19: Approximate location of the worst estimated erosion at ground level (arrow), at the southern end of Buffalo Beach (CCS27).

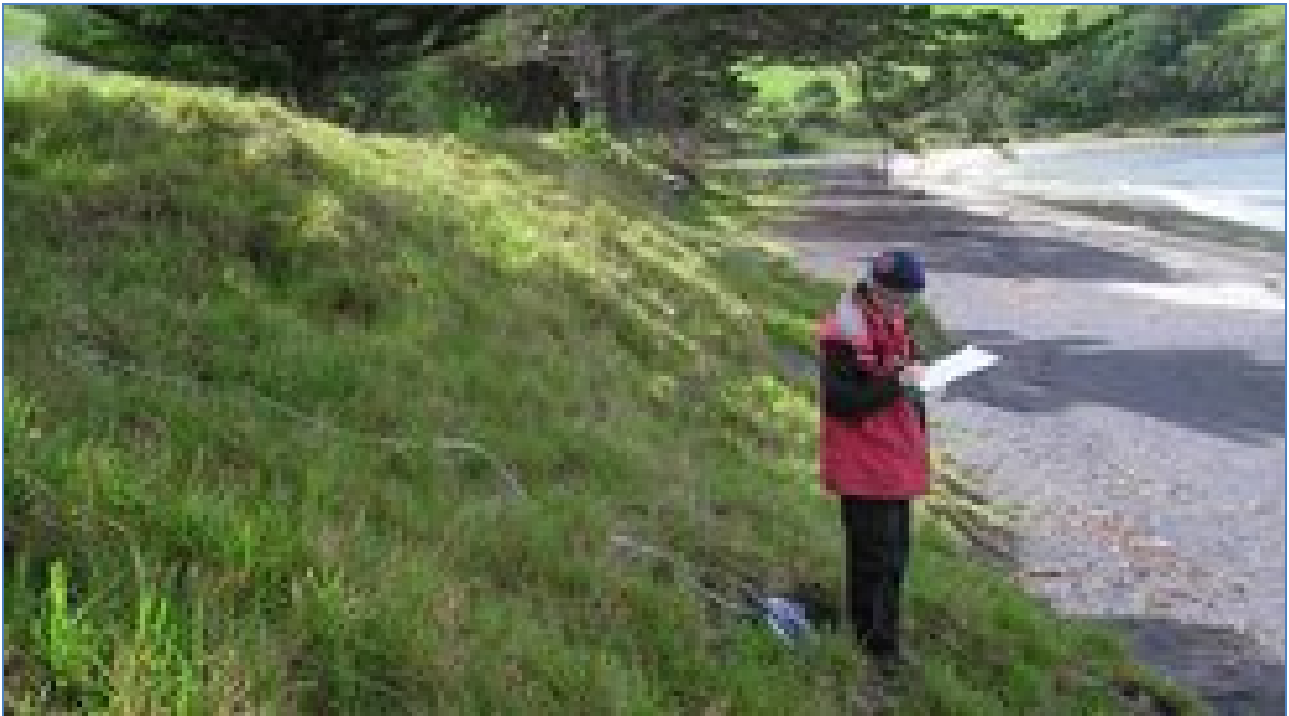
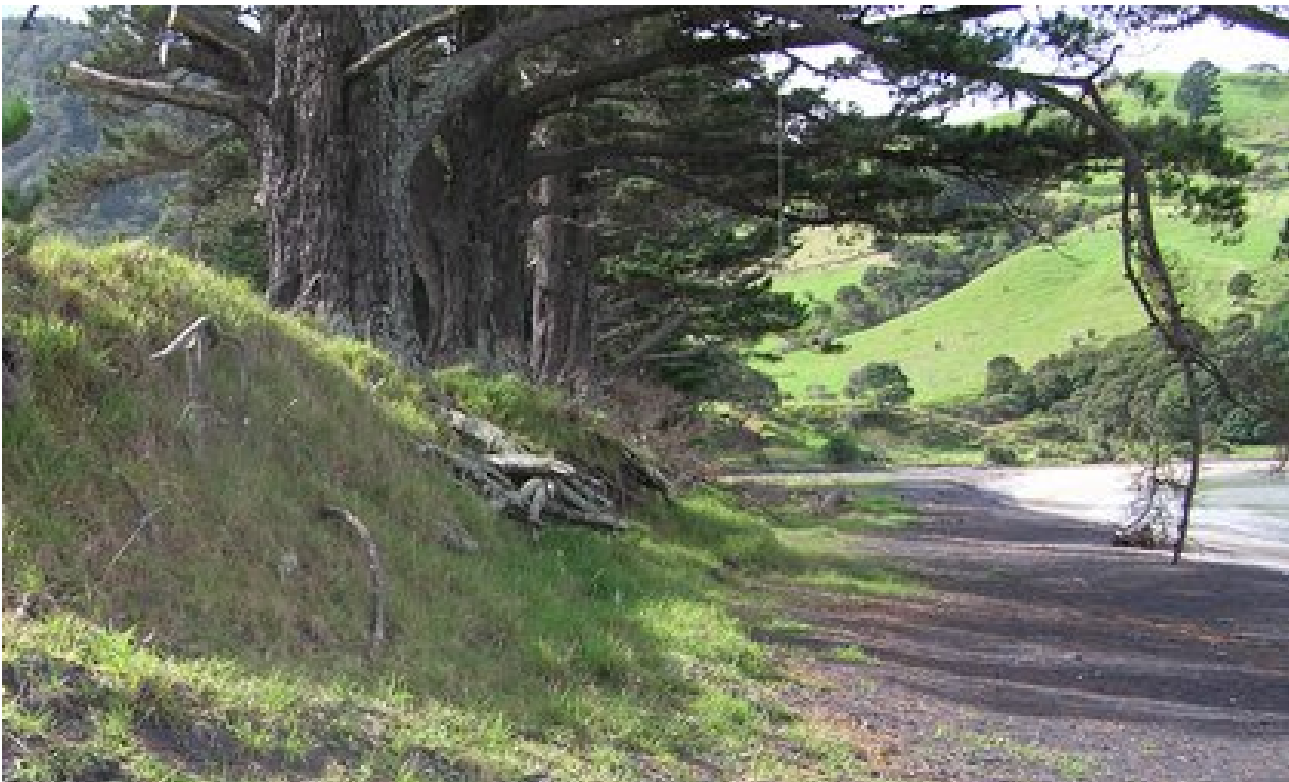
Figure 20: Approximate location of estimated most eroded toe of dune at CCS22/11 (top photo). Note large old pines indicating shoreline has not been landward of the present dune crest for many

decades.

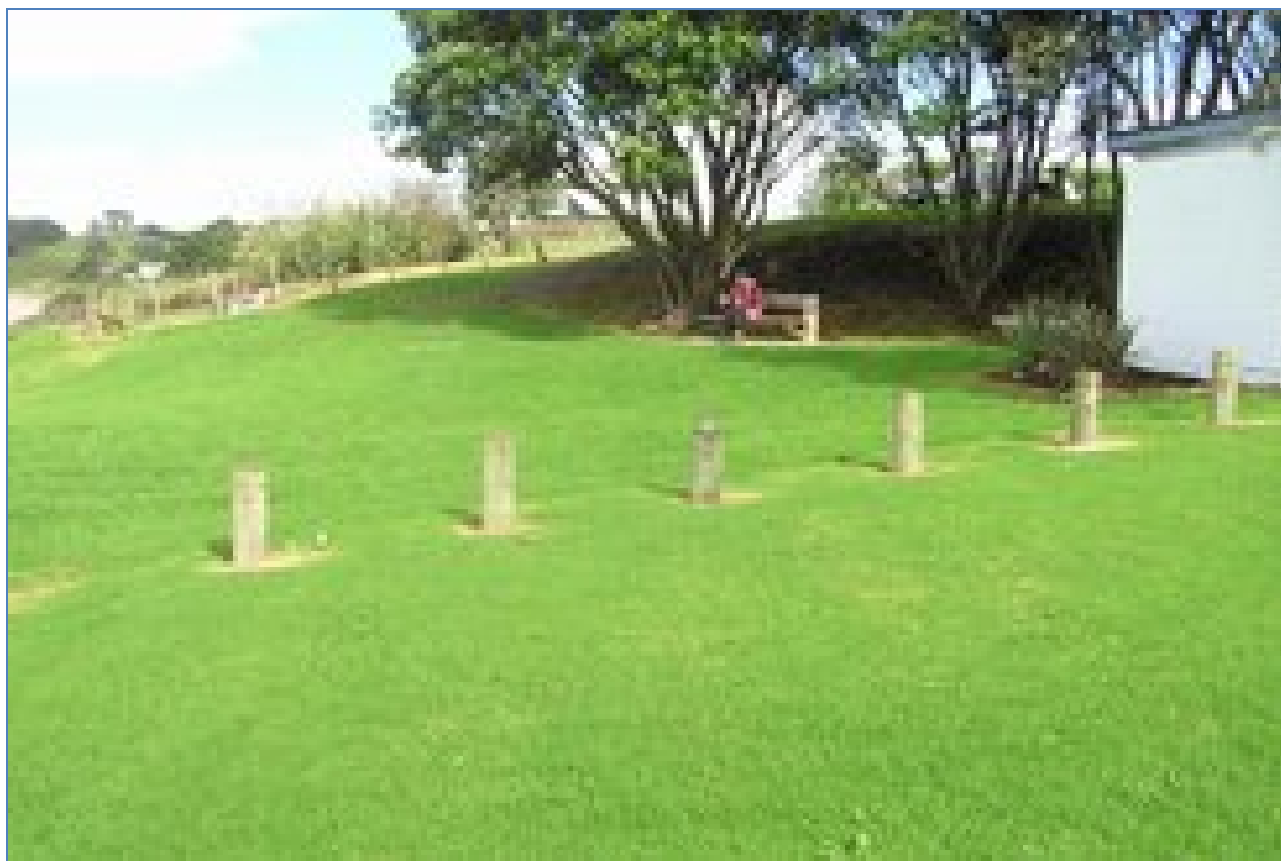
Figure 21: Toilet block at Wharekaho beach profile site CCS22. A clay bank is evident immediately landward of this structure.

Field inspections indicate that the limited erosion in this area reflects erosion resistant materials underlying the dune, which is generally just a relatively thin veneer of Holocene sands. A clay bank is visible approximately 16 m landward of the current toe of dune adjacent to the toilet block to the immediate north of the profile site (Figure 21). An old concrete structure also lies approximately 9 m landward of the current toe of dune, several metres landward of the worst estimated erosion (Figure 22). Previous property specific reports also indicate that erosion in this general area is limited by erosion resistant materials.

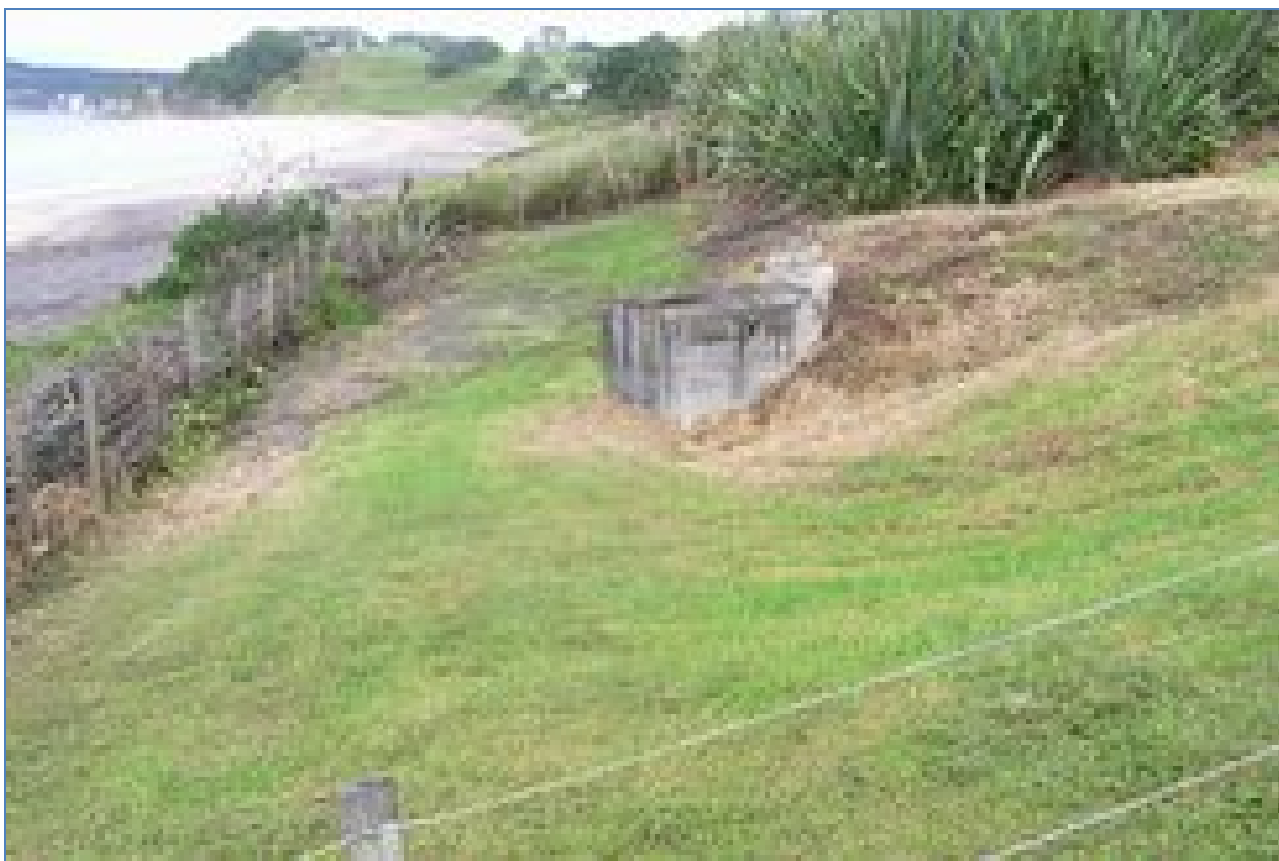
Figure 22: Concrete structure at beach profile site CCS22.

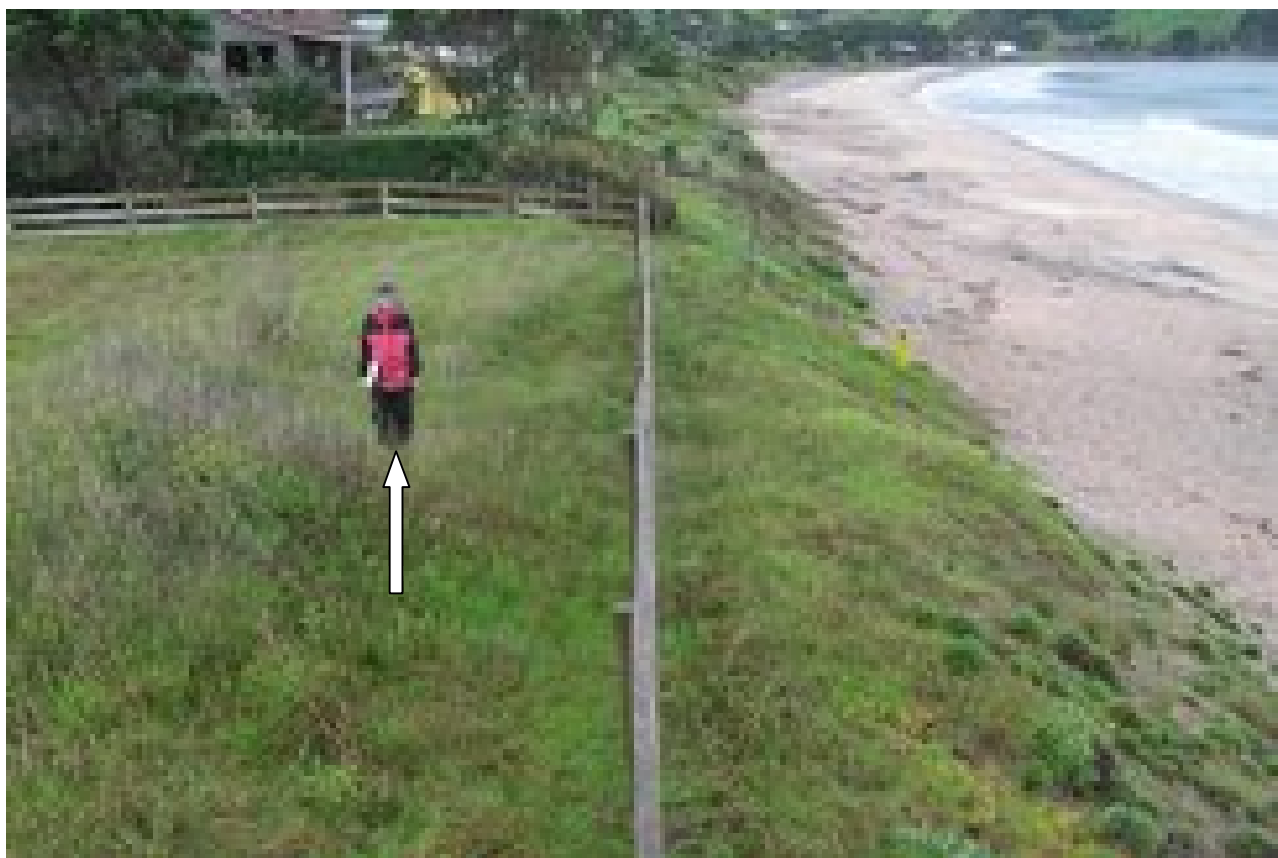
Figure 23: Most severe calculated erosion at ground level (arrow) at Wharekaho CCS23 (excluding safety factors).
