Coromandel Beaches - Coastal Hazards:

Review of Primary Development Setback at Selected Beaches

Thames Coromandel District Council

October 2009

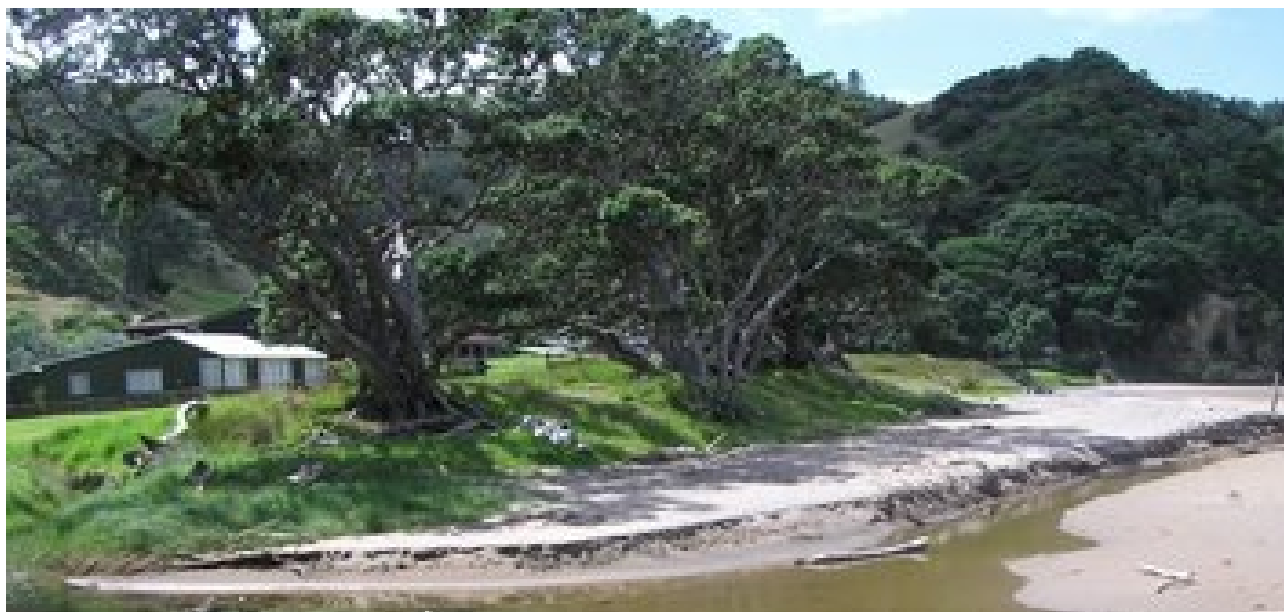
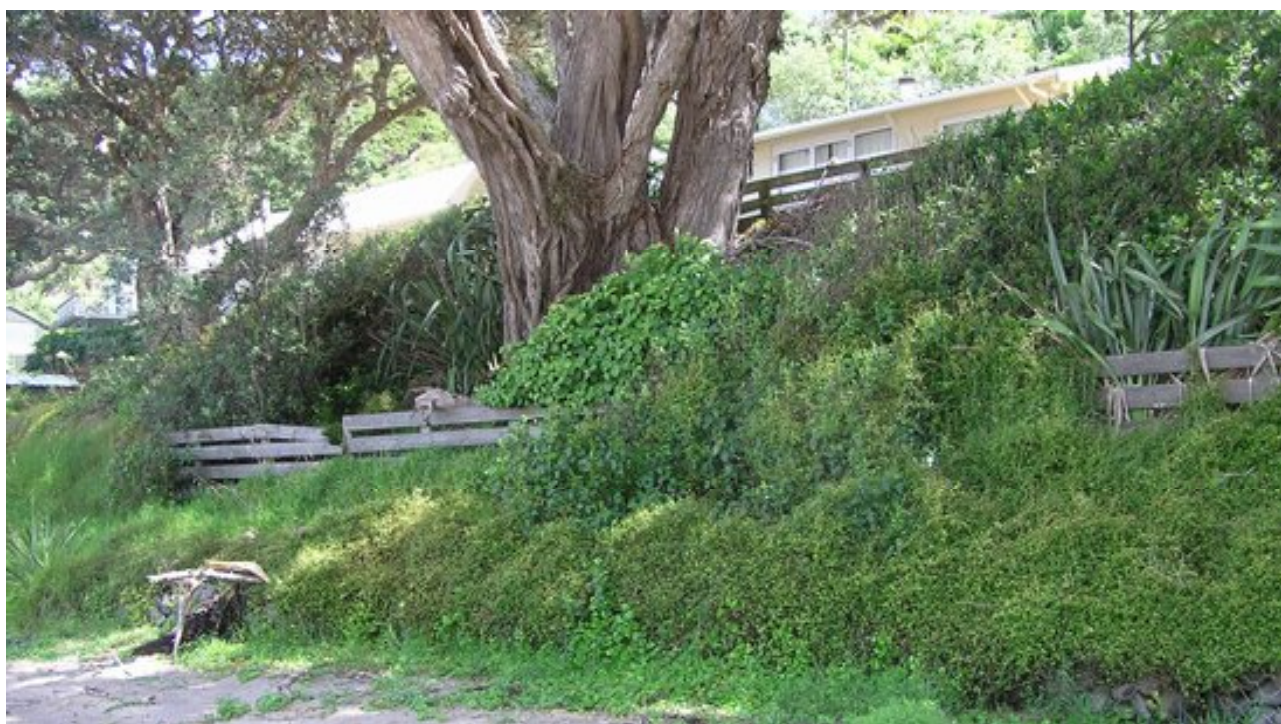
Figure 25: Large pohutukawa located close to the back of the beach at Matapaua, east (top) and west (bottom) of the small un-named stream which discharges into the centre of the bay

Field inspection indicates that large pohutukawa occur close to the back of the beach both to the east and the west of the small stream discharging in the middle of the beach – suggesting limited erosion of this bank. This reflects the occurrence of erosion resistant materials.

A dune occurs along the back beach to the east of the stream (see top photo in Figure 25), though field inspection and auguring indicated erosion resistant materials underlying these sands a short distance back from the beach. The resistant materials are also directly exposed towards the eastern end of the beach

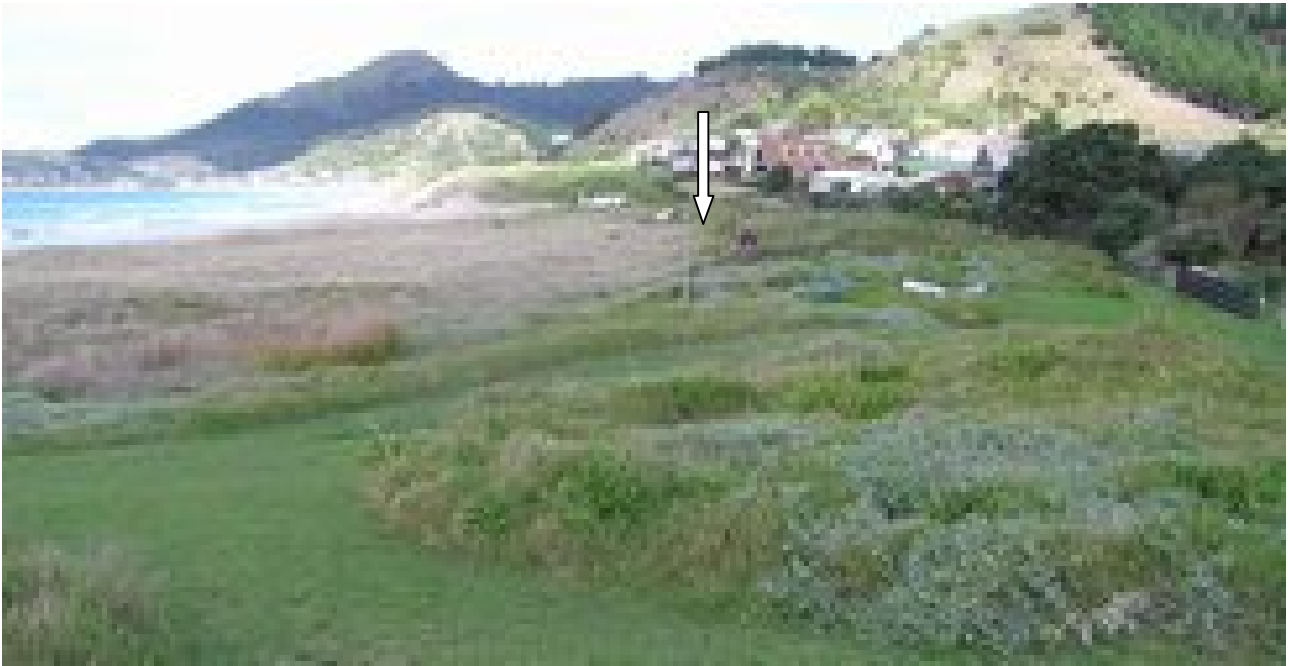
Figure 26: Photo looking south at CCS 49. Arrow indicates approximate location of worst measured erosion (old erosion scarp), largely relating to past stream changes.

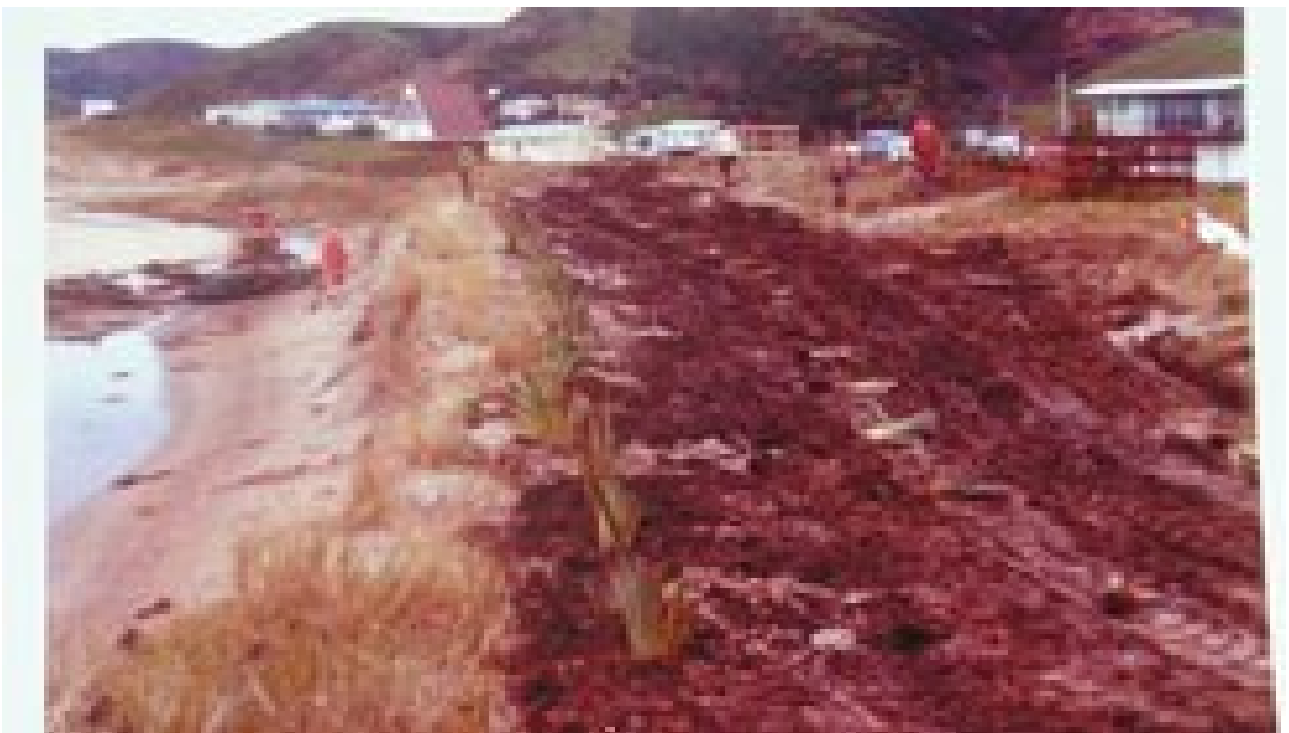
Figure 27: Photo provided by local property owners showing erosion caused by movement of the Waitaha Stream at the northern end of Opito Bay in 1981. Photo also shows works being undertaken by locals to relocate the path of the stream and plant the dunes.

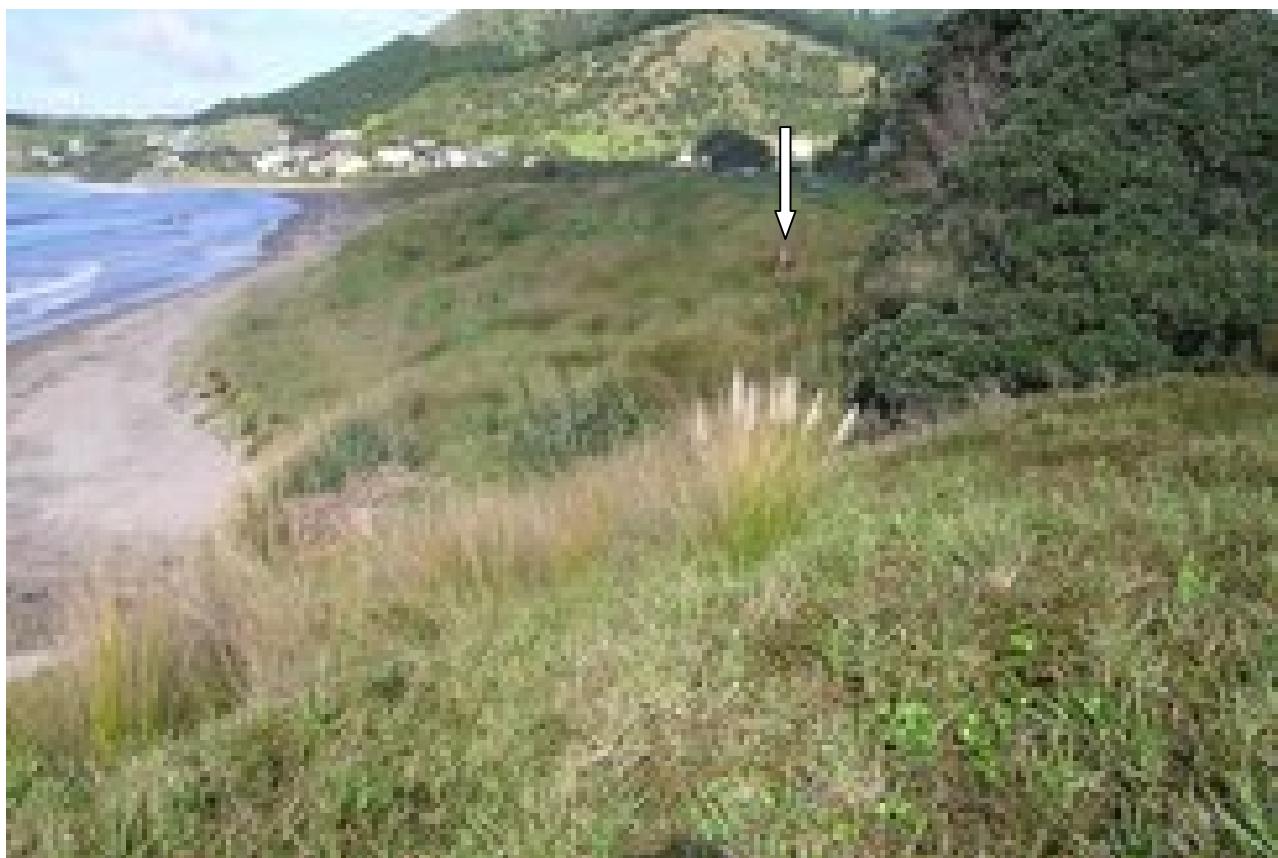
Figure 28: Opito Bay beach at CCS49/1. Note large frontal dune and mature vegetation. Arrow shows approximate landward limit of calculated likely erosion. Midden deposits occur seaward of this position in places suggesting the estimate is precautionary.

A large frontal dune exists at the site and the area seaward of the road appears to be erodible sand, though there may be erosion resistant materials at depth. Field inspections indicate large trees (Figure 28) and midden deposits with soft and old shell on the dunes seaward of the road, suggesting that there has been no erosion extending back near the road in recent centuries. This is also consistent with geomorphic evidence.

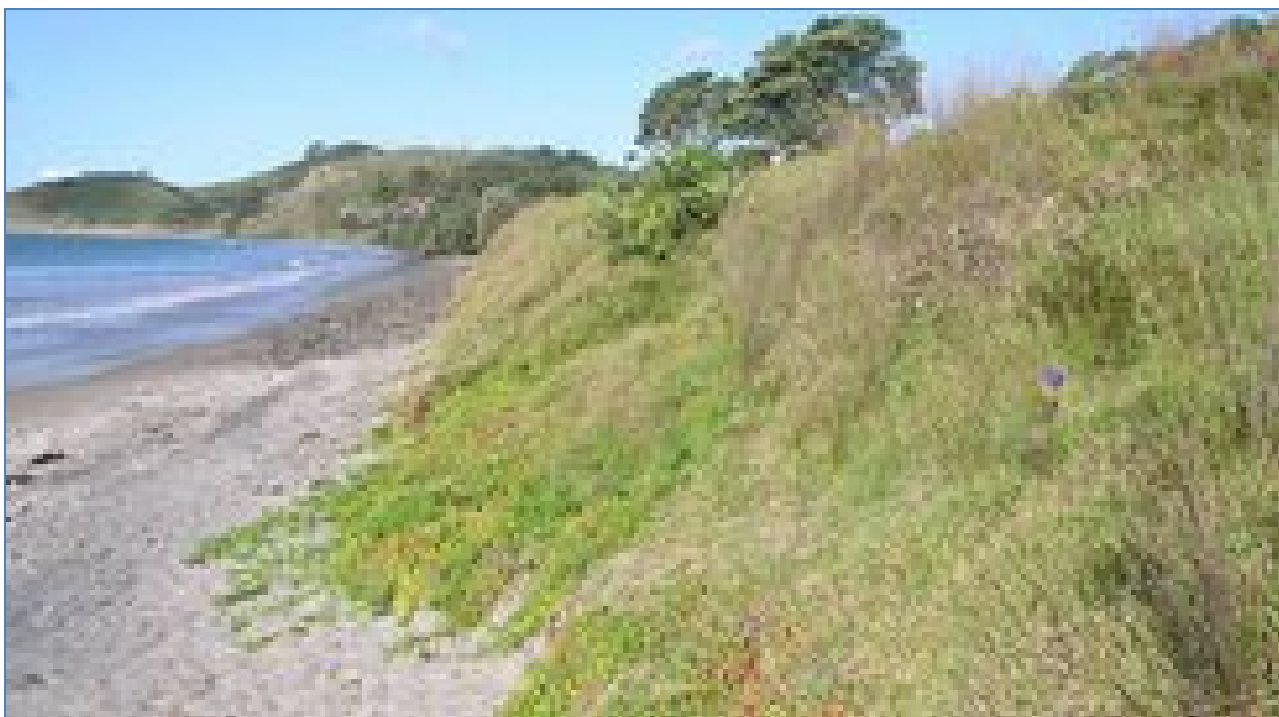
Figure 29: Beach profile CCS47/1 near the centre of Opito Bay. The steep bank at this site has experienced little movement over the beach profile record. Hard material is exposed further south on the beach and can be felt at a shallow depth at this site.

Beach profile data at CCS47/1 near the centre of the beach showed dune toe fluctuations of just 2 m since 1996. The site is characterised by a steep vegetated bank (Figure 29).

Field observations at this site confirm the presence of consolidated and relatively erosion resistant Pleistocene sediments slightly (0.3-0.4 m) below the surface of the beach and underlying dune sands along the back of the beach (exposed directly behind the beach in places – including an approximately 40 m to

the east of the beach profile site). Auguring confirms these materials extend to elevations near the top of the dune and will preclude any significant erosion of the dunes in this area. The Pleistocene sediments appear to be beach or dune sediments and probably formed at the time of the last interglacial period when sea level was at or about present sea level (c 120,000 years ago).

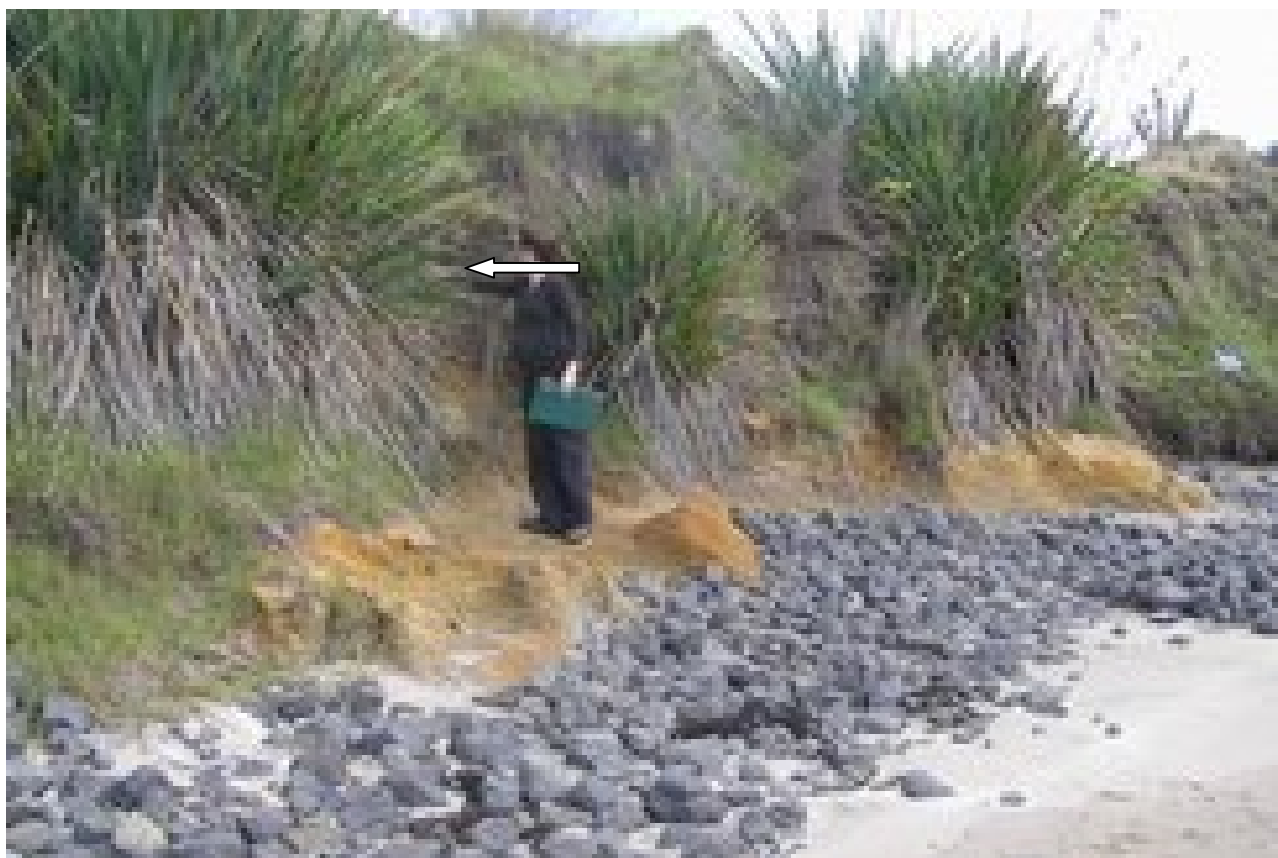
Figure 30: Erosion resistant Pleistocene sediments exposed along the back of the beach in southeastern areas of Opito Bay (photo near CCS48). This material has prevented significant shoreline erosion over the last 30 years. Arrow marks approximate elevation of top of hard material.

Field inspections confirm erosion resistant Pleistocene sediments also underlie the beach and dune in this area. The consolidated material are sometimes exposed directly behind the beach (e.g. from Stewart Stream entrance in the north to the southern extent of residential development) (Figure 30). In other places they underlie a shallow veneer of dune sands. These consolidated materials prevent any significant erosion of the dune face – reflected in the fact that maximum observed duneline fluctuations at CCS 48 are less than 1 m. The erosion resistant materials were noted close to the existing shoreline in all areas to the east except for the property immediately east of the volcanic promontory. Erosion resistant materials may also exist in this area at greater depth under the dune (our site inspections did not excavate beyond 1 m depth in most areas). However, as a precaution the setback has assumed erodible sands and is therefore slightly wider in front of this property – though still reduced relative to the existing PDS. The setback in this area also allows for aggravation of erosion in areas close to the stream.

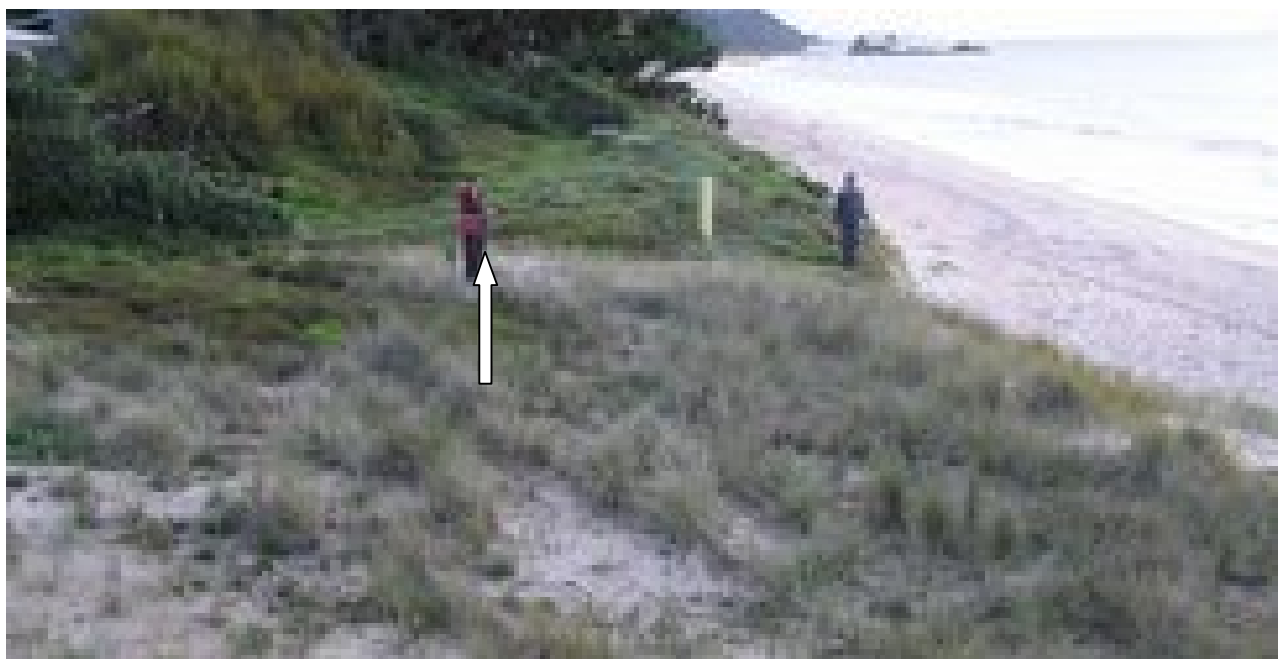
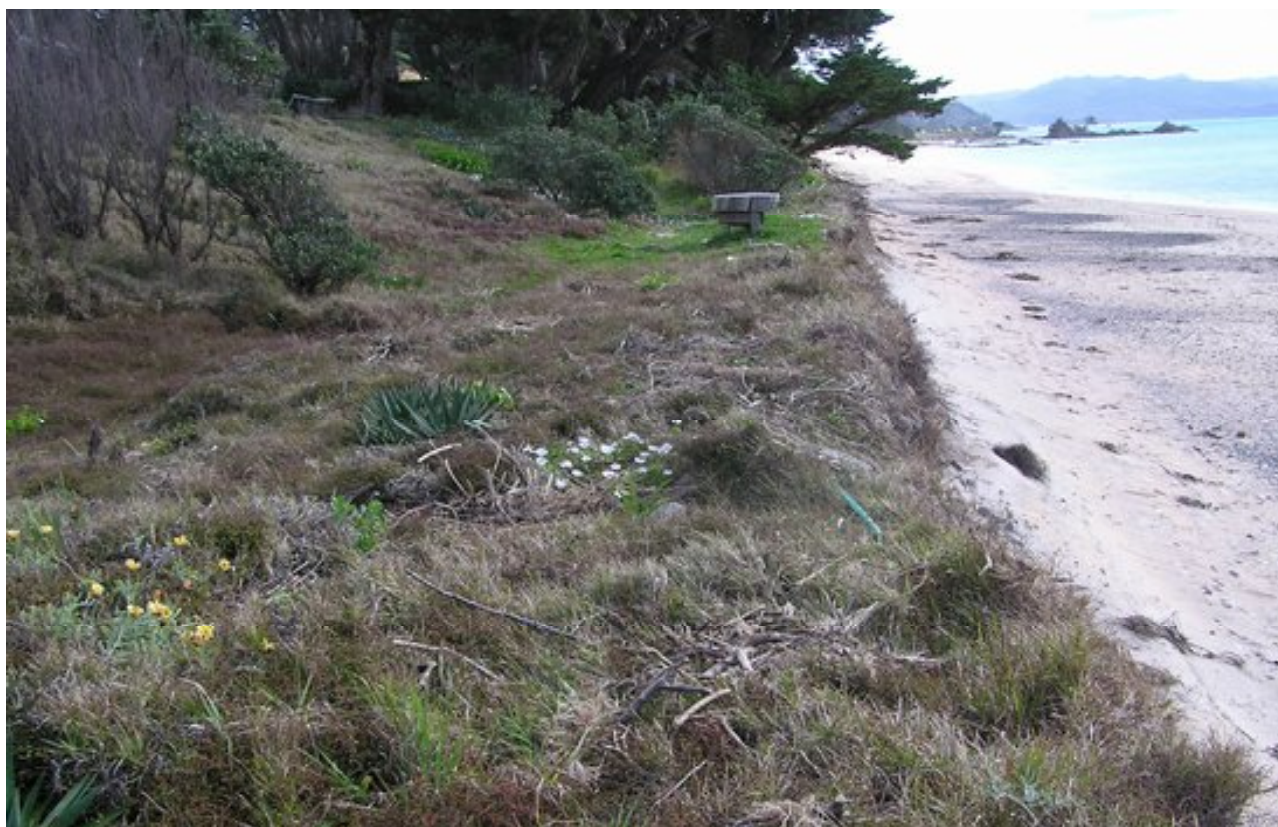
Figure 31: Approximate line of worst estimated erosion at ground level (top photo arrow) at CCS2012 at the southern end of Kuaotunu East Beach. Bottom photo shows same area (just beyond the people in the top photo) after the mid 2008 erosion.

The data from CCS20/2 prior to the storm erosion of July and August 2008 indicated dune toe fluctuations of about 11 m since 1988. The worst estimated erosion calculated from the beach profile data is shown in Figure 31 (top photo) compared to a second shot in this area after the mid 2008 erosion. The calculated erosion lay 6 m landward of the dune toe before the storms of 2008 and about 3 m landward after the storm. However, the relatively low nature of the dune at the point of worst estimated erosion suggests to us that this area has been eroded in recent decades (prior to the beach profile data). We therefore believe the estimate is probably not precautionary.

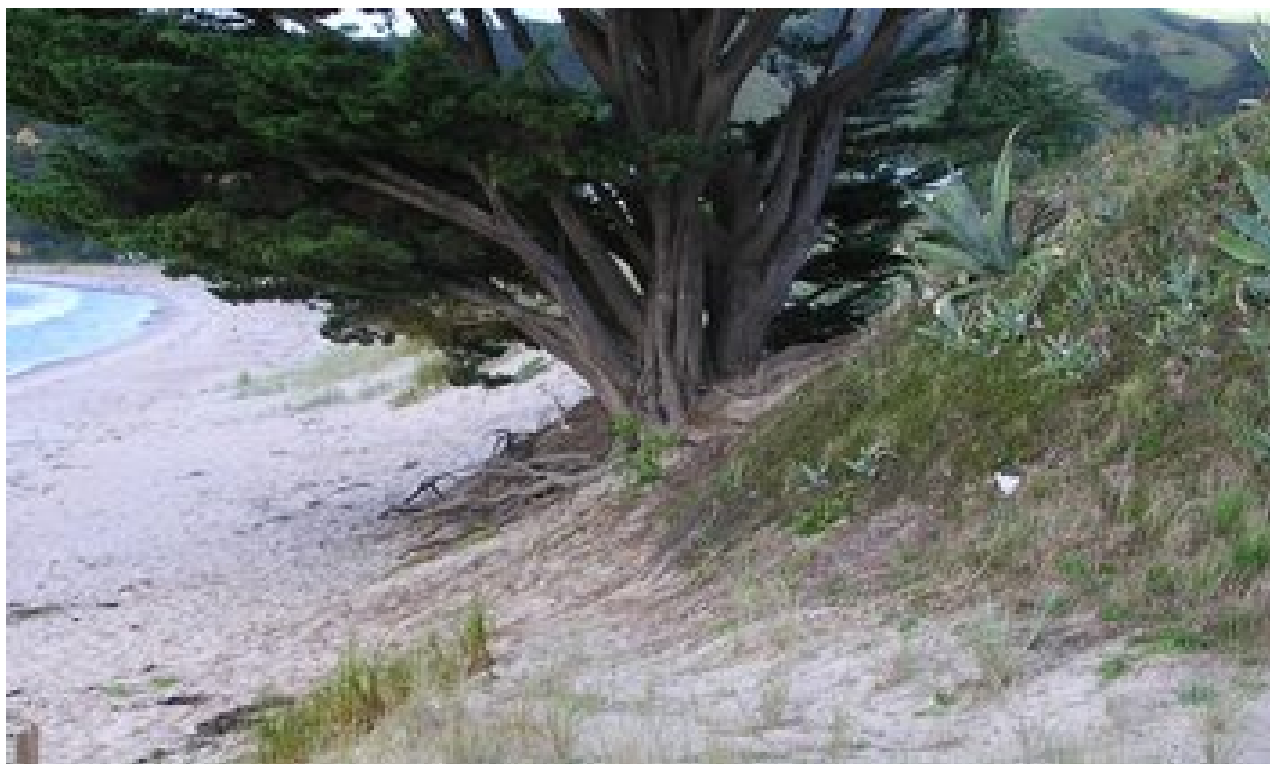
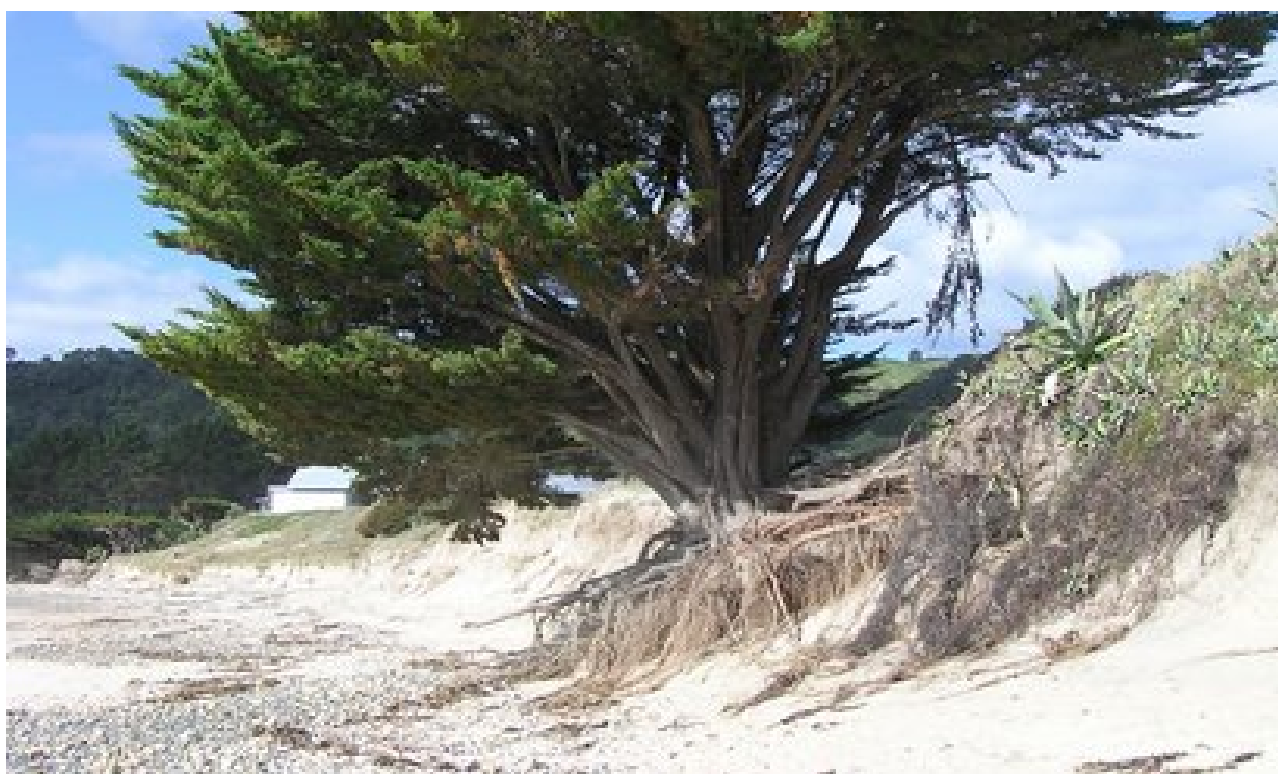
Figure 32: Large macrocarpa near top edge of dune face north of beach profile site CCS20/2 – before (top) and after (bottom) severe erosion of July/August 2008).

Field inspection indicated mature trees growing on the frontal dune close to the sea to both the east and west of the profile site. These trees included a large macrocarpa located approximately 5 m seaward of the estimated most eroded dune toe (Figure 32). This tree appears to be relatively old (probably >50 years). The erosion of 2008 outflanked this tree and eroded about 1m landward (Figure 32). This erosion is seaward of our estimate and clearly the worst for several decades in that location. However, a rip-head embayment further south of the tree extended a further 3-4 m landward – probably close to our erosion estimate. Therefore, once again the post-storm data suggests the estimate is not precautionary.

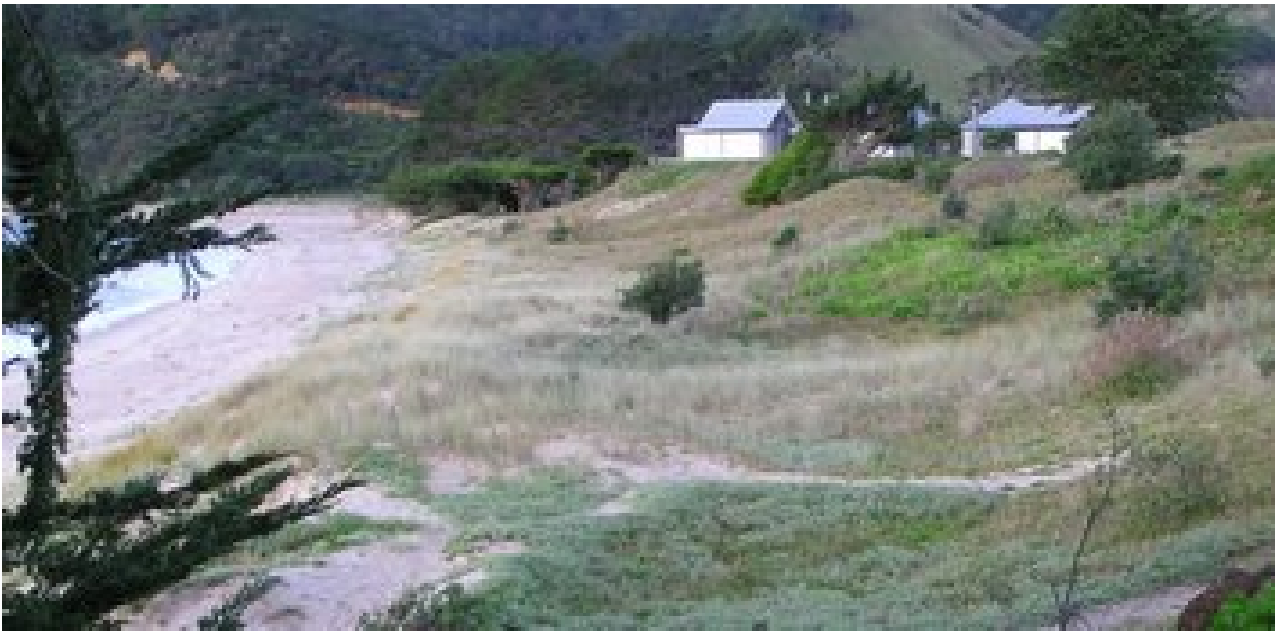
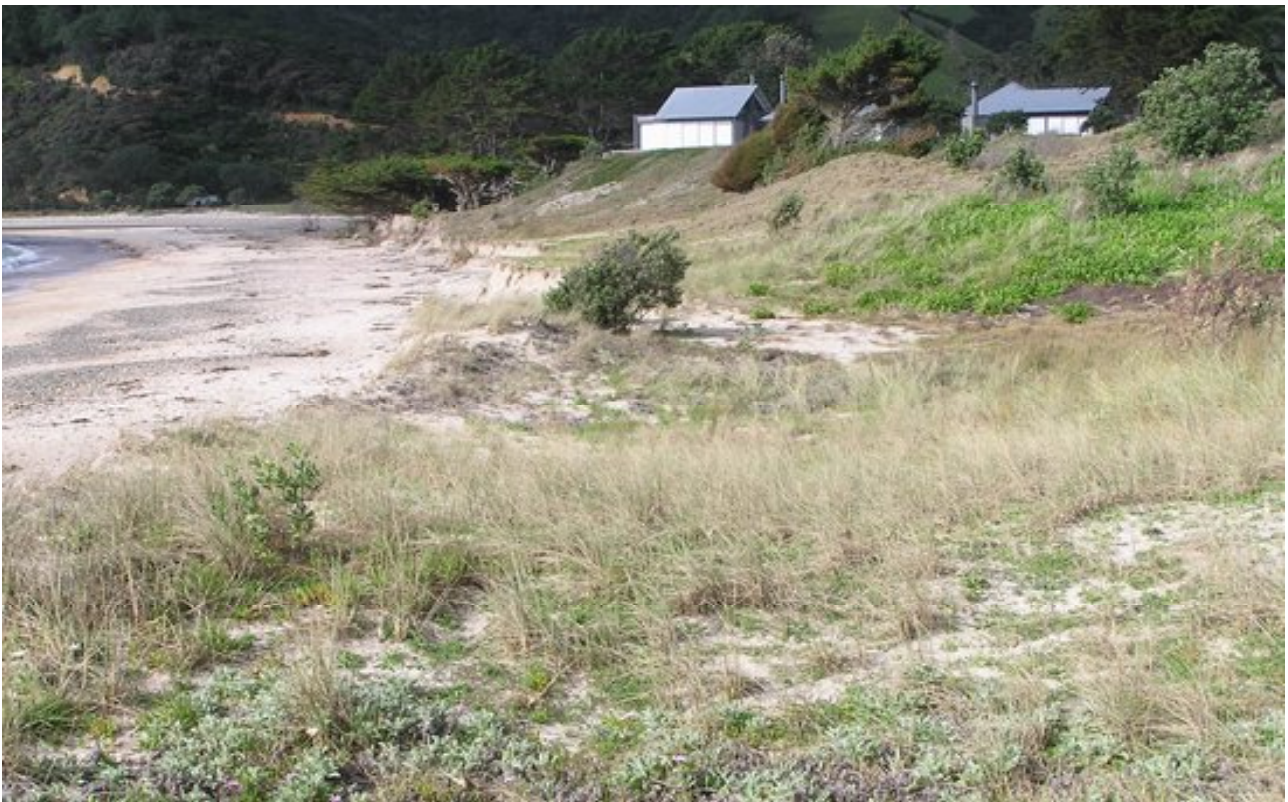
Figure 33: View along part of Kuaotunu East beach before and after mid 2008 erosion. The low dune areas landward of the 2008 erosion suggest this erosion is exceeded on occasions - probably extending back to the higher dune area behind.

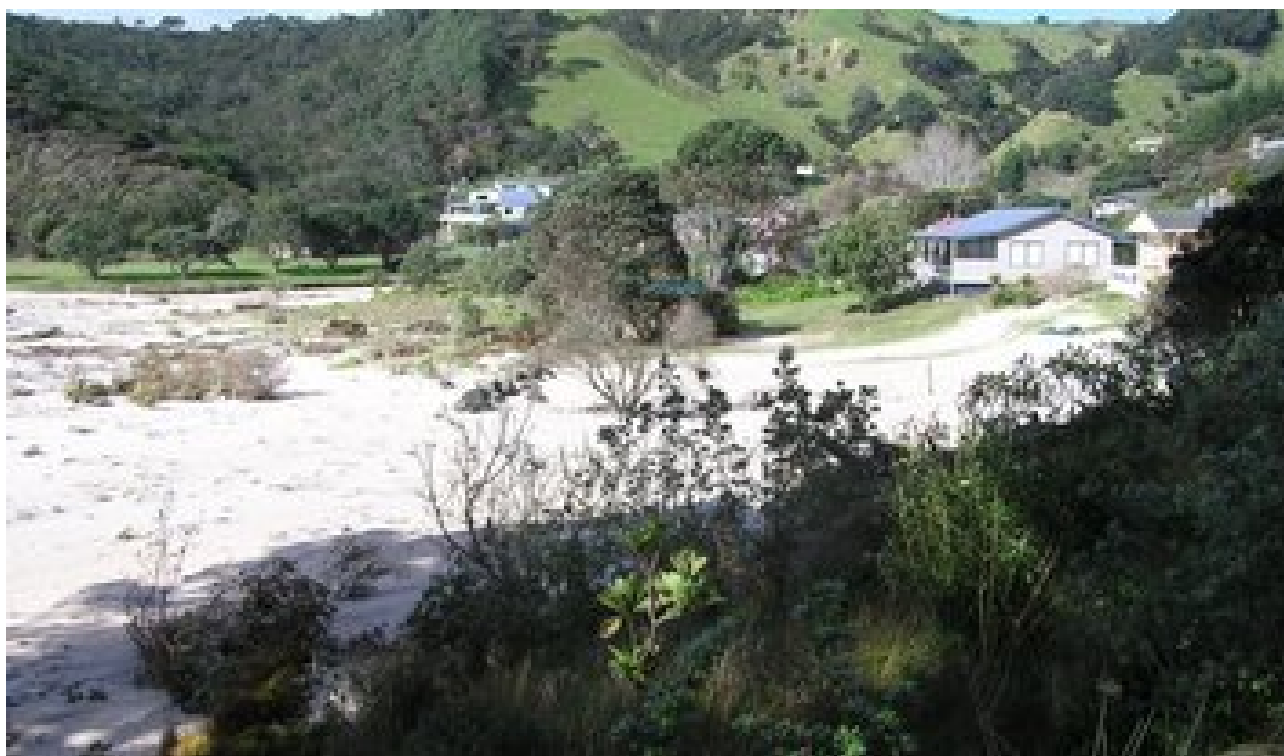
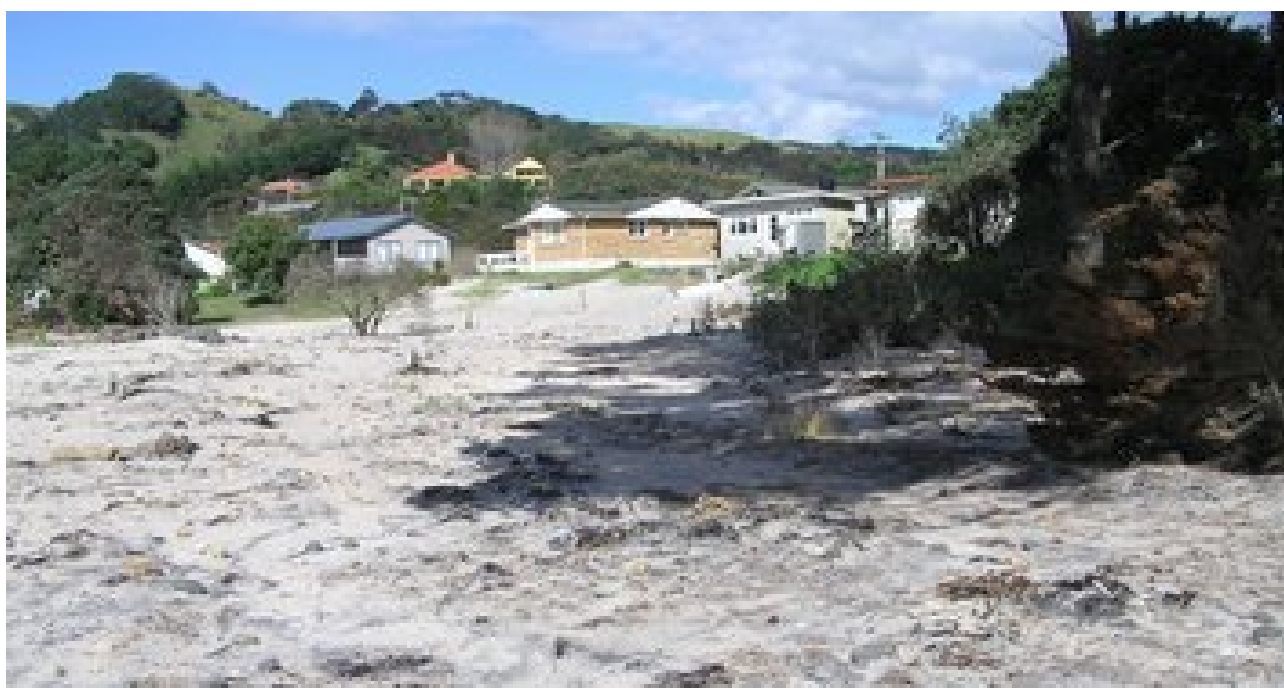
Figure 34: Eastern end of Kuaotunu Beach near Kuaotunu River mouth following storms of July and August 2008 showing areas subject to wave overtopping and run-up.

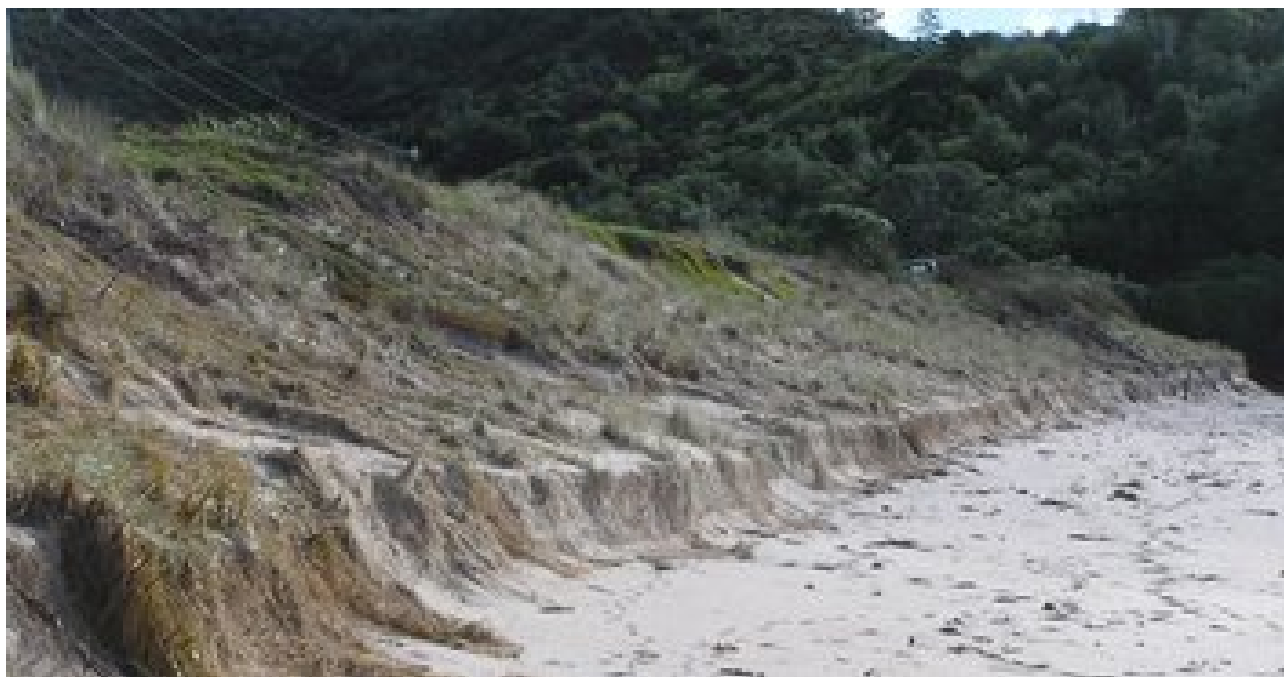
Figure 36: Minor dune toe erosion at north end of Rings Beach following storms of July and August 2008

A recent storm in August 2008 caused some beach lowering and toe erosion towards the northern end of the beach, with slightly more significant erosion occurring around the small stream entrance at the extreme northern end of the beach. The central and southern areas of the beach were relatively unaffected though wave run-up extended half way up the beach face in some places.

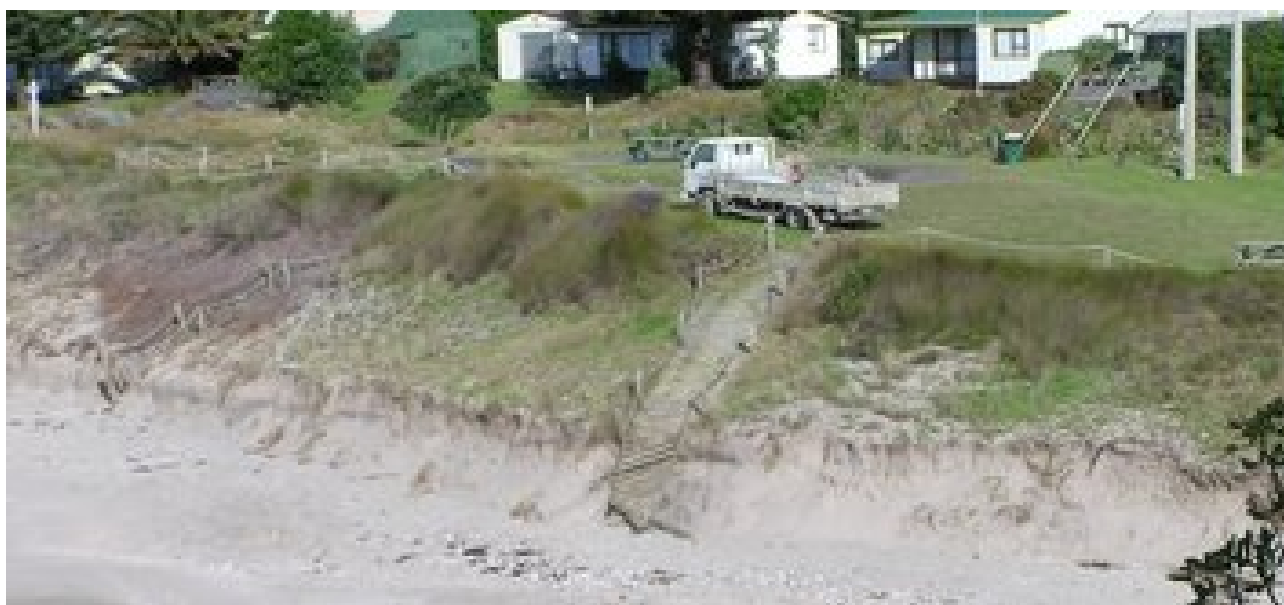
Figure 37: Dune toe erosion at very north end of Rings Beach following storms of July and August 2008

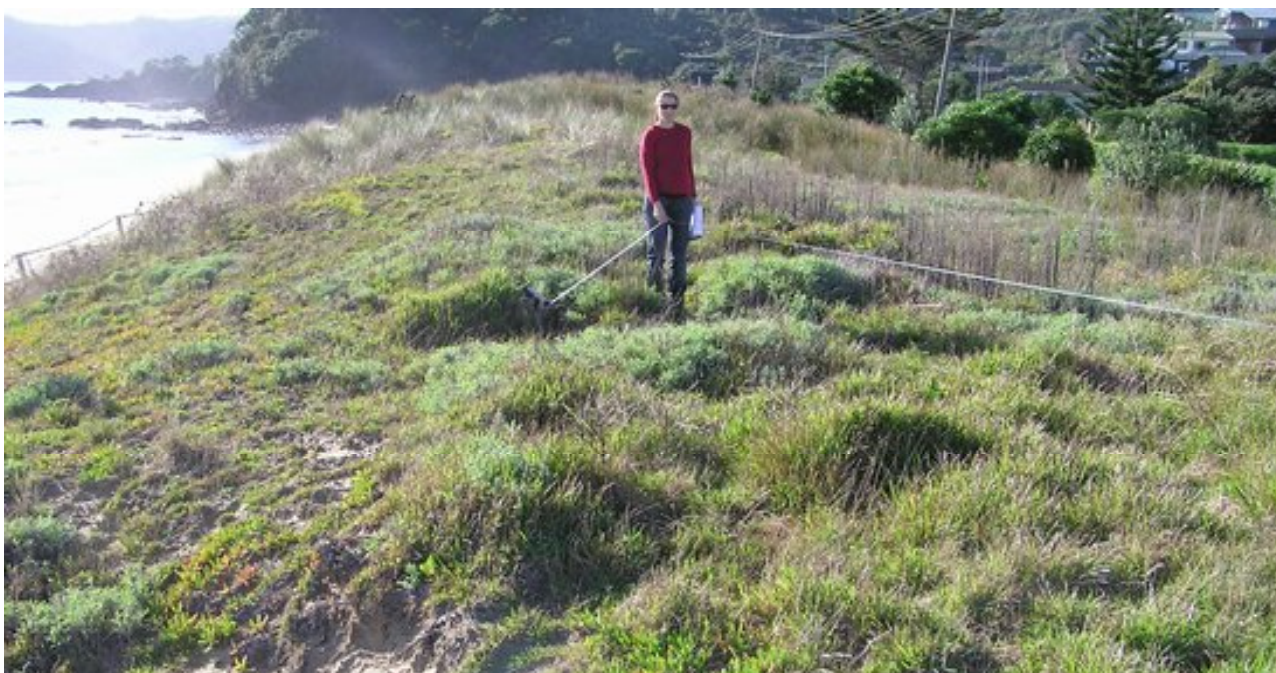
Figure 38: Worst estimated erosion as estimated for Rings Beach

Field observations and community information indicate that the estimate is precautionary for existing coastal processes, being well landward of any evidence of erosion over the last 50-100 years.

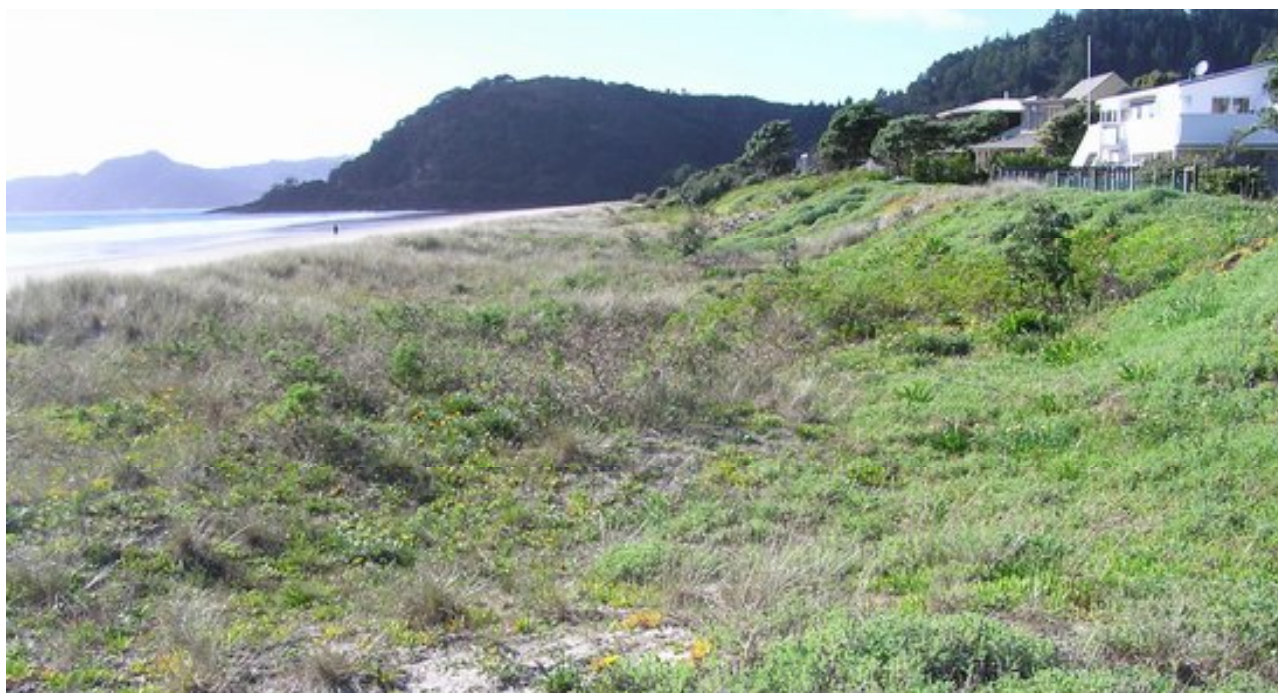
Figure 40: View of dune fronting the southern end of Matarangi Beach (seaward of Kenwood Drive) taken in April 2008. Note the low incipient dune to seaward that typically characterises this area. The 1978 storm scarp is still evident in the dune to landward (see text).

The main frontal dune along the back of the beach in this area is generally fronted by a low spinifex dune typically up to 15-20 m wide (Figure 40). The July 1978 storm eroded this incipient dune and scarped the face of the 3-4 m high dune to landward. Observations of aerial photographs suggest the erosion may even have occurred earlier – with a Whites Aviation photo from August 1972 (WA 70519) showing this high dune faceted along most of the length of the beach. The recent storms of July and August 2008 also caused severe erosion of the low incipient dune and in places cut back to the high dune further landward – though the erosion was slightly less significant than that evident in the 1979 beach profile survey and the 1972 imagery noted above. While the exact date of the severe erosion evident in the 1970s is not clear, there appears to be 30-40 years between this and the more recent period of extreme erosion, further reflecting the multi-decadal nature of extreme erosion along this coast. The observed period is similar to erosion cycles noted at many other sites in this review.

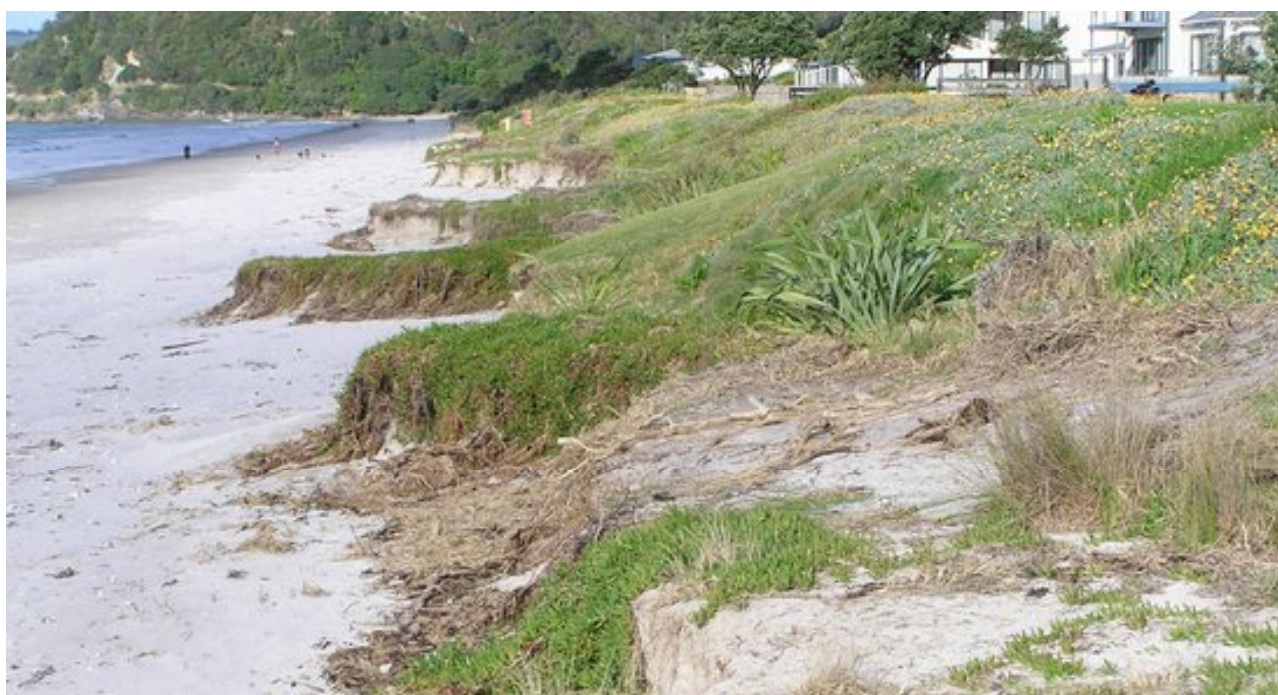
Figure 41: View looking south along the seaward edge of Kenwood Drive following the storms of July and August 2008

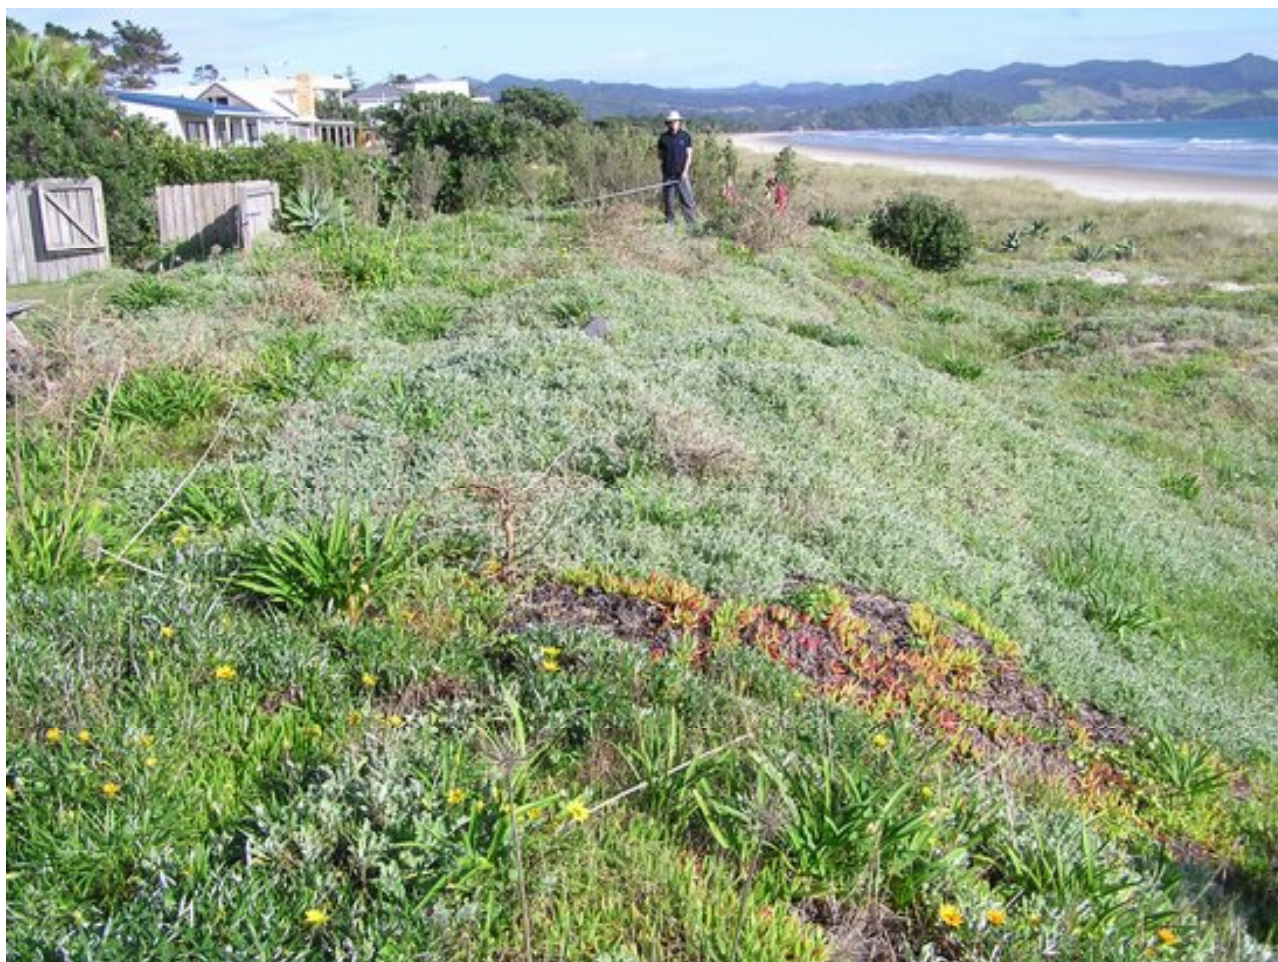
Figure 42: Location of worst estimated erosion (ground intercept excluding safety factors) at CCS 13. The estimate is close to (but landward of) historic erosion scarps but field evidence suggests the revised PDS (with the 10 m safety factor) is adequate.

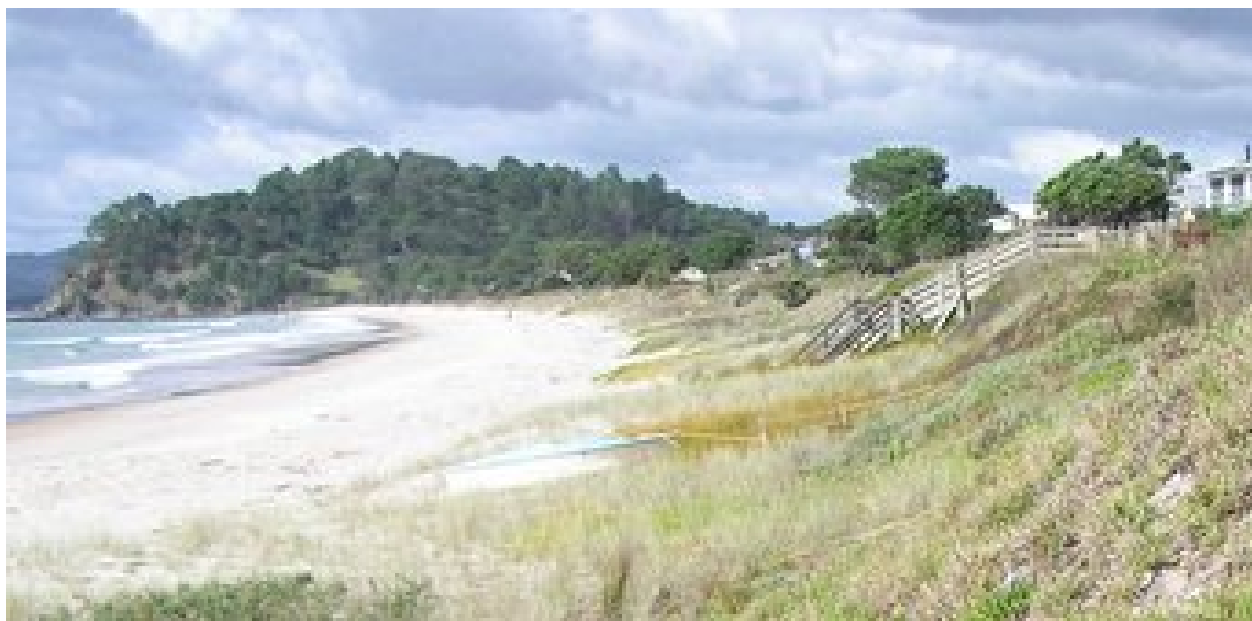
Figure 44: View south from CCS 12 in April 2008 showing early stages of dune recovery

The local Beachcare group has actively planted the eroded dune face since the early 2000s and the dune in this area was in early stages of recovery at the time of our initial field inspection in April 2008 (Figure 44).
