Coromandel Beaches - Coastal Hazards:

Review of Primary Development Setback at Selected Beaches

Thames Coromandel District Council

October 2009

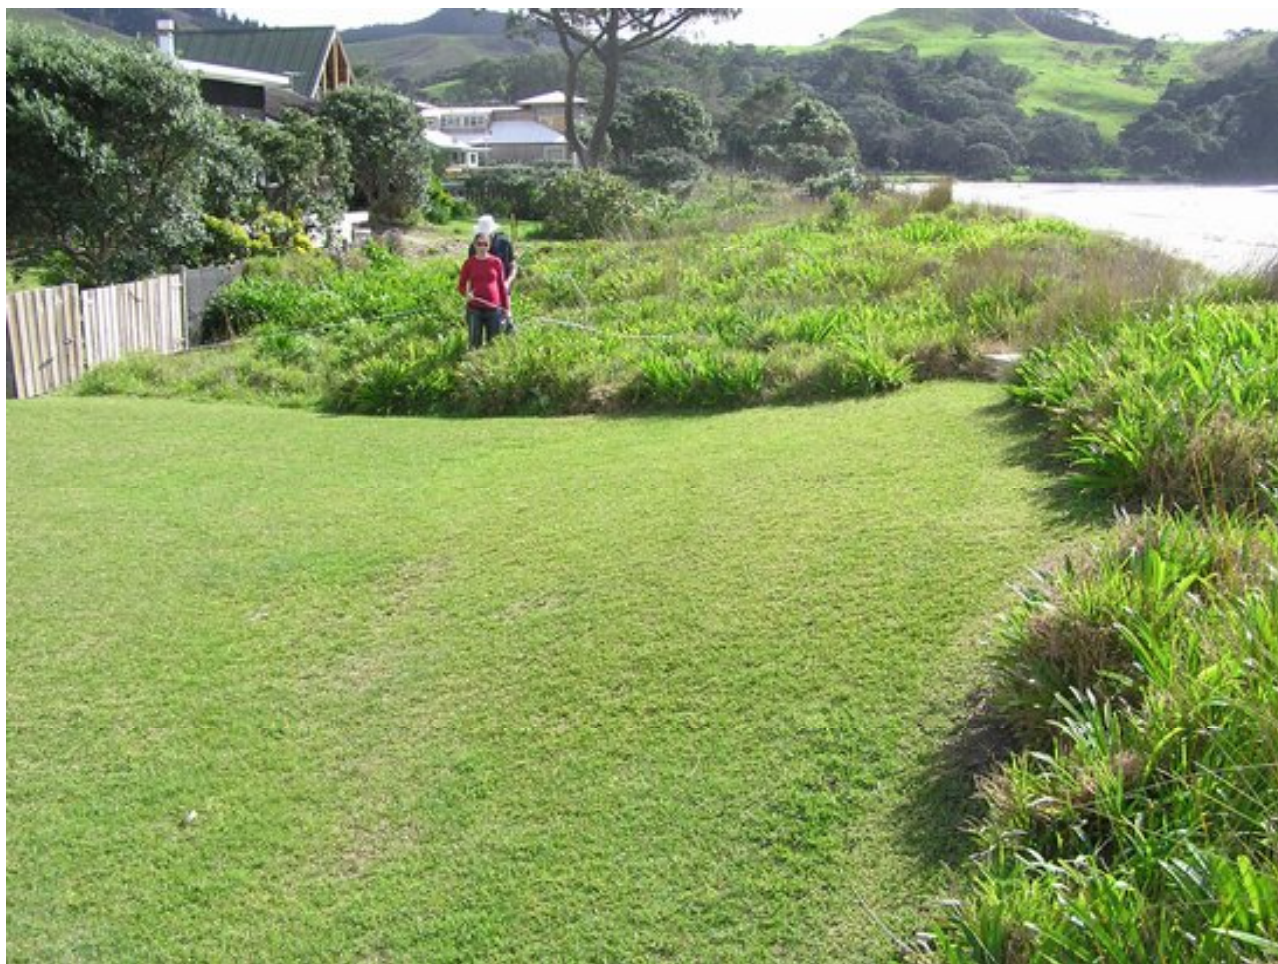
Figure 45: Location of worst estimated erosion in swale behind frontal dune.

The predicted worst estimated erosion extends approximately 10-11 m landward of the worst measured erosion and is located in the swale behind the frontal dune. All available evidence for the site suggests the estimate is reasonable and approximately 8-11 m landward of any erosion recorded over at least the last 50 years.

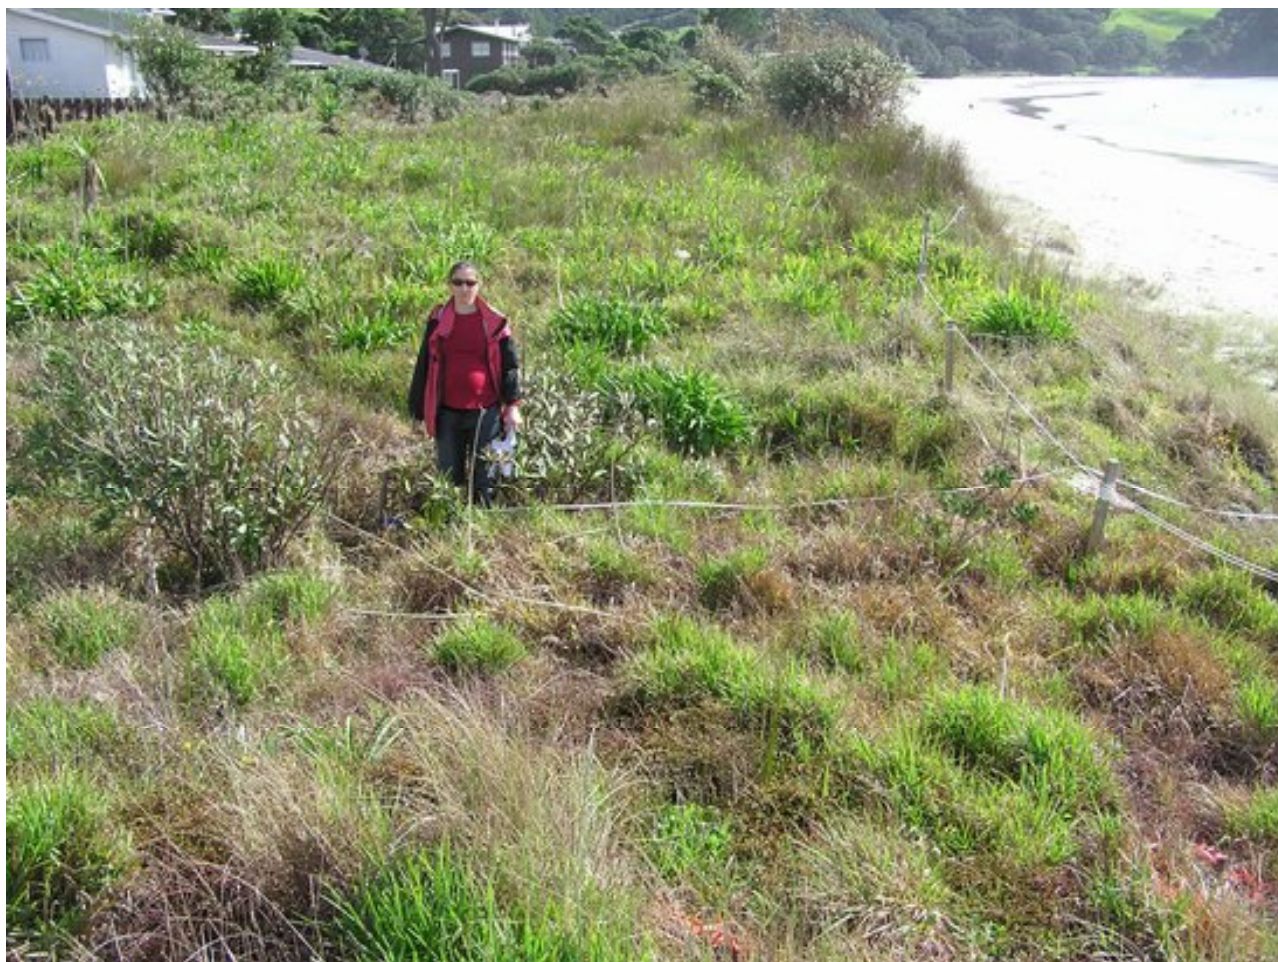
Figure 46: Worst estimated erosion at ground level at Whangapoua Beach, profile site CCS11.

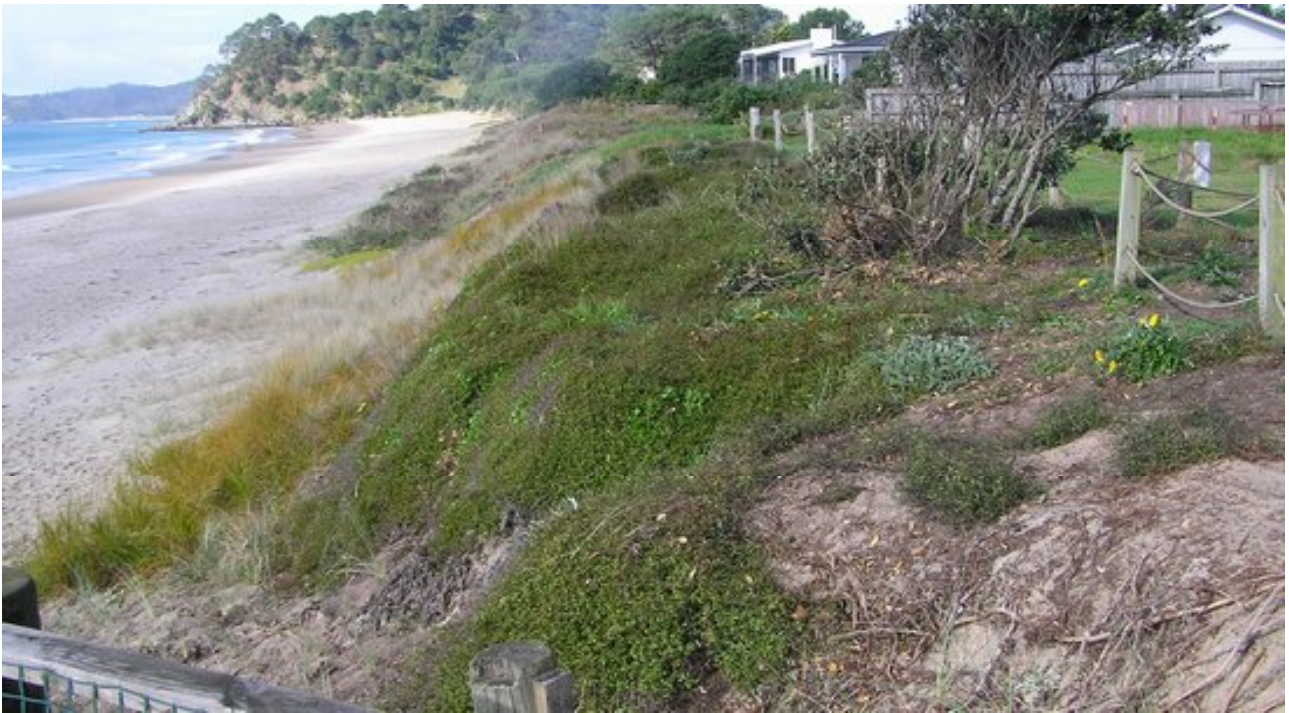
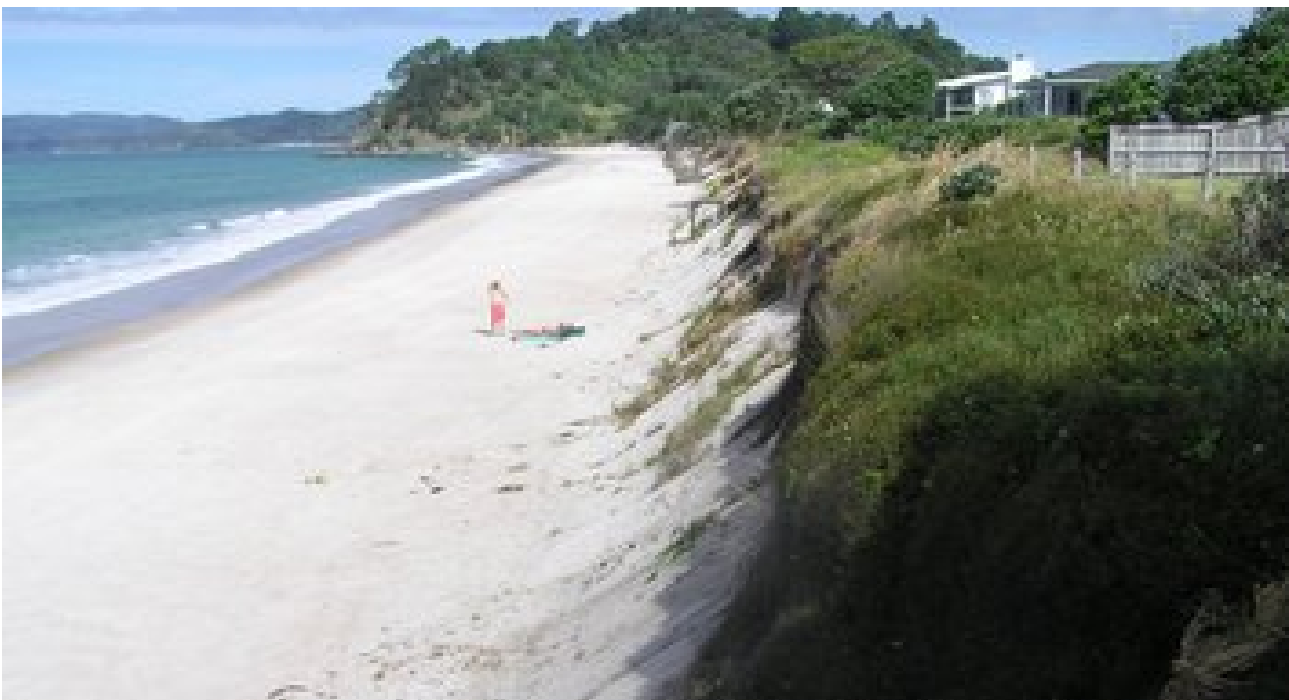
Figure 47: View looking south from centre of beach before (top, June 2007) and after (bottom, November 2008) erosion of July and August 2008

The erosion of July and August 2008 was extensive, with severe erosion extending 750 m northward from the southern end of the beach (Figure 47) and lesser erosion for at least a further 250 m. In places, the erosion severely threatened houses (Figure 48). Erosion mitigation works (dune reinstatement using beach scraping) were subsequently designed (Eco Nomos, 2008) and implemented.

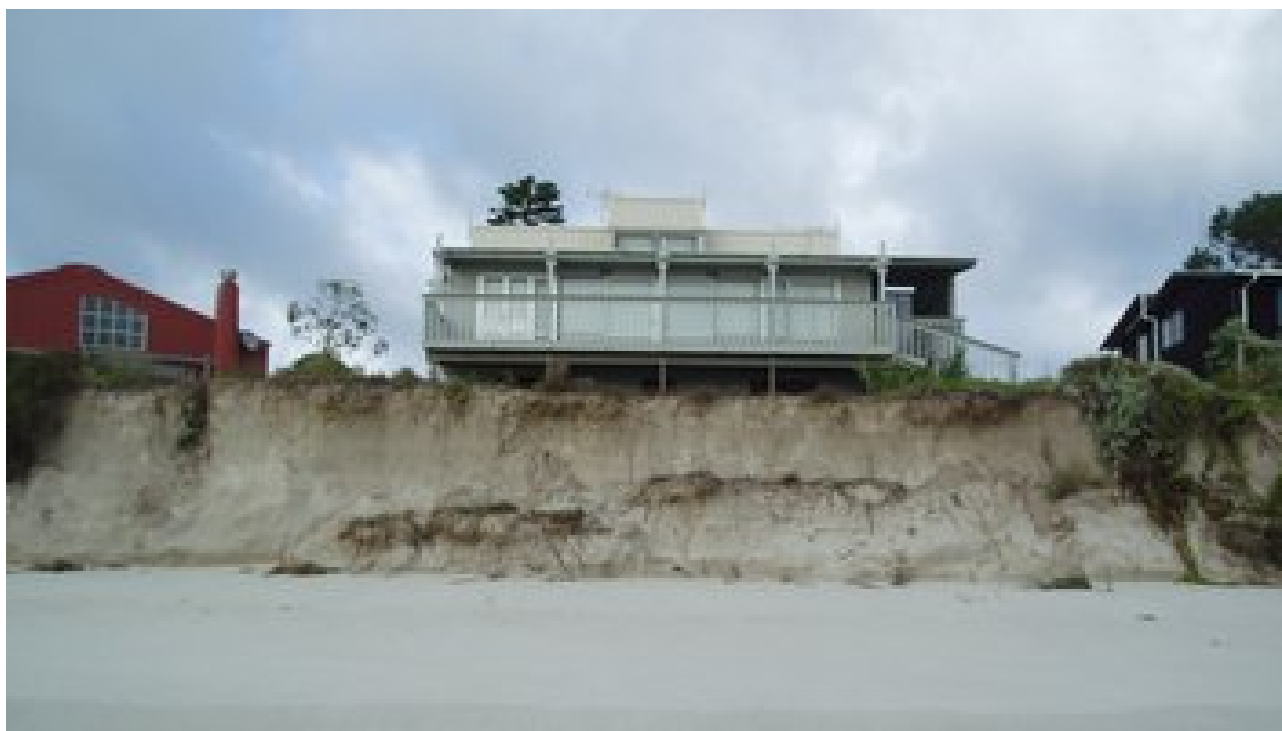
Figure 48: View of erosion scarp in central-southern beach following storms of July and August 2008 (Photo: Meg Graeme – taken August 2008).

The of worst estimated erosion calculated using the data from CCS 11/1 intercepts ground level about 8 m landward of the top edge of the erosion scarp measured following the July and August 2008 storms (the worst erosion since at least the early 1960s). There is no field evidence of more severe erosion. We believe the estimate is sufficiently precautionary to use to revise the PDS in this area of the beach.

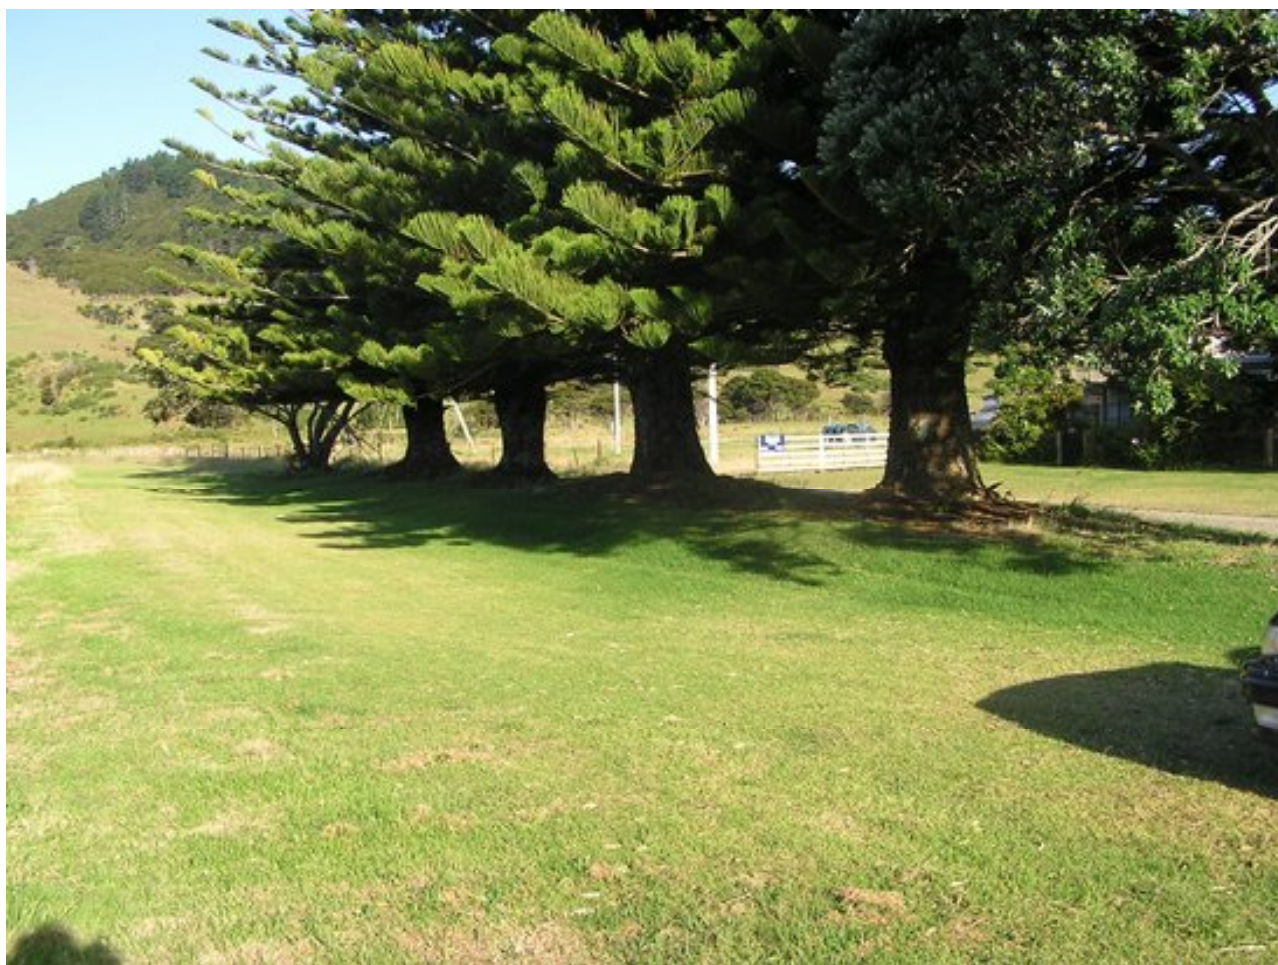
Figure 51: Large Norfolk Pines on public reserve seaward of road.

Field inspections and community information also confirm that the shoreline is relatively stable. Long-term residents indicate that the road landward of the reserve has never been threatened by erosion. This is consistent also with field evidence, including geomorphic evidence and the presence of relatively mature trees on the reserve seaward of the road (Figure 51).

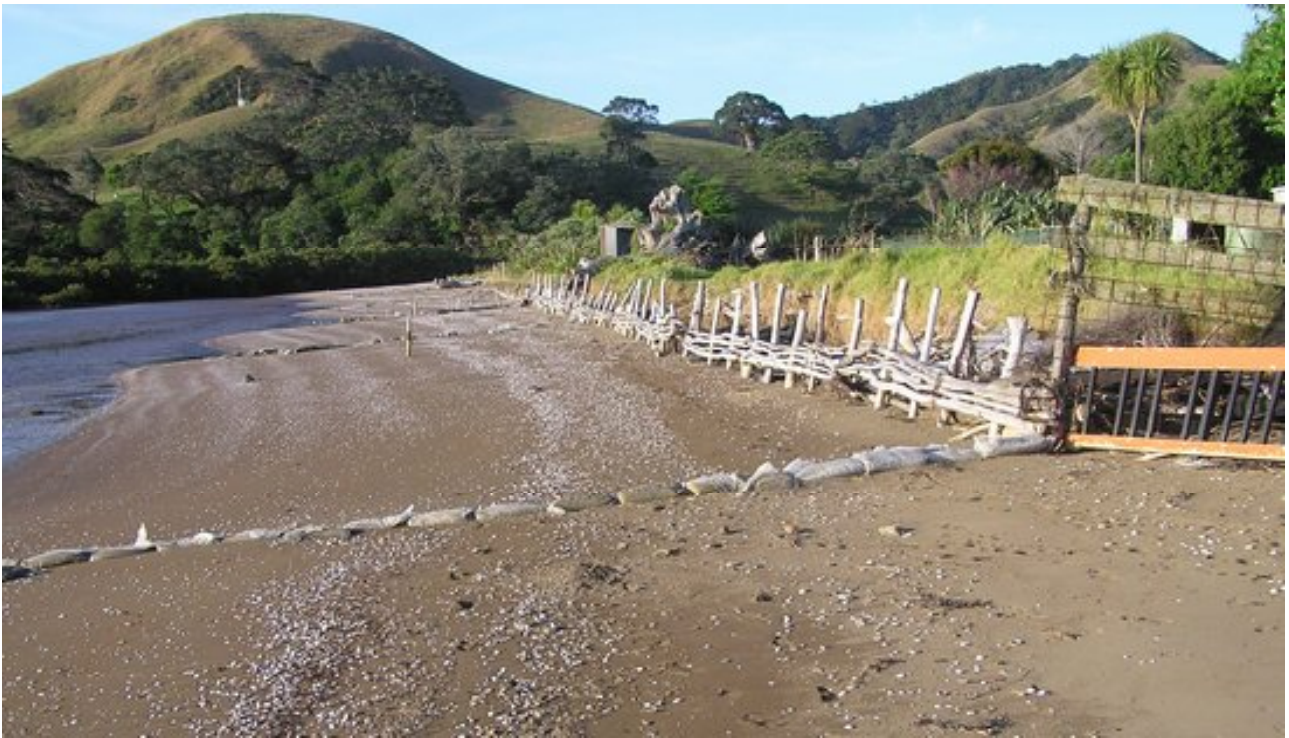
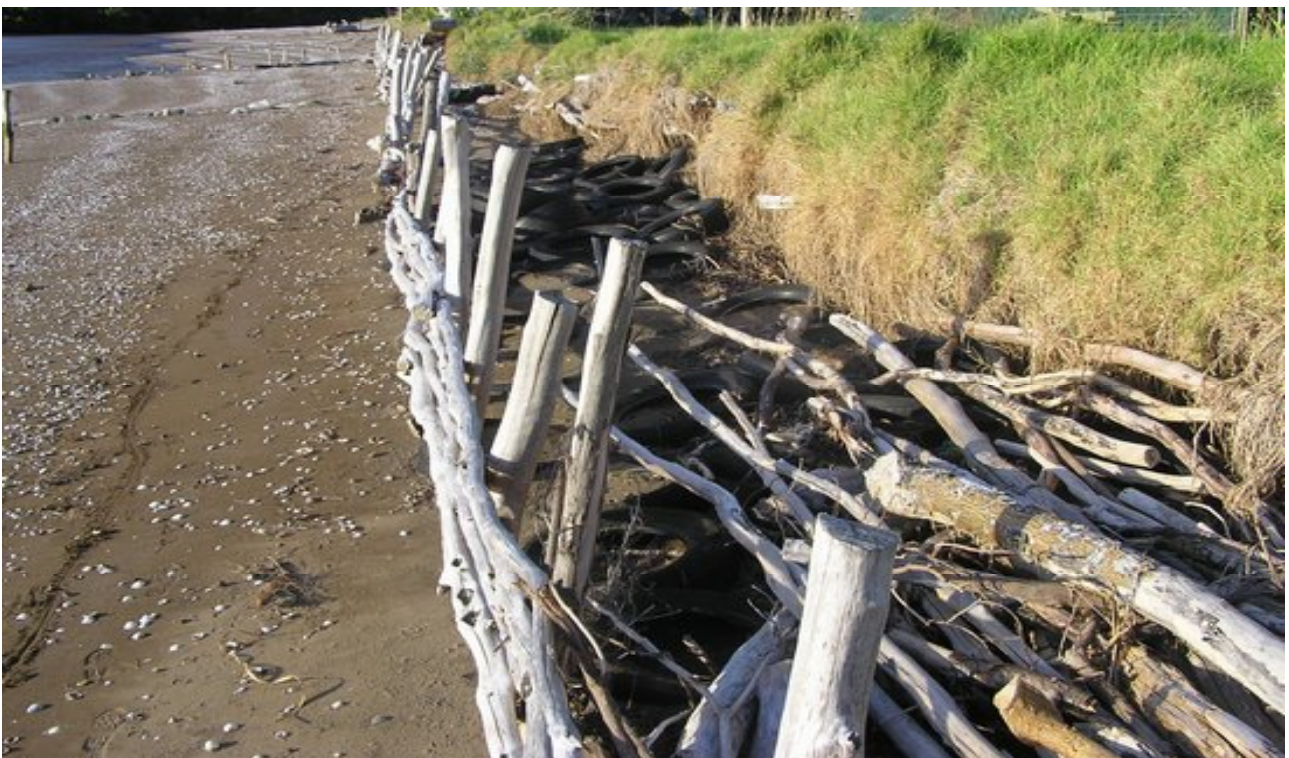
Figure 53: View of erosion at Port Charles east of CCS 6/1

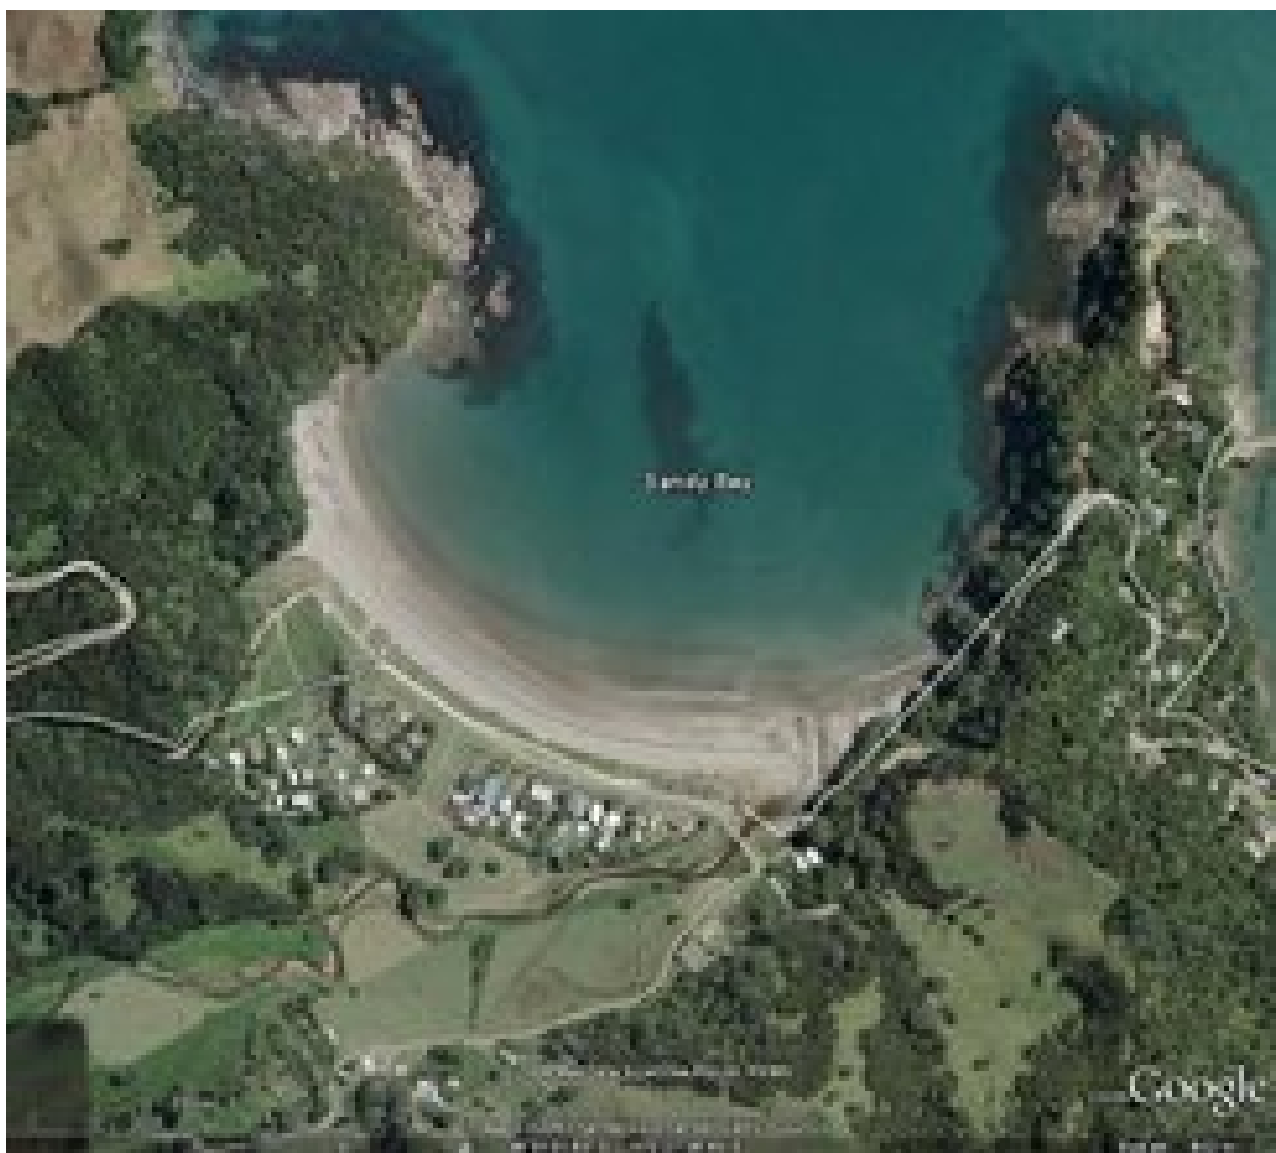
Figure 54: Sandy Bay

Sandy Bay (Figure 54) is an embayed beach located on the eastern side of the entrance to the Port Charles embayment. The beach is directly exposed to ocean waves from a northerly quarter (especially N and NW) but also impacted by easterly waves refracted around the Peninsula on the eastern side of the Port Charles embayment. The beach is primarily sand but gravel content increases significantly towards the eastern end where Okahutahi Stream flows onto the beach (Figure 54)

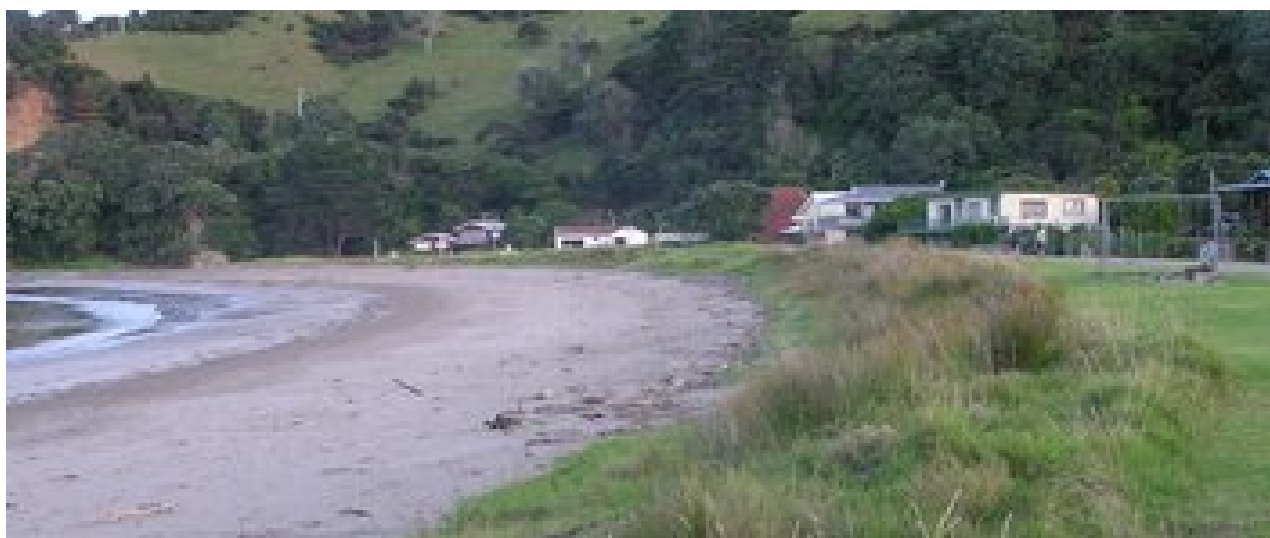
Figure 55: View of Sandy Bay beach and reserve from western end

Field examinations indicate the recovered dune face is typically vegetated with exotic stoloniferous grasses though it does contain patches of native vegetation (especially knobby clubrush) (Figure 55).

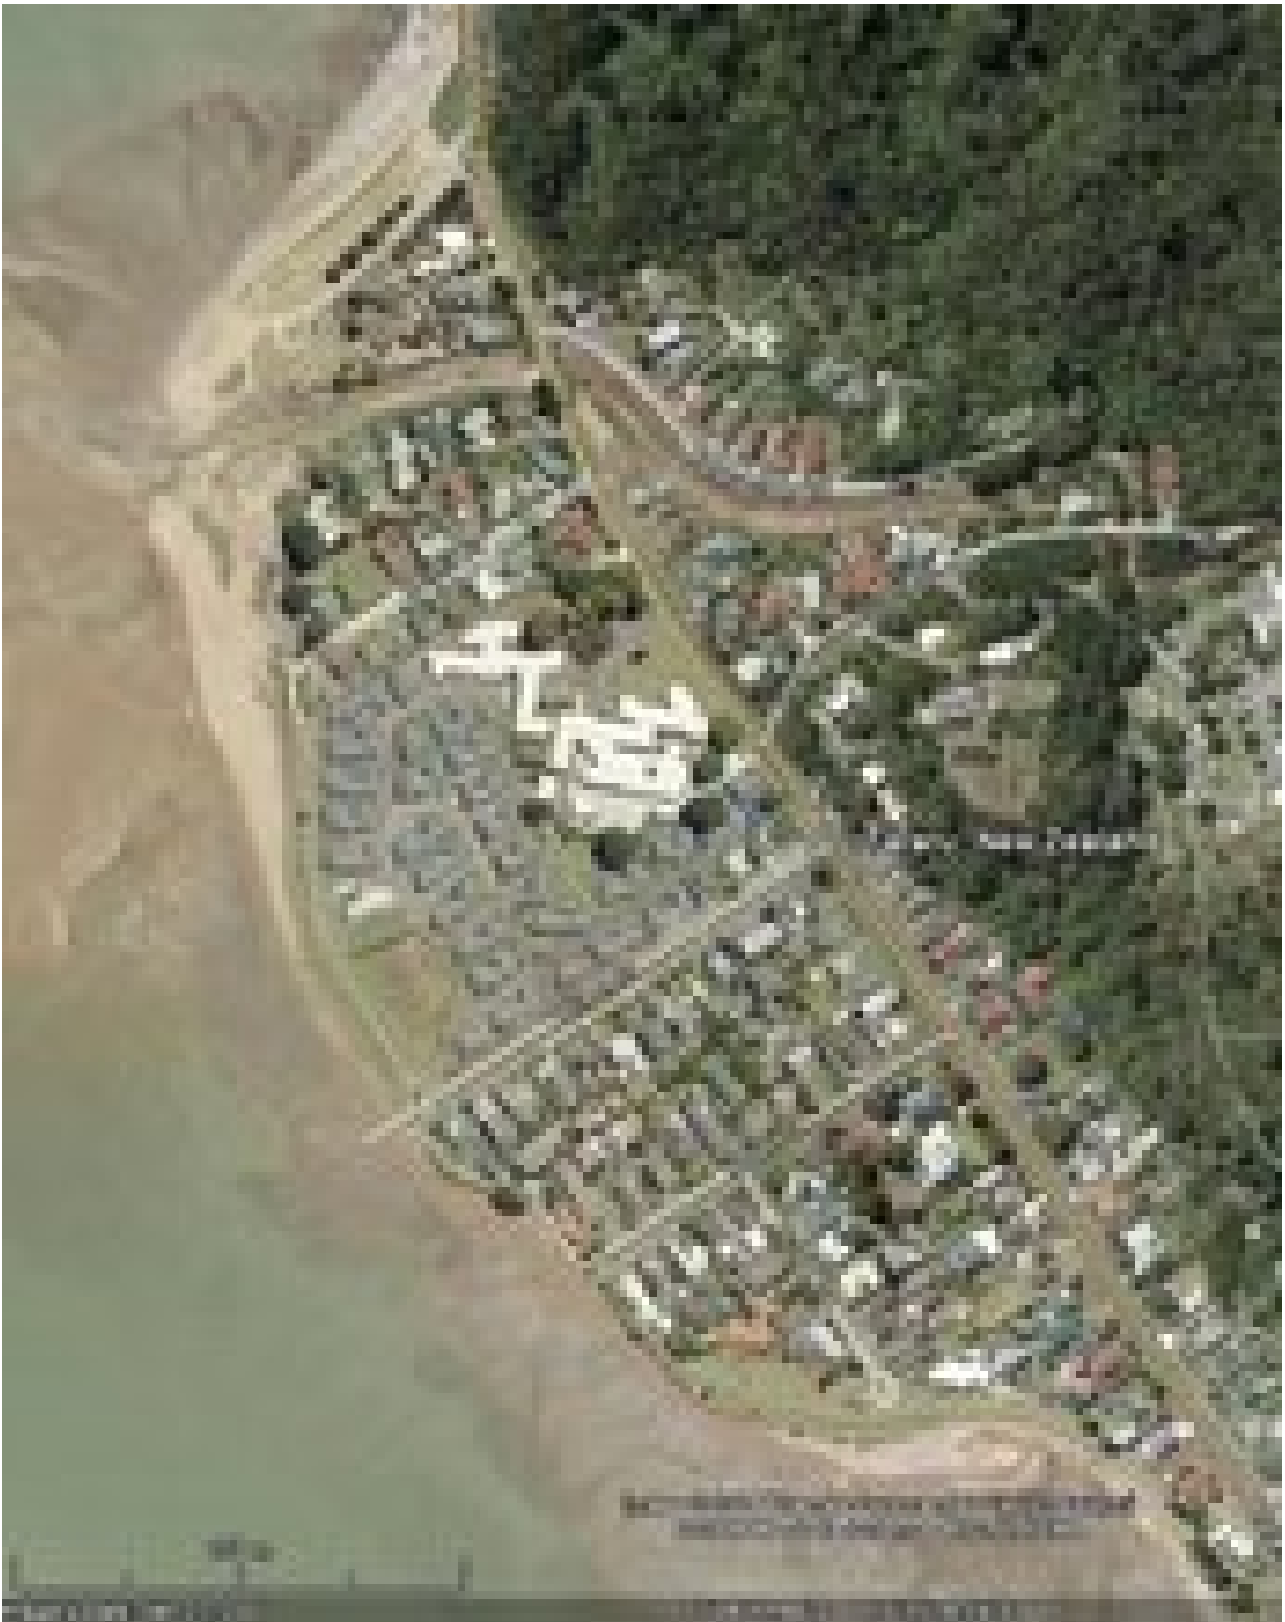
Figure 57: Tararu Stream delta showing locations referred to in text

The Tararu Stream delta (Figure 57) has an area of approximately 250,000 m², extends seaward about 300 m at its widest point, and has a total shoreline length of approximately 1420 m (Dahm and Munro, 2002). The Tararu Stream presently discharges towards to the northern end of the delta (Figure 57). There is limited information on historic changes near the entrance. However, historic photos dating back to the 1940s show the entrance in the same area, as well as the undated “old MHW” survey discussed in Section 3.1.2.2. Therefore, the stream entrance appears to have been in the same location for at least the last 60-100 years.

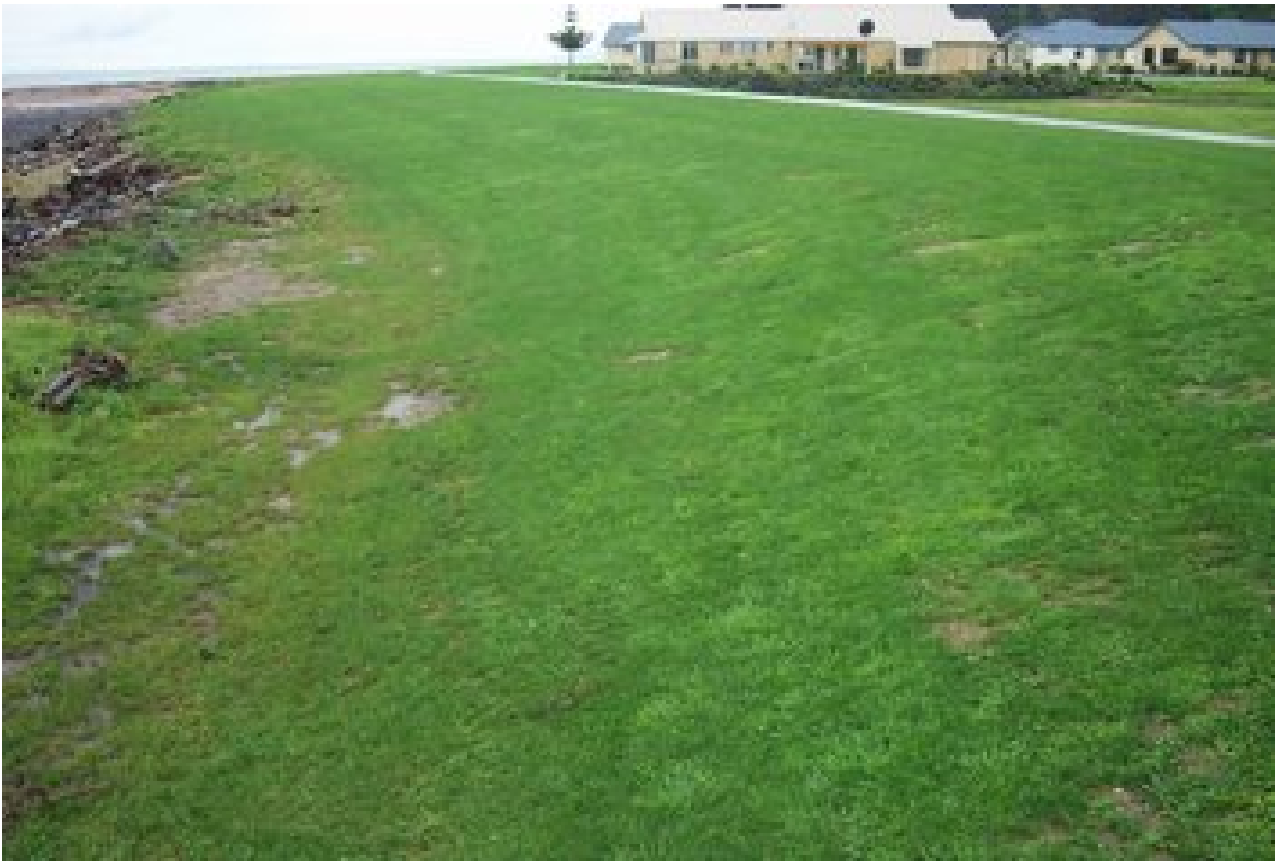
Figure 58: Flood protection embankment and footpath constructed north of Wilson Street

These materials were landscaped to form the present flood protection embankment and coastal footpath in this area (Figure 58).

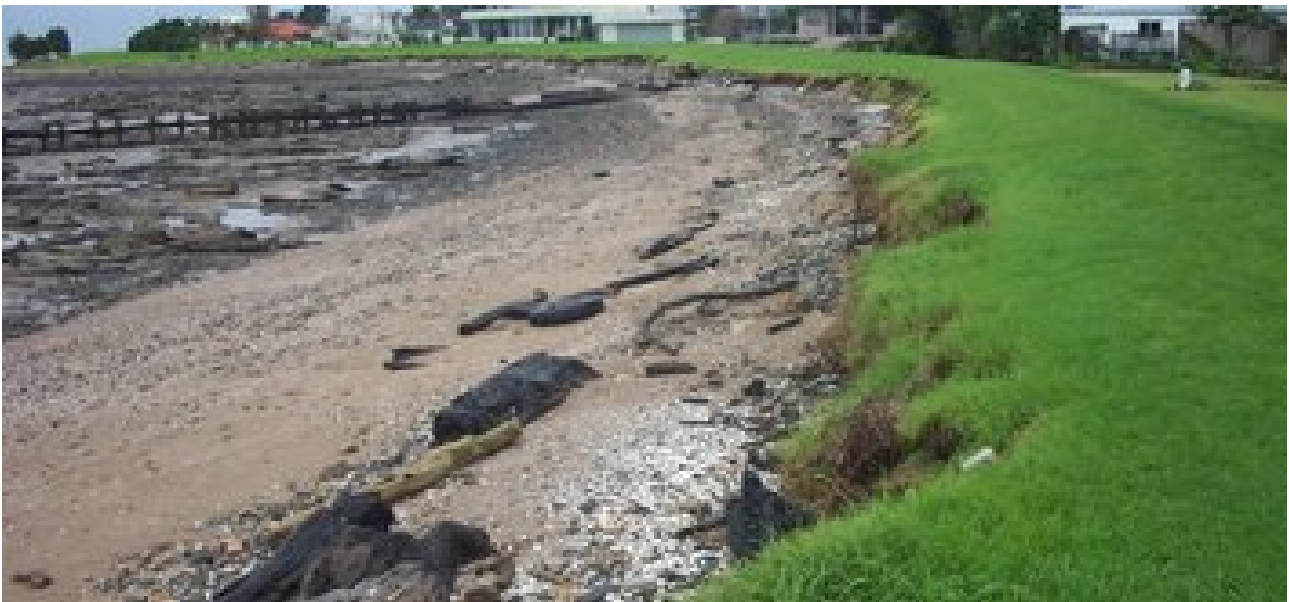
Figure 59: Erosion threatening flood protection embankment in July 2005

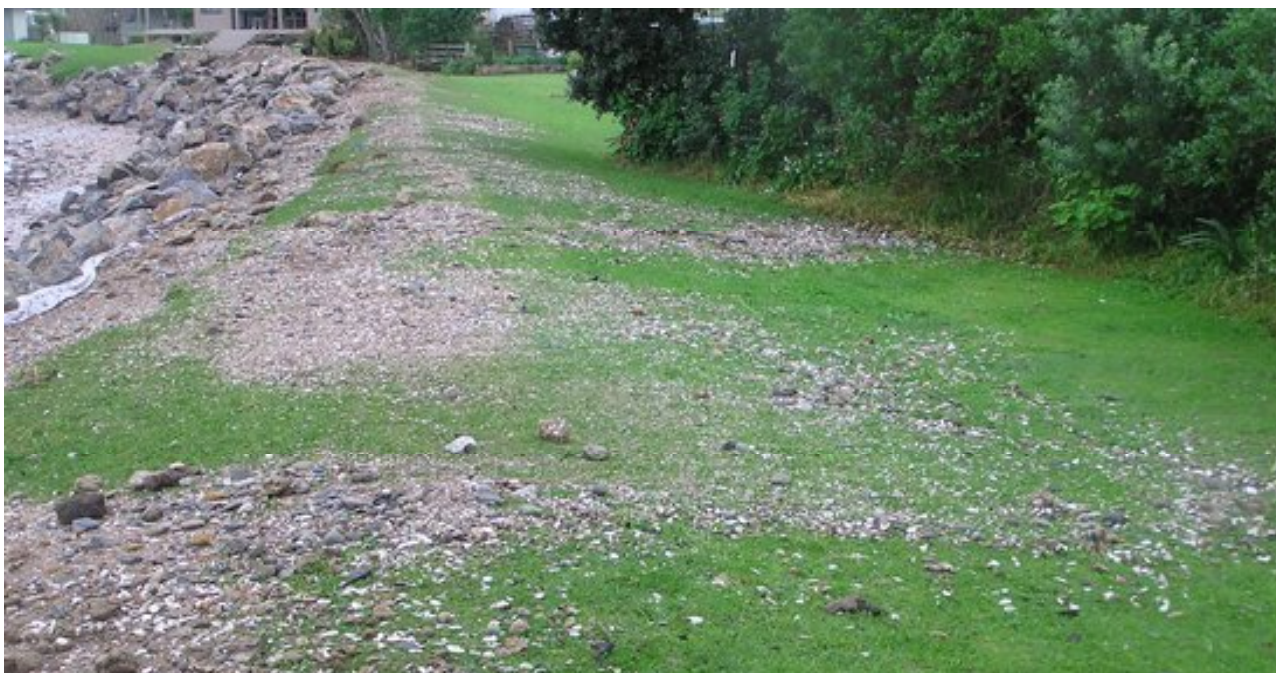
Figure 60: Overtopping and erosion September 2005, leading to placement of rock to protect flood embankment

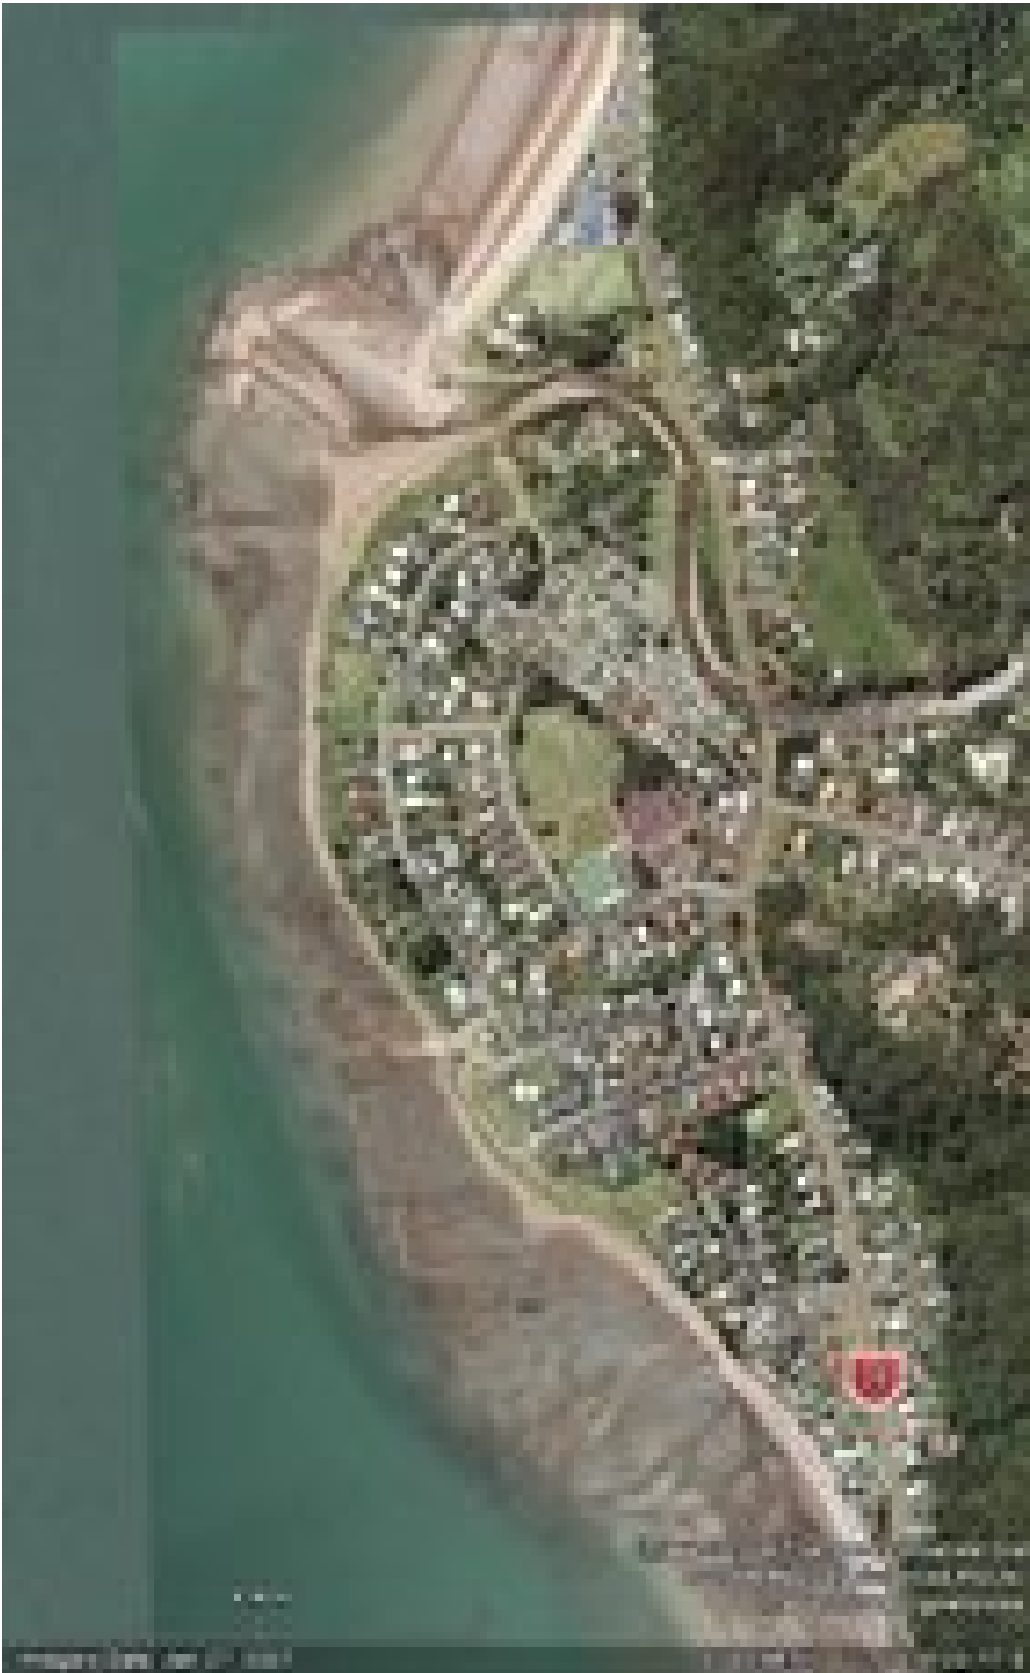
Figure 61: Te Puru delta

The Te Puru delta (Figure 61), the largest on the Thames Coast; has a total area of about 422,000 m², a total shoreline length of about 1760 m and extends about 400 m seaward at maximum width (Dahm and Munro, 2002).

The present stream entrance discharges near the northern end of the delta. Historic surveys back to the 1880's indicate that the main entrance has been in much the same location over the last 120-130 years. Historic photographs and surveys do however show two secondary entrances (discussed further below) suggesting considerable stream channel and entrance instability over periods of centuries.

The existing stream channel and entrance are now held relatively stable by shoreline armouring structures, flood embankments and regular entrance and channel dredging for flood protection. Dredged sediments are returned to the coastal system, generally in shoreline areas close to the stream entrance. The following sections discuss shoreline change around the delta.

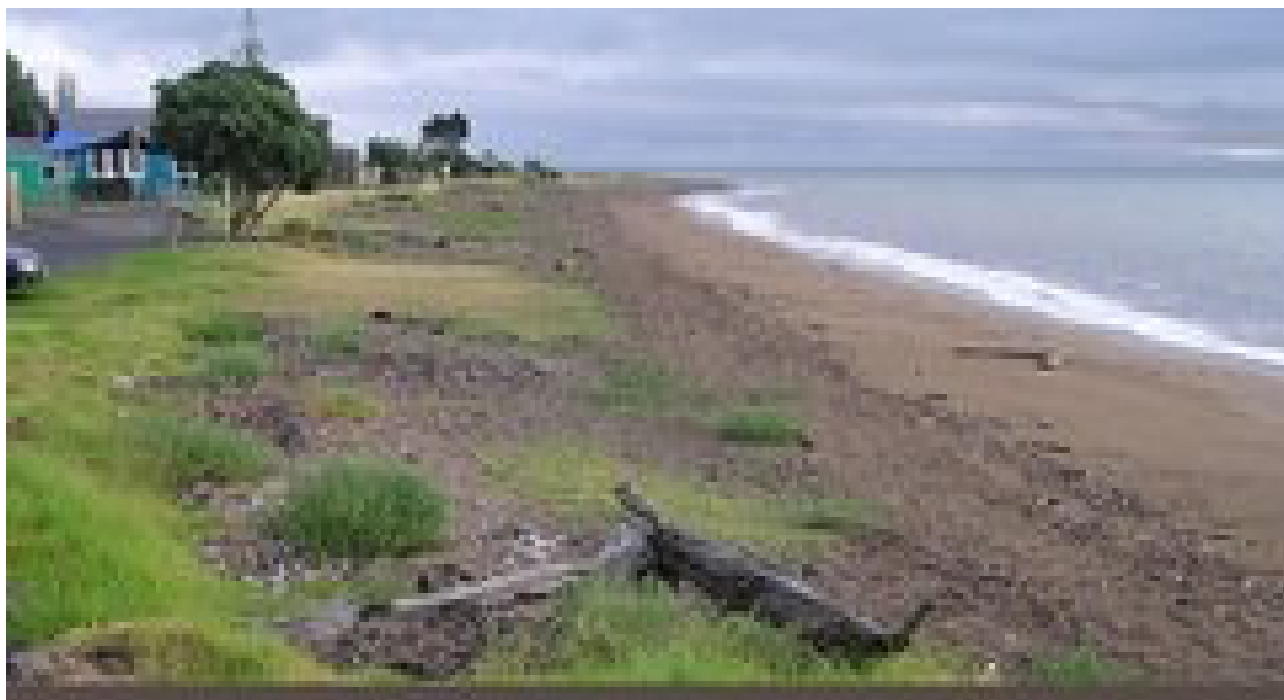
Figure 65: Wide high tide beach fronting Te Puru School (February 2009). The seawall is located immediately in front of the grassed area behind the wooden step structures.

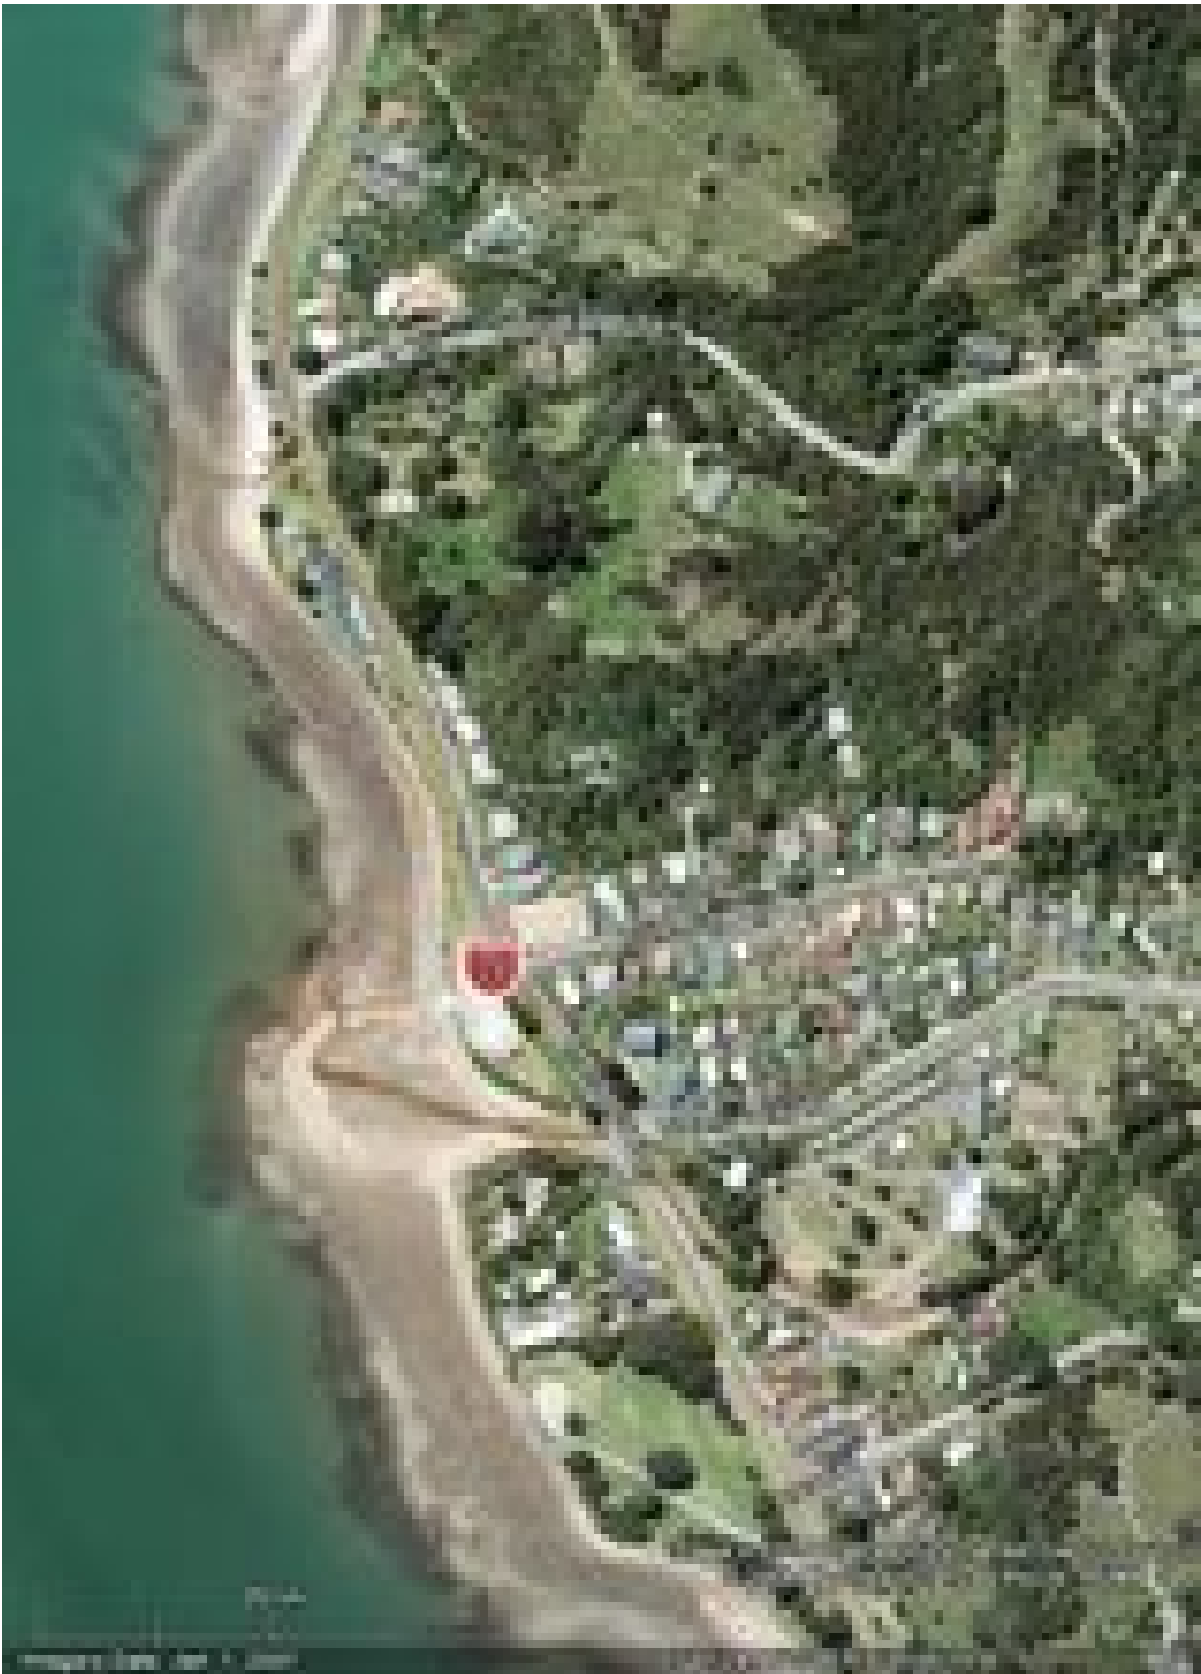
Figure 66: Waiomu Township, showing Waiomu and Pohue Streams and associated deltas

Waiomu Township has two small stream deltas along the coastal margin. The larger and southernmost of these is the Waiomu Stream delta which extends approximately 650 m alongshore and up to about 125 m seaward of SH 25. A much smaller delta associated with the Pohue Stream occurs further north, extending approximately 300 m alongshore and up to 30-35 m seaward of SH 25 (Figure 66). The streams discharge towards the northern end of both deltas, as typical along this coast, with the bulk of both features lying to the south of the streams (Figure 66), reflecting the net southwards littoral drift that prevails along the Thames Coast.

Settlement on the Waiomu Stream delta is limited to several properties immediately south of the streams, with the remainder of the delta being public reserve (Figure 66).

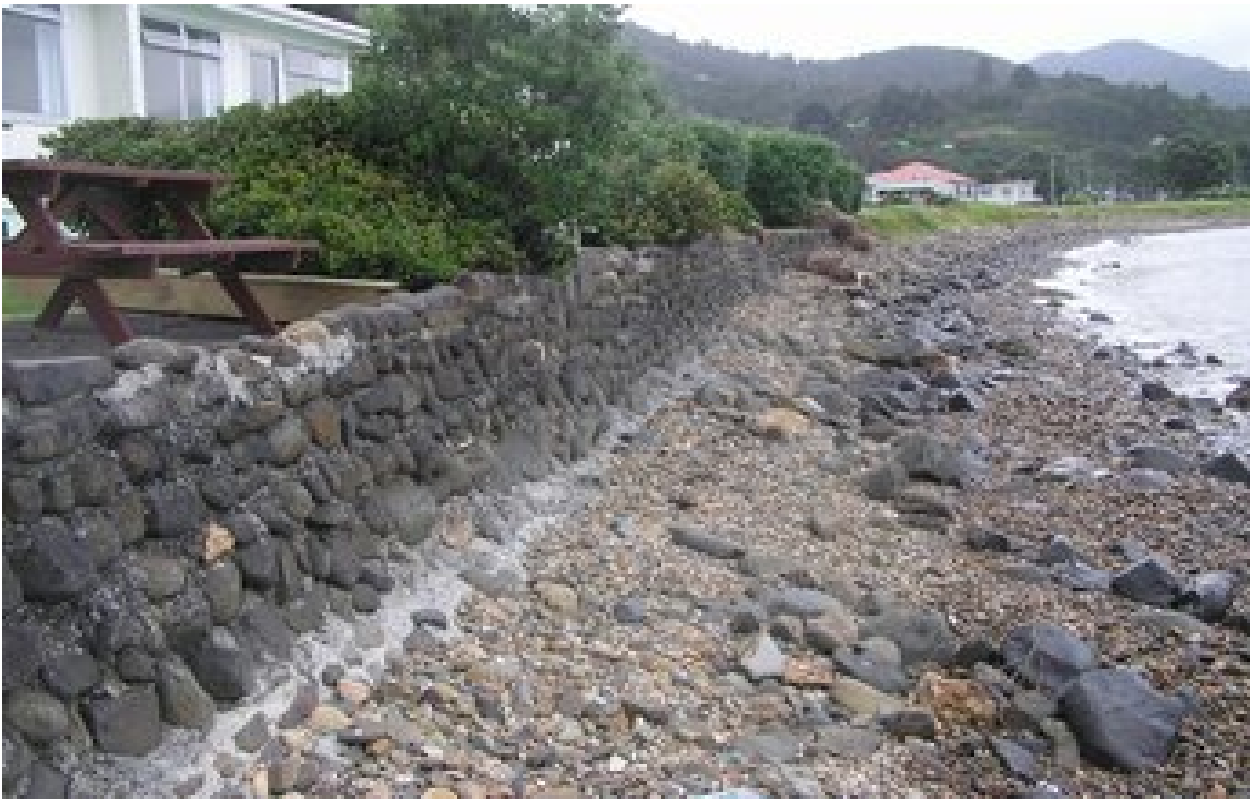
Figure 67: Seawall fronting motel south of Pohue Stream

The motel to the south is fronted by a seawall constructed in 1996 (Figure 67). Measurements conducted in the field and aerial photographs suggest the seawall fixes the property margin up to 3-5 m seaward of where the natural coastal margin would otherwise lie, with the most significant encroachment towards the northern end of the property. The toe of the former narrow beach can be seen extending seaward from the base of the seawall (Figure 67). This encroachment onto the active beach appears to have occurred at the time the property was originally developed and owners advise that the property has not experienced serious erosion in recent decades even prior to seawall construction. This probably reflects the fact that the site is moderately sheltered from rare higher energy northerly storm swell. Observations at this site during Cyclone Drena indicated that the swell waves broke oblique to the wall in this area.
