Coromandel Beaches - Coastal Hazards:

Review of Primary Development Setback at Selected Beaches

Thames Coromandel District Council

October 2009

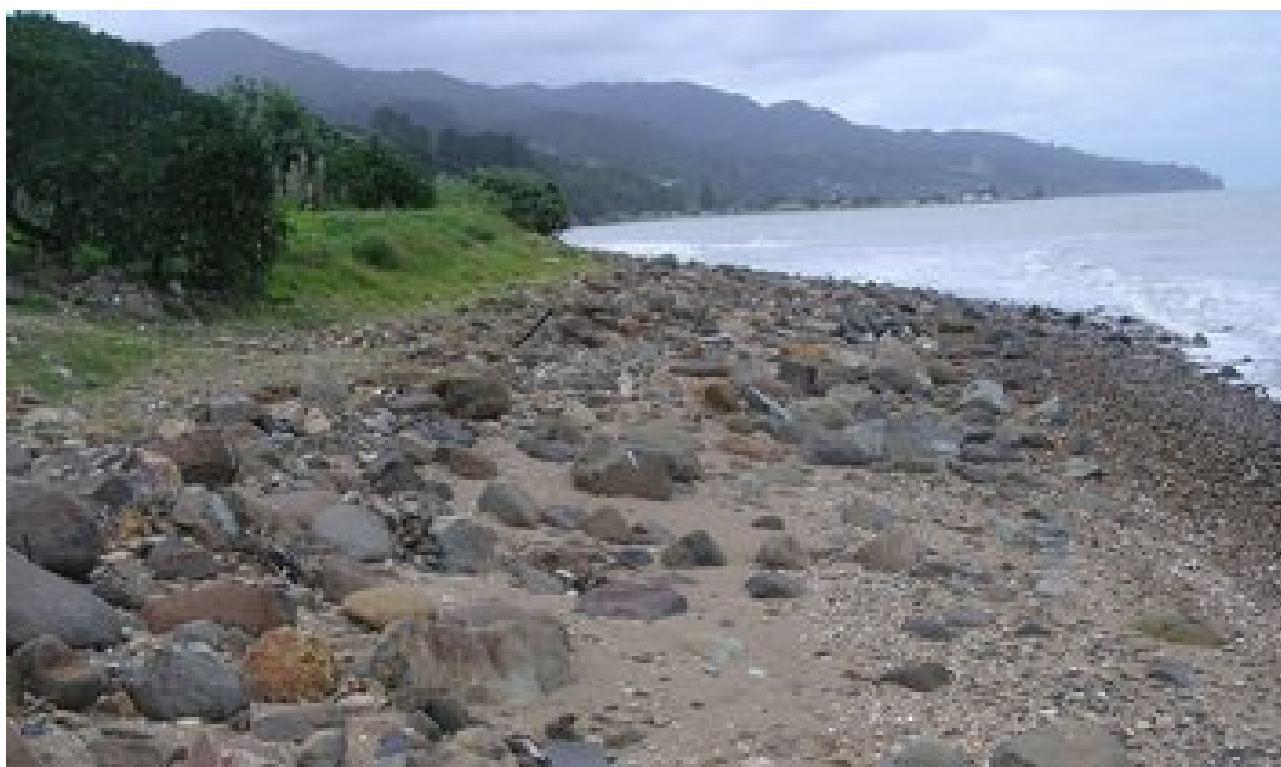
Figure 69: Shoreline fronting Waiomu Stream delta. Photo shows natural beach lagged with boulders and large rocks remnant from dredged sediment disposal (see text for discussion).

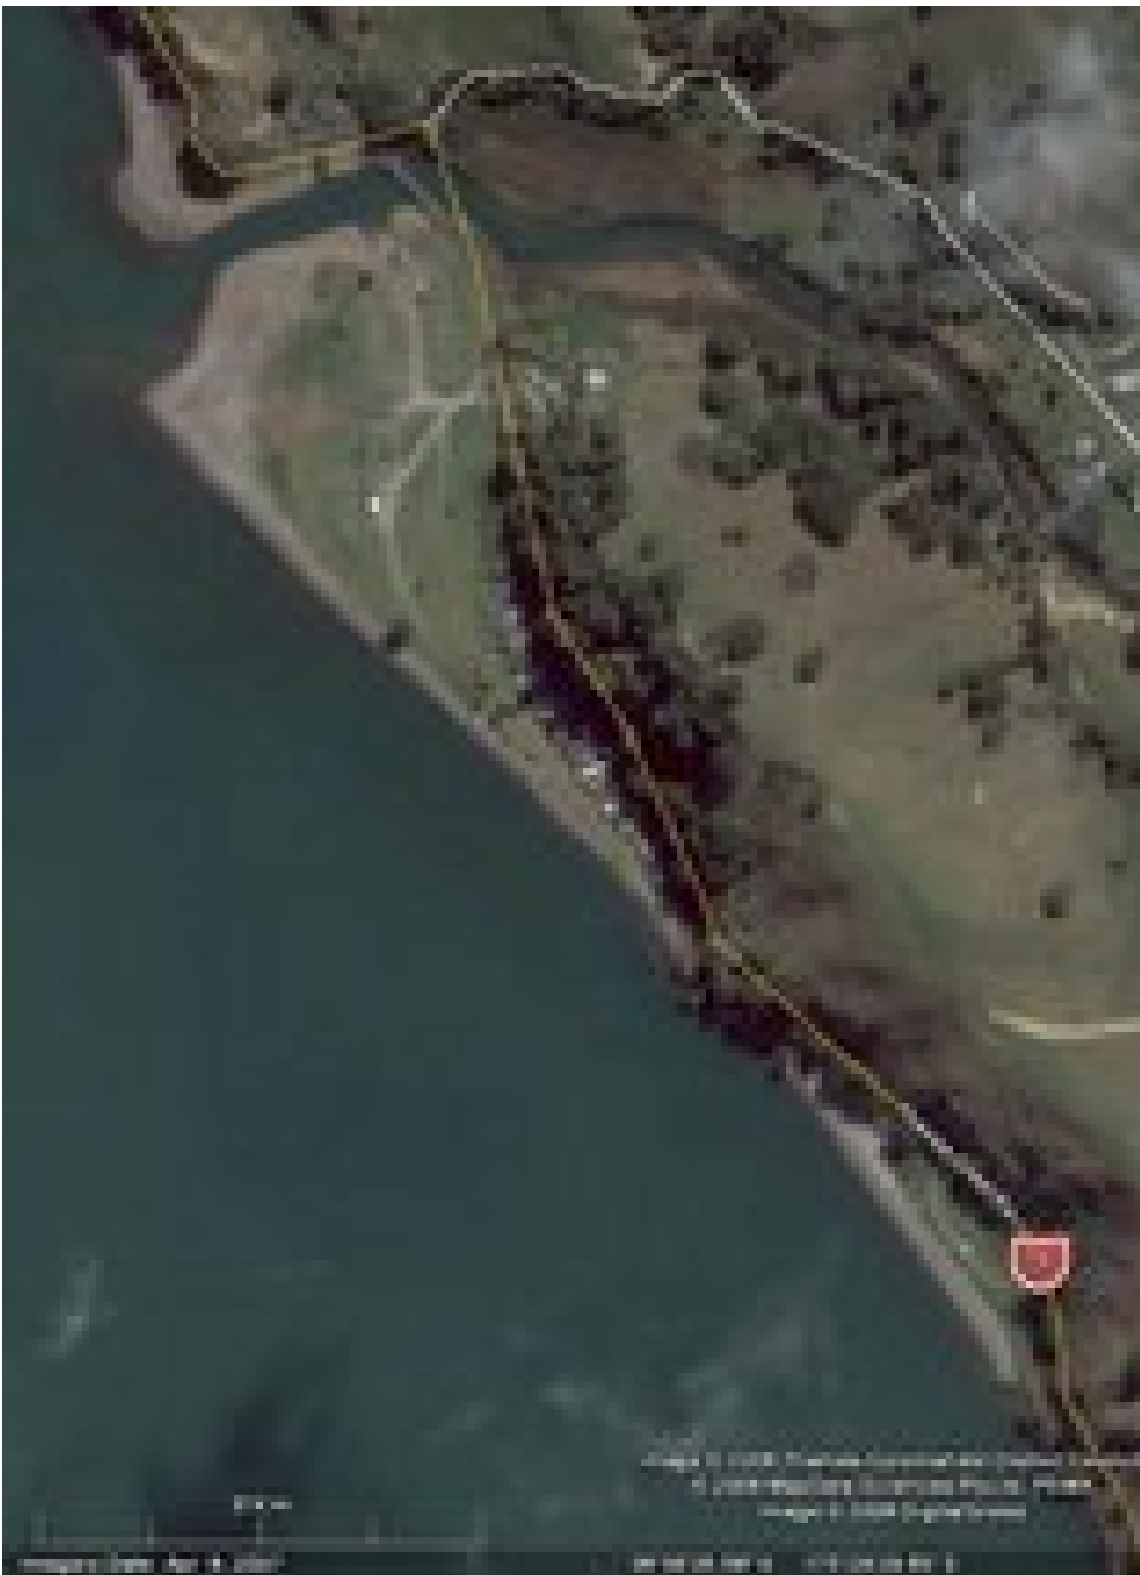
The Waikawau River delta extends approximately 1150 m alongshore (including the beach in the embayment immediately south, which is part of the total delta) and is up to 230 m wide. The delta is primarily public reserve though the southern area is occupied by a small bach settlement (former Auckland trams converted to holiday homes) operated by Waikawau Properties Ltd (Figure 71). The river is also the site of the most popular boat ramp along the Thames Coast (located just downstream of SH 25 bridge) and is now regularly dredged to maintain a navigable channel. Dredged sediment is placed on the rock-lagged intertidal flat fronting the beach (Eco Nomos, 2003; 2008).

Figure 71: Waikawau River delta. Note bach settlement (known locally as “the tram cars”) in centre of photo.

In spite of the general trend for seaward advance of the shoreline south of the river entrance, the shoreline fronting the trams has slowly retreated by 10-20 m since the earliest survey of 1925. This equates to an average rate of retreat of 0.15-0.25 m/yr. The rate has however been much slower in the period from 1939 to 1998 (typically averaging about 0.07 m/yr), which is probably more relevant to presently ongoing trends. This latter figure has been increased to 0.1 m/yr to ensure conservatism for the purposes of determining setback distances. We believe this figure is adequate in view of advice from long-term tram owners that little net loss of shoreline has been observed over the last 3-5 decades.

The area is also subject to erosion associated with dynamic shoreline fluctuations, estimated at 5 m. This appears to be precautionary given the limited erosion noted by long-term tram owners – though a low wooden seawall was placed in some areas in the past to limit erosion. The shoreline fronting the trams is currently showing signs of erosion in central to northern areas though it is not clear whether this erosion relates to dynamic fluctuations or long-term retreat.
