Whangaumu Bay

Coastal Erosion Hazard and Management Recommendations

Prepared for: Northland Regional Council

Prepared by: J Dahm, Eco Nomos Ltd

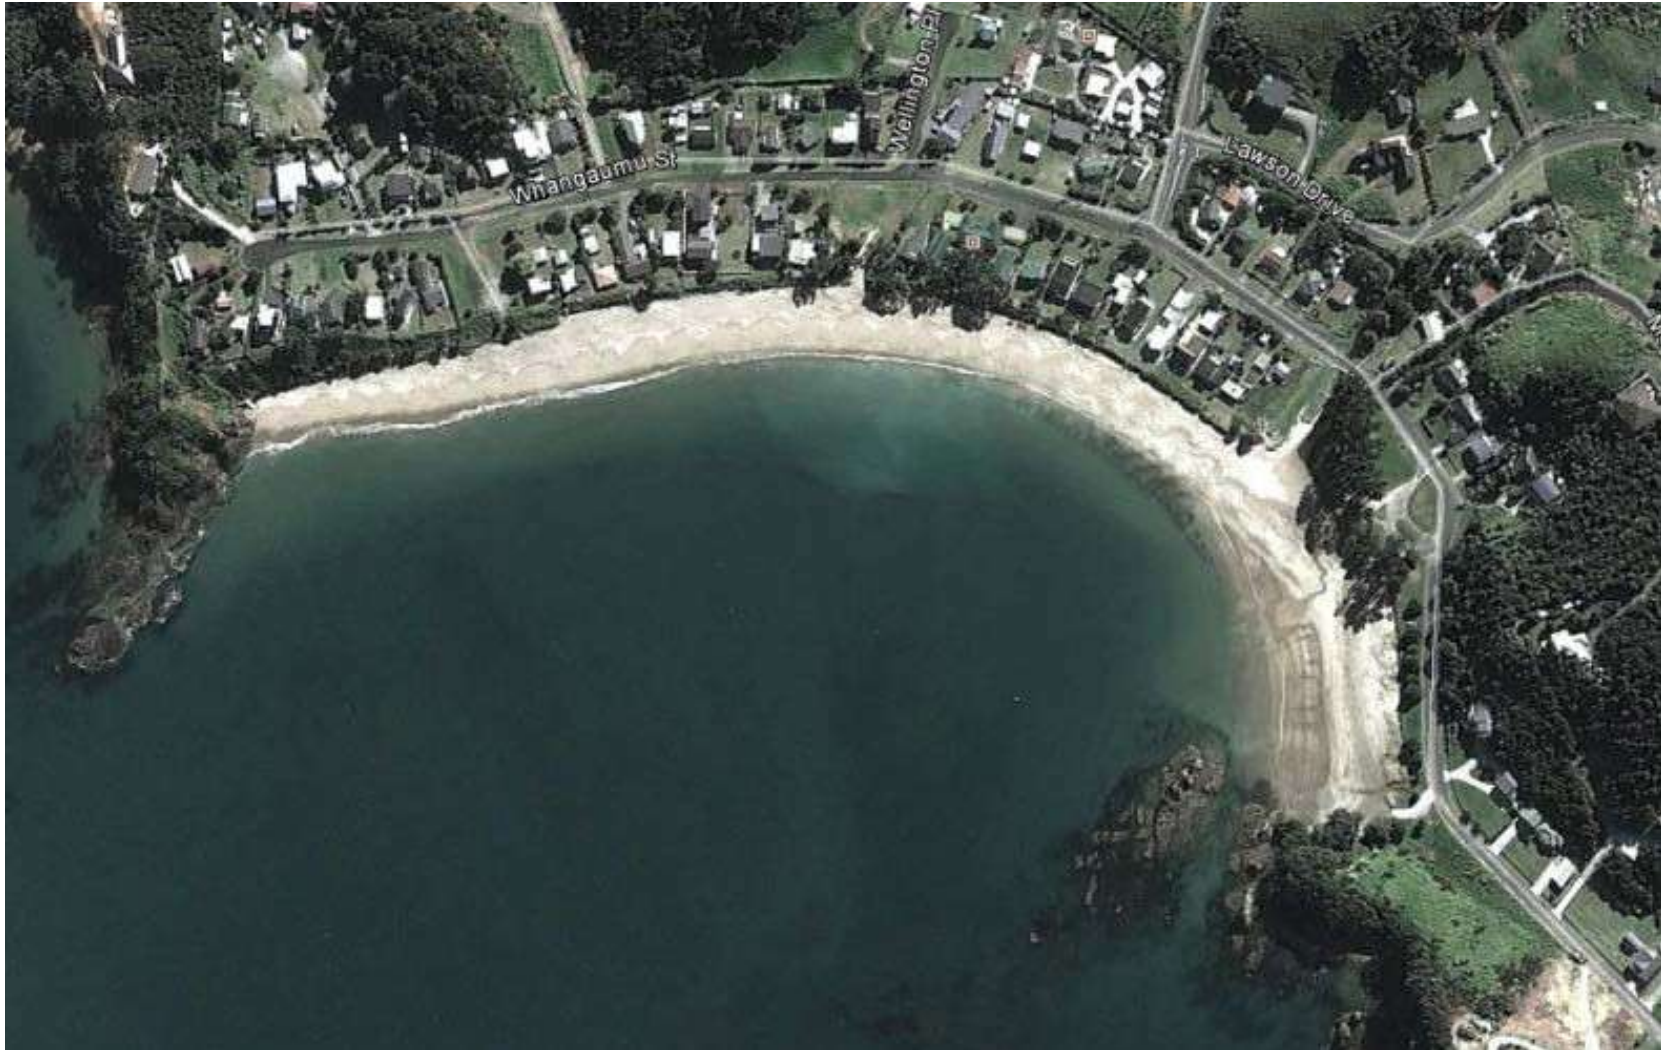
Figure 2: Recent aerial photograph of Whangaumu Bay (from Google Earth)

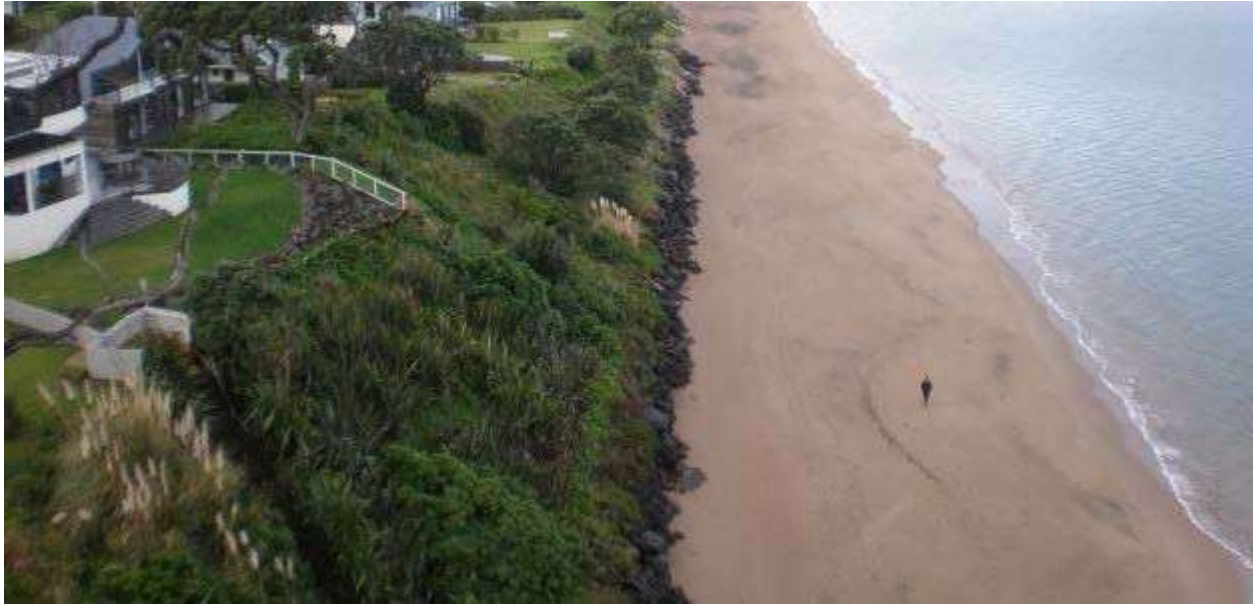
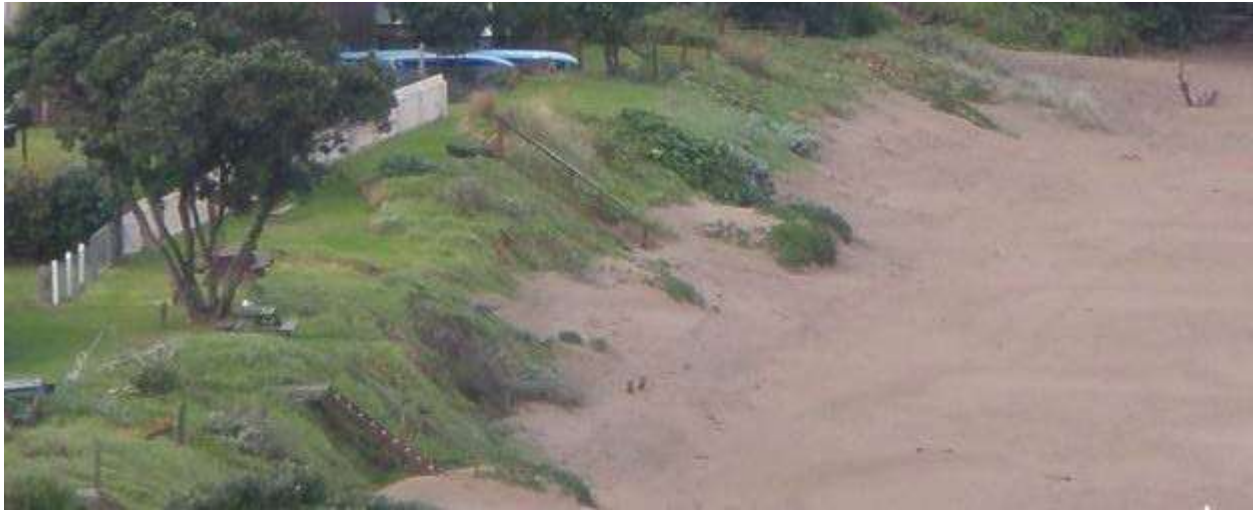
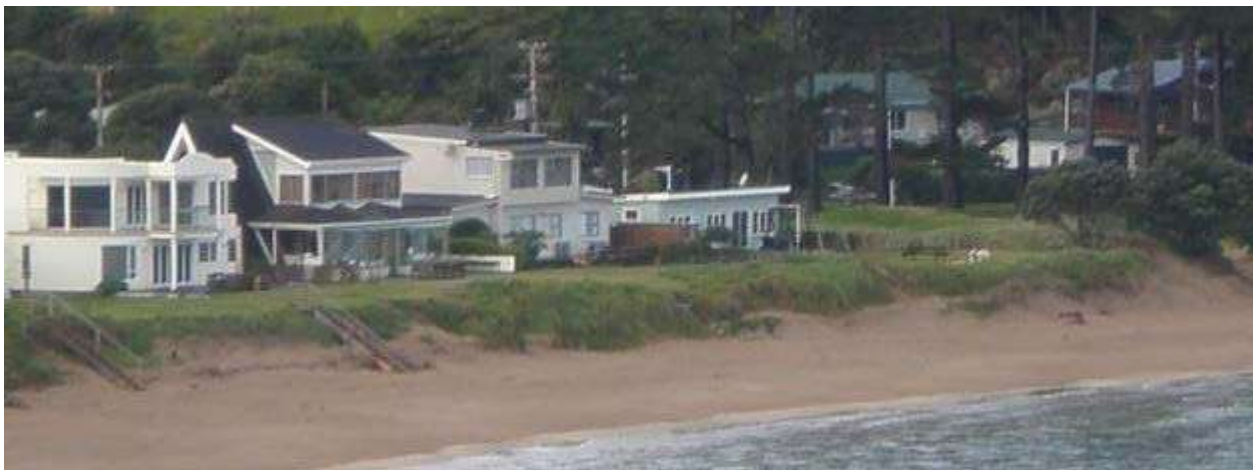
Figure 5: View of high dunes and rock revetment at western end of the beach (top) and dunes in central (middle photo) and eastern (bottom photo) ends of the beach

- **Loss of natural character and impacts on visual amenity.** The rock sea wall at the eastern end of the beach is a prominent and permanently exposed feature (Figure 5), imparting a human-built and engineered character to this section of the beach and reducing the natural character and visual amenity of the beach. This reflects the fact that the structure is located well seaward on the beach profile.

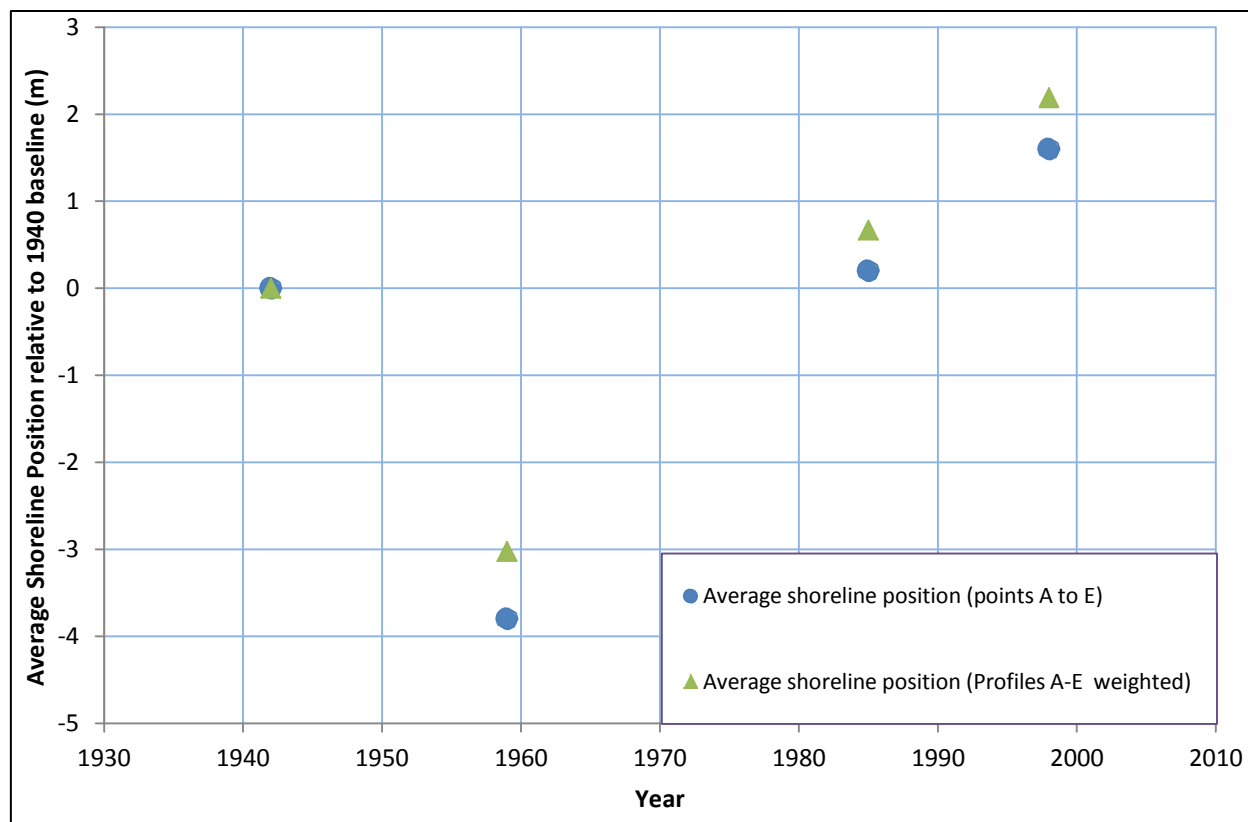
Figure 7: Average shoreline position in 1942, 1959, 1985 and 1998 relative to 1942 shoreline (see text for discussion)

This figure shows the average shoreline position along the main beach (i.e. Profiles A-E inclusive) relative to the 1942 shoreline – using data from Gibb (1998).³ It can be seen that the average shoreline position retreated significantly between 1942 and 1959 but by 1985 had recovered to a similar position to 1942 and by 1998 was seaward of the 1942 position.

An alternative approach to assessing long-term trends is shown in Figure 7.

- In 1942 the shoreline was in an accreted position (Figure 7) with a low frontal dune seaward of the higher bank behind (Figure 8). However, there is also clear evidence of an historic storm erosion scarp on the high bank behind the lower frontal dune (Figure 8).

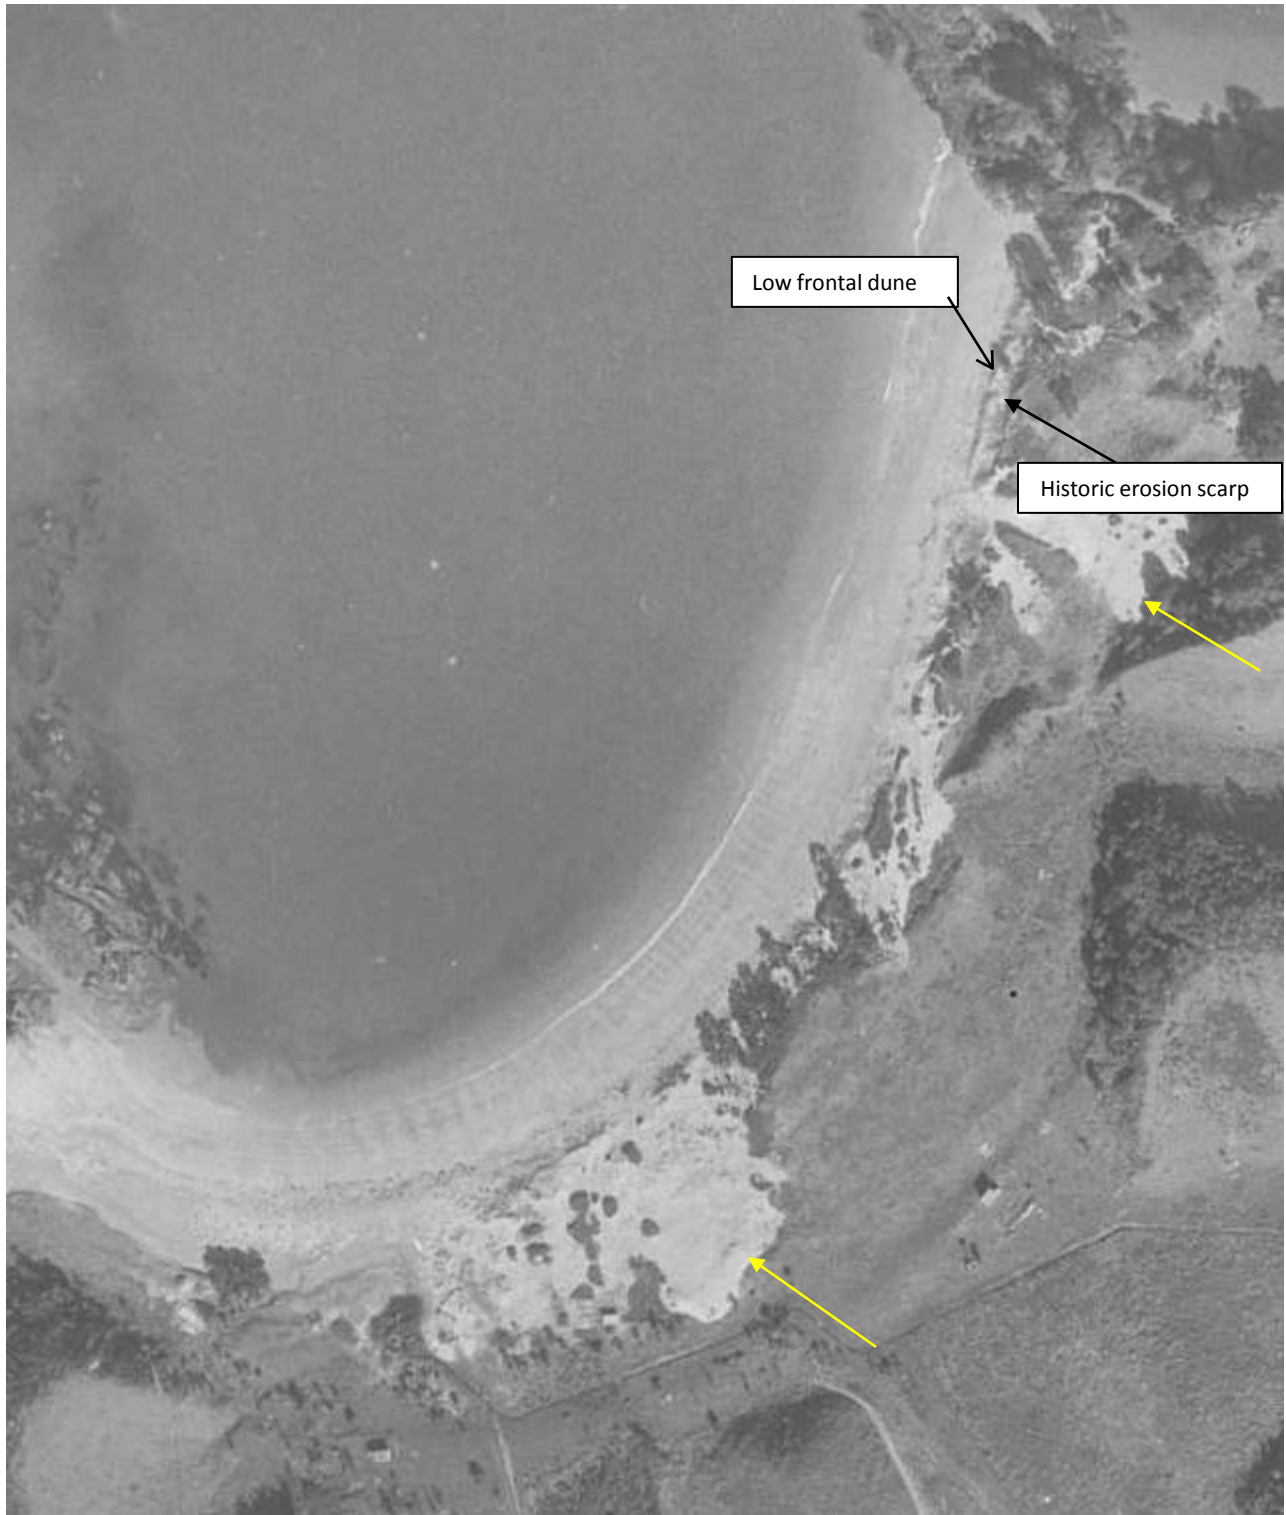
Figure 8: 1942 aerial photograph showing dune in accreted position. For instance, note the wide (8-10 m) dune seaward of the elevated land at the western end of the beach. The elevated area immediately landward of this dune also shows an erosion scarp (tip of black arrow) indicating previous periods of storm erosion similar to that shown in

The 1942 aerial photograph shows an historic erosion scarp landward of the (then) accreted shoreline (Figure 8), in very similar location to the erosion scarp evident after the 1978 erosion. The date of this earlier erosion is unknown. It may have occurred during the severe coastal storms of 1936 (two separate events - 1-2 February and 25-26 March, 1936) which caused severe coastal erosion at many east coast sites - but this is uncertain.

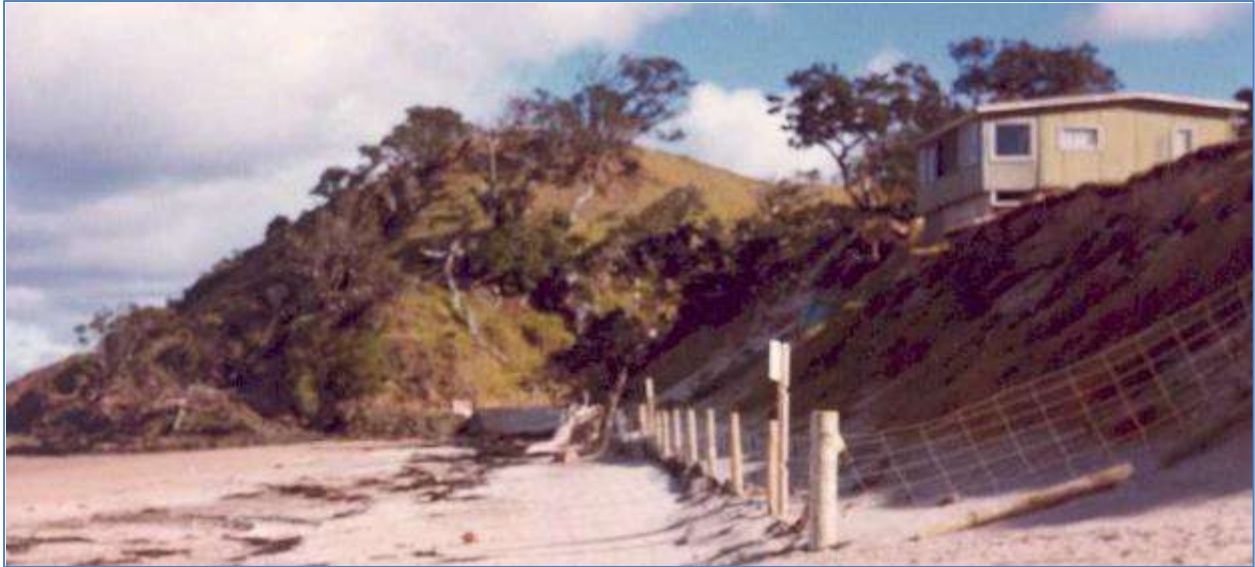
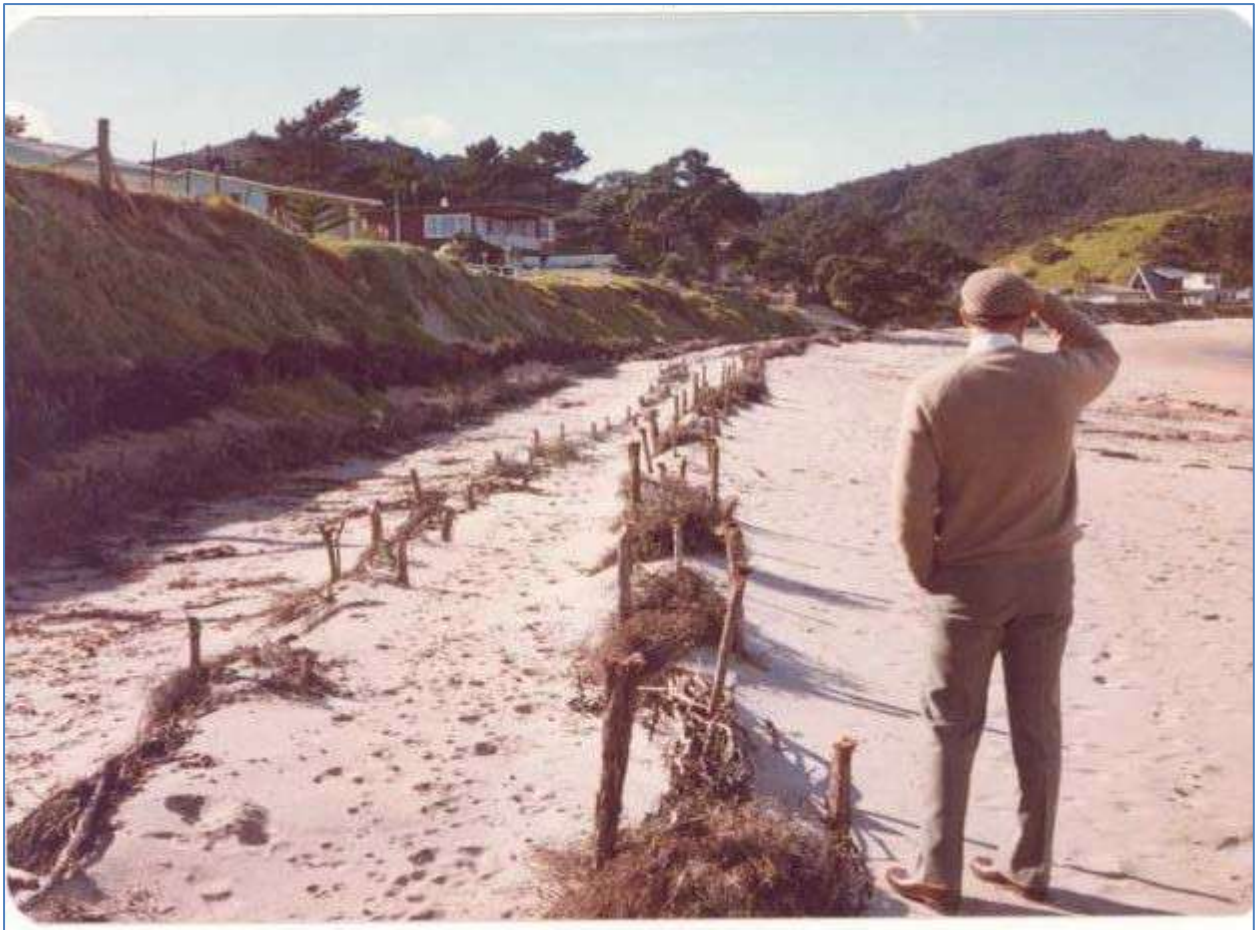
Figure 9: Severe dune erosion caused by storm of July 1978. The fencing (top photo), vegetation recovery on dune face (bottom photo) and the build-up around the brush dune fence (bottom photo) indicate the erosion occurred sometime before these photos were taken (Northland Regional Council photographs – believed to date from June 1979).

The most severe dune erosion evident in historic photographs is the erosion that occurred following the major storm of July 1978 (Figure 9). As noted earlier, this storm followed a prolonged period of negative IPO in which there was a reasonably high incidence of coastal storms and coastal erosion along the east coast of the North Island.

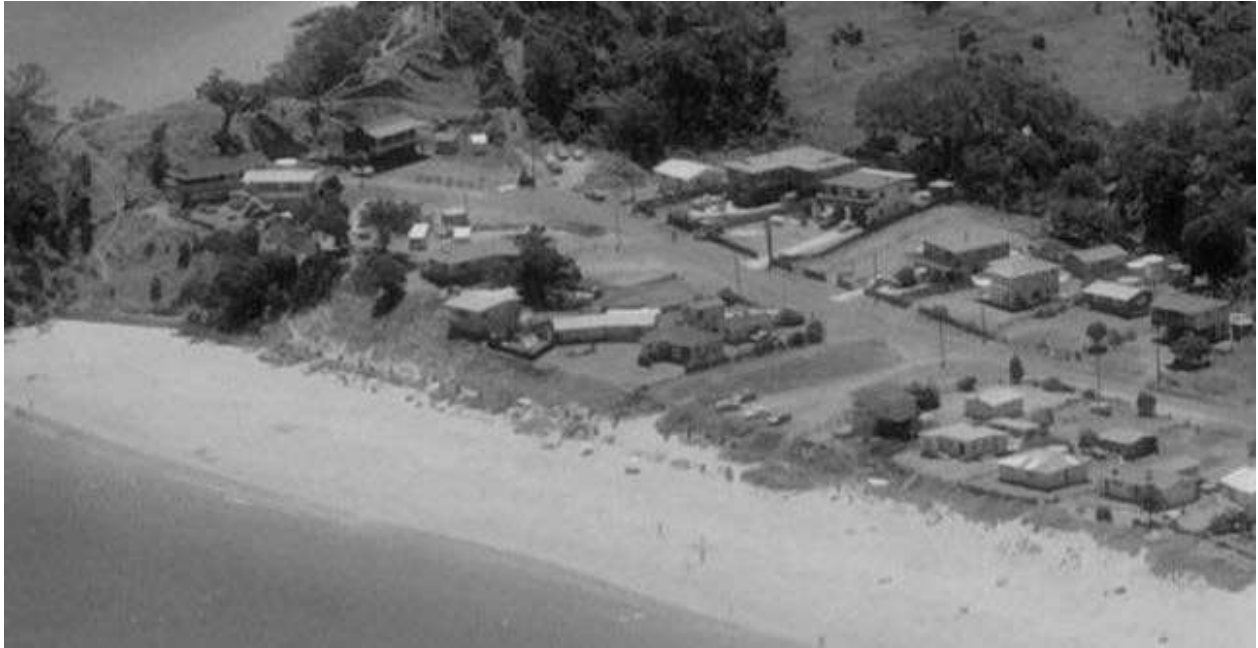
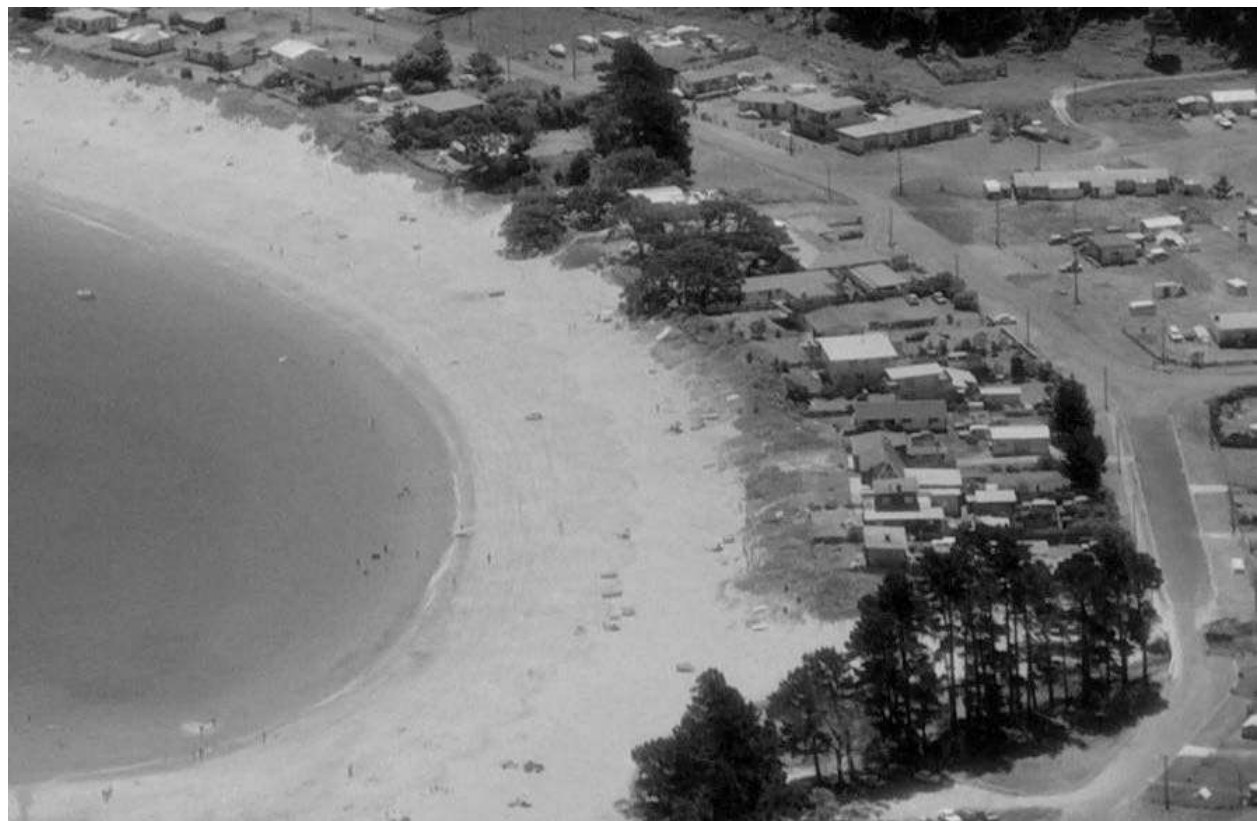
Figure 10: Aerial photographs from 7 January 1985 showing vegetated frontal dunes recovering from erosion in 1970's (Photo: Whites Aviation - WA78042F, Alexander Turnbull Library).

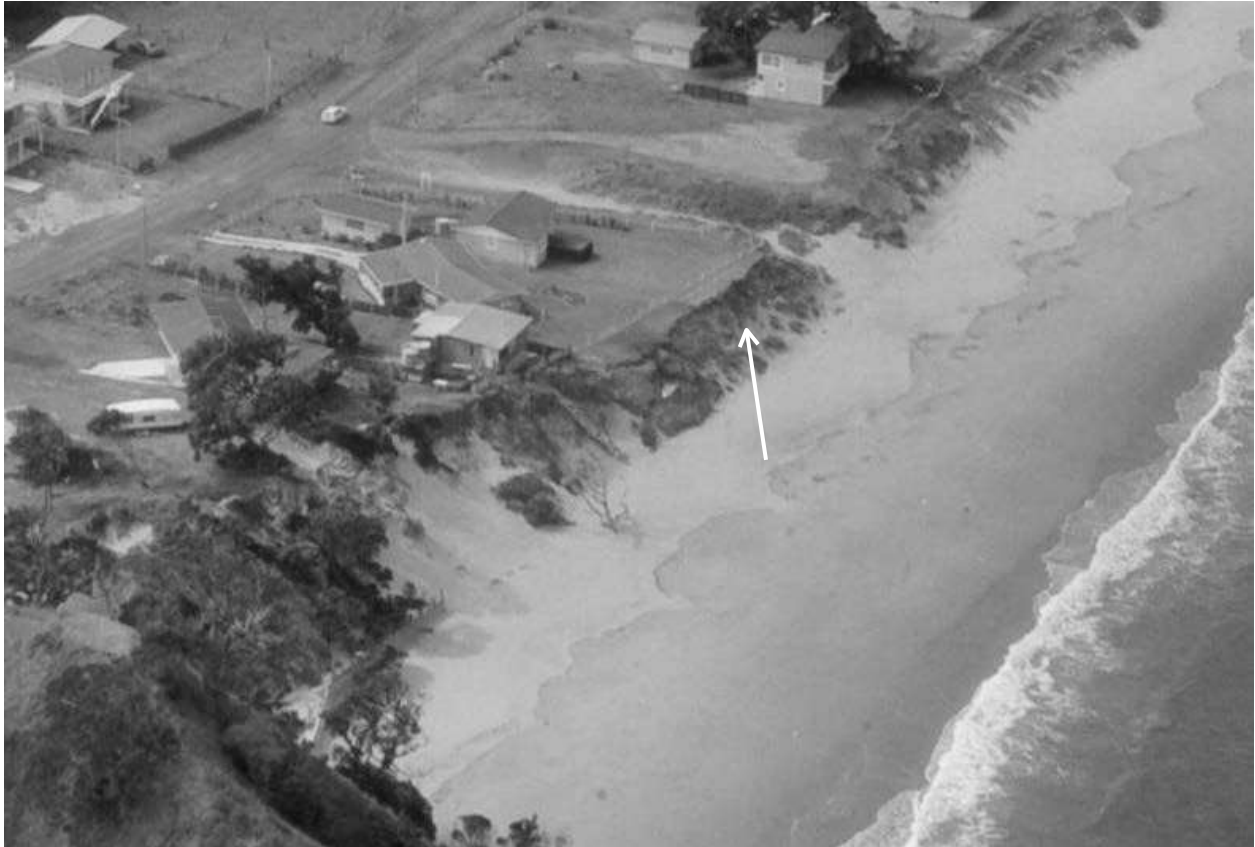
Figure 11: Photograph of south end of beach taken in April 1976. Note evidence of recent dune face erosion (arrowed). The subsequent July 1978 event extended erosion within some of the property boundaries in this area and also partly undermined the house nearest the bank (see Figure 9). The properties in the area of the arrow (14-18 Whangaumu Road) were levelled at or shortly after subdivision in the early 1960's, extending the flat grassed areas seaward over an earlier erosion scarp. So there were earlier erosion events that extended further landward than shown. The vegetated dune face (i.e. absence of recent erosion) at the extreme western end (bottom left of photo) reflects protection then provided by a wooden sea wall. (Whites Aviation photo WA72365F, Alexander Turnbull Library).

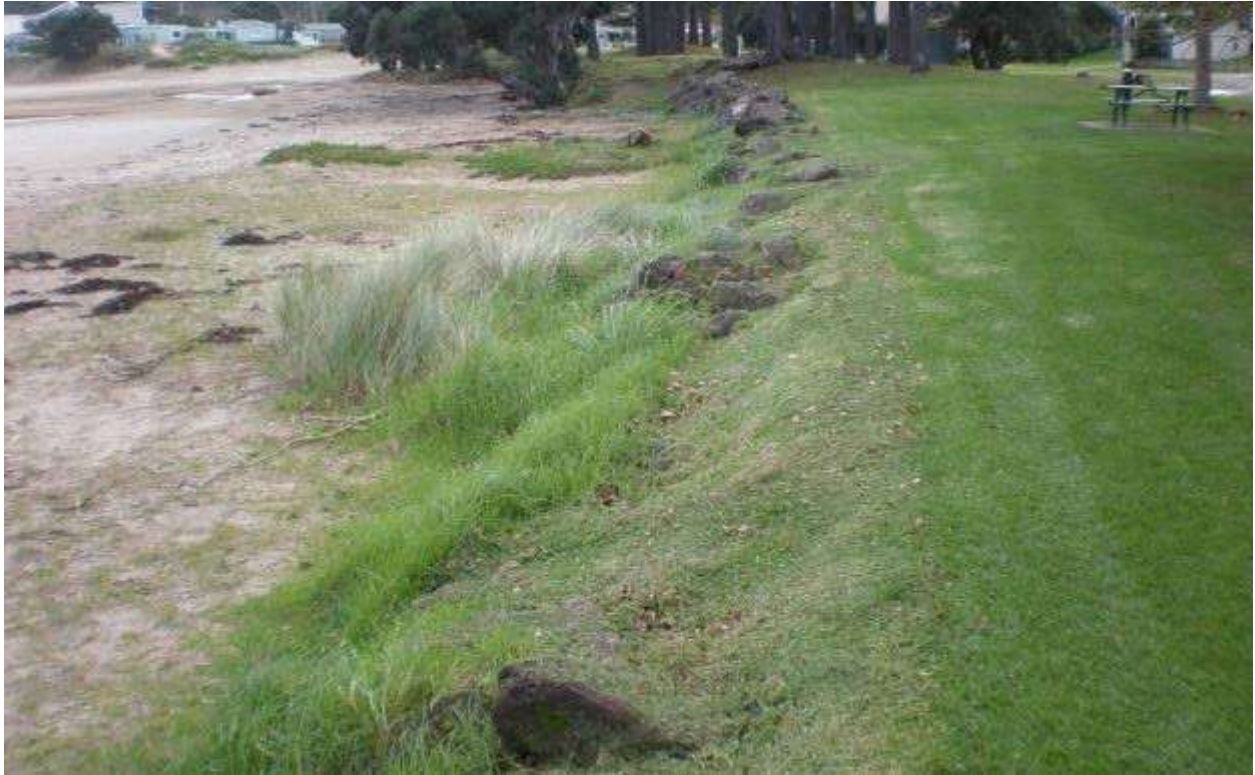
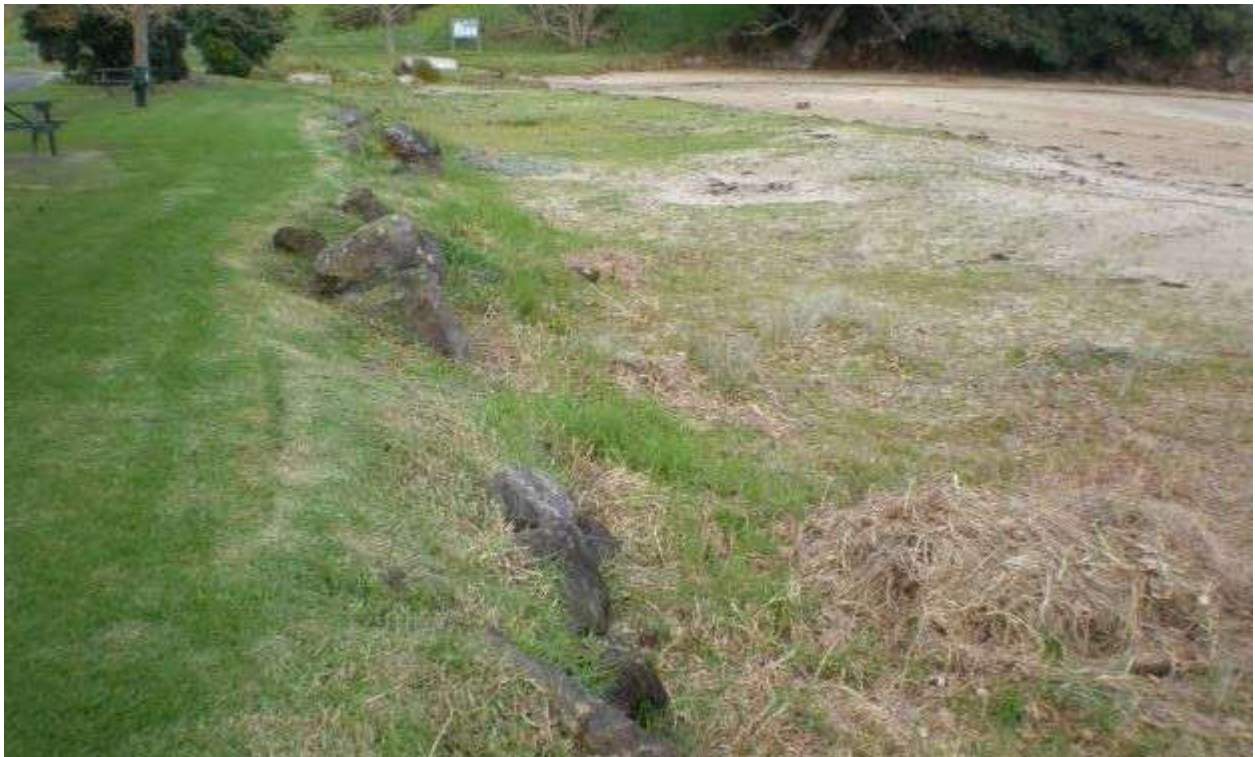
Figure 12: View of reserve frontage at eastern end of the beach showing rock protection placed to limit landward extent of stream and storm erosion. Note the low dune seaward of the rock wall.

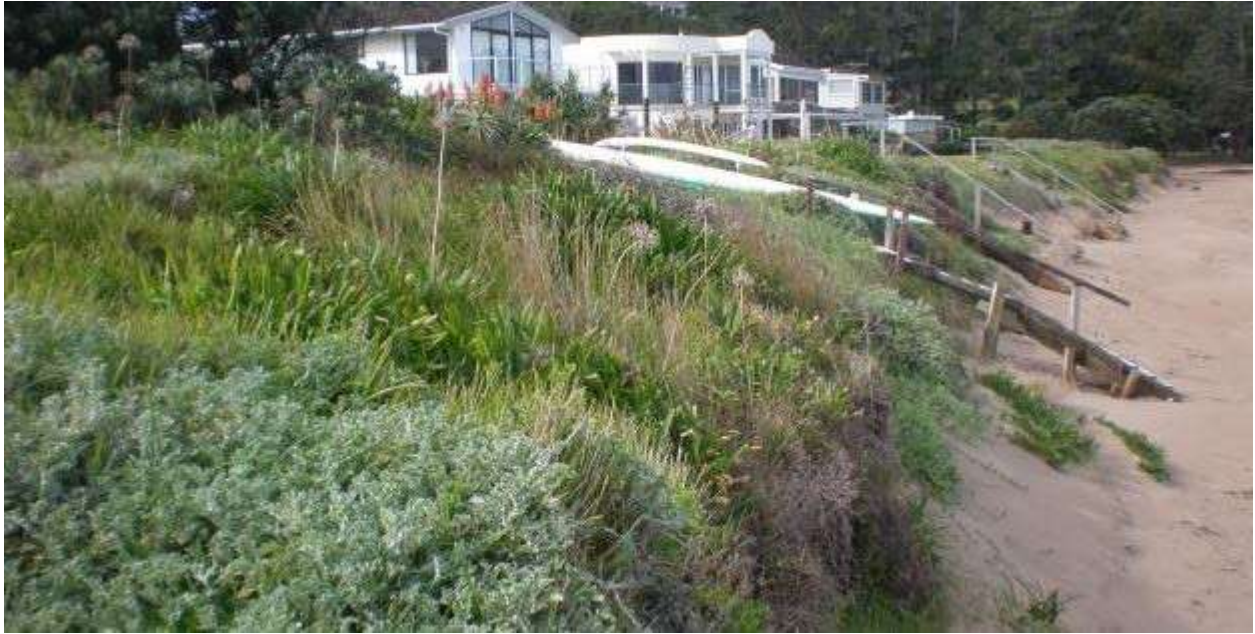
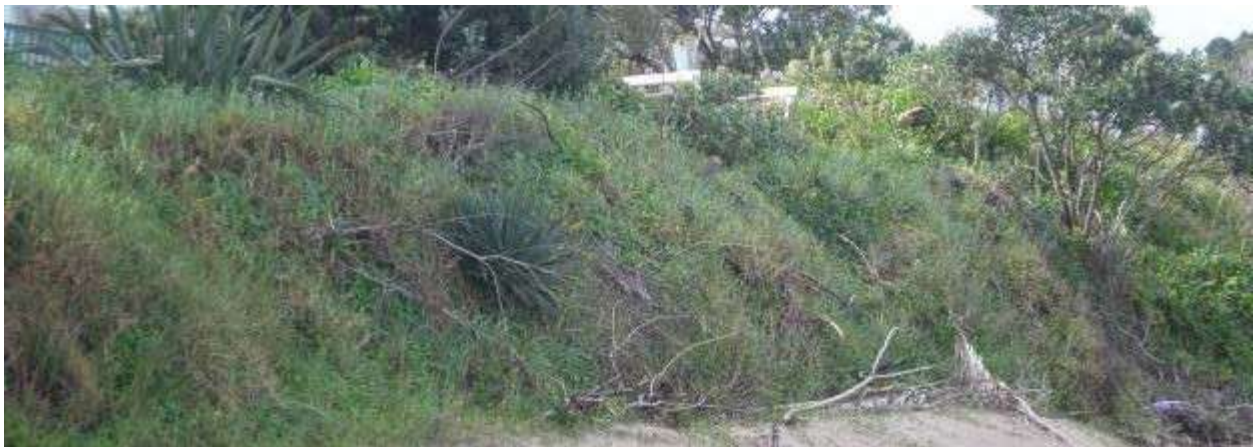
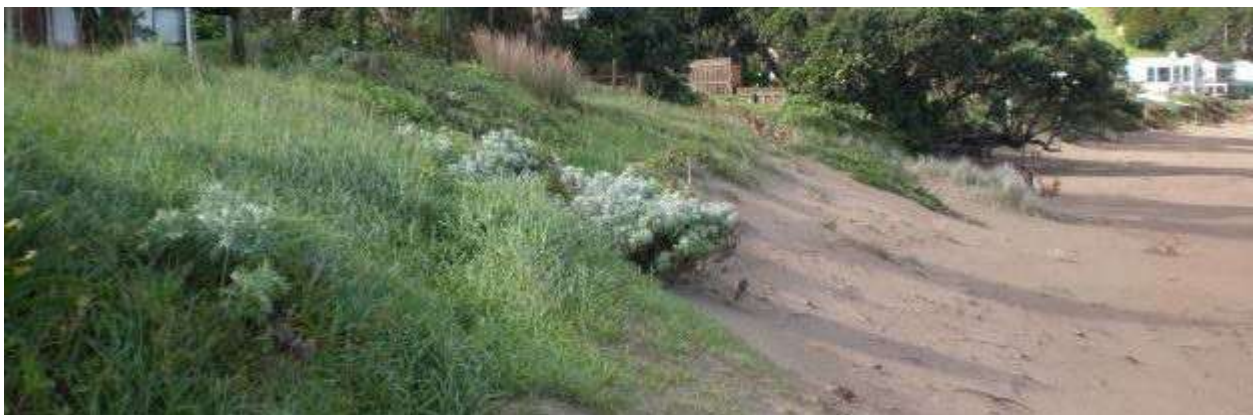
Figure 14: Views of dunes in eastern and central areas of the beach showing dominance of exotic vegetation including exotic perennial grasses and a wide range of garden plants and garden escapees (e.g. succulents, agapanthus, arctotis, and South African ice plant).

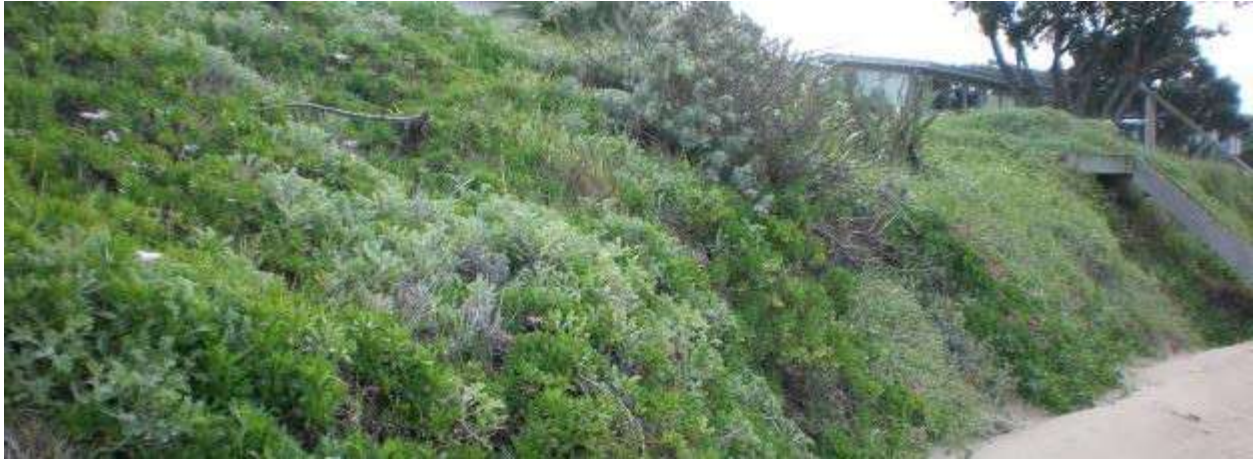
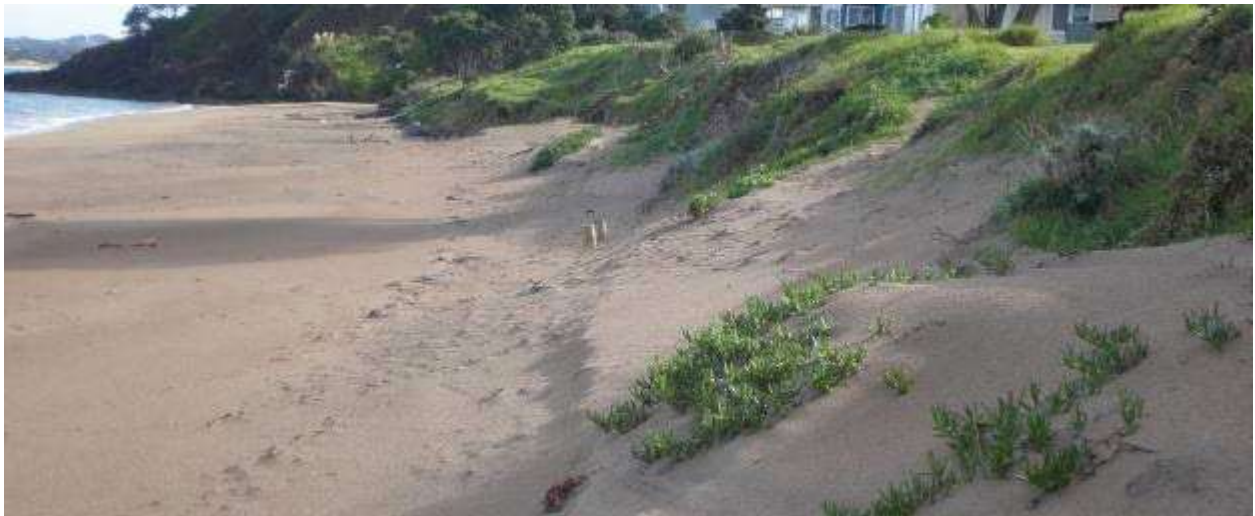
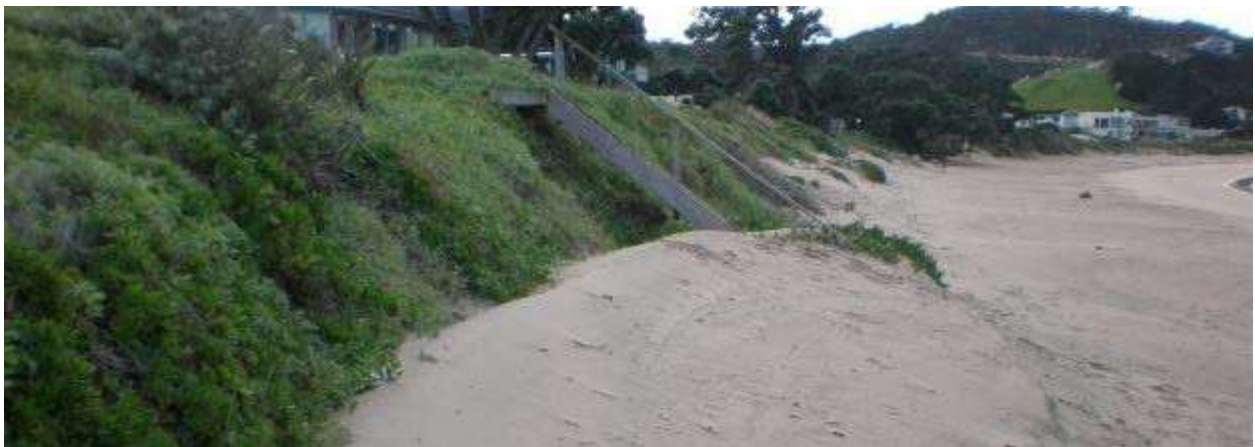
Figure 15: Various views of dunes towards western end of beach immediately east of seawall. As with other areas of the beach, the dune face is totally dominated by exotic species that are largely ineffective in natural dune repair. Note sand piled against base of dune by wind (bottom photo) indicating potential for active dune building and repair with more effective native trapping vegetation such as spinifex and pingao.

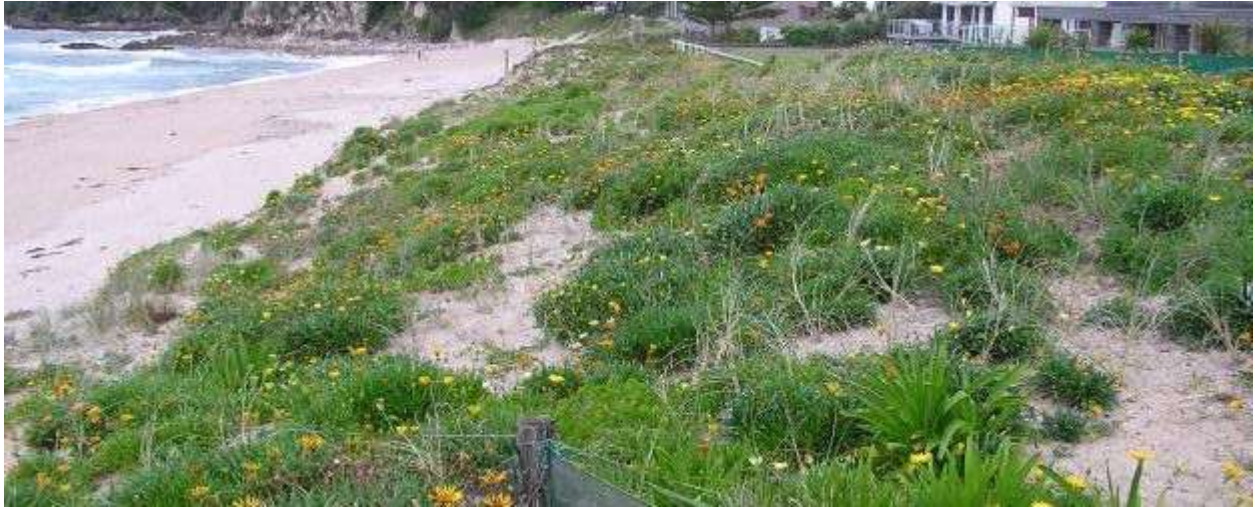
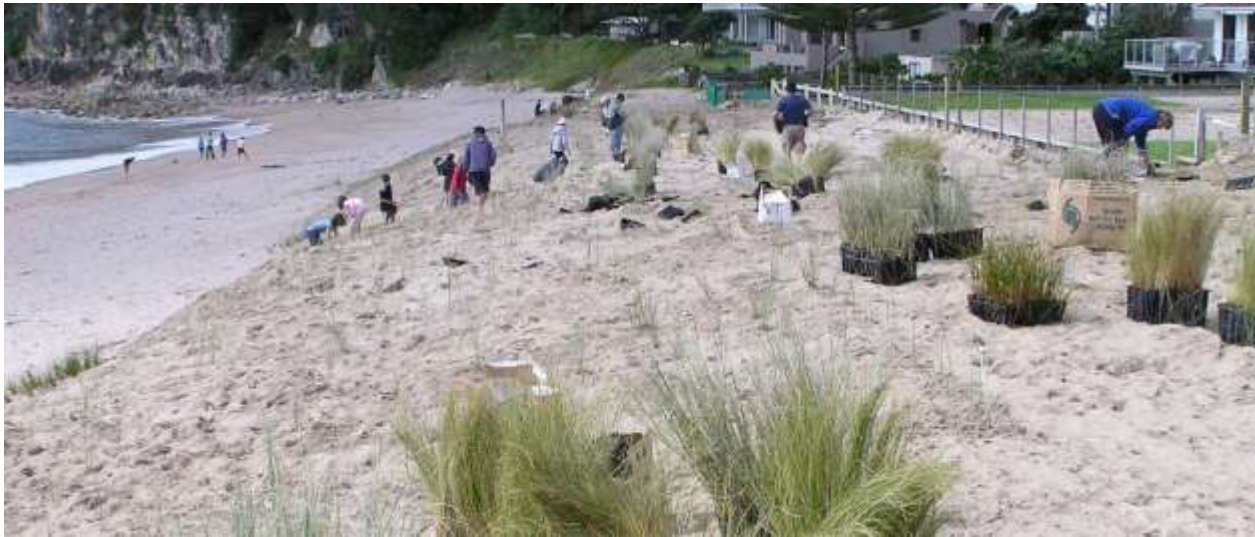
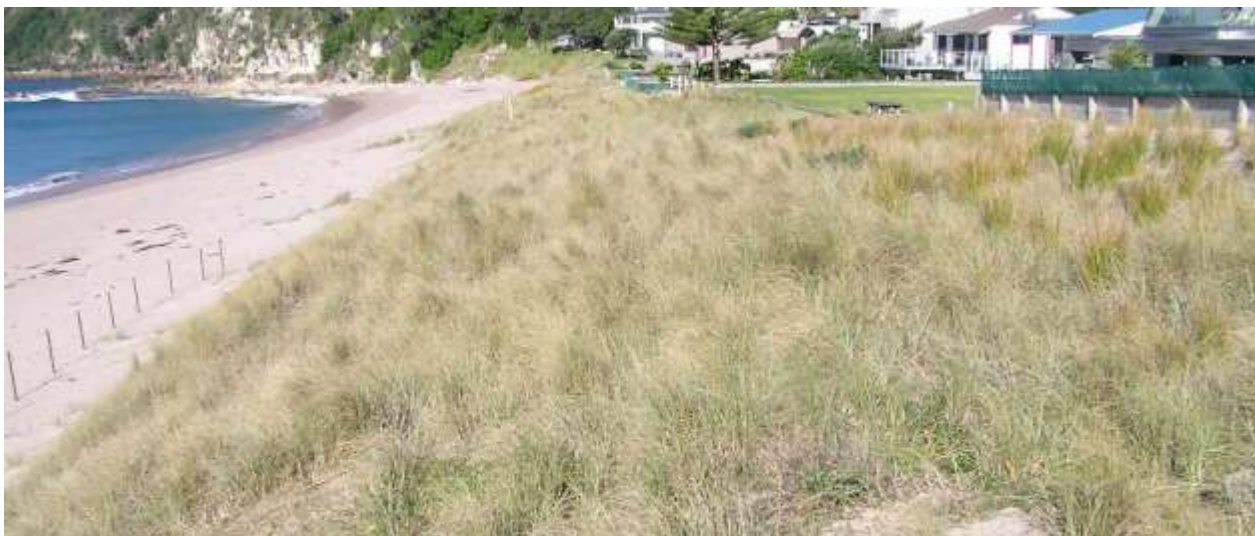
Figure 16: Dune restoration at Tairua Ocean Beach, eastern Coromandel showing exotic dominated dune (top photo), planting of natives following clearance (mid photo) and restored 1 year later (bottom photo).

Examples of similar dune restoration work elsewhere using the above approach are shown in Figure 16 to 18. It is important that the work is undertaken using a community-based approach (such as the NRC Coastcare programme) to encourage community ownership and learning.

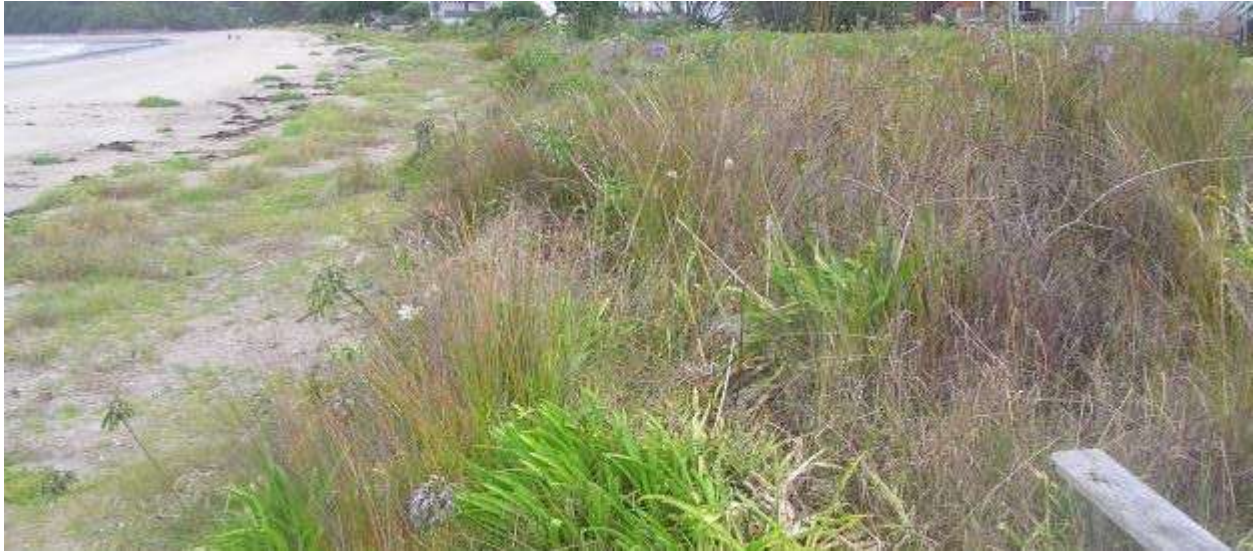
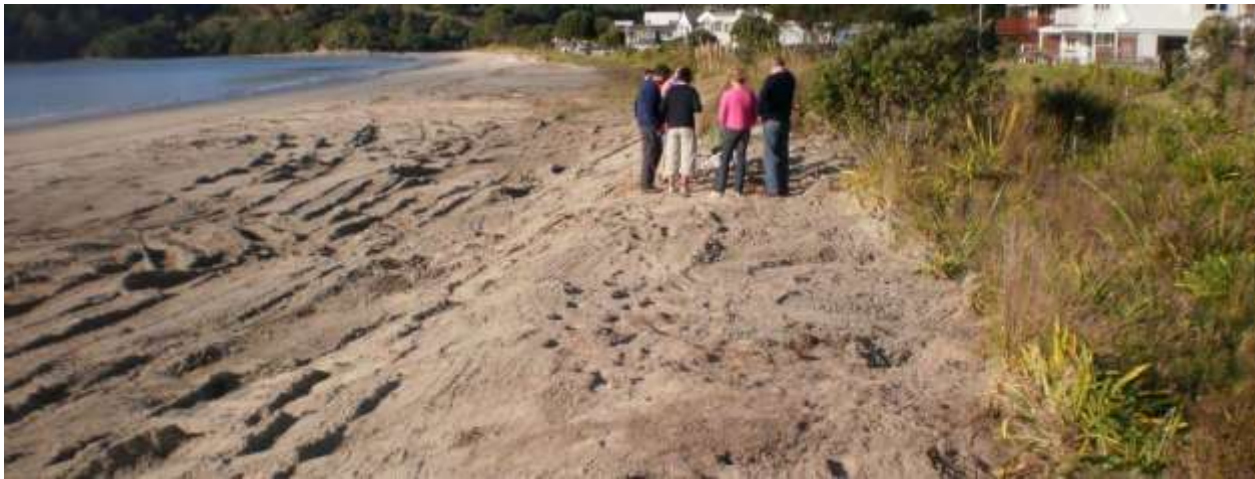
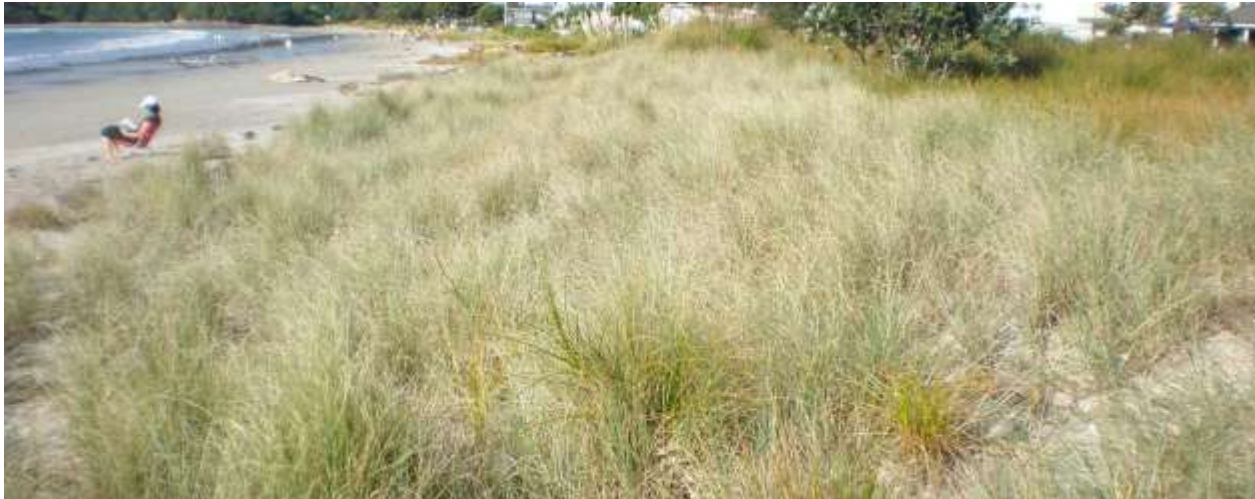
Figure 17: Restoration at Cooks Beach showing exotic dominated dune before (top), following excavation and prior to planting (middle) and restored dune (bottom).
