Whangaumu Bay

Coastal Erosion Hazard and Management Recommendations

Prepared for: Northland Regional Council

Prepared by: J Dahm, Eco Nomos Ltd

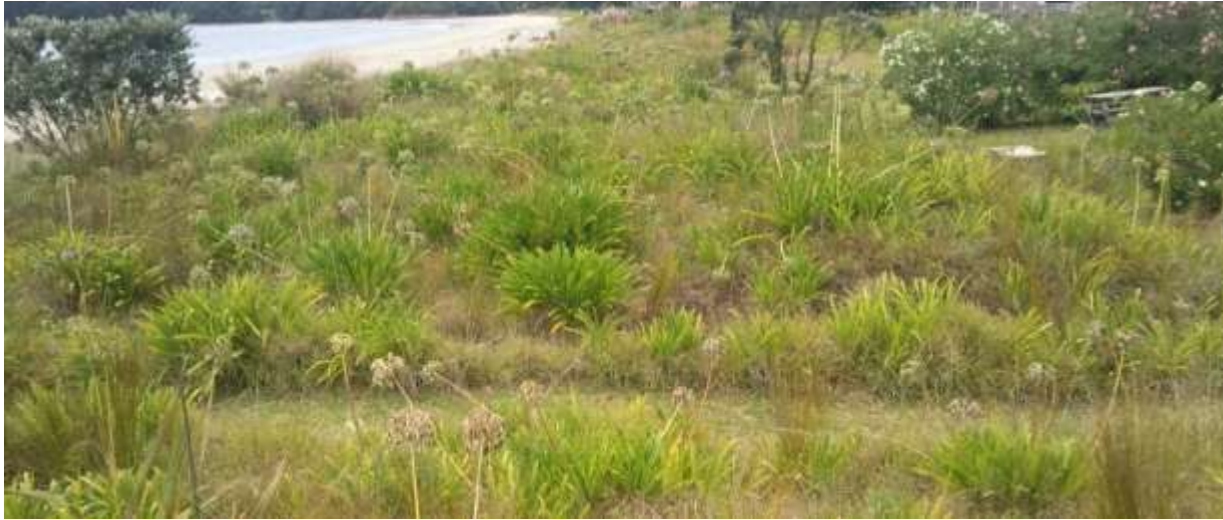
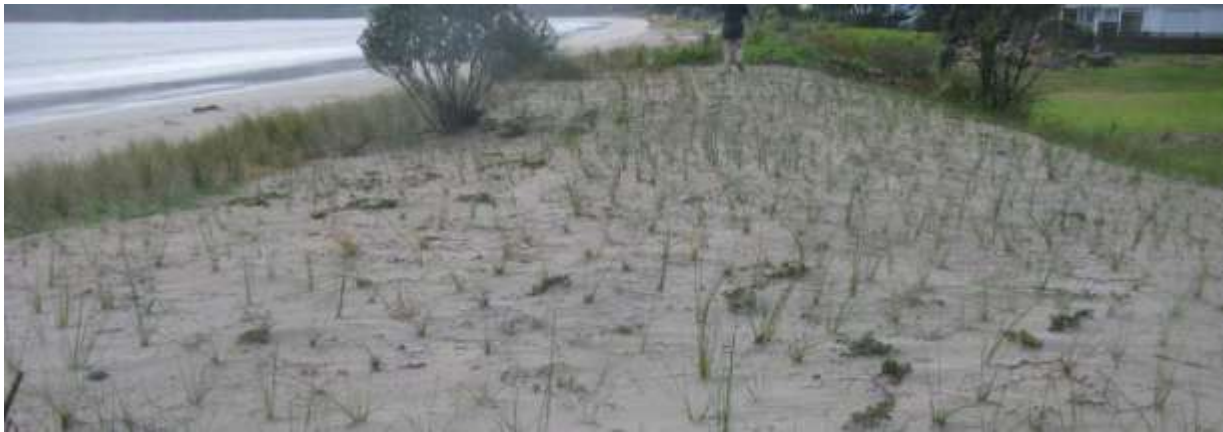
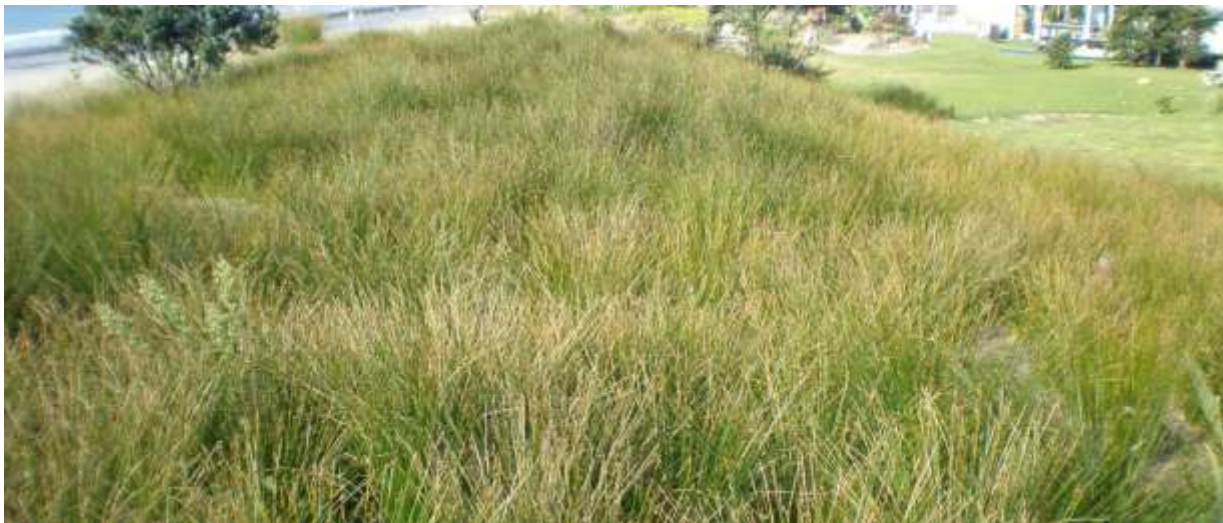
Figure 18: Restoration of Cooks Beach backdune - showing dune dominated by exotics (top), following excavation and planting (middle) and restore dune 1 year after planting (bottom).

Examples of similar dune restoration work elsewhere using the above approach are shown in Figure 16 to 18. It is important that the work is undertaken using a community-based approach (such as the NRC Coastcare programme) to encourage community ownership and learning.

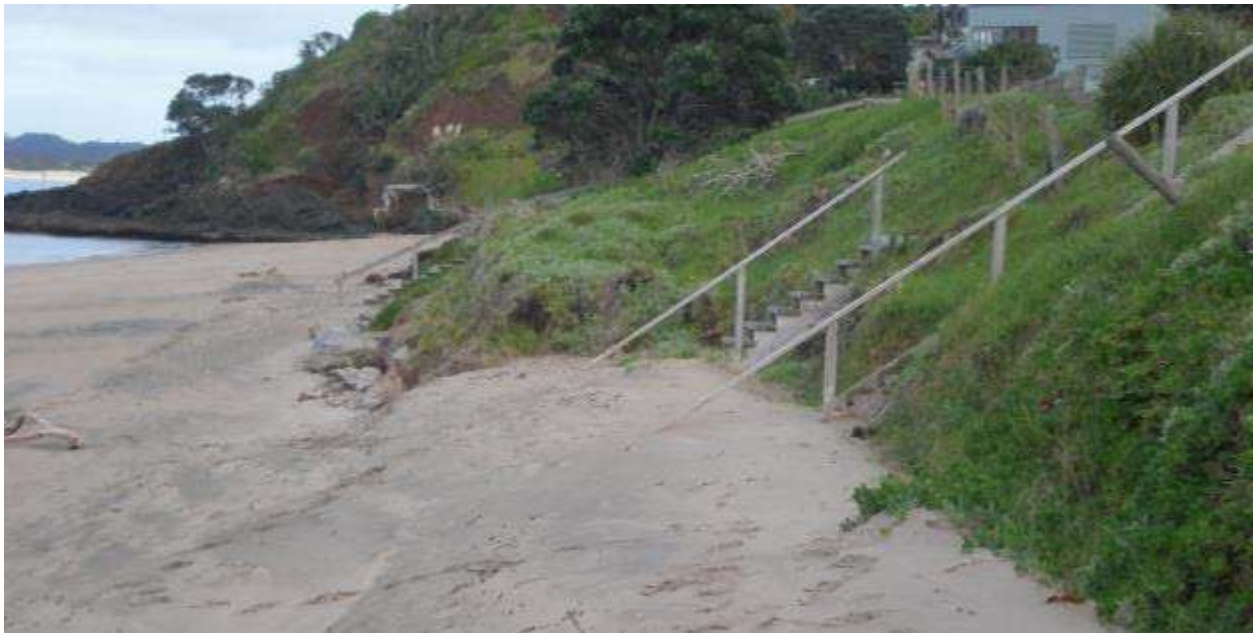
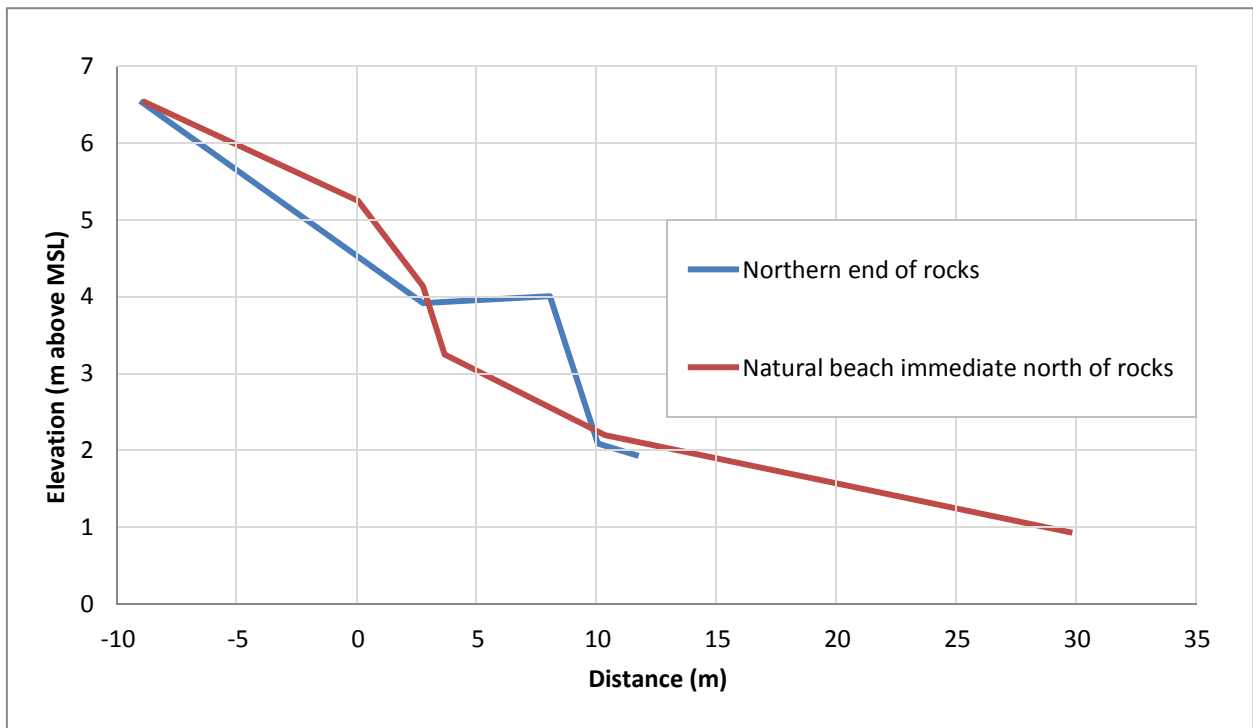
Figure 19: View of sea wall at western end of beach (top) looking westwards alongshore from adjacent unprotected shoreline. Note how rock wall extends seaward of the natural duneline. The bottom graph shows cross sections surveyed in the same area showing profile over the rocks compared to the natural shoreline.

There is some geomorphic evidence of this effect in unprotected areas immediately adjacent to the seawall at the western end of the beach. For instance, at the time of the beach surveys in May 2012, the beach width between high tide and the toe of the dune was typically 3-4 m wider than in other unprotected areas further east. This is a concern as the width of the dune seaward of adjacent private properties is relatively narrow in this area - aggravated erosion could generate pressure to extend the sea wall further eastwards. However, there are practical solutions for this issue as discussed in Section 4.3.3 below.
