# ADDENDUM 1: REVIEW OF COASTAL HAZARD MAPPING - WHAANGA COAST, RAGLAN SOUTH

This addendum describes additional coastal hazard mapping undertaken to further refine the coastal hazard mapping areas described in Focus (2020).

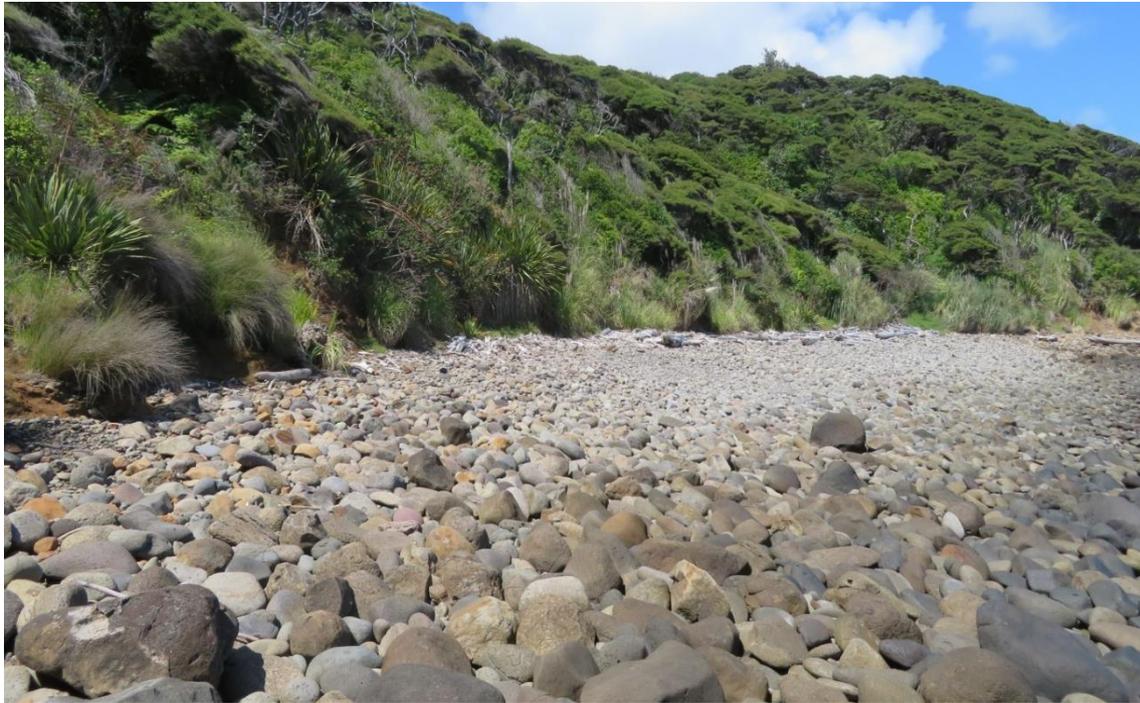
*Figure 2: View of boulder beach and heavily vegetated slopes typical around Whale Bay.*

The Whaanga Coast is predominantly a rocky shoreline constructed of hard volcanic substrates (Karioi volcanic formation), which are resistant to coastal erosion. Exposed rock shore platforms and sloping boulder beaches are backed by dense established vegetation in most areas of Whale Bay (e.g. Figure 2 & Figure 3) and Manu Bay (Figure 4 & Figure 5). There is little evidence of active erosion, except in exposed areas west of Whale Bay where bare, steep rocky cliffs occur (Figure 6).

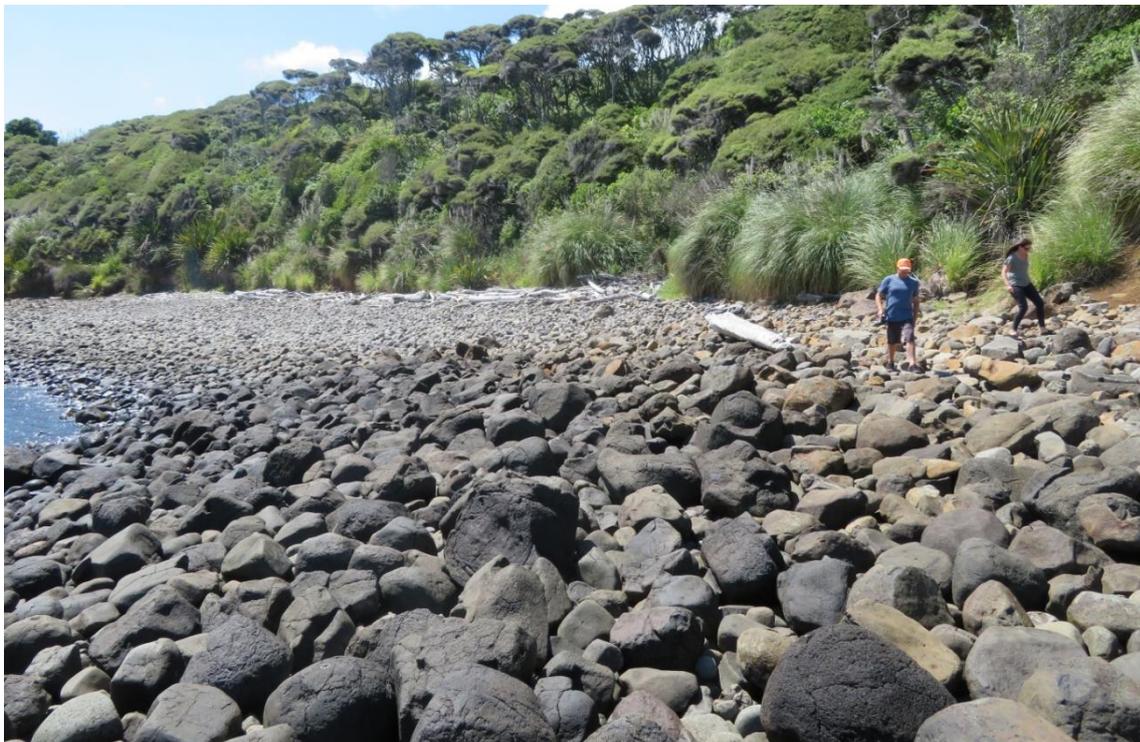
*Figure 3: Typical view of boulder beaches backed by steep vegetated slopes west of Whale Bay*

Much of the Whaanga Coast is backed by steep vegetated slopes (Figure 3 and Figure 5). Existing coastal cliff slope angles vary from near vertical exposed cliffs west of Whale Bay to the vegetated slopes (1:1 to 1:1.5) between Whale and Manu Bays. In most areas these cliffs are fronted by wide boulder beaches and/or hard volcanic rock outcrops and platforms/reefs (Figure 3 & Figure 4).

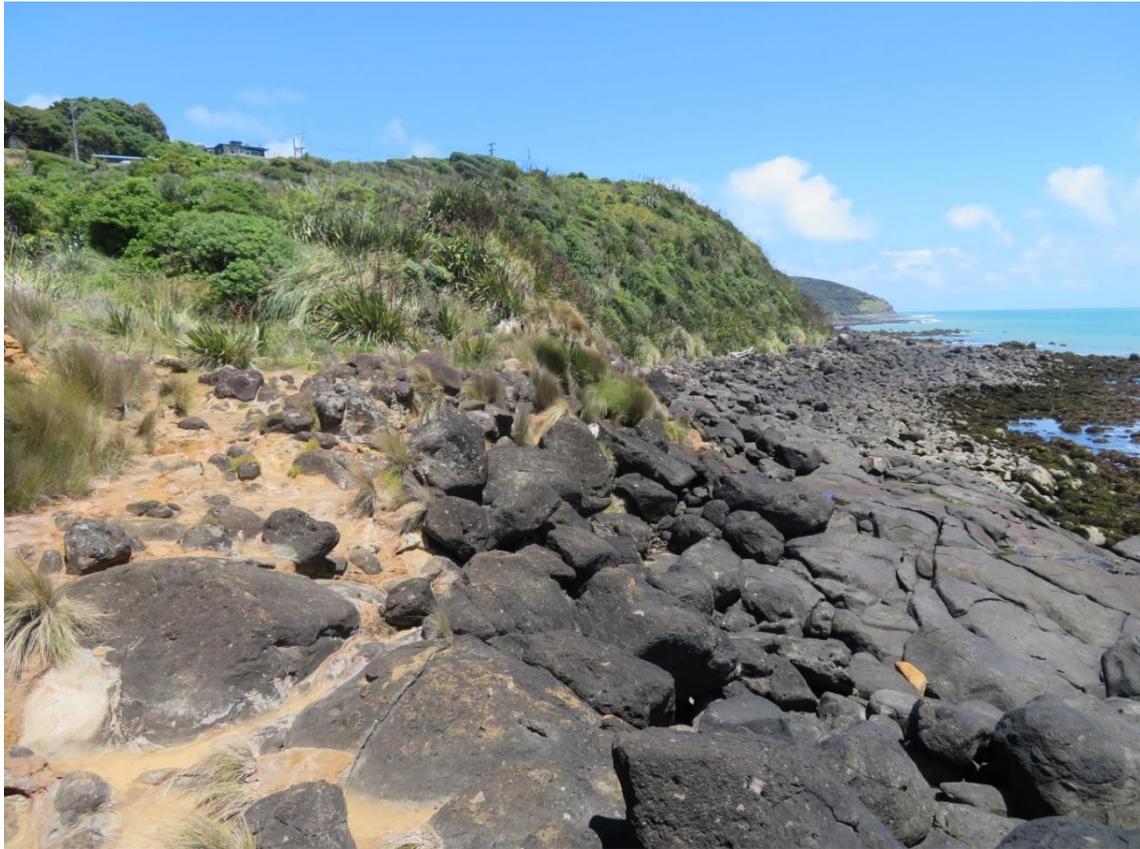
*Figure 4: Rocky shore platform at Manu Bay.*

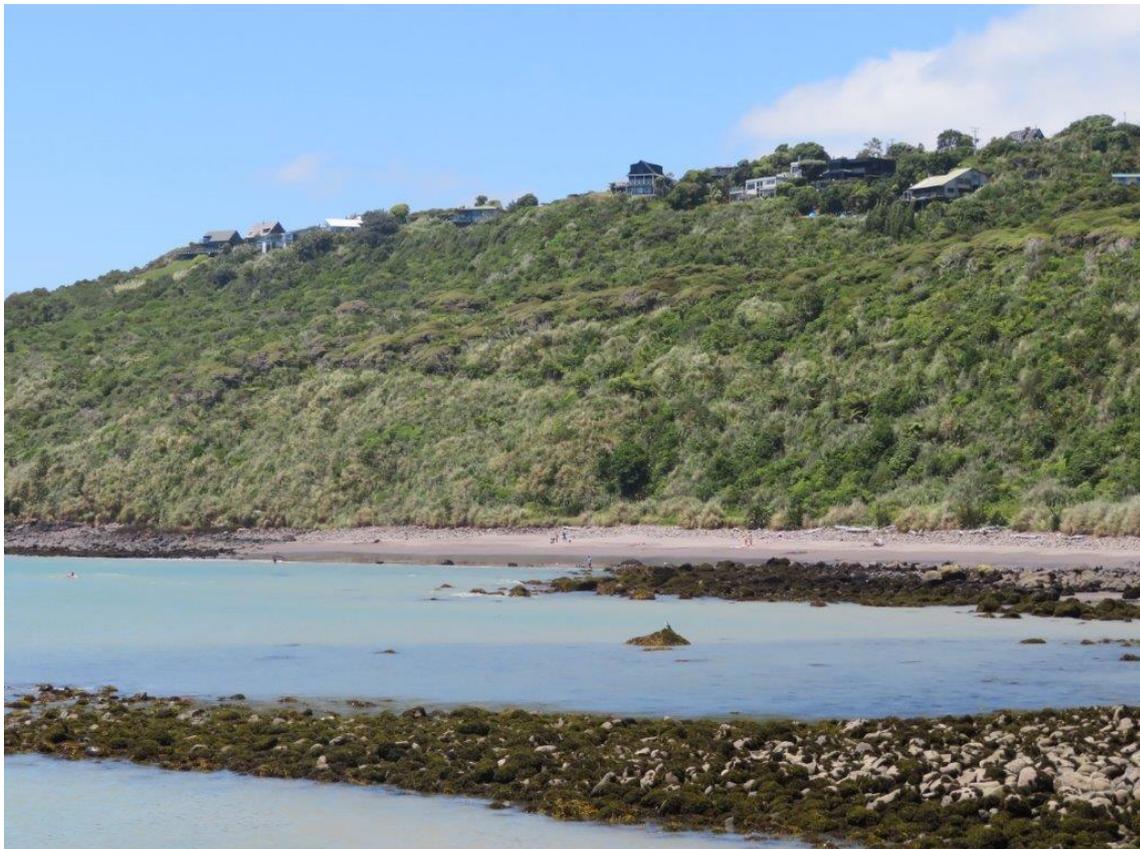
*Figure 5: Mixture of sand beach and rocky shore platforms backed by steep heavily vegetated slopes at Manu Bay.*

Lower terraces or slopes exist near Whale Bay and Manu Bay, fronted mostly by boulder beaches and rock platforms (Figure 9). Isolated sand beaches exist at Manu Bay (Figure 5) and in the lagoon at Whale Bay. There are no active sand dune systems evident in the study area. Where sand or boulder beaches are present, we have made allowance for some landward and upward migration of the beach slope in response to sea level and a stable slope (e.g. Figure 10).

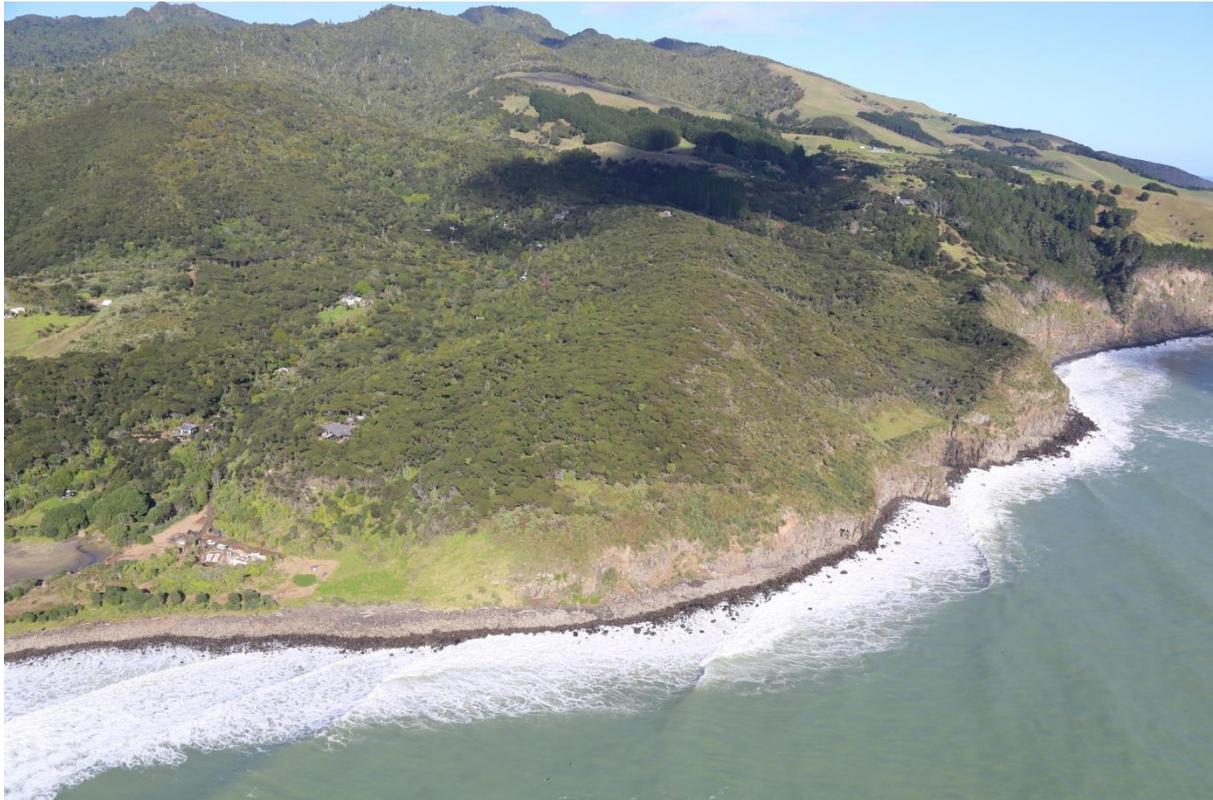
*Figure 6: View of exposed coast west and south of Whale Bay showing hard, steeply cliffed shoreline*

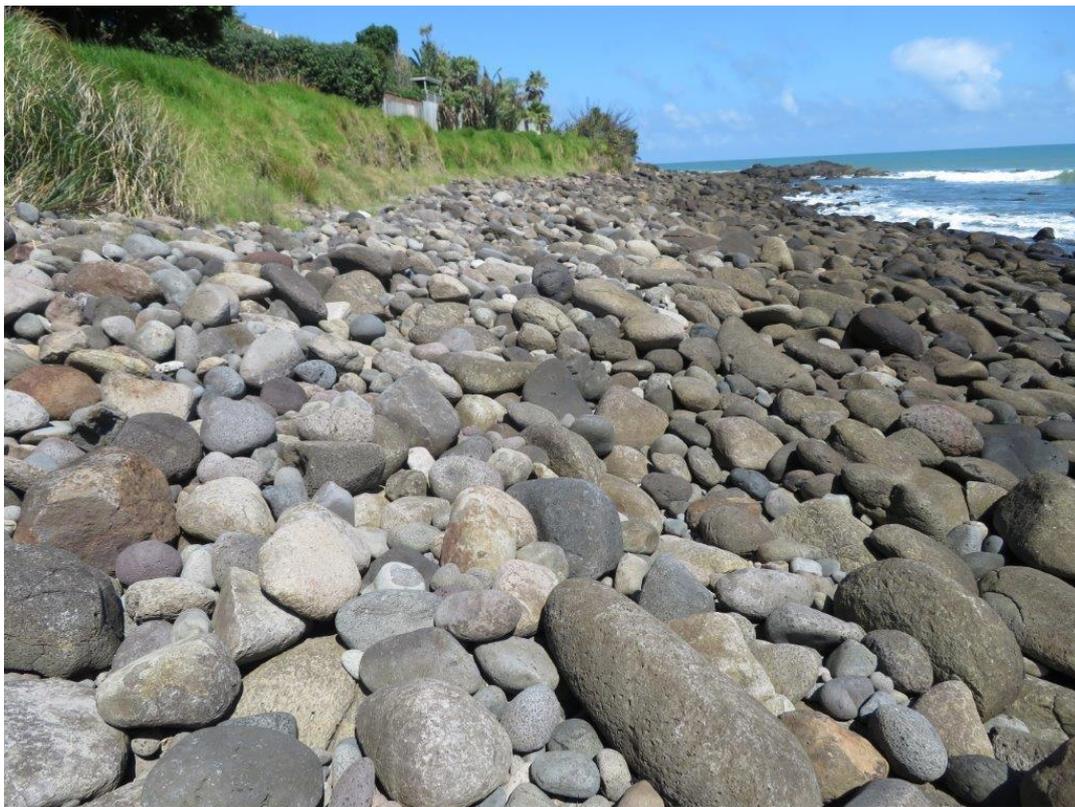
*Figure 9: Boulder beach at Whale Bay.*

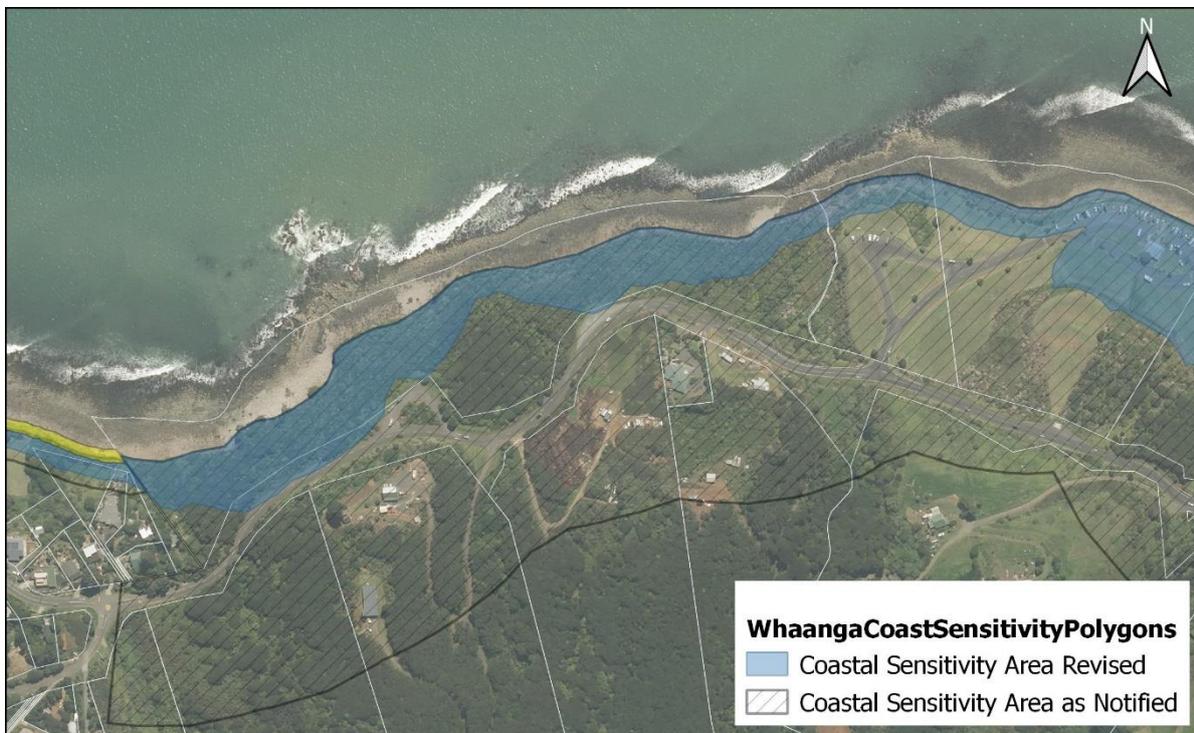
Figure 13: Revised coastal sensitivity area between Whale Bay and Manu Bay. The previous 200 m sensitivity area from the draft District Plan is also shown.
