## A Big Wave at Pouto, Kaipara Harbour, New Zealand

### INTRODUCTION

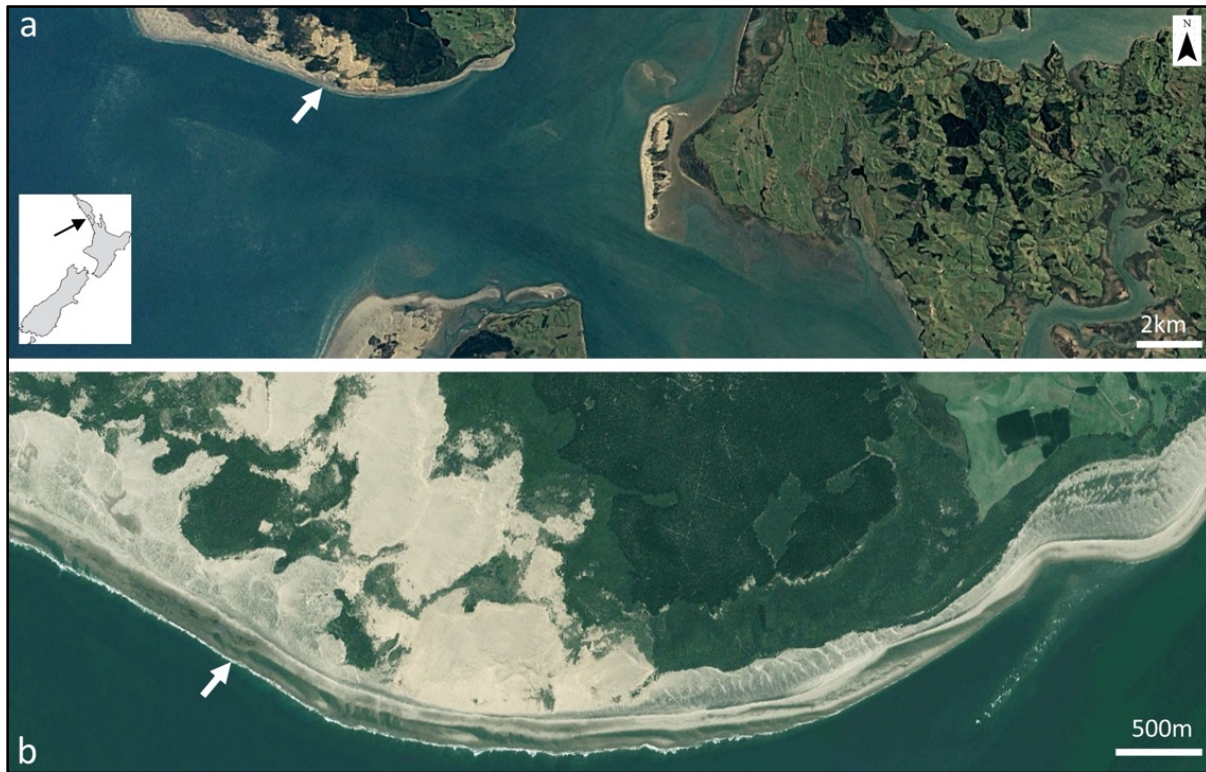
**Figure 1.** (a) The Kaipara tidal inlet showing the study site location (white arrow). (Source: ©Google Earth 2020, Landsat/Copernicus; Image: 2013.) (b) Pouto shoreline showing the study site location. (Source: ©Google Earth 2020, Maxar Technologies and CNES/Airbus; Image: 2012.)

For most of the time fieldwork is enjoyable. Occasionally it is uncomfortable, sometimes frustrating. Rarely, it can be terrifying. One such occasion was during an overnight experiment being undertaken on the northern tidal inlet shore of the Kaipara Harbour, North Island, New Zealand (Figure 1). The Kaipara Harbour entrance has a massive ebb tidal delta, creating treacherous conditions for boats trying to cross it. At the time I was an academic at the Geography Department at the University of Auckland and the research, involving quantifying sediment transport along the tidal inlet shoreline, was a part of the *Kaipara Sand Study* (Hume *et al.*, 2003) sponsored by sand extraction companies and administered by the Auckland Regional Council. This part of the study was undertaken by Philip Osborne and me, with technical support from Shane Thomson and David Jenkinson. On 12 February 2001, sensors (ADV, pressure sensors, OBSs) were deployed across the intertidal profile. The seaward-most instrument was an InterOcean S4A current meter (sampling at 2Hz) deployed at about low tide level. With the exception of the S4A, sensors were hardwired to computers and power supplies housed in a trailer located well landward of the swash line and high-tide berm, in a backshore area with small incipient dunes (Figure 1).

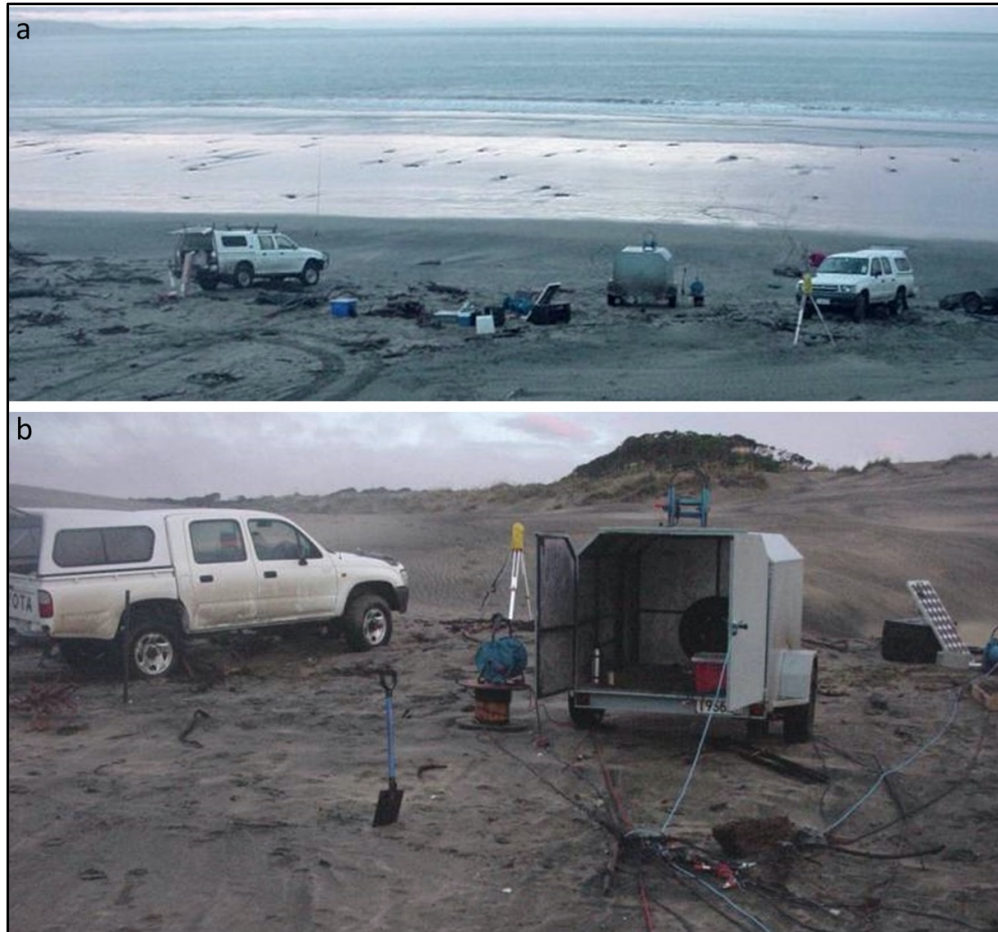
**Figure 3.** Cleaning up, the morning after the big wave. (a) The view of the field site along the profile line. (b) The trailer that had housed computers, power supplies, a desk and chair, and miscellaneous other items. Note the tangle of cables. (Photos: K.E. Parnell.)

The wave broke into the trailer, pushing it landward by about 10-15 m. I recall seeing Shane Thomson's head just above water level in the trailer before the lights went out. The receding wave dragged out almost all the contents of the trailer. There was no similar wave that night. After establishing that we were safe (albeit wet and cold), my biggest concern was that we were due to be replaced by Phil Osborne and David Jenkinson (who had been sleeping at our accommodation in Pouto village) at about 0300h. Reaching the site by AWD (quad) bike required passing a high consolidated dune with a very steep eroded face and very narrow dry beach. If a similar wave were to hit as they passed that location, the result would likely to have been disastrous. There was no mobile phone coverage so they were not able to be contacted. Fortunately, they arrived safely to help with the clean-up once it got light, by which time significant wave height was about 0.6 m (Figures 2a and 3a).

There is substantial evidence that the big wave was highly unusual for that night. It was the only wave to cross the berm/incipient dune field to reach the dune face. The wave eroded the shoreline and caused sand dunes to slump. To the west of the profile, there was 1-2 m of dune slumping along the shoreline. This dune was seen to be intact not long before the wave and was observed again as soon as we had secured the site after the damage had occurred. To the east, along a section of high and old consolidated dune, there was considerable slumping at the base. Slumping occurred during the night, but cannot be attributed solely to the single wave as it was not observed over this period. Near Pouto village, approximately 6 km to the east of the field site, a low-lying dune flat was inundated, which had been dry for many days previously. Overnight, large amounts of beach debris shifted, including some large logs.
