NERMN beach profile monitoring 2011

Prepared by Shane Iremonger, Environmental Scientist

Bay of Plenty Regional Council Environmental Publication 2011/14

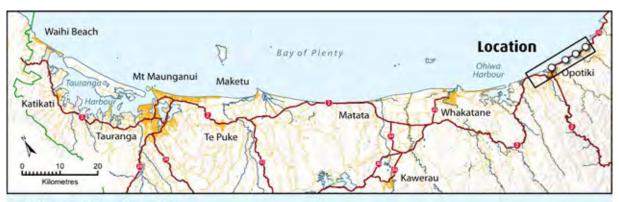
Hikuwai Beach section

This section of sandy beach coastline extends for 13.6 kms and has a morphodynamic type of "rhythmic bar and beach". The morphology of this section of coastline from the Waioeka River entrance to Opape has been the subject of a number of recent reports (Eco Nomos, 2007; Dahm, 2010; Iremonger, 2011). Detailed shoreline assessment was also undertaken by Gibb (1994). This coastline is thought to experience net alongshore sediment transport to the west toward Waioeka River entrance, though any net westward littoral drift is generally assumed to be relatively low (Gibb, 1994). Net drift may even be oscillatory, varying over time betwen easterly and westerly.

The 21 years of NERMN record for this eastern group of sandy beach profiling sites shows a dominance of erosion patterns being exhibited (Figure 2). The eastern most site at Opape shows signs of stability, possibly a reflection of its proximity to the headland at the eastern end of the beach, a localised eddy effect in the longshore drift (as a result of the headland) could cause sediment supplied by the Opape Stream to remain in the vicinity.

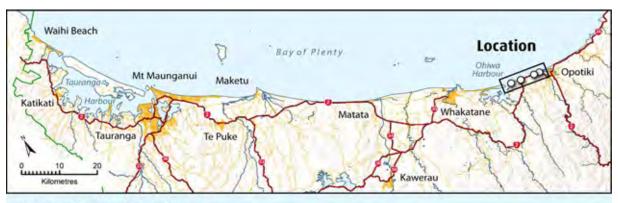
Waiotahi Beach section

The four profile sites that cover this 9.5km section of sandy "longshore bar and trough" beach are bounded in the east by the Waioeka River entrance and in the west by the highly dynamic Ohiwa Harbour entrance. This area can be further divided into two groups due to the presence of the Waiotahi River entrance midway along this section. Like the previous section, this area has also received a fair amount of attention with the development of the Waiotahi Drifts subdivision (Gibb, 1998) and the more recent residential development on one of the beach front sections at Ohiwa Spit. (Gibb, 2006).

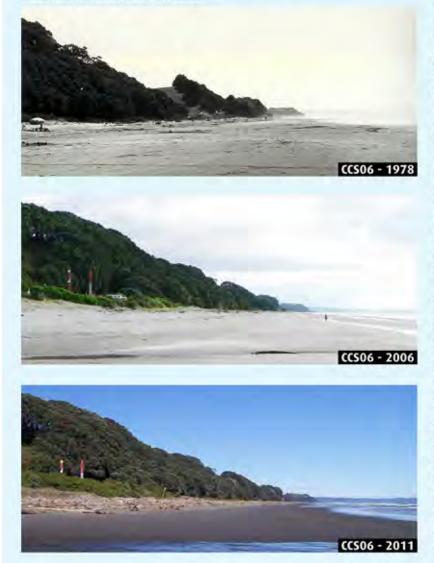
The profile at CCS05 which is within 600m of the Waioeka River entrance is still categorised as being in an erosion state for the collected record, although recent toe of foredune data shows a seaward progression when compared with positions measured in the early to mid 2000's.

Stability and acretion are the pattern for the three more eastern profile sites, with a strong patern for those sites east of the Waiotahi River entrance. Both CCS07 and CCS08 have exhibited strong seaward growth of the upper beach. CCS07 is curently in a maximum seaward position for the 20 years of monitoring, CCS08 shows a current toe of foredune position that is nearly 200m seaward of that measured in 1990. Sediment supply should be strongly positive for this section of coast with three significant catchments bringing suspended sediment material into this system. This accretion patern does fluctuate and during the early to mid 1970's this eastern section underwent a strong erosion cycle where at the CCS08 site several houses were lost to the sea (see Gibb,1977).

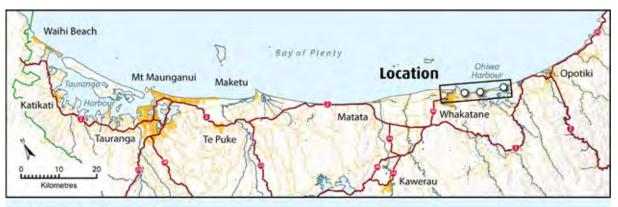
Ohope Beach section

Ohope Beach is located on the non volcanic eastern side of the Volcanic Front, and therefore does not share the same downward movement of the Rangitaiki Plains (Mitchell, 1998). This beach system can be generally divided into three zones – West End, central Ohope Beach and the Ohope barrier spit. There is one representative profiling site in each of these zones. The total length of this system is approximately 12km. West End is the western 2-3km of Ohope Beach and currently consists of a flat wide beach at the western end and decreases in width and increases in gradient towards the eastern section of West End.

West End, Ohope receives sediment under normal conditions from material transported down the Whakatane River and around Kohi Point (although Smith (1987) and Mitchell (1998) noted a reduced grain size and improved sorting towards West End indicating a small but significant sediment transport towards the west). If the supply of this material is limited, or the erosion rate is faster than the rate of accretion, then net erosion of material from West End will occur.

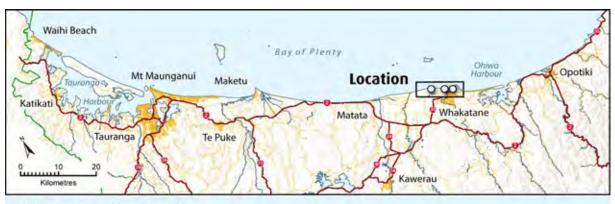
Whakatane Beach section

The Whakatane Beach system is occupied by three monitoring sites and stretches from the Whakatane River to the eastern flank of the cuspate foreland at Golf Links Road. The distance of sandy beach covered by these sites is 6.3km. For the 20 year period of record an assortment of trends are calculated for these sites, a pattern of stability is evident in close proximity to the river entrance, suggesting a neutral to positive sediment supply available to the adjacent beach system. The Tonkin & Taylor (2002) report, highlights beach movement patterns since 1875 for this section of beach at the spit. From 1875 to 1923 + 1.3m/yr, 1923 to 1939 - 3.1m/yr, 1939 to 1952 + 4.0m/yr,

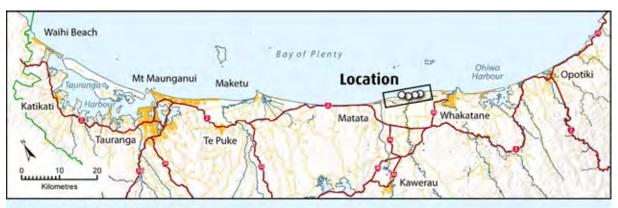
Rangitaiki Beach section

Three sites are reported on for this section of sandy coastline. The longshore distance covered by these sites equates to aproximately 5km, spread either side of the Rangitaiki River entrance. CCS15 is located 2.3 km east of the Rangitaiki River entrance. This section of coast, located in the lee of Moutohora (Whale) Island, shows dynamic fluctuation on beach position as a result of the wave shadow/focusing effect from the island and sediment supply from both Whakatane and Rangitaiki rivers. The Rangitaiki River sediment contribution has diminished since the construction of the mid catchment Matahina Dam, commissioned in the late 1960's.

For the two central Rangitāiki Plains sites (CCS14 and 15) located on the flanks of the cuspate foreland, the pattern is tending towards erosion. This trend is possibly a result of the modified local wave climate caused by this geomorphic feature during this current climatic cycle. Historically this area has shown steady signs of progradation due to the wave shadow effect of Whale Island and the supply of sand from the Rangitaiki and Whakatane Rivers. Positive shoreline change rates of 1.08 to 1.54 m/yr have been determined by Gibb (1994). Current rates from the NERMN record show retreat of the frontal dune by ~0.3 m/yr.

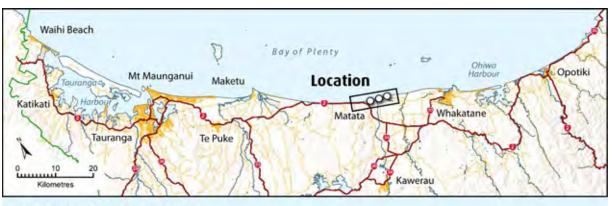
Tarawera Beach section

These three sites are located in proximity to the Tarawera River entrance. CCS18 is 2.8km to the east and CCSS20 is located 1.8km to the west of the entrance. The sand and gravel yield from the Tarawera River entering the coastal environment has been calculated at 82,000 tones/year (Bell, et.al. 2006). Trend analysis suggests all three sites are in a stable equilibrium state. The toe of foredune trends for CS19 and CCS20 are slightly negative although the curent position of this feature for both sites is within the envelope measured over the last 20 years.

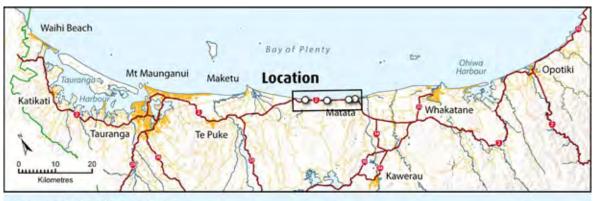
Matata Beach section

Site CCS21 is located 1km to the west of the Matata Domain. This site fronts Clem Elliot Drive and the adjacent sand mining area. Healy (1977) gave the movement of 31m retreat for the period 1868 to 1977 (during this period there was a time of advance (1914-1949) which was attributed to the diversion of the Tarawera River). Site CCS22 is situated 500m of the east Murphys Motor Camp. The beach borders a narrow Holocene coastal plain of sand barriers. CCS23 is located 200m east of the Pikowai Camping Ground and the Pikowai Stream, both of these features have had an effect on this section of beach due to pedestrian trafic and stream migration.

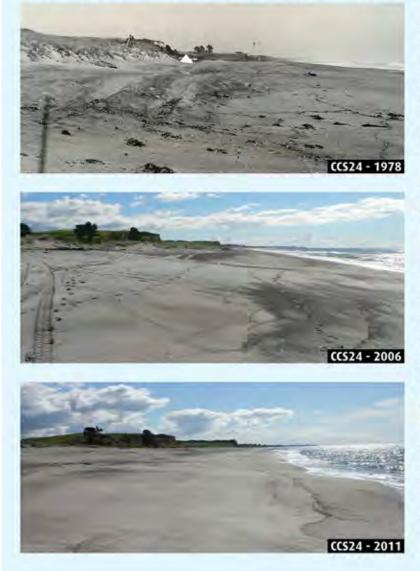
CCS24 is located 1km to the east of where the Waitahanui Stream passes beneath the railway line. Historicaly this was one of the most intensely monitored sites within the Matata beach system with over 50 profiles collected. This interest was derived from the sand extraction operation undertaken by JW Paterson & Sons. Their consent (40289) for this extraction was surrendered in 2001. This extraction occurred within 3 zones between the Waitahanui Stream and the Pikowai Stream (6km of beach) (Smith, 1997). The two eastern monitoring sites continue to maintain a stable pattern, which is in marked contrast to the two western sites which both show strong retreat (-1.0m/yr 1990-2011). Sediment supply would be from littoral drift and fluvial inputs from the many small catchments exiting on this section of coastline. Pedestrian and vehicle pressures are significant as the two western sites are in close proximity to the two main beach access point for this section of beach. Coastcare and WDC work has endeavoured to control these access points recently.

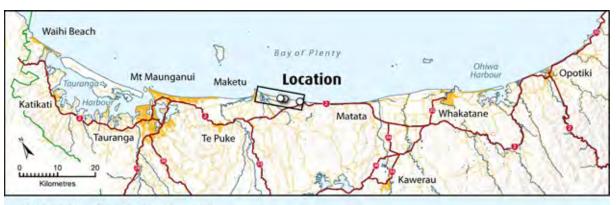
Pukehina Beach Section (1)

Site CC525 is located 150m to the east of Rodgers Road. The site consists of a single steep foredune developed in front of Pleistocene cliffs some 20m in elevation (Phizacklea, 1993). Gibb (1994) states a long-term trend (1927-1994) of shoreline retreat of approximately ranging from 15 to 25m, a rate of retreat of -0.2m/yr has been calculated for 1990-2011. Site CC526 is located 6.5km to the east of the Waihi Estuary. This site is backed by 40m high vegetated Pleistocene cliffs. The site shows long term erosion, with scarping along the base of the frontal dune caused by berm wash over and a predominant narrow high tide beach width.

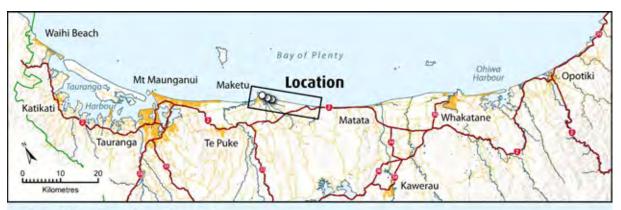
Pukehina Beach section (2)

Site CCS28 is located 2.3km to the east of the Waihi Estuary inlet. Spinifex is present in the foreground of the dune with muelenbeckia covering the upper back slope. Access points have been defined to confine human traffic across the lower dune section. For the period of record in this report the trend for CCS28 is one of suspected stability. CCS29 is located 1.3km from the Waihi Estuary entrance, and 250m east from the end of residential development at Pukehina Beach. At this distal end of the spit the beach flattens in the lower profile and a low tide terrace morphodynamic type is predominant. The 1978 photograph shows the dune in an eroded state

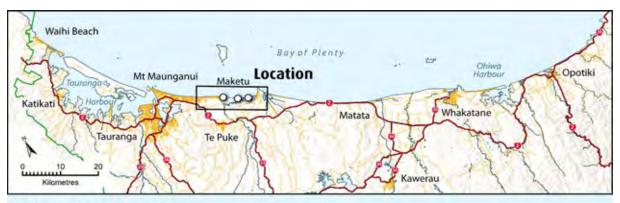
Kaituna Beach section

The CCS32 site is located on the Maketu Spit (2.3km to the west of the Maketu Estuary and 1.1km to the east of the Kaituna Cut). The Spit is a 3.45km-long sand beach bordering a 75 to 150m-wide free form Holocene sand spit that has grown from northwest to southeast to partially enclose Maketu Estuary (Gibb, 1994). Site CCS31, which was located to the east was lost in 1978 when the Maketu Spit was breached. Site CCS33 is located 1.5km to the west of the Kaituna Cut. The site has a heavily scarped frontal dune which is sparsely colonised by spinifex, which has been common since the late 1970's. In the back dune area an exotic forest block has been developed, over

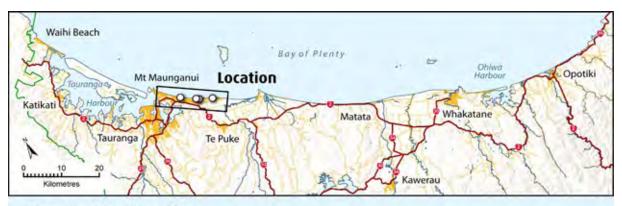
Papamoa Beach section

The CCS34 site is located at the western end of Taylor Street, which is at the eastern end of the Papamoa development. The Papamoa Beach system is an 8.8km-long sand beach bordering Holocene coastal plain of sand dunes. The foredune ranges from 30 to 50m in width and 4.7 to 13.0m above MHWS (Gibb, 1994). Analysis by Healy et al. (1977), Gibb (1994) and Hodges and Dealy (1997) indicate that the beaches are subject to cyclical erosion events with the frontal dune complex periodically exhibiting a strongly faceted foredune that is subject to blowouts. This pattern is seen in the photographs below. The 1978 image shows a poorly vegetated frontal dune

with evidence of human and wind induced erosion. This has been reversed in the 2006 and 2011 images with a well vegetated incipient frontal dune. Site CCS36 is located centrally between Omanu and Papamoa beaches. A high (10m) frontal dune system is present. The site is approximately several hundred metres east of an old sand extraction site. The CCS37 site is located in front of the Papamoa Surf Club at the Papamoa Domain, 100m east of the beach front carpark. It is one of the CoastCare programme sites. This section of beach is popular for recreational activities, portions of the frontal dune have been retired from human traffic and exhibit thriving populations of spinifex and pingao. A mixture of trend patterns are presented for these four sites. With some stability in the foredune position and volume over the last 5-6 years the statisitical test is now returning a stable trend being present. Moderate seaward movement of the foredune has ben recorded at the two central sites. CCS38 continues it's retreating trend of the last 20 years.

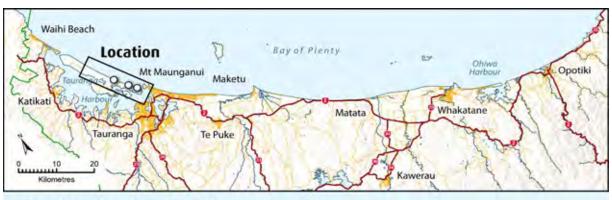
Matakana Beach system (1)

Site CCS41 is located 2km from the Tauranga Harbour tidal inlet at the southern end of the barrier island. The physical characteristics of this site are dominated by the ebb tidal delta and the sediment transfer between this delta and the adjacent open coast beach. The island is dominated by exotic forestry on the open coast side. In some places this forestry occupies land right to the seaward edge of the frontal dune. In many places the foredune has been altered by trees falling onto the upper beach section, other vegetation species found on the dunes are *Ammiphina arenana* and *Spinifex sericeus* (Muller, 2011). Due to access issues and the lack of residential

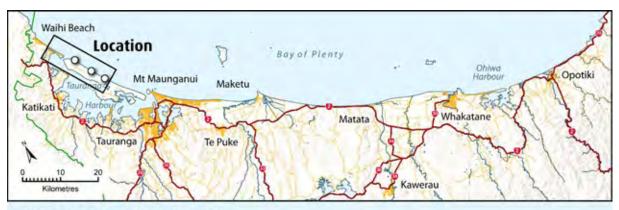
Matakana Beach section (2)

The CCS44 site is located 12km from the Tauranga Harbour tidal inlet in a central position along the barrier island. The profile history shows a tighter grouping of profiles with less variability at this site when compared with sites to the east on the barrier island. The 2011 profile is located around the average of the recorded dataset. Statistical p-tests and also regression analysis shows that this section of beach is in a stable state. The CCS45 site is located 7km from the Tauranga Harbour northern entrance at Bowentown. The profile history shows a tighter grouping of profiles with less variability at this site when compared with sites to the east on the barrier island.

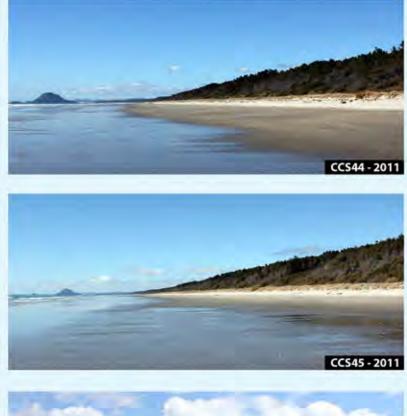
The 2011 profile is located around the average of the recorded dataset. The earlier recorded offshore profiles (se Iremonger, 2007) also reflect this pattern of low variability. All three ofshore profiles converge at -7m. Only slight offshore bar development is shown to occur at this site and is a reflection of the stable nature of the onshore profile sections. Statistical p-tests and also regression analysis shows that this section of beach is in a stable state. Site CCS46 is located 3km from the Tauranga Harbour northern entrance at Bowentown. The site is affected by the tidal inlet and the dynamic nature of the associated ebb tidal delta and the eastern orientated lateral channels that develop. The geology of the headland provides a natural barrier and restriction to any movement of the entrance to the northwest. This restriction means often tidal flows are directed towards the monitoring site. The profile history at this site shows a landward retreat of ~70m for the 20 years of measurements.

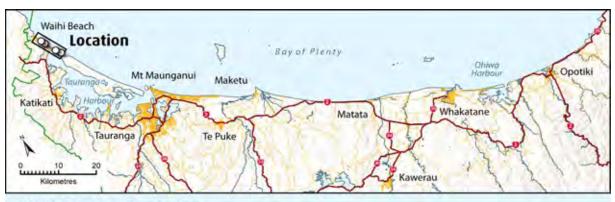
Waihi East Beach section

Site CCS47 is located 500m northwest from the Bowentown entrance to the northern Tauranga Harbour. The site is strongly affected by the tidal inlet and associated localised circulation patterns caused by tidal flows through this inlet. Interaction of sediment between the ebb tidal delta and this section of beach is strongly linked. The frontal dune at this site has been modified dramatically by human activity. The site is located at a popular access point; historically this has not been well managed. Today a timber wall has been erected to try and halt foredune retreat. This work has also been supplemented with retiring sections of the dune and undertaking re-vegetation with native species. Eco Nomos Ltd (2003) stated 9m of duneline progradation between September 1978 and April 1994. The profile history shows a wide band of movement in beach position evidenced by the maximum and minimum envelope location. The 2011 profile is positioned around the long term average.

Site CC548 is located 2km to the northwest of the Bowentown entrance. Gibb (1994) states the section of beach from Ocean Beach to Island View is 4km long sand beach bordering a 250 to 750m wide tombolo of Pleistocene and Holocene dune complexes derived primarily from offshore sources. An erosion trend continues to be recorded at this site.

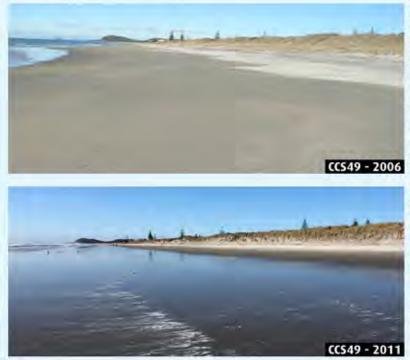
Site CCS49 is located approximately half way along the Waihi Beach system, 6km northwest of the Bowentown Entrance. Eco Nomos (2003) stated that in the area of Waihi Beach to the south of Island View, available data is limited and subject to significant uncertainties but suggests that (i) duneline fluctuations considerably exceed the scale of changes likely to be associated with storm cut and recovery, and (ii) the larger fluctuations evident in this area probably reflect the additional influence of deep, arcuate duneline embayments (see Stephens, 1996) and (at the southern end of the beach) the adjacent Bowentown ebb tide delta. The 2006 photograph shows a beach with a well vegetated foredune and the development of an incipient dune in the foreground, no berm or low beach feature is present. The 2011 photograph shows the loss of these lower beach features and also a scarp present on the frontal dune face.

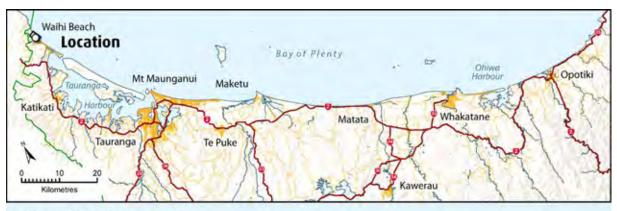
Waihi West Beach section

Site CCS51 is located at the southern boundary of the popular Waihi Beach. A 5m high frontal dune is present at this site which is vegetated by a mixture of exotic and native species. An incipient dune has also formed and is presently colonised by a dense cover of spinifex. Toe of foredune and beach volume data both show trends of accretion for this site. Site CCS52 is located at Waihi Beach at The Esplanade. The site was installed in 1998 as part of a monitoring programme focussing on an area were significant CoastCare work was to be undertaken. The profile origin for this site is located in an area that has been fenced to deter human traffic and planted with a range of native species. Like CCS51 this site is also showing trends of acretion in both the foredune position and the volume of sediment in the upper beach system. Site CCS53 is the western most of the beach profile monitoring sites. (CCS54 is located to the east of this site). The site is located at the western end of The Esplanade on the eastern side of the small stream. Like CCS52 the site origin is located in a CoastCare fenced area planted with native vegetation. Positive trends in both measured parameters are calculated for this site. Site CCS54 is located at the centre of The Esplanade on the eastern side of the small stream. The site is located in a CoastCare fenced area planted with native vegetation. Profile history shows the "earthworks" undertaken to develop a dune at the start of the CoastCare programme. Like the other two sites in this area the beach exhibits a low angle with a wide high tide beach present. No berm feature is present for the majority of the time although the maximum envelope plot does show evidence of sand in a berm formation at times.
