Proposed Nukumaru Station Road Extension Archaeological Assessment

Project title: Nukumarū Station Road Extension

Proposed Works: Extension and realignment of Nukumarū Station Road

Ivan Bruce, Archaeological Resource Management, March 2017

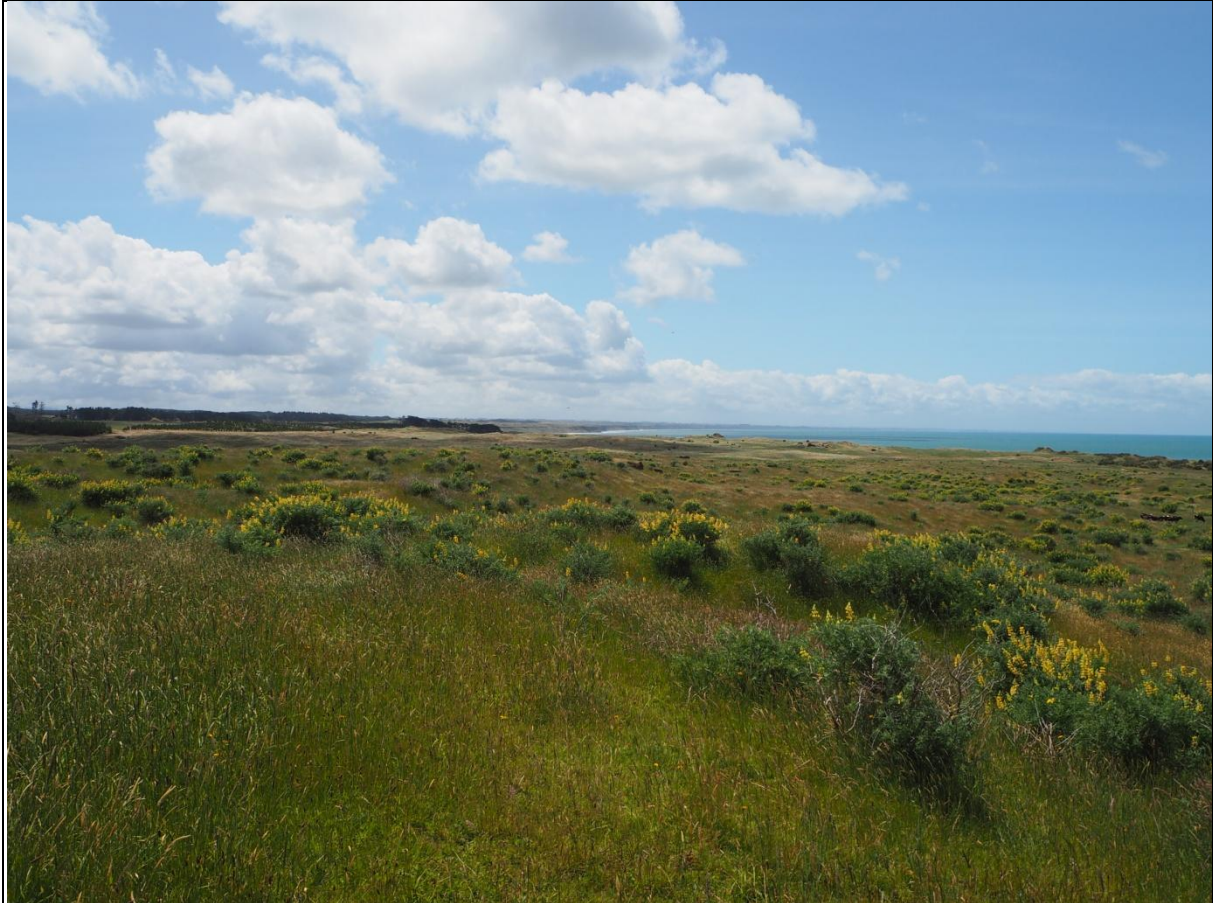
Figure 2: Stabilised dunes, under pasture and grazed by dry stock, near the Waiinu Beach Road intersection

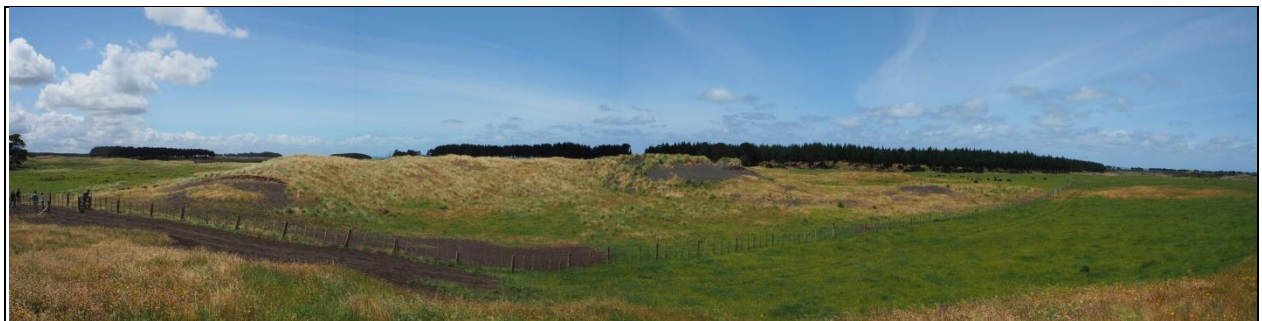
Figure 4: Sand dunes becoming stabilised under grass in the southern half of the project area.

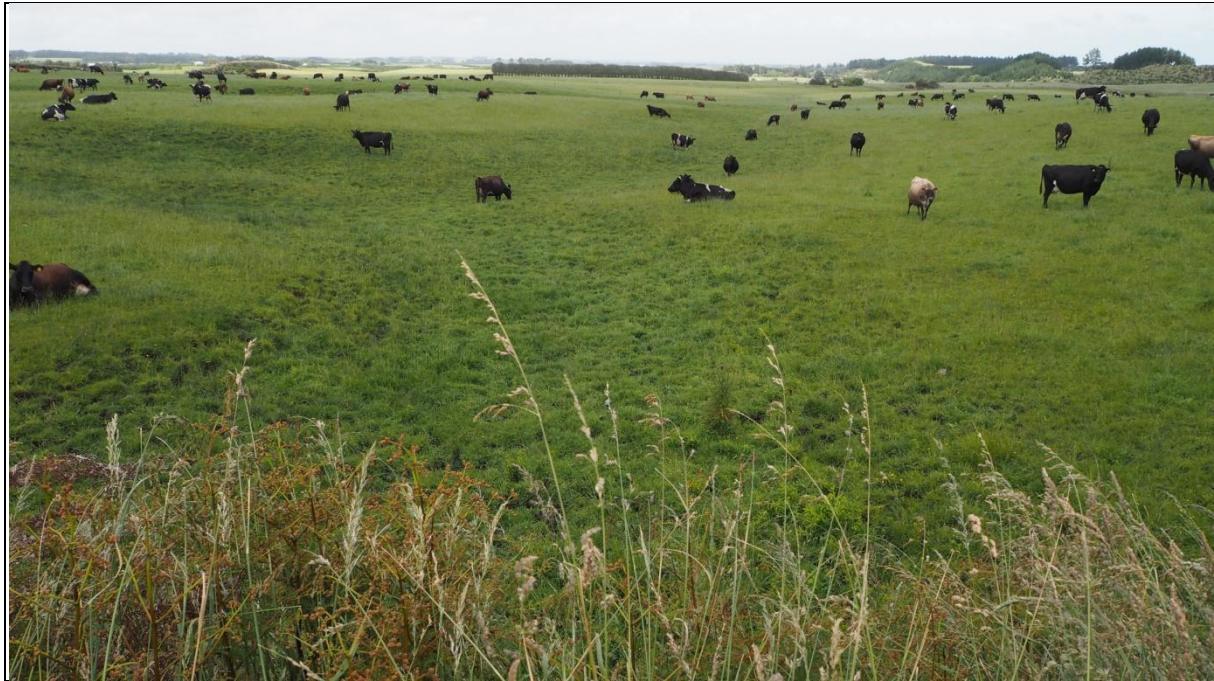
Figure 5: Dairy herd grazing on Taranaki Ash soils and now drained wetland area beside Nukumaruru Station Road.

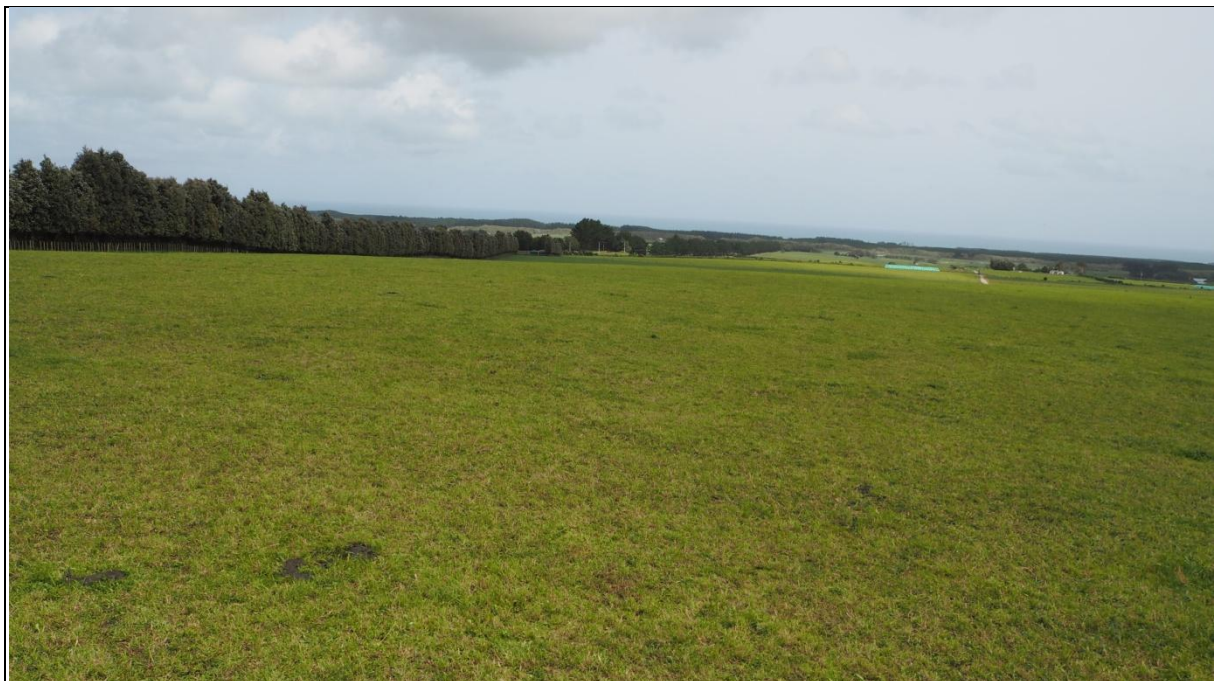
R22/323. Pit and borrow complex. This site represents a widespread distribution of storage pits and possibly sand borrows covering the paddocks on the eastern side of Nukumaru Station Road, between the dog leg bend and SH3. The site was recorded by local archaeologist Colin Smart in 1962, based on an aerial photo survey and field survey. Smart noted that the site consisted of scattered pits in pairs, lines and groups, as well as single, over an area of 700 by 1000 yards. A review of the 1942 aerial photograph confirms Smarts interpretation. The pits have long since been ploughed over and surface evidence was not found in the 2006 NZAA site recording upgrade, however the likelihood of subsurface archaeological evidence was noted.

Figure 12: Current condition of paddocks containing site R22/323, ploughed and levelled.

Site	Value	Assessment
R22/323 Pit and borrow complex	Surface Condition	Poor - largely levelled by ploughing
	Rarity/ Uniqueness	Common - Archaeological evidence of pit and borrow complexes are recorded throughout South Taranaki. A number of examples are indicated in the immediate vicinity (Table 1). The greater part of this site will remain unaffected by the road construction
	Contextual Value	Low. The pit and borrow features are examples of widespread Maori horticultural practise in the Nukumaru area.
	Information Potential	Moderate. It can be expected that earthworks will encounter a number of sub surface food storage pits and associated evidence of Maori occupation, including bases of dateable cooking fires and hearths where these features were originally cut deeper than the plough zone. More finely grained data relating to intra site settlement pattern, such as patterns of post holes from house and palisade structures, or substantially intact garden soils are likely to have been destroyed by ploughing.

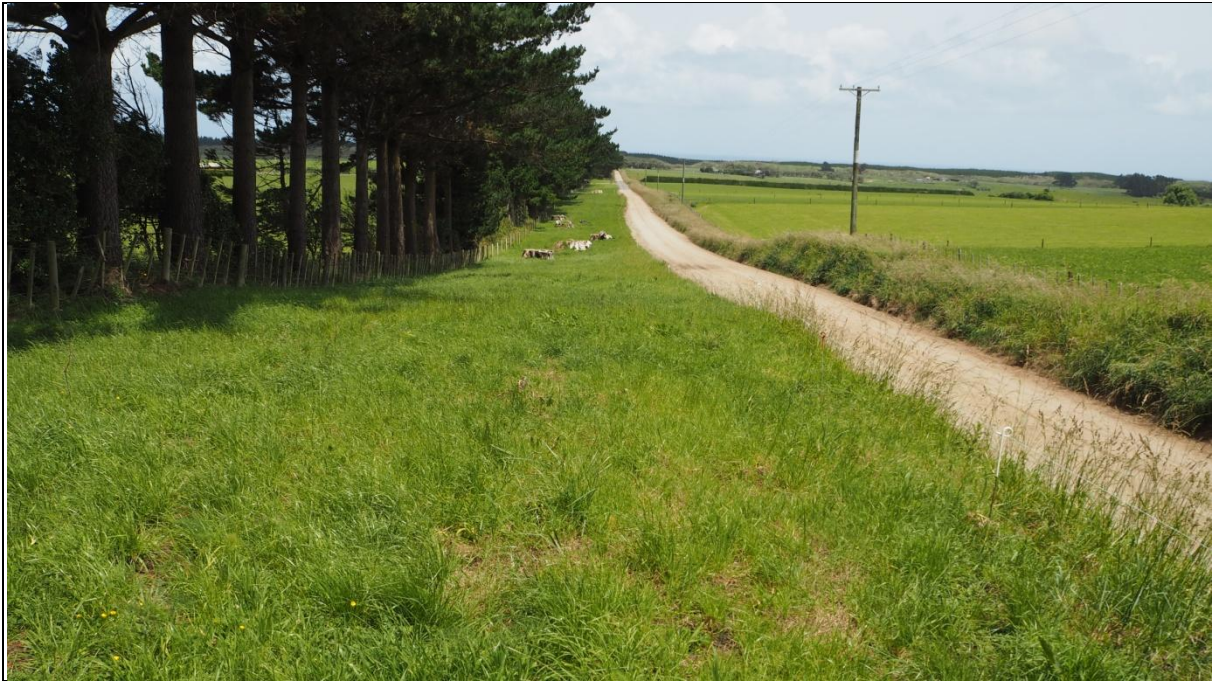
R22/494. Ditch and Bank fence. A remnant section of colonial era ditch and bank fence. Situated on the eastern side of Nukumaru Station Road. Recorded in 2008.

Figure 13: Location of ditch and bank fence recorded as R22/494, ditch now back filled and bank levelled

Site	Value	Assessment
R22/494 Ditch and bank fence.	Surface Condition	Nil - recently back filled and levelled.
	Rarity/ Uniqueness	Common - Ditch and banks were commonly used throughout the Taranaki Region by colonial farmers to fence stock. While very few of these remain in original or even recognisable condition, the Nukumarū District will contain numerous subsurface examples, such as this one
	Contextual Value	Low. The ditch and bank is an examples of widespread colonial farm practise.
	Information Potential	Low. The archaeological evidence is likely to consist of two parallel shovel dug trenches. There is potential for the trench fills to contain mid to late 19th C artefacts such as bottle glass, iron and ceramic.
	Amenity Value	Low. No surface evidence
	Cultural Associations	Low. The plan of the events at Handley's woolshed (Figure 10) make it clear that this fence is not associated nor necessarily extant to those actions, as suggested by the site record. As such this site represents a relatively common place colonial farm feature and the cultural associations relating to this are limited.

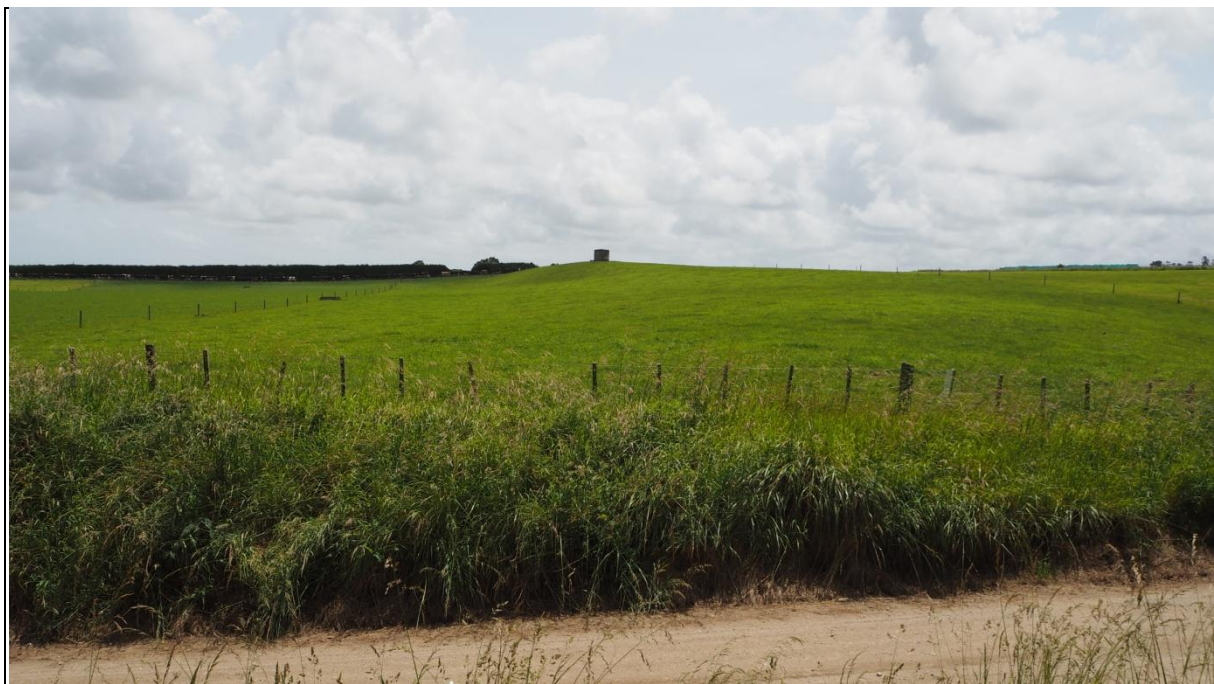
R22/318. Six shallow, wide depressions on top of small hill - possibly pits or bulldozer damage/modification during silage pit construction. Three additional depressions (and grass growth discrepancies) to the north, adjacent to road. originally recorded by Smart, later confirmed by NZAA site recording upgrade 2008, although in my view the NZAA location appears to be incorrect; as the site description given by Smart compares better to the site location indicated in the 1942 aerial image in Figure 17.

Figure 14: Site R22/318, location marked by the water tank. See 1942 aerial for confirmation.

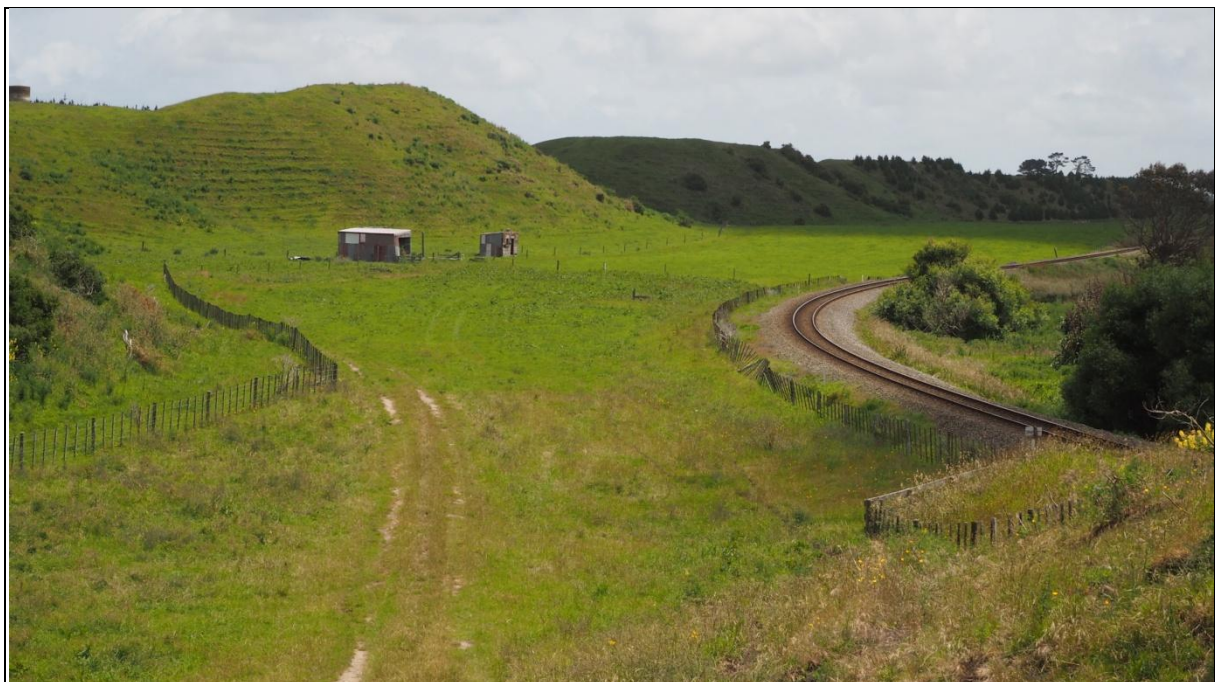
Figure 15: Site of the military camp is situated on the flat land beyond the bend of the railway track, to the right of the farm buildings. The project route does not extend towards this site beyond the position the photograph was taken.

R22/536. Site of a large military camp constructed in 1865. There is a mass grave for Maori killed in battle of 25 January 1865 somewhere in the area. Located nearby and to the east of Lake Paetaia, railway line passes through site. Camp area measures approximately 100m N-S x 400m E-W. Identified by campaign map, no surface evidence.

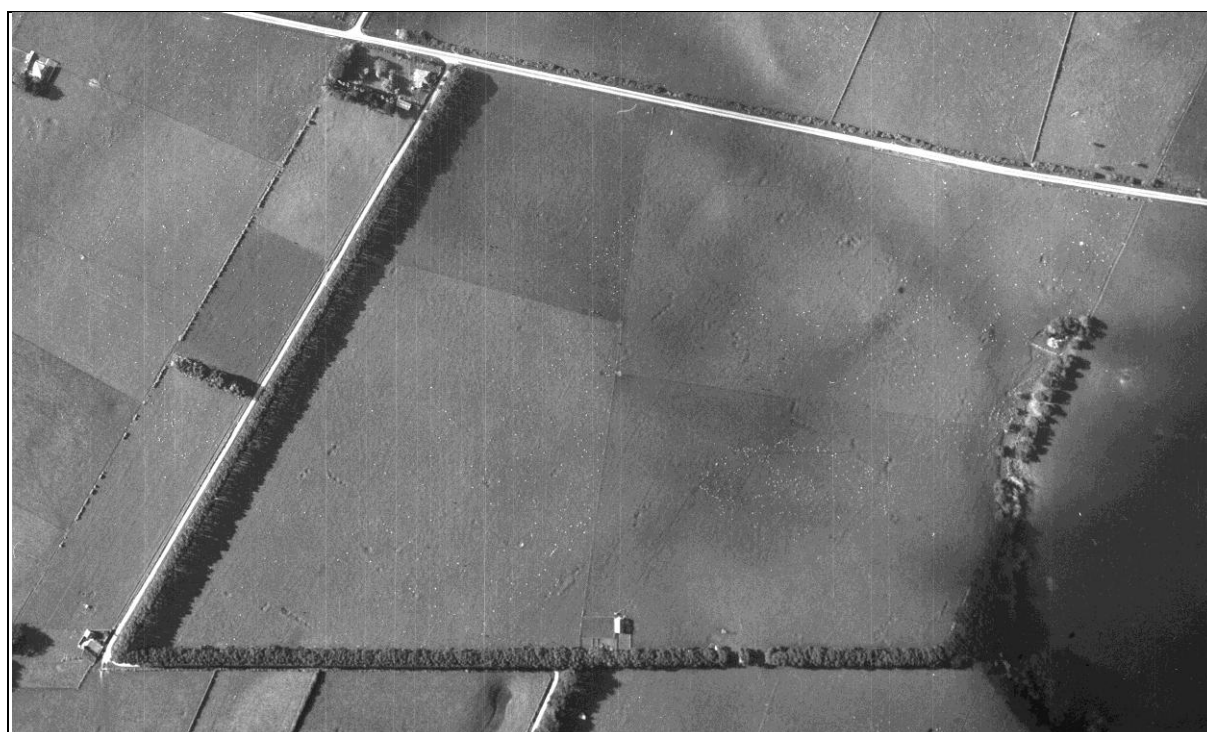
Figure 16: 1942 Aerial image of site R22/323, comprising the area between SH3 and the dog leg in Nukumaru Station Road. A close examination of the image shows the area is pock marked by numerous pits and or borrows. The project alignment follows the north south fence line in the centre of shot.

11.2 My impression from reviewing the aerial photography is that the site recording paradigm adopted by the NZAA site record will in some cases give a misleading view of the real archaeological record, with the extent and complexity of the sites in the immediate vicinity of the project being under emphasised. For example site R22/323 is recorded as single site, when in reality the record refers to a prehistoric Maori gardening landscape, comprising widespread groups of pits and borrows covering an area of nearly 50 hectares.

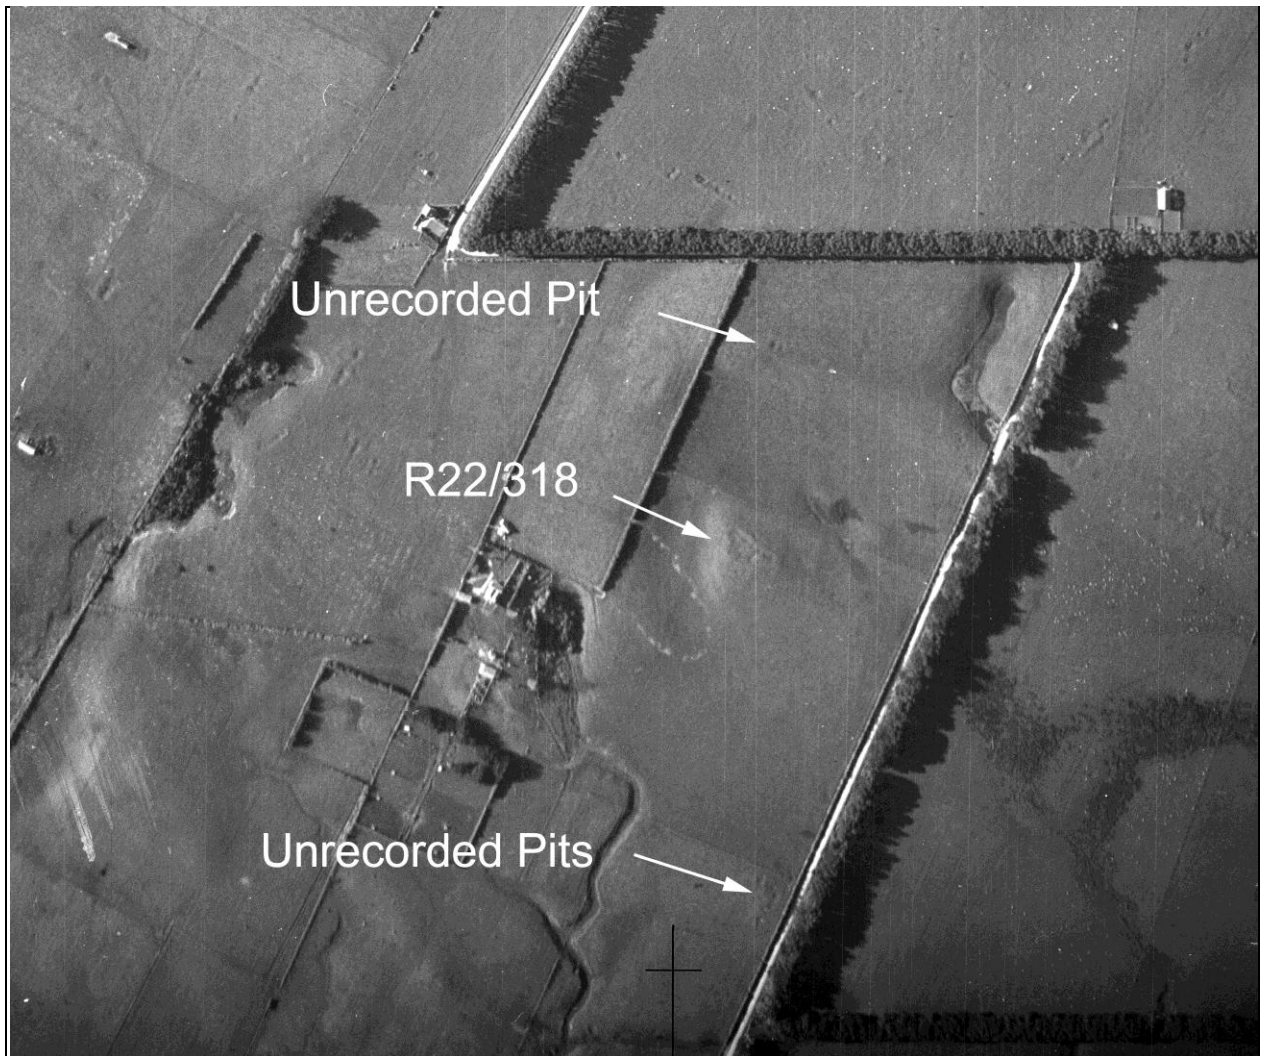
Figure 17: 1942 aerial image showing the location of site R22/318, on the western side of Nukumaru Station Road. Two other currently unrecorded pit sites are indicated.

11.3 Furthermore a closer inspection of the 1942 aerials in particular show unrecorded clusters of pit features were formerly visible below the dogleg on the western side of Nukumar Station Road (Figure 17). It seems likely that the Smart (1962) survey, during which these Maori pit features were originally recorded, focussed primarily on the more obvious complexes and in particular those that still retained a surface trace in 1962. Lesser or peripheral features were not recorded on the NZAA site recording scheme.

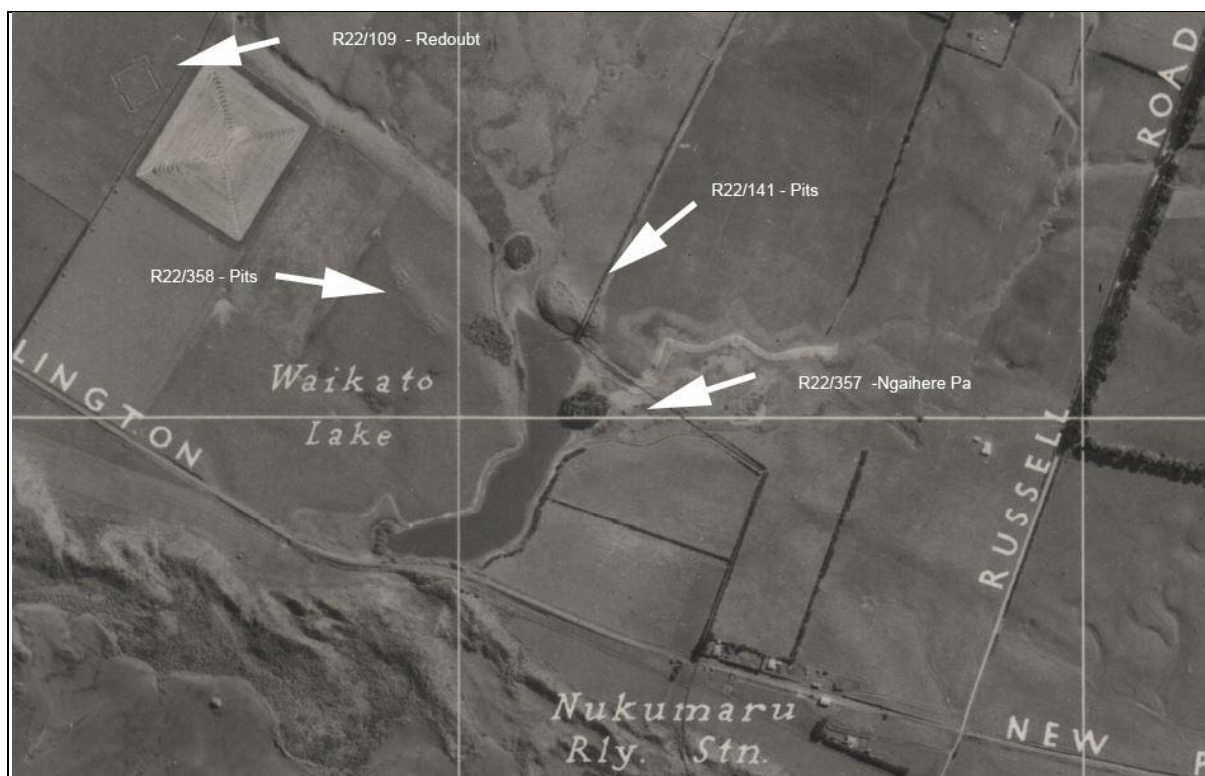
Figure 18. Archaeological sites surrounding lake Waikato identified in the 1956 aerial image. Nukumar station and outbuilding are also identified.

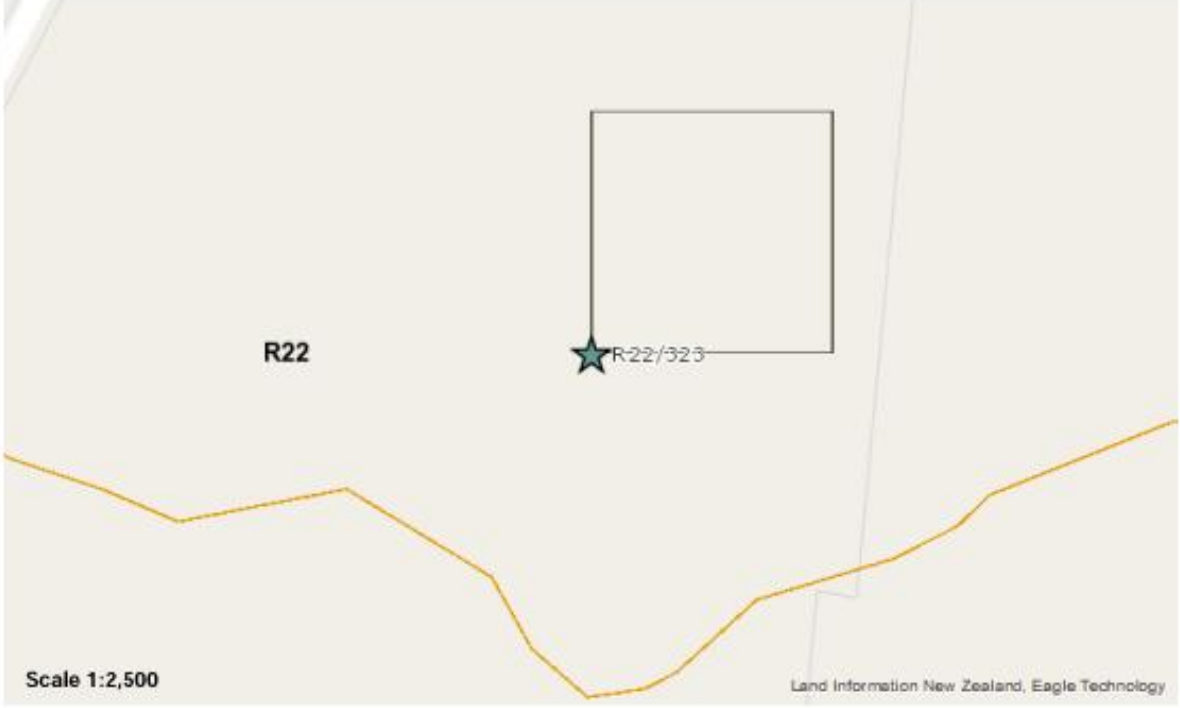
<p>Site Record Form</p>	<p>NZAA SITE NUMBER: R22/323</p> <p>SITE TYPE: Pit/Terrace</p> <p>SITE NAME(s):</p> <p>DATE RECORDED:</p>
<p>SITE COORDINATES (NZTM) Easting: 1753960 Northing: 5590889 Source: CINZAS</p>	
<p>IMPERIAL SITE NUMBER: N137/170 METRIC SITE NUMBER: R22/323</p>

<p>Scale 1:2,500</p> <p>Land Information New Zealand, Eagle Technology</p>	
<p>Finding aids to the location of the site The current grid reference puts the site in the paddocks c.300m east of Russell Road, Nukumarū, c.400m south of SH3.</p>	
<p>Brief description Originally recorded as scattered surface pits in pairs, lines and groups, as well as singles.</p>	
<p>Recorded features Pit</p>	
<p>Other sites associated with this site</p>

SITE RECORD HISTORY	NZAA SITE NUMBER: R22/323
<p>Site description</p> <p>Condition of the site The pits were not found. They were in poor condition in 1962 and the paddocks in this area had been well worked up since then. There may have been subsurface evidence.</p> <p>Statement of condition</p> <p>Current land use:</p> <p>Threats:</p>

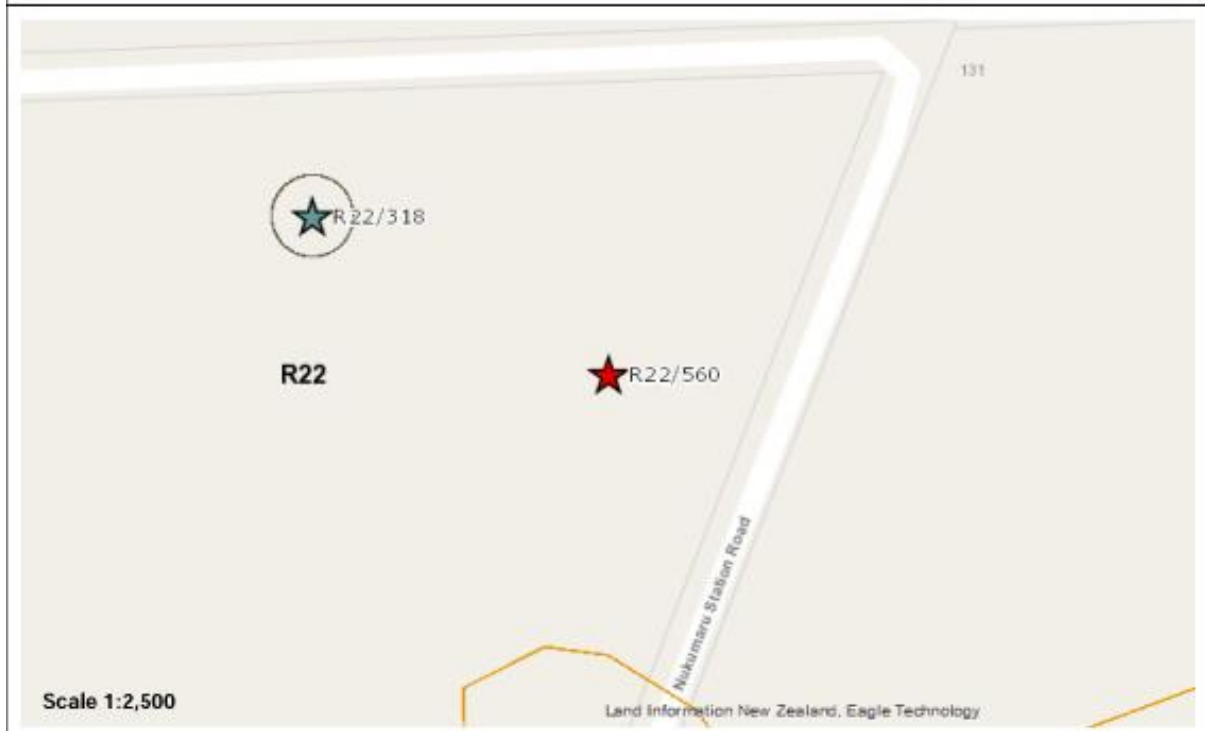
<p>Site Record Form</p>	<p>NZAA SITE NUMBER: R22/560</p>
	<p>SITE TYPE: Artefact find</p> <p>SITE NAME(s): N/A</p> <p>DATE RECORDED:</p>

Finding aids to the location of the site
 The wetland containing the artifacts is situated on the western side of Nukumaru Station Road, below and south of the dogleg bend in the road.

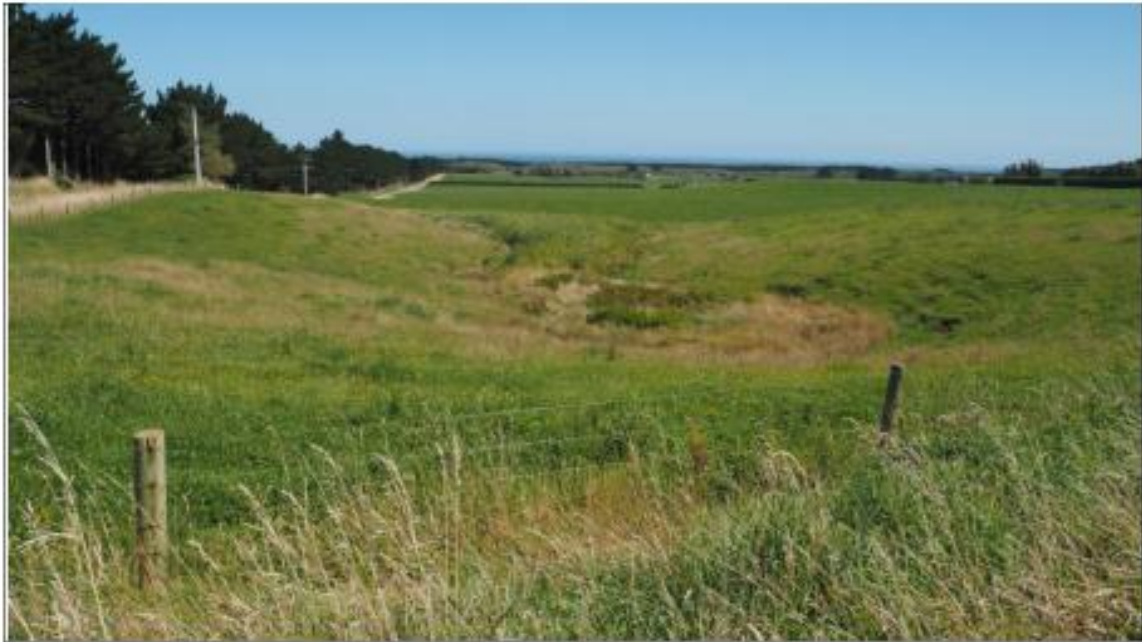
Wetland area photographed north of the dogleg bend in Nukumarū Station Road, photo taken looking south. Area pointed out as find spot by Di Handley 2017.

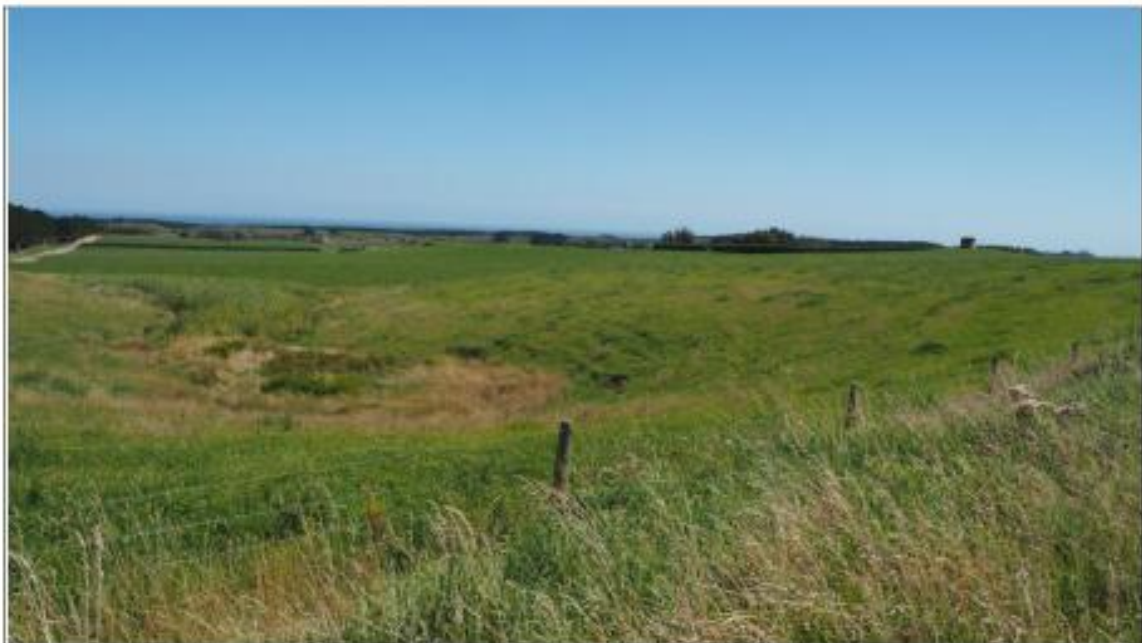
Wetland area to the left of shot and water tank of hill to the right marks location of a number of rua pits visible in aerial images 1956.
